Effects of ductile phase volume fraction on the mechanical properties of Ti-Al<sub>3</sub>Ti metal-intermetallic laminate (MIL) composites

A Thesis submitted in partial satisfaction of the requirements for the degree Master of Science

Engineering Sciences (Mechanical Engineering)

Richard David Price

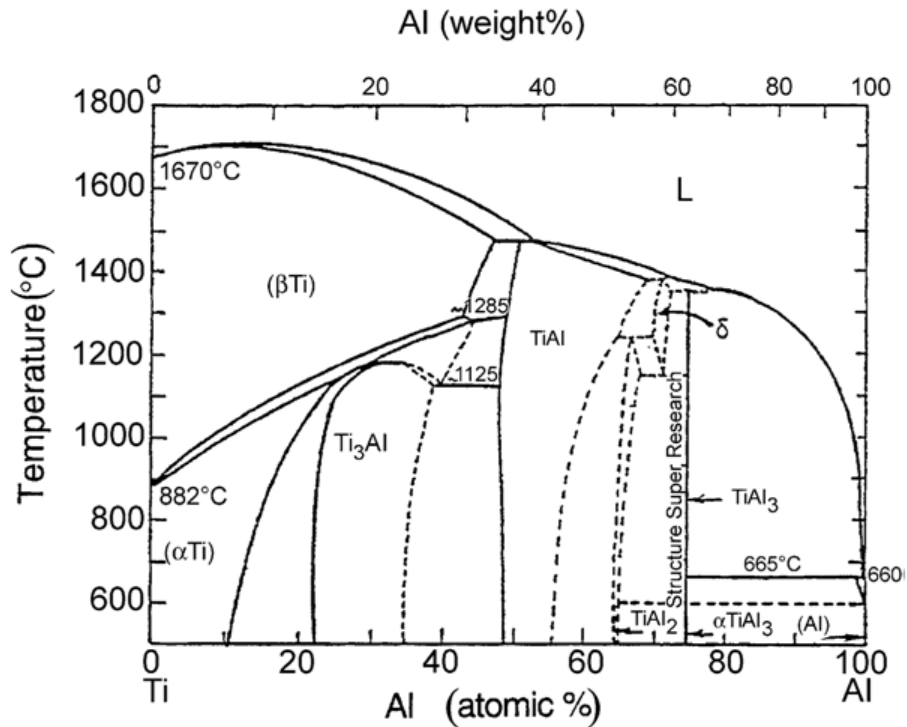
Figure 2.3 - The Ti-Al phase diagram showing the location of Al<sub>3</sub>Ti [21].

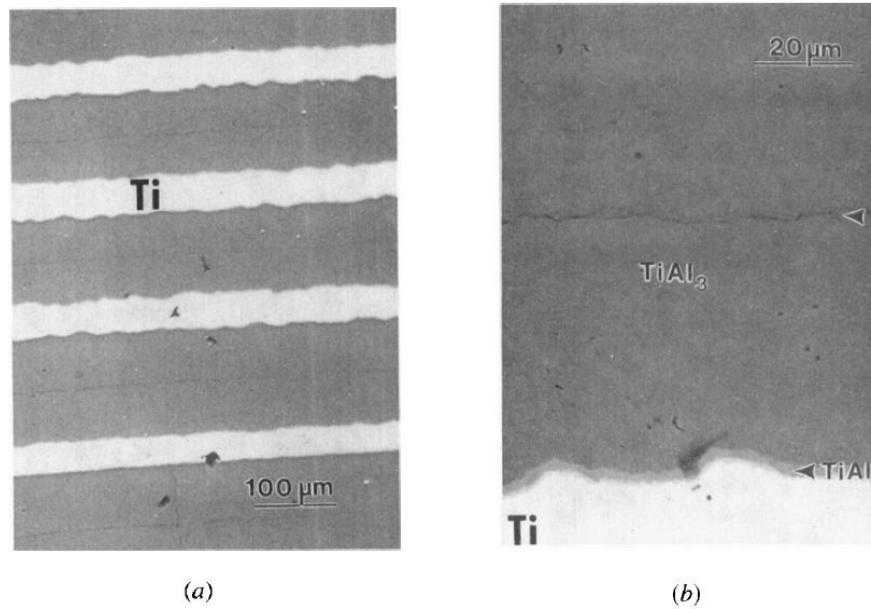
Figure 2.4 – Microstructure of the Ti-Al layered composite produced in vacuum from 0.15 mm thick Ti and Al foils at (a) low magnification and (b) high magnification [24].

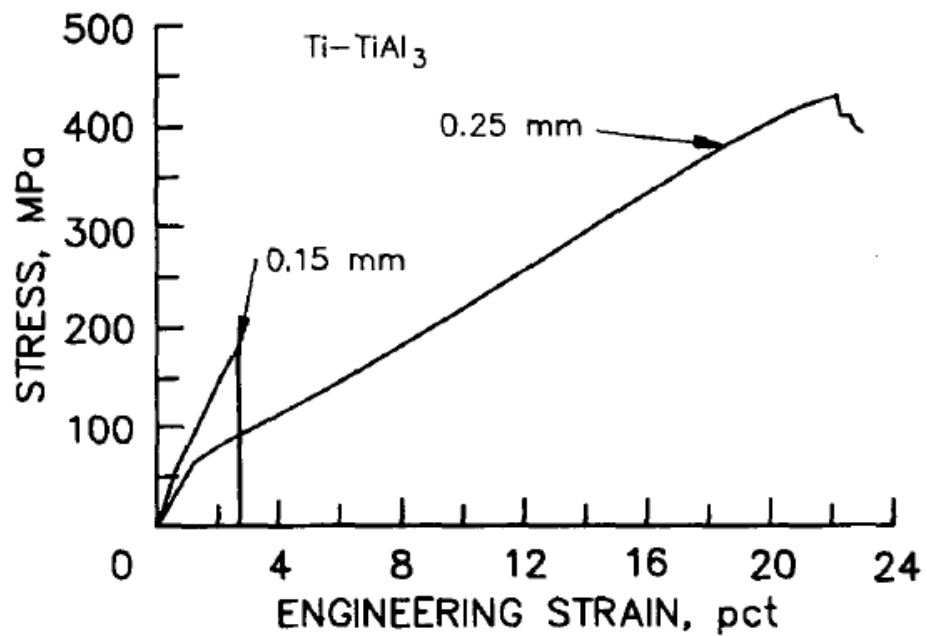
Figure 2.5 – Effect of initial foil thickness on the tensile behavior of a Ti-Al<sub>3</sub>Ti MIL composite fabricated in vacuum via SHS [24].

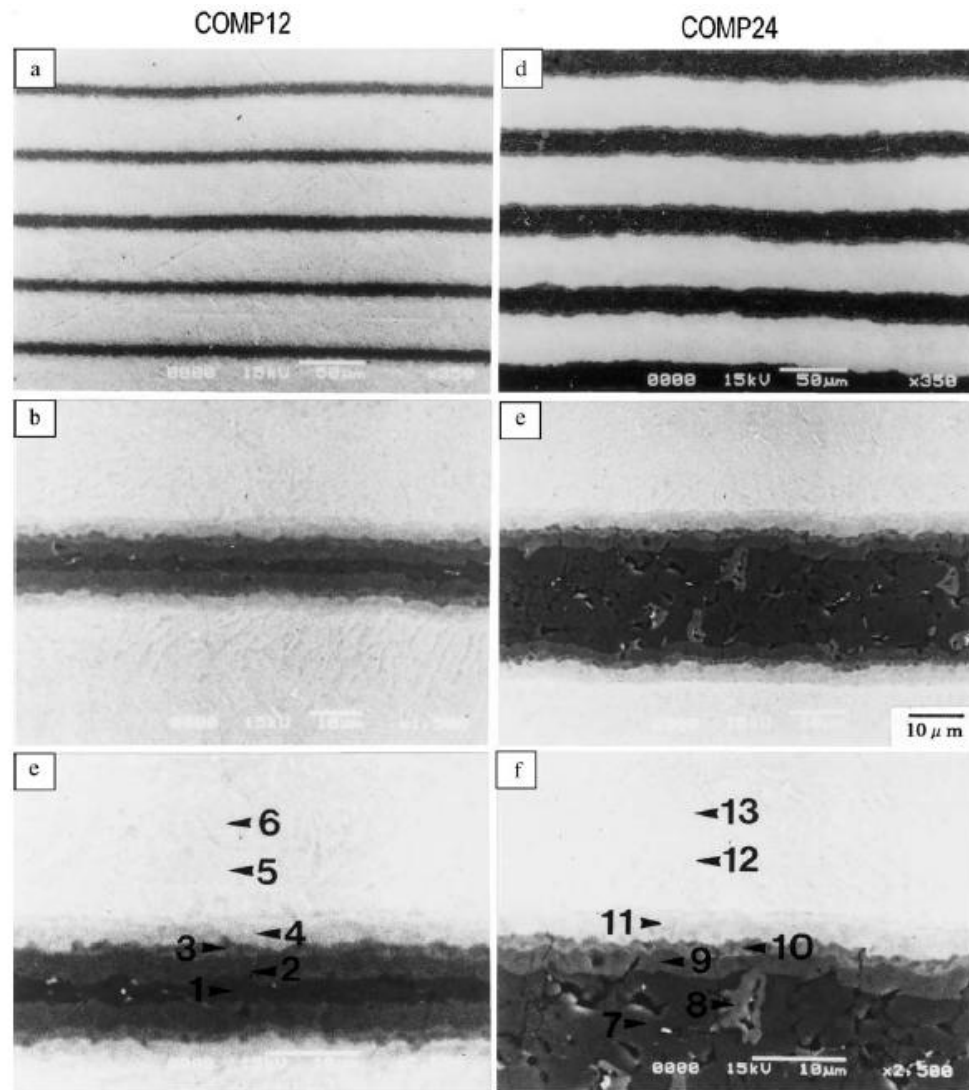
Figure 2.7 - Layered structure of two composites formed from a pulsed-current hot pressing method. The presence of several other aluminide layers can be seen in the magnified images [28].

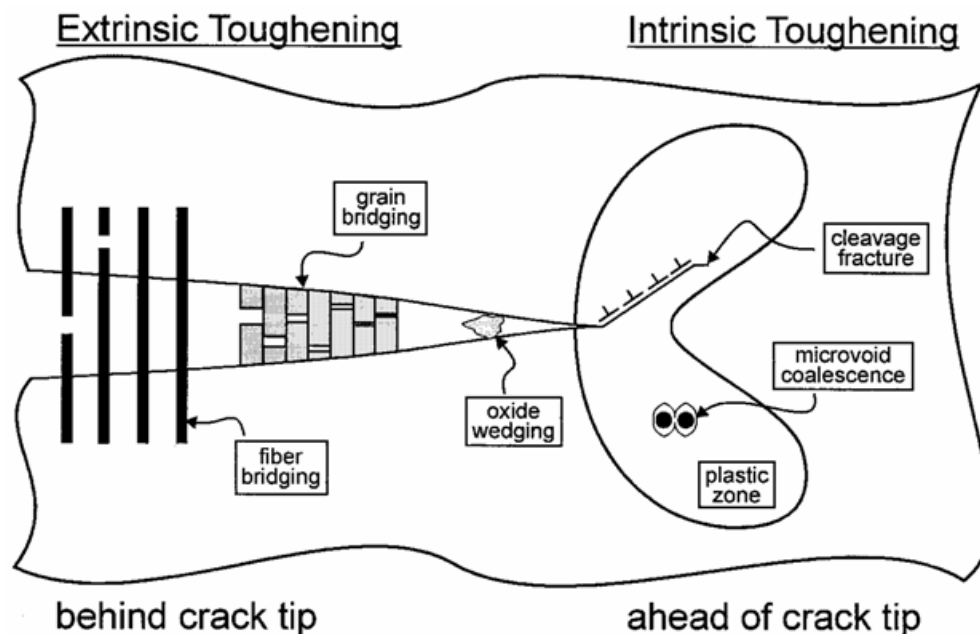
**Figure 2.10 - Diagram of mutual competition between intrinsic mechanisms of damage/crack advance and extrinsic mechanisms of crack-tip shielding involved in crack growth [38].**

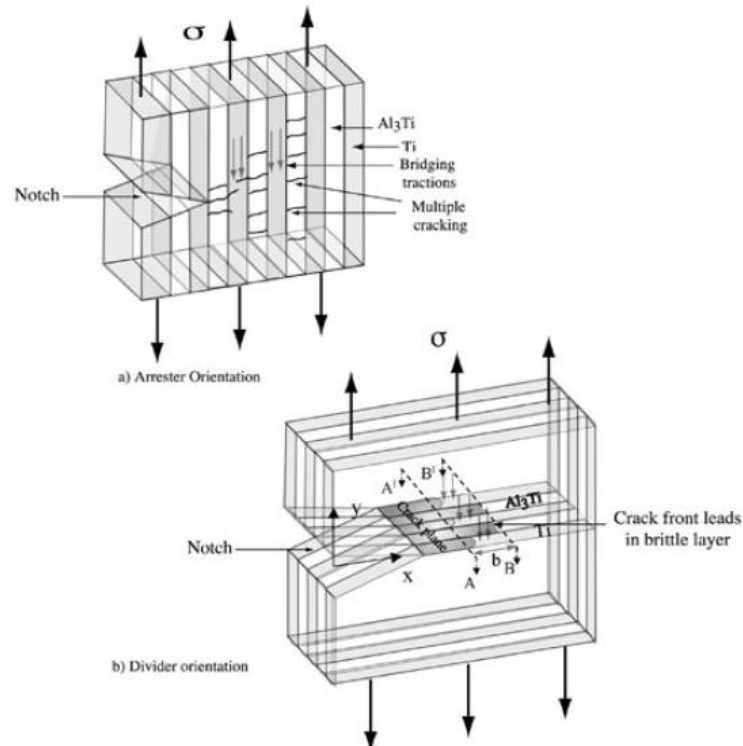
**Figure 2.12 - Schematic diagram illustrating crack bridging: (a) crack-arrestor orientation and (b) crack-divider orientation. Planes AA and BB indicate cross sections of the laminate composite near the crack tip. The arrows between the planes indicate bridging tractions over the length of  $b$  [39].**

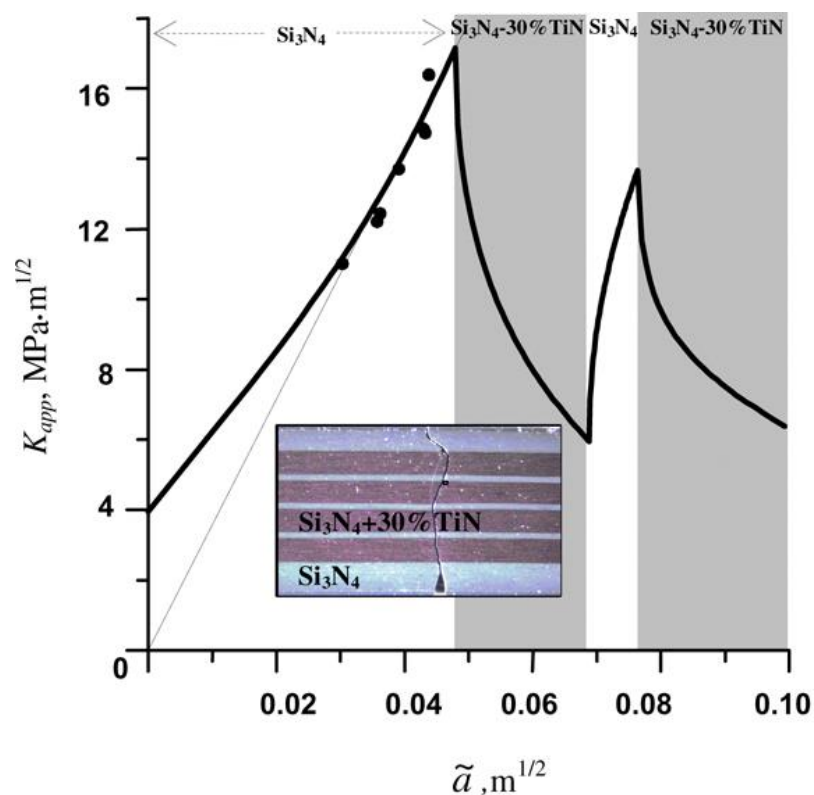
Figure 2.13 - The apparent fracture toughness as a function of the crack length parameter  $\tilde{a}$  in a laminate with an outer layer under residual compressive stress [40].

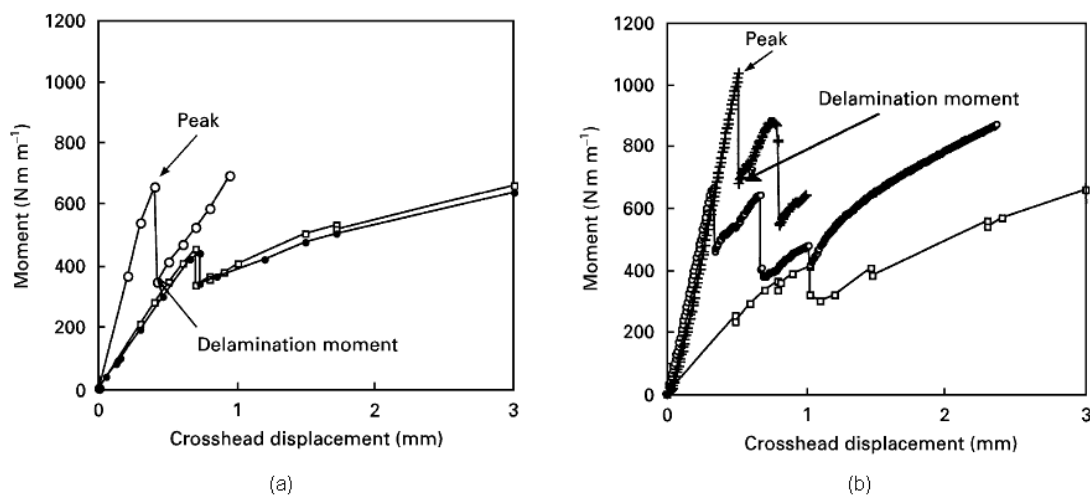
**Figure 2.15 – Moment-Displacement curves showing delamination (a) after and (b) before crack extension [48].**

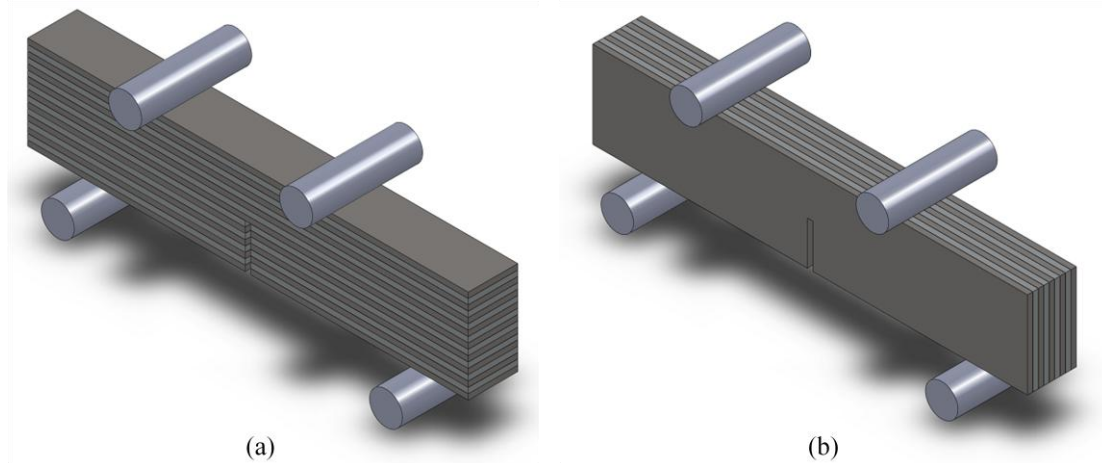
**Figure 3.4 –Schematic diagrams of SE(B) in (a) crack-arrester and (b) crack-divider orientations**

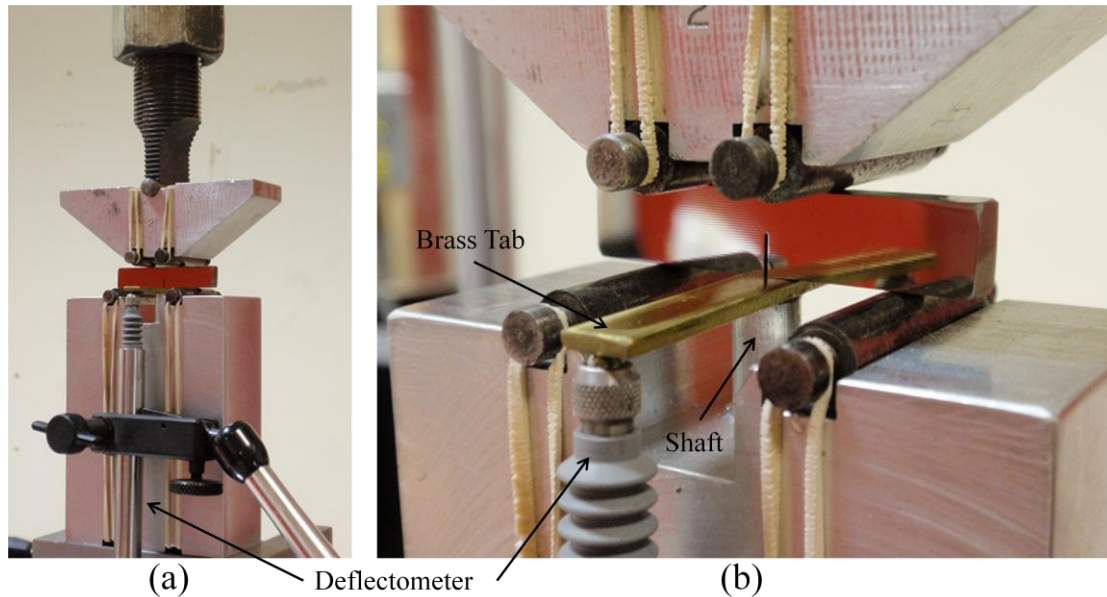
**Figure 3.5 – Novel apparatus designed to test small samples in quasi-static 4PB: (a) overall setup in the load frame; (b) close-up of the bending area. As the crack opens, the sample pushes down on the shaft and tab, which is recorded by the deflectometer.**

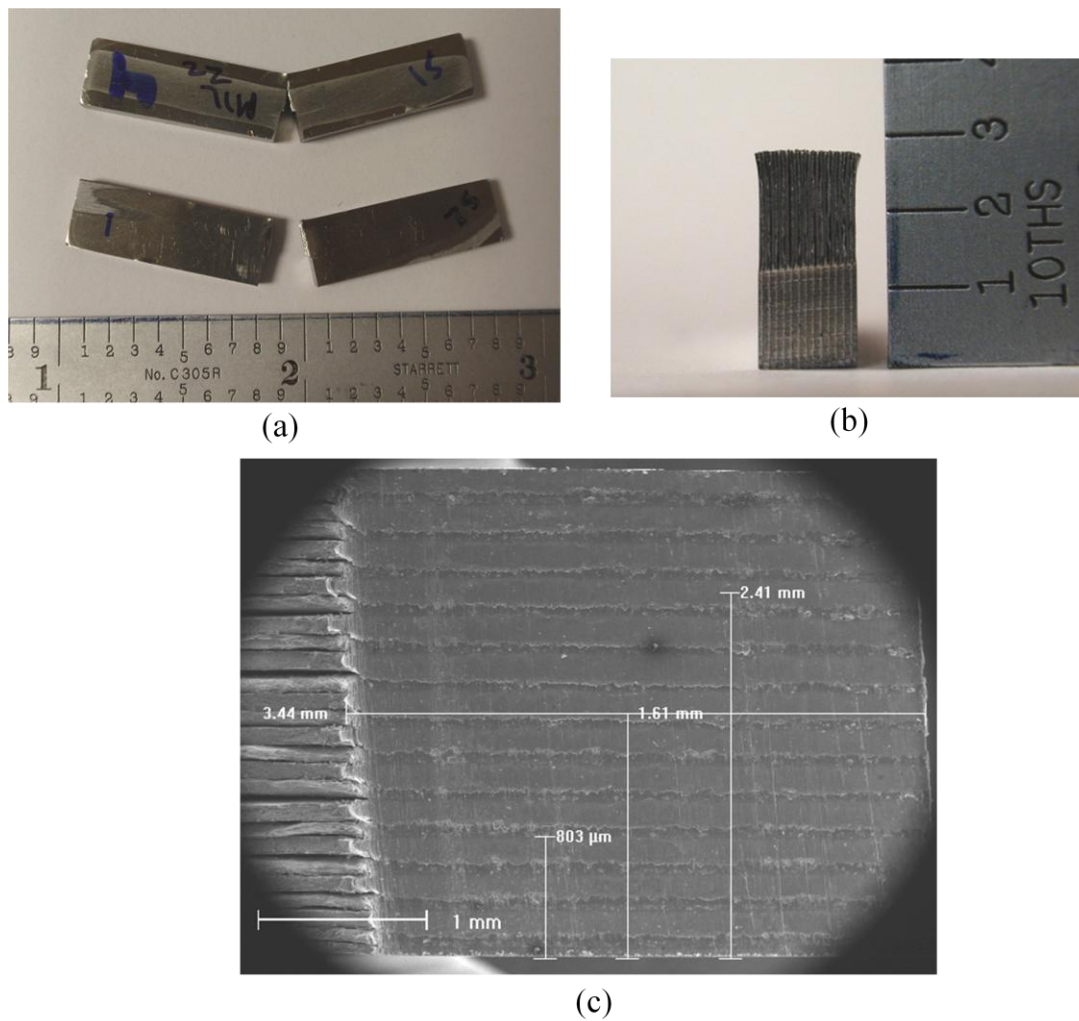
**Figure 3.6 – Photographs of (a) broken and unbroken crack-divider samples and (b) the end-on view of the fracture surface. (c) SEM image of the notch depth measurement of a crack-divider sample.**

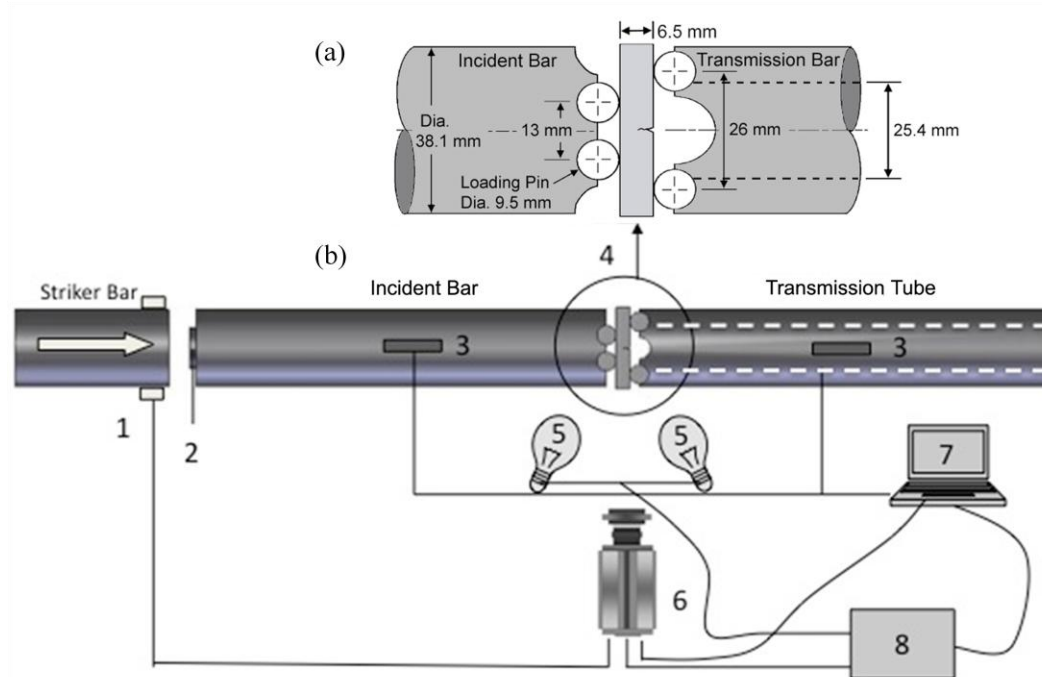
**Figure 3.8 – (a) Schematic of the sample mounting setup. (b) SHPB setup for dynamic fracture toughness experiments: (1) photo gate trigger, (2) pulse shaper, (3) strain gage, (4) SE(B) specimen, (5) lighting for (6) high speed camera, (7) data acquisition, (8) power supply [59].**

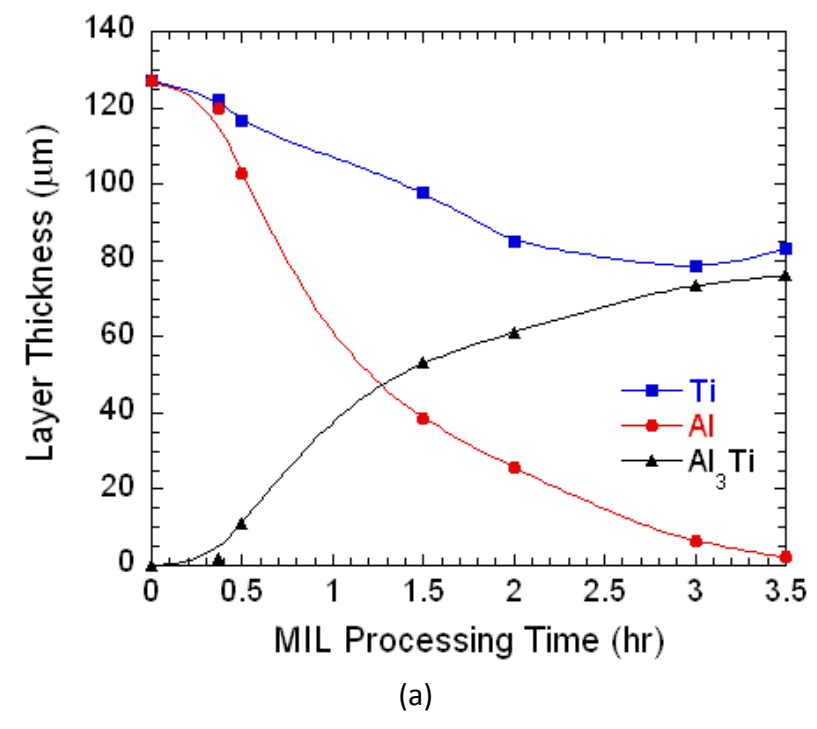
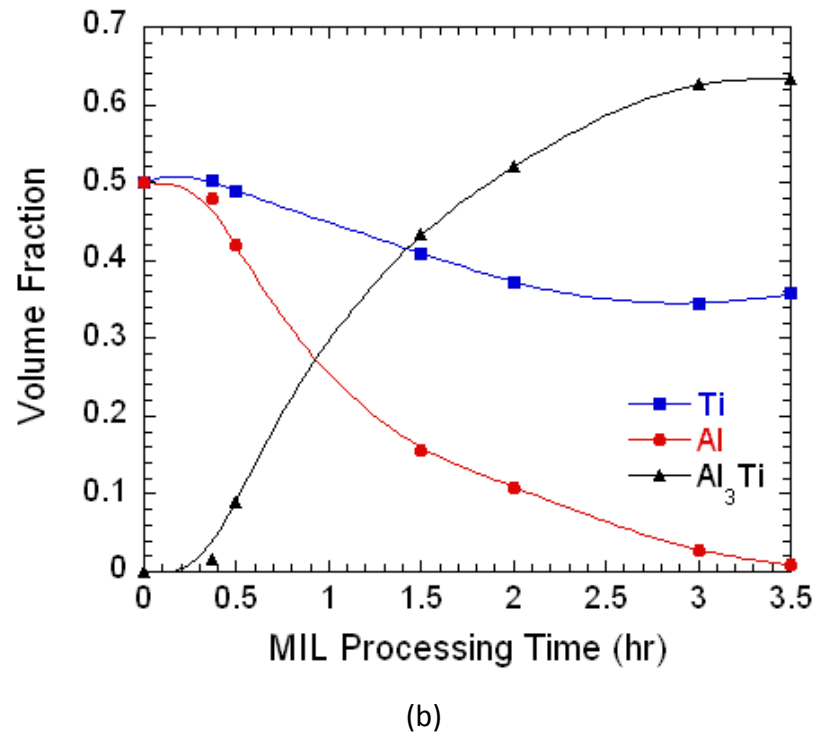
Figure 4.1 – The effect of processing time on (a) layer thickness and (b) volume fraction.

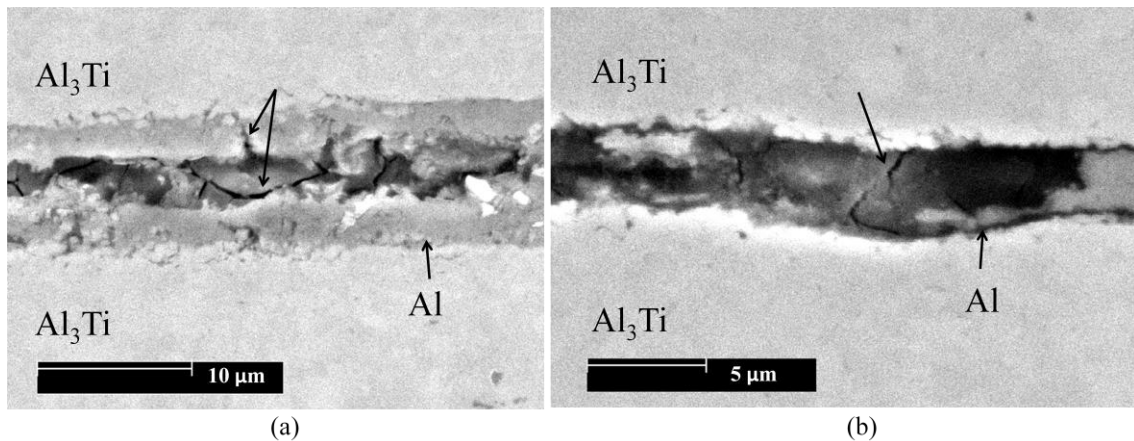
**Figure 4.6 – SEM micrographs of crack propagation and creep caused by residual thermal stresses in (a) MIL-3 and (b) MIL-1.**

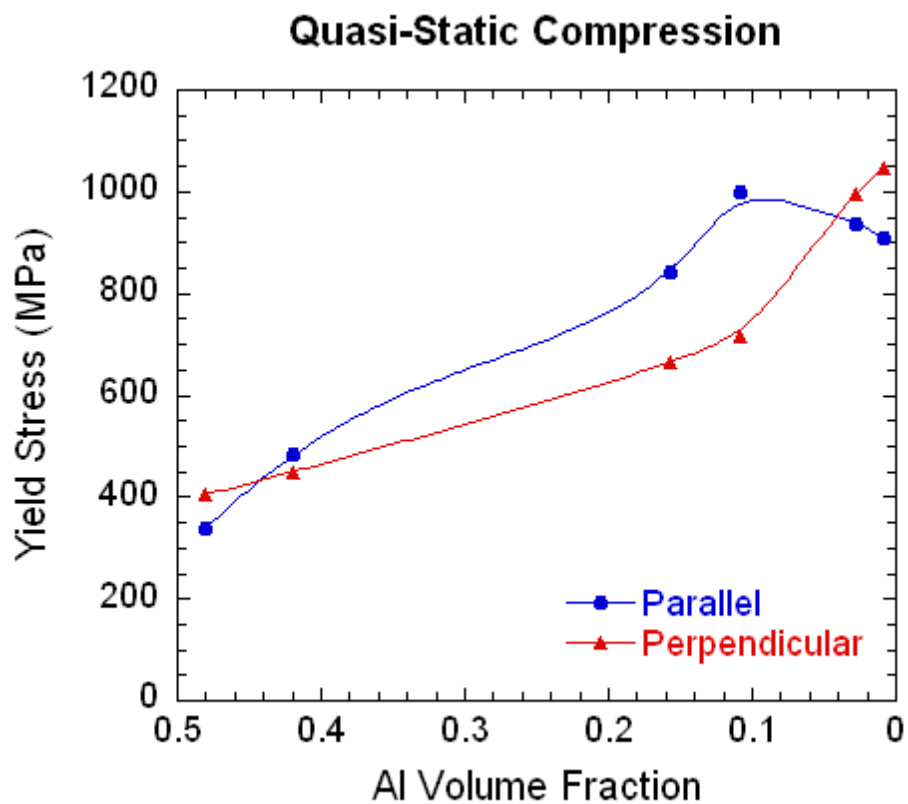
Figure 4.7 – Affect of residual aluminum volume fraction on compressive stress in parallel and perpendicular loading orientations.

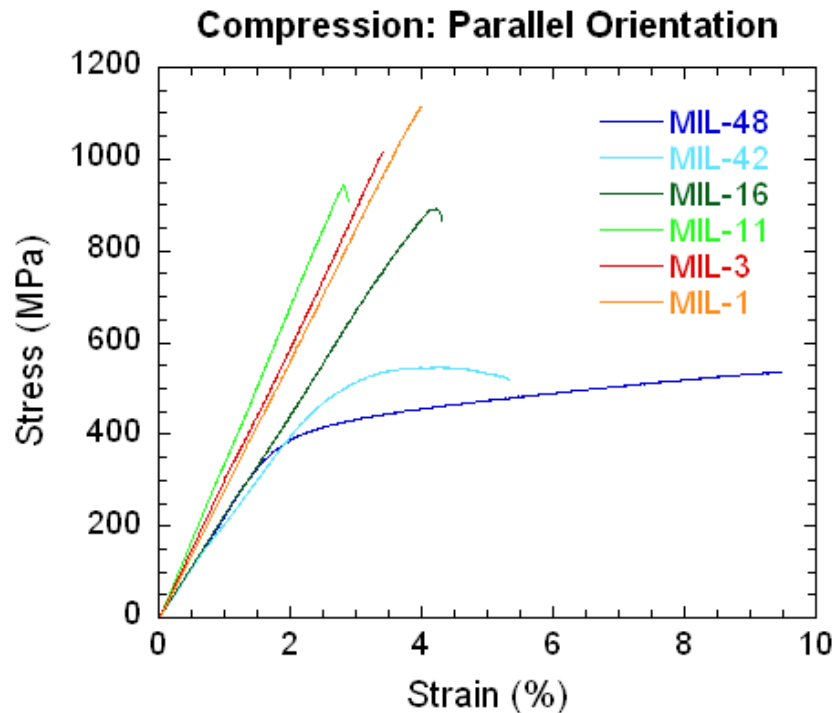
**Figure 4.8 – Representative stress-strain curves of each specimen tested under quasi-static compression at 0.001/s with layers oriented parallel to the applied load.**

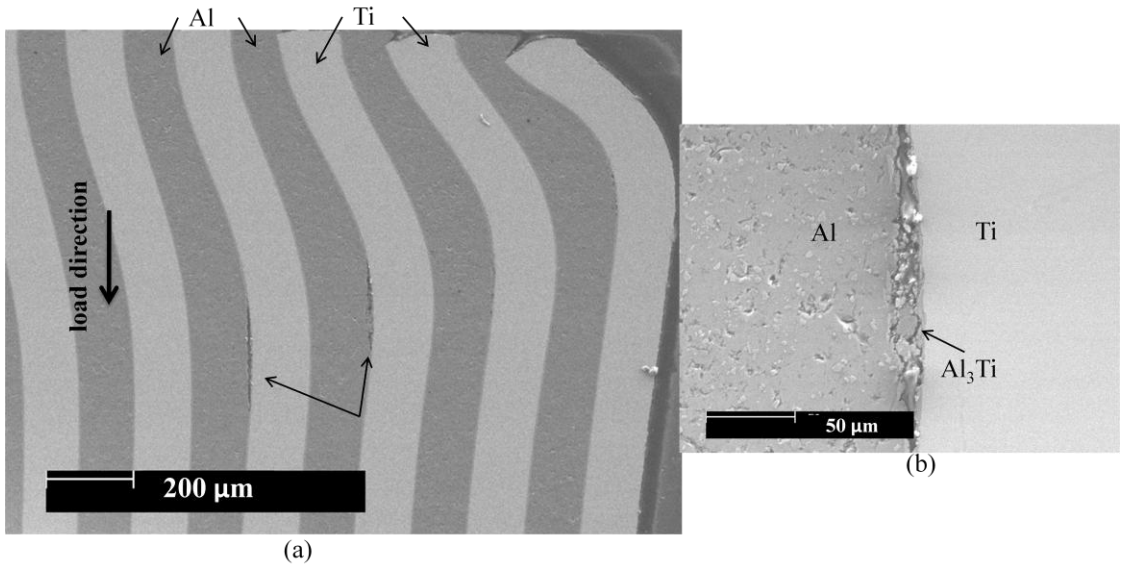
Figure 4.9 – SEM micrograph of MIL-48 sample (cold-mounted and polished after quasi-static compression) showing (a) buckling and (b) minor delamination cracking near the load face.

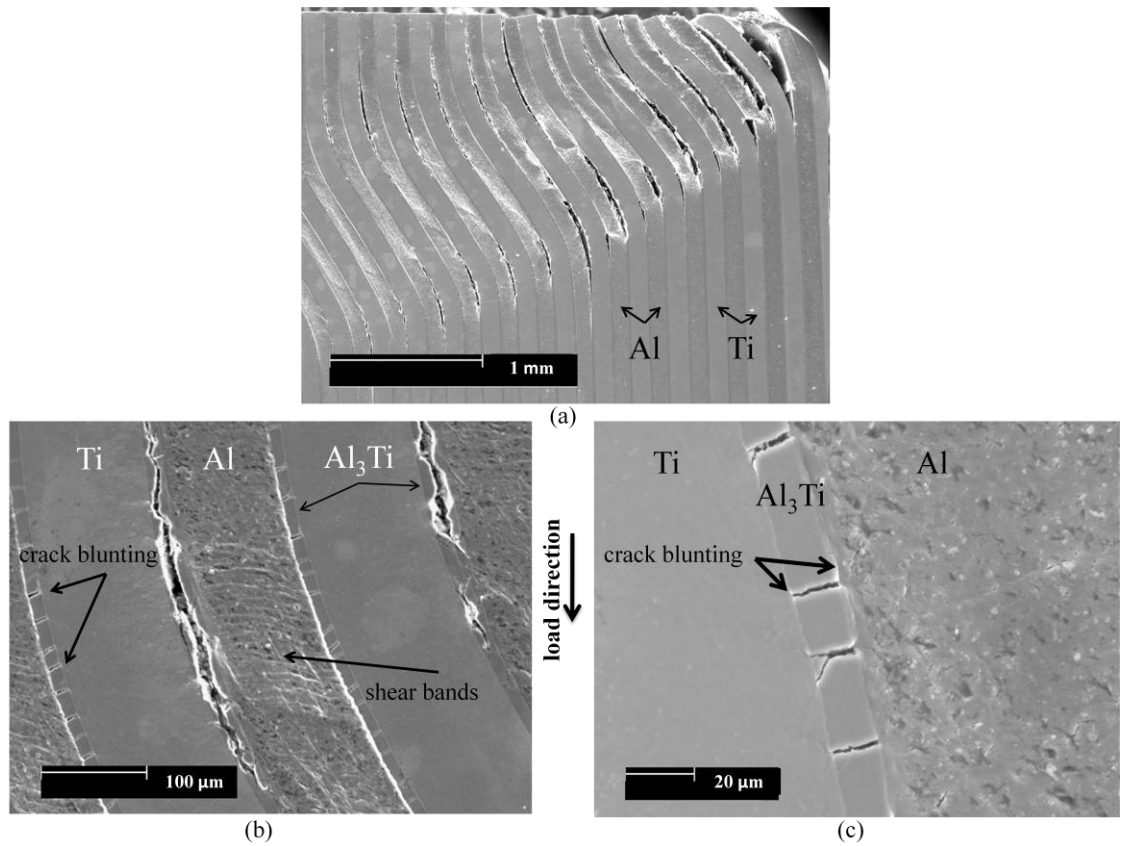
Figure 4.10 – SEM micrograph of MIL-42 sample under quasi-static compression (0.001/s) in parallel loading showing Al<sub>3</sub>Ti centerline cracking, shear band formation, and transverse cracking at regions of (a) large and (b) small deformation.

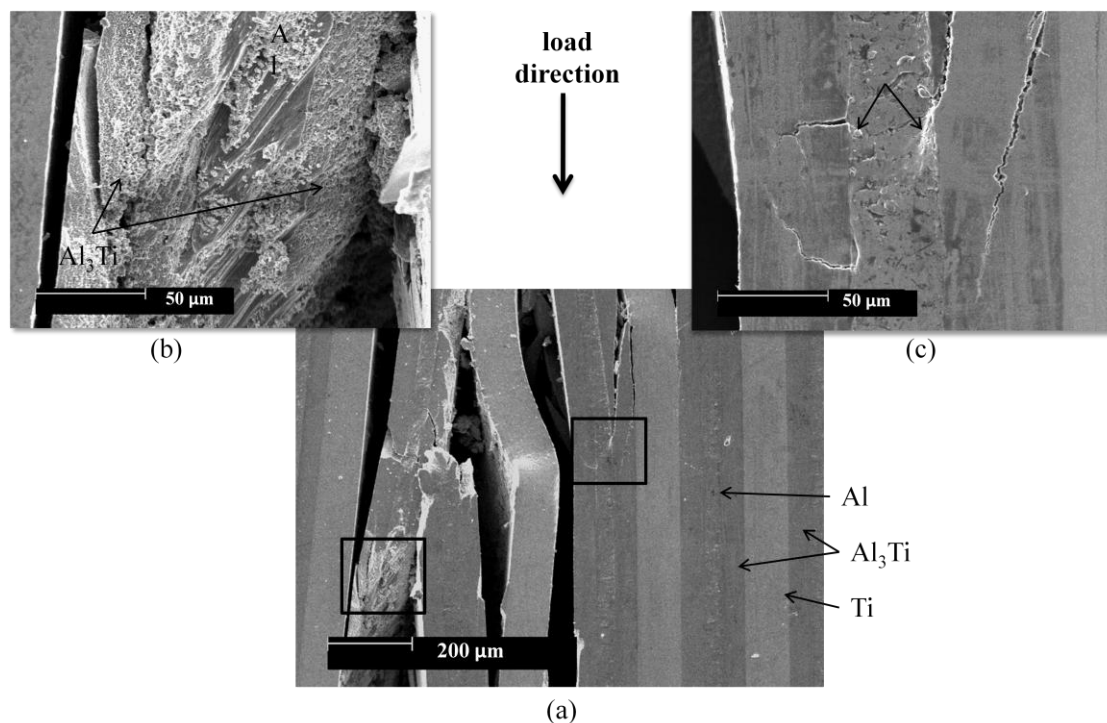
**Figure 4.11 – Fracture of MIL-16 under quasi-static compression (0.001/s) with layers oriented parallel the applied load: (a) cracked Al-Al<sub>3</sub>Ti layers and intact Ti layers, (b) magnification of fracture surface, (c) crack bridging by Al layer and shear band formation (arrows).**

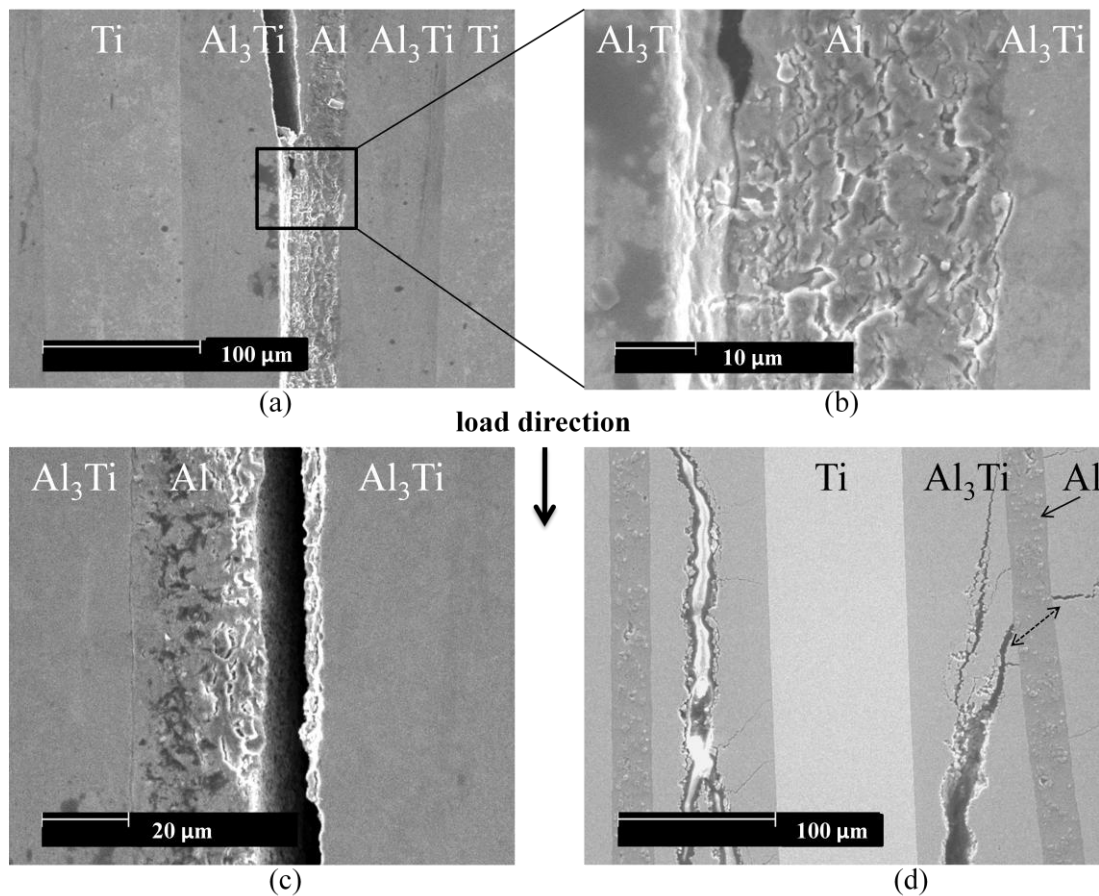
**Figure 4.13 – Fracture of MIL-11 under quasi-static compression (0.001/s) with layers oriented parallel to the applied load. SEM micrographs showing: (a) crack blunting in Al layer; (b) magnification of microcracking and plastic deformation; (c) fracture without clean delamination; (d)  $\text{Al}_3\text{Ti}$  centerline fracture and crack propagation through the Al layer.**

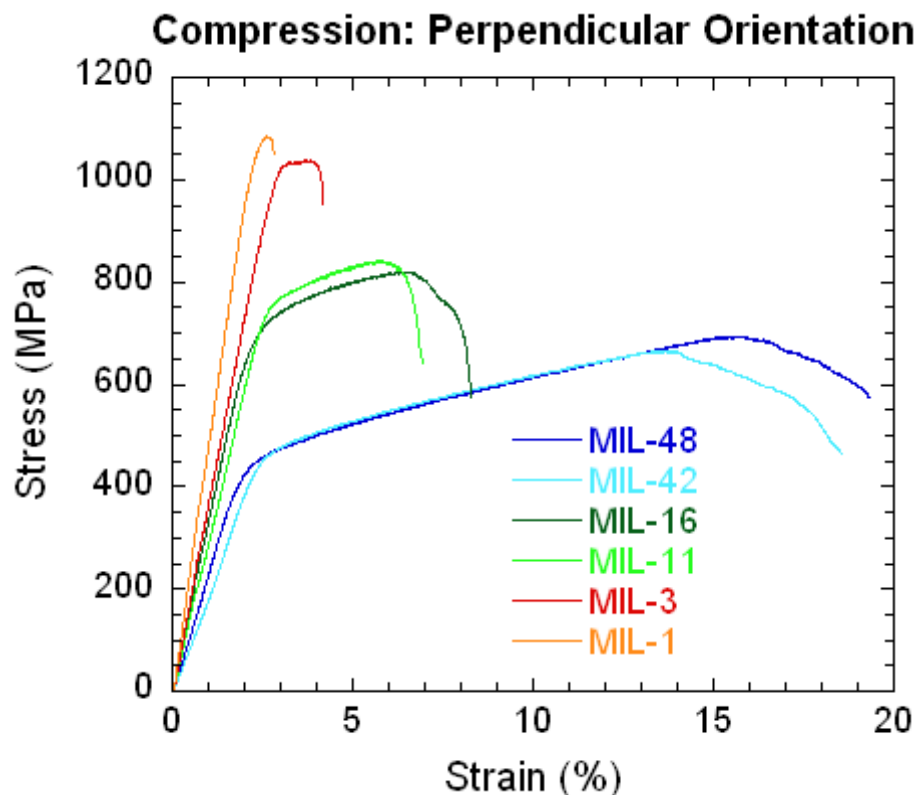
**Figure 4.16 – Representative stress-strain curves of each specimen tested under quasi-static compression at 0.001/s with layers oriented perpendicular to the applied load.**

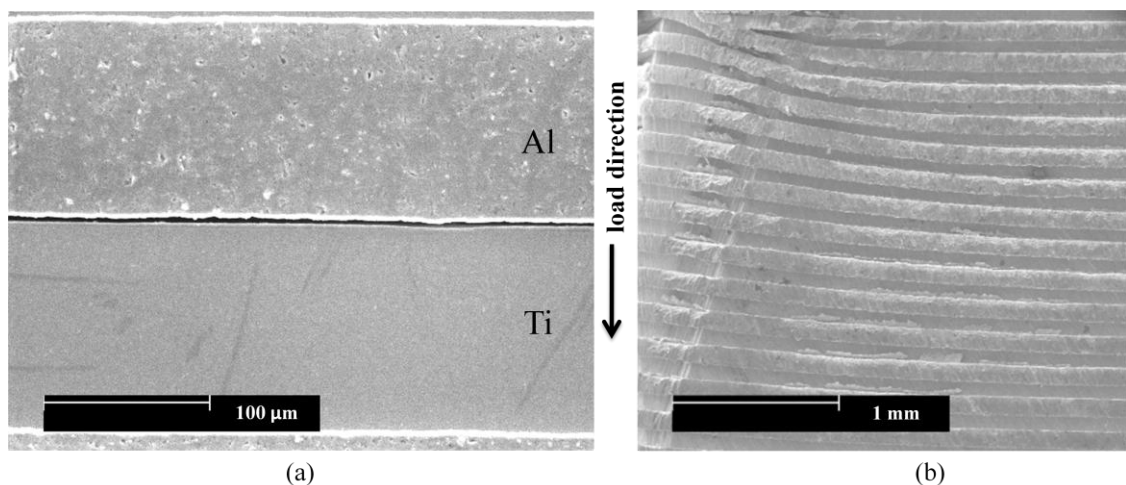
**Figure 4.17 – SEM micrographs of MIL-48 and (a) stopped before the failure strain showing small scale delamination, and (b) macroscopic deformation and Al expulsion of a failed sample.**

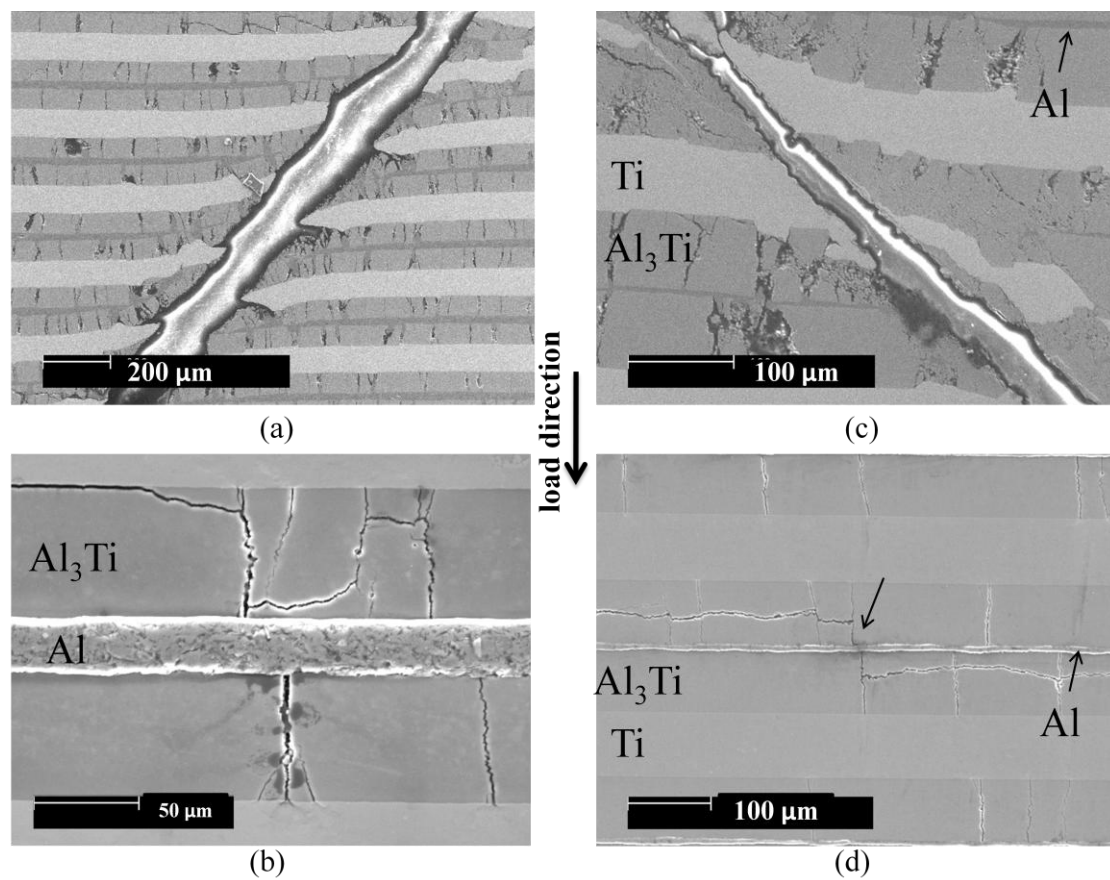
Figure 4.20 – SEM micrographs comparing catastrophic failure and cracking before failure in (a), (b) MIL-11 and (c), (d) MIL-3.

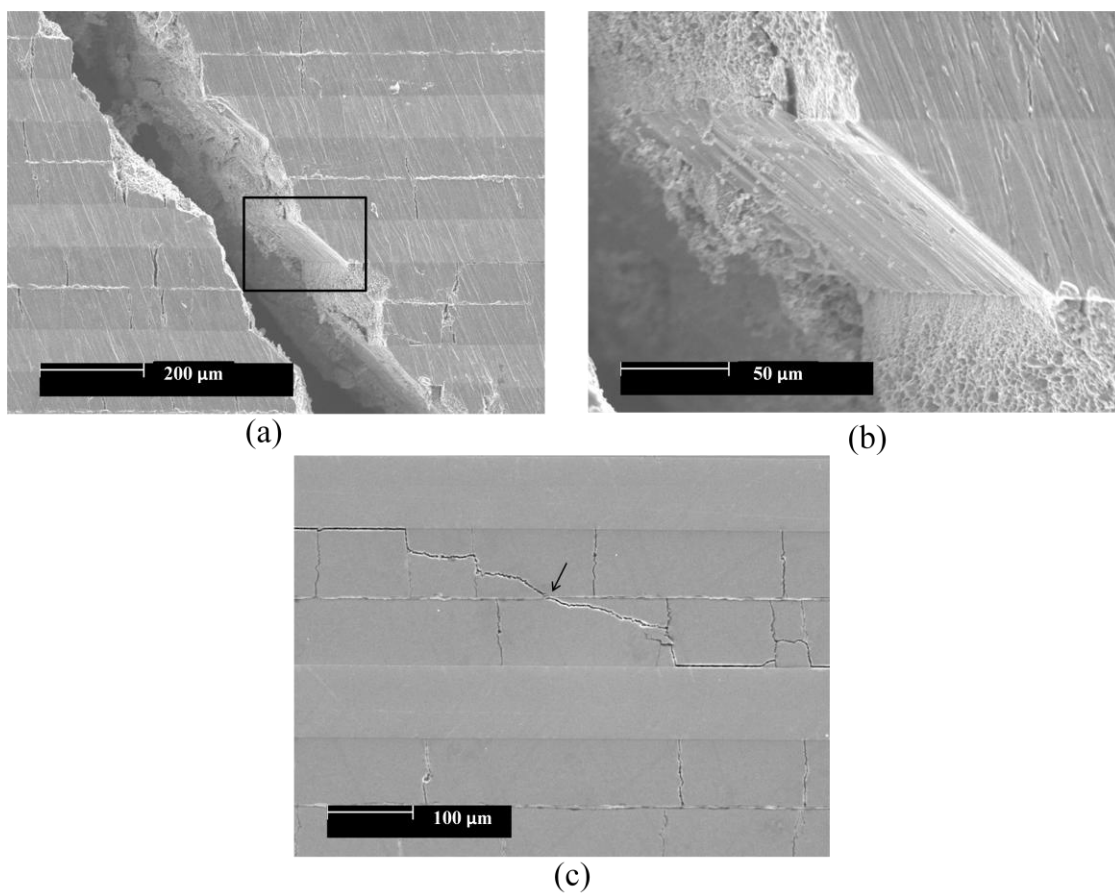
**Figure 4.21 – SEM micrographs of MIL-1: (a) and (b) catastrophic failure by a-type shear fracture; (c)  $\text{Al}_3\text{Ti}$  crack ignored residual Al centerline in a sample stopped before failure.**

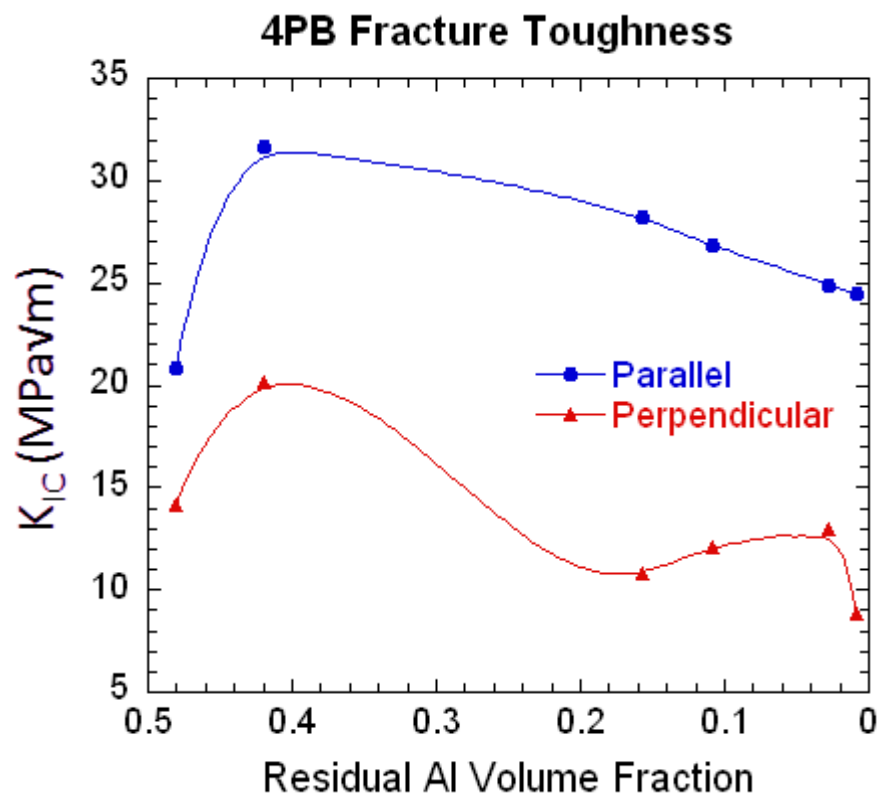
Figure 4.22 – Affect of residual aluminum volume fraction on fracture toughness in parallel and perpendicular loading orientations.

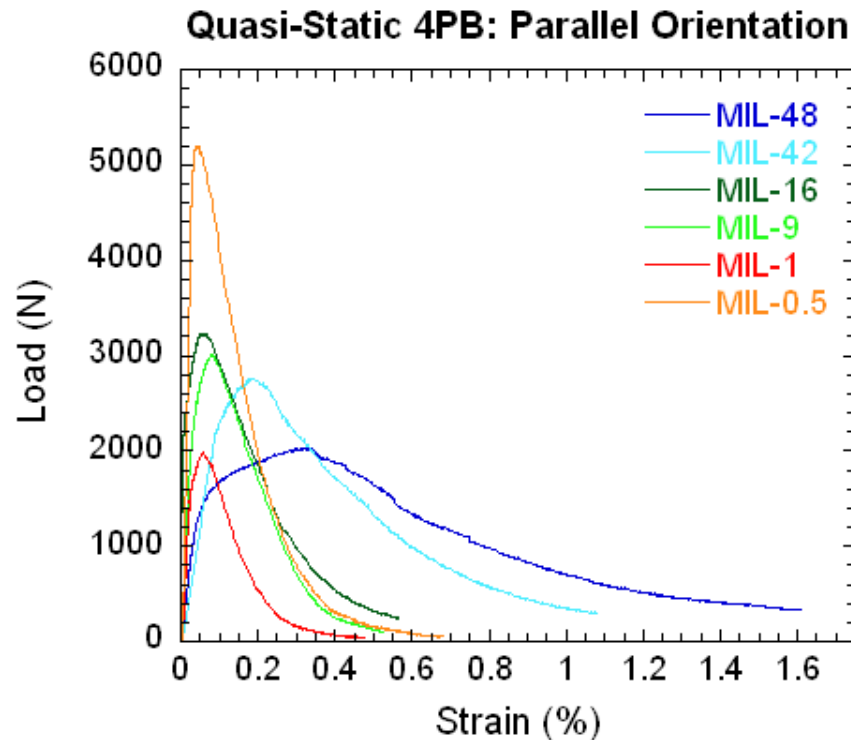
**Figure 4.23 – Representative stress-strain curves of each specimen tested under quasi-static 4PB at 0.001/s with layers oriented parallel to the applied load.**

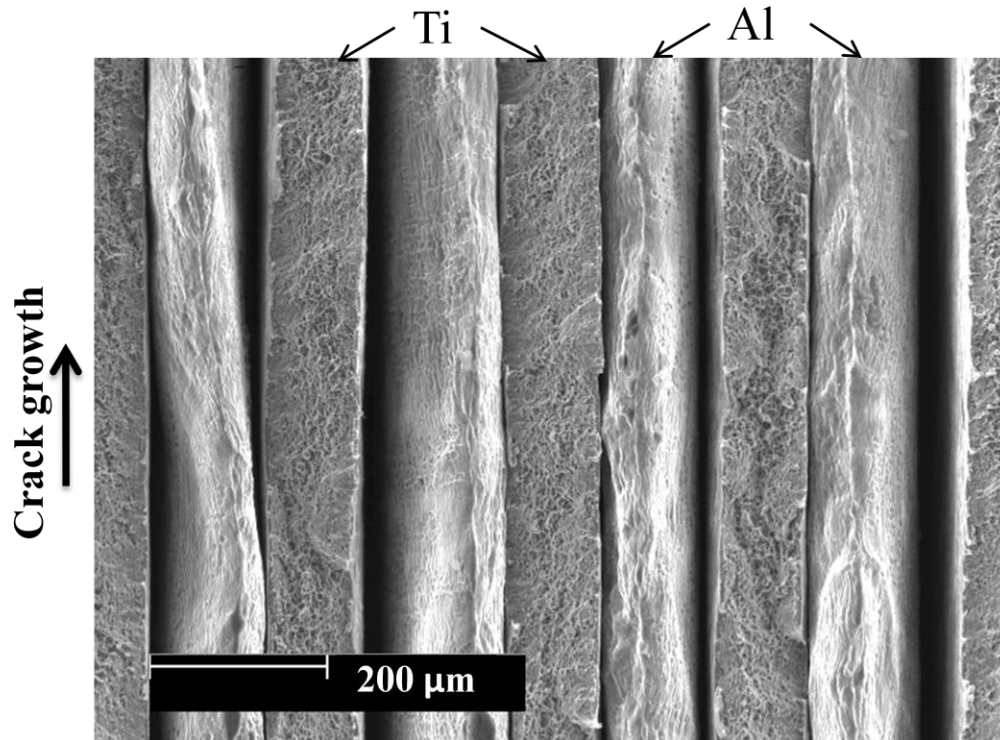
**Figure 4.24 – SEM micrograph of the fracture surface of MIL-48 in quasi-static bending showing ductile fracture, tearing, and delamination.**

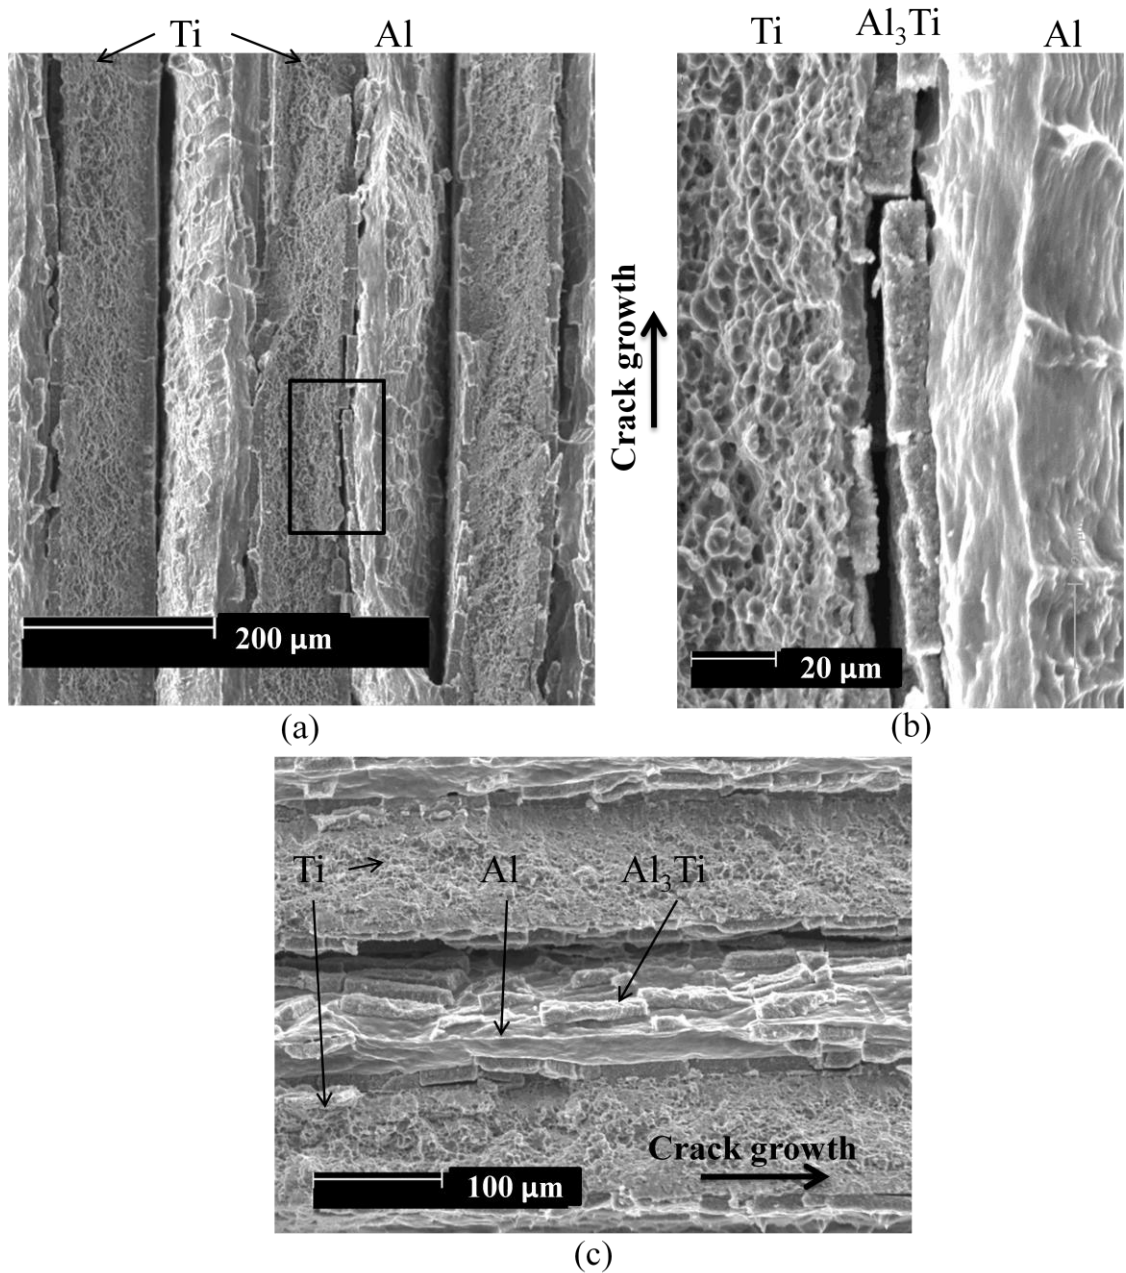
**Figure 4.25– SEM micrographs of the fracture surface of MIL-42 crack divider samples in quasi-static bending. (a) Ductile fracture of Ti layers, Al layer tearing, and Al<sub>3</sub>Ti layer cracking. (b) Detail of image (a) showing Al<sub>3</sub>Ti cracking. (c) Segmented Al<sub>3</sub>Ti fragments still bonded to Al layer after separation indicative of increased interlaminar bond strength.**
