Effects of ductile phase volume fraction on the mechanical properties of Ti-Al<sub>3</sub>Ti metal-intermetallic laminate (MIL) composites

A Thesis submitted in partial satisfaction of the requirements for the degree Master of Science

Engineering Sciences (Mechanical Engineering)

Richard David Price

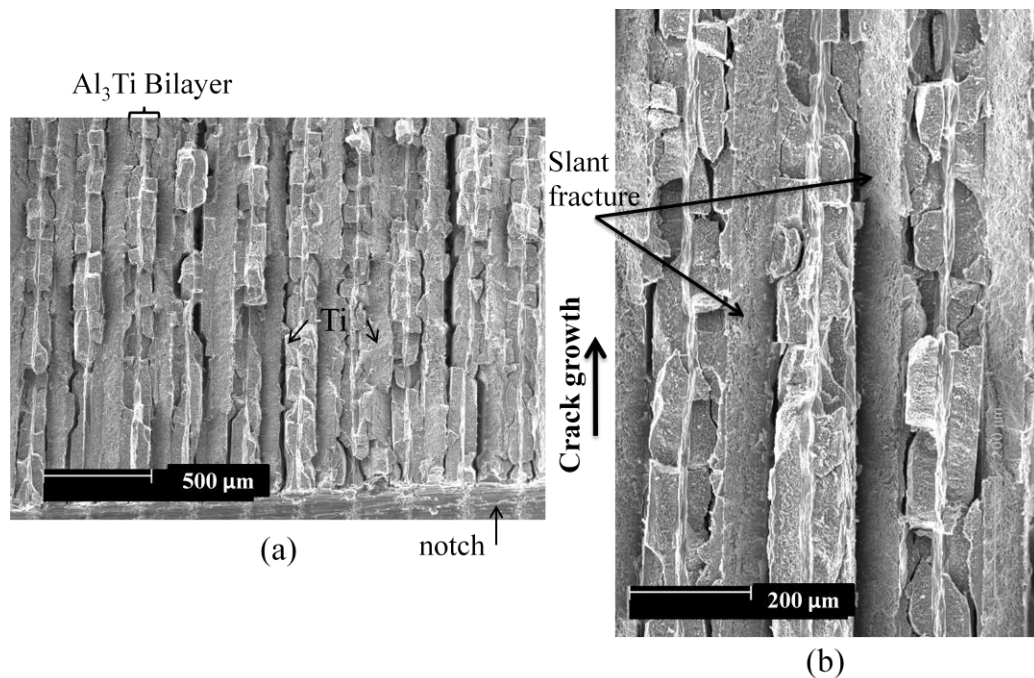
**Figure 4.26 – SEM micrographs of the fracture surfaces of MIL-16 in the crack divider orientation after quasi-static 4PB testing showing stair step  $\text{Al}_3\text{Ti}$  fracture and slanted Ti fracture.**

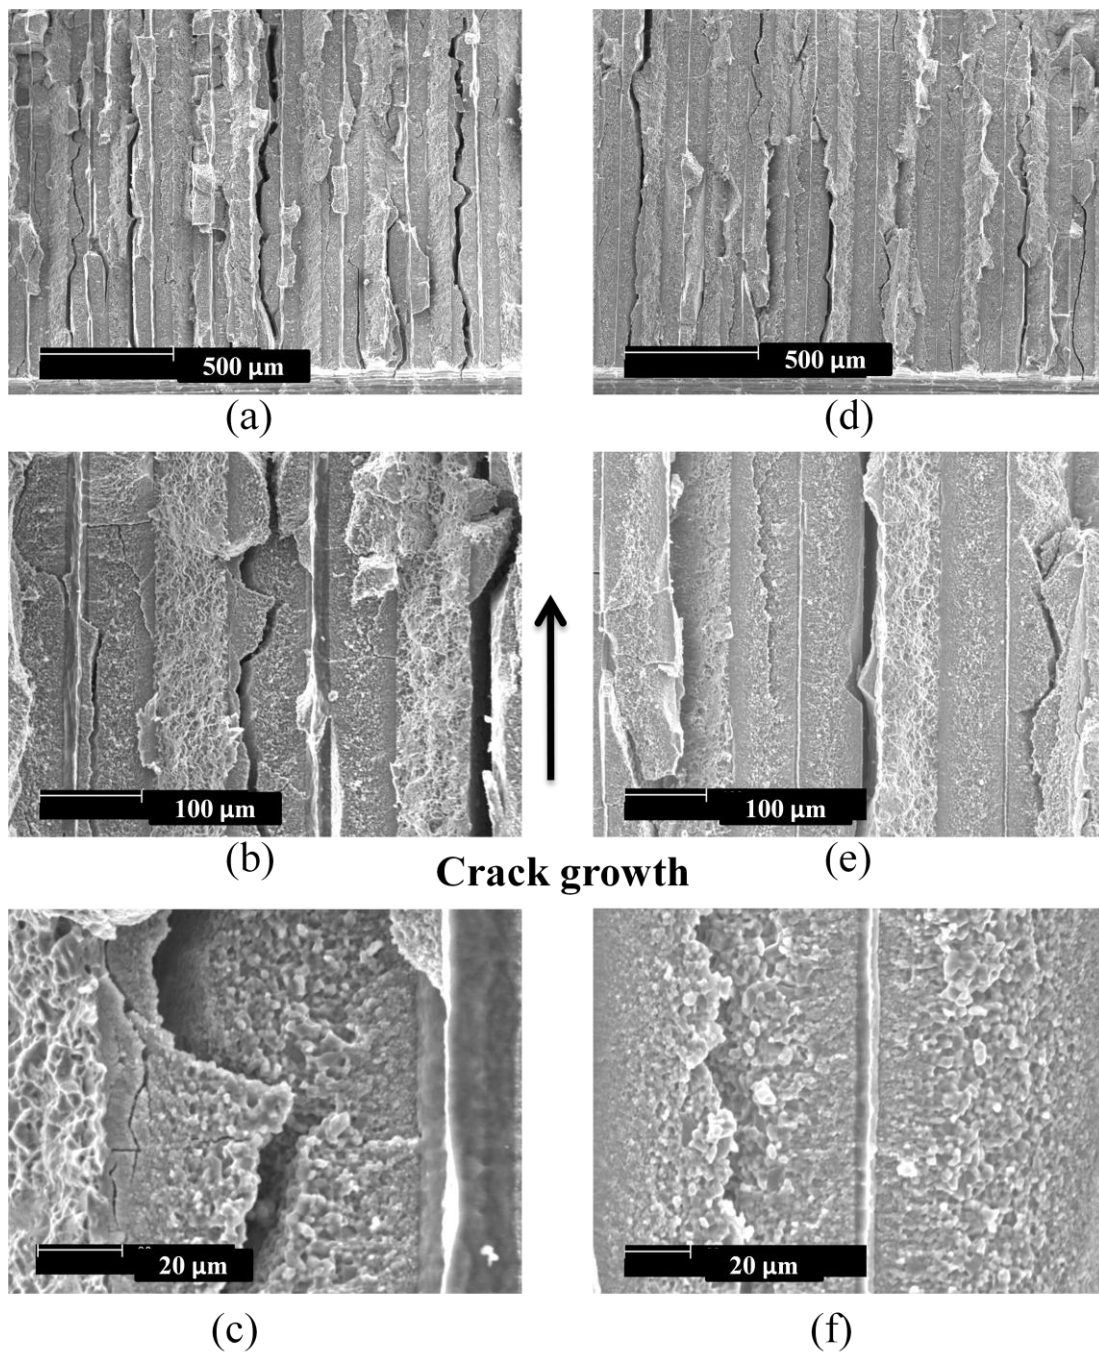
Figure 4.27 – SEM micrographs of the fracture surfaces of (a)-(c) MIL-11 and (d)-(f) MIL-3 in the crack divider orientation after quasi-static 4PB testing.

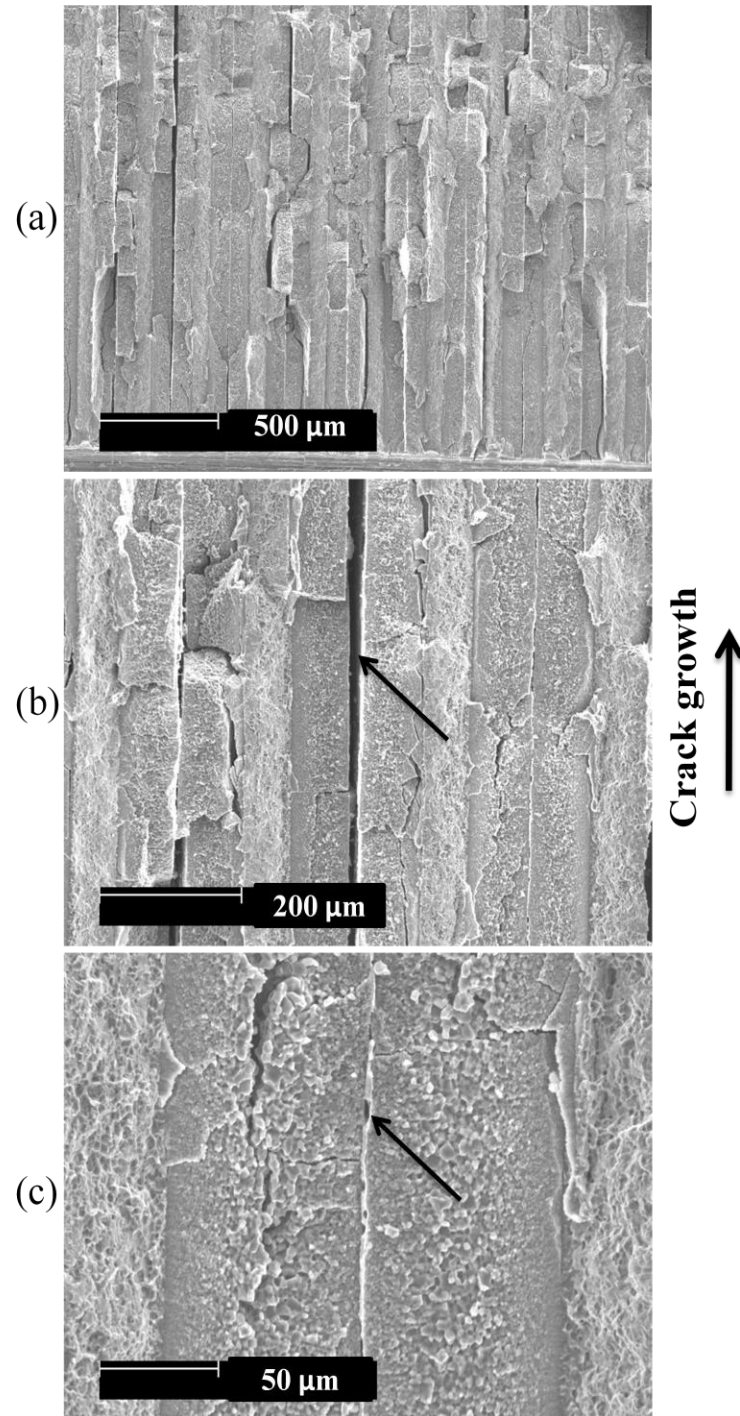
Figure 4.28 – SEM micrographs of the fracture MIL-1 in the crack divider orientation after quasi-static 4PB testing: (a) overview of fracture surface showing a higher percentage of  $\text{Al}_3\text{Ti}$  flat cleavage fracture; (b) magnified image showing  $\text{Al}_3\text{Ti}$  delamination from residual Al; (c) magnified image showing intermetallic centerline fracture, transverse cracking, and centerline cracking/delamination.

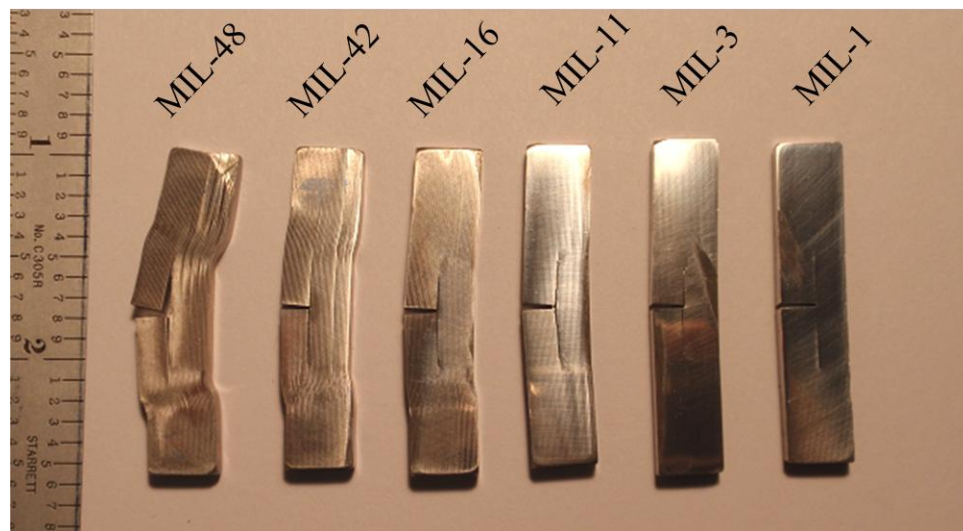
**Figure 4.29 – Photograph of an arrester samples from each specimen after testing in quasi-static 4PB. Notice the lack of fracture in the notch direction.**

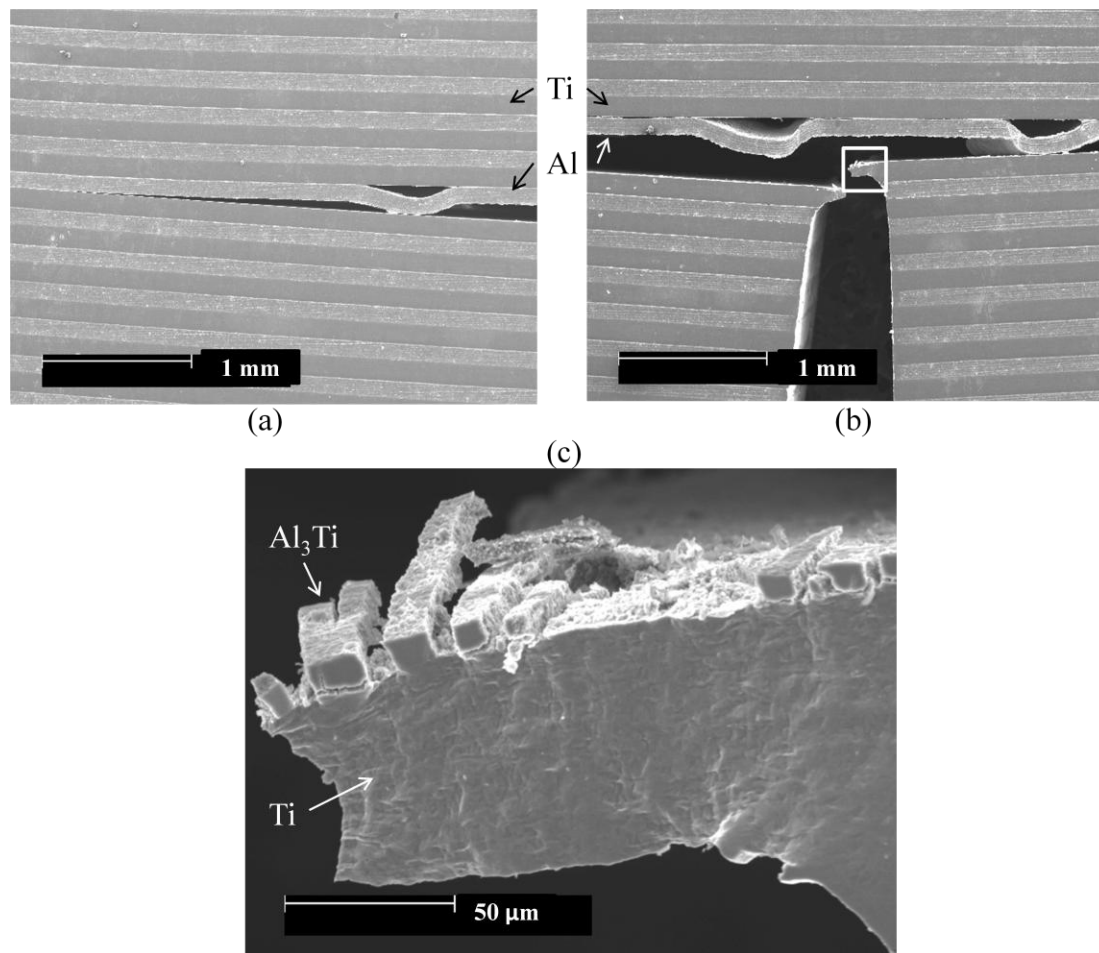
**Figure 4.32 – SEM micrographs of MIL-42 arrester samples after quasi-static 4PB testing showing: (a) ductile crack termination without significant microstructural damage; (b) Al delamination and plastic deformation, and (c) Ti necking and fracture at the notch nip.**

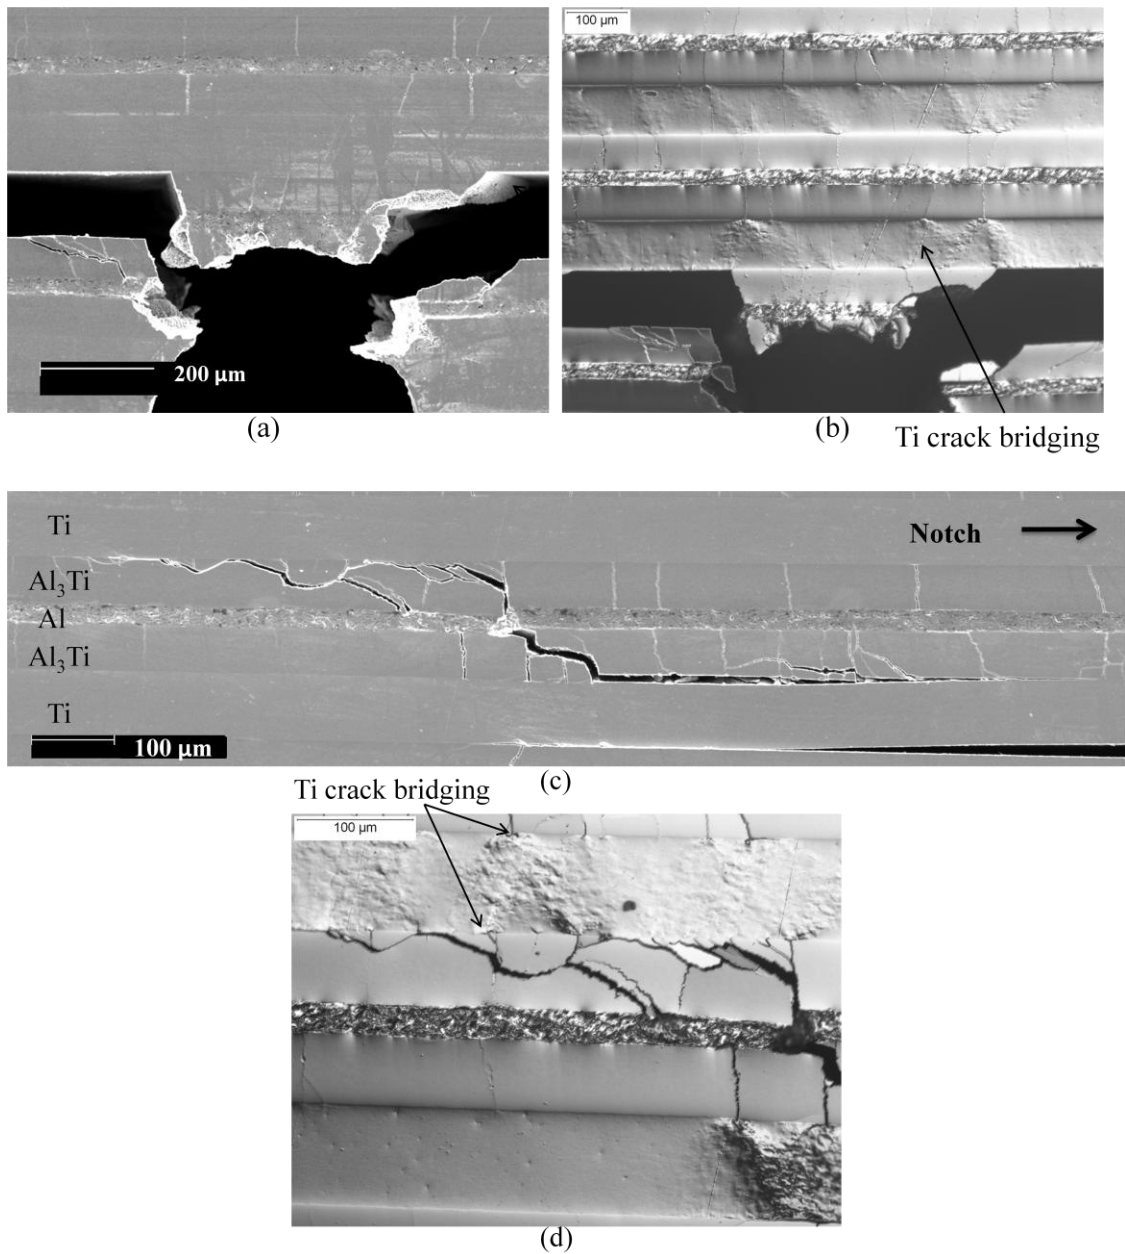
**Figure 4.34 – Failure of MIL-11 crack-arrester samples under quasi-static 4PB. (a) and (b) show vertical intermetallic cracking and shear band formation in the Ti layers. (c) and (d) show plastic deformation and Al and Ti crack bridging. (a) and (c) are SEM micrographs, and (b) and (d) were taken by an optical microscope.**

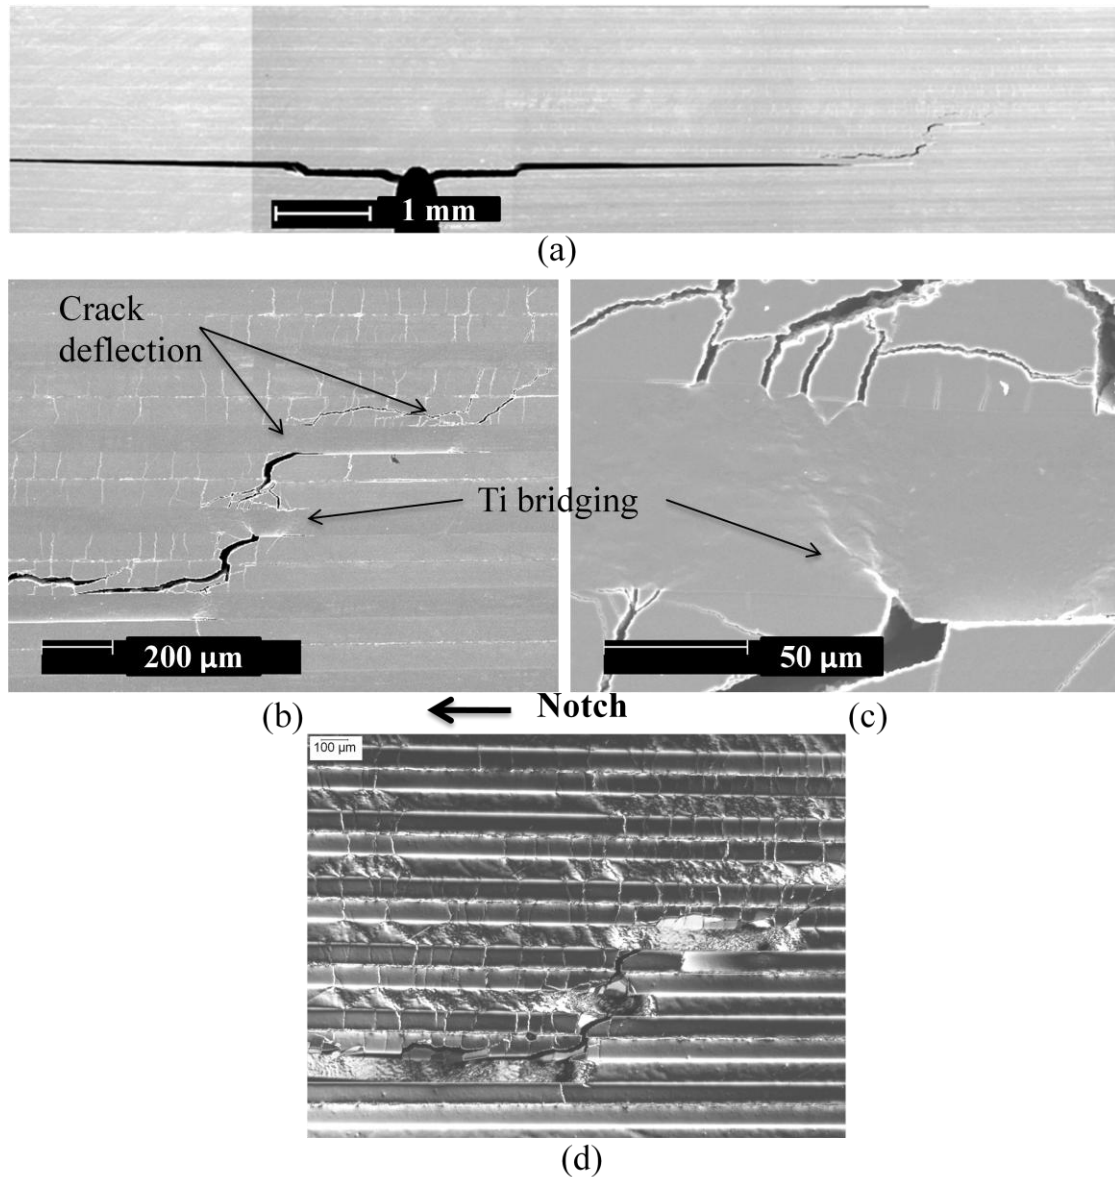
**Figure 4.35 – Failure of MIL-3 crack-arrester samples under quasi-static 4PB. (a) Stitched panorama of the transverse delamination that propagated from the crack tip and (b, c) cracking and arresting at the tip. (d) Optical micrograph of the region in (b) showing shear band deformation and crack bridging by Ti layers.**

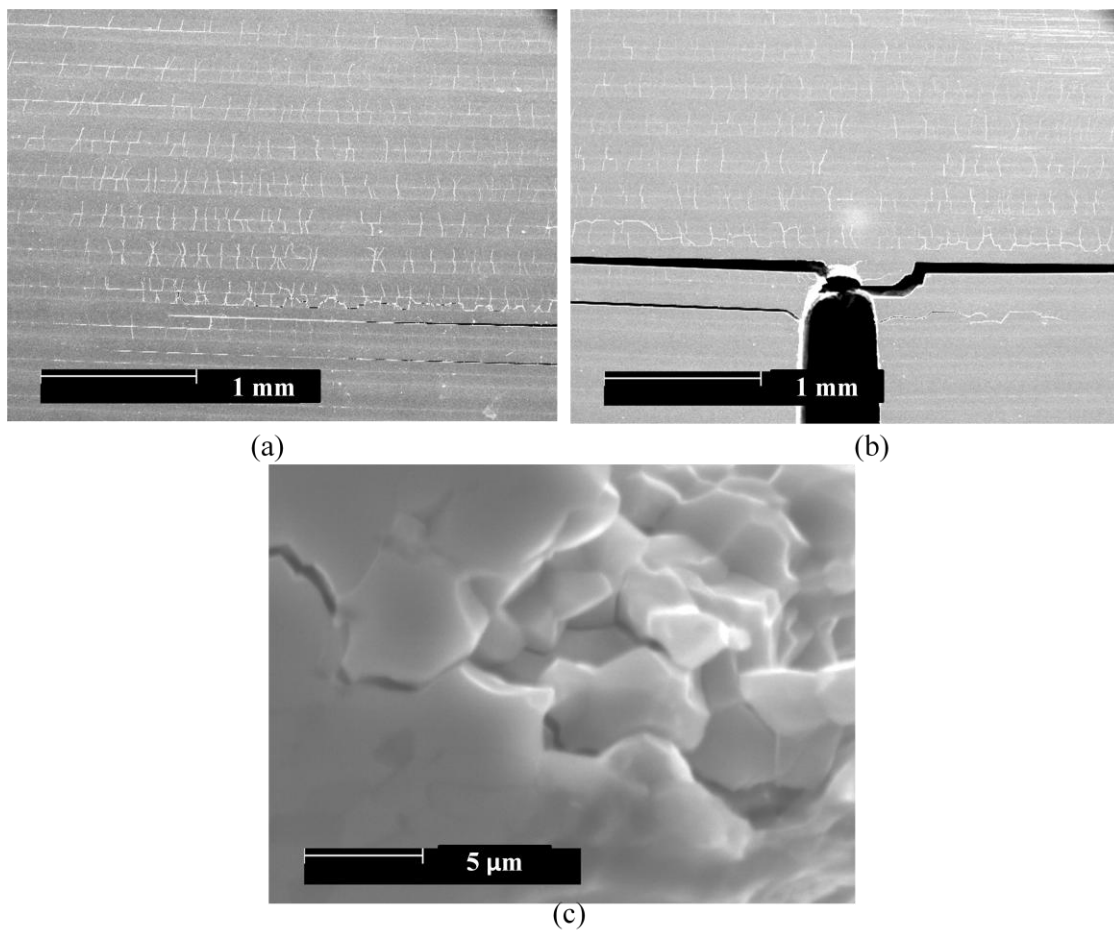
**Figure 4.36 – Failure of MIL-1 crack-arrester samples under quasi-static 4PB. SEM micrographs of: (a) significant  $\text{Al}_3\text{Ti}$  cracking without propagation of a single fracture; (b) delamination and fracture at the notch tip; (c) inter- and intragranular fracture of  $\text{Al}_3\text{Ti}$  grains near the crack tip.**

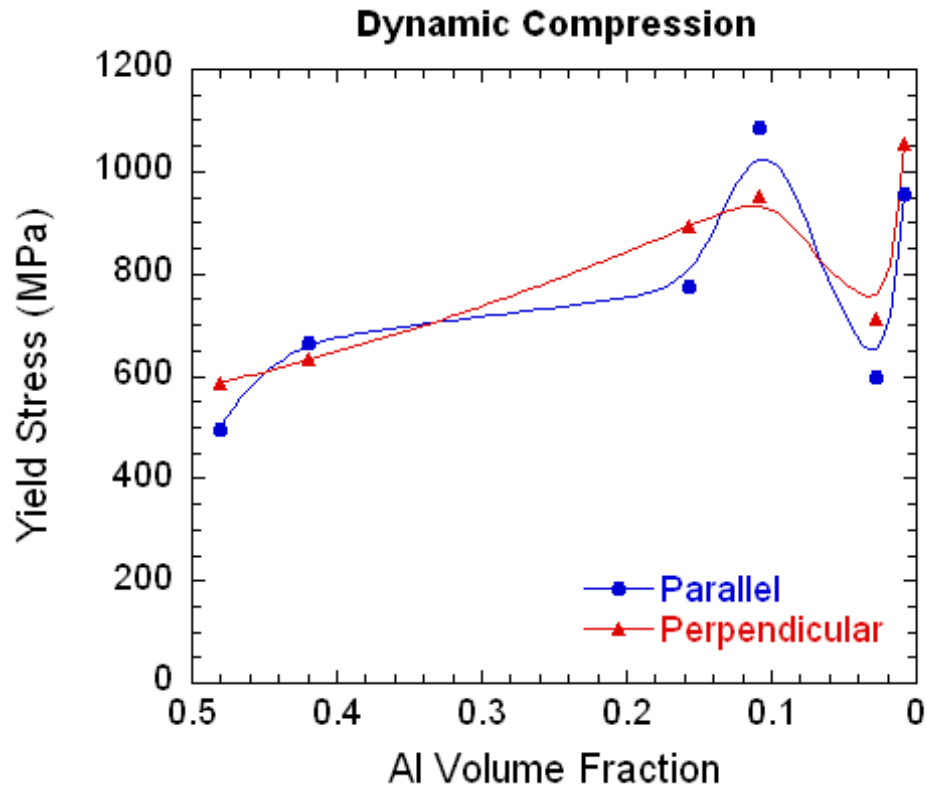
**Figure 4.38 – Affect of residual aluminum volume fraction on compressive yield stress in dynamic testing of parallel and perpendicular loading orientations. Compare to Figure 4.7**

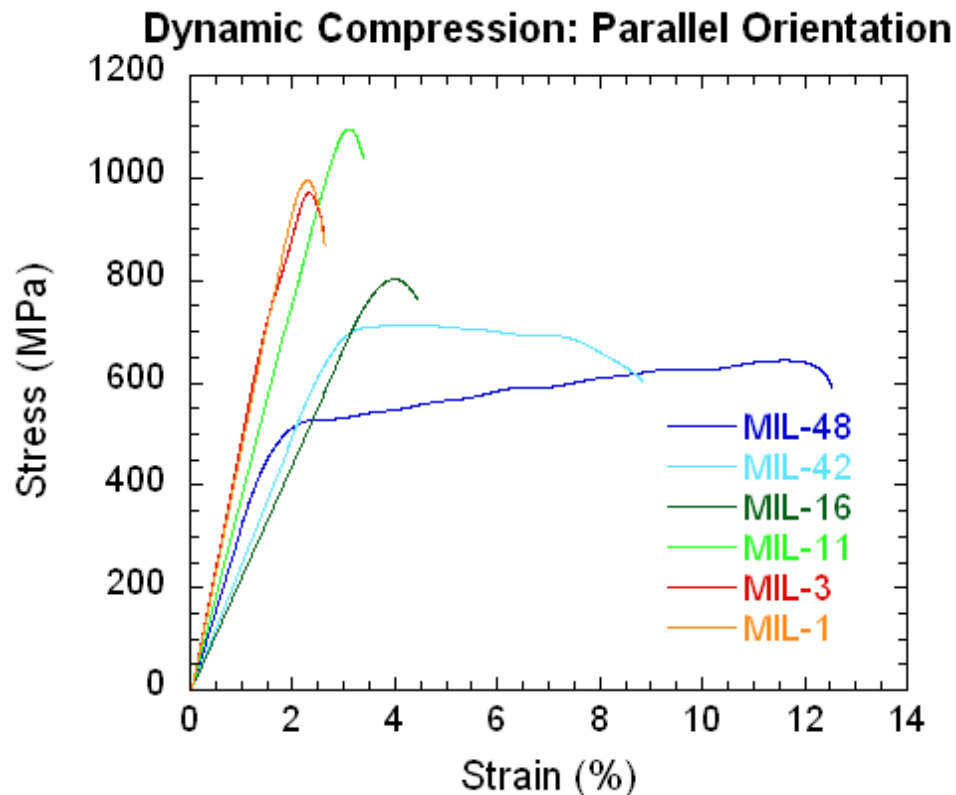
**Figure 4.39 – Representative stress-strain curves of each specimen tested under dynamic compression at 1000/s with layers oriented parallel to the applied load.**

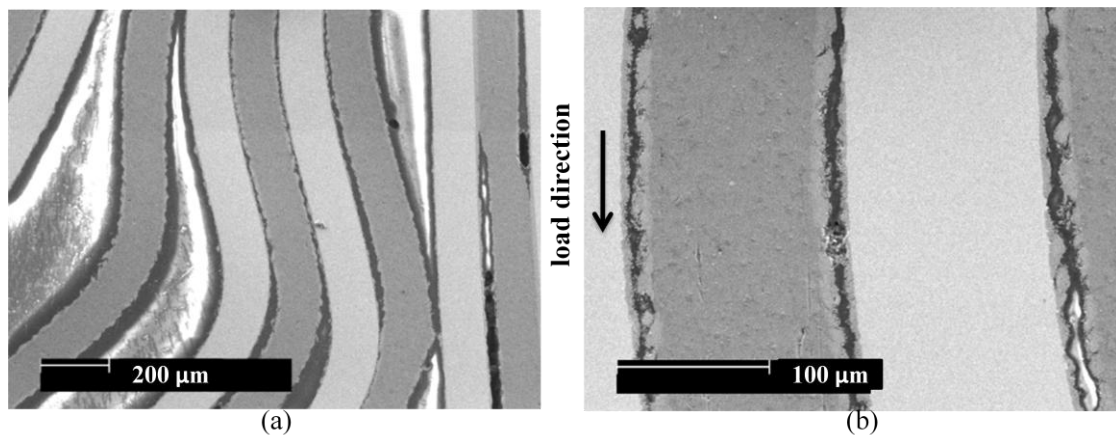
**Figure 4.41 – SEM micrographs of MIL-42 cold-mounted and polished after dynamic compression showing (a) large scale delamination, buckling, and (b)  $Al_3Ti$  centerline fracture. Light layers are Ti, dark layers are Al.**

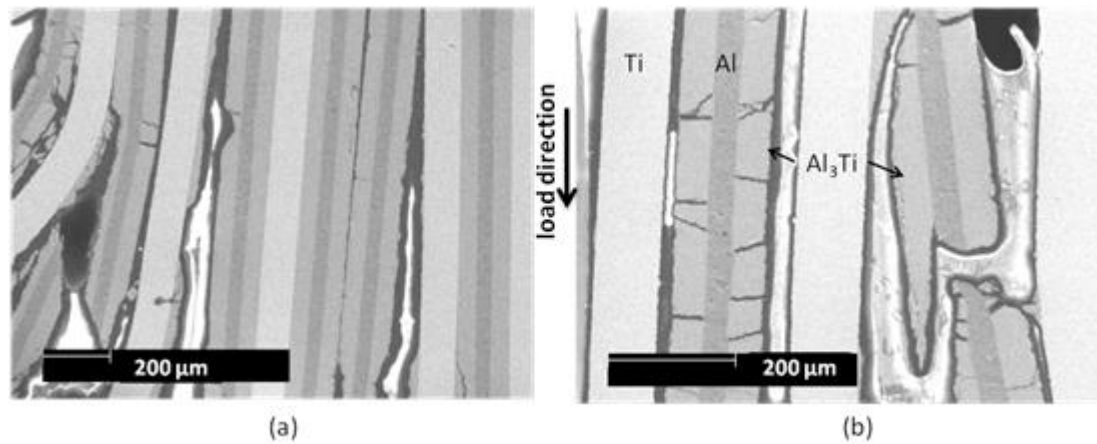
**Figure 4.42 – SEM micrographs of MIL-16 cold-mounted and polished after dynamic compression showing (a) delamination cracking, buckling, and (b) Al<sub>3</sub>Ti centerline fracture.**

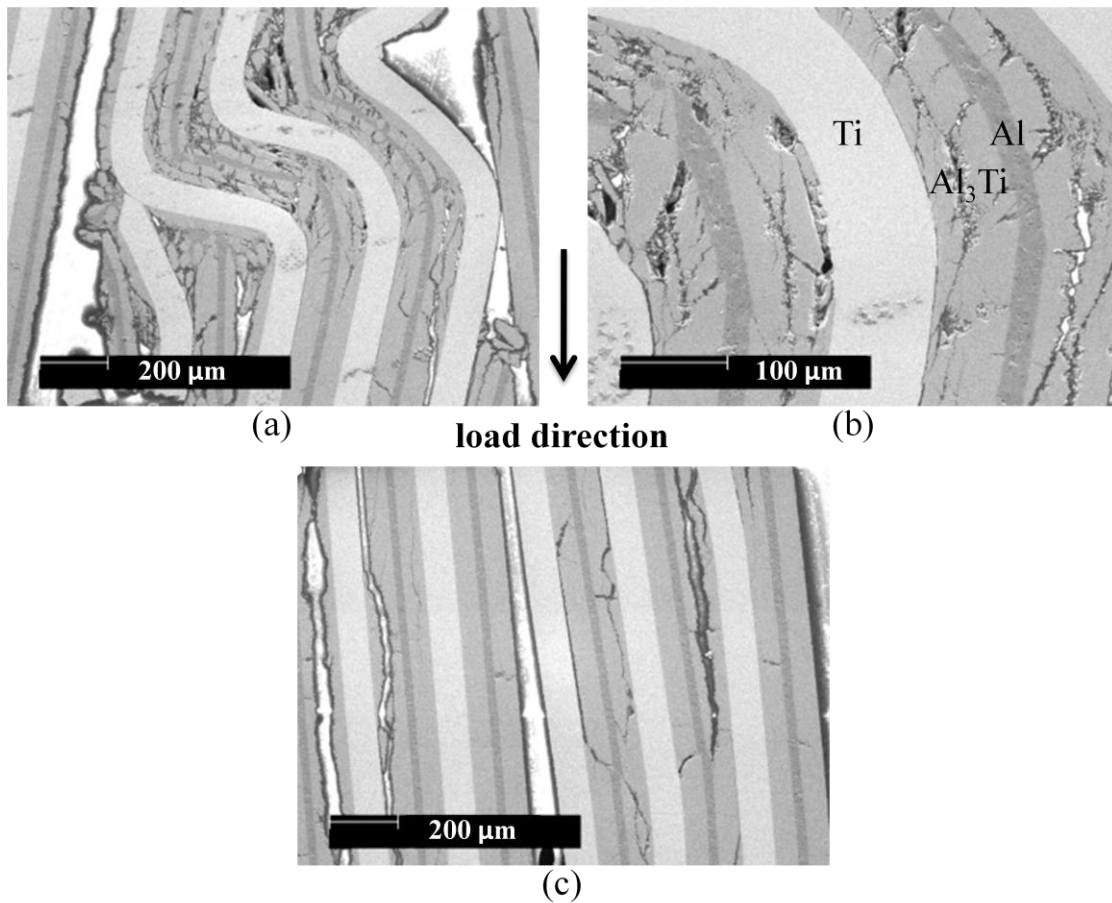
Figure 4.43 – SEM micrographs of MIL-11 cold-mounted and polished after dynamic compression showing (a, b) intermetallic layer reinforcement by plastic deformation of Ti layers, and (c) Al<sub>3</sub>Ti centerline fracture.

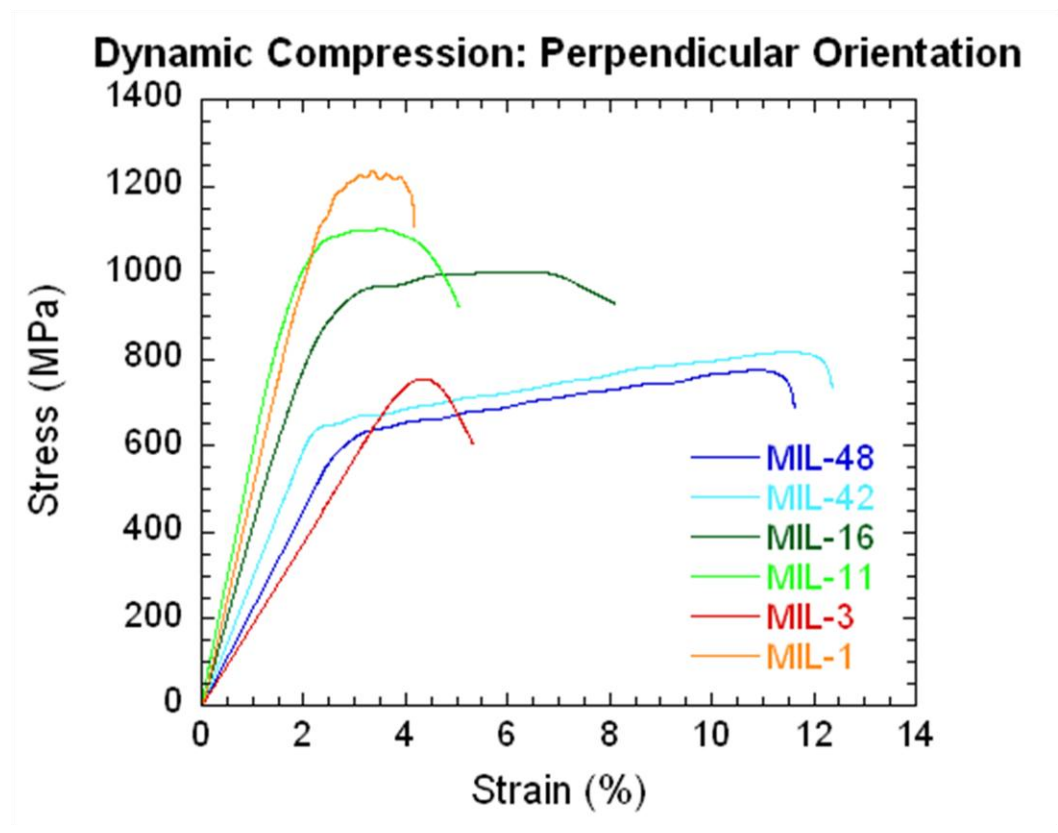
Figure 4.46 – Representative stress-strain curves of each specimen tested under dynamic compression at 1000/s with layers oriented perpendicular to the applied load.

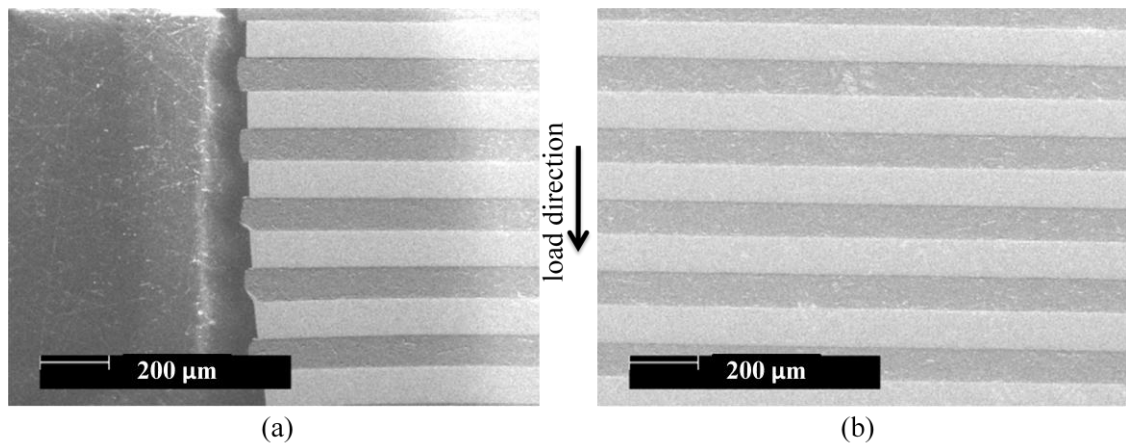
**Figure 4.47 - SEM micrographs of MIL-48 cold-mounted and polished after dynamic compression showing**

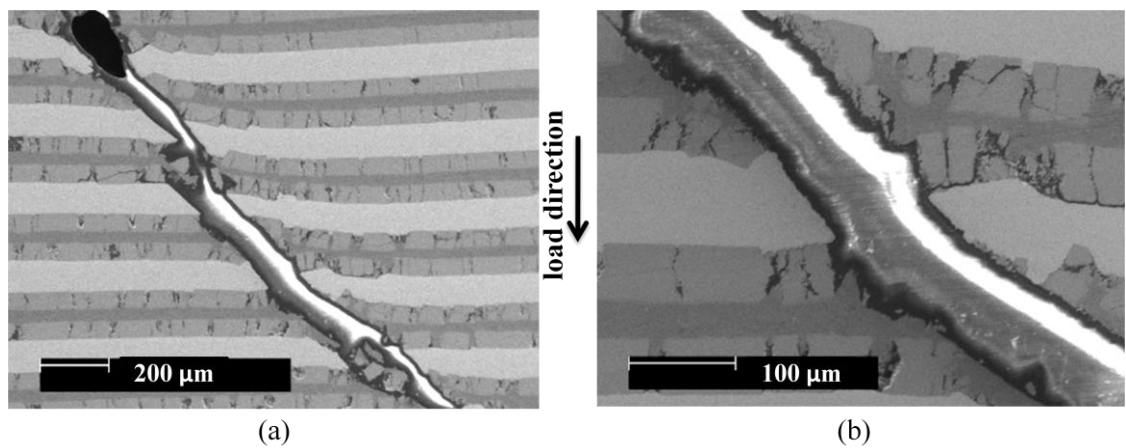
Figure 4.49 - SEM micrographs of MIL-16 cold-mounted and polished after dynamic compression showing (a) shear fracture and (b) and magnified image of intermetallic cracking and Ti shear deformation.

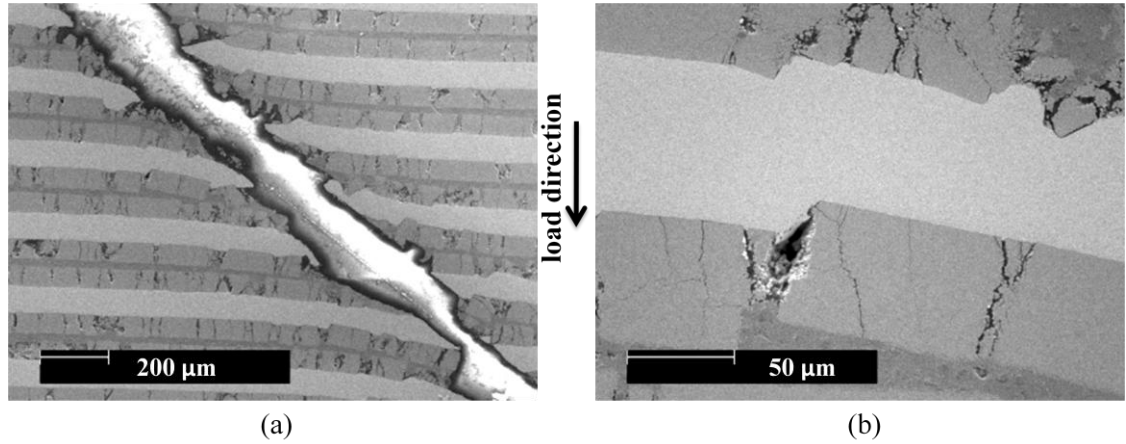
Figure 4.50 - SEM micrographs of MIL-11 cold-mounted and polished after dynamic compression showing (a) shear fracture and (b) magnified image of intermetallic cracking and Ti shear deformation.

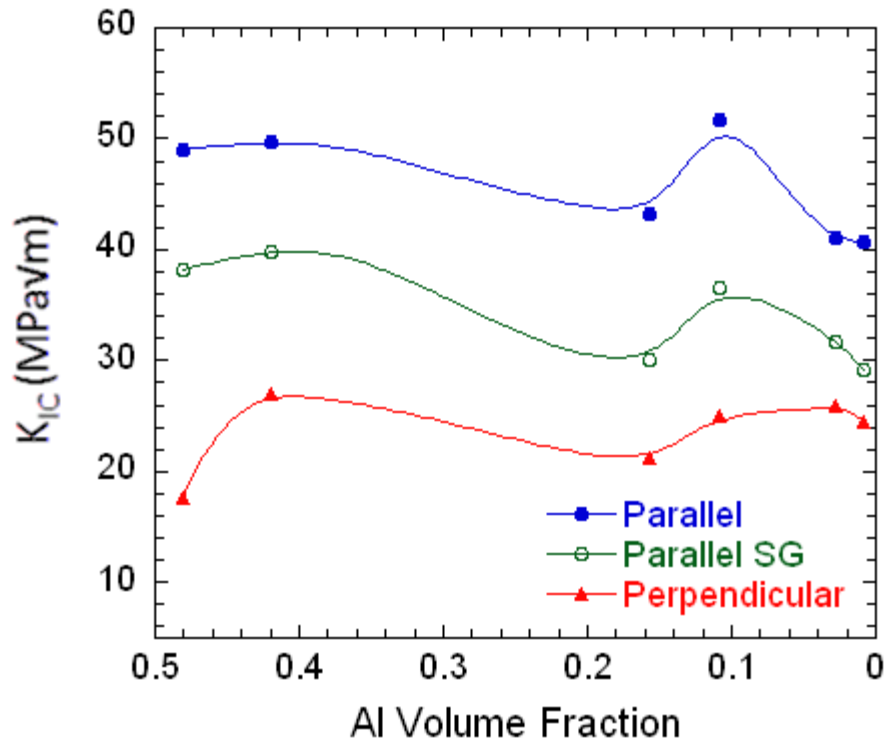
**Figure 4.53 – Affect of residual aluminum volume fraction on fracture toughness  $K_{IC}$  in parallel and perpendicular loading orientations under dynamic 4PB. The parallel orientation curves generated by the high-speed camera and strain gage methods show almost identical trends.**

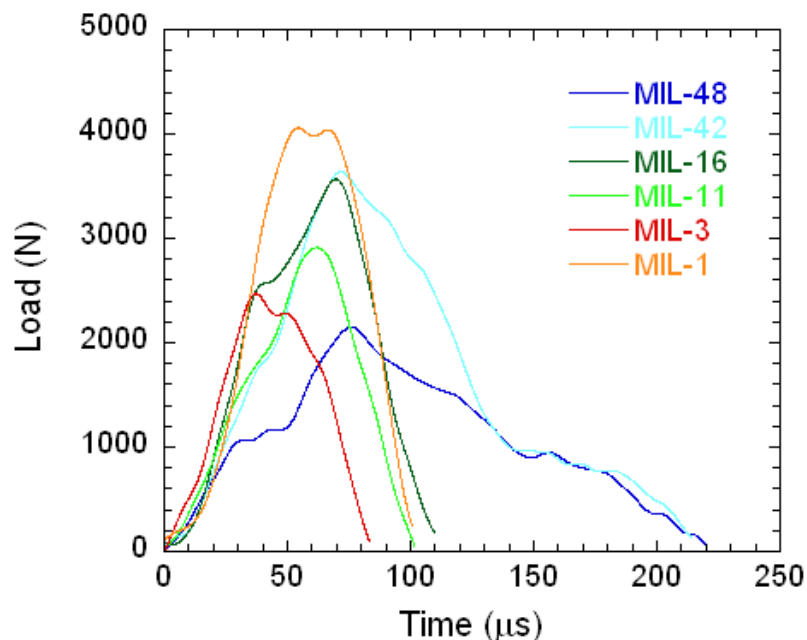
**Figure 4.54 – Representative load-time curves of each specimen tested under high strain-rate 4PB with layers oriented parallel to the applied load.**

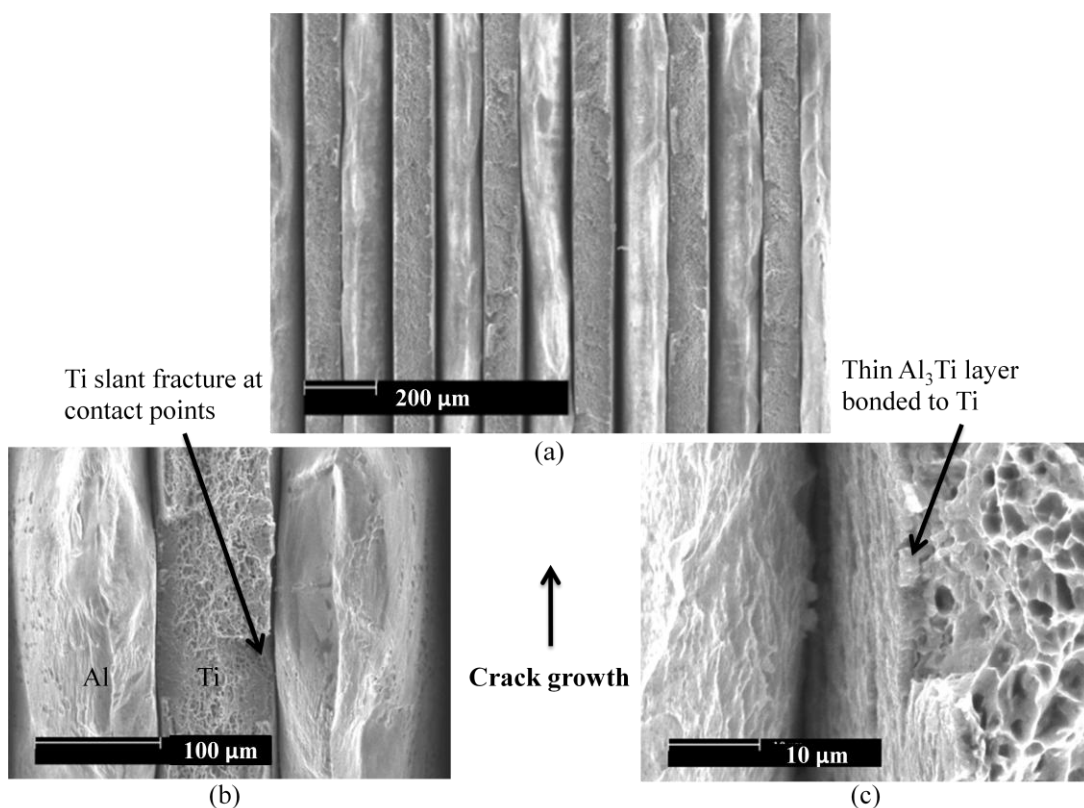
**Figure 4.55** – SEM micrographs of the fracture surface of MIL-48 in dynamic 4PB showing: (a) a fracture surface similar to quasi-static 4PB samples; (b) Al layer tearing, and Ti layer microvoid coalescence and slant fracture; (c) the thin intermetallic layer still bonded to the Ti layer.

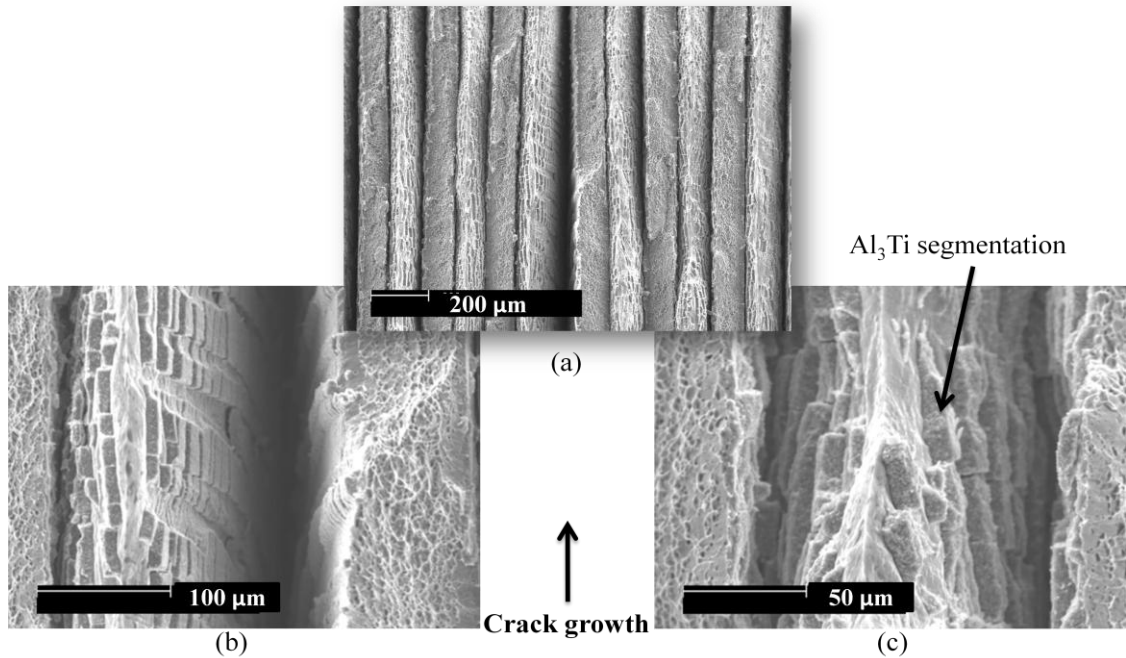
Figure 4.56 – SEM micrographs of the fracture surface of MIL-42 in dynamic 4PB showing: (a) wide-spread ply separation and intermetallic segmentation; (b) and (c) magnifications of intermetallic segmentation.

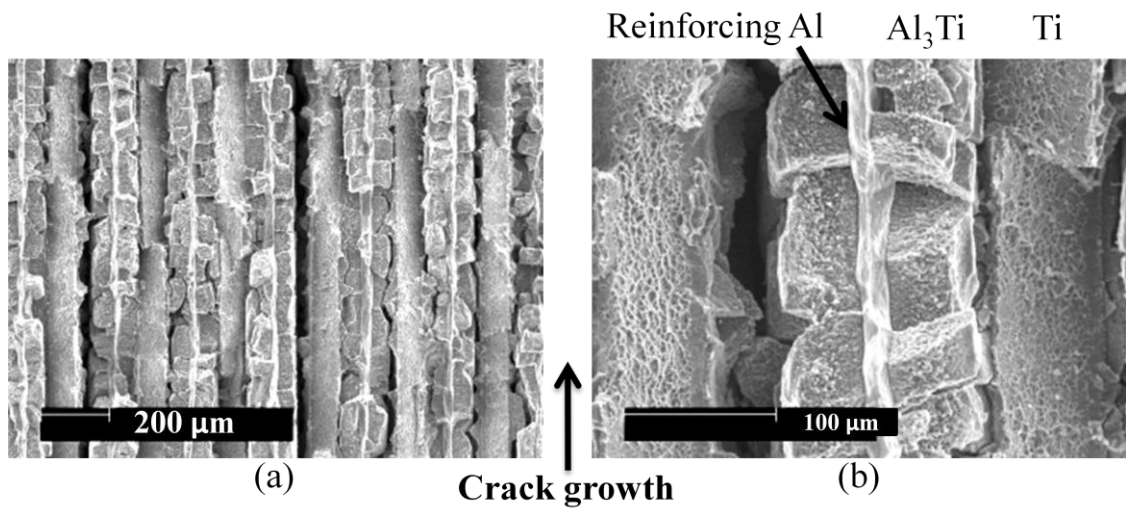
Figure 4.57 – SEM micrographs of the fracture surfaces of MIL-16 in the crack divider orientation after dynamic 4PB testing showing (a) stair-step Al<sub>3</sub>Ti fracture and slanted Ti fracture. (b) Magnification of (a). The Al layer provided enough ductile reinforcement to prevent flat cleavage fracture of the Al<sub>3</sub>Ti layers seen in specimens with less Al content.

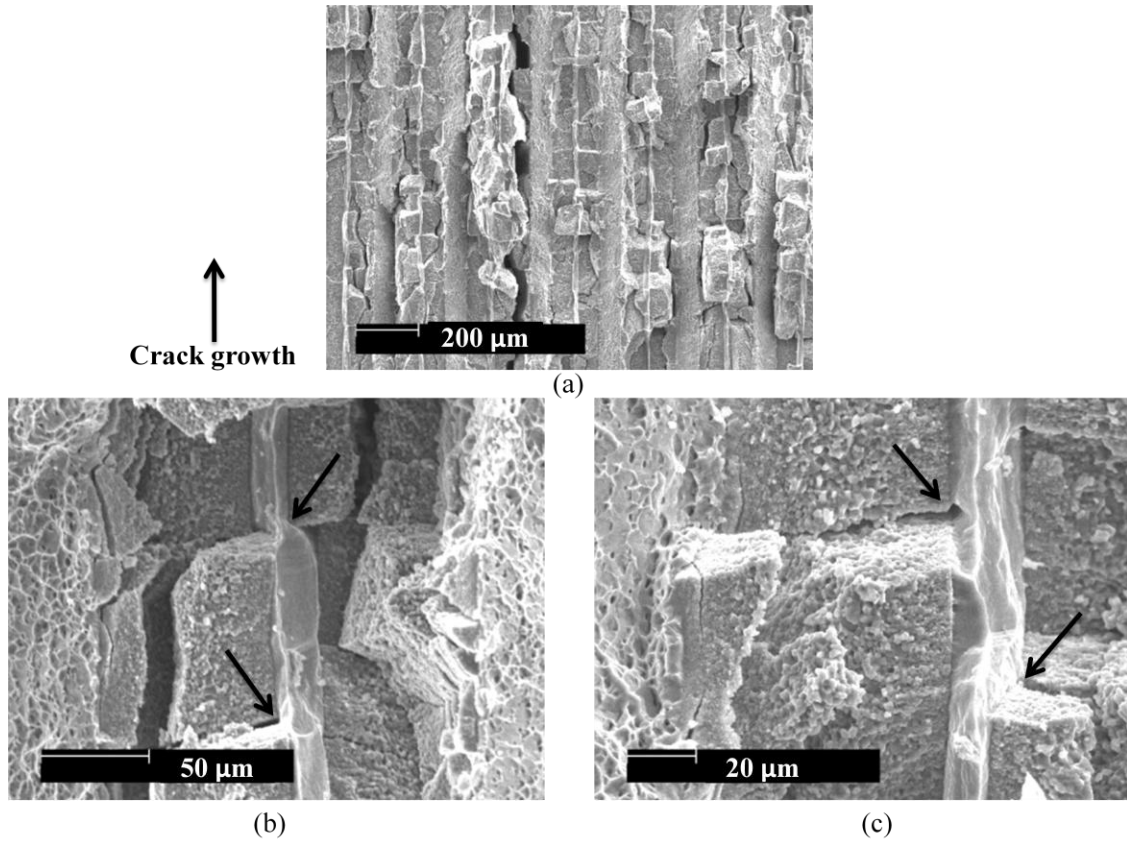
**Figure 4.58 – SEM micrographs of the fracture surface of MIL-11 after dynamic 4PB testing showing: (a) less interfacial fracture than MIL-16; (b) and (c) the Al centerline prevented transverse fracture of the Al<sub>3</sub>Ti bilayers.**

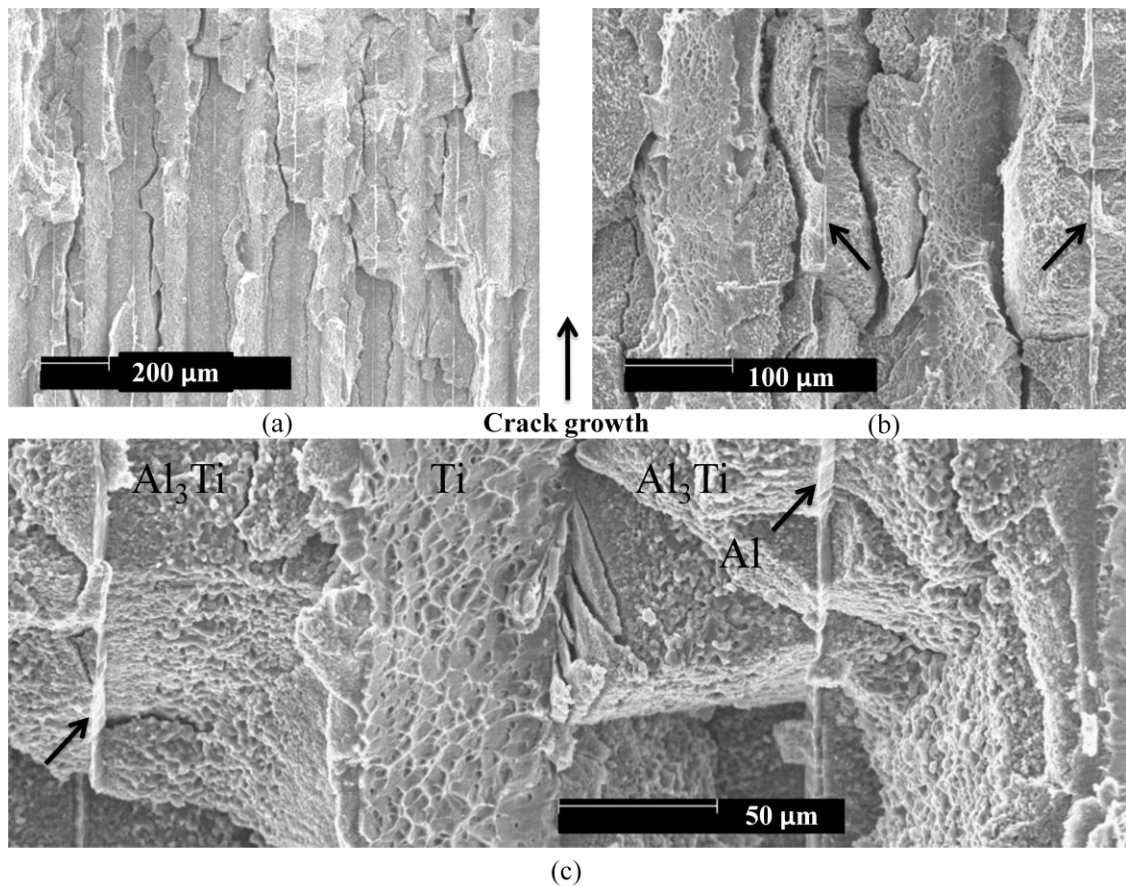
Figure 4.59 – SEM micrographs of the fracture surface of MIL-3 after dynamic 4PB testing showing: (a) increased presence of intermetallic flat cleavage fracture; (b) and (c) the residual Al centerline (indicated by arrows) was not thick enough to prevent transverse fracture in the  $\text{Al}_3\text{Ti}$  bilayers.

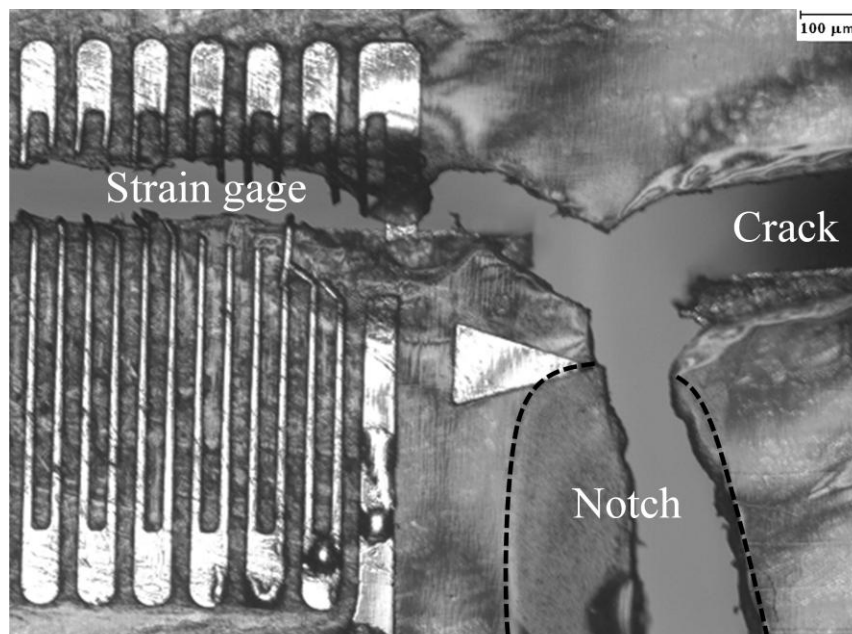
**Figure 4.61 – Optical micrograph of a broken strain gage spanning the transverse crack of a crack-arrester sample.**

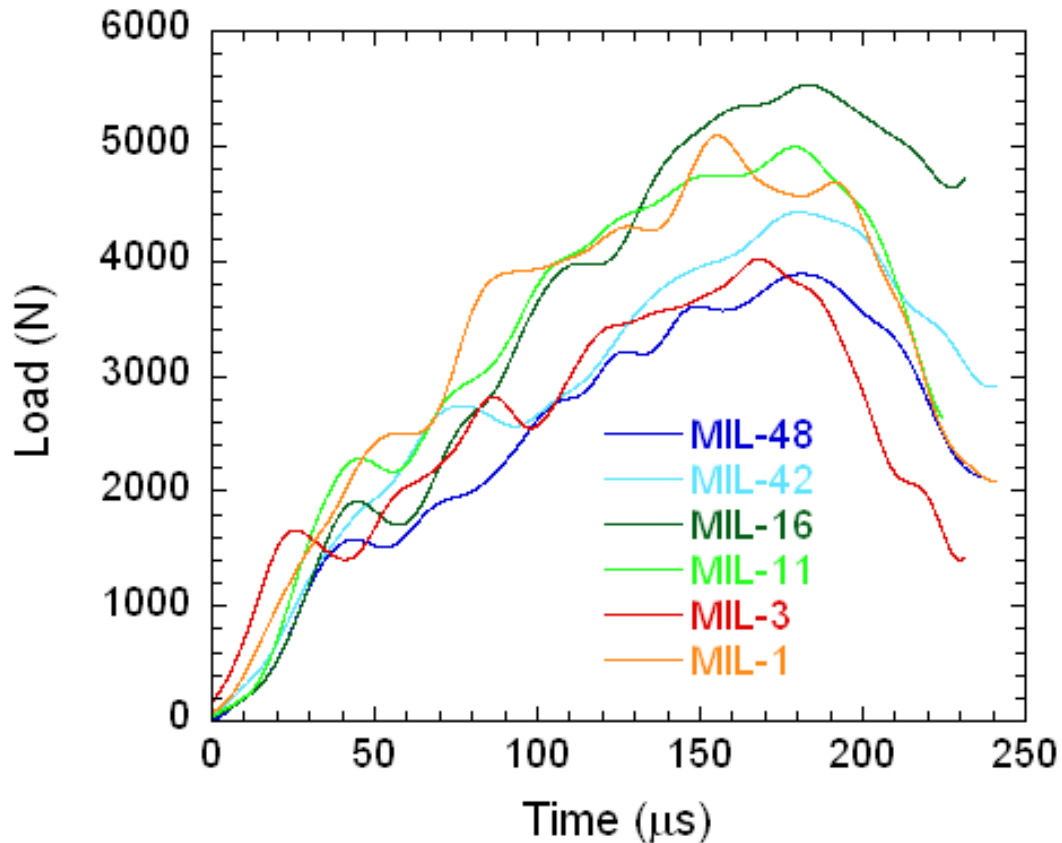
**Figure 4.62 – Representative load-time curves of each specimen tested under high strain-rate 4PB with layers oriented perpendicular to the applied load.**
