Effects of ductile phase volume fraction on the mechanical properties of Ti-Al<sub>3</sub>Ti metal-intermetallic laminate (MIL) composites

A Thesis submitted in partial satisfaction of the requirements for the degree Master of Science

Engineering Sciences (Mechanical Engineering)

Richard David Price

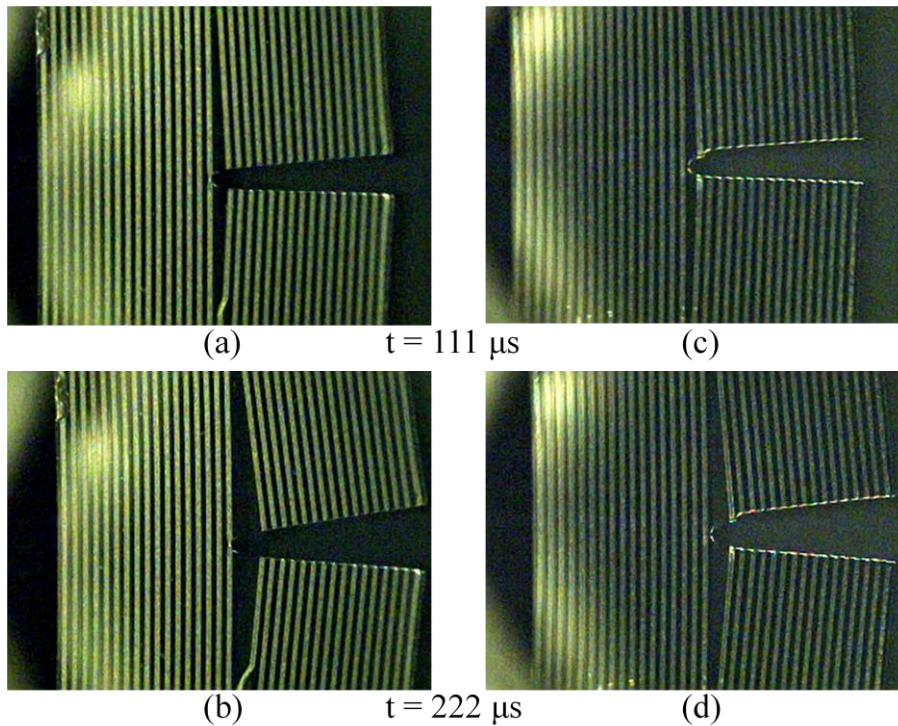
**Figure 4.63 – High-speed camera images showing the failure of (a, b) MIL-48 and (c, d) MIL-42 crack-arrester samples under dynamic 4PB.**

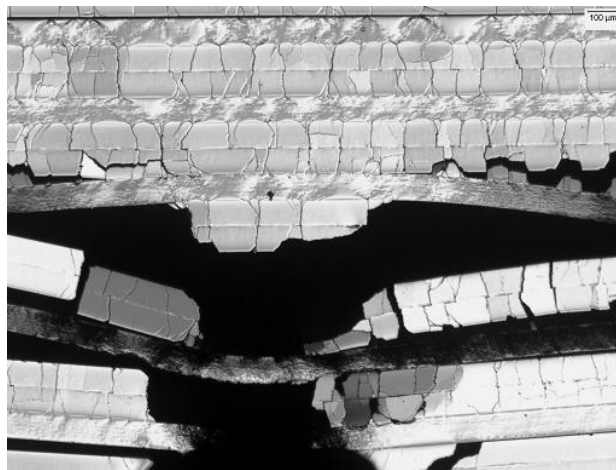
**Figure 4.67– (a) High-speed camera images showing the failure of MIL-1 under dynamic 4PB. (b) Optical micrograph of the notch tip seen in (a) at 222 microseconds.**

Figure 4.67– (a) High-speed camera images showing the failure of MIL-1 under dynamic 4PB. (b) Optical micrograph of the notch tip seen in (a) at 222 microseconds.....	119
