ASSESSMENT OF THERMOCOUPLE TEMPERATURE MEASUREMENTS DURING IN SITU HEATER EXPERIMENTS AT STRIPA, SWEDEN

Technical Information Report No. 54

E. Binnall and M. McEvoy

October 1985

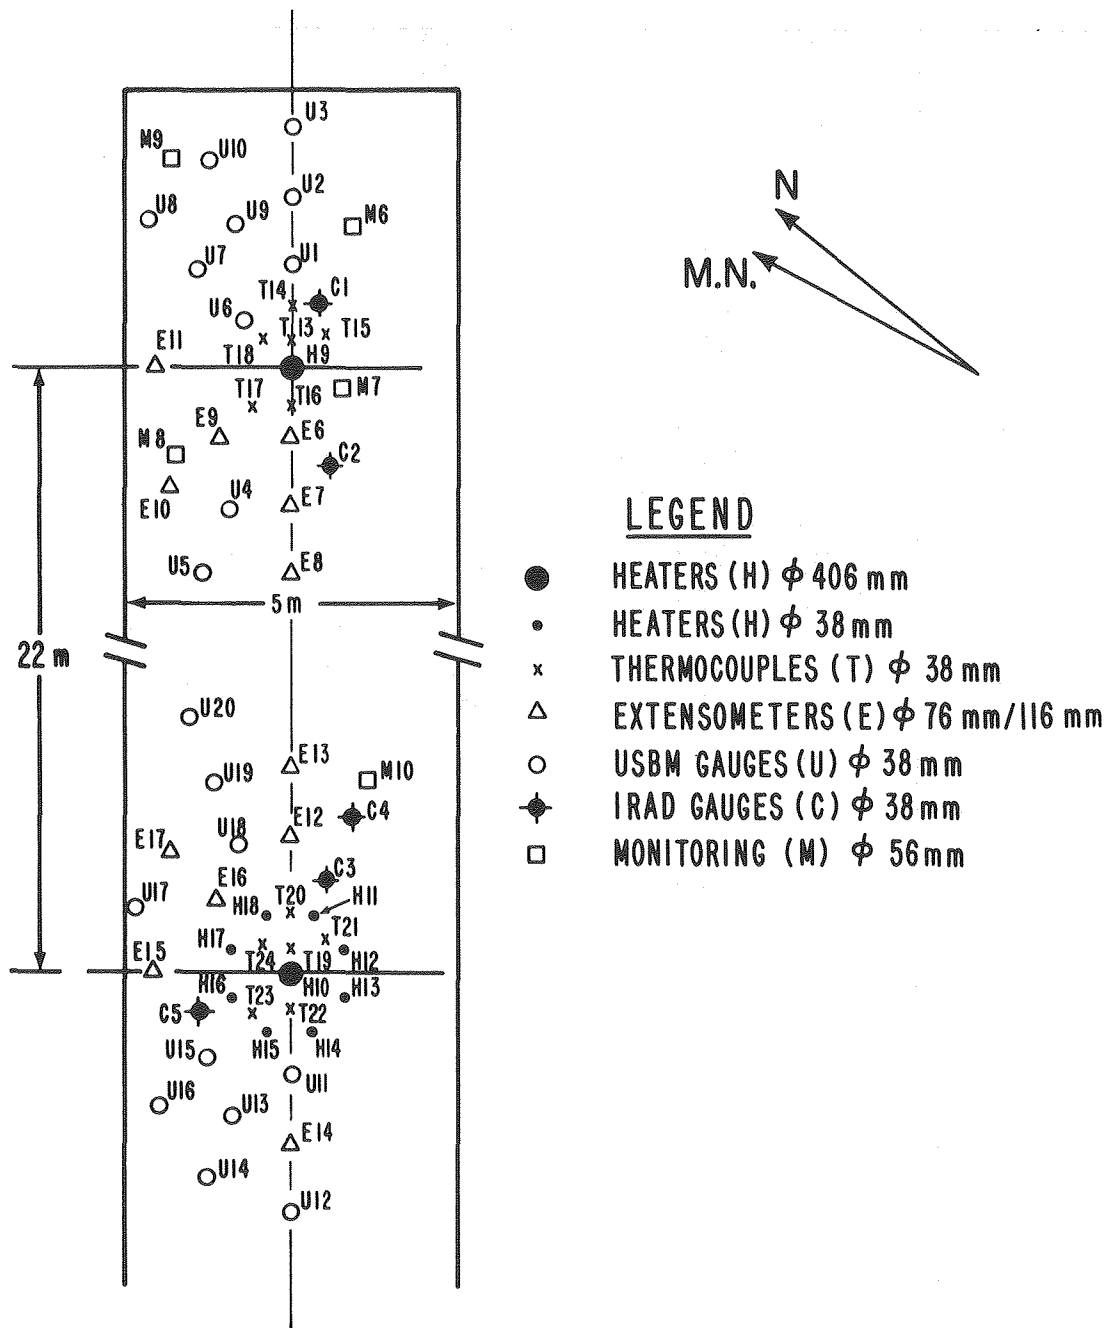
Fig. 3. Borehole layout in the full-scale drift (from Kurfurst et al., 1978).

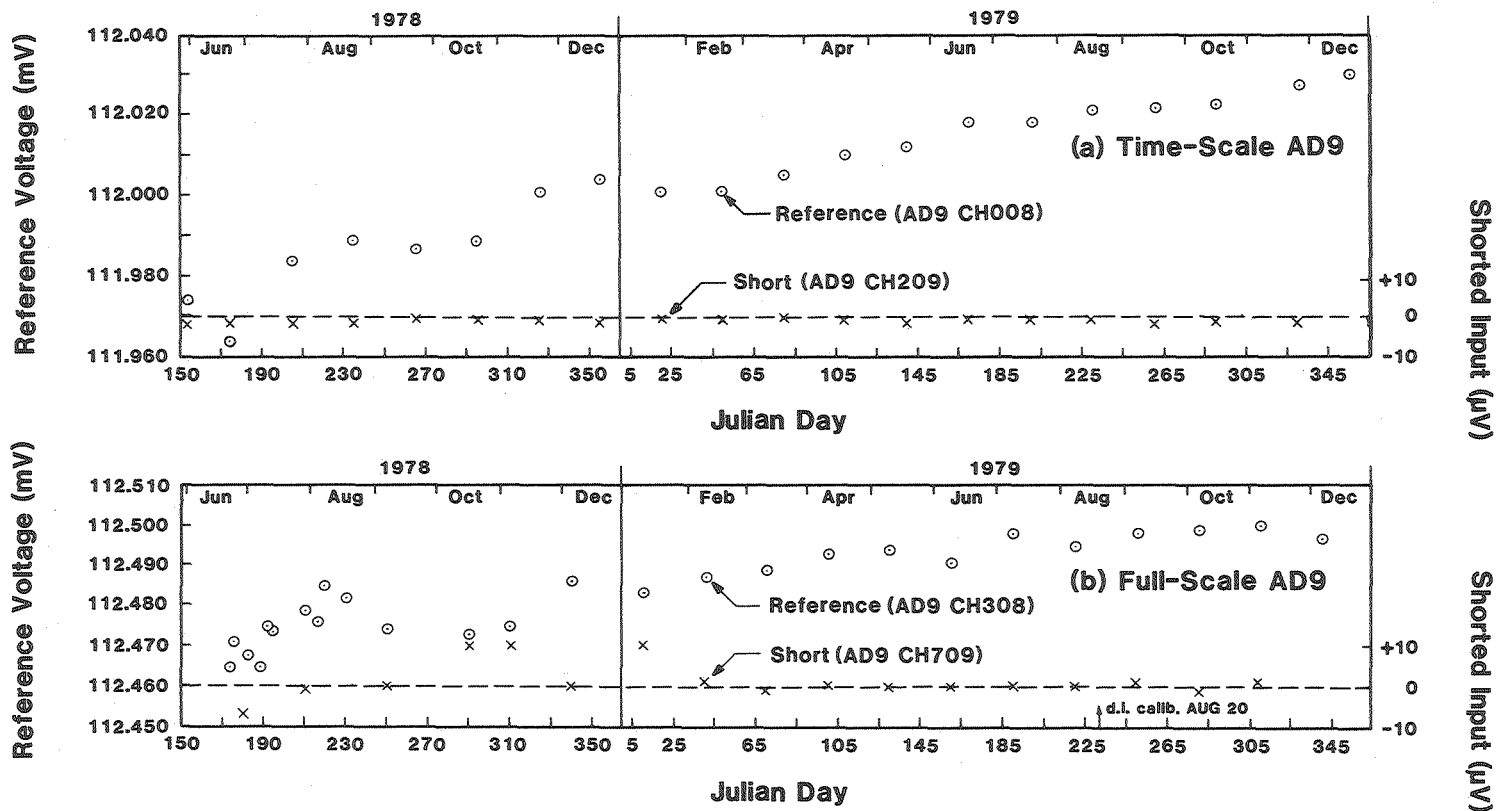
Fig. 10. Reference voltage and shorted input measurements for: (a) Time-scaled AD-9 and (b) Full-scale AD-9 (from Chan et al., 1980).

Long term stability of the AD-9s is discussed in Appendix B of Chan et al. (1980). Each AD-9 continuously recorded a voltage from a dedicated reference voltage source, and zero-volt references from short-circuited input terminals. Figure 10 shows the reference voltages recorded by the data loggers, which indicate that drift occurred. Full-scale drift amounts to about 40 μV and time-scaled drift about 60 μV . The same reference voltages recorded in parallel on other data logger channels agreed to within one or two microvolts. The stability of the reference source voltages, shown in Table 7, indicates that the AD-9 data loggers drifted rather than the source voltage with the exception of a negative 10- μV drift in the reference voltage source used with the full-scale AD-9. For a reference voltage of approximately 0.112 V, this brings the total drift in the full scale AD-9 up to 50 μV , nearly equivalent to the 60- μV drift monitored in the time-scaled AD-9. Drift on the shorted inputs was essentially zero. Calibrations discussed in Section 3.4.2 furnish additional information on the AD-9s, and how their accuracies affect temperature data.

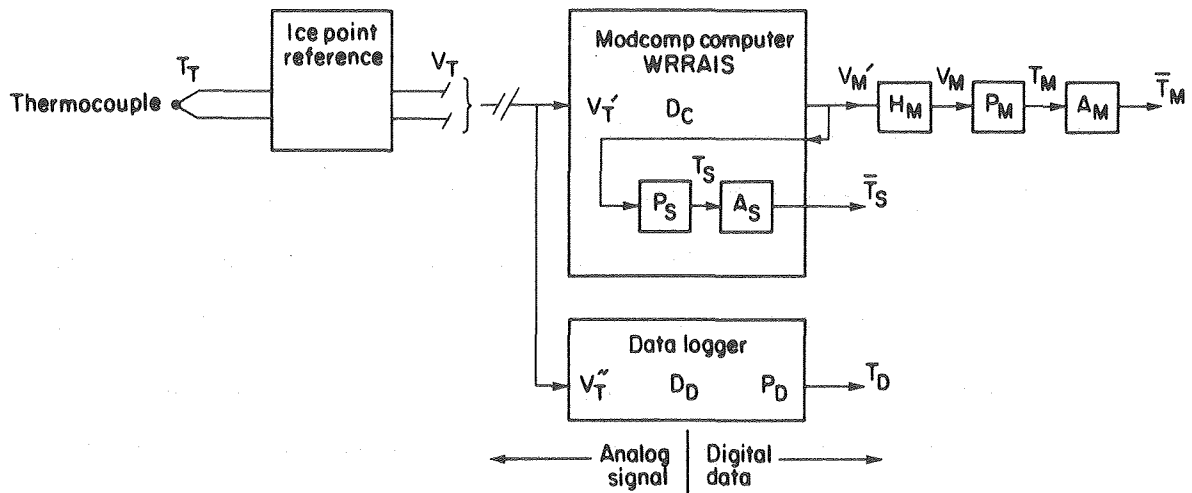
- T_T Temperature of thermocouple junction.
 V_T Voltage generated by thermocouple at temperature T_T .
 V_T' V_T plus noise voltage sensed by computer's analog circuitry (e.g., from ground loop currents, common-mode and normal-mode noise pickup, etc.). Common-mode noise was not rejected well by computer input circuits.
 V_T'' V_T plus noise voltage sensed by data logger circuits: Common-mode noise was well rejected by data logger input circuits.
 V_M' Computer digitized and recorded voltages

The block diagram in Fig. 11 represents the Stripa temperature measuring system including thermocouples, data acquisition equipment, signal and data flow paths, and conversion and correction algorithms. The effects of the various components of the system on the signals and data are also listed in the figure. Some of the operators and algorithms were generated from results of the in-situ thermocouple system calibrations that encompassed the associated data acquisition hardware, and others were generated from standards and calibration tables and other calibrations of the computer's analog-to-digital conversion hardware (Chan et al., 1980).

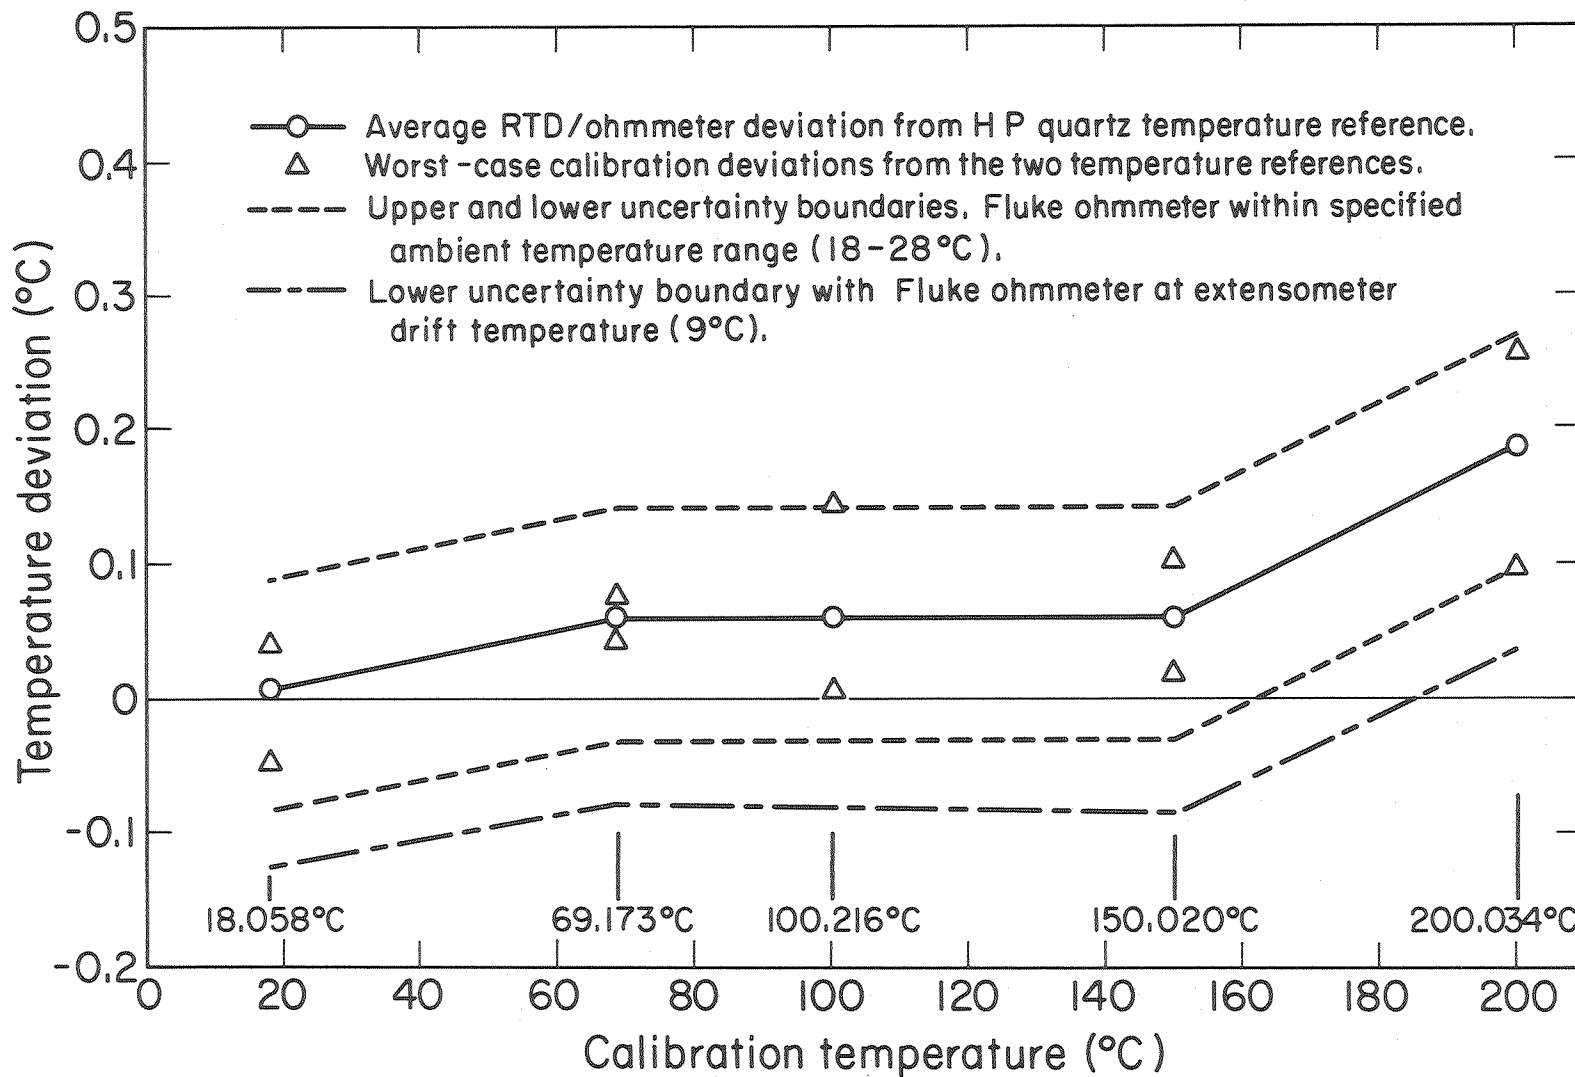
Fig. 13. Temperature reference system (RTD and Fluke ohmmeter) calibration summary with uncertainty boundaries.

As explained in Section 3.2, it was discovered that the temperature reference RTD had been self-heating during the original thermocouple calibrations and first recalibrations. Self-heating is caused by I^2R electrical power dissipation in the RTD resistance element. This was significant during the Stripa calibrations due to the relatively high

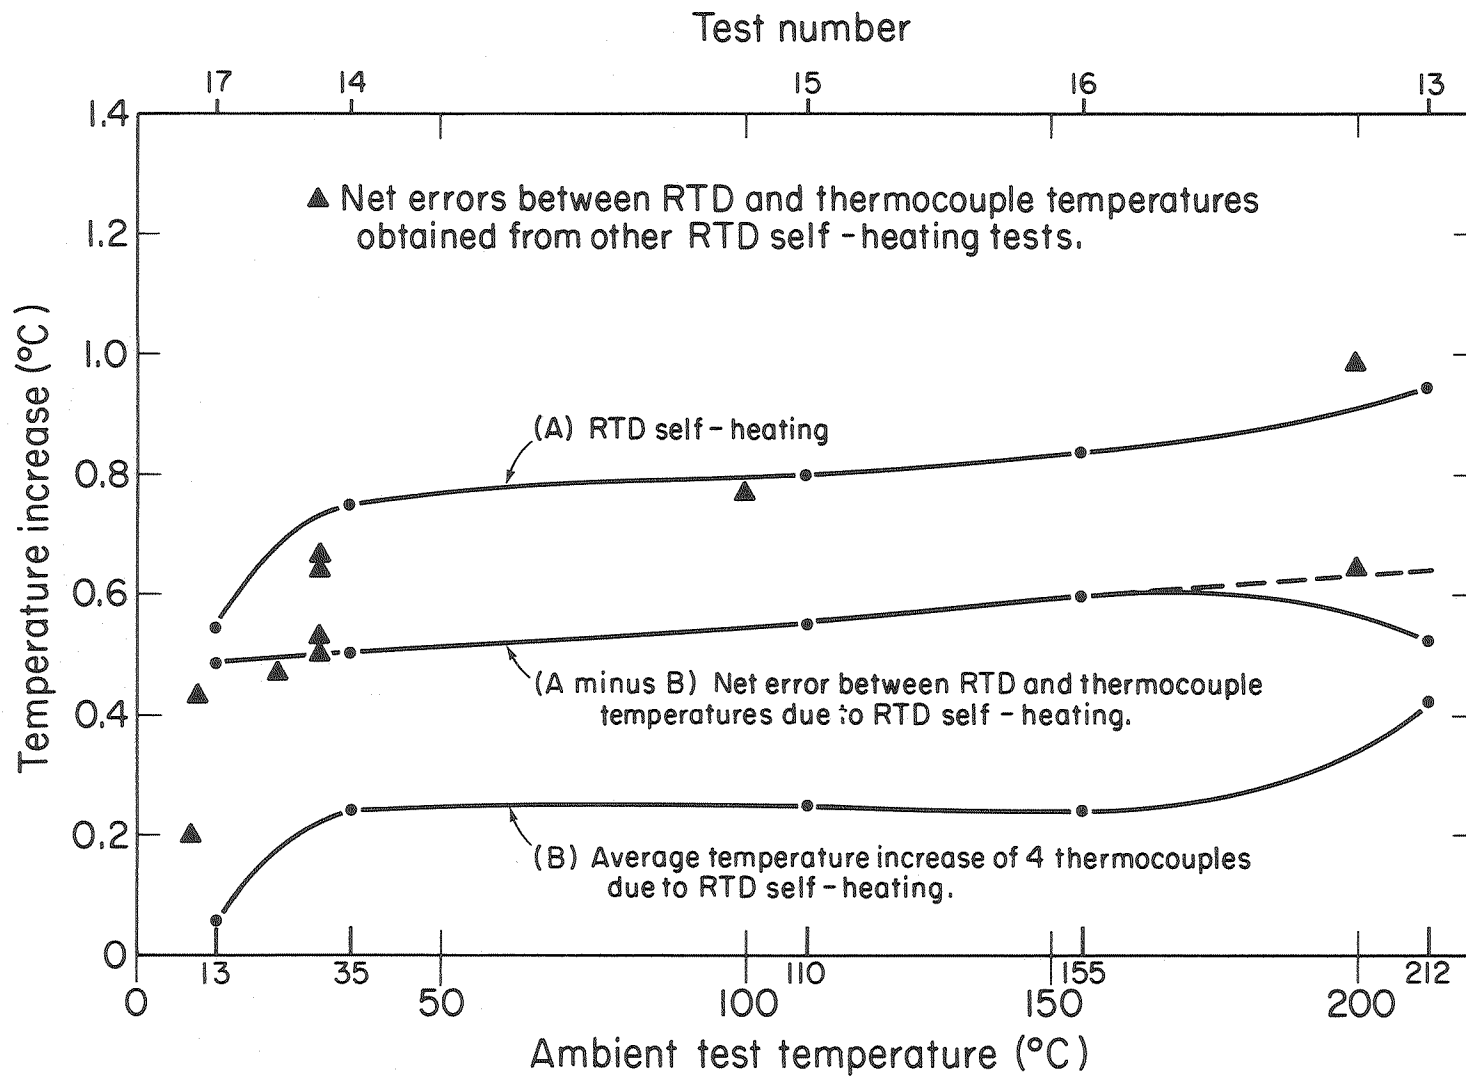
Fig. 14. Results of RTD self-heating tests.

The amount of RTD self-heating was a function of variations in thermocouple bundling around the RTD, placement in the aluminum cylinder, the amount of insulation and method used to close the cylinder opening, and the selected oven temperature. As a result RTD self-heating varied from a low of 0.55°C with the RTD and thermocouple bundle in contact with the aluminum cylinder and the oven at 13.5°C , to a high of 1.2°C with the bundled RTD centered in the cylinder and the oven at 200°C .

The RTD self-heating also caused a rise in temperature in the thermocouples bundled around it. The effect on any thermocouple in the bundle was dependent on its proximity to the RTD; the closer to the RTD, the greater the heating, and, consequently, the less the calibration error. Figure 14 shows the results of the best behaved series of self-heating tests at five oven temperatures from 13 to 212°C . Each test was done at a fixed oven (ambient test) temperature. Test temperatures are shown on the figure. The bundle configuration and placement in the oven were the same for all five temperatures. RTD self-heating (A) and the resulting average temperature increase of four randomly picked thermocouples (B) in the bundle are plotted. The third plot (A minus B) shows the average error that should have been introduced between the four thermocouples and the RTD due to self-heating during a thermocouple calibration run. This error is approximately 0.5°C at low temperature, increasing to about 0.6°C at higher temperatures for tests in the full-scale experiment drift. The low values on curves A and B at 13°C are probably due to a slight change in the oven temperature during that test run. This should have negligible effect on the A minus B point at 13°C .

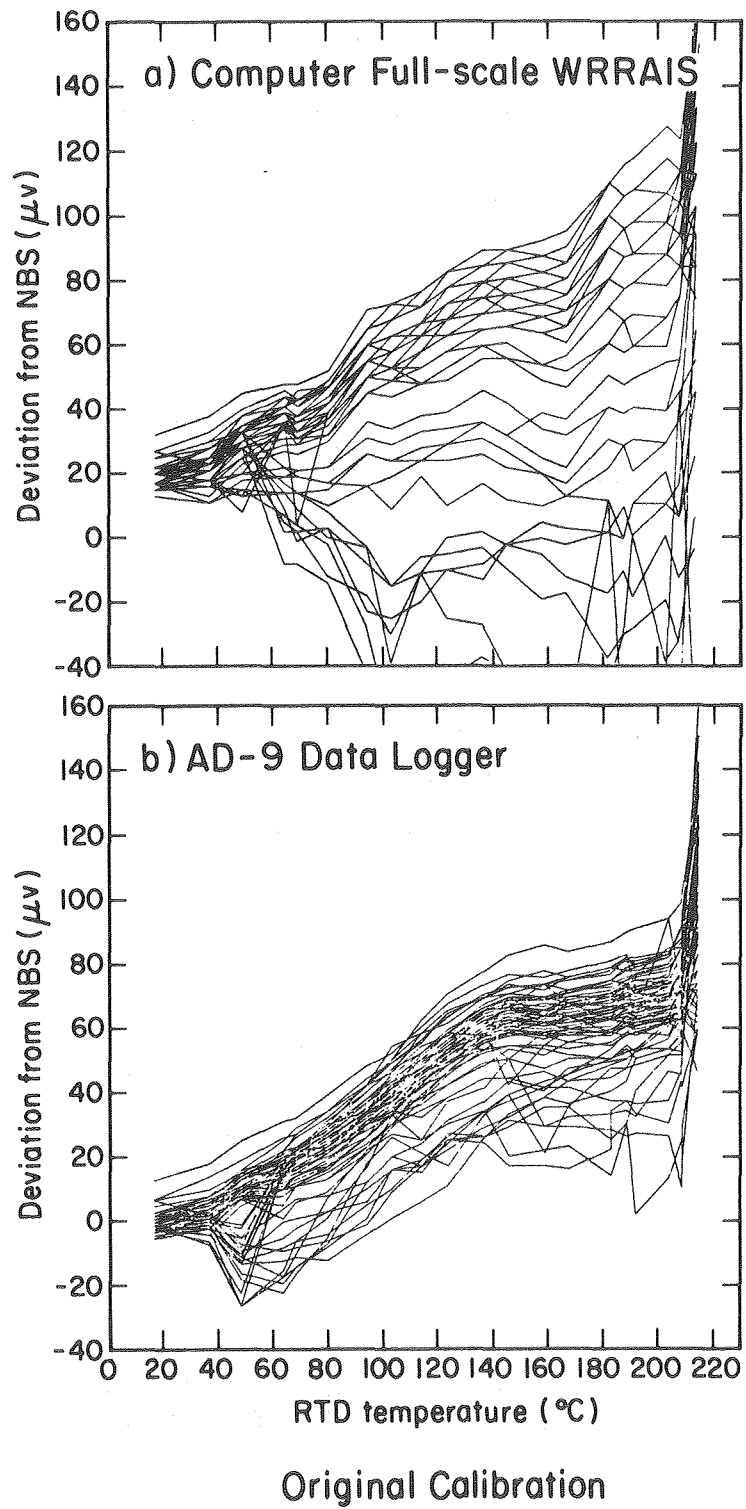
Fig. 18. Deviations of the stainless steel sheathed thermocouple calibrations from the NBS reference.

Errors from several sources have been removed from the calibration data. The plots shown in Figs. 16-21 have been corrected for the error values given below. Chan et al. (1980) described errors that occurred in the computer's wide-range relay analog-input subsystem (WRR AIS). During the original calibration, the full-scale WRR AIS had a voltage offset of 22.8 μV and a gain of 0.99775, and the time-scaled WRR AIS had a voltage offset of 32.5 μV and a gain of 0.99637. During the first and second recalibrations, the full-scale WRR AIS had a voltage offset of 81 μV and a gain of 0.9945, and the time-scaled WRR AIS had a voltage offset of -1.8 μV and a gain of 0.9982. The effects of the RTD self-heating and ohmmeter zeroing problem were estimated using the AD-9 data logger calibration data at the lowest calibration temperature readings. The RTD self-heating and non-zeroing of the ohmmeter caused an offset in the deviation of the thermocouple calibration voltages from the NBS values. This is most obvious at the lowest calibration temperatures where that deviation should approach zero in the deviation plots. RTD self-heating also causes a spreading in the thermocouple calibration voltage deviations from NBS values due to varying degrees of thermal coupling from the RTD to the thermocouples bundled around it during calibrations. This spreading is also most obvious at the lowest calibration temperature since the thermocouples should approach a common voltage output when near the cold junction reference temperature. Offset voltages for corrections to the deviation plots were determined by computing average offset at the lowest calibration temperatures for each class of thermocouples. These voltage offsets were -22.5 μV during the original calibration, 8.8 μV

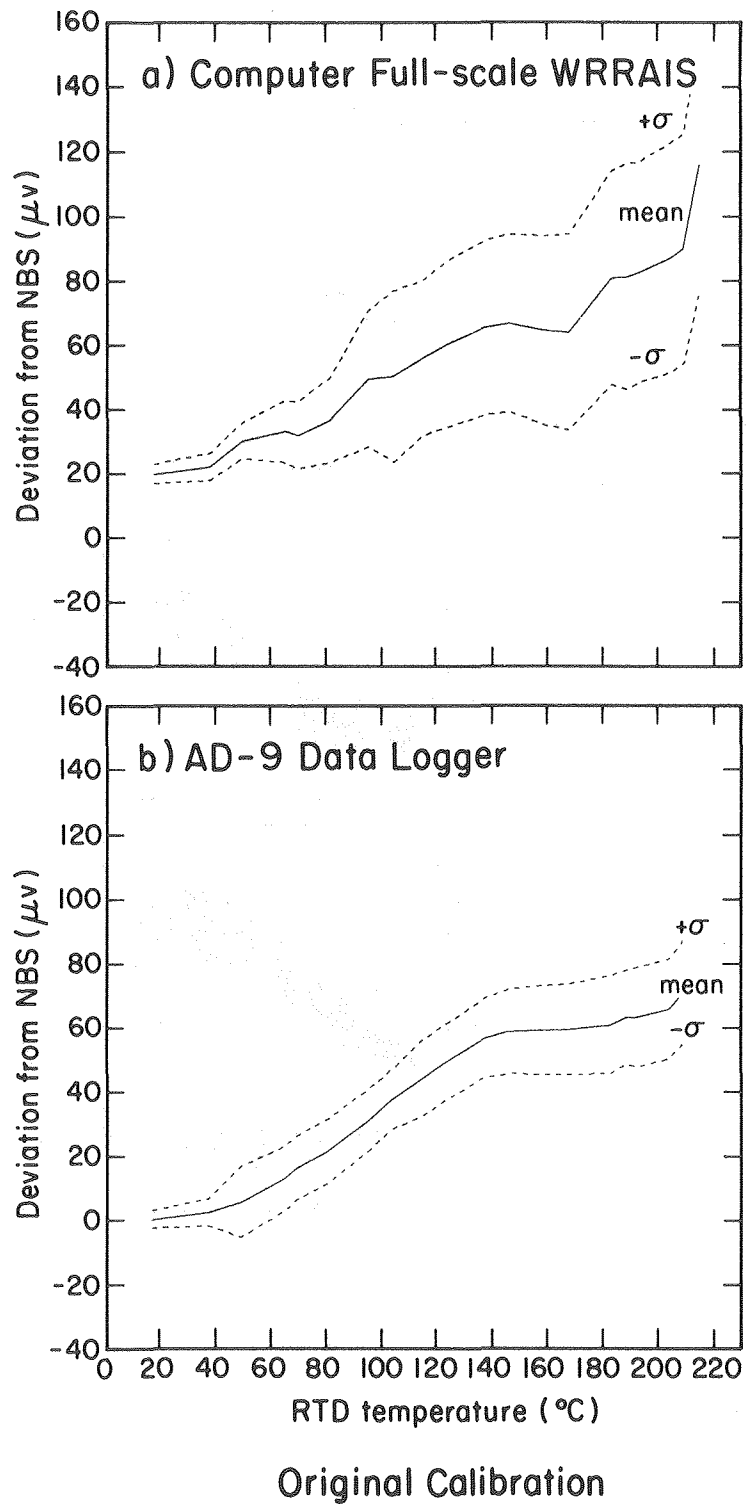
Fig. 19. Statistical deviations of the stainless steel sheathed thermocouple calibrations from the NBS reference.

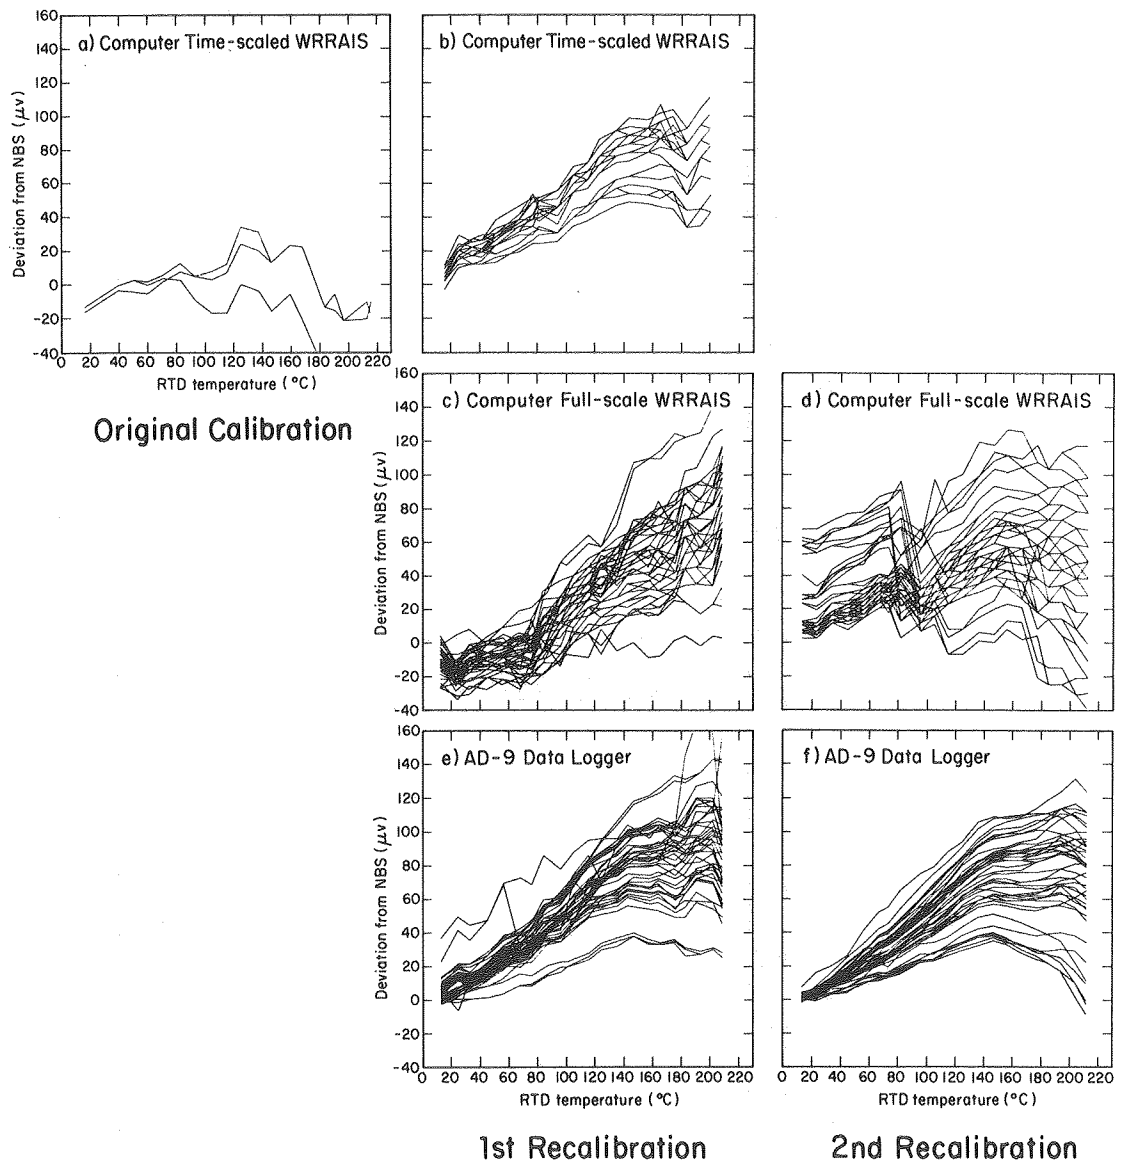
Fig. 20. Deviations of the Inconel sheathed thermocouple calibrations from the NBS reference.

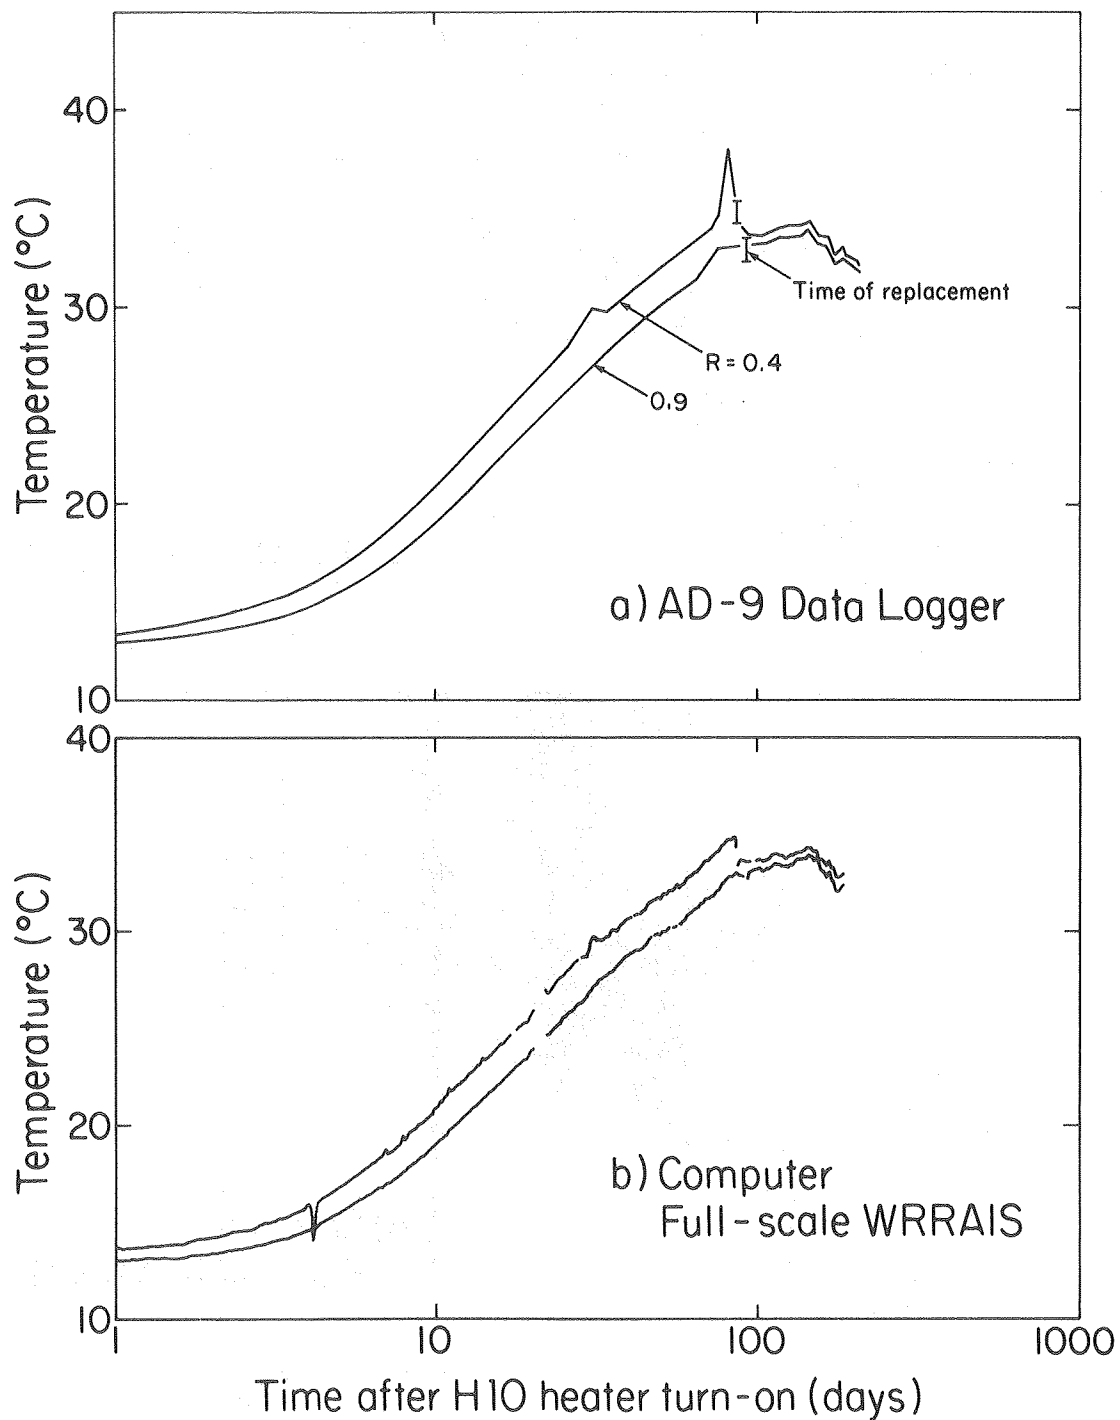
Fig. 22. Temperature after H10 heater turn-on, measured at $z = +3\text{m}$ by: (a) AD-9 data logger (from Javandel and Witherspoon, 1981) and (b) full-scale WRR AIS.

programmed to acquire data at intervals as great as 6 hours while the computer acquired data at 15-minute intervals. Figures 22-24 are provided as examples comparing plots from data logger and computer-acquired data as a function of time.

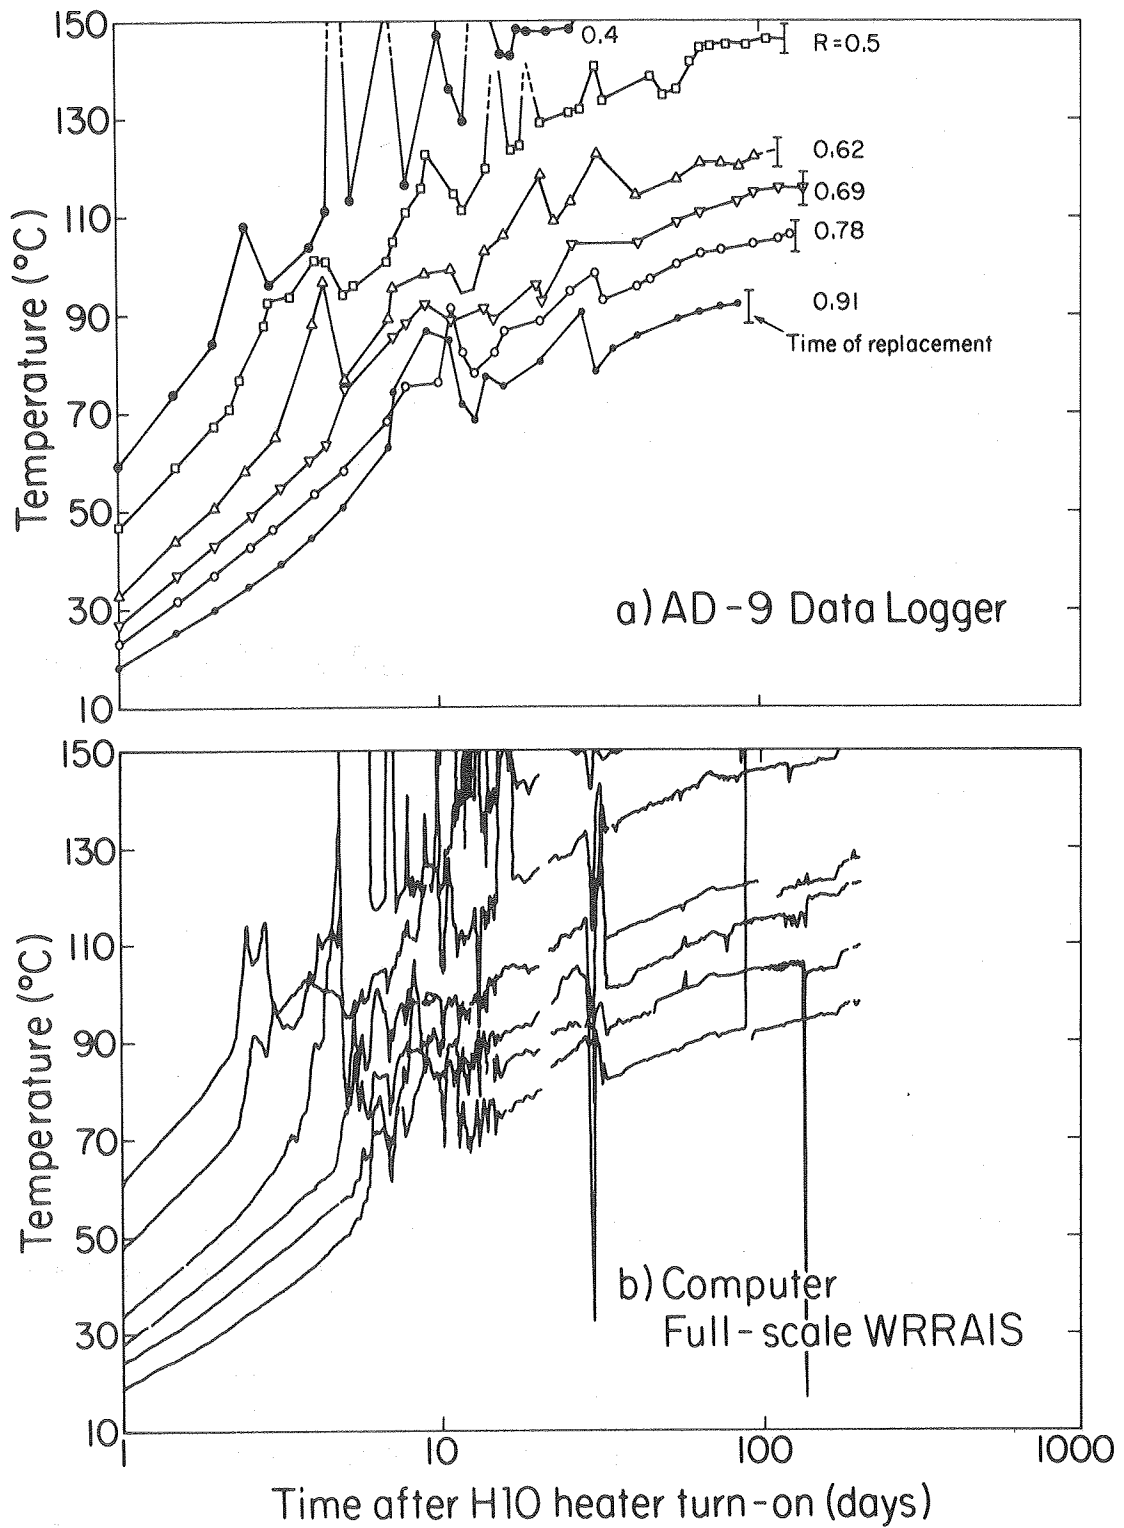
Fig. 23. Temperature after H10 heater turn-on, measured at heater midplane ($z = 0.0$) by: (a) AD-9 data logger (from Javandel and Witherspoon, 1981) and (b) full-scale WRRRAIS.

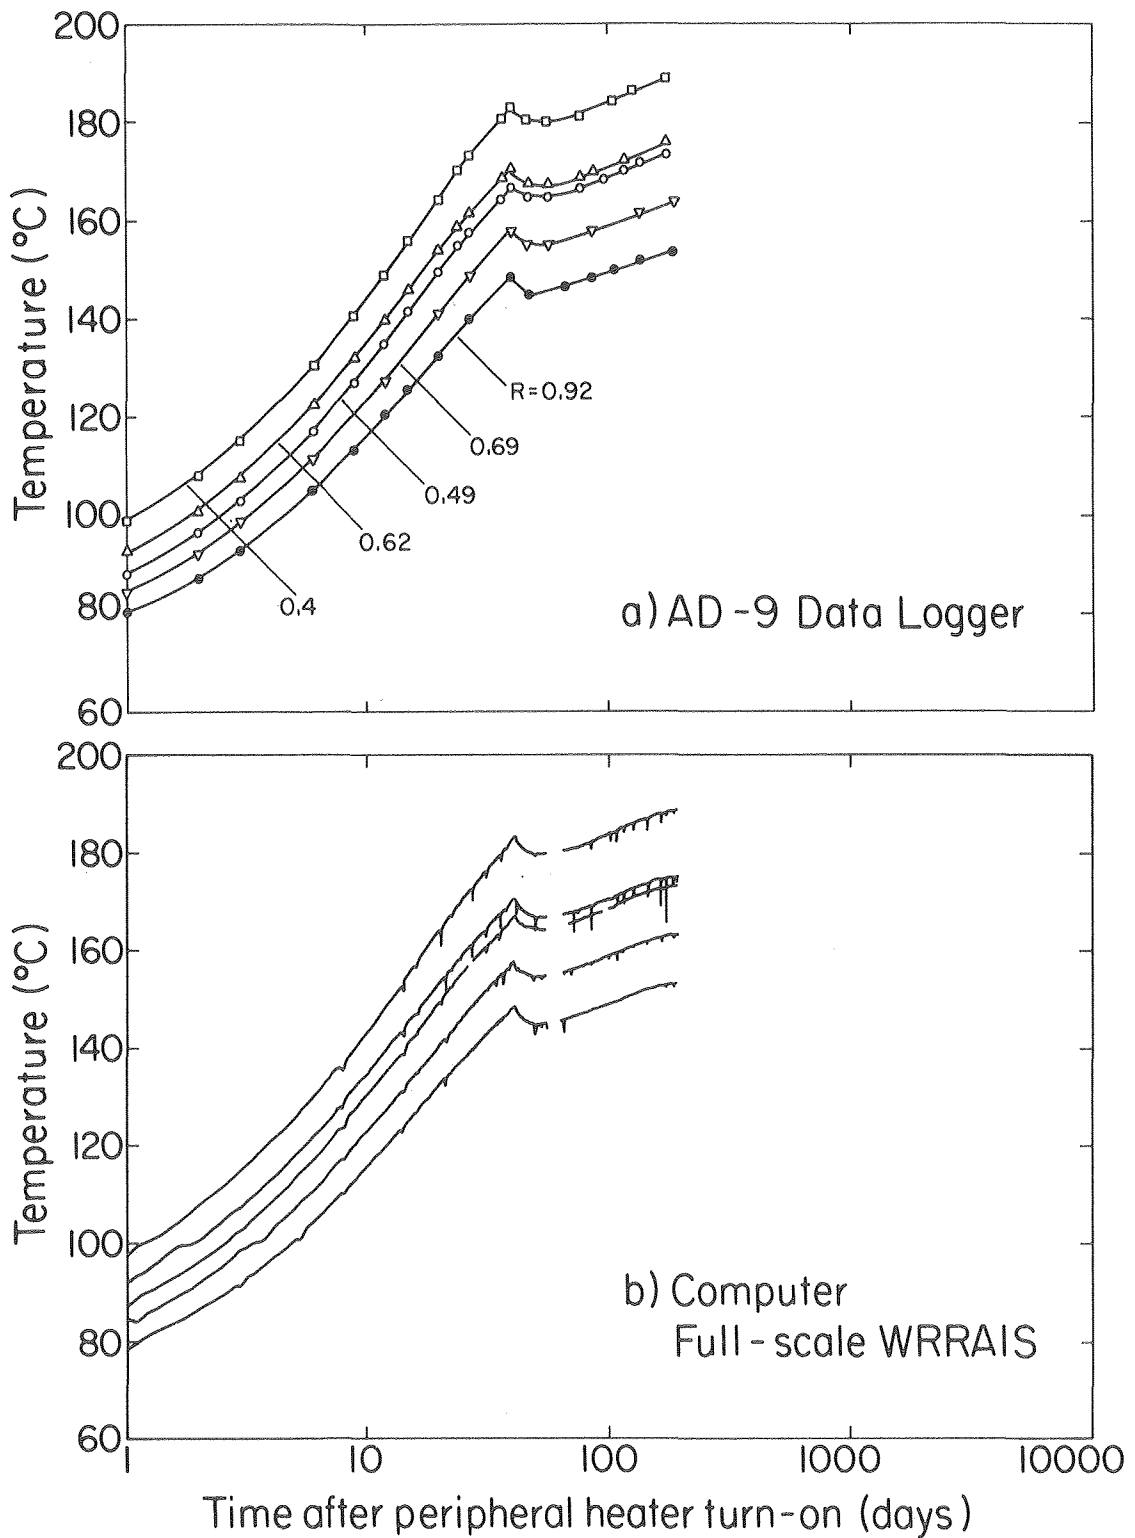
Fig. 24. Temperature after peripheral heater turn-on, measured at $z = -1.5$ m by: (a) AD-9 data logger (from Javandel and Witherspoon, 1981) and (b) full-scale WRRAIS.

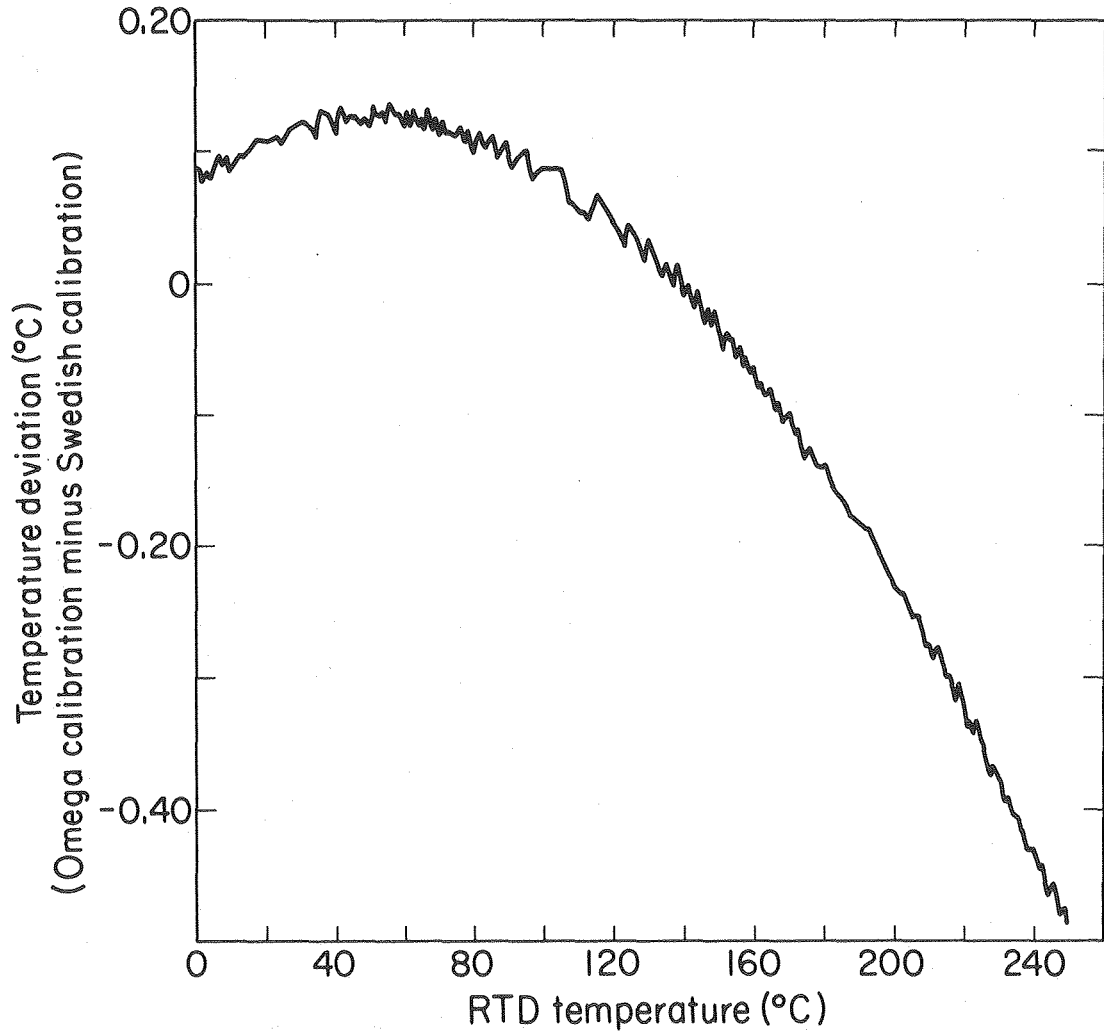
Fig. A-3. Deviation between RTD calibrations from Omega Engineering and the Swedish Bureau of Standards.

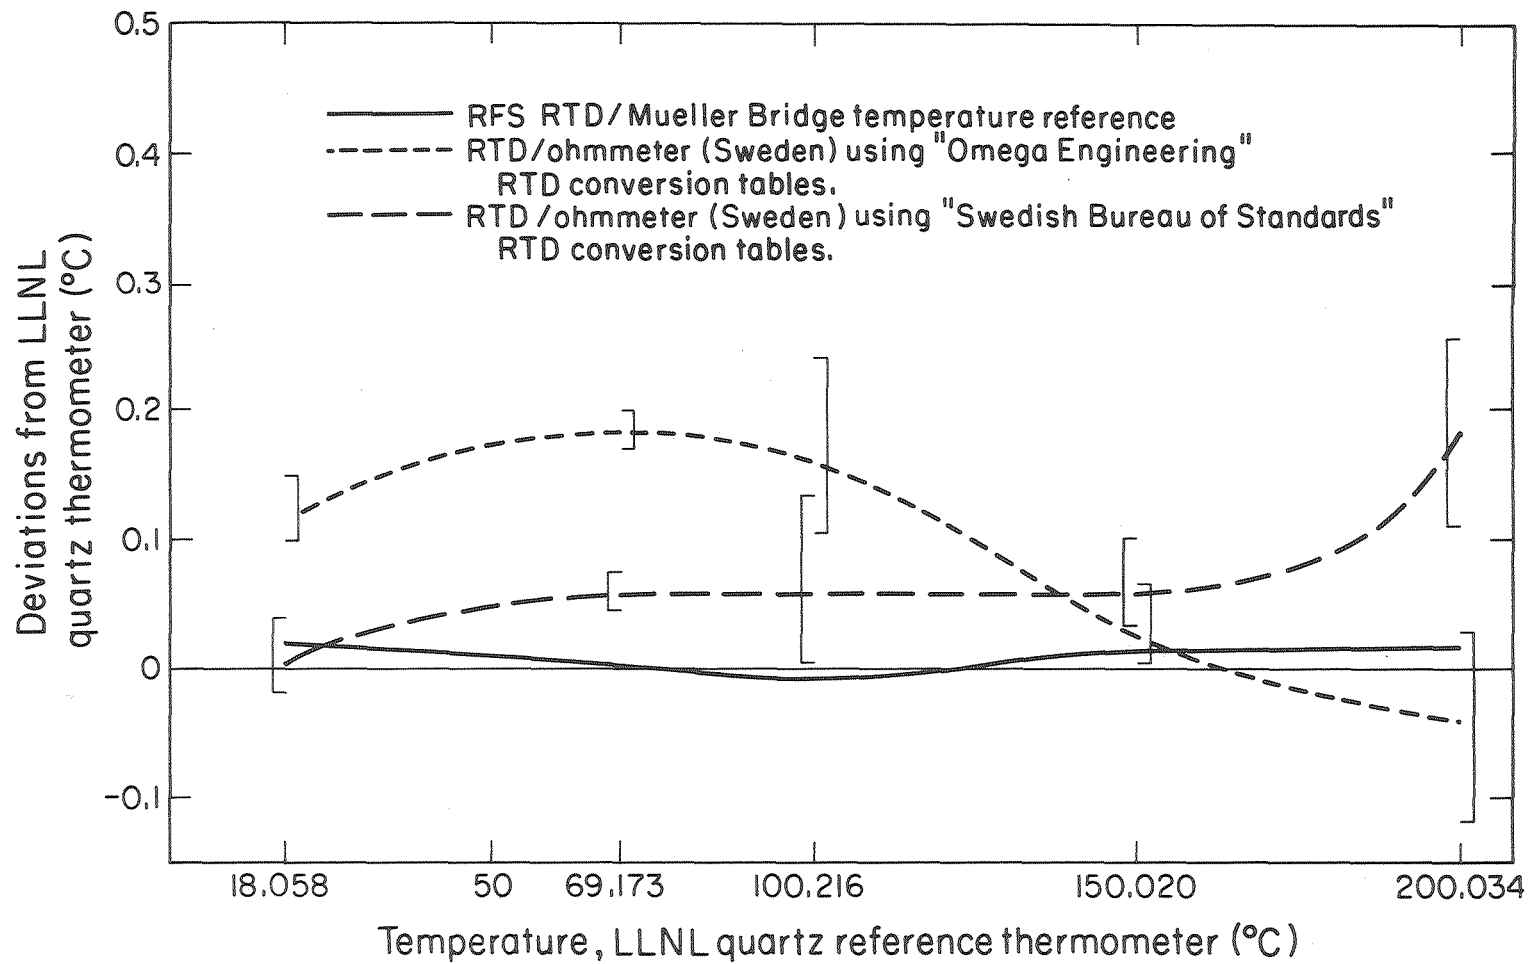
Fig. A-4. Richmond Field Station Calibration of RTD (S/N 1116) and Fluke 8500A ohmmeter (S/N 805003) used in Sweden for thermocouple calibrations.
