Deep Energy Retrofits - Eleven California Case Studies

# Deep Energy Retrofits—Eleven California Case Studies

Brennan Less, Jeremy Fisher and Iain Walker

October 2012

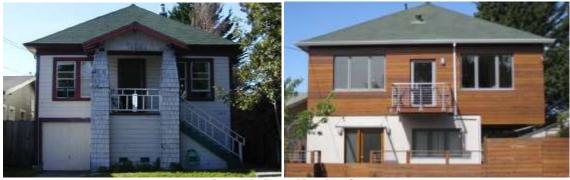
Image 1 P1 Pre- and Post-Retrofit

P1	Pre-Retrofit	Post-Retrofit
ENVELOPE		
Wall Insulation	None	1 <sup>st</sup> floor: 5.5" dense pack (dp) cellulose – R19 2 <sup>nd</sup> floor: 3.5" dp cellulose, 2" PolyIso – R23
Attic/Roof Insulation	Some fiberglass	10" dp cellulose in attic floor- R38
Foundation Insulation	None	1" XPS slab perimeter – R5 3" Polyiso over slab with thermally broken wooden sleepers – R21
Windows	Single pane wood frame, double hung replacements	2 pane, low E, Argon, wood frame – U-0.3, SHGC-0.35, VT- 0.54
Air Leakage		271 CFM <sub>50</sub> , 1.1 ACH <sub>50</sub>
MECHANICAL		
Cooling	None	None
Heating	Gas Floor Furnace, 60% efficient, on second floor, no distribution	Electric resistance baseboard heaters in each room
DHW	40 gal gas tank in garage	Gas Tankless, 0.84EF. 11-199kBtu/hr
Ventilation	Natural	ERV – ECM motor, humidistat controlled, fully ducted bath & kitchen exhausts, bedrooms and living room supply. SRE 81-83, TRE 44-53

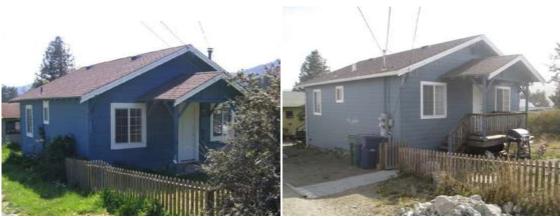
Image 14 - P5 Pre- and Post-Retrofit

P5	Pre-Retrofit	Post-Retrofit
ENVELOPE		
Wall Insulation	2X4 fiberglass batts	3.5" cellulose, 1" XPS – R18
Attic/Roof Insulation	Some fiberglass batts	16" loose fill cellulose – R57
Foundation Insulation	R-19 fiberglass batts	Sealed crawlspace, 11.5" blown cellulose – R41
Windows	Single pane aluminum frame	2 pane, Low E, argon filled, fiberglass frame. Unknown values
Air Leakage		292 CFM <sub>50</sub> , 2.4 ACH <sub>50</sub>
MECHANICAL		
Heating	Wood fireplace	Electric wall radiators
DHW		40 gal. electric tank EF 0.88
Ventilation		Bath and kitchen exhaust, point source ERV
LIGHTS/APPLIANCES/MEL		Mostly CFL, fairly inefficient appliances, very low MELs
RENEWABLES		None

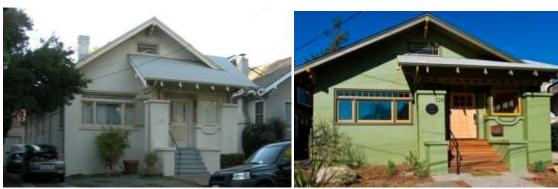
Image 34 - P8 Pre- and Post-Retrofit

P8	Pre-Retrofit	Post-Retrofit
ENVELOPE		
Wall Insulation	None	3.5" blown cellulose – R13
Attic/Roof Insulation	Some fiberglass batts	4" closed cell spray foam – R28
Foundation Insulation	None	Fiberglass batts – R19
Windows	Single pane wood frame	Most windows replaced with 2 Pane, Low E, Argon, fiberglass frame – U: 0.33 SHGC: 0.3
Air Leakage		2,397 CFM <sub>50</sub> , 9.3 ACH <sub>50</sub>
MECHANICAL		
Heating and DHW	Old gas furnace with 2 floor grills, gas tank DHW	3 panel solar thermal combisystem with 96% efficient condensing gas boiler, 120 gal storage tank, hydronic baseboard radiators, zone controlled
Ventilation	None	Bath and kitchen exhaust
Distribution	Sheet metal	Insulated Pex
LIGHTS/APPLIANCES/MEL	Old, inefficient	New, highest efficiency, CFL & LED lighting, 2 <sup>nd</sup> Refrigerator in garage, high MELs
RENEWABLES	None	2.7 kW PV

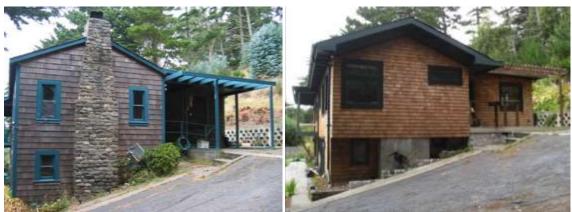
Image 43 - P10 Pre- and Post-Retrofit

P10	Pre-Retrofit	Post-Retrofit
ENVELOPE		
Wall Insulation	None	3.5" low density SPF – R13 5.5" low density SFP in garden room – R19
Attic/Roof Insulation	None	7.5"- 9.5" low density SPF – R25-R32
Foundation Insulation	None	4.5"- 6" low density SPF – R16-R22
Windows	Single pane wood frame	Most windows replaced with 2 Pane, Low E, Argon, Aluminum Clad – U: 0.29-0.34 SHGC: 0.23-0.32
Air Leakage		1,455 CFM <sub>50</sub> , 6.1 ACH <sub>50</sub>
MECHANICAL		
Heating and DHW	Wood fireplace	Woodstove, 75% thermally efficient, 2 panel solar thermal combisystem with 96% efficient condensing gas boiler, 120 gal storage tank, zone controlled underfloor hydronic heating
Ventilation	None	Bath and kitchen exhaust
Distribution	None	Insulated Pex
LIGHTS/APPLIANCES/MEL	Old, dark, inefficient	Energy Star appliances, CFL, LED & Halogen lighting, skylights and solatubes, medium MEL
RENEWABLES	None	3.3 kW PV, two solar thermal panels

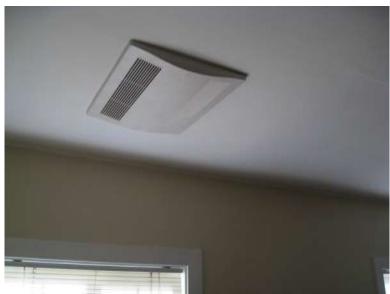
Image 48 - P5 Ceiling Mounted ERV

control. Prior to monitoring, it was reported that this unit was initially connected wrong, and it simply re-circulated air for the first year of occupancy. P3 also used an ERV with ECM motor, and after only 8 months of occupancy, the supply air intake grill had become completely clogged with debris from yard work, despite being nearly 8 feet off the ground. This blockage caused the ERV to increase its average wattage from 61 Watts to 117 Watts (see Figure 171 below). As seen below, the ERV was unclogged near the end of June 2011, and the power draw slowly increased until another cleaning in April 2012. The blockage increased noise and contributed to imbalanced system airflow, which can affect the recovery efficiency, ventilation rate and cabinet leakage of the unit. Without monitoring, this fault would likely have gone undetected, and maintenance may not be kept up in the future. P5 uses a small ERV with the supply outlet and exhaust inlet located on the same ceiling-mounted unit (see Image 48 below). Short-circuiting may be a concern in such systems, but this issue was not addressed in our research. Several visits to the home revealed that the ERV was not turned on for part of the monitoring, but it was eventually turned on and remained so. This illustrates the "stickiness" of occupant controls once they are on, they stay on, and once they are turned off, they stay off. P2 used HRVs integrated into its basement and attic air handlers to provide mechanical ventilation on a continuous schedule. The hourly power demand of the basement air handler is pictured in Figure 172 below. From March 2011 to early June 2011, the air handler cycled regularly at ~120 watts for eight hours, providing ventilation. From mid-June to August 2011, it never stopped ventilating, and after a few more transitions, in mid-November 2011, the unit completely ceased providing regularly scheduled ventilation. Fresh air was still brought in during system operation, but if there was no heating or cooling demand, no ventilation was provided. The attic air handler never operated on a set schedule, and no operation or ventilation was observed from early May 2011 to September 2011.
