Reflective Cracking Study: First-level Report on HVS Testing on Section 591RF - 45 mm
MAC15TR-GOverlay

Research Report: UCPRC-RR-2007-04

Reflective Cracking Study: First-Level Report on HVS Testing on Section 591RF — 45 mm MAC15TR-G Overlay

Partnered Pavement Research Program (PPRC) Contract Strategic Plan Element 4.10:
Development of Improved Rehabilitation Designs for Reflective Cracking

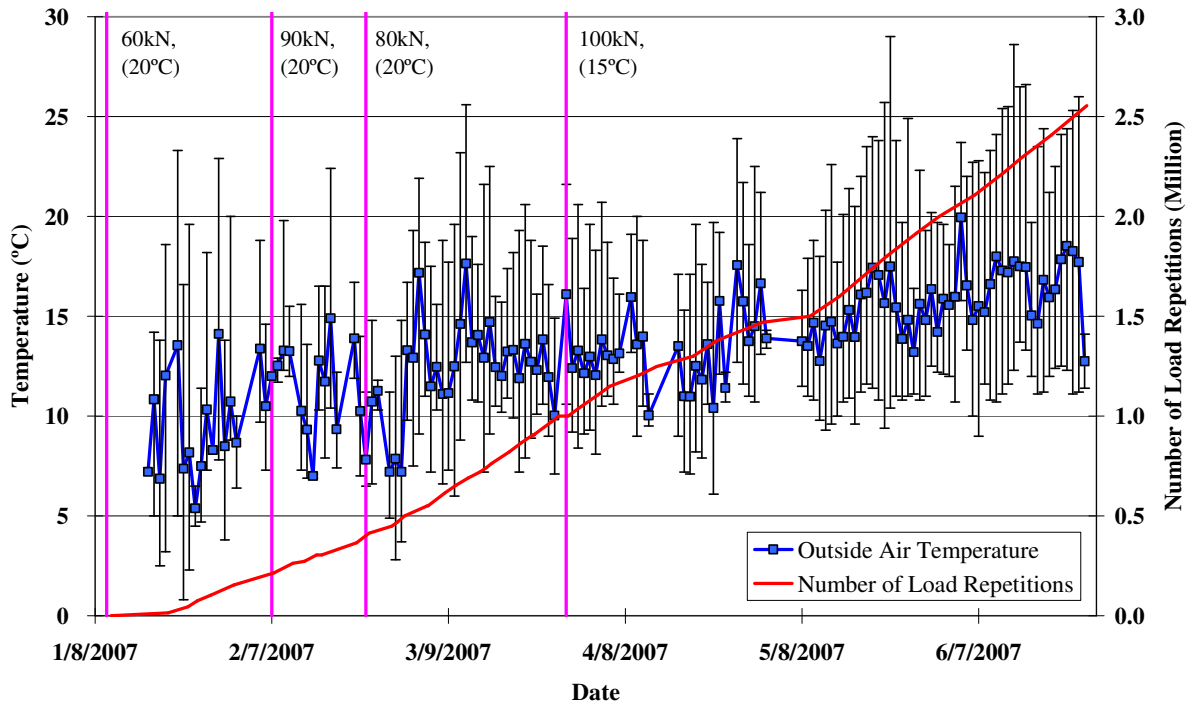
Figure 3.3: Daily average air temperatures outside the temperature control chamber.

Outside air temperatures ranged from 0.8°C to 29.0°C with an average of 13.4°C and are summarized in Figure 3.3. Vertical error bars on each point of the graph show daily temperature range.

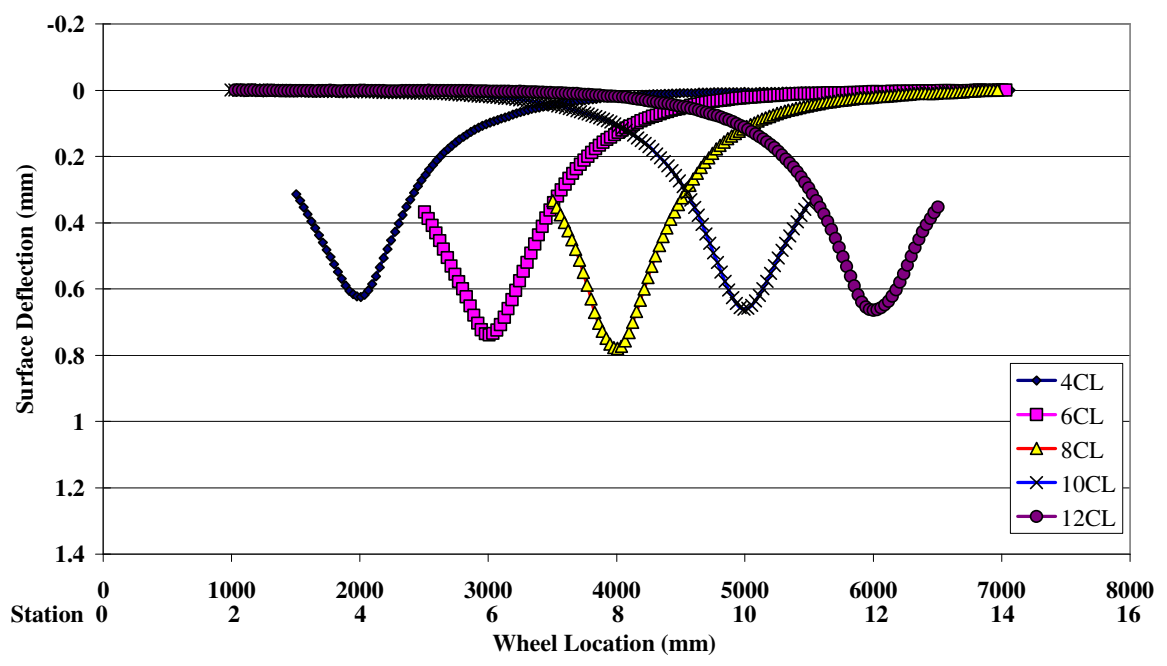
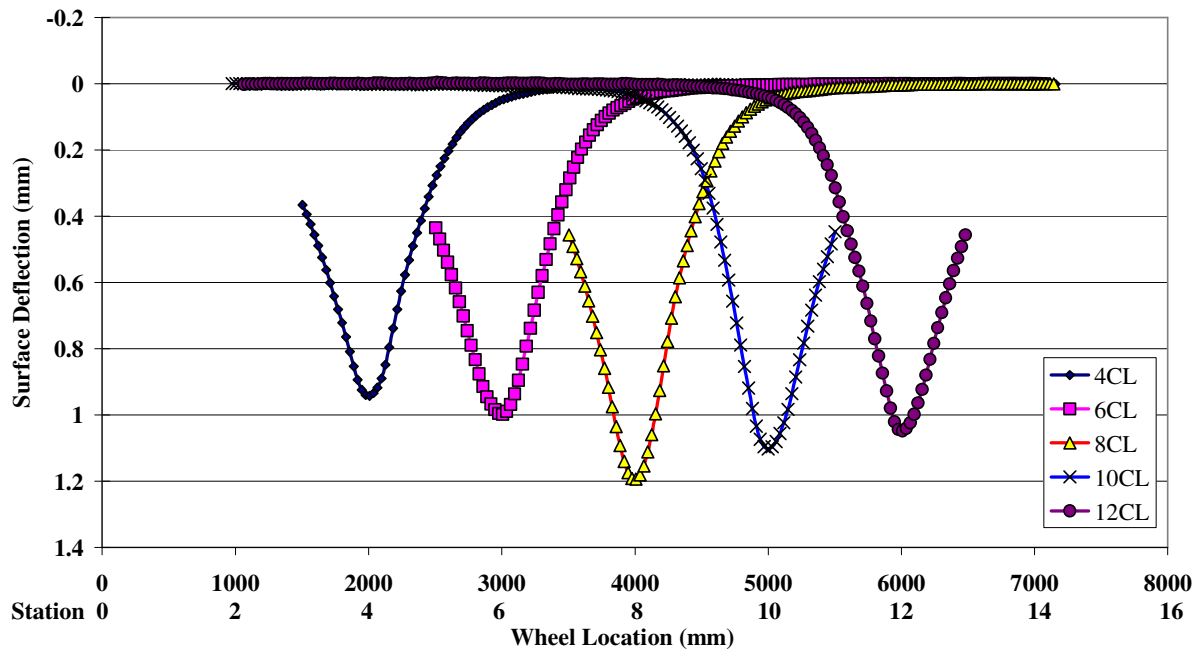
Figure 3.6: RSD deflections at CL locations with 60 kN test load at test start.

Figure 3.7: RSD deflections at CL locations with 60 kN test load after 215,000 repetitions. (90 kN load change)

Figure 3.8: RSD deflections at CL locations with 60 kN test load after 410,000 repetitions. (80 kN load change)

Figure 3.9: RSD deflections at CL locations with 60 kN test load after 1,000,000 repetitions. (100 kN load change)

Figure 3.10: RSD deflections at CL locations with 60 kN test load after 1,500,000 repetitions.

Figure 3.11: RSD deflections at CL locations with 60 kN test load after 2,000,000 repetitions.

Figure 3.12: RSD deflections at CL locations with 60 kN test load at test completion.

Deflections and damage rates both increased with increase in load. Figures 3.6 to 3.12 compare the deflection bowls at the same centerline locations at test start, at the three load change intervals, at 1.5 million and 2.0 million repetitions, and at test completion. The same scale is used on all the figures, and the increasing deflection in the early part of the test is clear. However, deflections did not increase when the load was increased to 100 kN (Figure 3.9). This is partly attributed to drying back of the base material. The higher deflections at Stations 8CL, 10CL, and 12CL over the more densely cracked underlying DGAC can be observed in Figures 3.10 to 3.12.

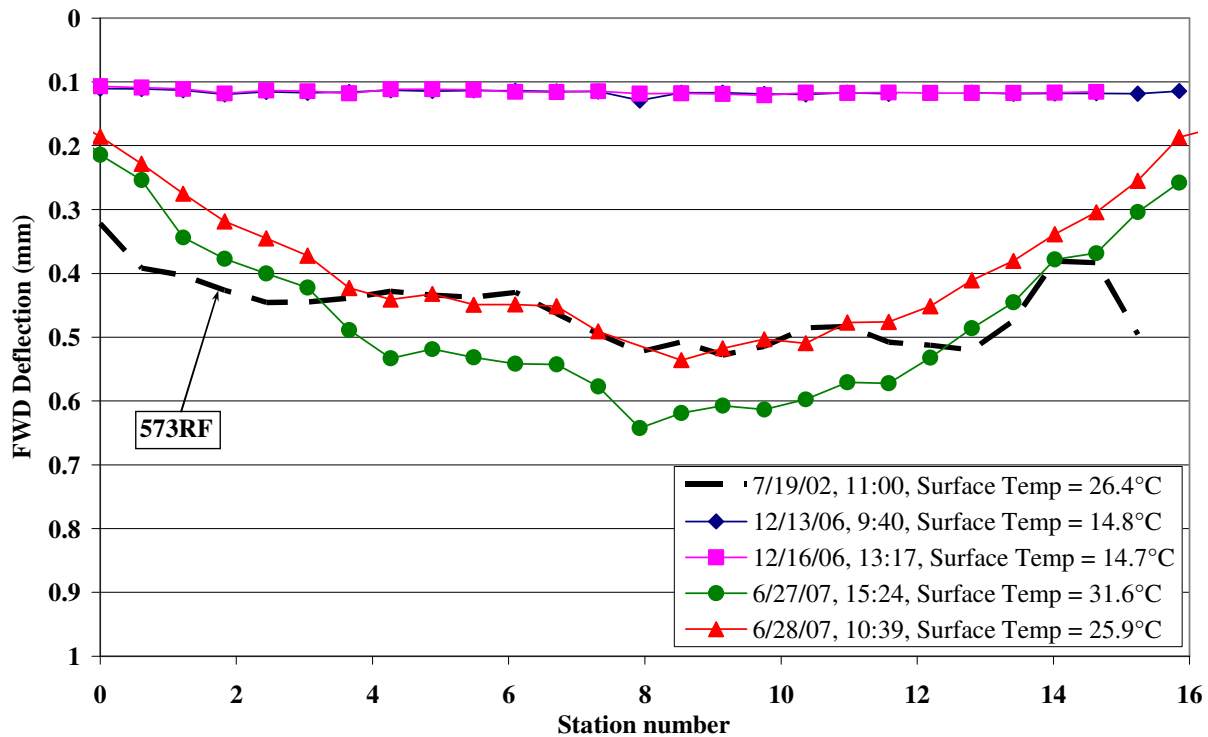
Figure 3.15: Composite pavement stiffness (FWD Sensor 1) on section centerline.
