City Of Anaheim / Caltrans / F H W A Advanced Traffic Control System Field Operational Test Evaluation: Task C Video Traffic Detection System

**City of Anaheim/Caltrans/FHWA
Advanced Traffic Control System Field
Operational Test Evaluation:
Task C Video Traffic Detection System**

UCB-ITS-PRR-98-32

Video Traffic Detection System

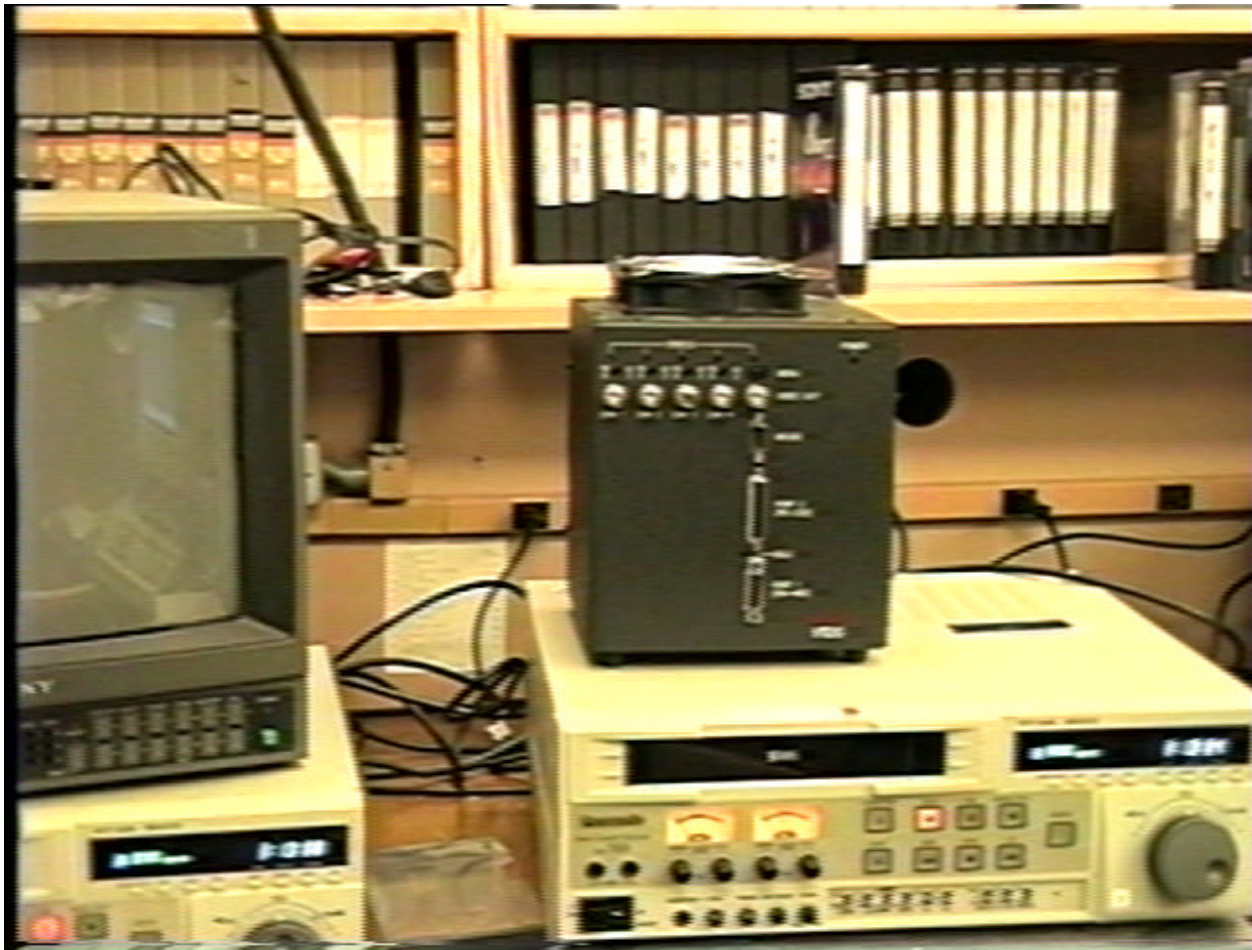
Figure 1. Odetics VTDS Evaluation Unit (on top of video tape recorder).

Following the November 1996 EOT meeting, we took delivery of a VTDS evaluation unit at Odetics' Anaheim facility. Odetics staff confirmed that the unit was fully operational, with the most recent firmware available, and was properly calibrated. Figure 1, below, is a single video frame from our documentary video records showing the evaluation unit prior to setup for testing at the Cal Poly Transportation Electronics Laboratory.

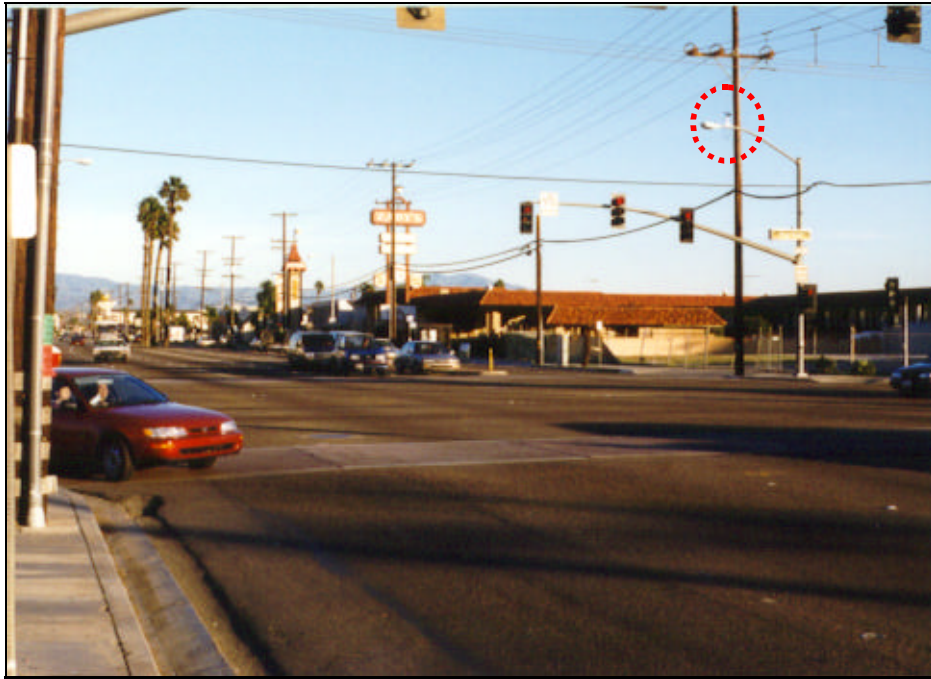
Figure 5. Harbor and Katella Test Intersection.

Figures 5 and 6 below are ground-level photographs of the Harbor/Katella and Clementine/Freedman test intersections, at which most of the test conditions were recorded. The positions of the VTDS cameras in each photograph are highlighted by dashed circles.

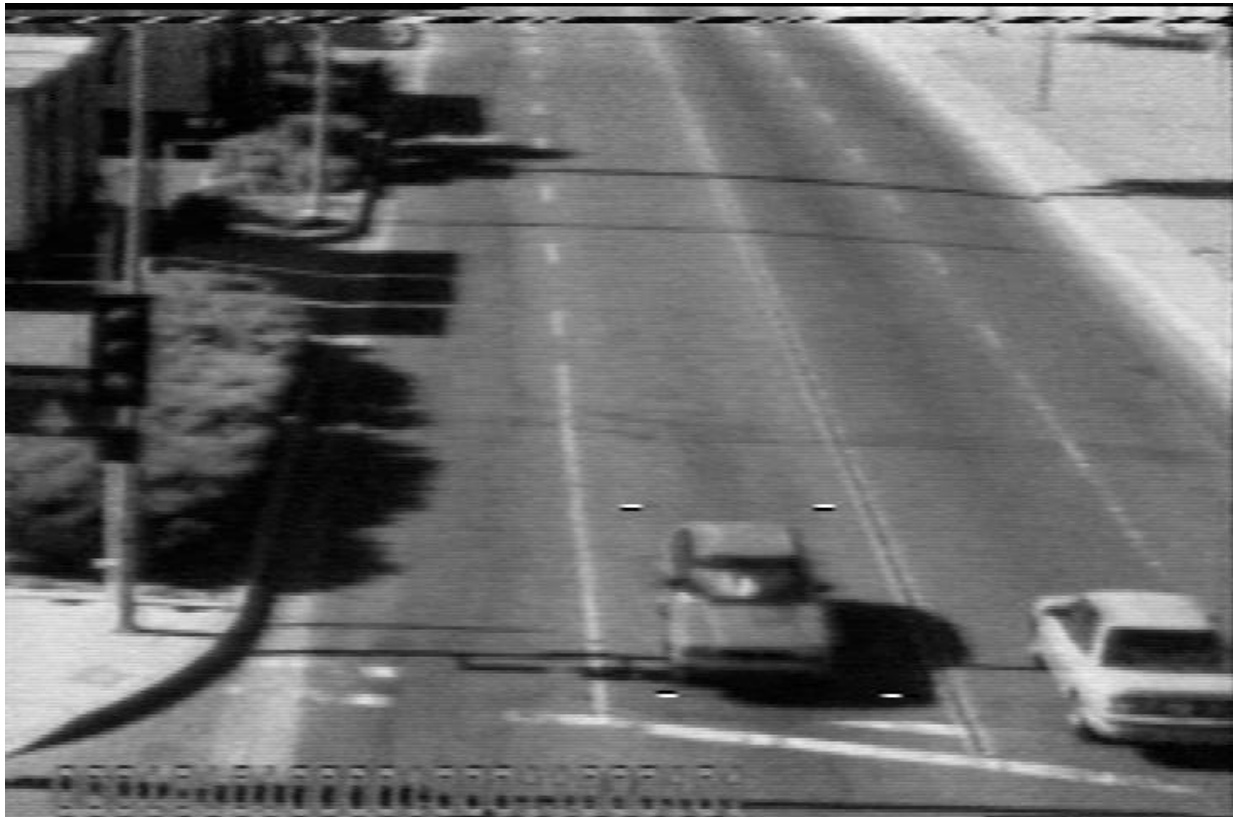
Site Plan:

Date/Time: 17 December '96, 11:00

Event Class 2: Detection w/ Latch

Location: Harbor & Katella, NB

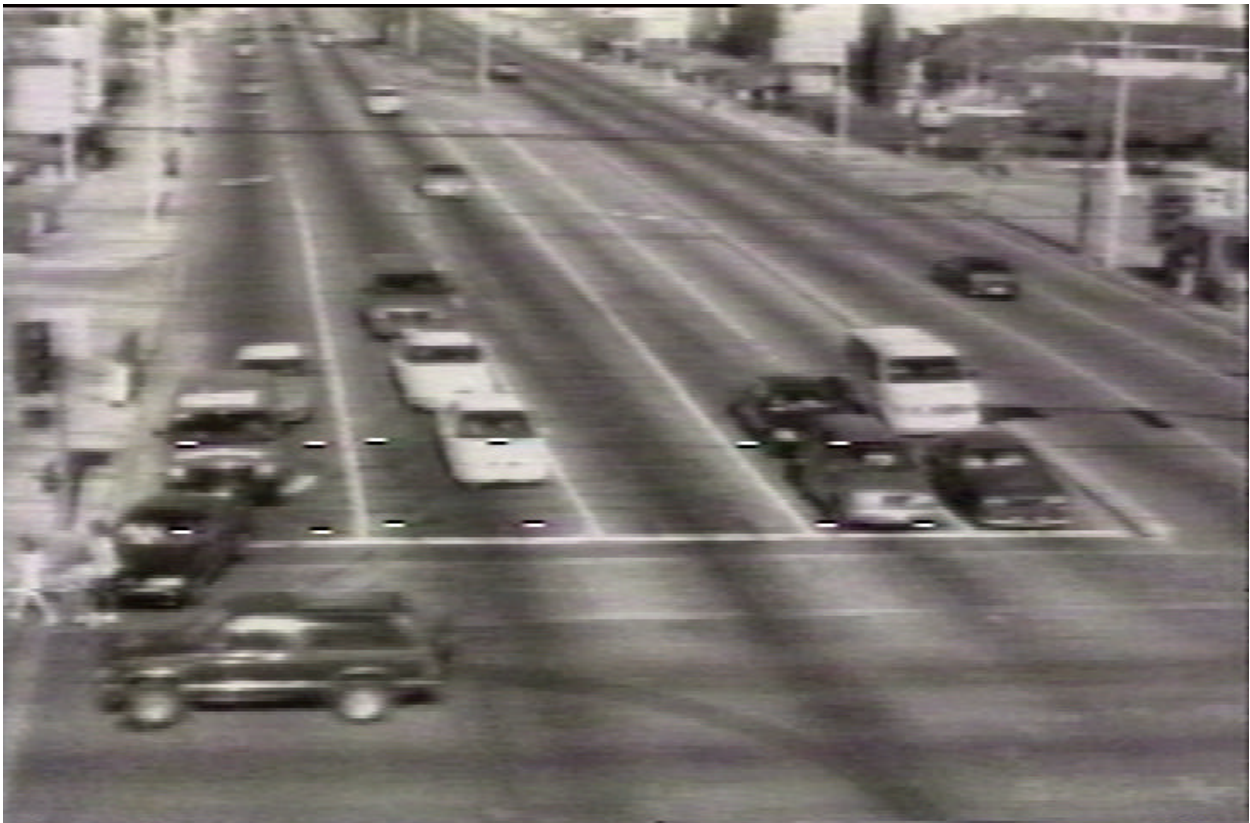
Event Class 3: Multiple Detection

Location: Harbor & Katella, SB

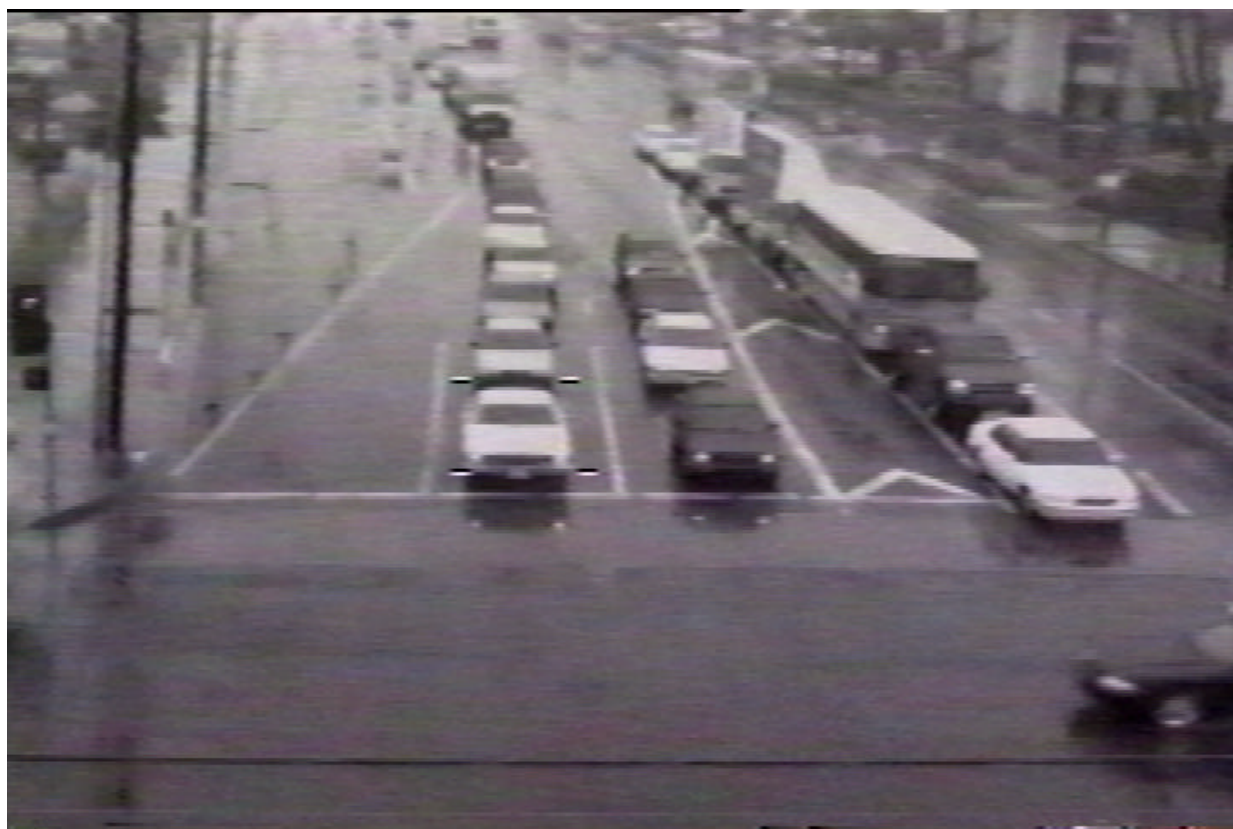
Event Class 5: Dropped After Detection

Location: Harbor & Katella, NB

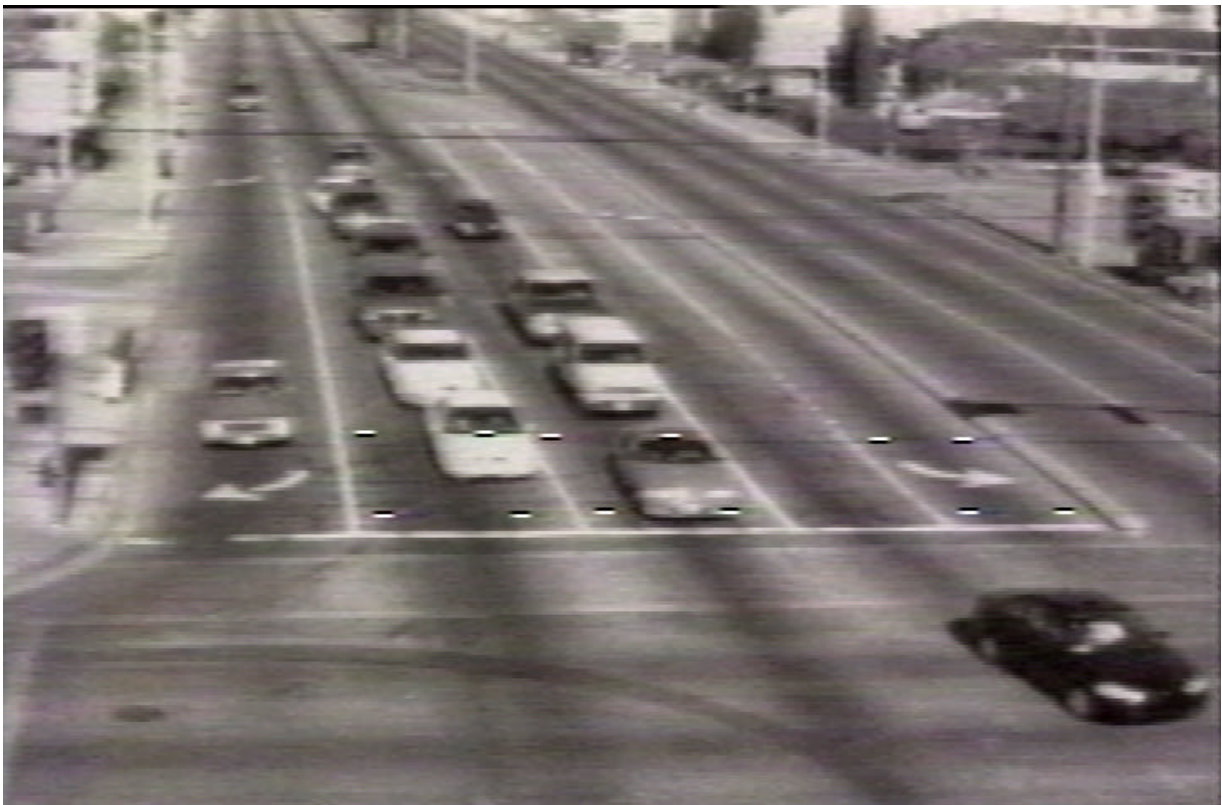
Event Class 7: Tailgate w/ Latch
(Tailgate with Latch after Final Vehicle)

Location: Harbor & Katella, SB

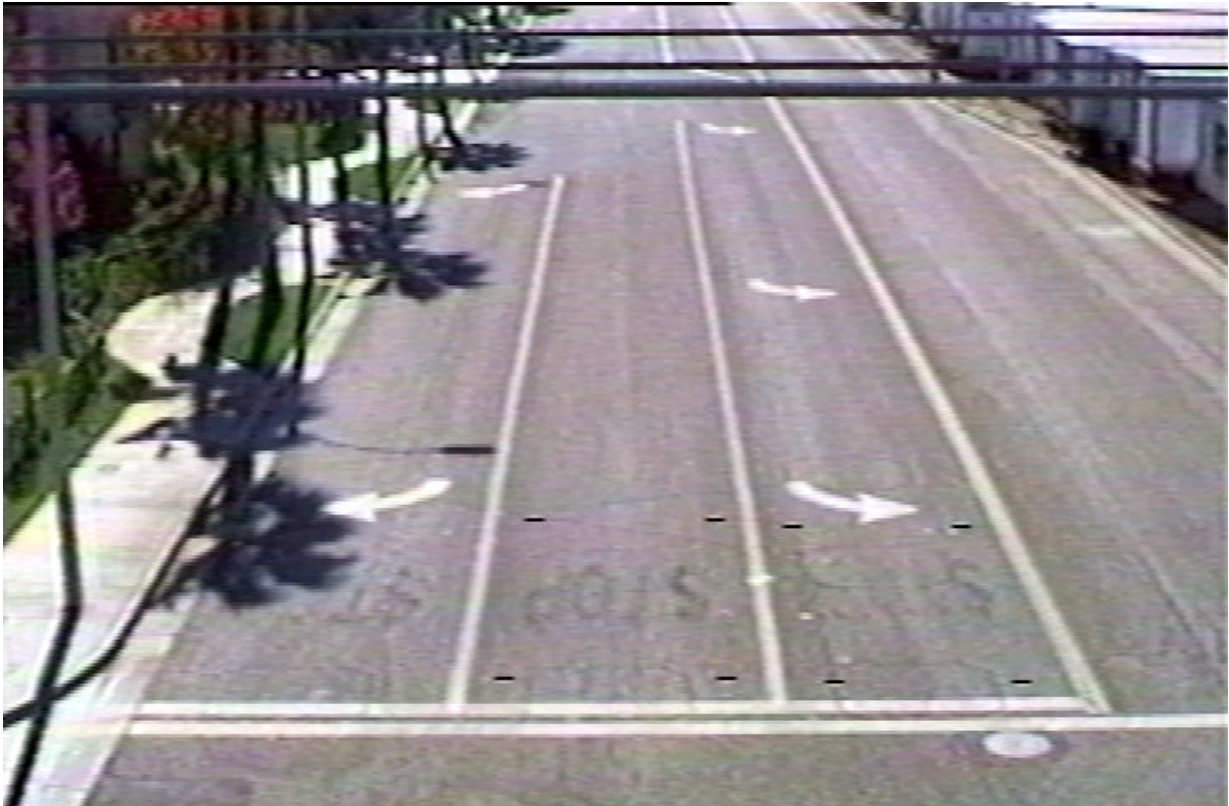
Event Class 8: False Detection

Location: Freedman & Clementine, NB

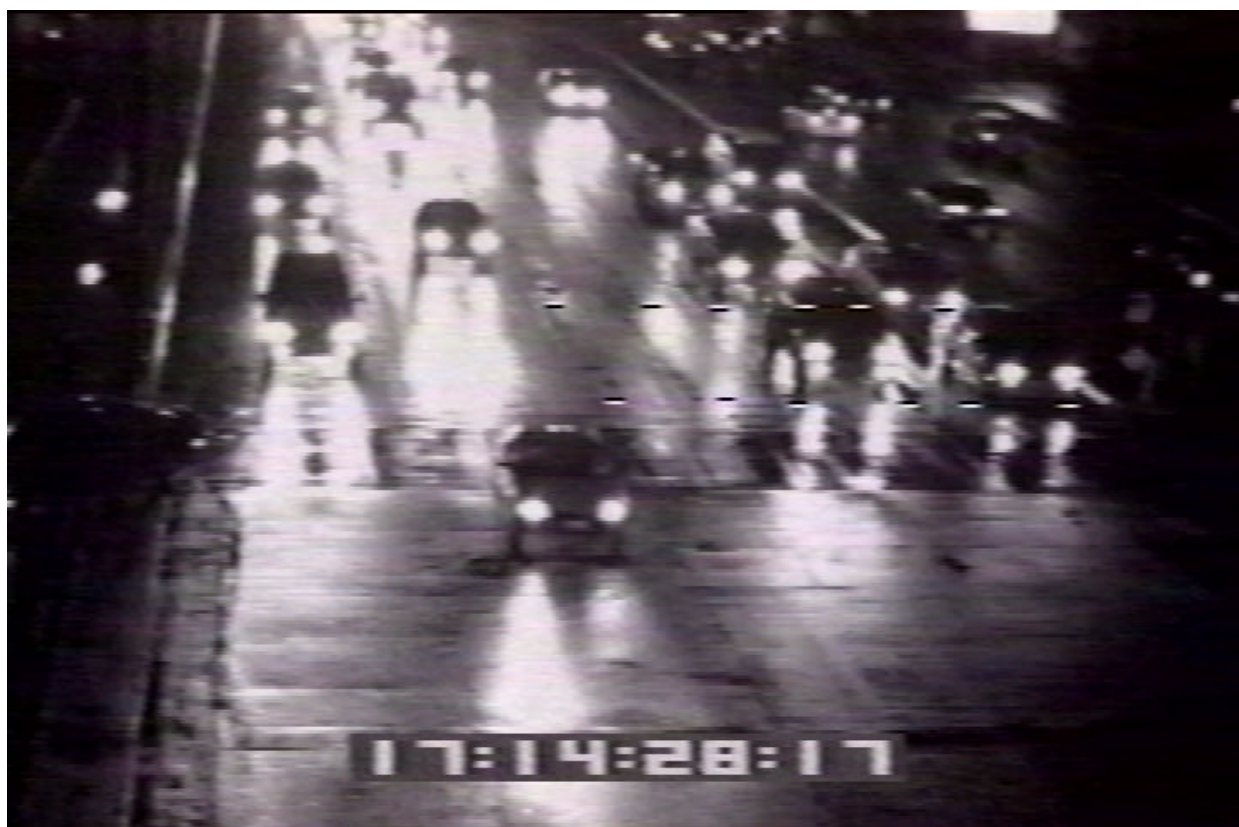
Event Class 9: False Detection w/ Latch

Location: Harbor & Katella, EB

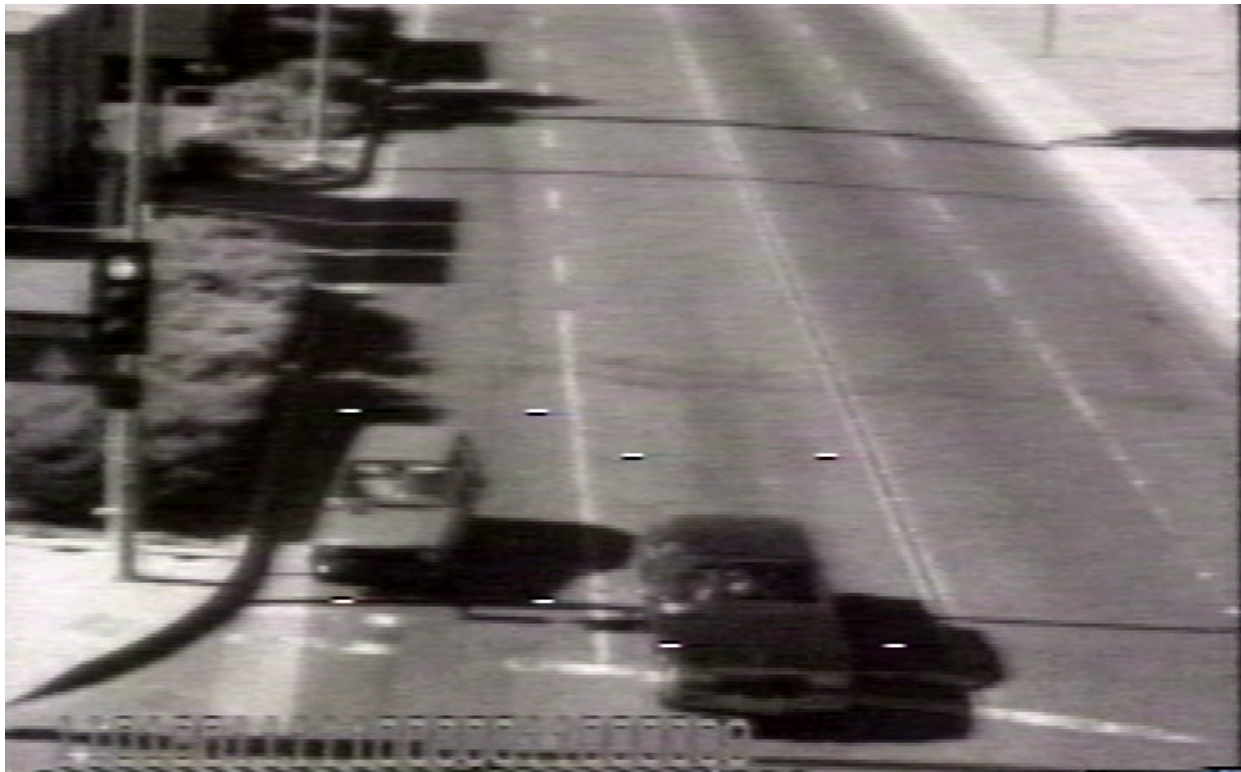
Site Plan:

Date/Time: 17 December '96, 11:00

Phase Detection Class 2:
Red Interval (Call for R/G Transition)
Incorrect Actuation:
Failure to Actuate Correctly

Location: Harbor & Katella, SB

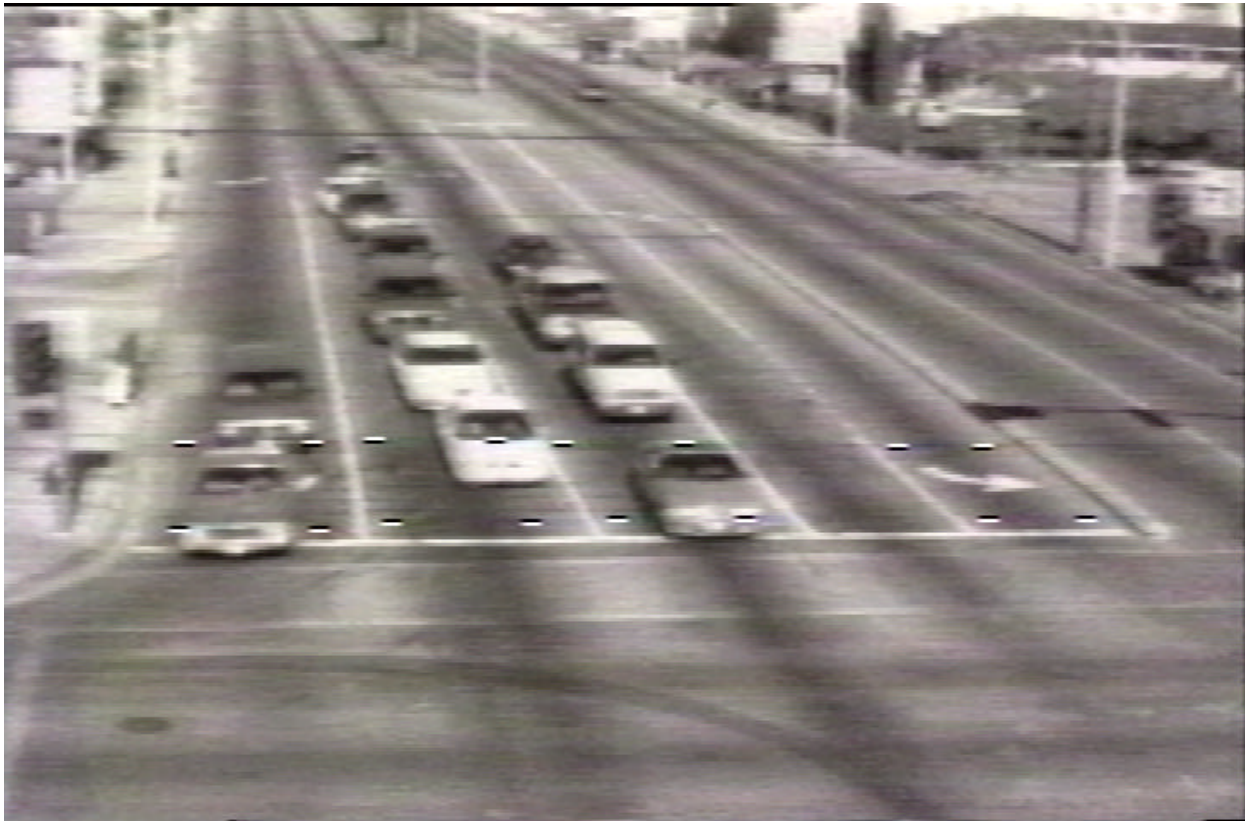
Phase Detection Class 3:
Red Interval (Call for R/G Transition)
Incorrect Actuation:
Potential False Actuation

Location: Harbor & Katella, SB

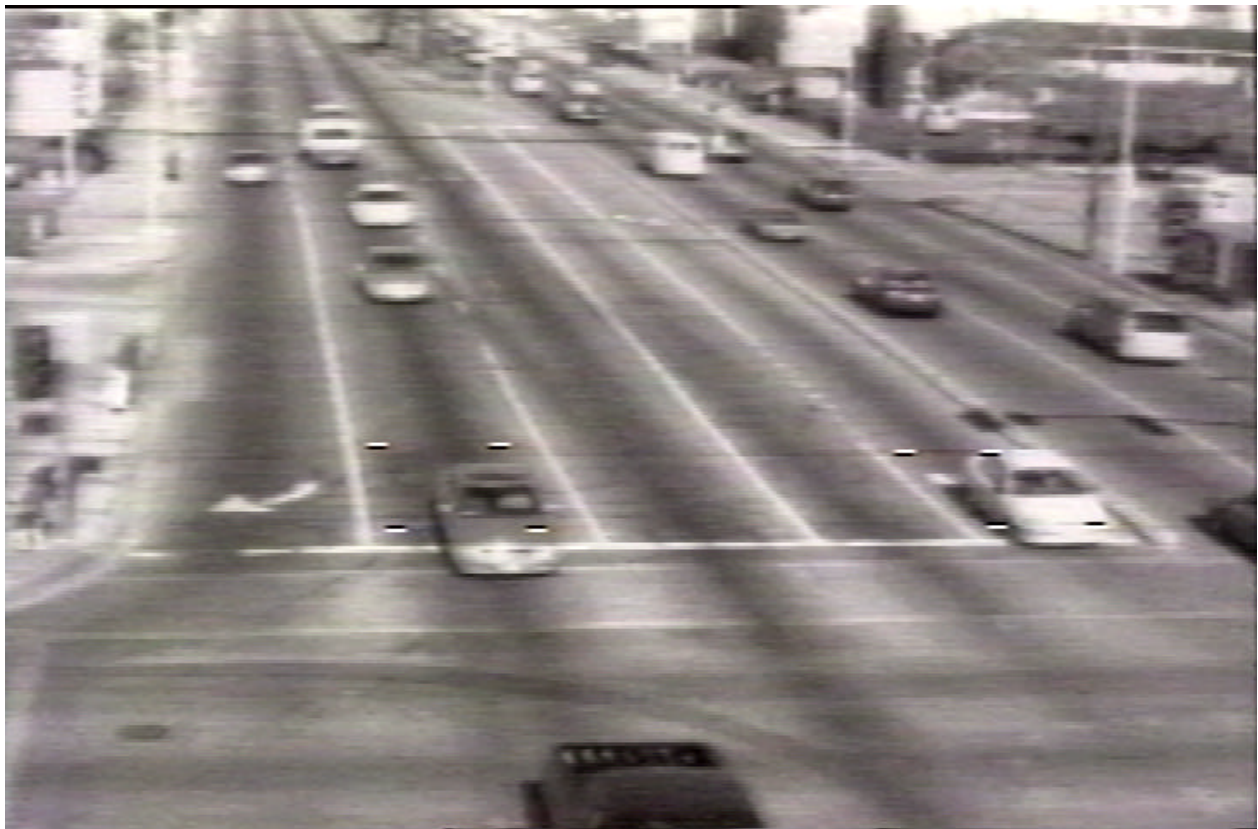
Phase Detection Class 4:
Green Interval (Green Extension)
Correct Extension

Location: Harbor & Katella , SB

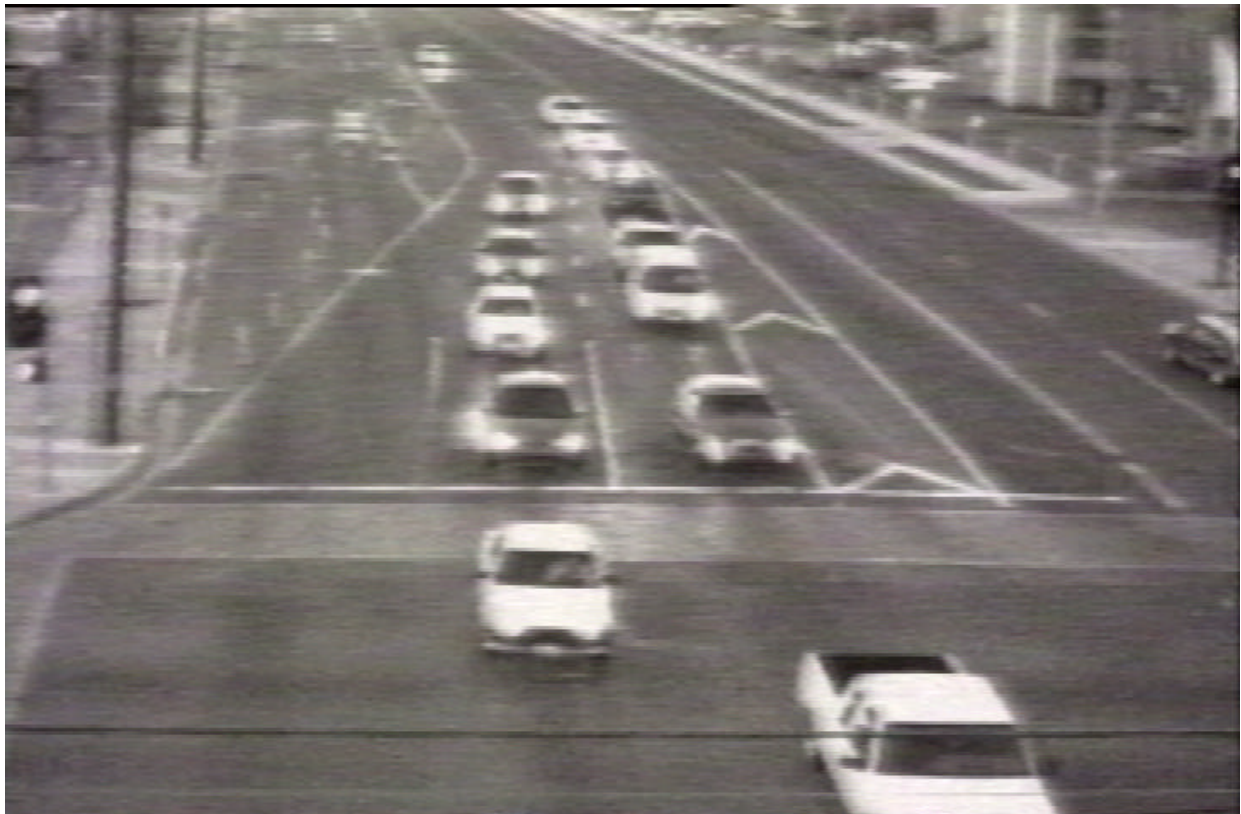
Phase Detection Class 5:
Green Interval (Green Extension)
Incorrect Extension:
Potential Failure to Extend

Location: Harbor & Katella, NB

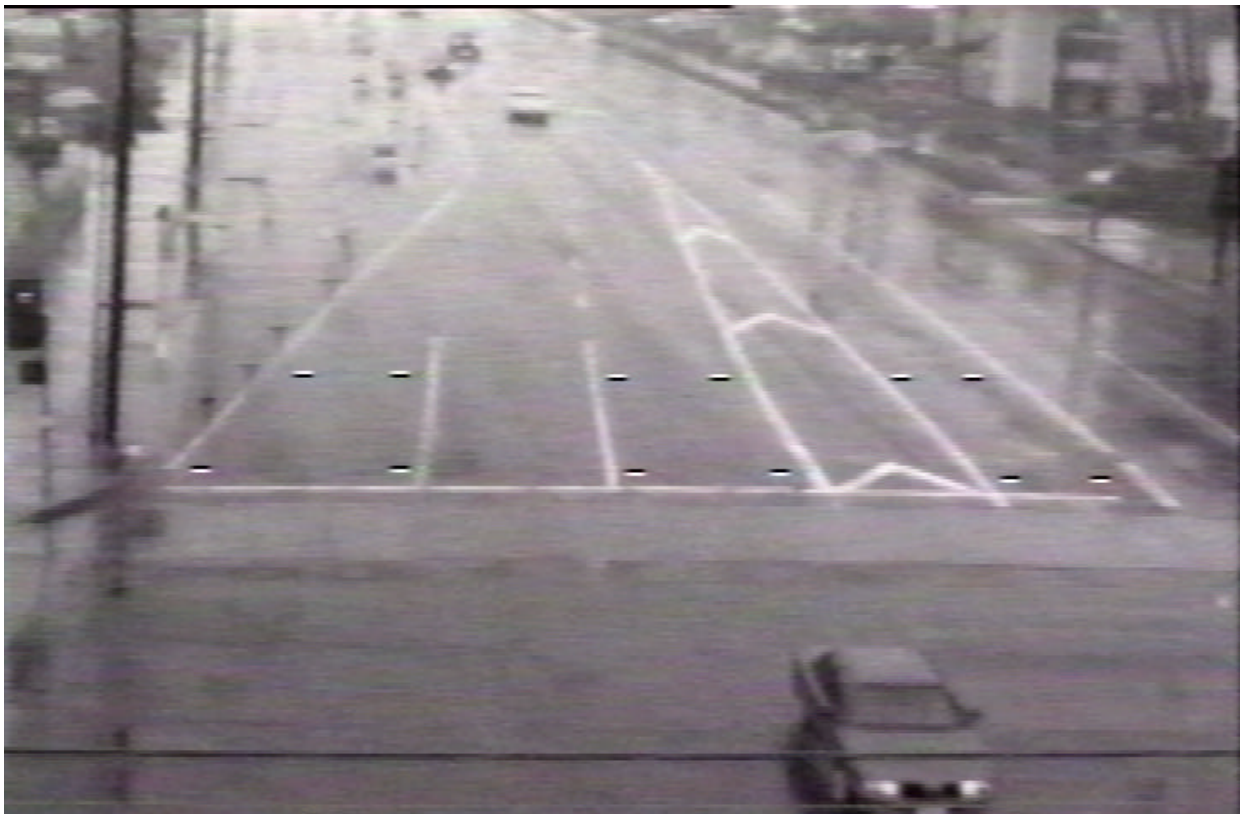
Phase Detection Class 6:
Green Interval (Green Extension)
Incorrect Extension:
Potentially False Green Extension

Location: Harbor & Katella, NB
