Low Velocity Blunt Impact on Lightweight Composite Sandwich Panels

A Thesis submitted in partial satisfaction of the requirements  
for the degree Master of Science

Structural Engineering

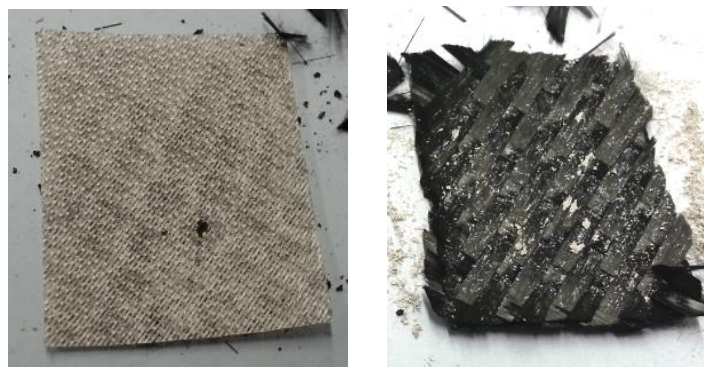
Using a resin burn-off method, in which a small specimen of the top and bottom facesheet was placed in a tube furnace and heated to above  $450 \text{ }^\circ\text{C}$  for 30 minutes, the layup of the top and bottom facesheets were determined to consist of two plies. The inner layer contacting the honeycomb core was plain weave fiberglass, while the outer layer is carbon fiber with a  $[45/-45]$  and over two under one weave configuration. The two layers are pictured in Figure 2.2.2.

**Figure 2.2.2. Inner fiberglass layer (L) and outer carbon fiber layer (R) of top and bottom facesheets**

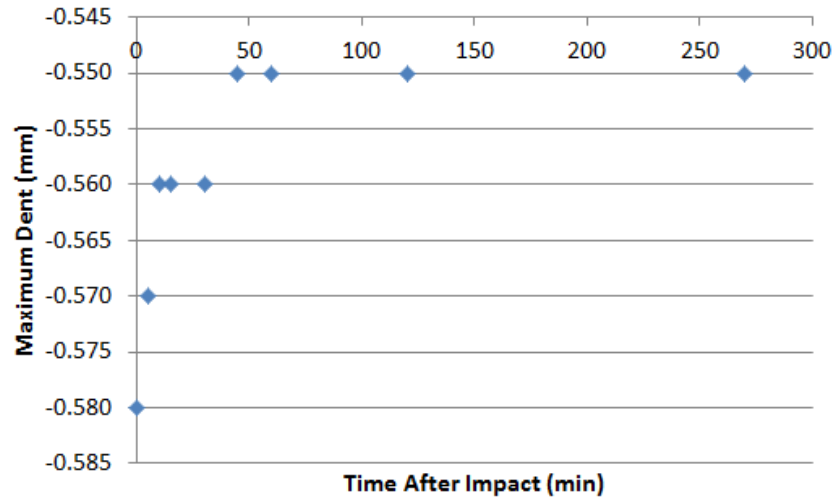
Figure 3.3.2. Time history of maximum dent depth for test LVS-016 (R50.8 mm at 4 J)

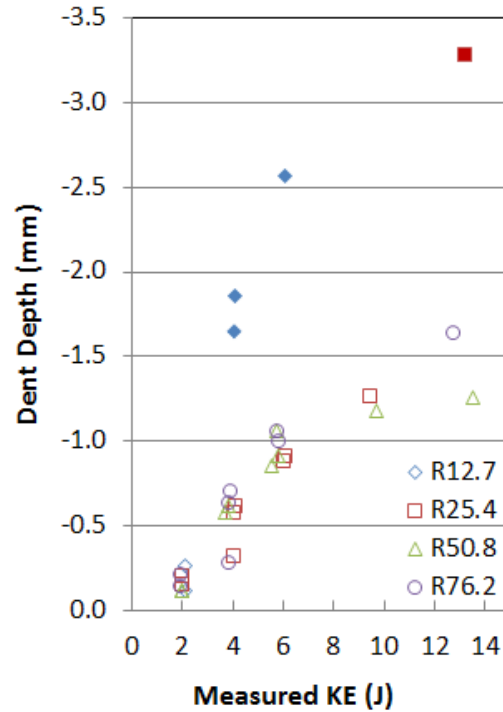
A plot of the relationship between measured kinetic energies and immediate maximum dent depth can be seen in Figure 3.3.3. The correlation between dent depth and kinetic energy was fairly linear in the lower energy levels up to 6 J. All points seemed to overlap regardless of the four different tip radii in the lower energy range (up to 6 J). At higher energies of 10 to 14 J, the dent depths varied considerably for the different radii, suggesting that the depths increase at different rates with increasing impact energy. In most cases, the panel experienced only surface dent damage. The four outlying points (filled-in points in the plot) are instances where the facesheet was cracked. These instances occurred only in impact test with tip radius 12.7 mm (diamond) and 25.4 mm (square).

**Figure 3.3.3. Maximum dent depth vs. measure kinetic energy level**

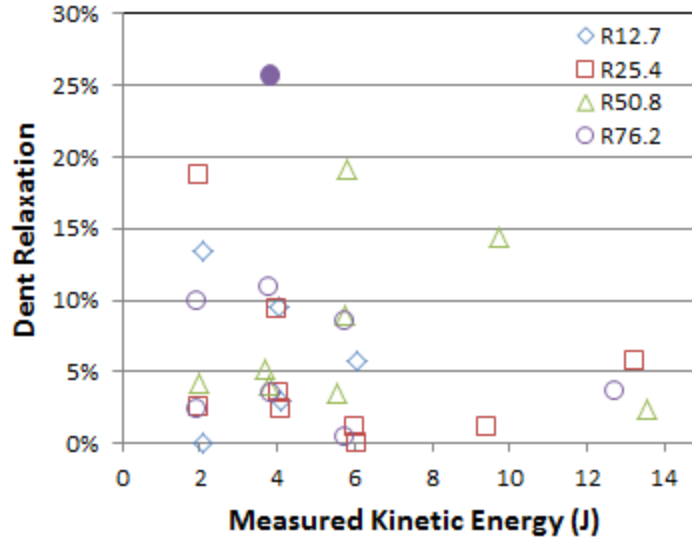
These dents exhibited very low levels of relaxation; most dents relaxed less than 10 percent of the immediate depth, while several approached 20 percent. The only instance where relaxation exceeded 20 percent, indicated by the filled-in data point in Figure 3.3.4, occurred in cases of lower impact energy with very small dent depths (~0.10 mm). Variability in these very small depth measurements had a large impact on relaxation percentage, resulting in a dent relaxation that is considerably higher than the remaining cases. Although relaxation is generally low, it is still necessary to report impact damage immediately after it occurs since the shallow dents may not be easily detected in future inspection because of its barely visible nature.

Figure 3.3.4. Level of dent relaxation

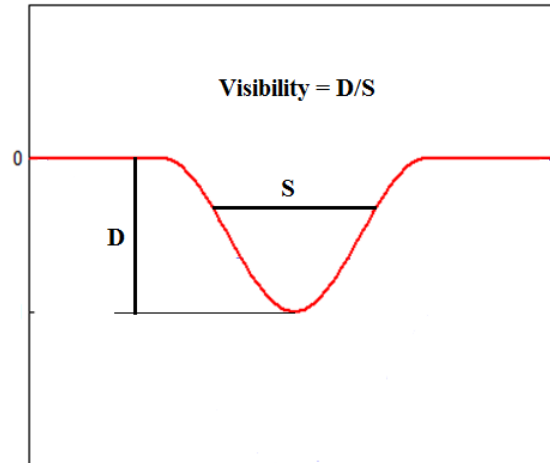
The depth of a dent is a common measurement used to indicate the extent of impact damage, but it cannot be the sole basis used to characterize external damage. In this study, the visibility of the dent was quantified based on a parameter defined as the maximum depth  $D$  divided by the dent span  $S$ . Dent span  $S$  was determined as the span of the dent at one-third of the depth below the original surface plane, as shown in Figure 3.4.1. Because visual detectability of damage is dependent on both span and depth, this parameter is more indicative of its visibility than depth alone.

**Figure 3.4.1. Visibility parameter as ratio of depth/span**

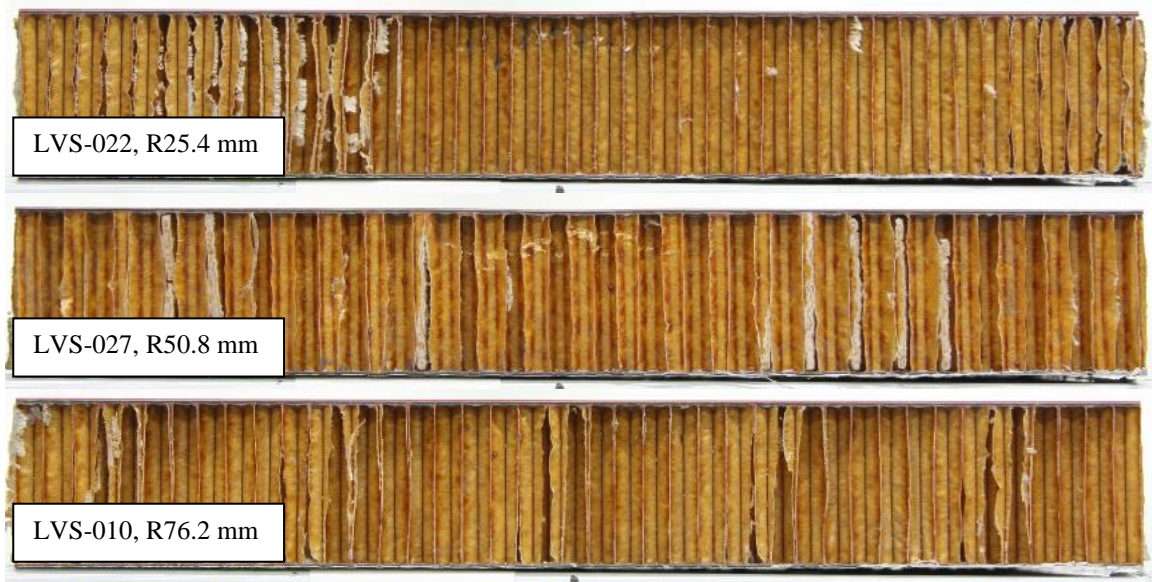
The honeycomb core in sites impacted with the R50.8 mm tip displayed more severe damage than those impacted by the R76.2 and R25.4 tips, as seen in the cross-sections of Figure 3.6.5. This behavior is unexpected and suggests a possible interaction between maximum damage behavior, and the cell size of the core. However, this relationship remains an area for future investigations.

**Figure 3.6.5. Cross section of tests LVS-022, 027, and 010 impacted at 4 J with increasing tip radii**

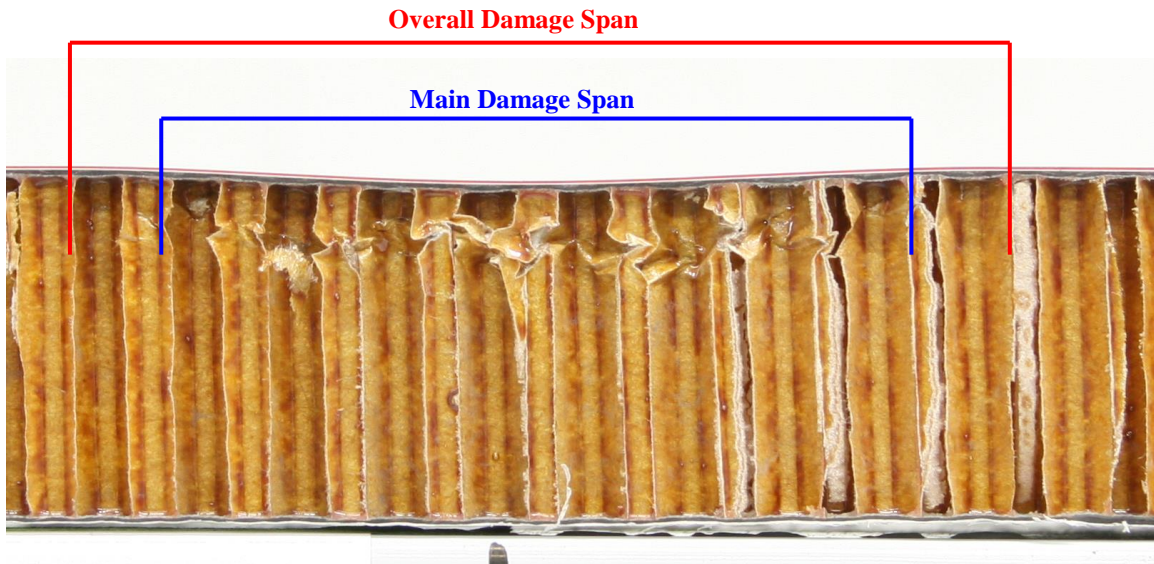
The damage span and depth in the core was measured for each test site. These measurements included parts of the core exhibiting any sign of damage (Modes A through D). An example of overall and main damage span is shown in Figure 3.7.1. As expected, and seen in Figure 3.7.2, the internal damage span increased with increasing impact energy. At the lower energy levels of 2 to 6 J, the spans overlap, indicating there is little dependence of damage span based on impact tip radii. However, when impact energies were increased beyond 6 J, the spans varied considerably more. The plots suggest that the damage span could plateau with increasing energy (e.g., see R25.4 mm and R50.8 mm data points), but more tests in the relatively higher energy range would be necessary to be certain.

Figure 3.7.1. Overall and main internal damage span

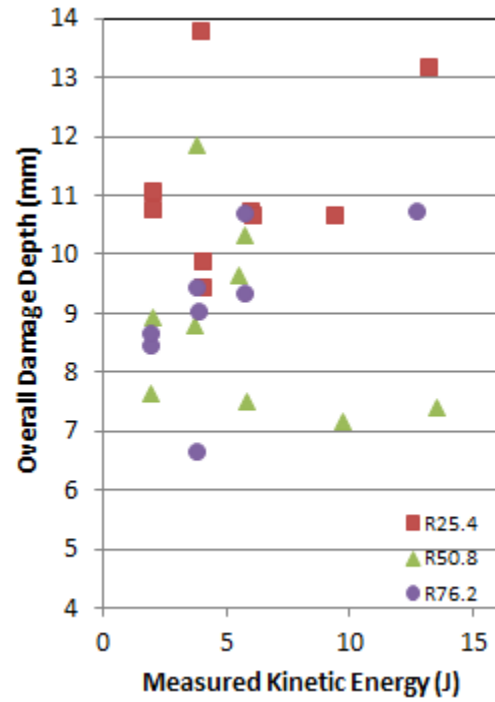
The extent of internal damage was also observed and quantified using its damage depth. The damage depth was determined with respect to the neutral surface plane (original undamaged facesheet surface) of the panel, and measured the depth of core damage, as shown in Figure 3.7.4. Two types of damage depths were investigated. The overall damage depth was measured from the neutral plane to the furthest point in the core where any evidence of wrinkling was present, and no damage was observed below that point. There is no clear dependence on impact energy, as evident in Figure 3.7.5. Although the damage depth seems to vary with tip radii, there is too much scatter in the data to identify clear trends.

Figure 3.7.5. Internal overall damage depth with increasing kinetic energy

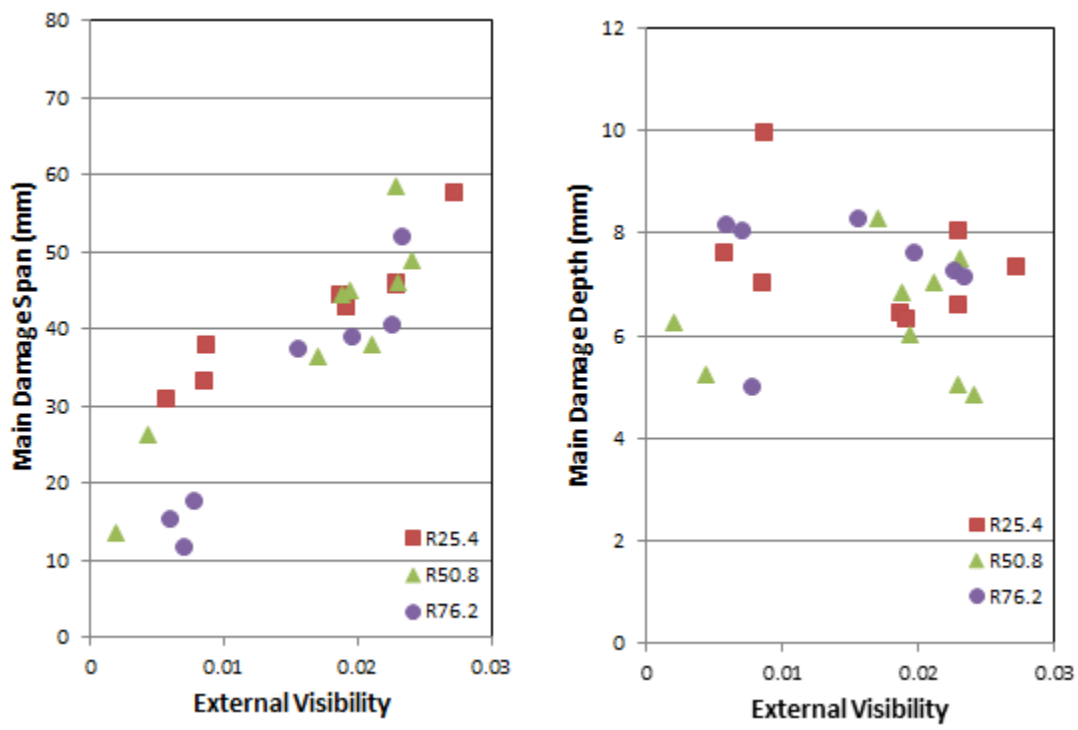
The damage depth cannot be determined by external visual inspection. While the damage span increases with increasing external visibility, as shown in Figure 3.7.8, there is no correlation for damage depth. The damage depth remains in a narrow range

regardless of visibility. This depth range is hypothesized to be a function of the core wall and cell size geometry. Similarly, the damage span increases fairly linearly with increasing dent span, as shown in Figure 3.7.9, suggesting that external dent span is a good indicator of internal damage span. The dotted line shows a 1:1 relationship, showing that the internal span damage is larger than the externally-observable span. However, damage depth remains in a narrow range regardless of external dent depth. Thus, internal damage depth cannot be predicted based on external observations.

Figure 3.7.8. Internal damage span (L) and depth (R) with increasing external visibility

Internal damage span increased with increasing impact energy as well as increasing external visibility. Thus, knowing the visibility (dent span and depth) would provide a good estimate of the internal damage span. However, this is not the case for internal damage depth. The damage depth was independent of both energy and visibility, indicating that traditional methods of visual inspection of damage are insufficient to characterize core damage. Furthermore, the most severe damage mode observed (Mode D), where core walls exhibited fracture, was not always accompanied by facesheet cracking and cannot be visually detected without sectioning the panel. Thus, the usefulness of external damage inspection and visibility is questionable, as it does not accurately reflect the extent of internal damage in lightweight honeycomb sandwich panels.

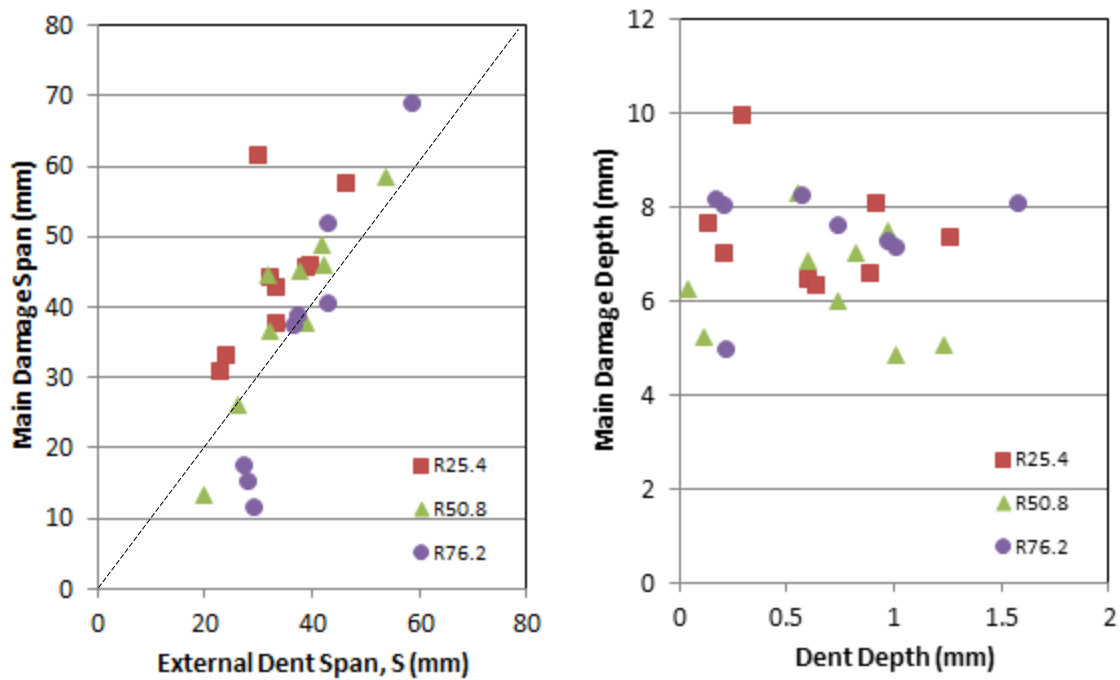
Figure 3.7.9. Internal damage span (L) and depth (R) compared with external damage
