In situ expanding foam based carbon/epoxy sandwich jackets for column retrofit

Insitu Expanding Foam Based Carbon/Epoxy Sandwich Jackets for Column Retrofit

A thesis submitted in partial satisfaction of the requirements
for the degree Master of Science

Structural Engineering

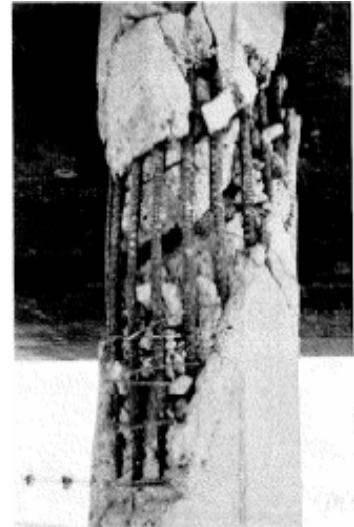
Figure 1-3: Foothill Freeway Column Failure [2]

common design practices were reviewed. In a research report submitted after the quake by Paul C. Jennings, one of the obvious support column deficiencies was reported. "...the extent of the failures in the central columns was aggravated by the inadequate ties. Only one of the lapped ties on Column 1 was found to have yielded and fractured. The other ties became ineffective when the concrete shell outside the reinforcement cage cracked and spalled" [2]. Figure 1-1 is the picture of the Column 1 noted in the quotation and Figure 1-2 and Figure 1-3 are additional pictures representing this failure type.

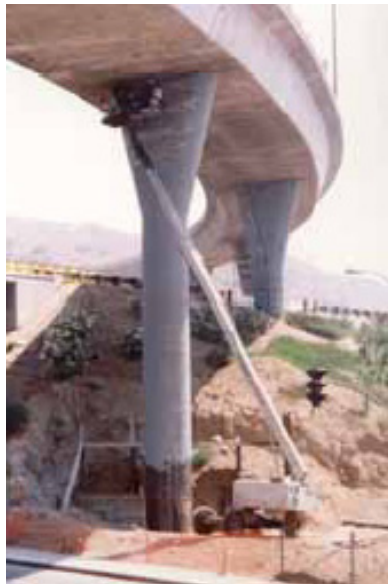
Figure 1-9: Welding of Steel Jacket for a Caltrans Strengthening Project [26]

Steel jacket strengthening is not without its problems. Placement and construction of heavy steel plates is not simple. Welding the jacket seams together is a time intensive and costly procedure. The integrity of the seam welds is also a concern. Quality control of field welding is difficult to ensure and expensive to inspect but because the performance of the jacket is dependant on the quality of the welded connection, field assessment of weld quality during construction is necessary and critical. Figure 1-9 illustrates the scale of work for the welding of

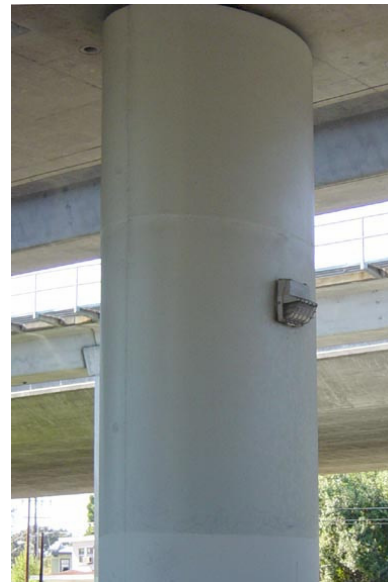
Figure 1-10: Completed Steel Jacket Column Retrofit [27]

the jacket's seams on a typical column. Once completed as in Figure 1-10, corrosion of the exposed steel also becomes an additional concern.

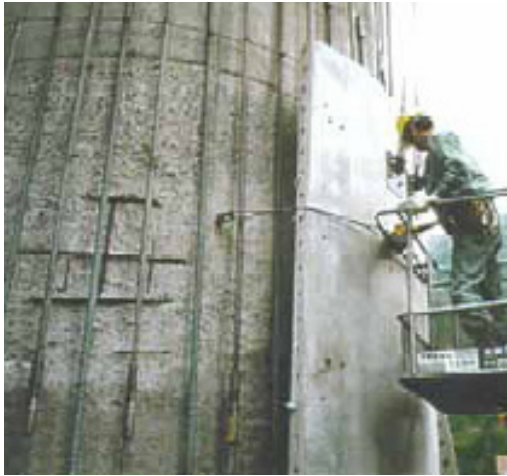
Figure 1-11: Installation of a Pre-Cast Concrete Shell Jacket [26]

as shotcrete application. In California, Caltrans has utilized shotcrete constructed concrete jackets (concrete mixture that is projected by a high velocity pressure spray to a surface) to encase an inadequate column with additional reinforcement. This is not the only method of strengthening with concrete, though. Figure 1-11 shows the installation of a pre-cast concrete shell jacket and Figure 1-12 displays the installation of a pour-in-place concrete jacket.

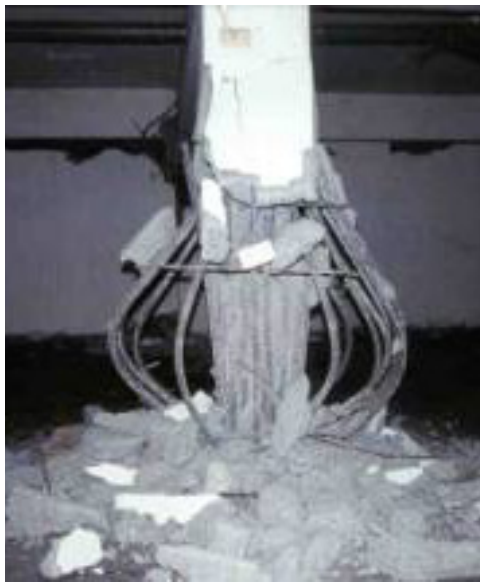
Figure 1-14: Non-ductile Column Failure [37]

Lack of structural ductility will typically produce a failure mechanism in the plastic hinge region of an element as seen in Figures 1-14 and 1-15. Deficient columns were typically designed without any consideration of the structure's ductility. These columns tend to have a ductility level range of 2-3, which is well below the needed ductility for seismically loaded bridge columns. These low ductility levels can result in high concrete strains in the plastic hinge region of the column, which as noted above, do not have the adequate confinement pressure necessary to prevent the concrete from critically degrading [12]. A composite strengthening method designed to provide additional concrete confinement will therefore, improve the column's ability to deflect and in turn increase its ductility.

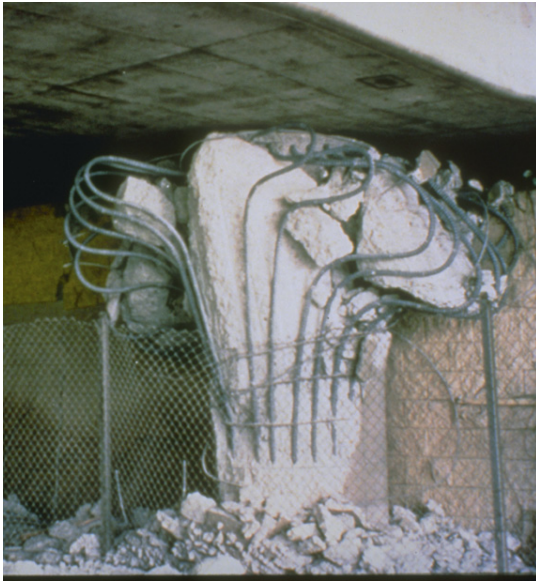
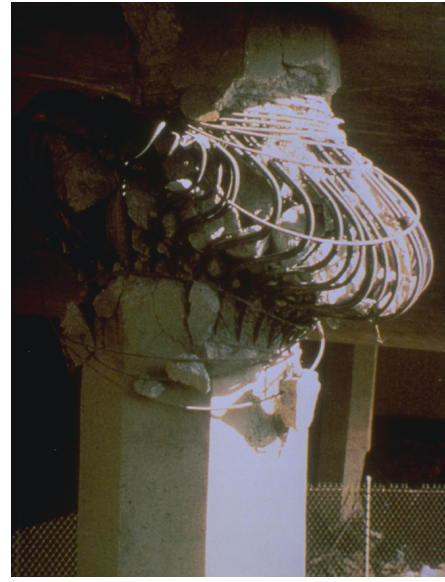
Figure 1-16: Lack of Confinement Failure [37] **Figure 1-17: Lack of Confinement Failure [37]**

repetitive loading [39]. This confinement is essential to prevent the longitudinal tensile reinforcement bars from buckling and/or lateral expansion of the column concrete. Without sufficient concrete confinement, failures such as those seen in Figure 1-16 and Figure 1-17 may occur.

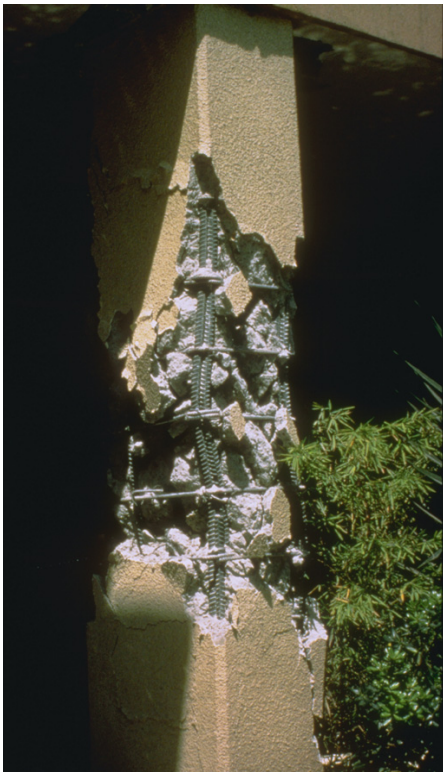
Figure 1-19: Column Shear Failure [37]

The shear strength on concrete column is the result of a blend of mechanisms involving concrete compression shear transfer, aggregate interlock along inclined flexure-shear cracks and truss mechanisms making use of horizontal tie reinforcement. Knowing that these shear mechanisms work together in a complex fashion it is not surprising that shear failure is brittle and involves rapid strength degradation [12]. Strengthening columns for deficient column shear becomes important in turning a brittle failure into a ductile one that provides significant warning of impending failure. Table 1-4 is a selection of equations used to determine the required thickness of a composite jacket necessary to strengthen a column in shear. Each equation is similar with the variables and coefficients presented in a different configuration.

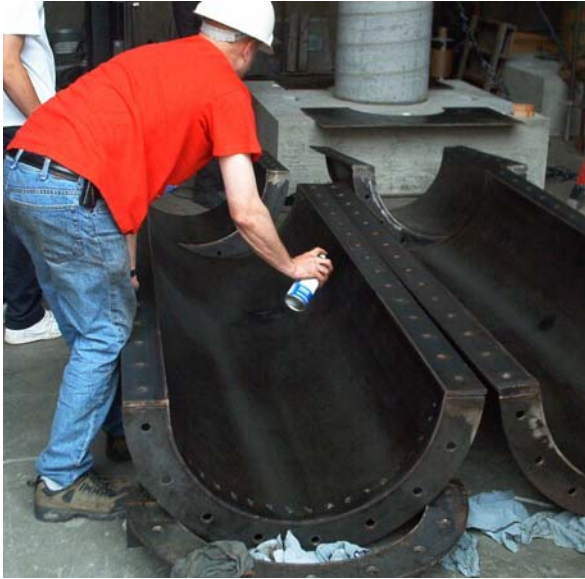
Figure 2-19: Application of Mold Release

The process of application involves a wet-layup process and the need for a jacket mold. The photographs in Figure 2-19 to Figure 2-29 show the jacket application process. A steel mold was used for the retrofit of the experimental test columns. The mold was first cleaned, polished and then a release agent was applied to the interior face of the mold before the fabric was placed as shown in Figures 2-18.

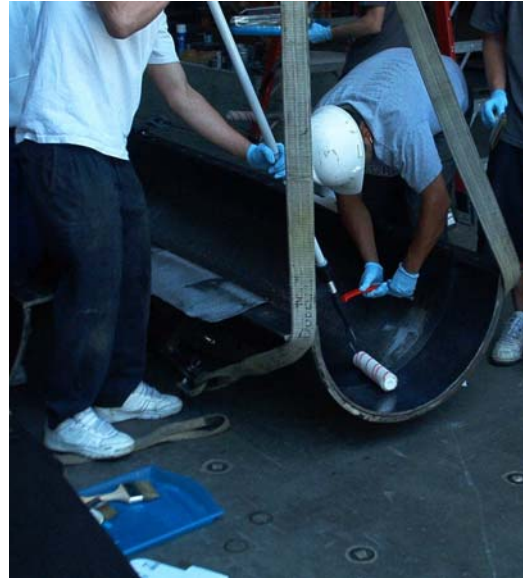
Figure 2-20: Placement of Carbon Fabric

The composite layers were constructed with a two-part epoxy resin that was weighed and mixed at a 2:1 ratio of resin to hardener. This system was used to wet out the unidirectional carbon sheets. The first fabric layer was draped in the mold and then pressed to remove any entrapped air before the next layer was added to the exterior shell construction in the jacket mold. This process is shown in Figure 2-20 and Figure 2-21. The process was then repeated as required to obtain the necessary composite thickness of approximately 1.5 mm for each column.

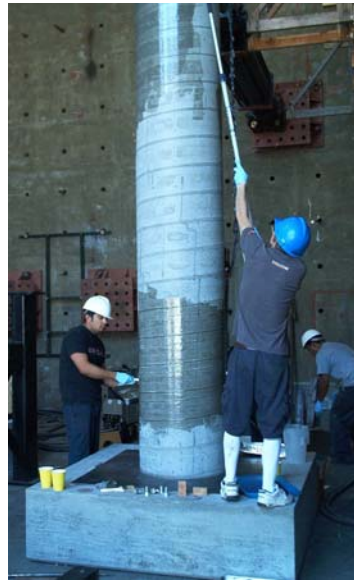
Figure 2-22: Column Preparation

In order to prepare the concrete substrate for application of the inner layer of the composite, the surface was lightly sanded by hand and then the epoxy mixture was rolled onto the surface as illustrated in Figure 2-22. A unidirectional carbon fabric was then horizontally placed around the column circumference processed following the same procedures as used for the exterior skin.

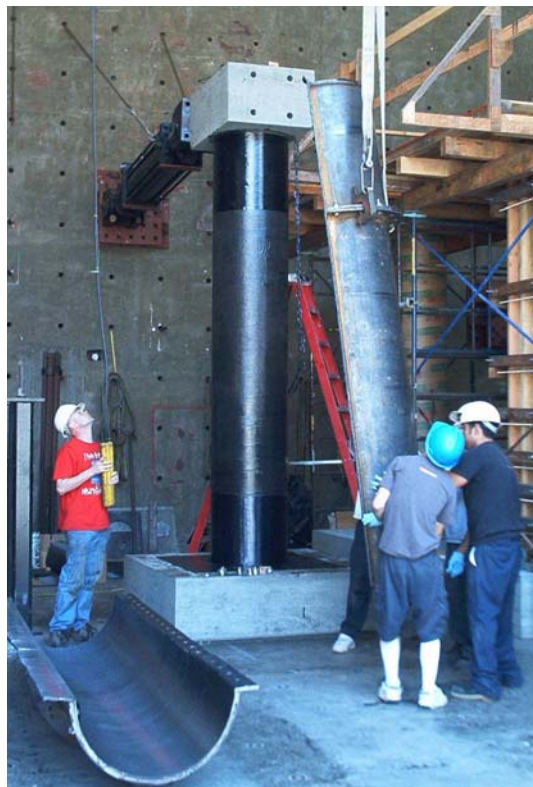
Figure 2-24: Placement of Steel Mold

With the carbon composite skins formed, the prepared steel mold was then lifted into place. Before the mold was placed, a half inch steel plate was placed at the base of the column to provide for the necessary jacket gap between the column and its base. The seal between the mold and steel plate was provided by simple modeling clay. This progression of lifting and placing the steel mold around the column is shown in Figure 2-24 and Figure 2-25.

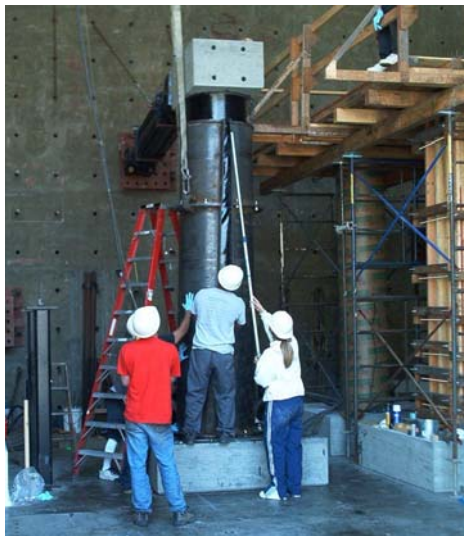
With the steel mold in place and prior to bolting the mold halves together, the exterior composite shell halves were lapped at the seams. This was accomplished by tucking one edge under the other as seen in Figure 2-26. The lap length varied in the column wrapping on the 6-columns due to the construction process from 10 cm to 20 cm. Once this lapping was complete the mold was bolted together at the seams.

Figure 2-26: Lapping of the Jacket Seams **Figure 2-27: Pouring of Expandable Foam Core**

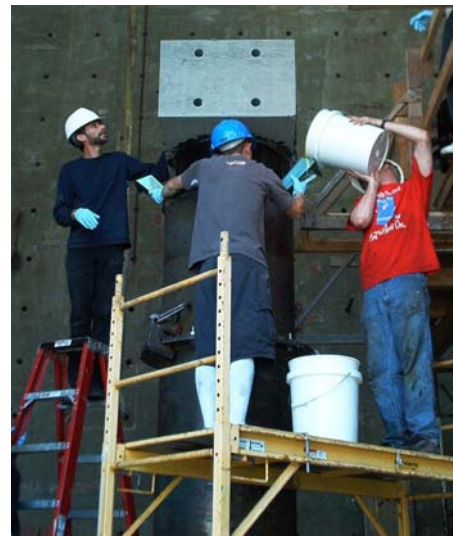
With the carbon jacket shells constructed within the steel mold, the mold in place and bolted together, an expanding resin to foam system was prepared for installation as the retrofit jacket foam core center. The core material was comprised of a two-part urethane type resin system with each component weighed to ensure the proper 2:1 ratio. Once the mixture was combined and mixed, it was immediately poured into the void between the two carbon shells. The core component had a quick set time of 90 seconds requiring the immediacy of placement. A demonstration of this placement is presented in Figure 2-27.

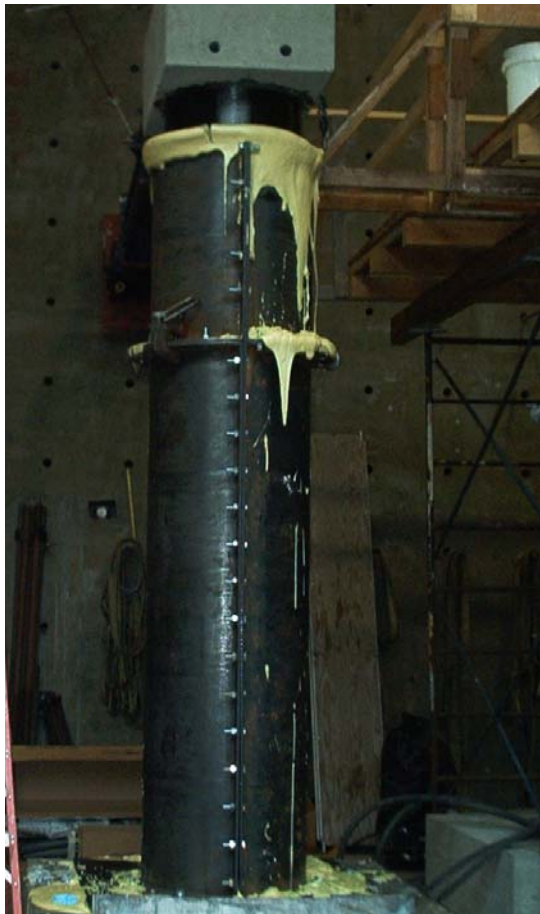
Figure 2-28: Curing of Jacket

Once the foam mixture was in place, a 4-hour cure was used before the removal of the steel mold shown in Figure 2-28. During this cure time, the foam component expands and also

undergoes an exothermic reaction. This reaction has the added benefit of forcing resin into the fabric skins, post curing the carbon shells, and increasing the compaction of the fabric layers, thereby increasing the mechanical properties of the composite. Once the jacket has cured, the removal of the mold may take place. This is shown in Figure 2-29. At this time, the column strengthening system is complete.

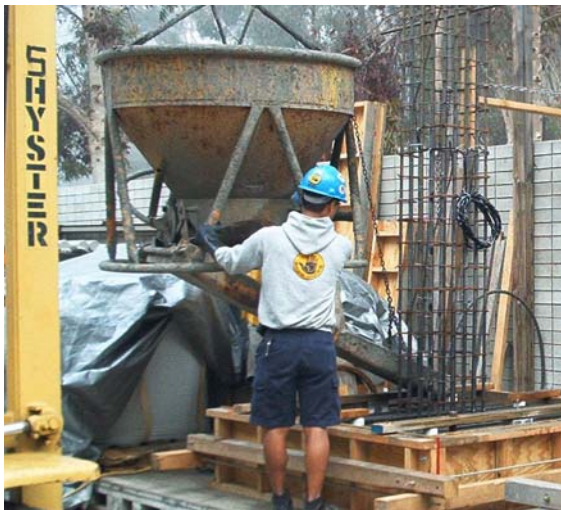
**Figure 3-5: Column Base Concrete Pour**

Once the column base cages were encased within the column's casting formwork, concrete was poured as shown in Figure 3-5. The concrete poured was specified to have minimum 28 day compression strength of 20.7 MPa (3000 psi). Nine test cylinders were cast at this time as well to enable determination of the progression in the concrete compression strength until the day of testing. Figure 3-6 shows a finished base and Table 3-2 lists the resulting concrete compression strength taken from the test cylinders.

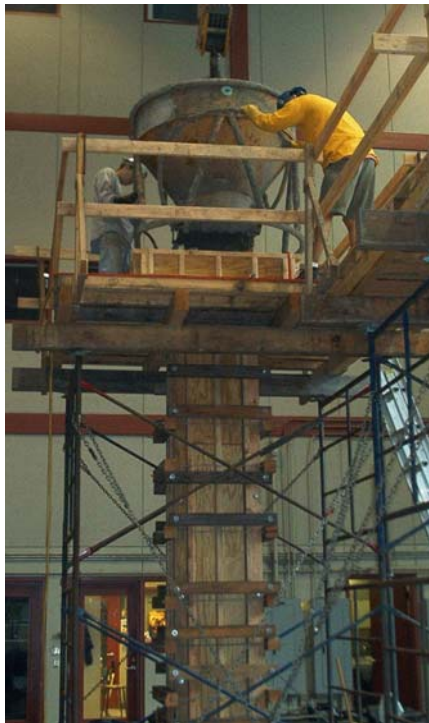
Figure 3-7: Shear Column Concrete Placement

Once the column bases were poured, the formwork for the column was added around the reinforcement cages. Once in place the concrete was poured. This is illustrated in Figure 3-7 and Figure 3-8. Figure 3-7 shows the large hopper that was used to lift the concrete over the formed square column to allow for the placement of concrete from the top of the formwork. Figure 3-7 shows the use of a concrete vibrator which was dropped into the concrete filled column to ensure proper consolidation (removal of voids and air bubbles).

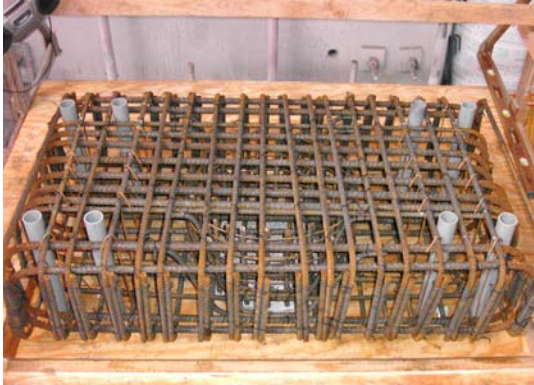
Figure 3-9: Shear Specimen Load Stub Cage

Due to the load stub complexity required on the shear columns, additional concrete was required to be placed prior to the conclusion of the test column construction. The load stubs were constructed such that the size and reinforcement due would support the testing procedure and test set-up required to induce a shear failure within the column. Figure 3-9 and Figure 3-10 show the amount of reinforcement steel present in the shear load stubs. The already cast circular column body can be seen in the center of Figure 3-10. After the load stubs were constructed and form

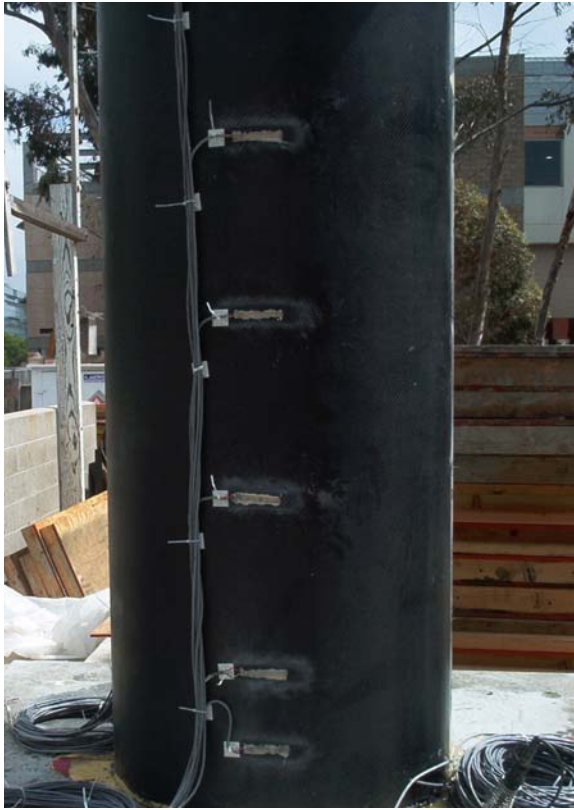
Figure 3-11: Jacket Gages at Located at North Load Face of Shear Column

With the construction of the shear test columns completed, the columns were scheduled to be wrapped with the experimental strengthening jackets 19 days after column concrete had been poured. This process is outlined in Chapter 2 since the process is common in all six of the test columns. With the retrofit jackets construction complete, thirty-two, 50 mm long strain gauges were applied to the jacket. These gauges were placed horizontally in the hoop direction on each face of the column in the same dimensional pattern as the reinforcement gauges in Figure 3-1 and Figure 3-2. These strain gauges were applied with a self-leveling adhesive to ensure a good bond to the carbon/epoxy jacket. Figure 3-11 and Figure 3-12 show the completed application of the jacket strain gages.

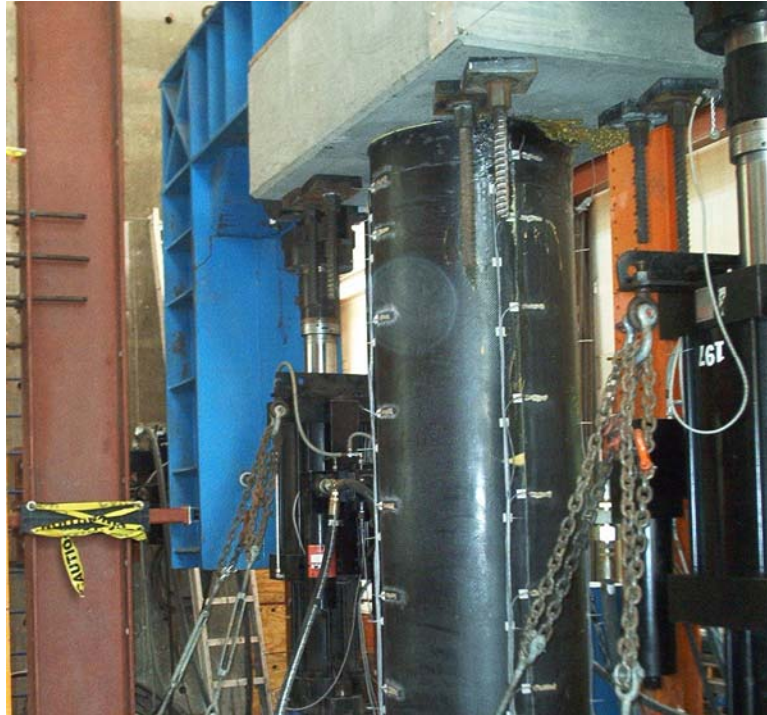
Figure 3-14: Overview of Shear Test Set-Up

For the two experimental shear columns, the test set-up comprised of a shear test frame which was attached to the top of a column's load stub by means of eight (8) high strength bars pre-stressed to 445 kN (100 kips) each. This frame restrained the rotation at the top of the column, modeling a fixed support condition. A rotation-restricted condition is necessary to induce forces on the test column required for a structural shear failure. The load setup applied to the frame to restrict the column motion to strictly linear displacement was also used to simulate bridge superstructure self-weight. This compression load is given in Chapter 2 below Figure 2-5 and Figure 2-6 and was maintained through the (2) vertical actuators in conjunction with the testing program software. A 978 kN (220 kip) capacity actuator with a 22 cm (9-inch) stroke, reacting against the strong wall was attached to the leg of the frame providing the cyclic seismic horizontal load simulation. Figure 3-14 and Figure 3-15 are given to show this test set-up for the shear test columns.

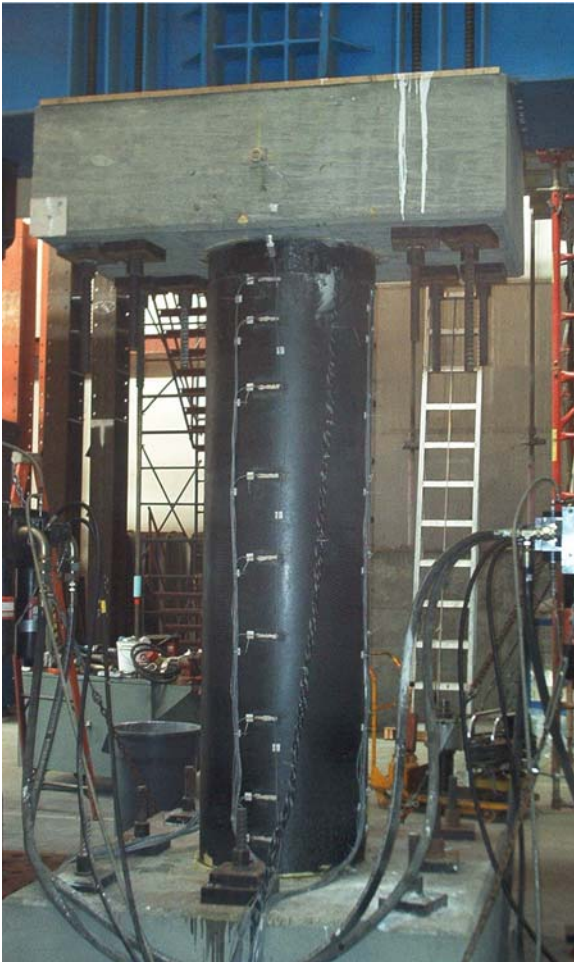
Figure 3-27: Shear Column during Load Controlled Cycling

Figure 3-27 and Figure 3-28 show the column during load controlled and deflection controlled testing.

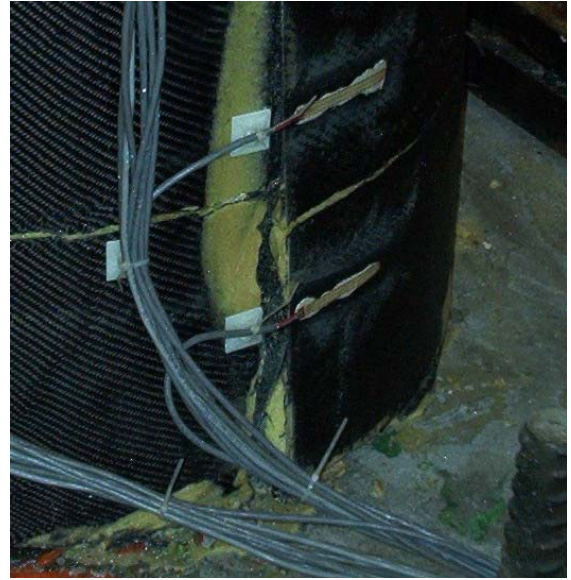
3-29. Within the next few cycles, visible crushing at the bottom of the jacket was also seen as shown in Figure 3-30.

Figure 3-29: Jacket Splitting at Seam

Figure 3-30: Jacket Splitting at Seam

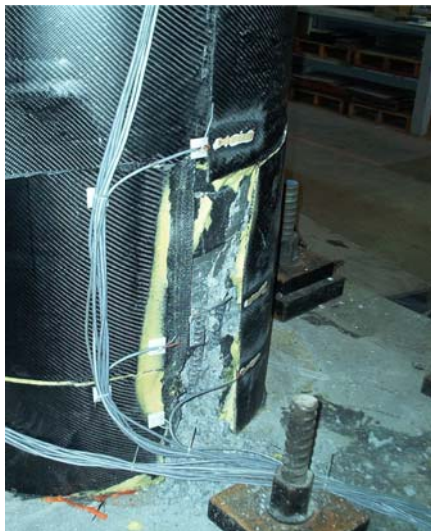
Figure 3-34: Jacket Failure

During the first cycle of ductility Level 8 loading, a brittle shear failure occurred. The failure produced a loud sound as the jacket ruptured. This rupture is shown in Figure 3-34. Large pieces of the interior foam core came loose from the fractured carbon shell as the jacket ruptured. A missing section of the jacket's interior foam layer is pictured in Figure 3-35.

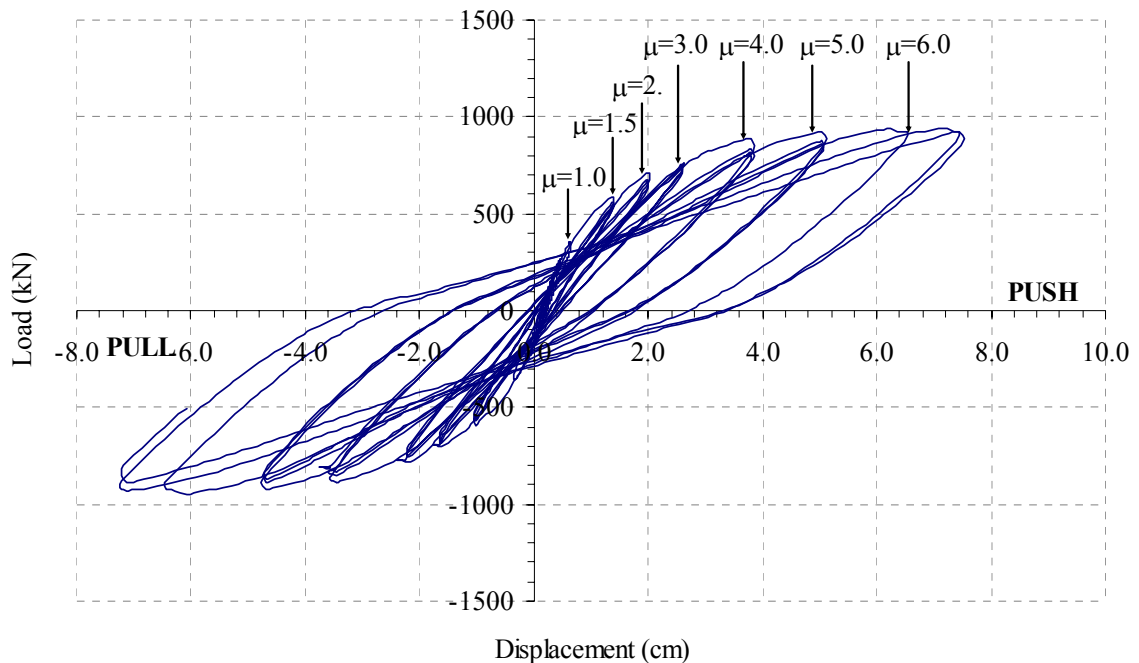
Figure 3-36: Circular Shear Column Load vs. Displacement Test Results

Stability under cyclic loading during the circular shear testing was measured to the displacement length of 7.28 cm (2.87 inches) with the column failure occurring at a deflection of 7.68 cm (3.02 inches). A hysteresis plot of the circular shear columns applied load to the resulting column displacement is seen in Figure 3-36. This graph shows a stable push-pull response with the positive push data mirroring the negative pull data about the zero load and zero displacement axes. The area outlined within the data point of graph is smooth elliptical shape with no abrupt jumps or drops in data to indicate instability.

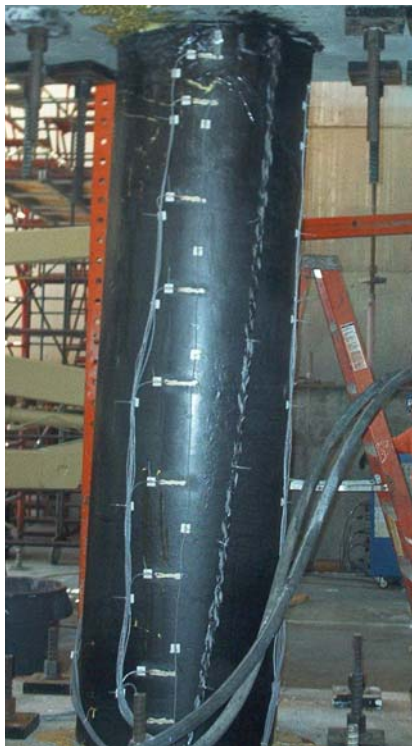
Figure 3-52: Shear Column during testing

Figure 3-52 and Figure 3-53 are pictures of the column during deflection load control testing.

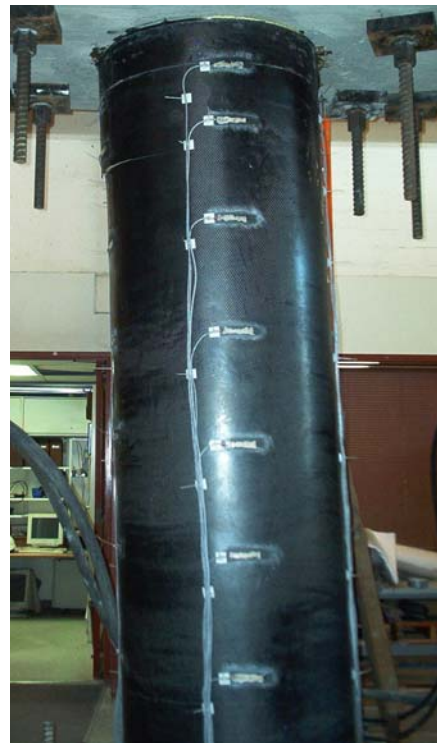
Figure 3-53: Column under 9.7 cm Deflection

Under deflection load control the jacket exhibited minor flexure cracking in the plastic hinge regions (first 45 cm from top and bottom of column). Under a 7.28 cm applied deflection at ductility Level 6, the retrofit jacket began to experience noticeable fractures and a separation of the construction seam as illustrated in Figure 3-54 with visible crushing at the bottom of the jacket. Also seen in Figure 3-55 is splitting at the top of the jacket at the location of a patch applied during the jacket construction.

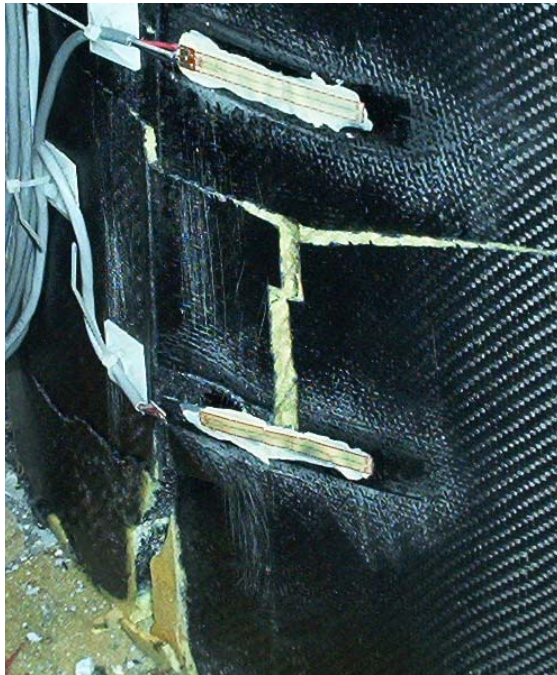
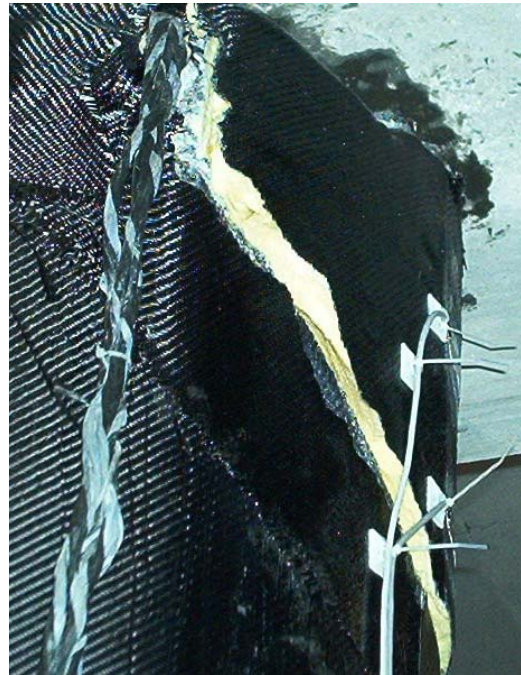
Figure 3-54: Jacket Splitting at Seam

Figure 3-55: Jacket Splitting at Seam

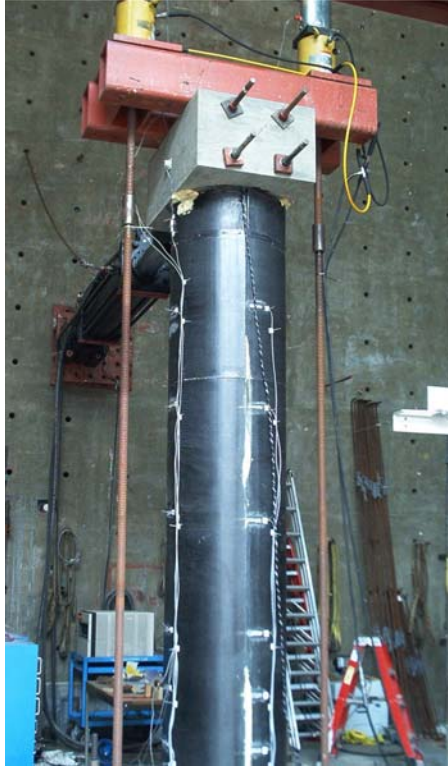
Figure 4-6: Overview of Flexure Test Set-Up

For the two experimental continuously reinforced flexure columns, the test set-up was comprised of a 978 kN (220 kip) capacity actuator with a 22 cm (9-inch) stroke, reacting against the strong wall which was attached to the top of a column's load stub by means of four (4) high strength bars. Atop the load stub was a frame supporting two (2) load cells used to apply a compression load to simulate bridge superstructure self-weight. This pre-described compression load is given in Chapter 2 below Figure 2-7 and Figure 2-8. Figure 4-6 and Figure 4-7 show this test set-up for the continuously reinforced flexural test columns.

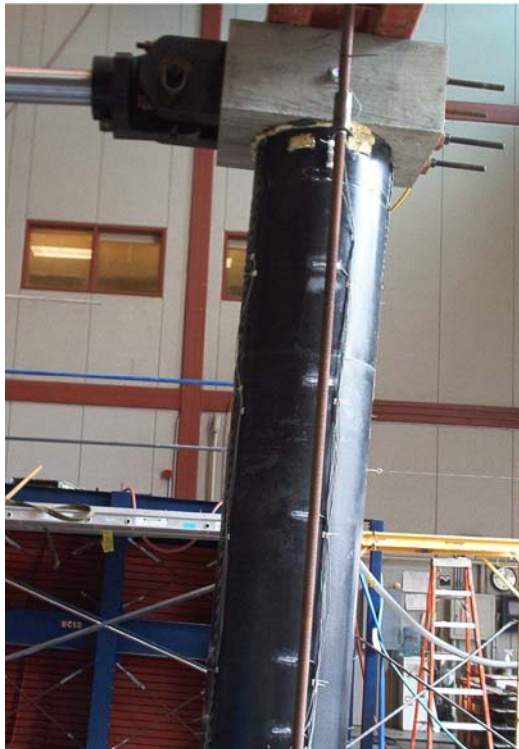
Figure 4-20: Continuously Reinforced Circular Flexural Column during testing

Figure 4-20 and Figure 4-21 show the column during deflection induced control testing.

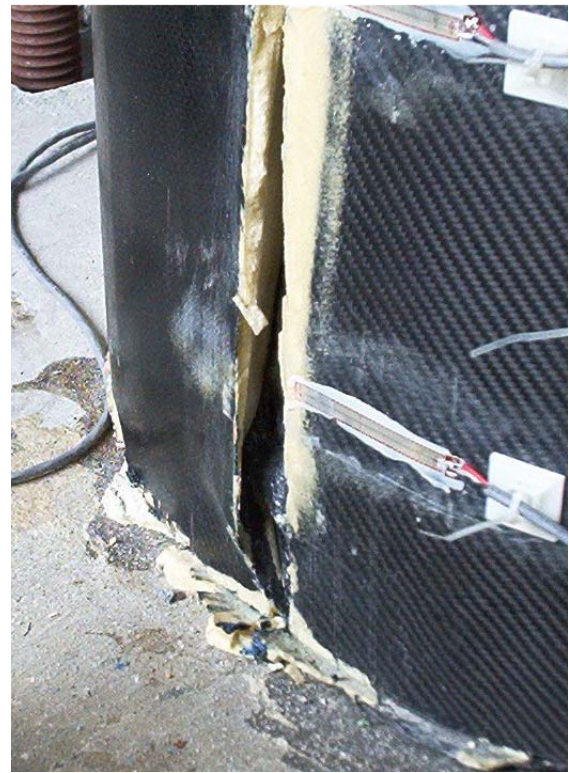
Under displacement control cycling, the jacket exhibited minor flexural cracking in the plastic hinge regions (extending to a height of 73 cm from the bottom of the column) most noticeably along the jacket seam as shown in Figure 4-22. Under a 9.291 cm applied deflection equivalent to ductility Level 4, the retrofit jacket began to experience an obvious separation of the construction seam illustrated in Figure 4-23.

Figure 4-22: Jacket Splitting at Seam

Figure 4-23: Jacket Splitting at Seam

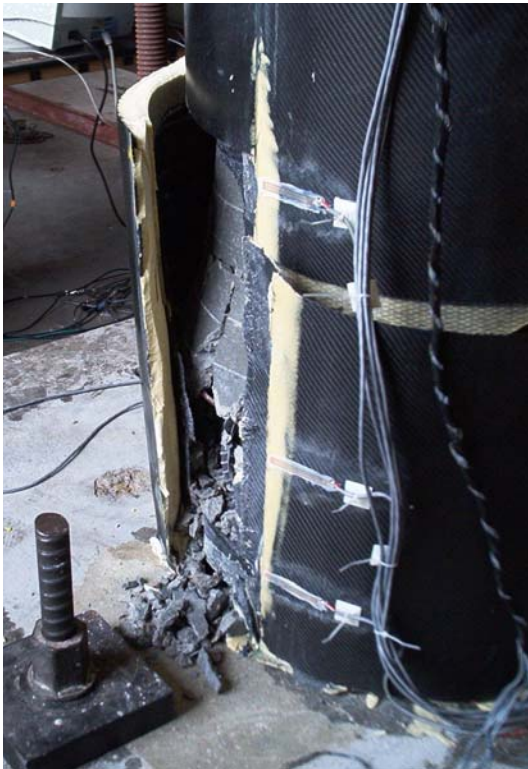
exposed internal reinforcement is shown in Figure 4-29 and it is clear that premature failure of the seam caused failure of the column. The effect of the seam on the failure can be clearly seen through the vertical crack in the concrete which coincides with the vertical end of the inner carbon fabric layer. This would have been avoided had the overlap region in the composite been longer, thereby avoiding an abrupt end of column testing resulting from the seam failure.

Figure 4-28: Jacket Failure

Figure 4-29: Close up of Jacket Failure

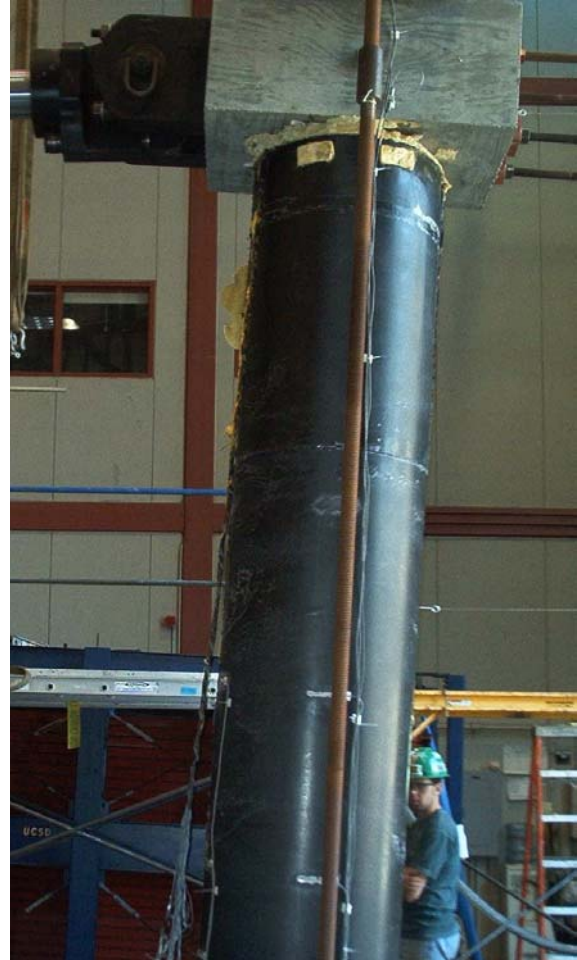
Figure 4-44: Continuously Reinforced Square Flexural Column during testing

Figure 4-43 and Figure 4-44 show the column during the pre-specified deflection induced control testing in a pull then a push cycle position.

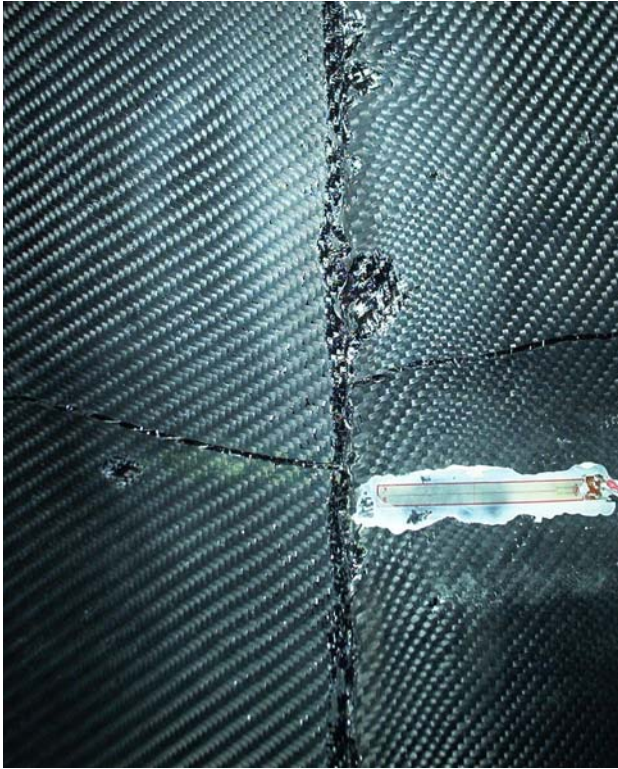
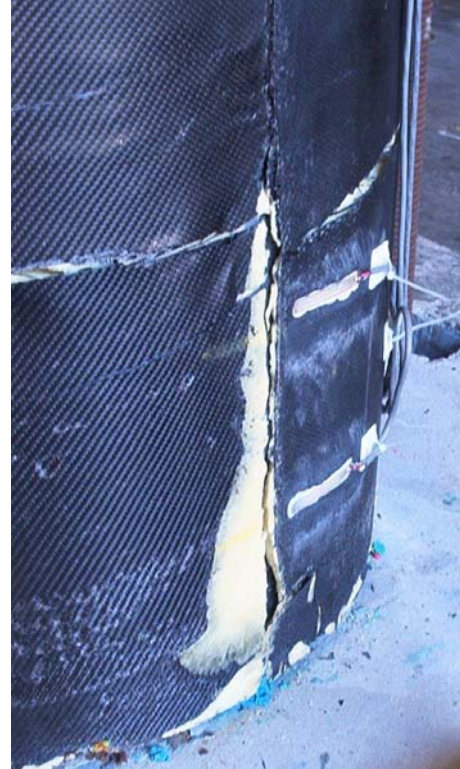
Under displacement control cycling, the jacket exhibited minor flexure cracking in the plastic hinge regions (first 73 cm from the bottom of the column) most noticeably along the top of the plastic hinge in the hoop direction during the level 3 ductility cycle as shown in Figure 4-45. Under a 19.89 cm applied deflection at ductility Level 5, the retrofit jacket showed an obvious separation of the construction seam along the overlap region as illustrated in Figure 4-46.

Figure 4-45: Horizontal Jacket Splitting

Figure 4-46: Jacket Splitting at Seam

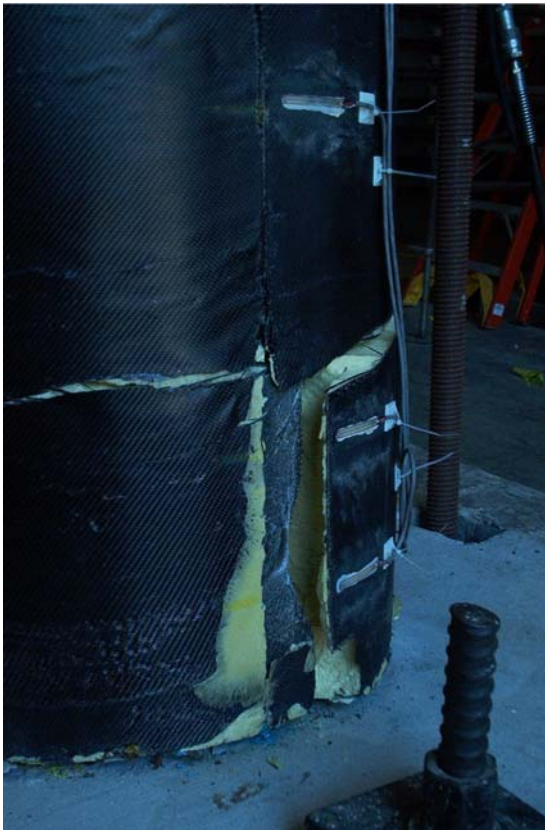
Figure 4-51: Square Column Jacket Failure

As previously noted, during the second cycle at ductility Level 8 loading, a jacket/confinement failure occurred. This jacket split is shown in Figure 4-51 and a close-up of the jacket with the exposed internal carbon jacket layer is shown in Figure 4-52. Unlike in the previous circular column case, failure was caused by the failure at the composite splice region with some fracture in the carbon/epoxy itself.

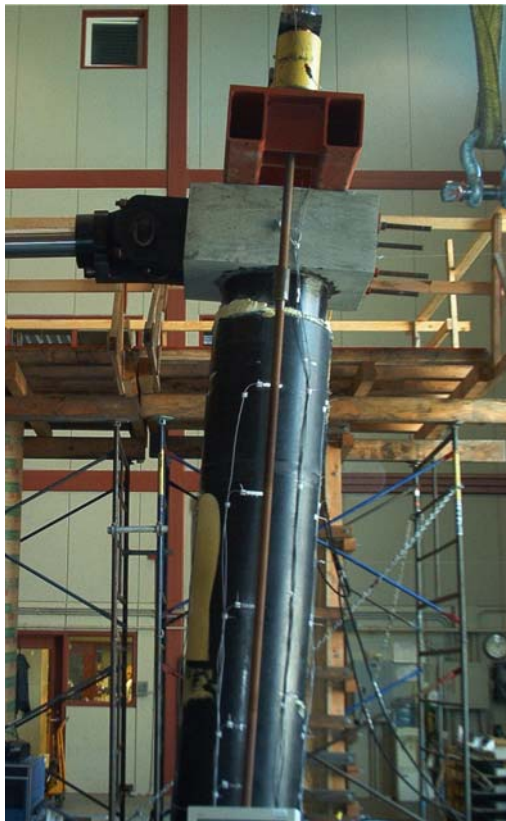
Figure 5-18: Lapped Reinforced Circular Flexural Column during testing

As the testing was continued under cycles of increased enforced displacements (see Figure 5-18 and Figure 5-19), the column began to separate from the footing base and cracks began to appear in the footing as well. Under an 8.968 cm applied deflection at ductility Level 4, the column began to separate from the footing base as shown in Figure 5-20.

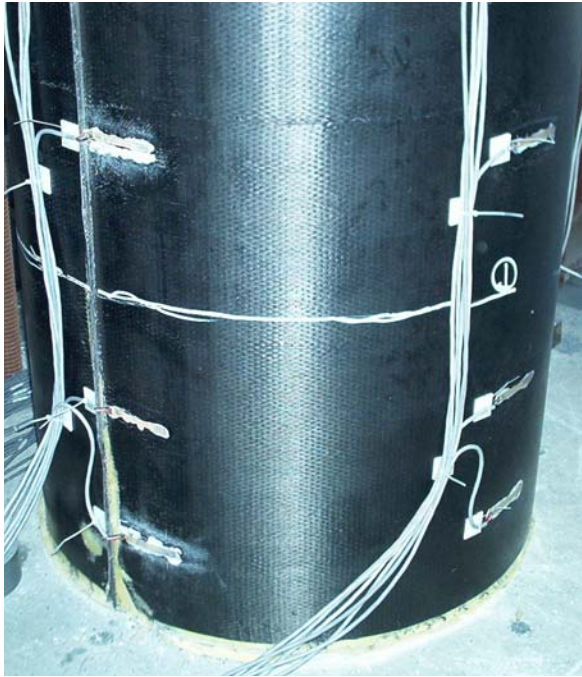
Figure 5-21: Composite Jacket Breaking in Hoop Direction of Column

The exterior of the composite jacket also exhibited minor flexure cracking most noticeably at the top of the plastic hinge region of the composite jacket (extending to a height of 73 cm from the bottom of the column) in the hoop direction, as shown in Figure 5-21 and Figure 5-22 marked with a white marker. These noticeable hoop cracks first began to appear at displacement ductility level 3 cycling.

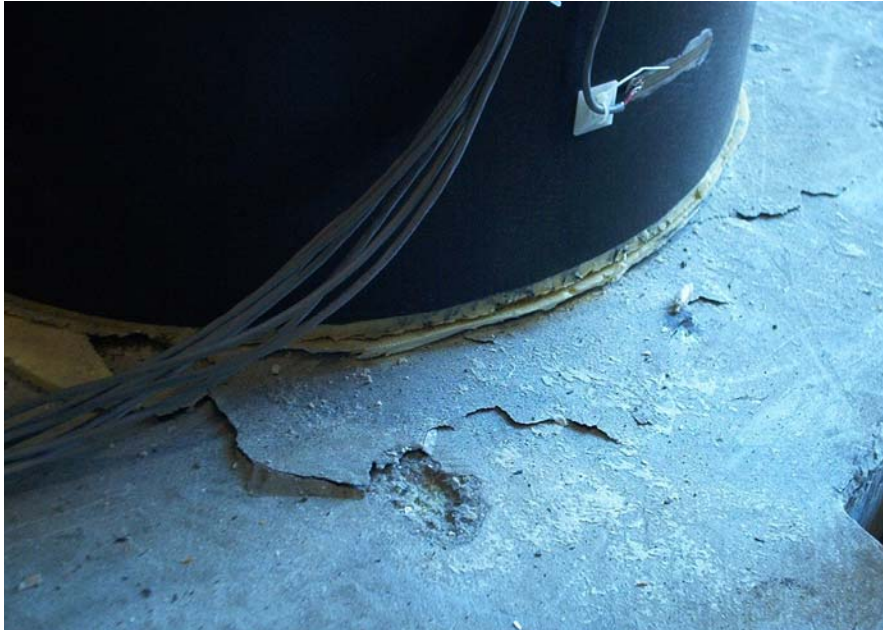
Figure 5-27: Concrete Base Cracking and Spalling

During the third cycle at ductility Level 8 loading, column failure was deemed to have occurred due to 15% drop in load required to displace the column 17.935 cm. This load decrease may have been due to the lap splice clamping failure of the column's footing splice bars

and column's vertical reinforcement. As seen in Figure 5-27, the column had begun to pull away from the base causing the base concrete to crack and spall.

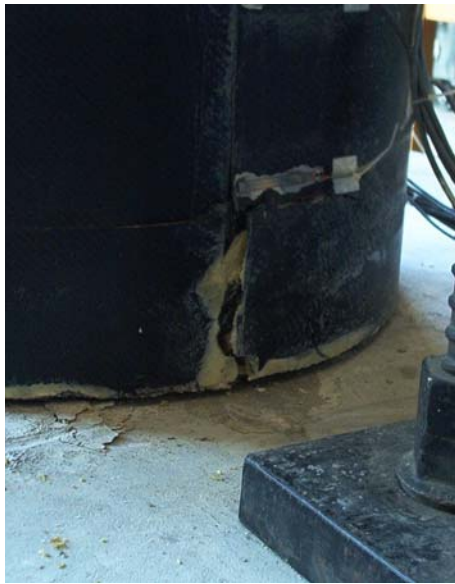
Figure 5-45: Jacket Splitting at Seam

Under deflection load control the strengthening jacket exhibited minor flexure cracking in the plastic hinge regions (extending to a height of 73 cm from the bottom of the column) most

noticeably along the jacket seam at the base of the column, shown in Figure 5-45. This strengthening jacket fracturing was amplified by crushing of the jacket against the base as the column's reinforcement splice began failing causing the column to rise up off the concrete footing base. Under an 11.794 cm applied deflection at ductility Level 3, the column and base gap became more visibly pronounced as the column continued to further rise up off the footing base, illustrated in Figure 5-46.

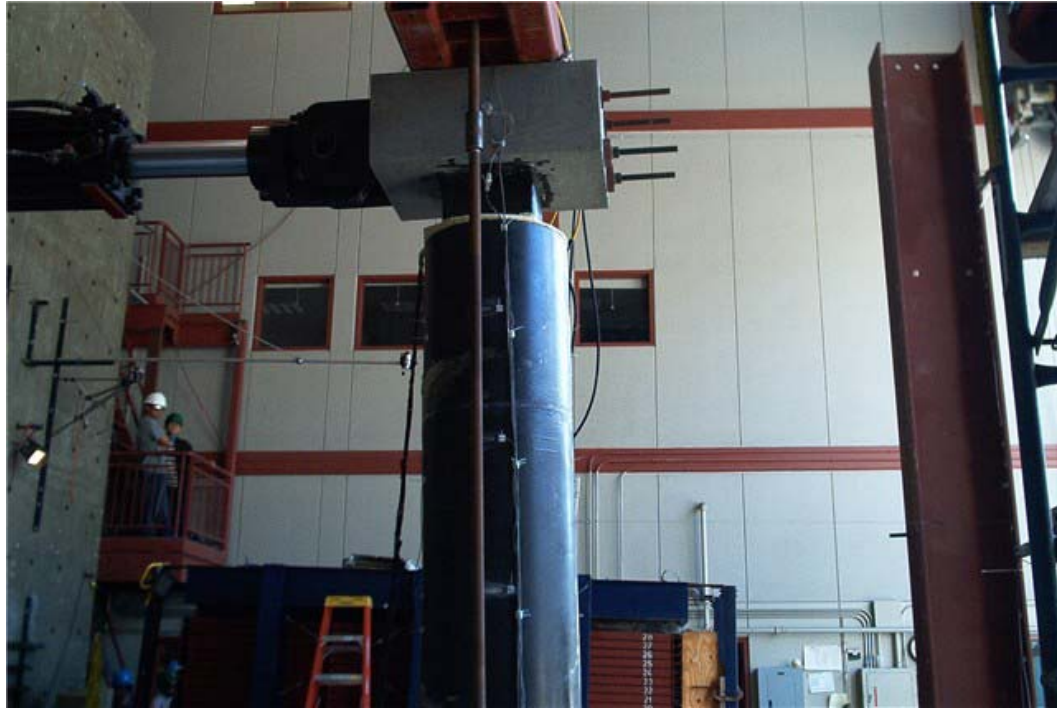
Figure 5-47: Lapped Reinforced Square Flexural Column during testing

Column testing continued with increased displacement controlled loading to a 23.587 cm (9.287 in) calculated ductility level 6. Figure 5-47 shows the column during this deflection load control testing.
