Post-Project Evaluation of Channel Morphology, Invasive Plant Species, and Native Fish Habitat in Putah Creek in Winters, CA Six Years After Channel Relocation

Final Draft

Gina Blackledge and Gabrielle Boisramé

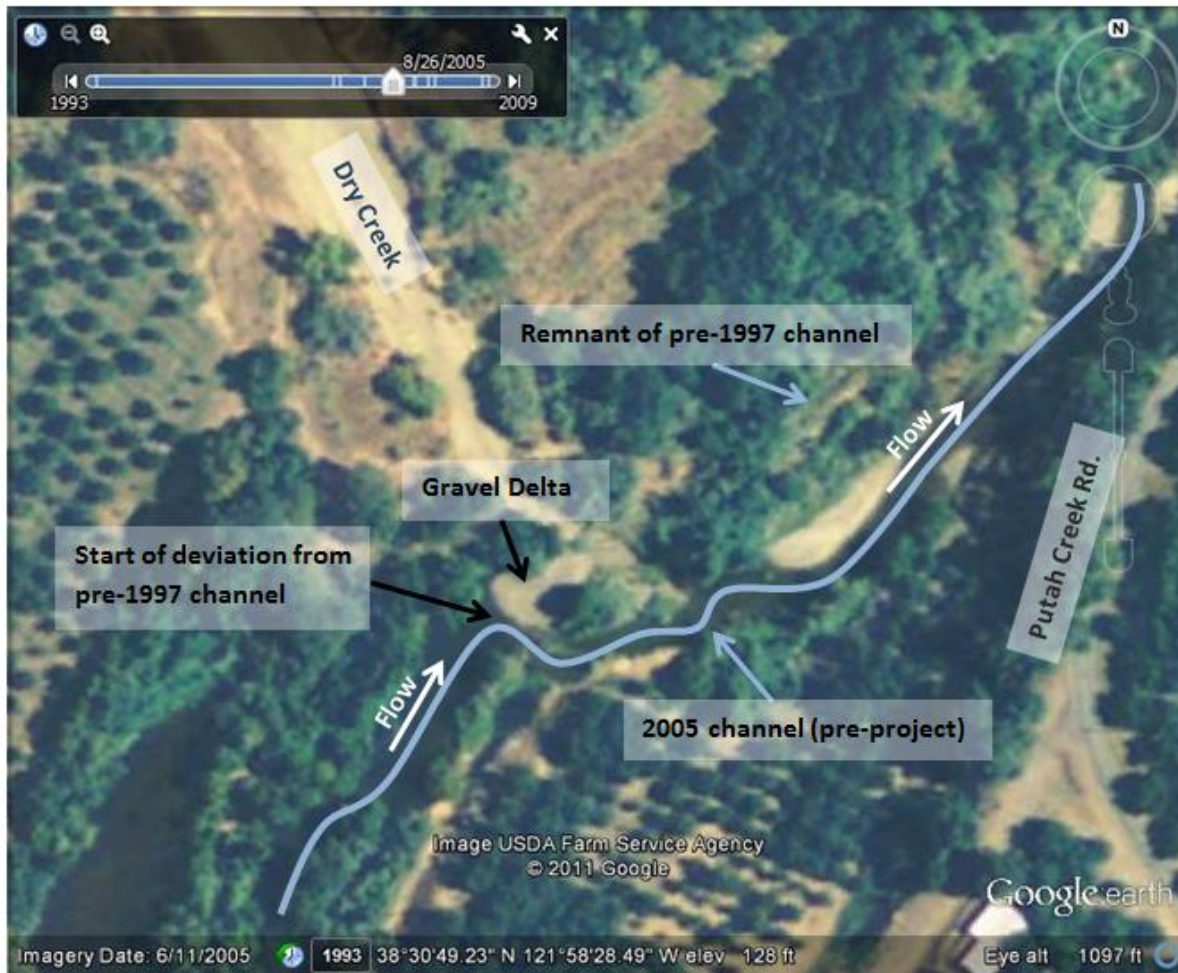
Figure 1. This 2005 Google Earth photo shows the gravel delta formed at the confluence of the creeks.

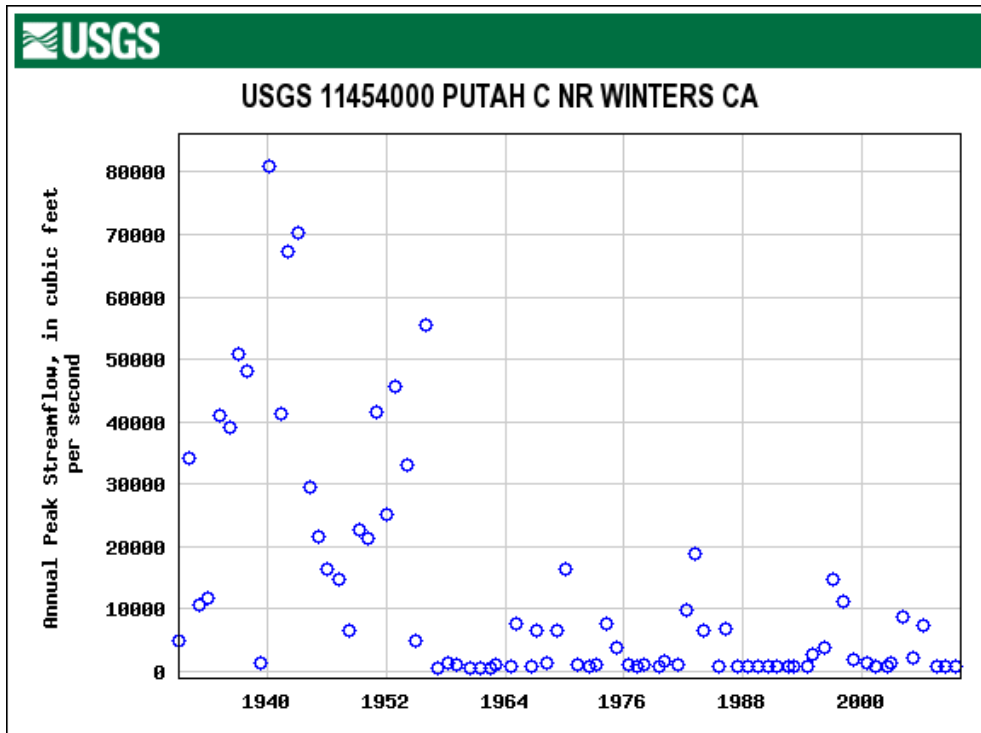
Figure 4. Annual peak streamflow in Putah Creek. Note drastic decrease after completion of the Monticello dam in 1957. Source: <<http://nwis.waterdata.usgs.gov>>.

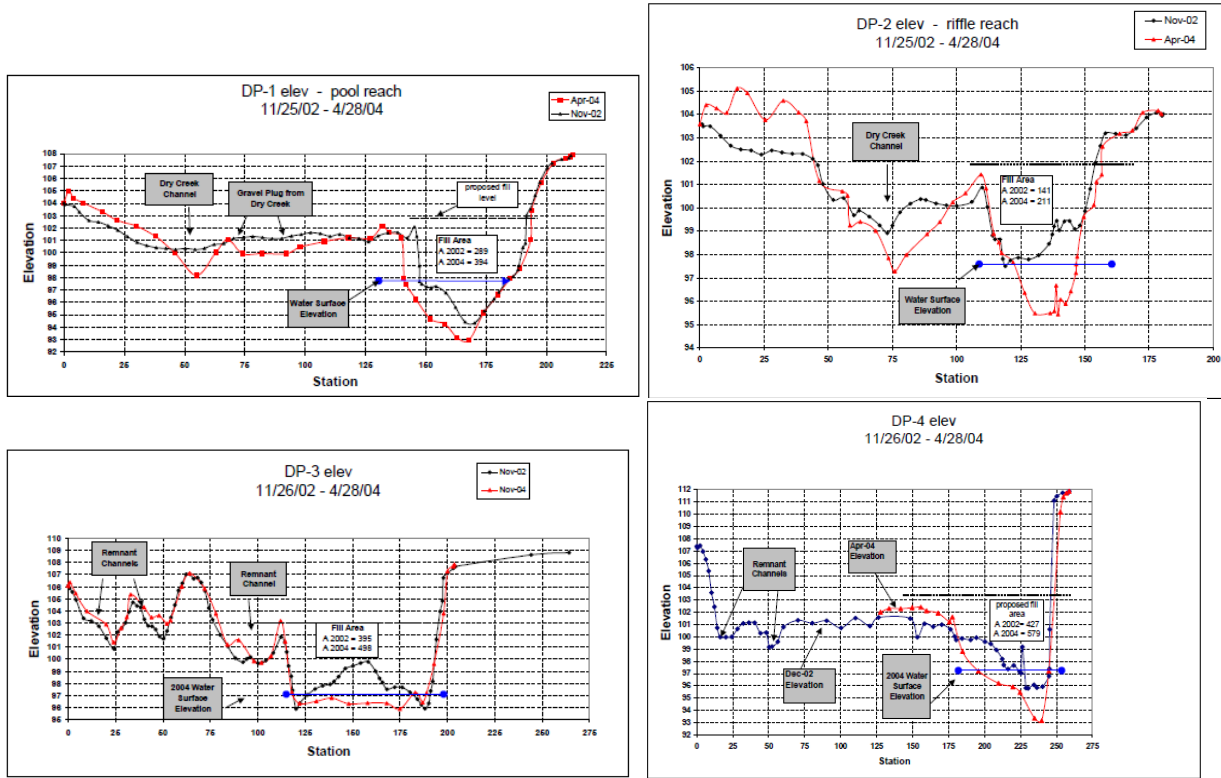
Figure 5. Transects from 2002 and 2004. (StreamWise 2004).

2004 shows the lateral migration and incision which occurred during this period (Figure 5).

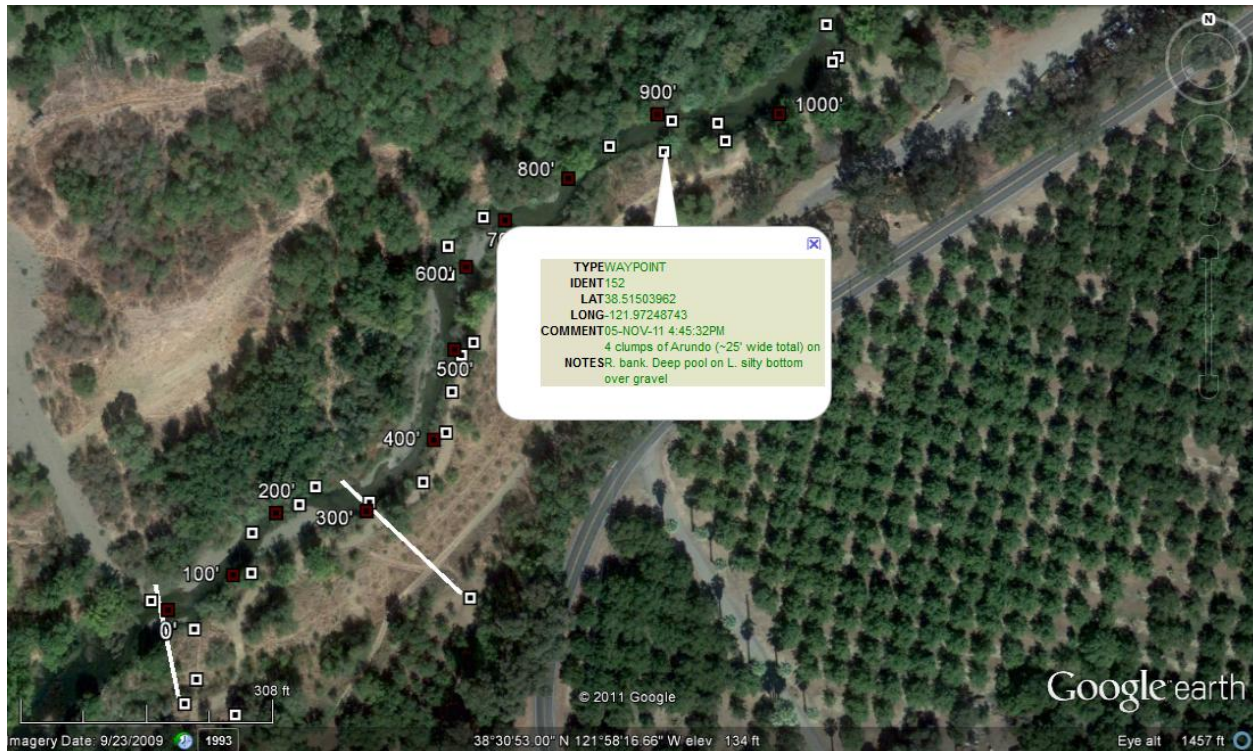
Figure 7. Screenshot of Google Earth showing our waypoints as squares. Red squares are the dividers of the 100 foot sections. White lines are the two transects we surveyed in 2011.

We documented the November 2011 condition of the site with photographs tied to GPS coordinates and used GPS points to map out areas of interest along the restored creek (Figures 7,10). This mapping was aimed at identifying locations of high erosion, sediment deposition, native fish habitat and invasive species growth to create a general picture of the current state of the channel and floodplain. We divided the restored reach into ten 100 foot sections starting at the Dry Creek confluence and going downstream in order to make the areas we mapped easier to locate (Figure 7).

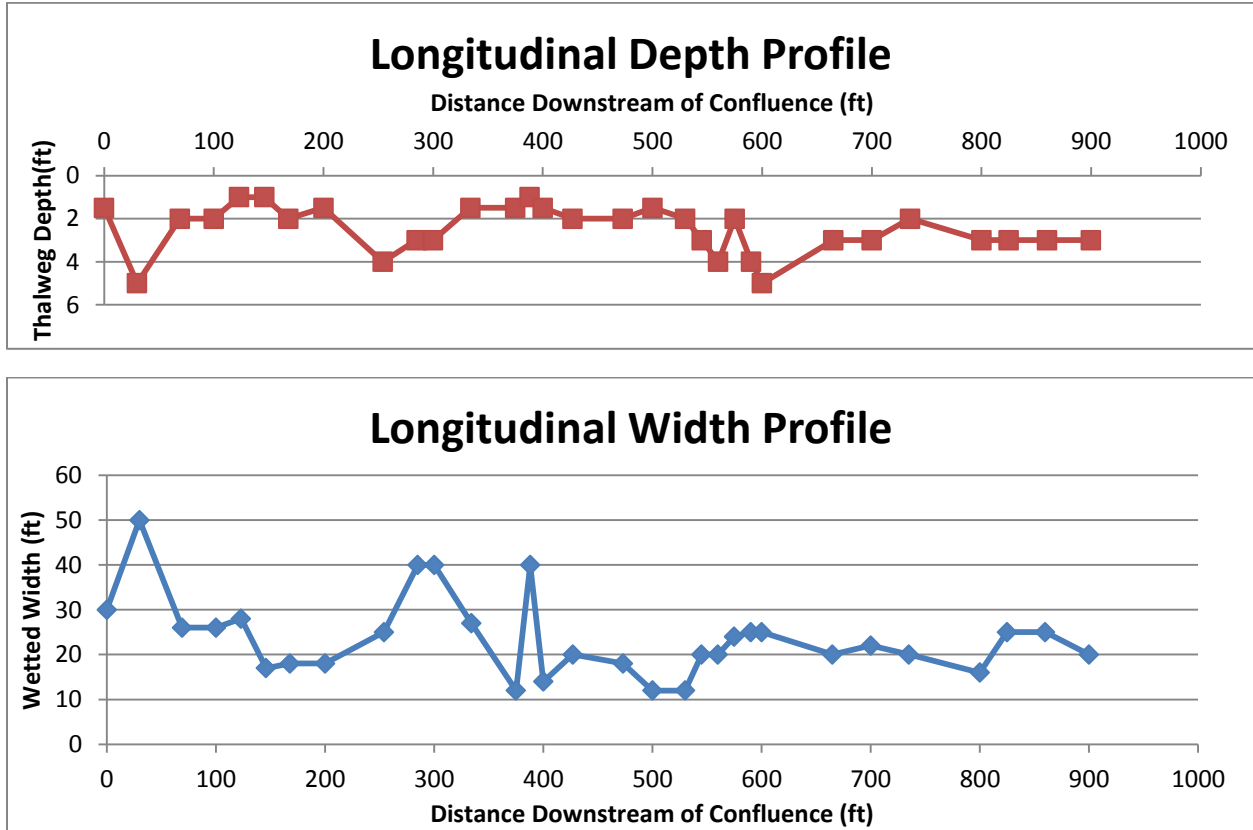
Figure 9. Longitudinal profile of Putah Creek showing variations in width and mix of riffle and pool features. (Deep areas are pools and most shallow areas are riffles). Starting at the confluence with dry creek, we measured the width and thalweg depth every 100 feet and at any points in between where there were large changes in either width or depth. Note that the depth axis and depth axis are ordered differently. This is to make the depth line easier to interpret (deeper areas are lower rather than higher).

riffle habitat (Figure 9). About 30% of the length of our 1000 foot longitudinal profile is pools and about 40% is riffle. There are many gravel bars and areas with gravel in the creek bed, but most of the in-stream gravel is silted over. In general, riffles where the fast-flowing area is less than 15 feet wide have clean gravel (such as between 146 and 200 feet along our longitudinal profile and around 540 feet ). In contrast, wider areas had mud, clay, or silty gravel in the streambed.

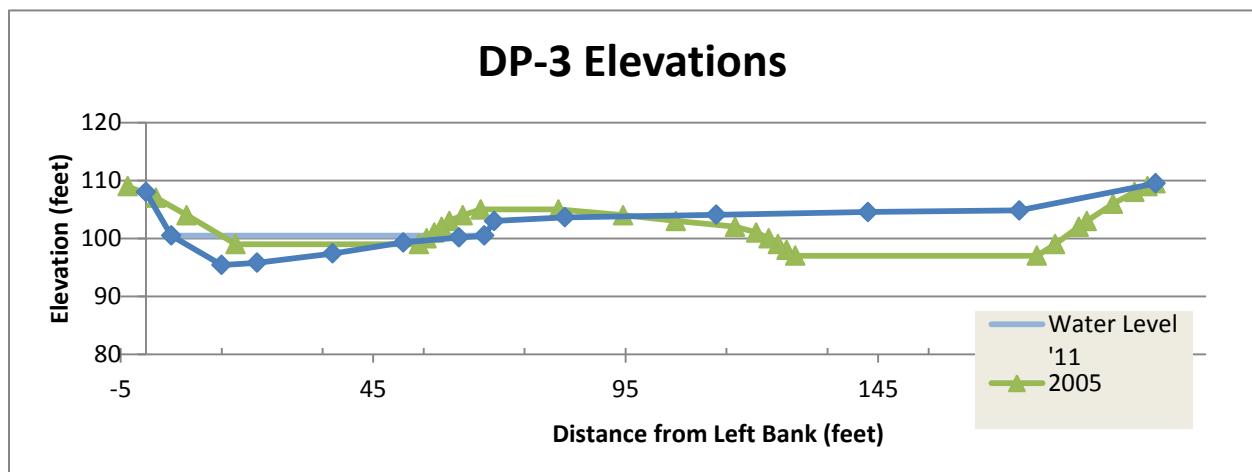
Figure 12. These lines show elevation along transect DP-3, starting with 0 at the left bank pin. The blue line shows our measurements in 2011. Elevations within the pool were difficult to measure and therefore are only expected to be accurate to within about one foot. The green line shows the elevations in September 2005, as measured using LIDAR. This shows that the channel has widened slightly at this point, and along the left bank the channel incised and the bank became steeper.

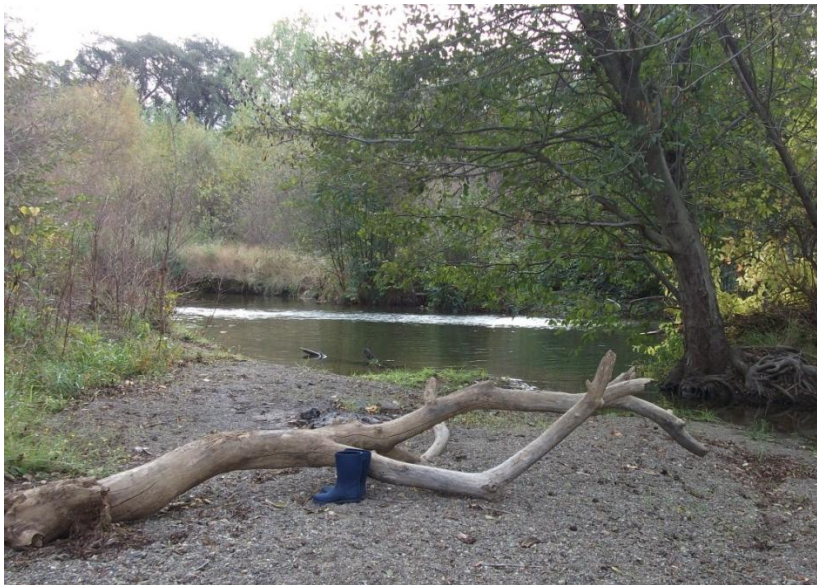
Figure 14. Standing in Dry Creek looking south across Putah Creek at waypoint 136. Photo by Gabrielle Boisramé.

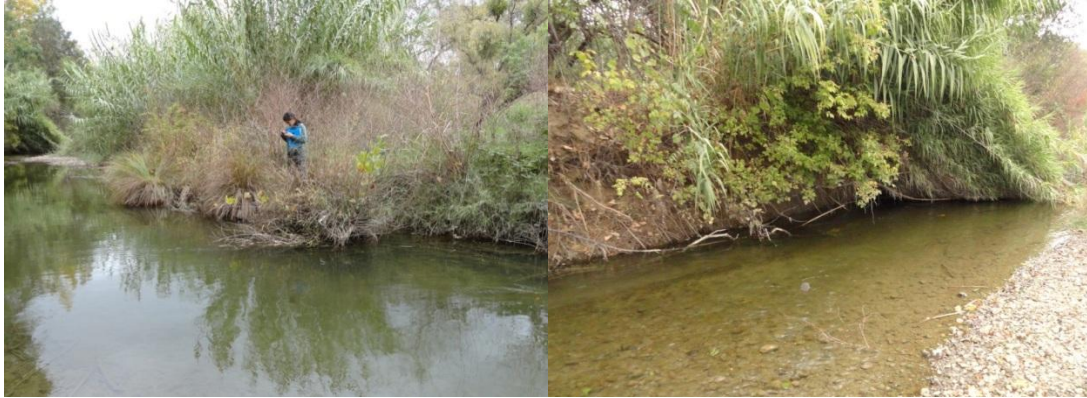
Figure 15. Looking downstream at *Arundo*, waypoint 152 (left). Looking downstream from right bank at *Arundo* stand over steep bank, waypoint 155 (right). Photos by David Pope.

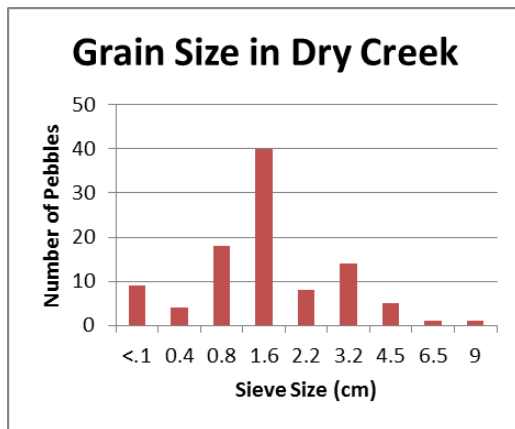
Figure 16. Results from pebble count in dry creek. Median grain size is 1.6cm.

Researchers have observed native fish in Lower Putah Creek, though salmonids are relatively rare (UC Davis 1998, Marchetti and Moyle 2001). According to the Putah-Cache Bioregion Project findings, the Dry Creek confluence had one to two orders of magnitude more native larval fish between 1994 and 1998 than the other sites sampled in Putah Creek (UC Davis 1998) (Details in Appendix E). This suggests a past native preference for spawning and rearing at the Dry Creek site and shows the importance of providing adequate habitat at this location. Salmonids use clean freshwater gravels to cover their eggs during incubation. One study of 135 salmonid spawning sites found that median grain sizes in these sites ranged from 5.4-78mm, with 50% of the medians falling between 14.5 and 35mm. One species which was included in the gravel study and has been found in Putah Creek is Chinook salmon, which had a median grain size of 31-66mm among California sites (Kondolf and Wolman 1993). Our pebble count at the mouth of Dry Creek showed a median grain size of 16mm (Figure 16). This is at the low end of the 5.4-78mm range for spawning gravels found by Kondolf and Wolman (1993). Although the

median is not in the 31-66mm range found for California Chinook, we did find pebbles in this size range. In fast flows, pebbles would theoretically become roughly sorted by size and potentially create gravel beds in Putah Creek with a larger median grain size. The presence of pebbles within the size range used by spawning salmonids within Dry Creek shows that it is possible for spawning habitat to be formed by the gravels it holds.

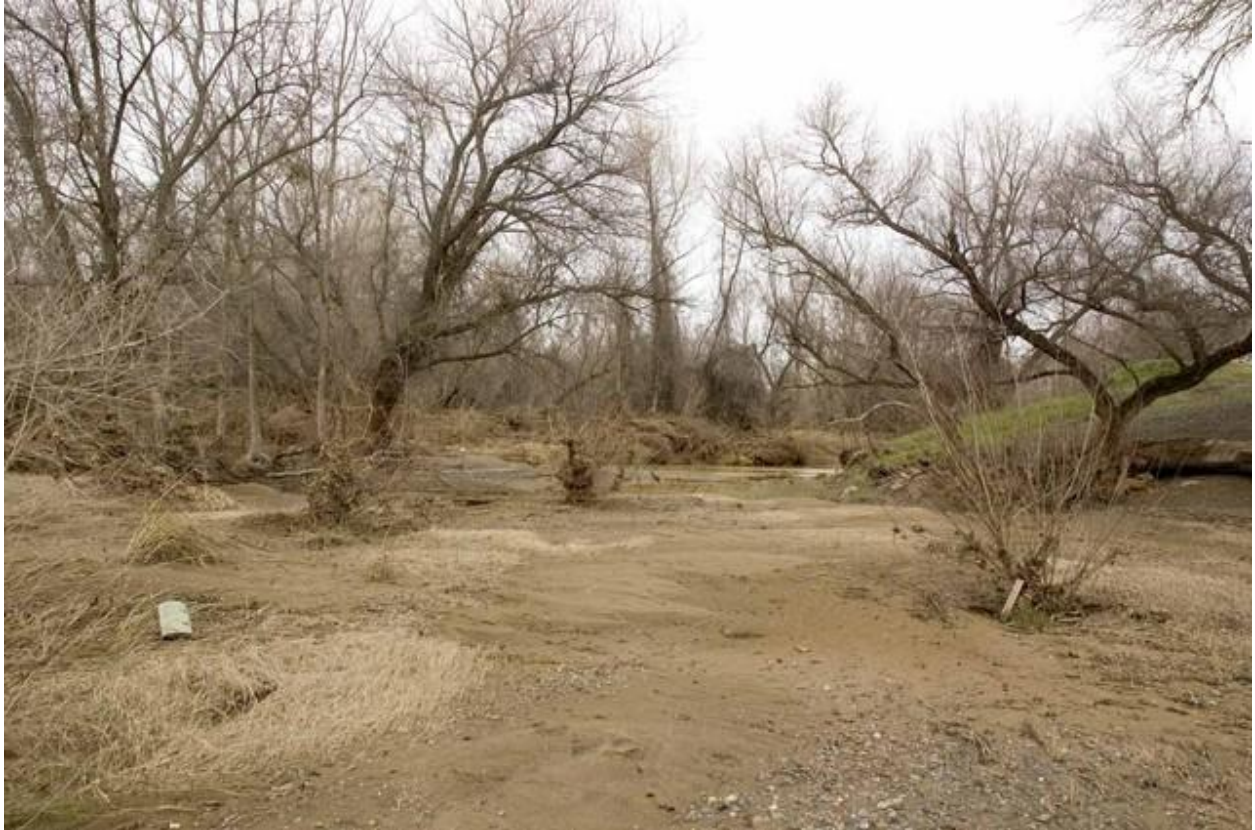
Figure 18. Fresh sand deposits on the banks of Putah Creek after a flood in 2008, showing that floodwaters inundated at least a portion of the floodplain.

Young fish which have access to floodplains have empirically observed higher growth rates, known as the “flood pulse advantage” (Figure 17). This advantage is a feature of floodplains which opens up the river system to greater and more diverse food resources, also providing shelters for hiding, increasing the successes of native fish survival against predators and other environmental circumstances. Along with supporting the largest fisheries, floodplain rivers also host greater diversity along with the services of surface water filtration, groundwater recharge, recreation, fish, timber and other plant resources with flood-management for low maintenance costs (Opperman et.al. 2010). Photographs of the restoration site from 2008 show that the creek has inundated the floodplain since the restoration project, meaning it is possible for fish to access the floodplain at least part of the year (Figure 18).

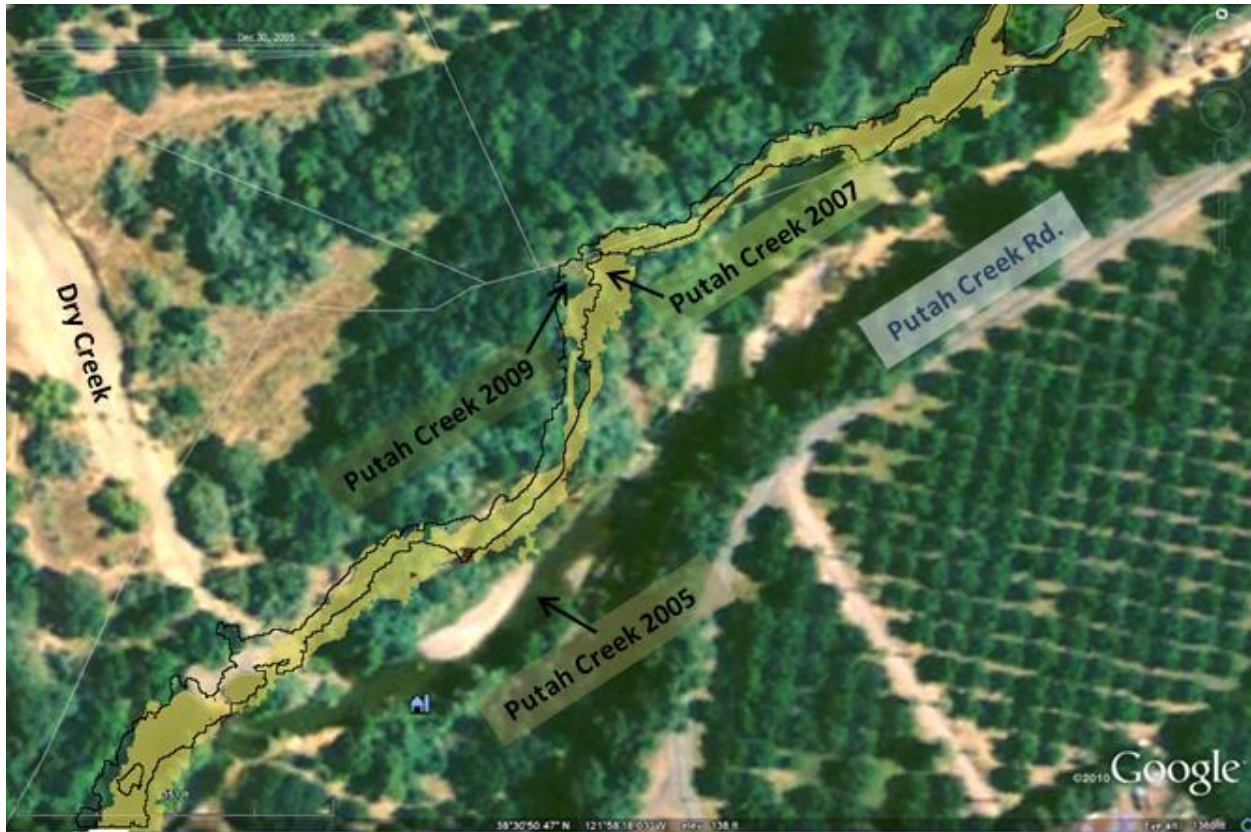
Figure 19. Channel Migration. Aerial photo from 2005 (pre-project). The solid shape overlay is the channel in 2007, and the outlined shape shows the channel in 2009. This shows that the channel did not change its course drastically between 2007 and 2009, and has not recaptured any portions of the 2005 channel. Image source: Google Earth.

The changes we observed in channel shape were minimal, and do not create a hazard for Putah Creek Road (Figure 19). In some locations, the creek migrated outside of its design channel (Figures 8). It is now under-cutting the north bank of the flood control channel and depositing sediment into the stream bed which may be counter to the efforts to establish fish spawning gravel which needs to be clean gravel.

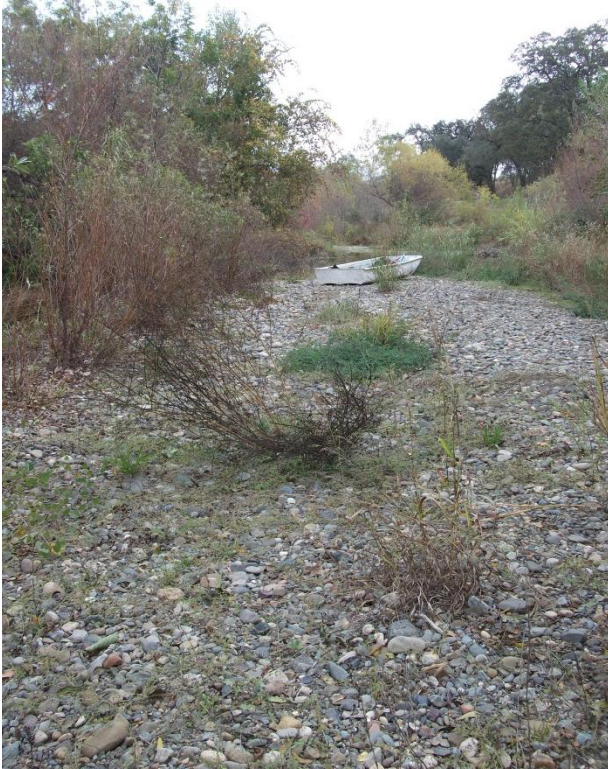
Figure 21. Gravel bar with small rowboat in background for scale. Photo taken at waypoint 141 by Gabrielle Boisramé.

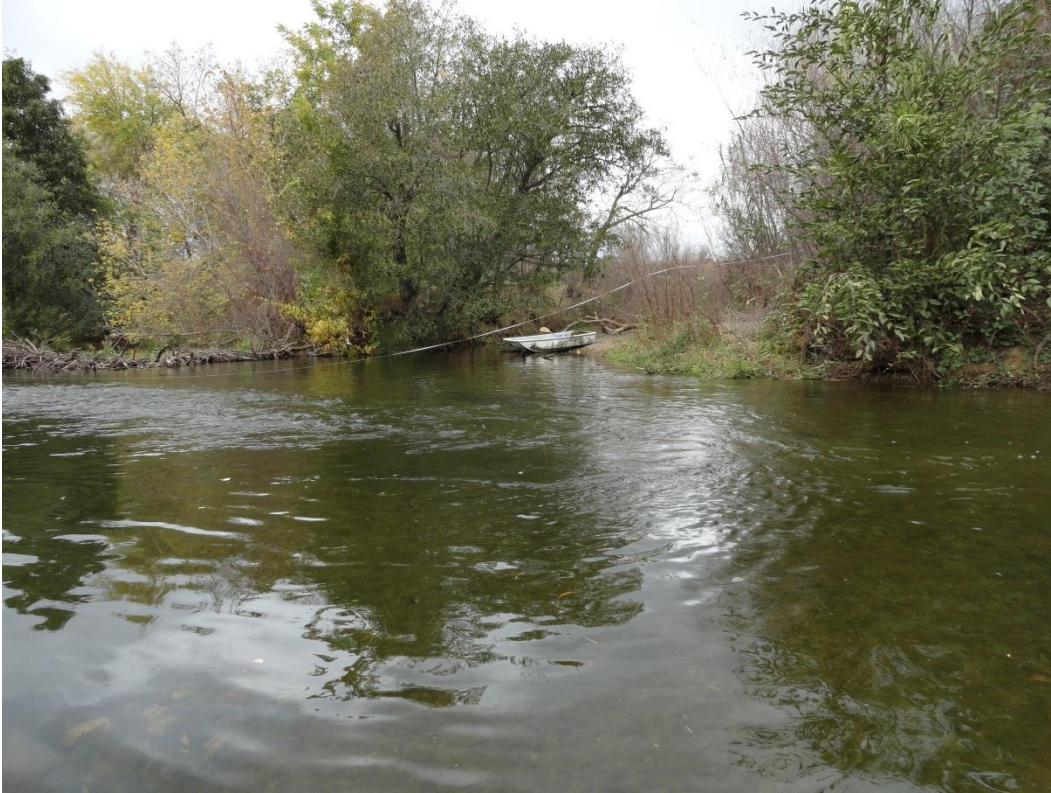
A.4. Standing mid-creek looking at South bank 000-100ft. of survey area  
Undercutting erosion of South bank building up sediment bar downstream.

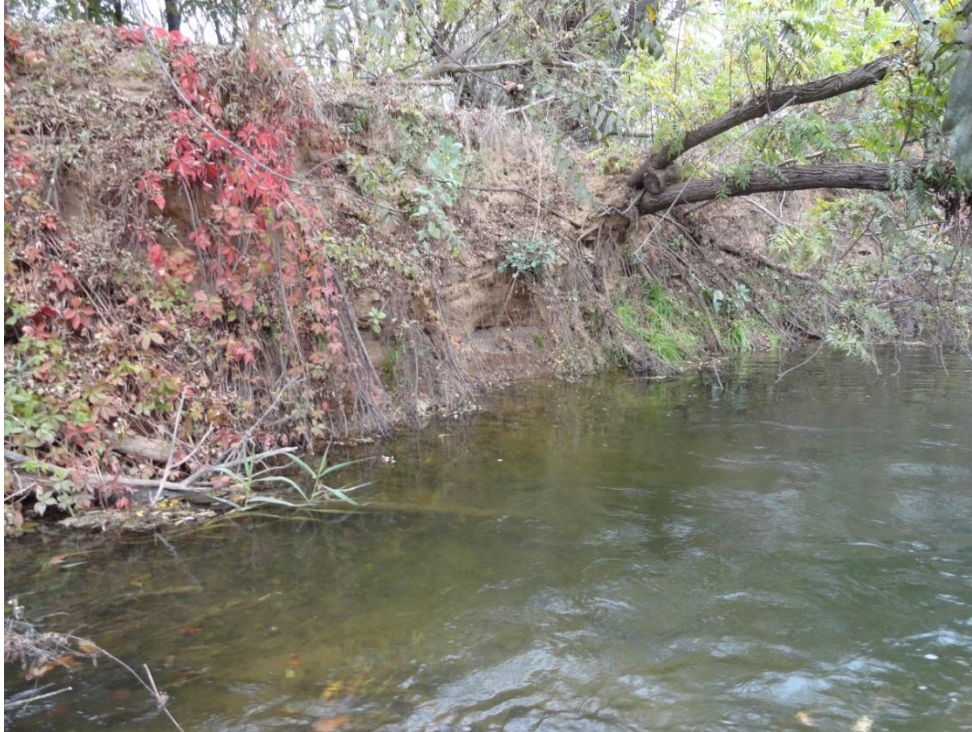
A.6. Looking upstream. Large pool downstream of same black walnut as previous picture. Steep cut bank. (Waypoint 143)

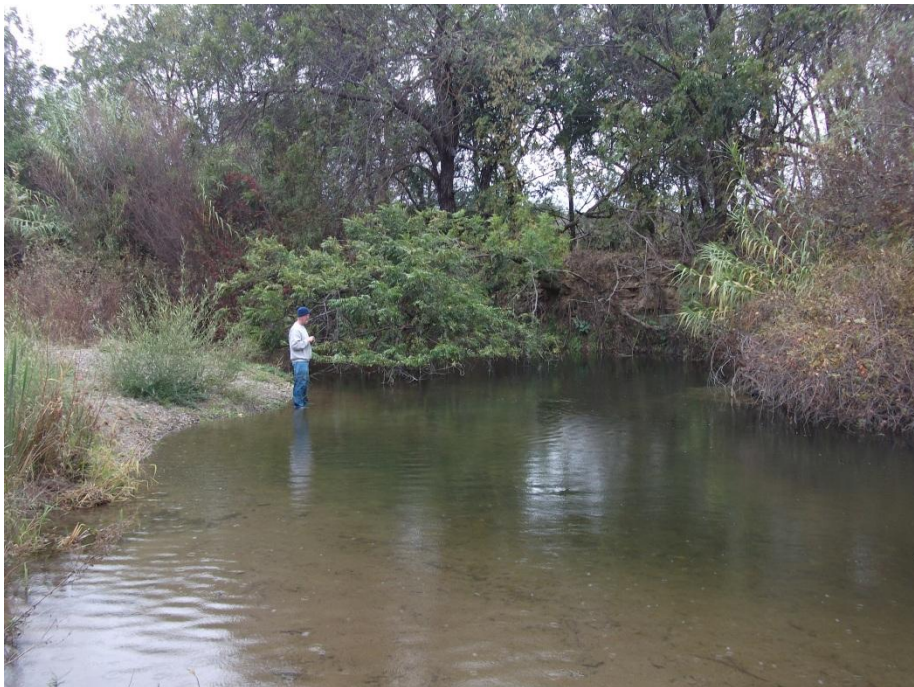
A.7. Looking downstream. Channel narrows to a riffle between gravel bar and beaver dam. (Waypoint 144).

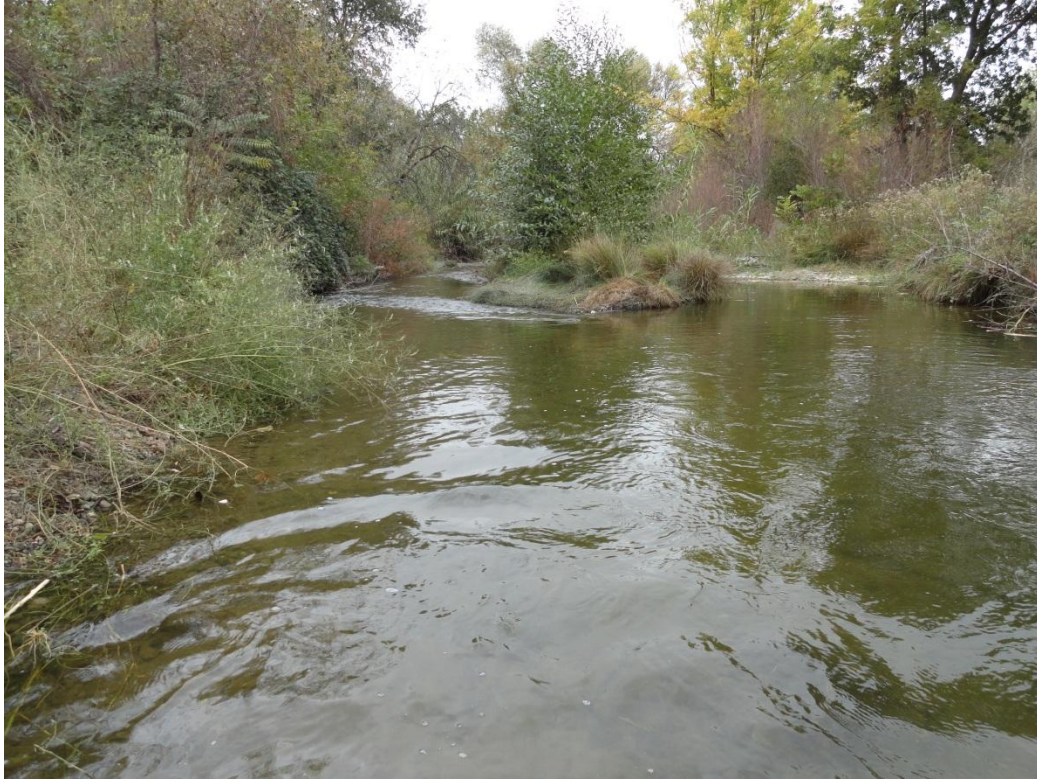
A.10. Looking downstream at deep pool under cut bank with Arundo. (Waypoint 151 is across creek from the Arundo)

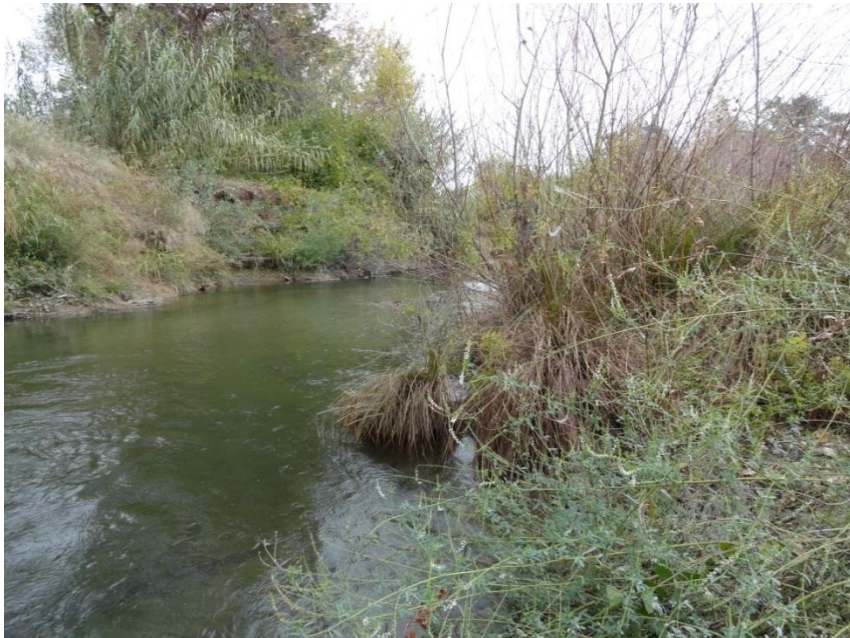
A.11. Clay bottom. (Waypoint 151)
