Final Report: Mobile Surveillance and Wireless Communication Systems Field Operational Test Volume 2: FOT Objectives, Organization, System Design, Results, Conclusions and Recommendations

**California PATH Research Report
UCB-ITS-PRR-99-7**

**Final Report: Mobile Surveillance and Wireless
Communication Systems Field Operational Test**

**Volume 2: FOT Objectives, Organization, System
Design, Results, Conclusions, and
Recommendations**

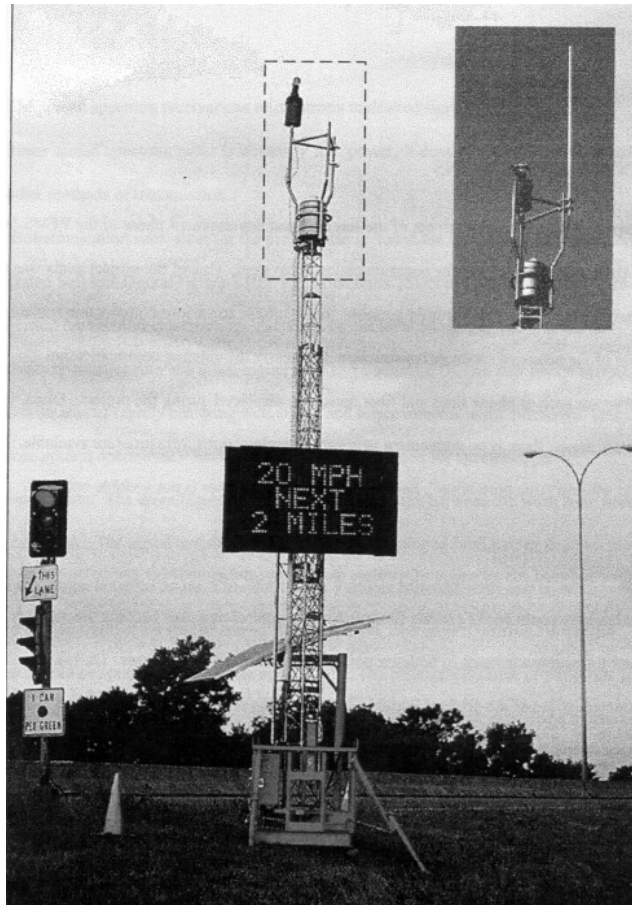
Figure 1-1. PTMS deployed on a skid

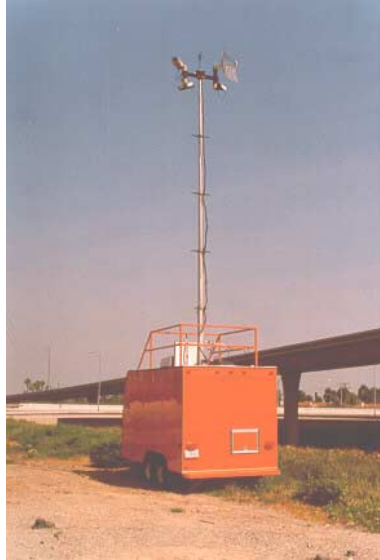
Figure 1-3. Surveillance trailer at First Street overlooking I-5 Freeway

The mobile surveillance and wireless communication system consists of surveillance and ramp meter trailers, a video and data retransmission or relay site, and video and data reception facilities at TMCs and the UCI-ITS research laboratory. Six surveillance and three ramp meter trailers were assembled as part of the FOT. Figure 1-3 shows a surveillance trailer. Its major components are a video image processor; two pan and tilt black-and-white cameras; one pan, tilt, and zoom color camera; one fixed black-and-white security camera; a 170 controller; wide and narrow bandwidth spread spectrum radios for video and data transmission; a telescoping 30-foot (9.1-meter) mast; a security system; and a propane-powered electrical generator and power supply system.

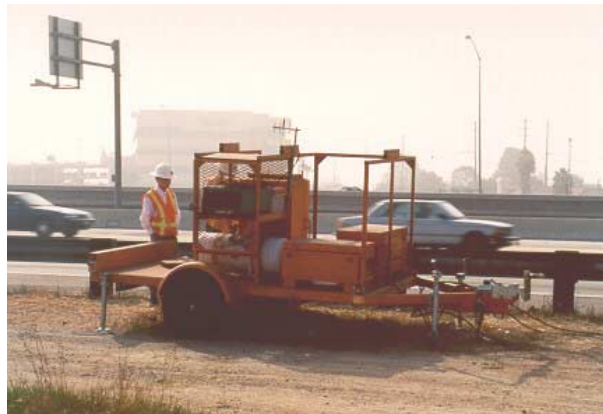
Figure 1-4. Ramp meter trailer at Grand Avenue alongside I-5 Freeway

Figure 1-4 shows a ramp meter trailer. Its major components are two traffic signal heads, a ramp meter-on sign, narrow band SSRs for data reception, and solar-powered electrical recharging systems for one of the signal heads and the meter-on sign.

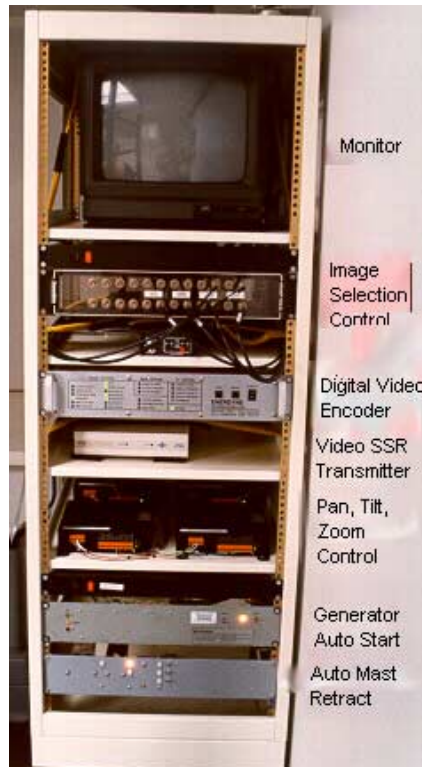
Figure 1-8. Surveillance trailer equipment racks

(a) Left equipment rack

(b) Right equipment rack

Figure 1-8 contains photographs of the two racks of equipment found in each of the surveillance trailers. The rack on the left contains the power distribution system, spread spectrum radios that transmit data to the ramp meter trailer and relay site, wide-area communications controller, AutoScope 2004 VIP, and the 170 controller that processes the VIP data. The rack on the right contains a monitor, controls for selectively displaying the imagery from the color surveillance camera or the black and white VIP cameras on the monitor, digital video encoder, spread spectrum radio that transmits compressed video imagery to the relay site, pan-tilt-zoom camera controls, generator auto start/battery recharge system, and the automatic mast retraction circuit.

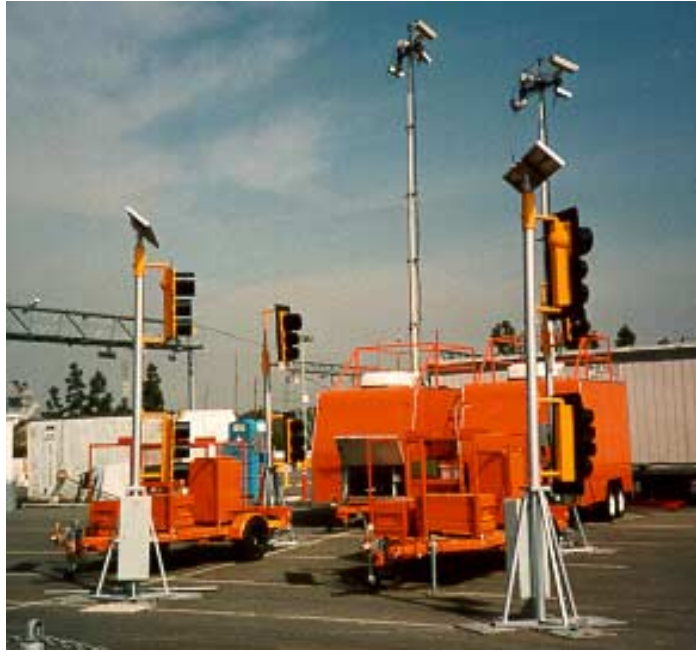
Figure 2-1. Trailer assembly at Hughes in Fullerton, CA showing ramp trailers and signal heads in foreground and surveillance trailers in background

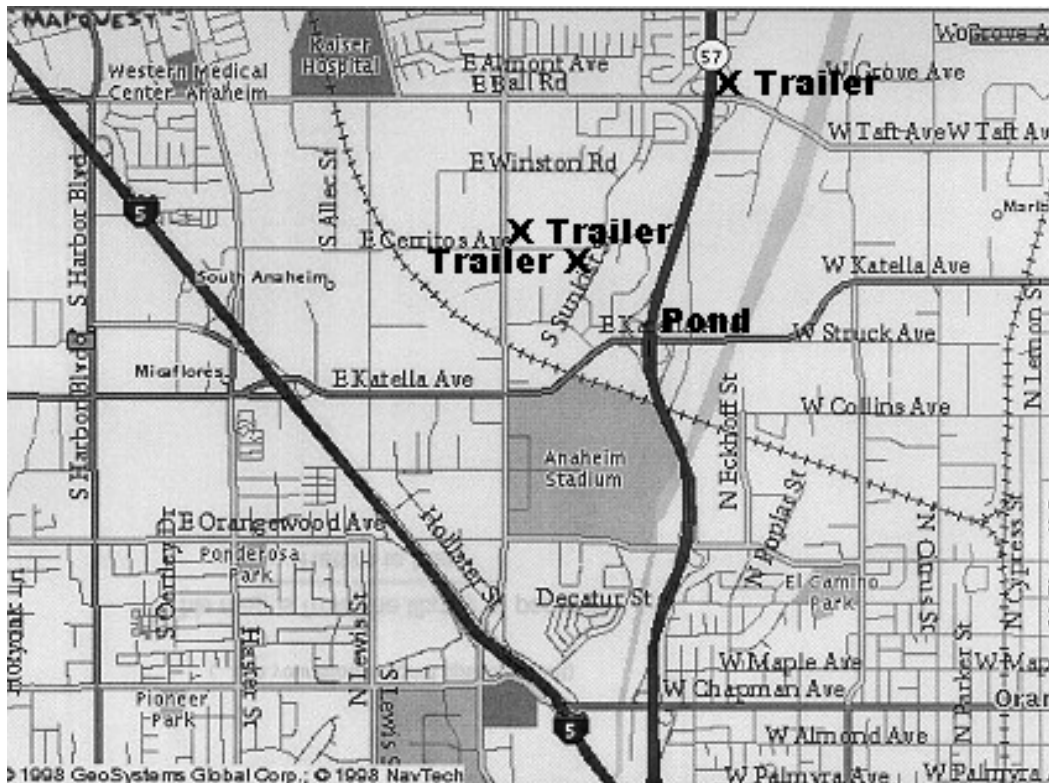
Figure 3-1. Surveillance trailer locations near the Arrowhead Pond

strength and afforded the cameras a view Phoenix Club Drive. The exact placement of the trailer to optimize viewing of traffic and avoid tree interference with imagery and signal transmission was not found until the trailer was actually deployed. The final surveillance trailer location sites are listed below and shown in Figure 3-1.

- Ball Road at the Northbound onramp to SR-57
- Cerritos Avenue and Sunkist Street
- State College Boulevard and Cerritos Avenue.

The trailers were placed in these locations for the April 1 event and then moved among the locations, prior to the other events, to gain more experience in transporting the trailers and to gather more data on trailer setup times.

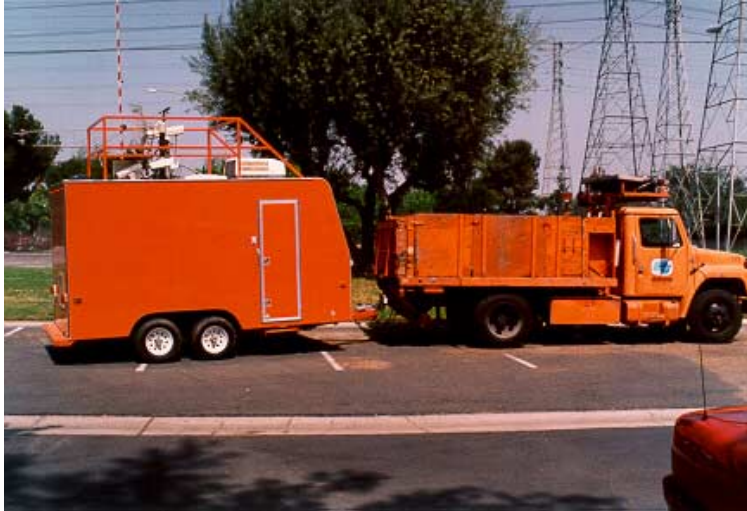
Figure 3-2. Trailer being positioned at Cerritos Avenue and Sunkist Street

Figures 3-2 through 3-4 show the trailers in position at the Anaheim Special Event Test sites.

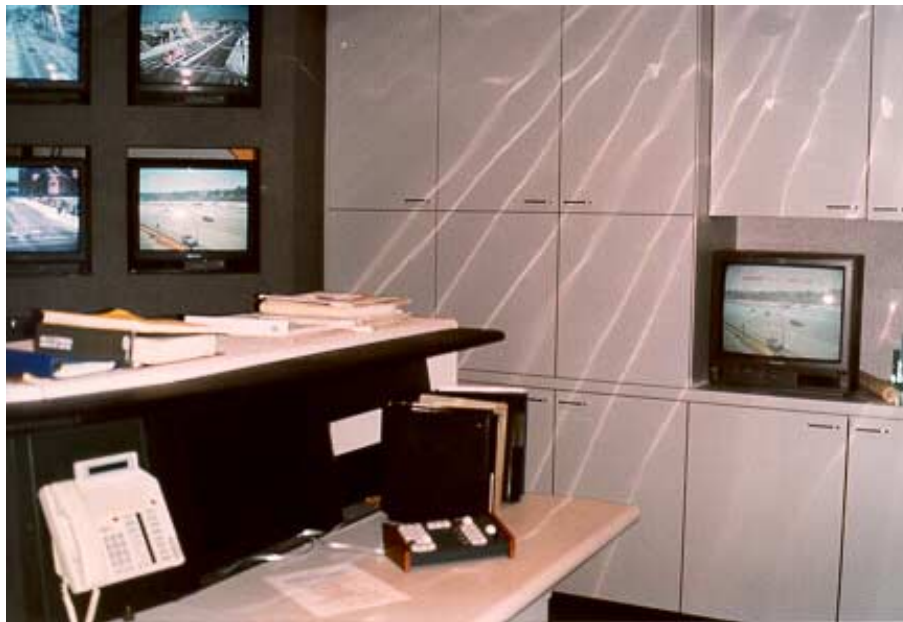
Figure 3-5. Anaheim TMC work area

Test data were collected by Anaheim TMC special event operators. The operators were given Camera Operability Data Sheets on which to record the quality of the camera image and camera control. A "check" (✓) mark indicated that image or control was available and an "x" indicated that image or control was unavailable. Whenever an "x" was entered, the operator indicated the nature of the problem on the data sheets found in Appendix D. Figure 3-5 shows the Anaheim TMC work area with the camera control keyboard on the desk and monitor on a counter in the background.

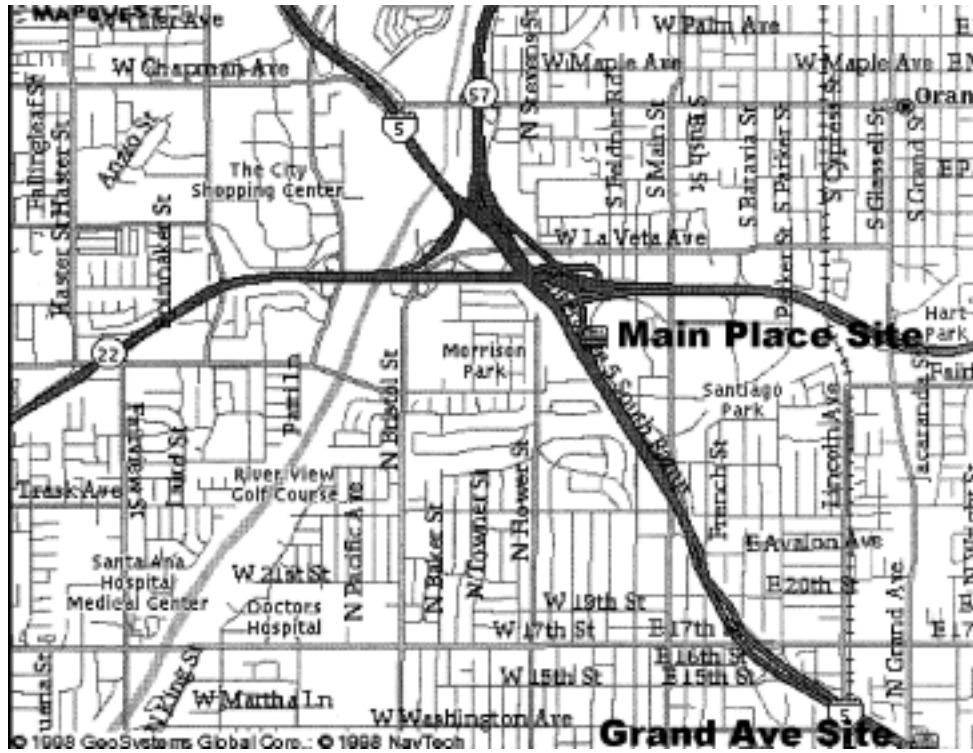
Figure 4-1. Main Place and Grand Avenue evaluation site locations along I-5

The maps in Figures 4-1 through 4-3 show the locations of the six surveillance trailers at Main Place, Grand Avenue, First Street, Tustin Ranch Road, Jamboree Road, and Culver Drive evaluation sites in north to south order along I-5. All, but the First Street trailer, were on the northbound side of the freeway. The relay site that retransmitted video and data from the surveillance trailers to the TMCs at Caltrans District 12 and Anaheim and to the ITS Laboratory at UCI is also indicated in Figure 4-2. During the evaluation, the trailers were powered from liquid propane fueled generators and storage batteries. The only

Site	Surveillance Trailer Number	Ramp Meter Trailer Number	Number of Ramp Lanes	Ramp Meter Signal Heads Deployed	Meter-on Sign Deployed
Main Place	115	n/a	n/a	n/a	n/a
Grand Avenue	109	17368	2	2	1
First Street	113	n/a	n/a	n/a	n/a
Tustin Ranch Road	114	17369	2	1	0
Jamboree Road	110	19280	2	1	1
Culver Drive	111	n/a	n/a	n/a	n/a

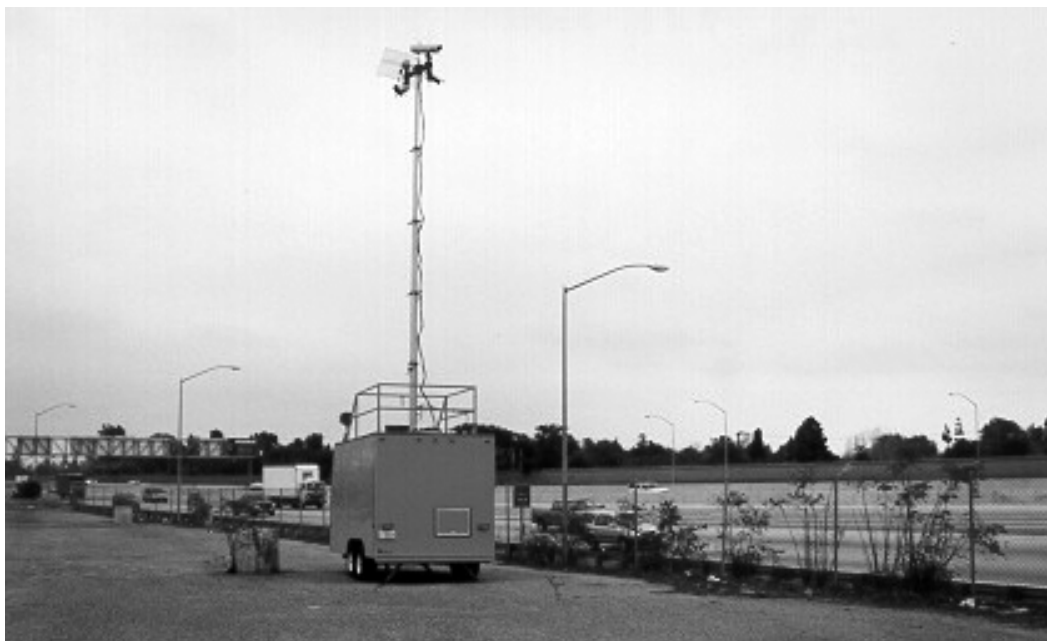
Figure 4-4. Surveillance trailer at Main Place looking south along I-5

exception was the surveillance trailer at Culver Drive that was connected to public utility landline power. With generator power, the unique aspects of trailer portability and reliability could be evaluated. On the other hand, the public utility power supplied to at least one trailer also allowed the alternate power system to be evaluated. Portable ramp meter trailers, including signal heads and meter-on signs, were placed at Grand Avenue, Tustin Ranch Road, and Jamboree Road. These locations were selected because they had ample room for the portable signal heads, ramp meter trailers, and meter-on signs. Photographs of the trailers and other equipment at the evaluation sites are shown in Figures 4-4 to 4-10.

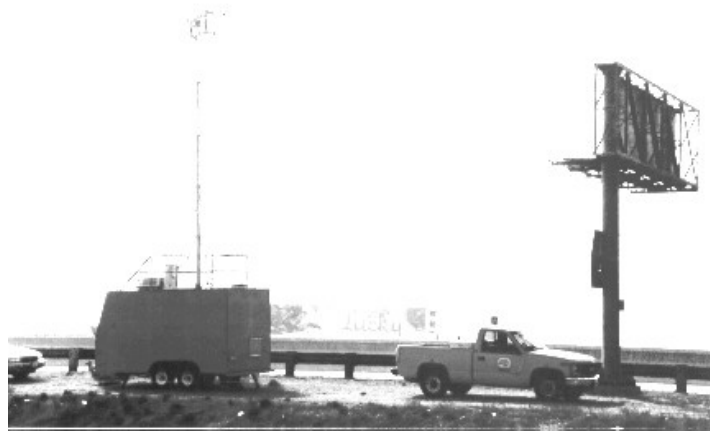
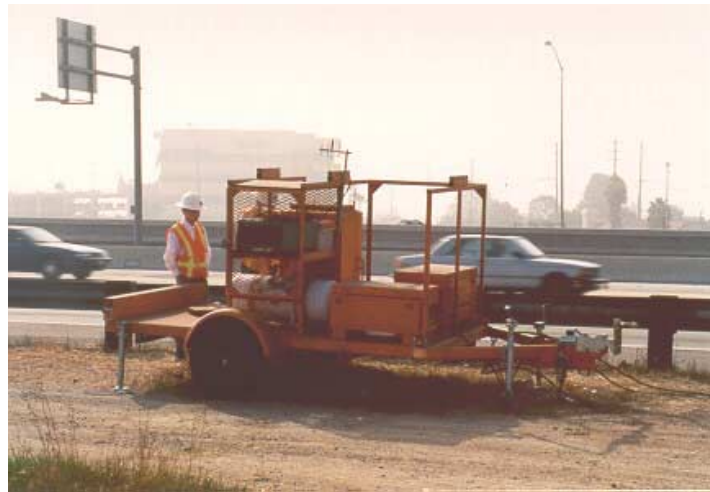
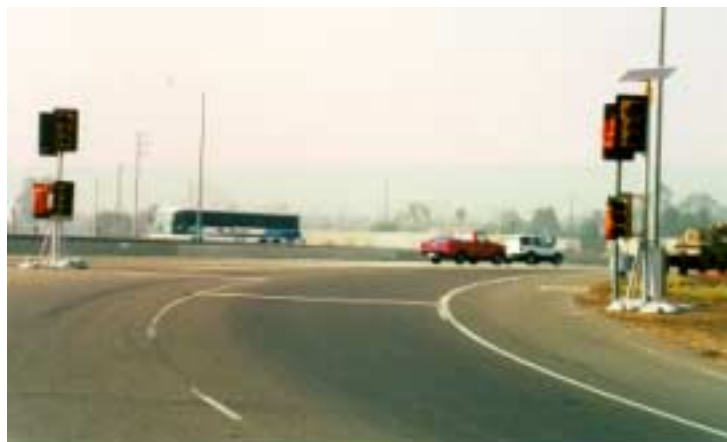
Figure 4-5. Surveillance and ramp meter trailers and signals at Grand Avenue

(a) Surveillance trailer

(b) Ramp meter trailer

(c) Ramp signals

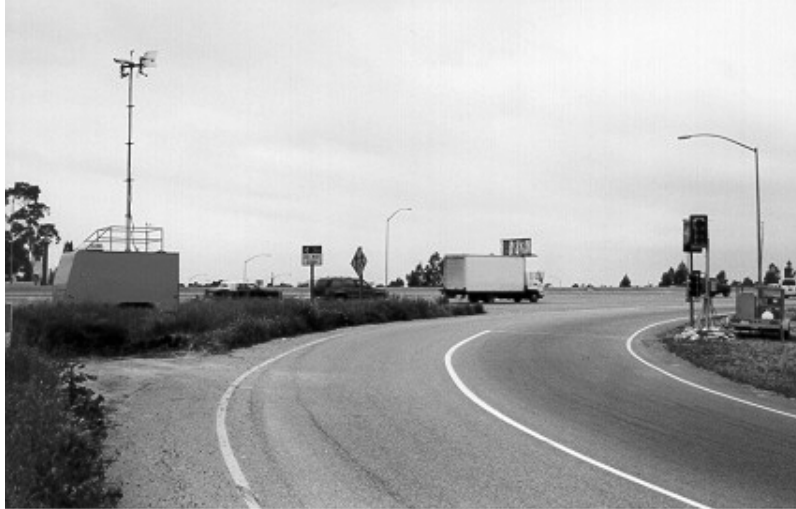
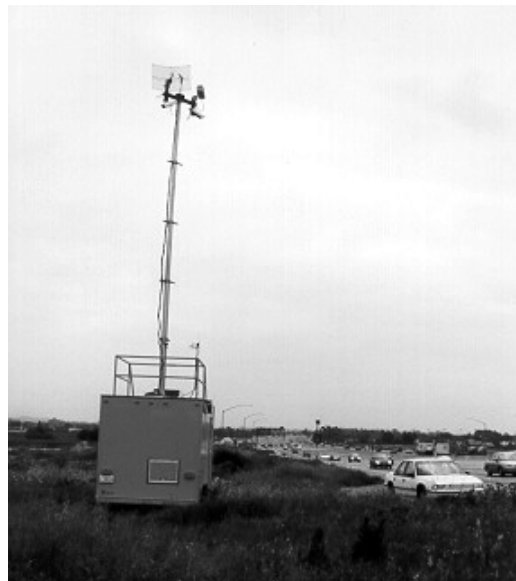
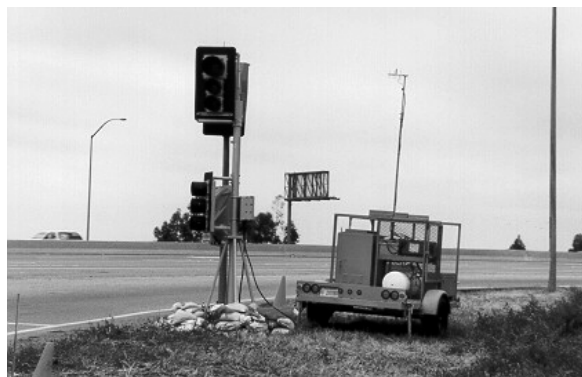
Figure 4-8. Surveillance and ramp meter trailers at Jamboree Road

(a) Onramp with surveillance trailer on left, ramp meter trailer and signal on right

(b) Surveillance trailer alongside of I-5 freeway

(c) Ramp meter trailer and signal

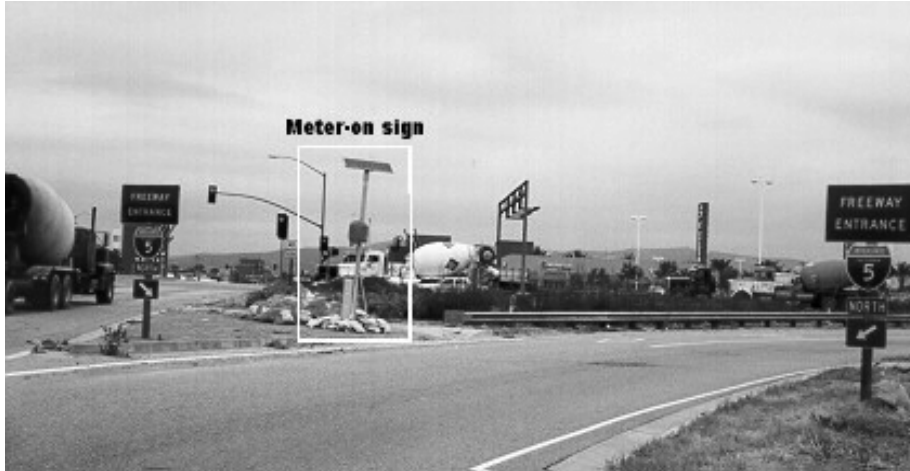
Figure 4-9. Meter-on sign with solar panel at Jamboree Road ramp entrance

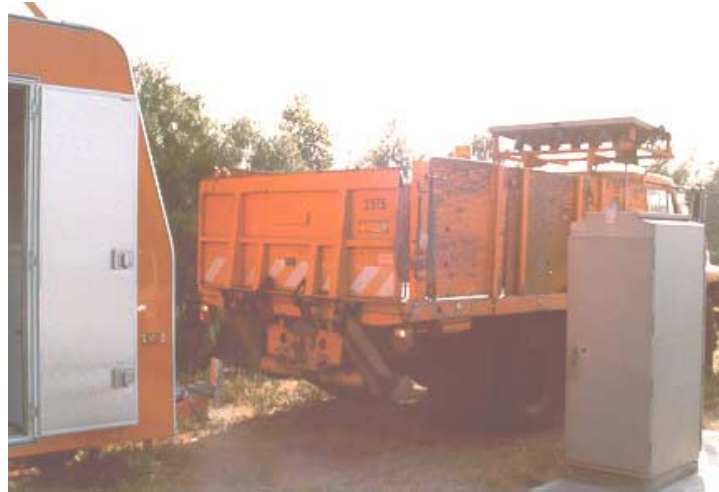
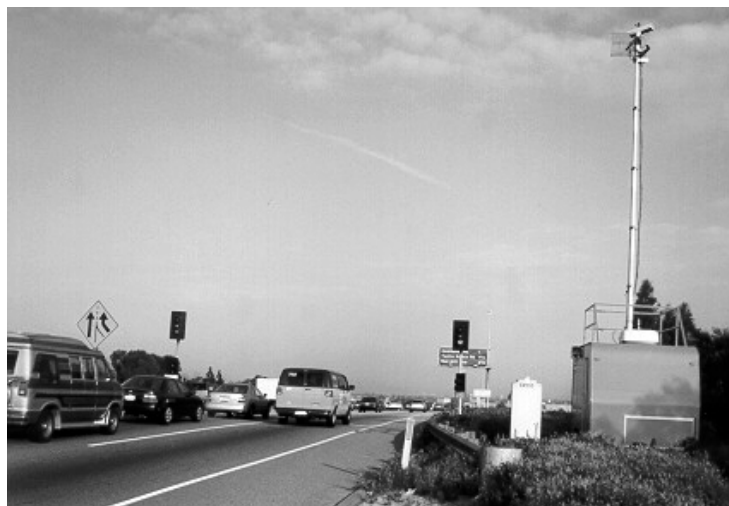
Figure 4-10. Surveillance trailer at Culver Drive

(a) Trailer and tow truck

(b) Trailer in position with mast extended

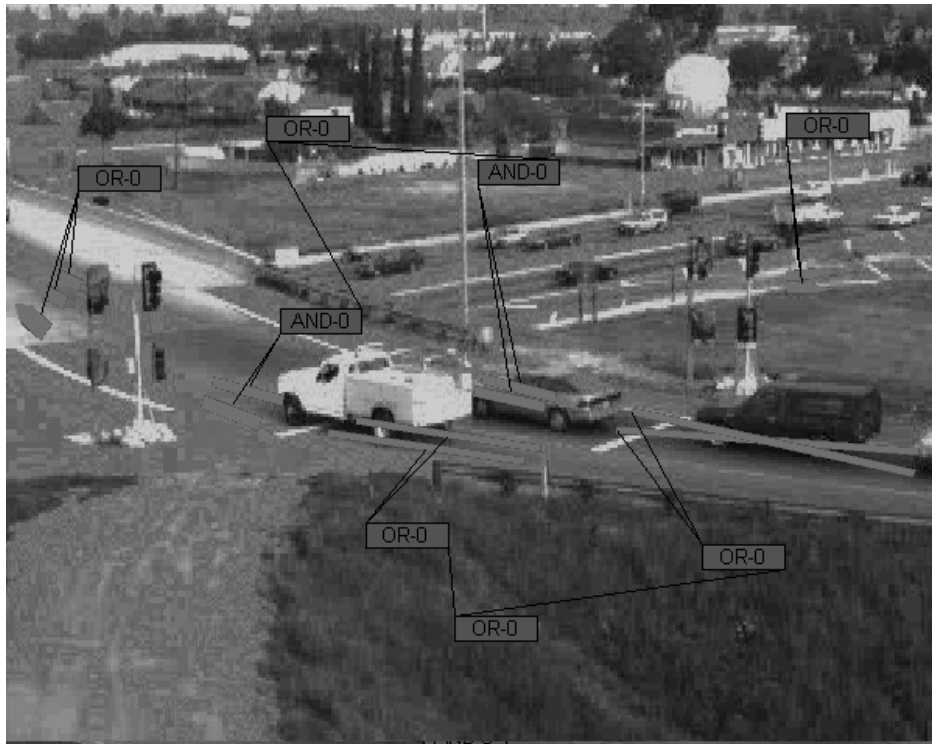
Figure 4-17. Mainline and ramp AutoScope detection zones at Grand Avenue

(a) Mainline detection zones

(b) Ramp detection zones

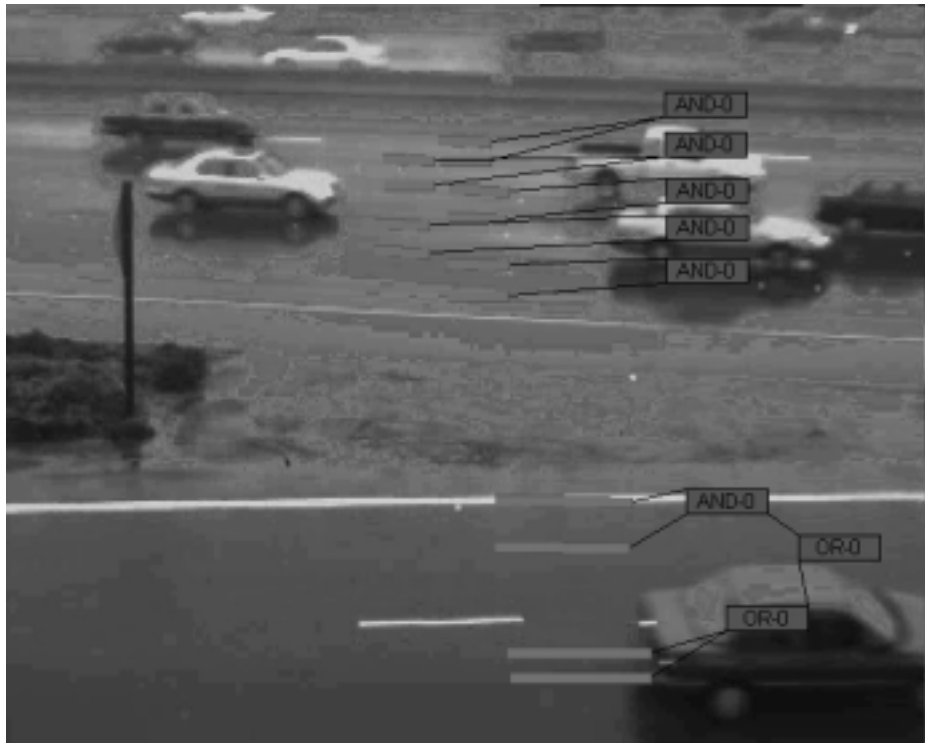
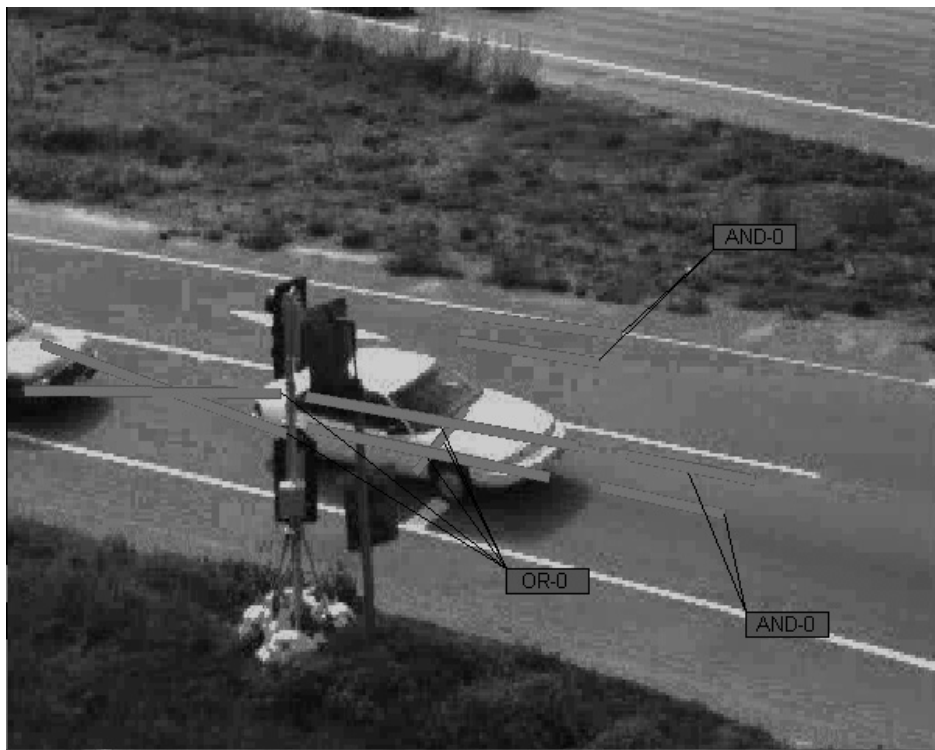
Figure 4-18. Mainline and ramp AutoScope detection zones at Tustin Ranch Road

(a) Mainline detection zones

(b) Ramp detection zones

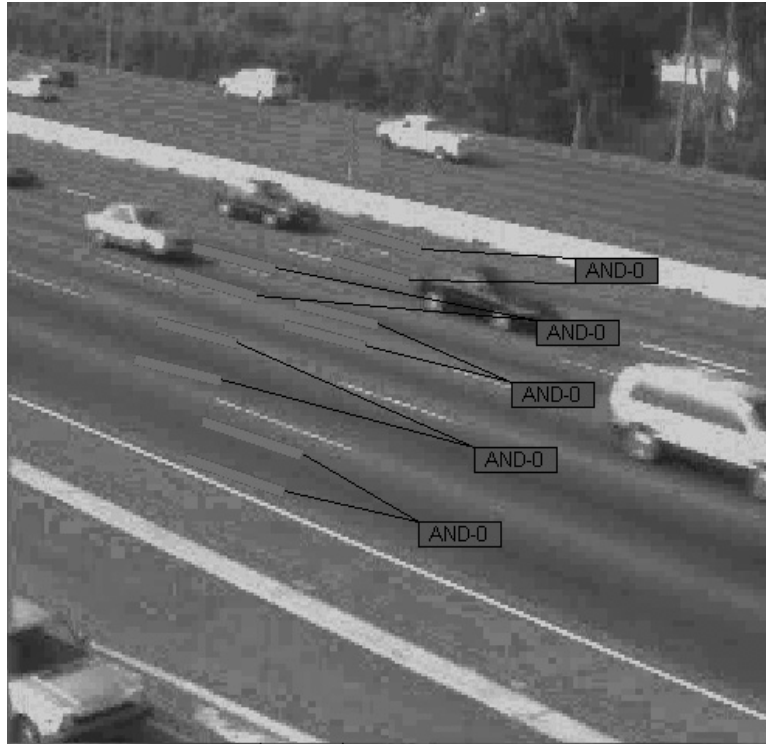
Figure 4-19. Mainline and ramp AutoScope detection zones at Jamboree Road

(a) Mainline detection zones

(b) Ramp detection zones

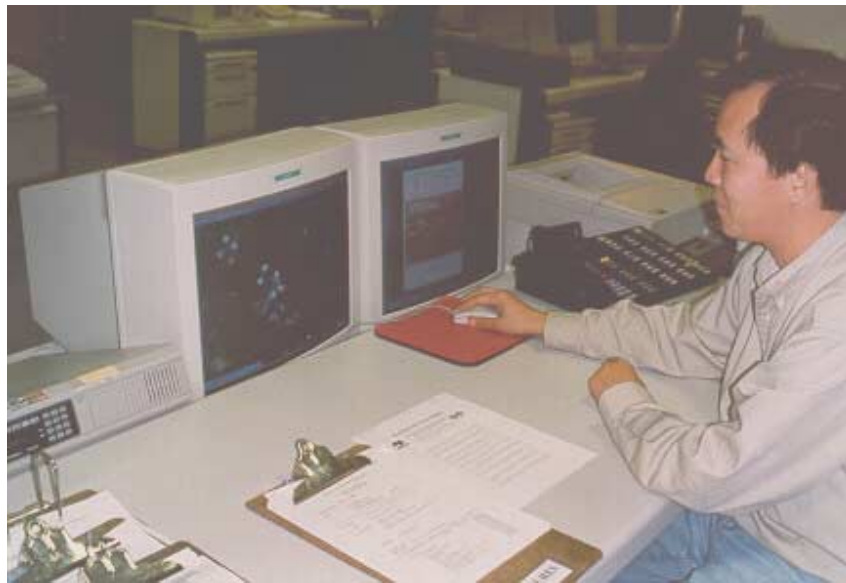
Figure 4-20. Caltrans District 12 workstation displaying camera selection icons on the left monitor

Figure 4-20 shows a District 12 TMC workstation from which camera control, image quality checks, and data acquisition could occur.

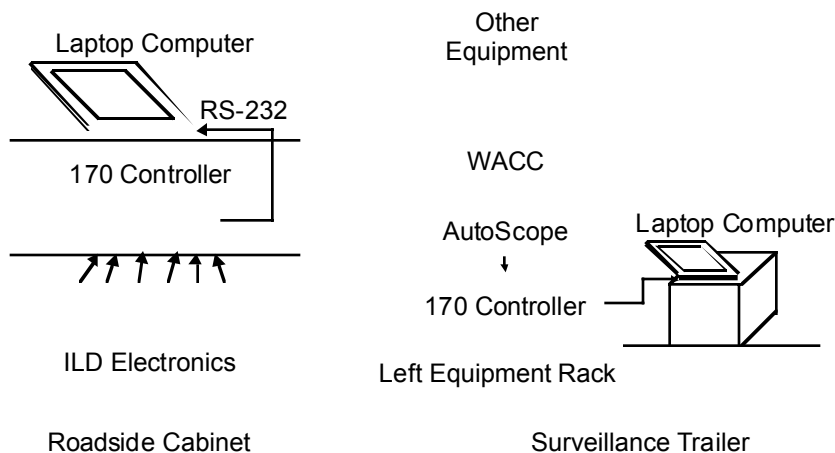
Figure 4-21. ILD and VIP data recording from 170 controllers using laptop computers

The clocks in both laptops were synchronized to within one 30-second polling interval. The clock in the 170 controller in the surveillance trailer drifted several minutes during a 4-hour run because of the non-ideal frequency stabilization that was characteristic of the portable electric power generation system. The laptop computer sent a synchronization signal to the 170 every hour in order to compensate for 170-clock drift.

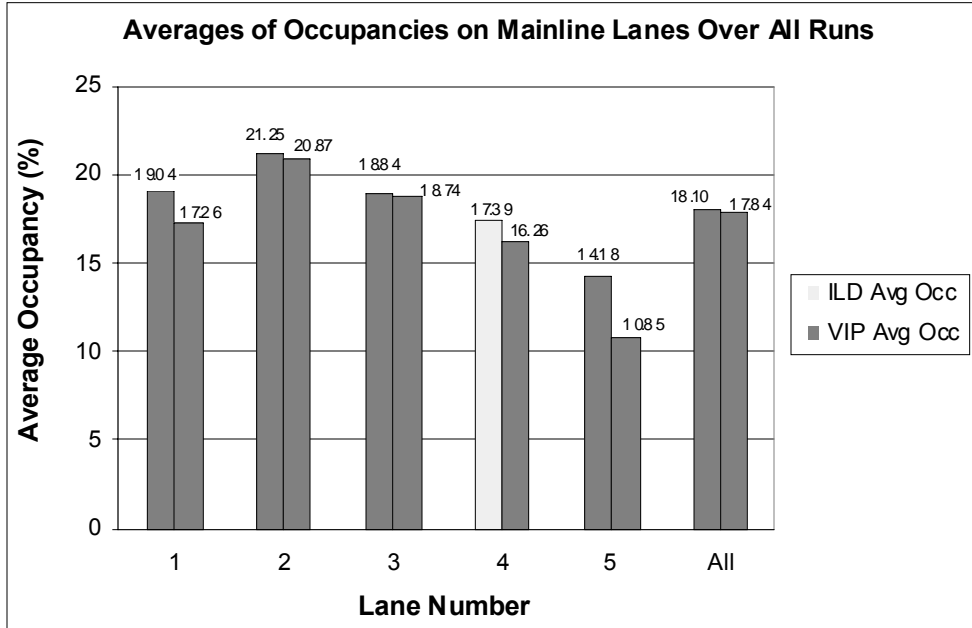
Figure 4-22. Average mainline occupancies over all runs as measured by the ILDs and VIP

Figures 4-22 and 4-23 display the averages of the ILD and VIP-measured mainline occupancy and volume data in graphical form. The numbers near the bars are the average values that appear in Table 4-12.

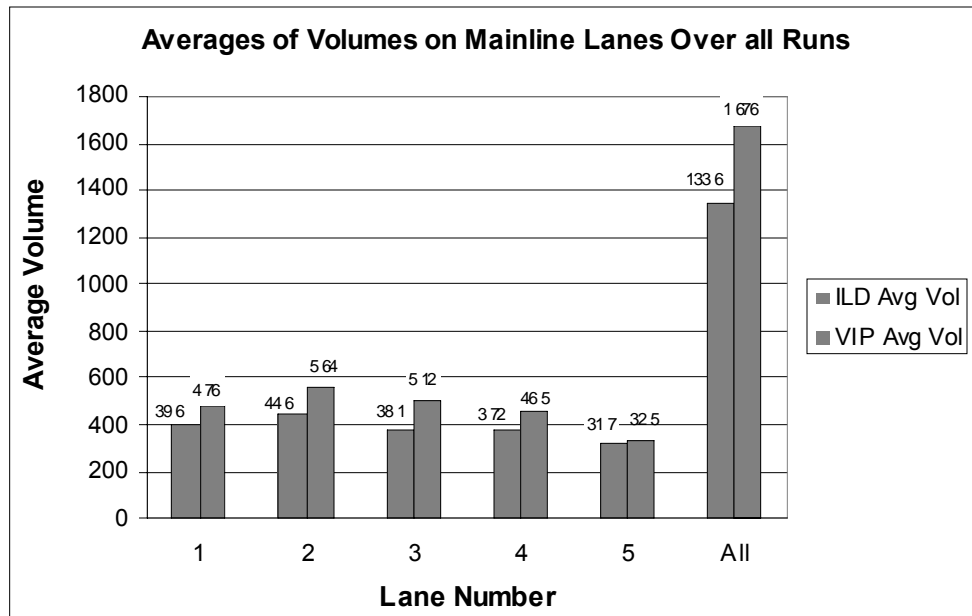
Figure 4-23. Average mainline volumes over all runs as measured by the ILDs and VIP

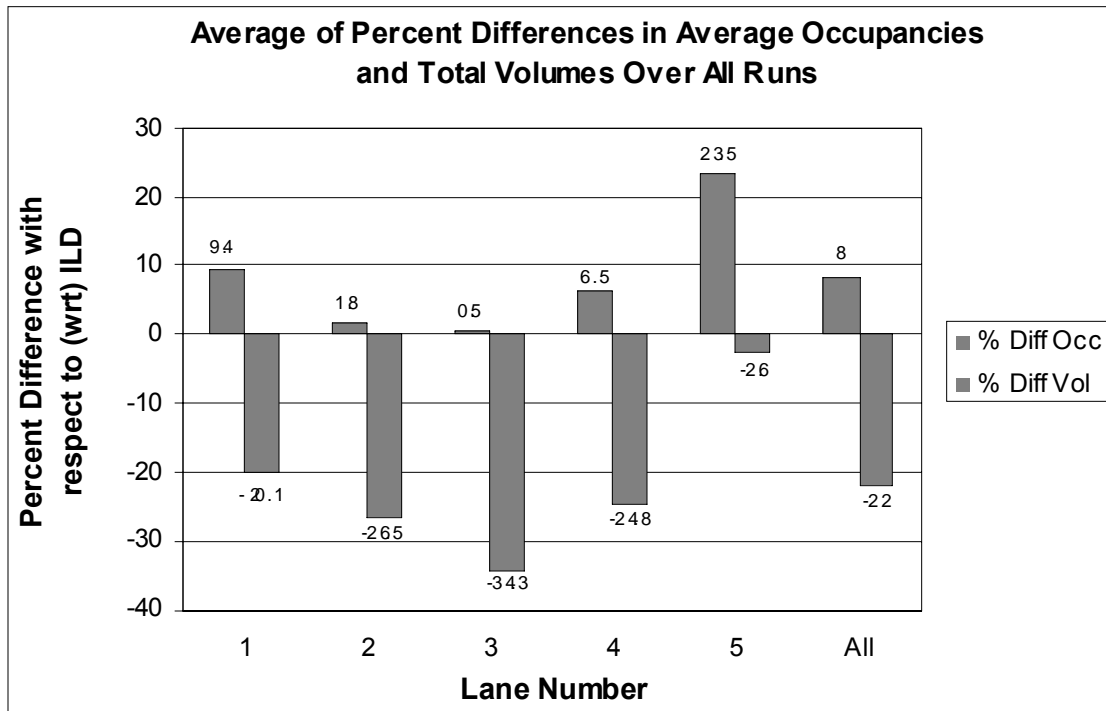
Figure 4-24. Average of the percent difference between the average occupancies and total volumes over all runs as measured by the ILDs and VIP

Figure 4-24 shows the averages of the percent differences between the ILD and VIP-measured average lane occupancies and total volumes for the fourteen runs. Lane 5, the lane closest to the shoulder, had the smallest percent difference in measured volume equal to -2.6 percent. The negative sign indicates that the VIP counted more vehicles than the ILD. Lane 3 had the smallest difference in occupancy measurement equal to 0.5 percent. The average percent differences in occupancy and volume over all lanes reporting good data were 8 and -22, respectively. The ability of the VIP to provide data with sufficient accuracy for the ramp-metering function is discussed in Section 4.10.

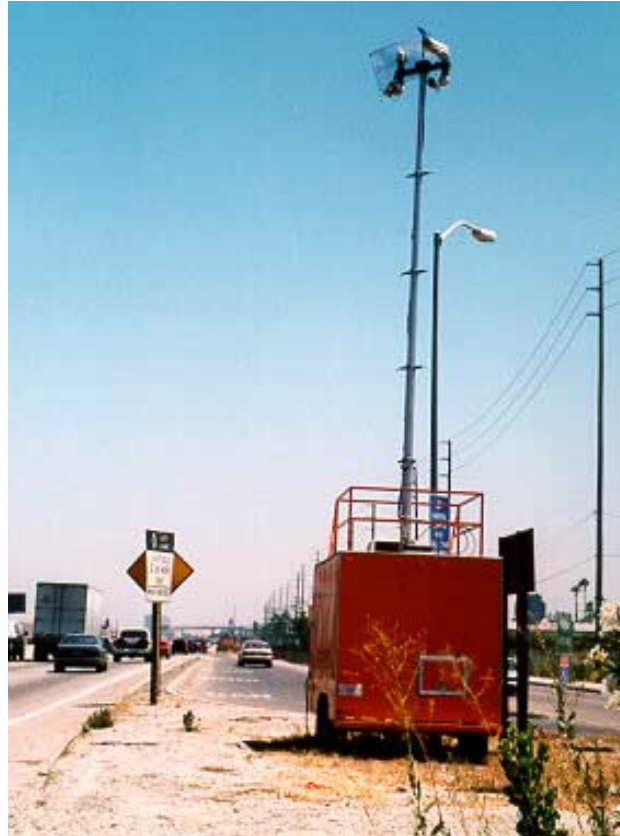
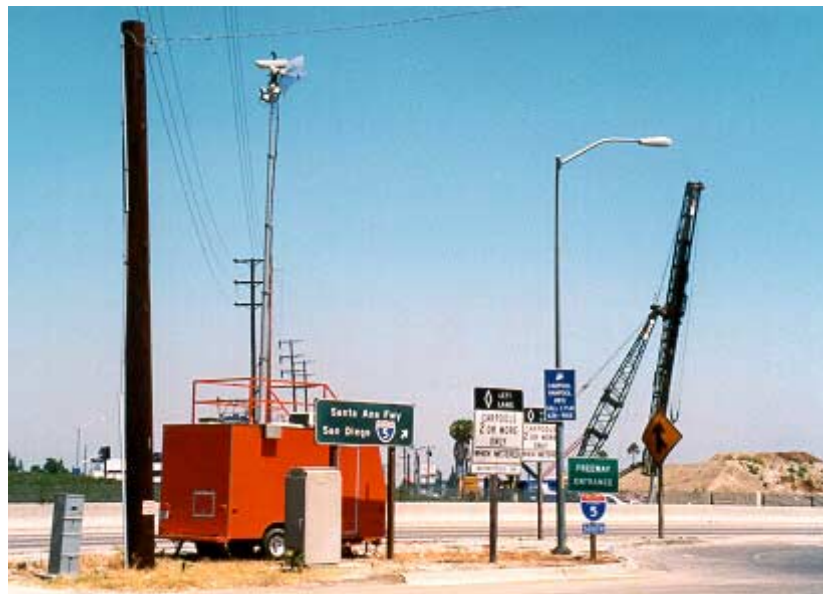
Figure 4-25. Surveillance trailer location at southbound entrance to I-5 at Katella Way

(a) Rear view of trailer showing southbound I-5 and entrance ramp

(b) Katella Way entrance ramp showing surveillance trailer to left of ramp

Eventually a surveillance trailer was brought to Katella Way and I-5 as shown in Figure 4-25. The intent was to gather information about the trailer's use in an actual construction area. The Caltrans District 12 TMC personnel periodically ensured that the cameras and their scanning controls were operational, but did not really use the video imagery in traffic operations. It is believed, however, that the imagery from the cameras would have been used if an emergency developed in the area surveilled by the cameras.
