Laboratory Evaluation of Corrosion Resistance of Steel Dowels in Concrete Pavement

Prepared for the California Department of Transportation

**Pavement Research Center
Institute of Transportation Studies
University of California Berkeley and
University of California Davis**

**March, 2005
Revised May 2005**

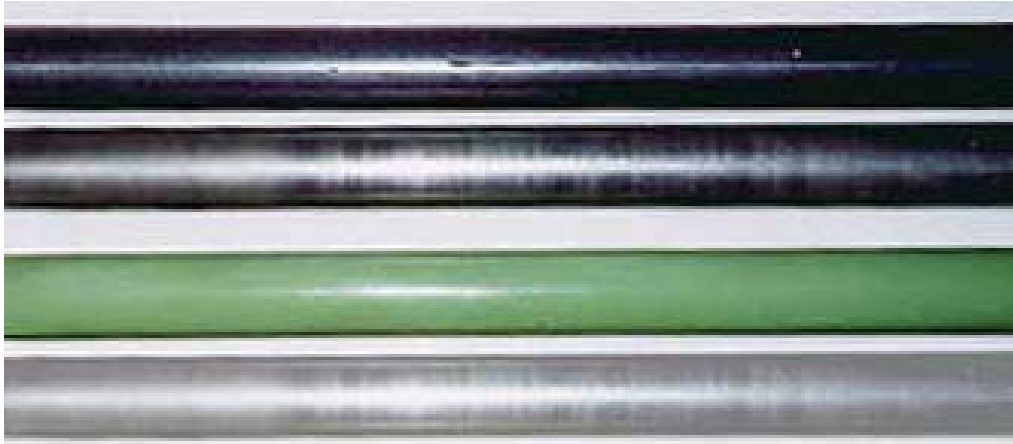
Figure 3. Steel dowel types investigated in Phase I. From top to bottom: carbon steel, stainless steel clad, carbon steel coated with bendable epoxy, and stainless steel hollow.

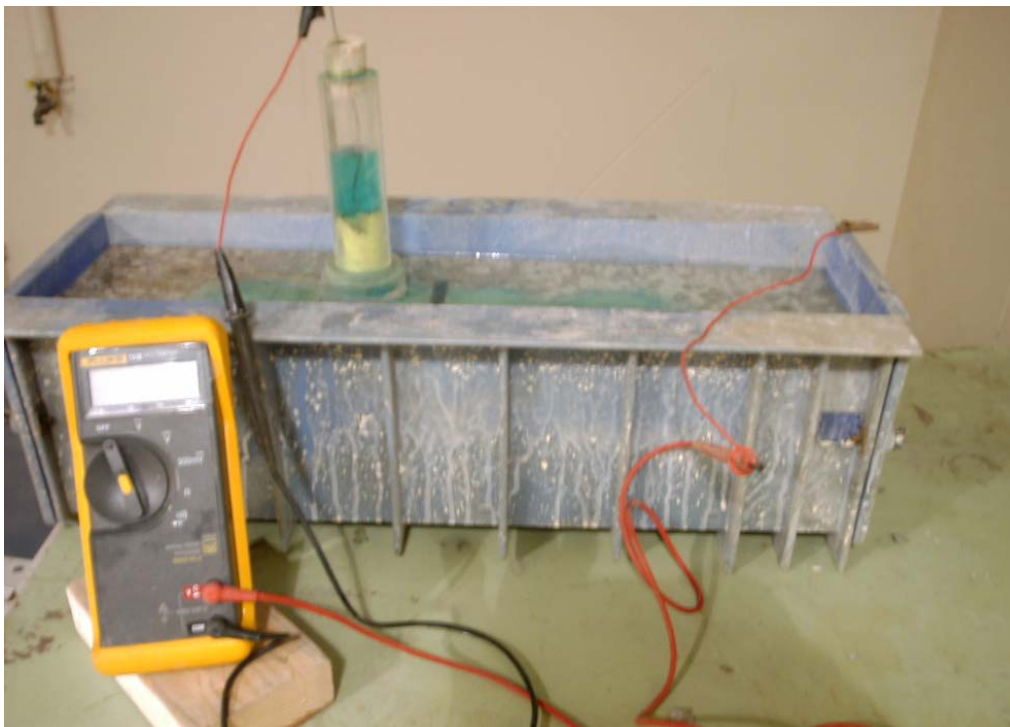
Figure 5. Half-cell potential test using a high impedance (10 Meg-Ohm) voltmeter, and a copper/copper sulfate reference cell.

Half-cell potential was monitored using a copper/copper sulfate (Cu/CuSO₄) electrode placed on the surface of the concrete for six months in order to determine the corrosion initiation period. Visual inspection of the corroded dowels was made after the experiments were completed. The salt solution was removed from the concrete surface before the electrical measurements were performed. As previously noted, three replicates for each type of steel dowel were tested. Figure 5 illustrates the experimental setup. Details of the half-cell potential test are included in Appendix A.

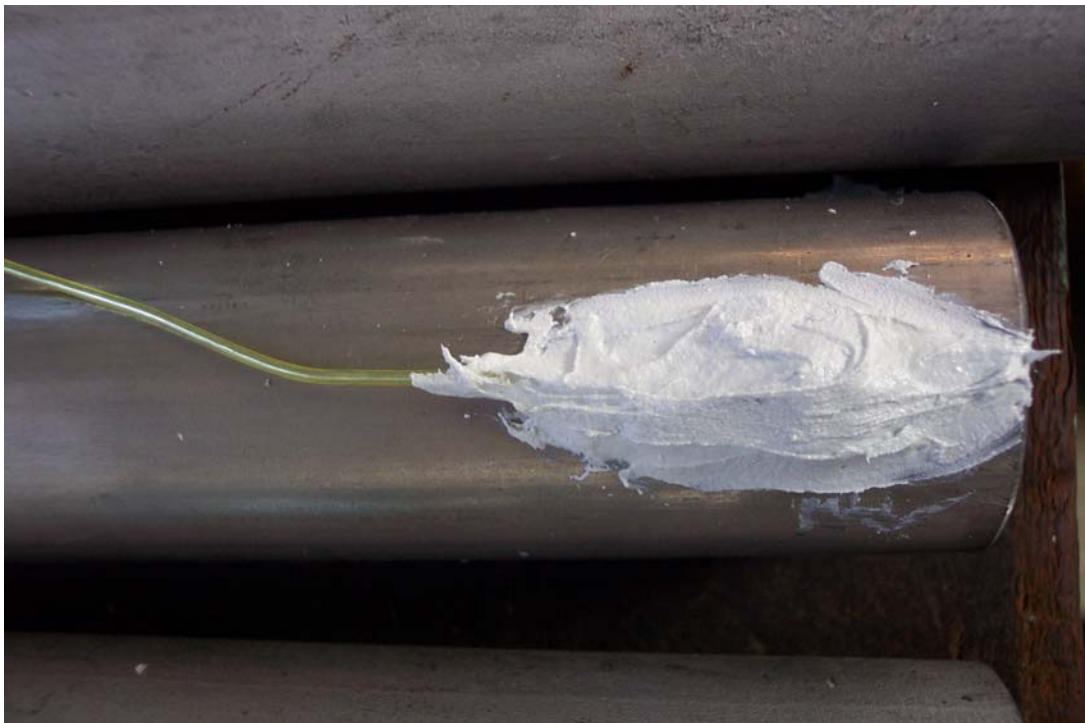
Figure 8. Electrical connections made to the stainless steel hollow specimens. Connections were made at the side of the dowel (a) and sealed with epoxy (b) before casting.

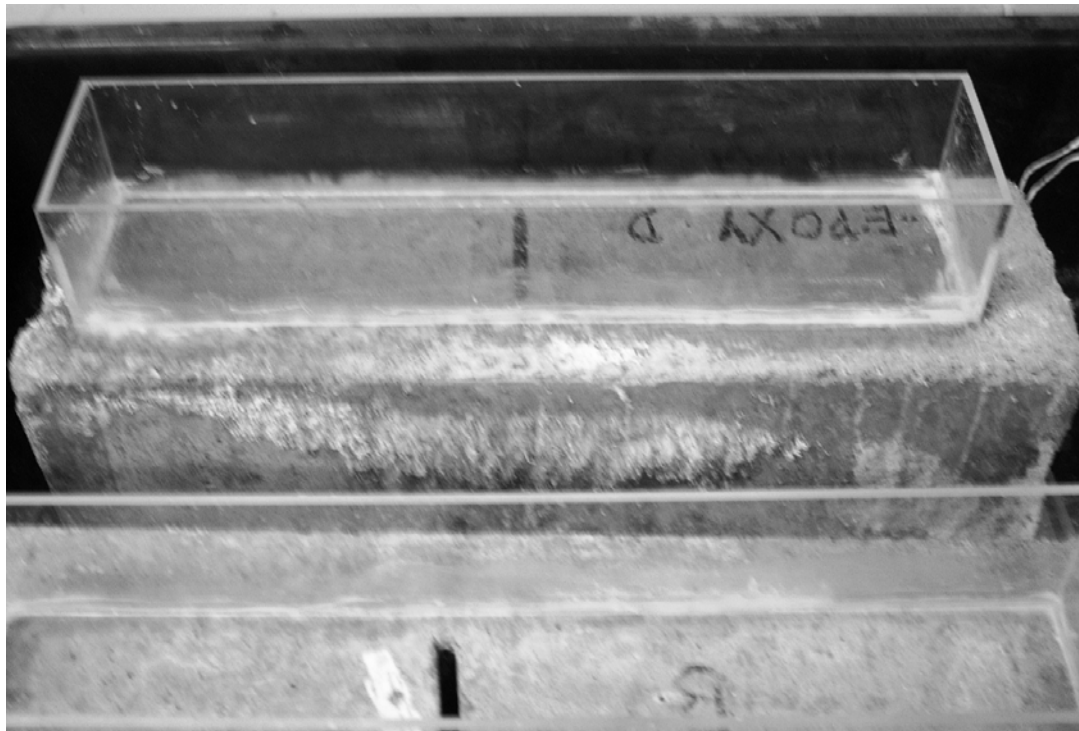
Figure 10. Picture of the experimental setup illustrated in Figure 9.

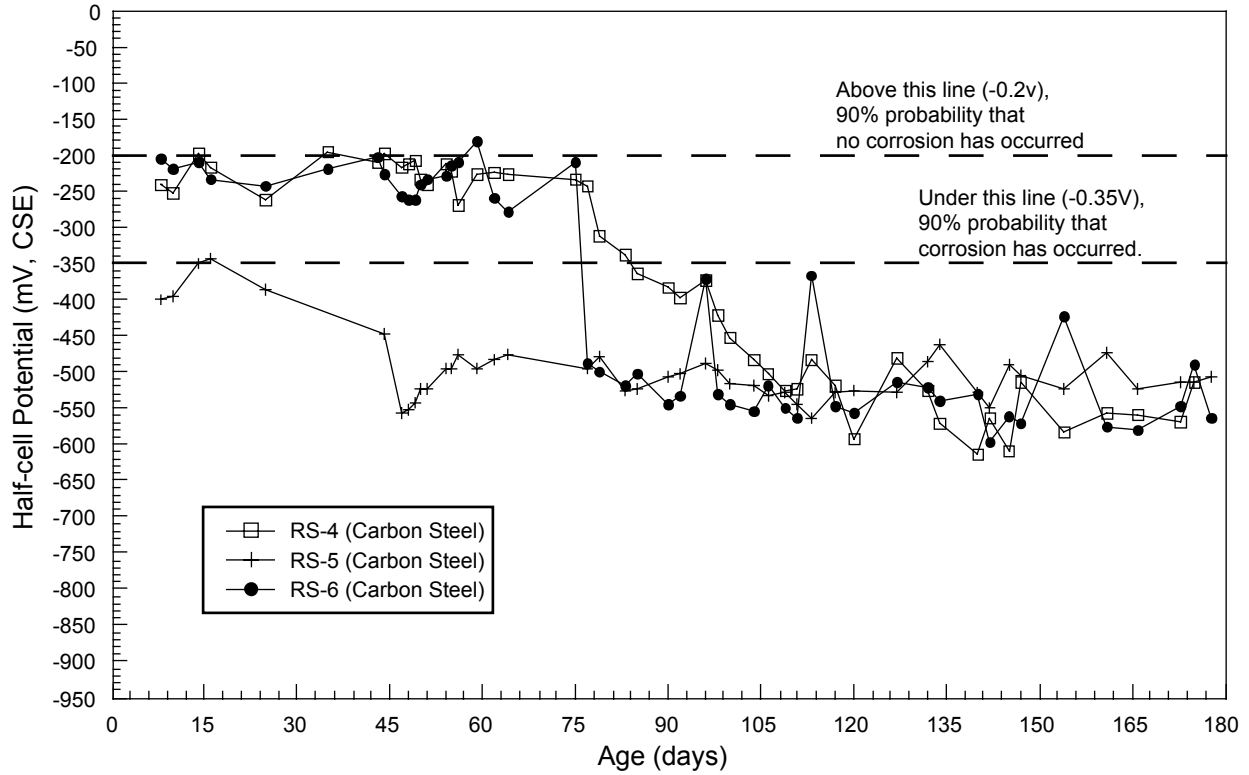
Figure 12. Half-cell potentials of carbon steel bars in Chloride ponding at 40-43°C.

Figures 12–19 show the measured half-cell potentials with time for the four types of dowels investigated in the first phase of this study. As can be observed in Figure 12, for two of the three replicates of the carbon steels at 40–43°C, the potentials moved to the active corrosion region (lower than -350 mV, indicating a 90 percent probability of corrosion as described in Table 1) after about 75 days. For Specimen RS5, the potentials were more negative than -350 mV from nearly the beginning of the test.

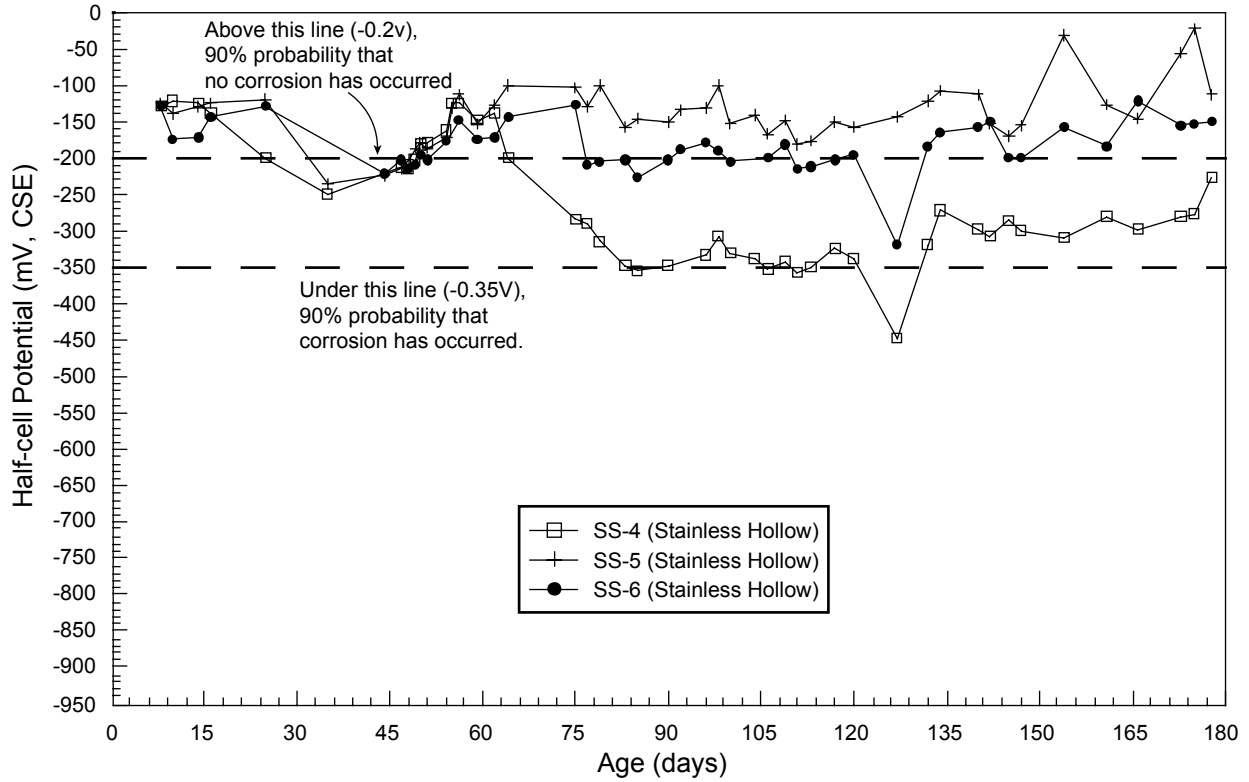
Figure 16. Half-cell potentials of stainless hollow steel bars in Chloride ponding at 40-43°C.

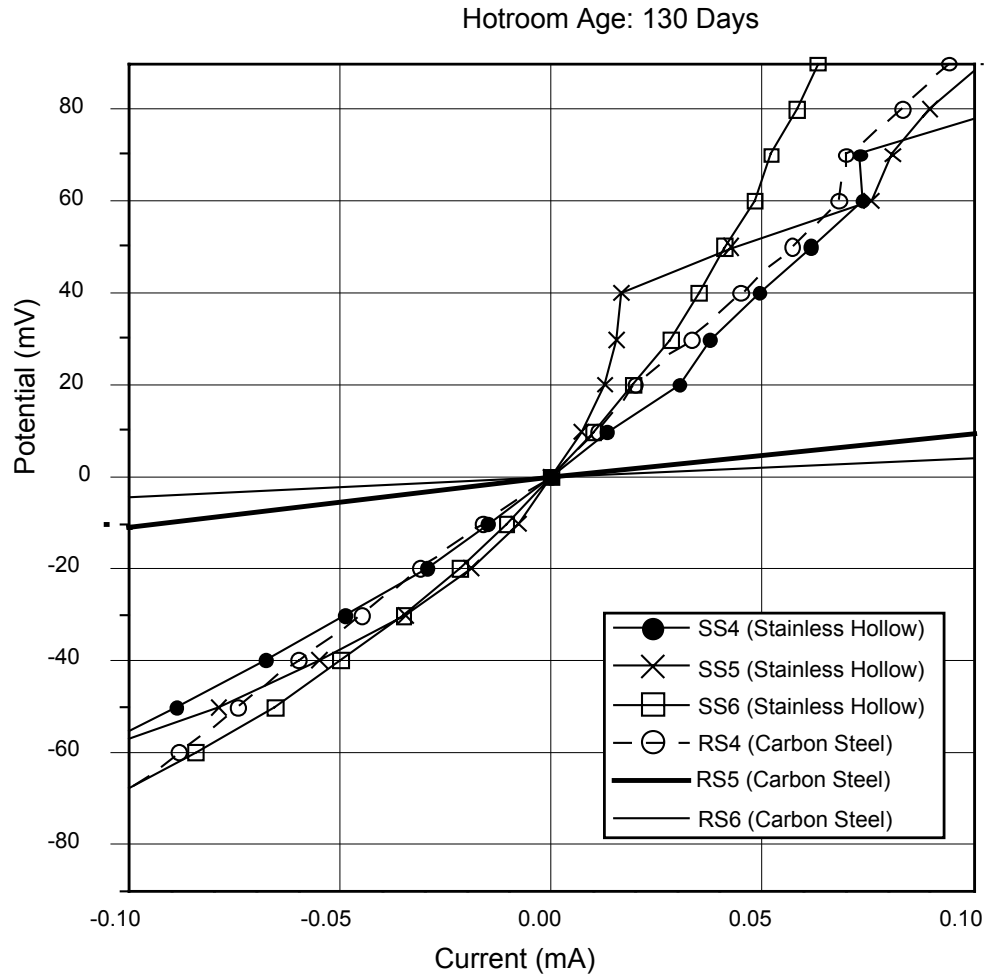
Figure 20. Linear Polarization of the carbon and stainless steels at 40-43°C.

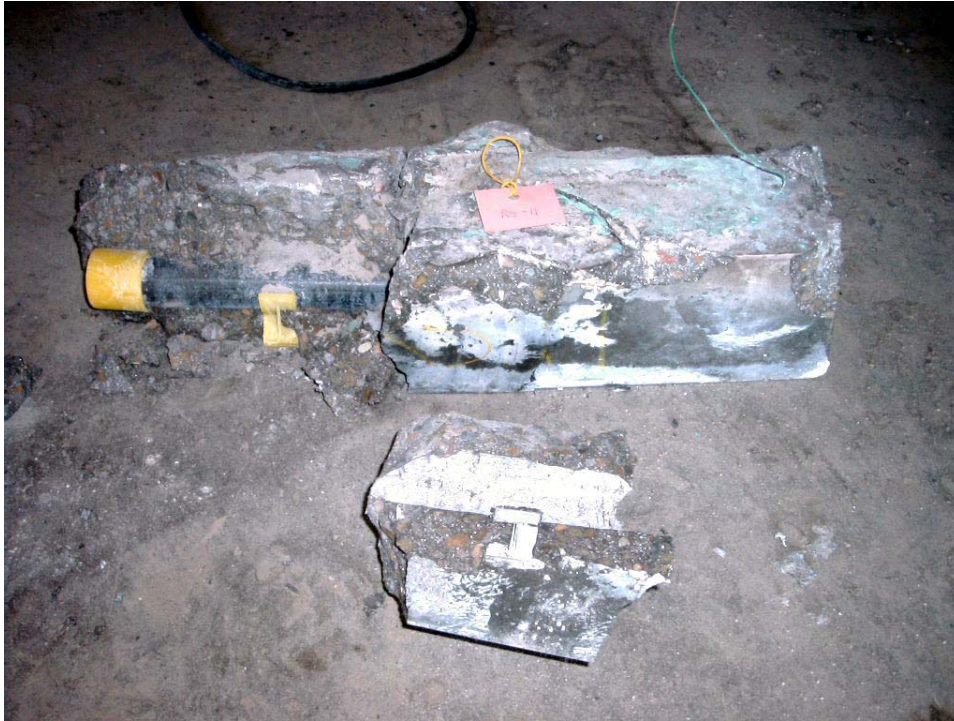
Figure 21. Extraction of dowels for visual inspection.

At the end of six months, the concrete beams were broken open and the dowels were retrieved and inspected. Figure 21 shows one of the concrete beams at the moment the dowel was being retrieved.

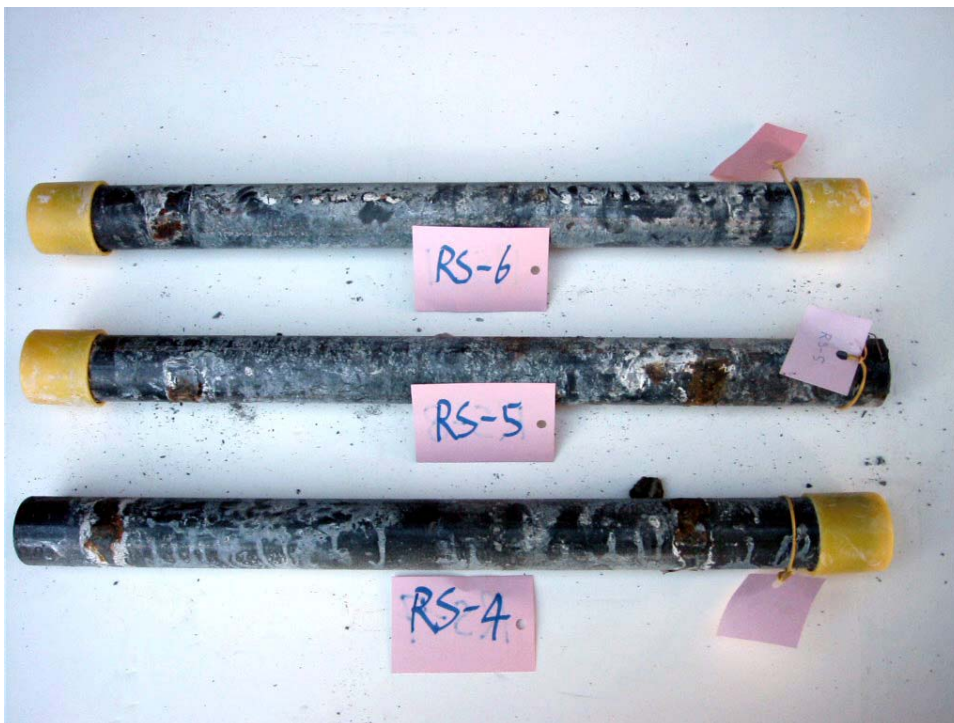
Figure 22. Corrosion along the carbon steel bars.

For the carbon steels exposed to Chloride ponding, corrosion products were distributed along the length and perimeter of the bars for both the cold and hot conditions, as shown in Figure 22. The epoxy-coated bars had localized corrosion mostly at the ends of the bars where the coating is the most vulnerable to damage. All the epoxy-coated bars exposed to Chloride ponding, except EX9, were corroded at the ends, as shown in Figure 23. The results matched the half-cell potential in the sense that once corrosion occurred and the coating was lifted, the measured potential was not zero anymore. No visible corrosion was found on either stainless steel hollow bars or stainless clad bars, as can be observed in Figures 24 and 25.

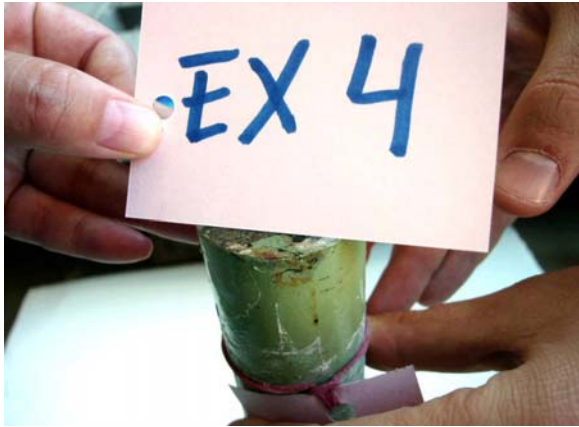
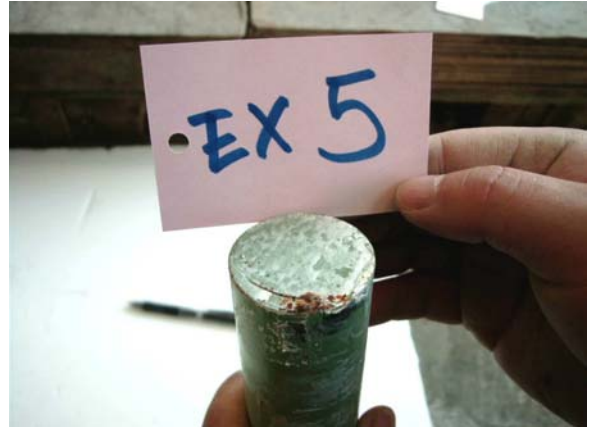
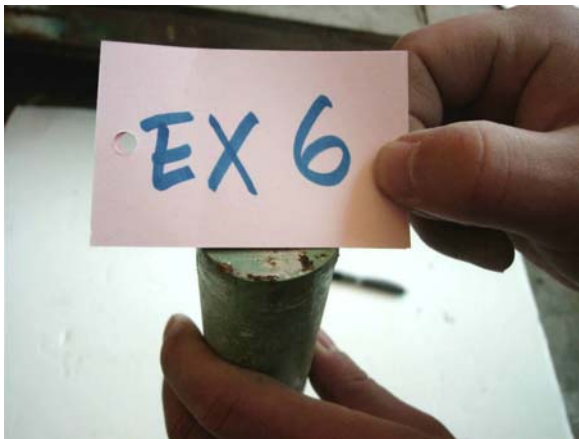
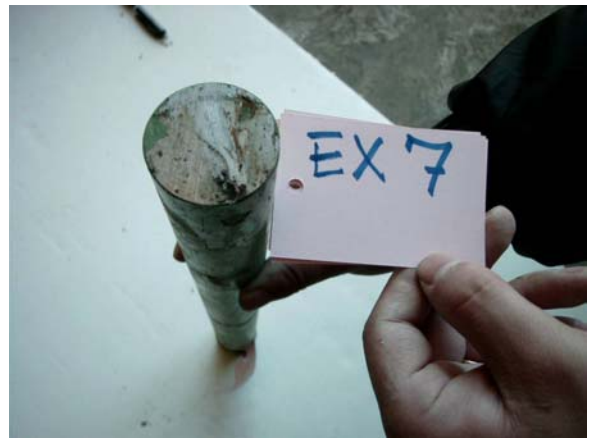
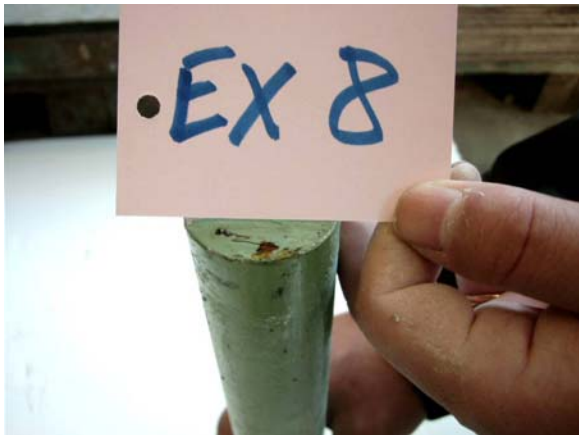
Figure 23. Corrosion on the epoxy-coated bars.

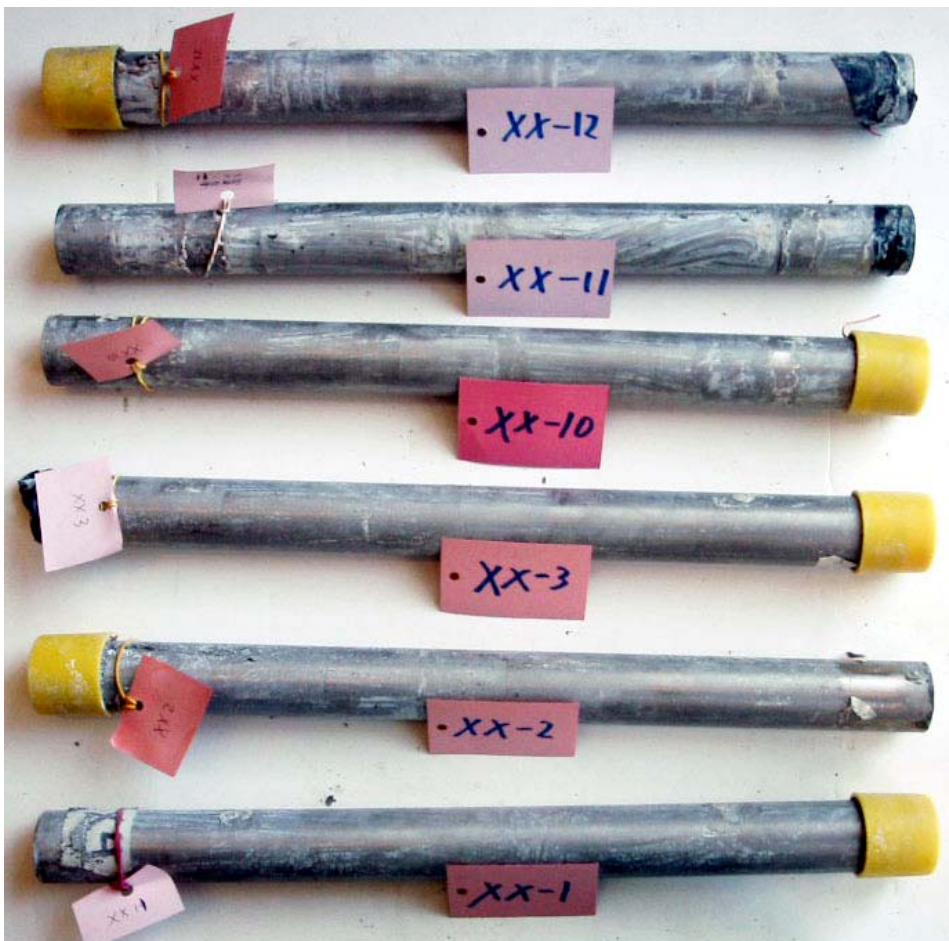
Figure 25. Appearance of stainless clad bars after tests.

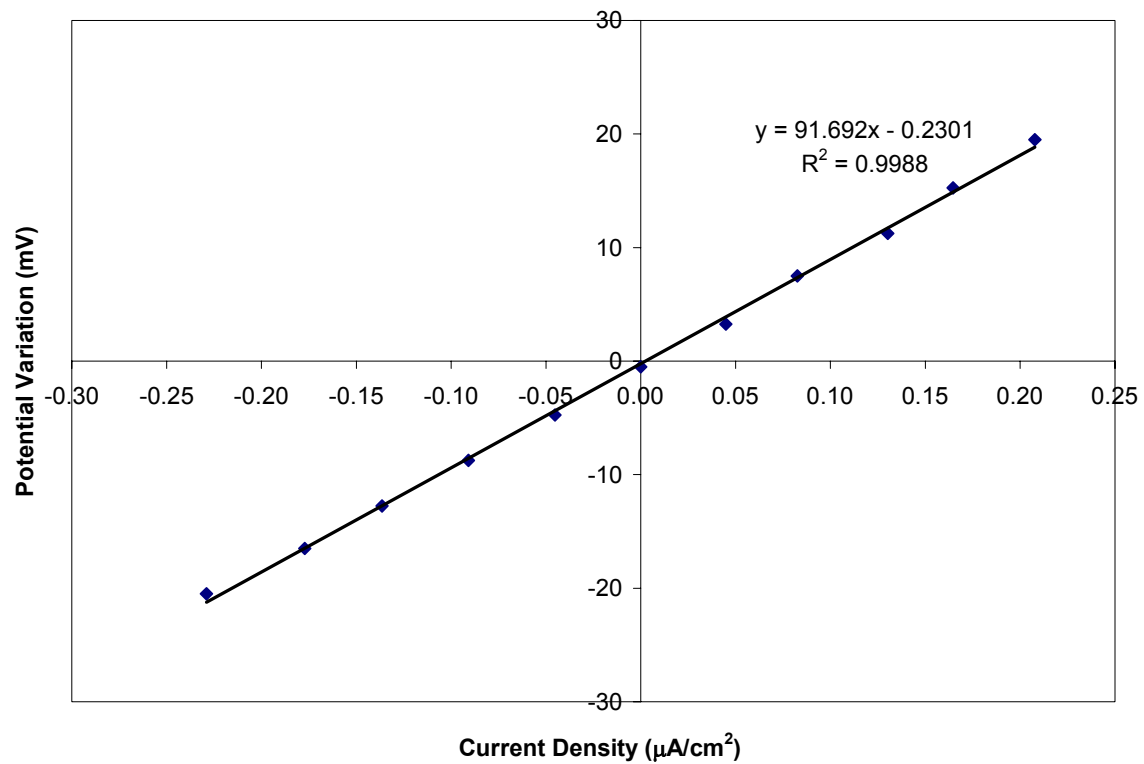
Figure 30. Linear Polarization Resistance results for non-flexible, purple epoxy-coated dowels.

Figures 30-32 present Linear Polarization Resistance plots for the epoxy-coated bars, respectively non-flexible (purple and gray) and flexible (green) epoxy coatings. Note that the results obtained for the epoxy-coated bars are not to be interpreted quantitatively. In coated specimens, corrosion is not uniform. Rather, it is concentrated at localized defective areas (such as pinholes, voids, etc.). Given that epoxy is an electrical insulator, polarization only occurs at these defective areas which cannot be accounted for in the calculation of the polarization resistance term. As mentioned in Section 2, it has been assumed that the polarized area corresponds to the surface of the dowels exposed to the NaCl solution inside the fabricated joints. Note that if the polarized area decreases in size, the corrosion current density (given in

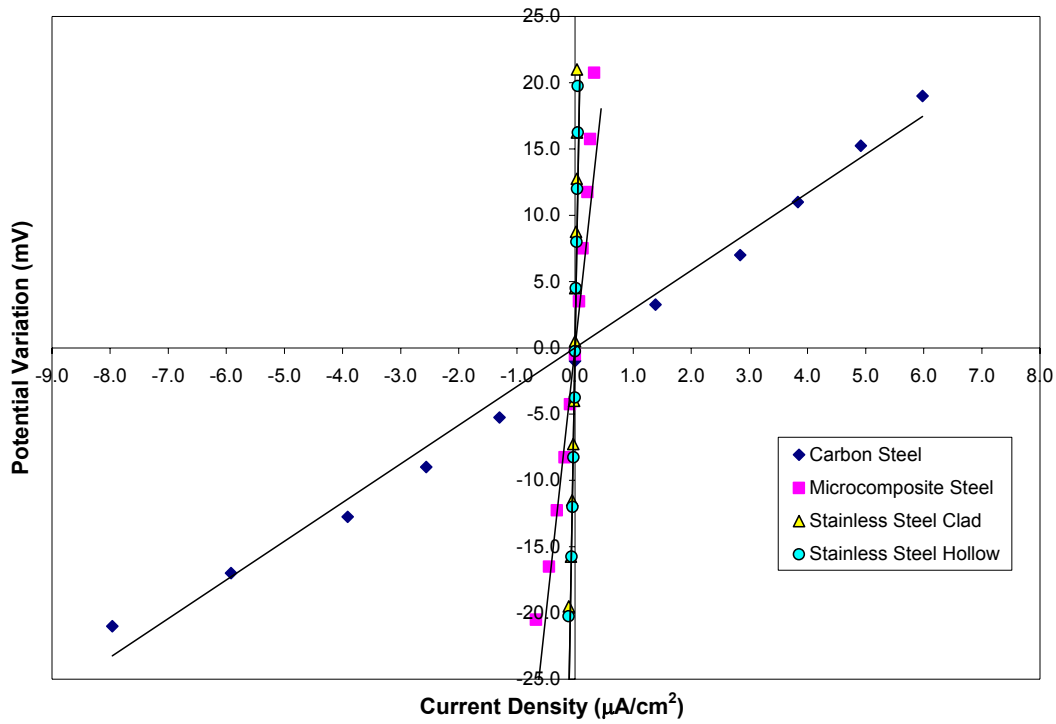
Figure 33. Summary plot showing the variation of potential and current density about the half-cell potential, for different dowels.

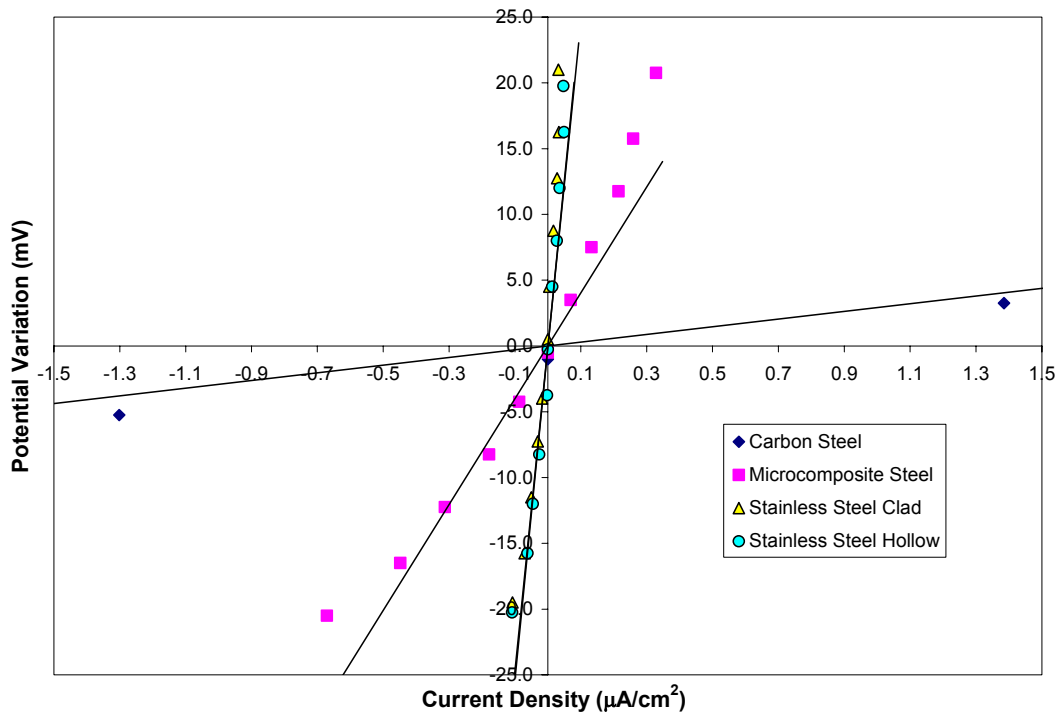
Figure 34. Detail of the region around the half-cell potential. The greater the slope, the higher the corrosion resistance.

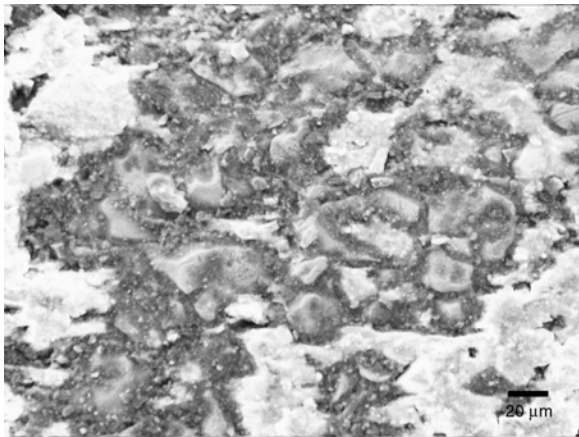
Figure 46. Hollow stainless steel samples: (a) view at the surface, 100×; (b) same region, 300×; (c) detail of the surface condition, 1000×. The surface appears rough, but no signs of corrosion damage were observed.

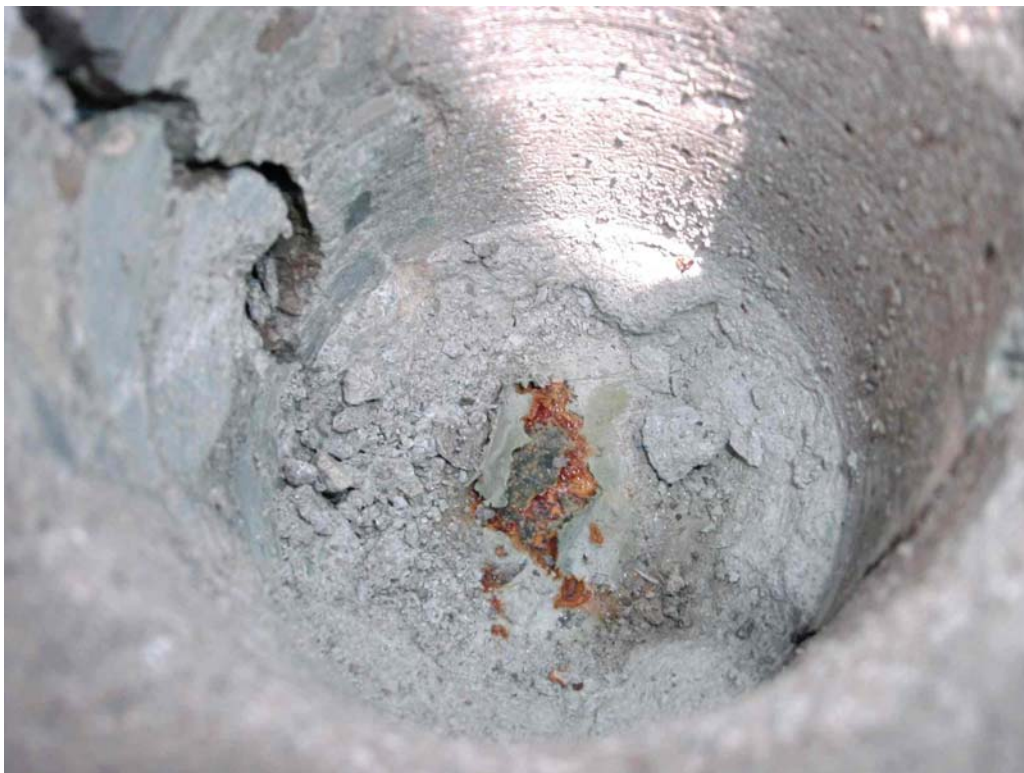
Figure 55. View of the interior of a recently made core hole showing corrosion products underneath the epoxy coating.

Figure 55 shows the interior of a core hole located at the joint immediately after coring. The top of the corroded dowel can be observed at the bottom of the hole. After scraping away

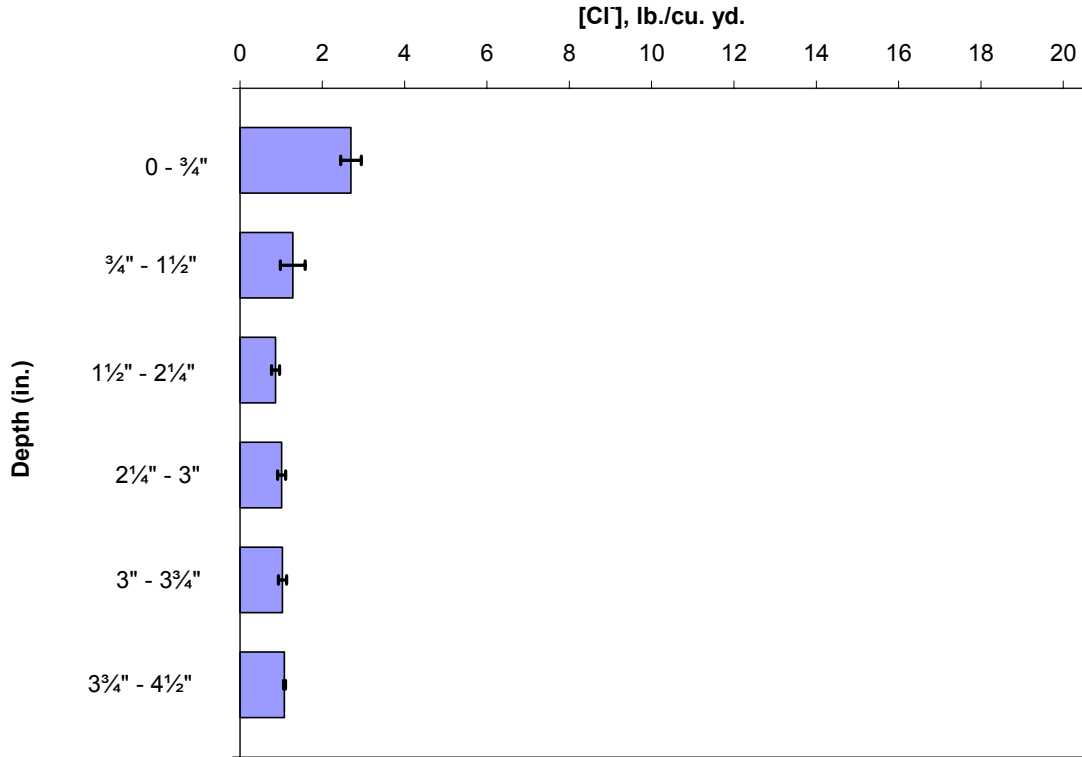
Figure 61. Chloride profile for SR 5 MP 166.00 (downtown Seattle).

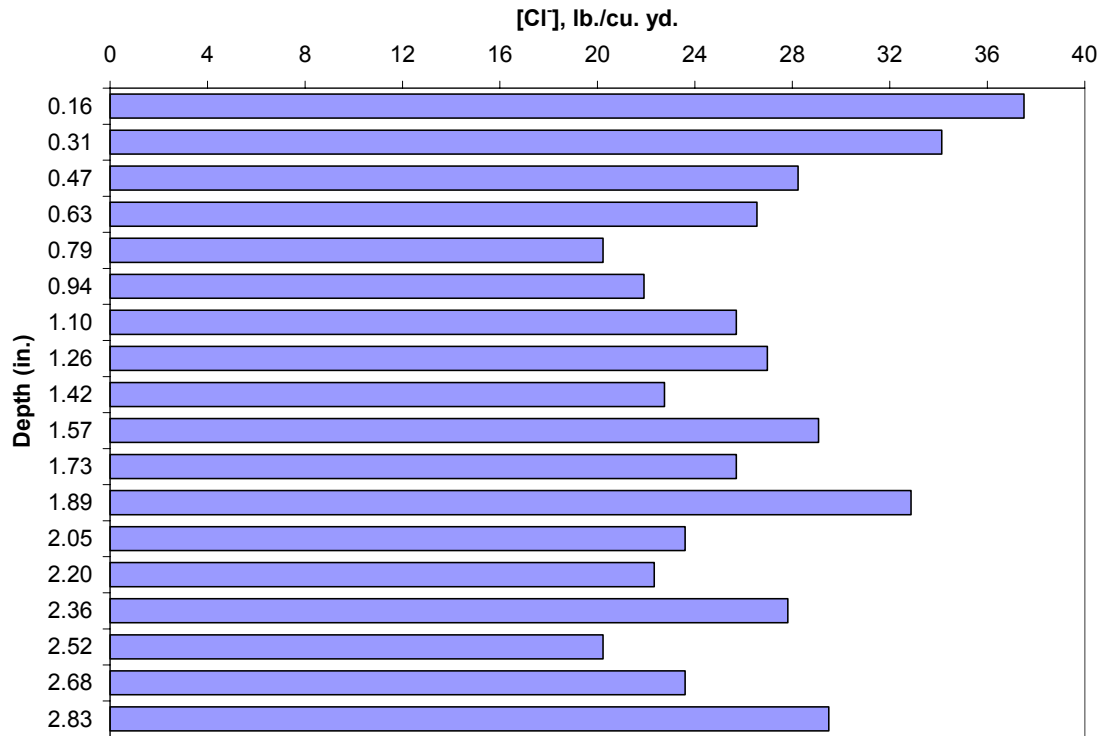
Figure 67. Chloride profile on the concrete of a stainless clad specimen.
