Flow Regime, Geomorphology, and Debris Transport of the San Pedro River: An Exploration of Flood History and Monitoring at the Border Wall

Hannah Hansen  
LDARCH 227 Restoration of Rivers and Streams  
Fall 2022  
Term Project Final Draft

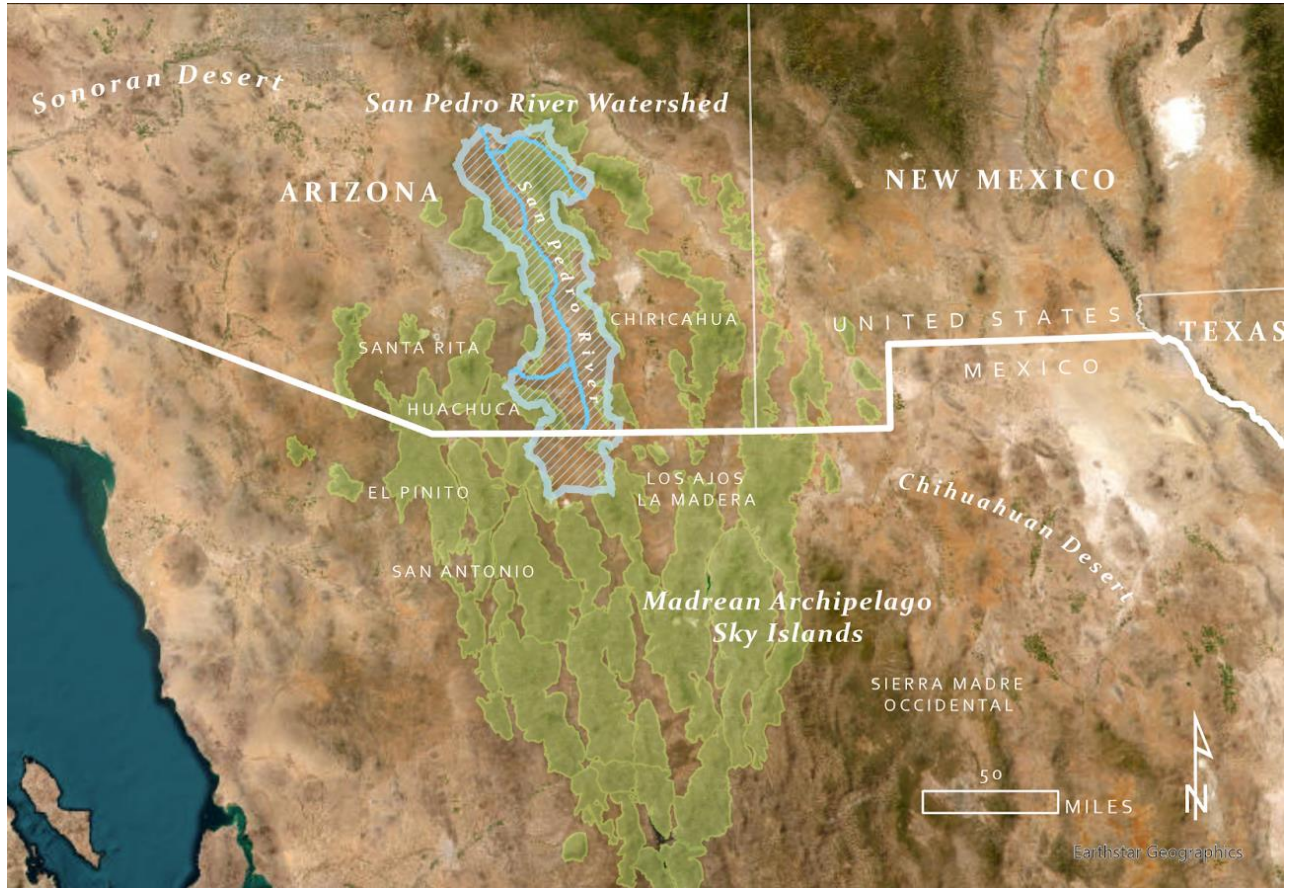
Figure 1: San Pedro River Watershed: Madrean Archipelago Sky Islands Ecoregion context.

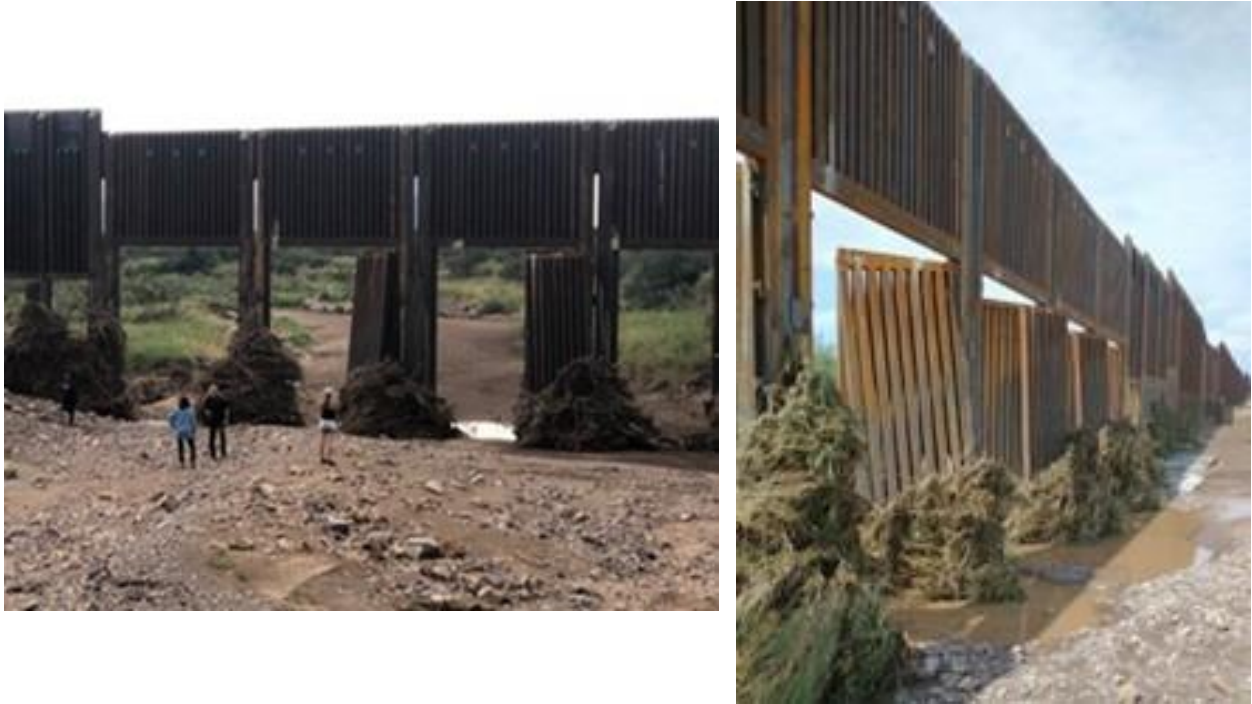
Figure 6: Flood gates torn from their hinges after the August 2021 monsoon on Silver Creek at the US-Mexico border wall. Photos by Fernando Sobrazo / Cuenca Los Ojos.

development in this environment, as evident from historical accounts of the river overbanking, cutting new channels, and destroying ranches, residences, and infrastructure, including bridges and railways. In 2020, the US-Mexico border wall was extended across the San Pedro River and its floodplain. A series of manually operated floodgates were installed with the intention of allowing large floods to pass freely. However, residents documented debris buildup at the floodgates in a flood of 5,640 cubic feet per second (cfs) in August 2021, a year after construction. It is not yet clear to what storm magnitude and debris stage the border wall and floodgates can withstand before failure, but the same storm system in 2021 severely damaged border wall floodgates at Silver Creek in San Bernardino National Wildlife Refuge (Figure 6).

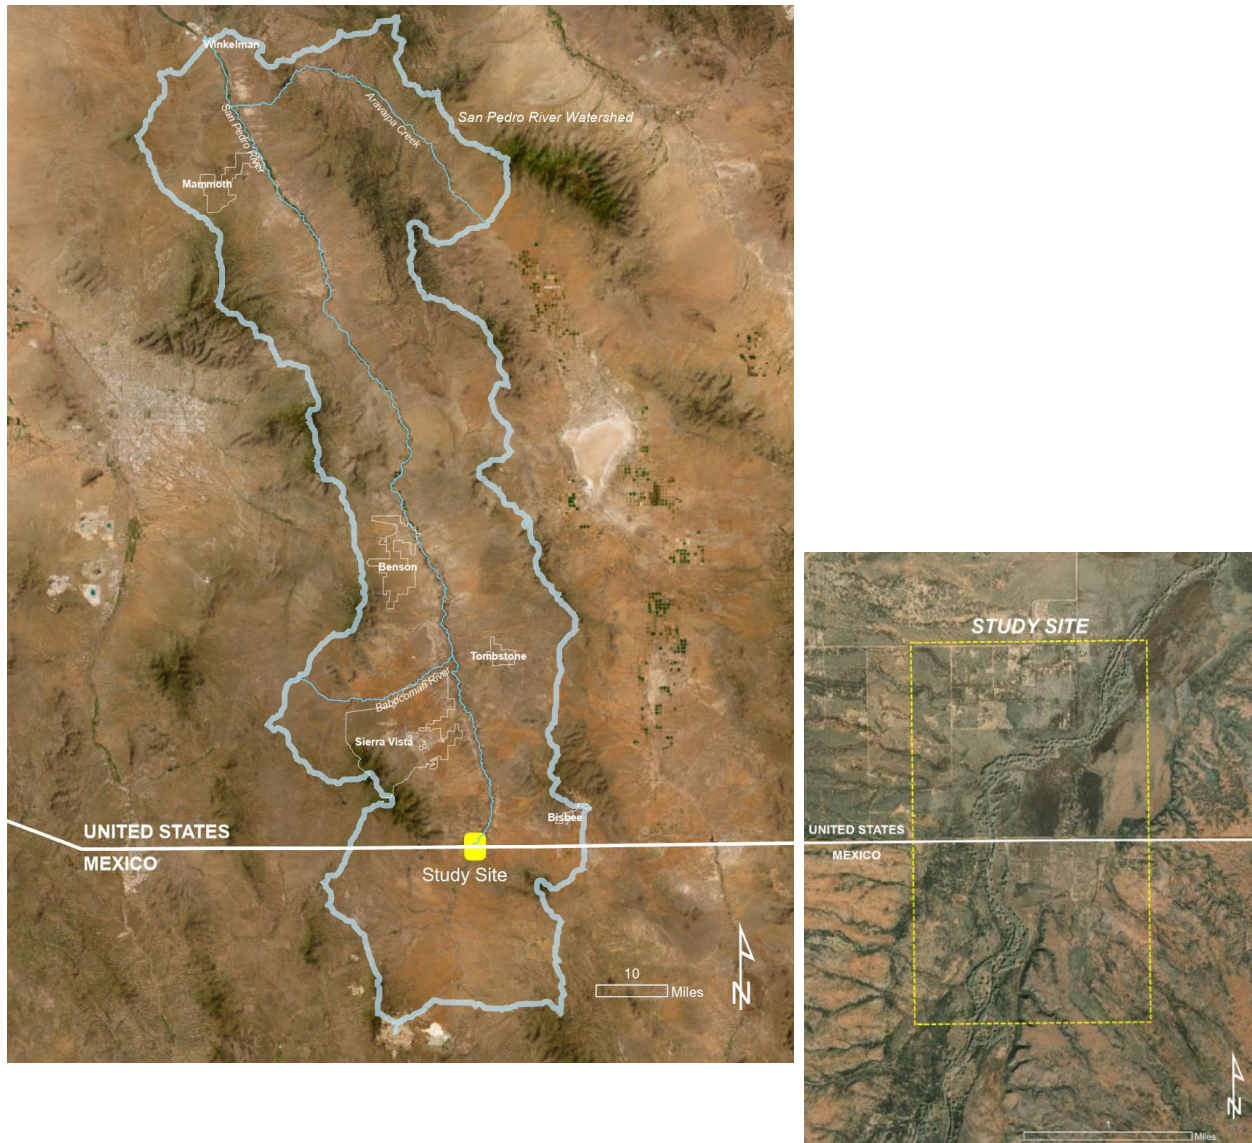
Figure 10a: Context within the San Pedro River Watershed and detail of study site (2 kilometers up- and downstream of the US-Mexico border wall).

Border wall floodgate measurements, photo points, and woody debris surveys at the San Pedro River were first recorded by G.M. Kondolf and graduate students during a site visit in May 2021 (Figure a). The group established 5 photo stations on the downstream side of the border wall and tagged, measured, and recorded GPS coordinates of 9 pieces of LWD (Figure 10b). Coordinates, compass bearings, and notes for repeating the photo station observations in the future are recorded in Table 2. Coordinates, measurements, tag numbers, and notes describing the LWD surveyed in May 2021 are summarized in Table 3. The May 2021 survey conveniently took place before monsoon season, which featured an August storm with a return interval of approximately 2 years (Figure 11). This storm was substantial enough that increased debris accumulation at the border wall floodgates was immediately evident (Figure 12; Figure 13). Of the nine pieces of LWD surveyed in May 2021, only one was found in its initial position during the December 2022 site visit (LWD 105; Table 3). Grain size analysis and comparison between subsequent photos from each station indicate a change in bedform from a flat, sandy channel in May 2021 to a topographically complex channel made up of gravels and small cobbles in December 2022 (Figure 14; Figure 15). In particular, photos from stations 8 and 10 show that riprap which was placed in a clean, straight line following construction of the floodgates was transported as far as 54

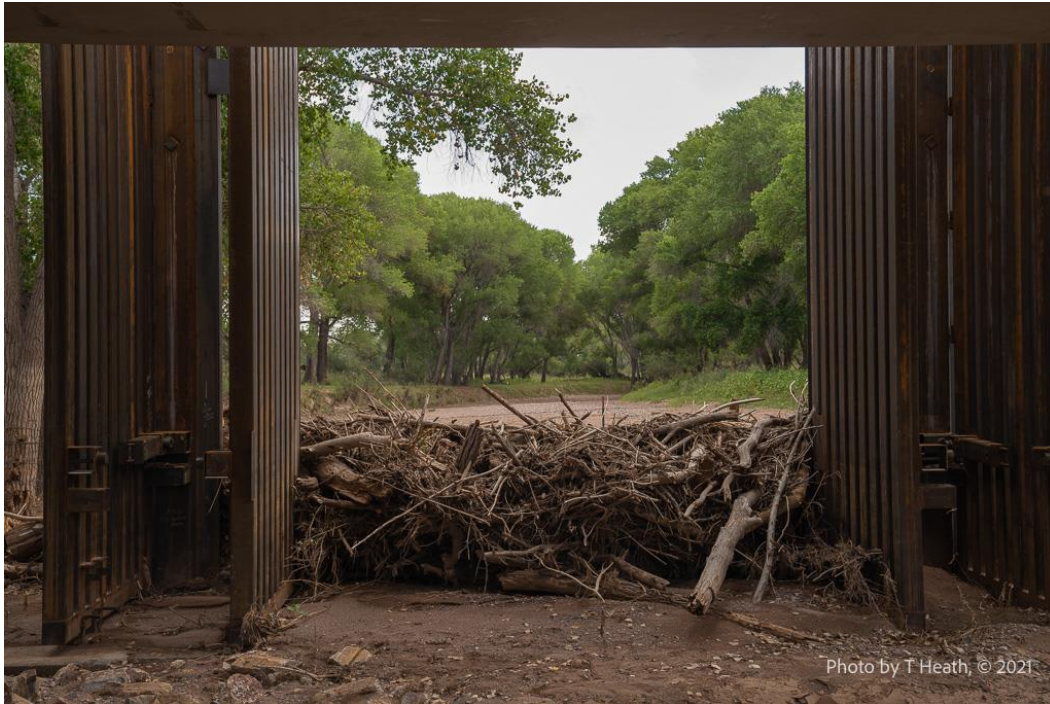
Figure 12: Looking upstream into the San Pedro River channel at the border wall floodgates following the August 2021 storms. Photo by Tony Heath.

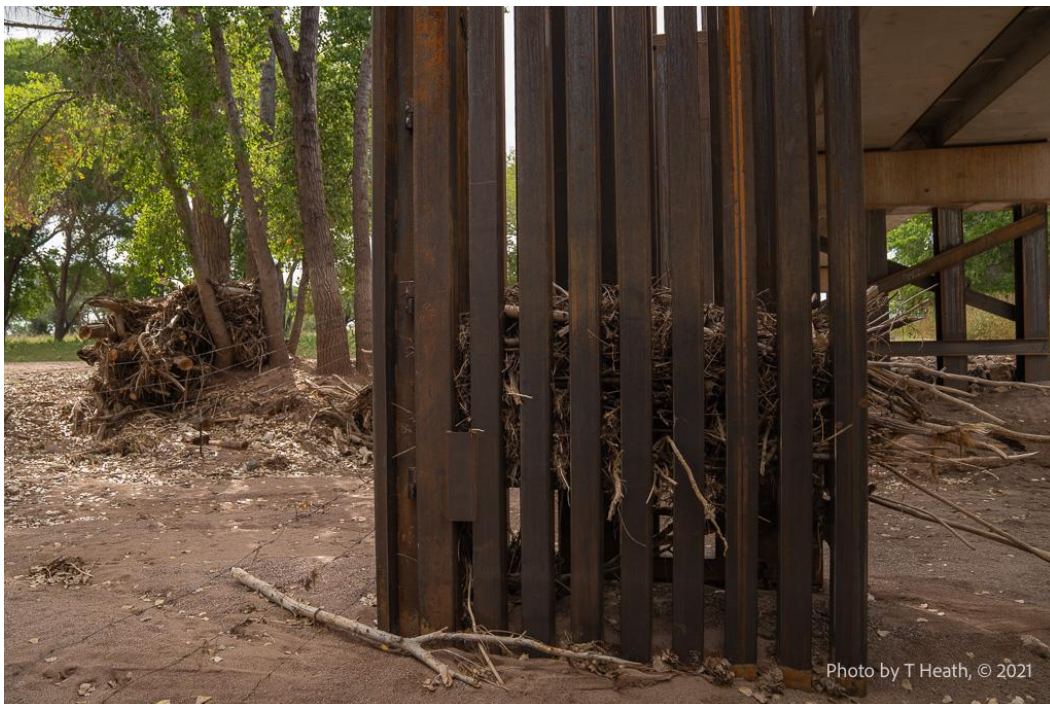
Figure 13: Woody debris accumulation following the August 2021 floods at the San Pedro River border wall. Photo by Tony Heath.

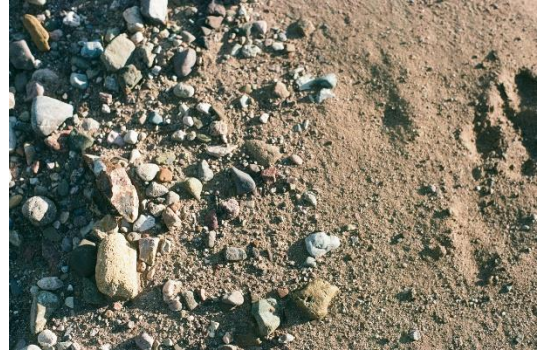
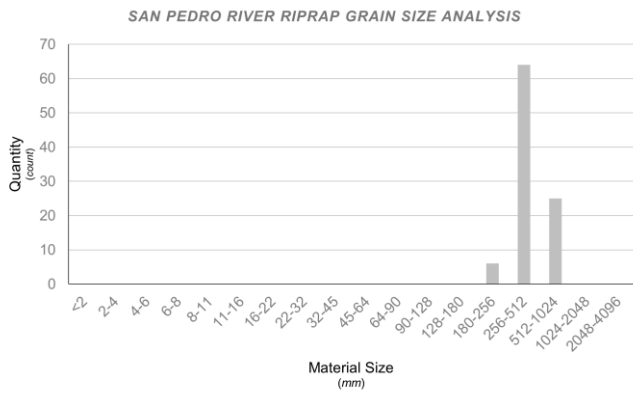
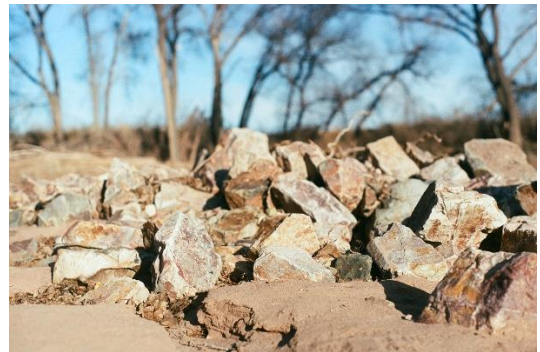
Figure 14: Results from pebble counts of riverbed material (top left), riprap (middle left), photos of riverbed material (top right) and riprap (middle right), and sketch of facies map (bottom center).

Natural riverbed material(s): small gravels and fine sand.

Riprap placed during floodgate construction: large cobbles and small boulders.

I reviewed archival evidence using public records available through the Library of Congress (*Chronicling America*) and related literature – namely that of J.C. Stromberg and G.R. Noonan – that have documented and summarized flood events on the San Pedro River and the subsequent geomorphic response, including channel widening, deepening, entrenchment, and arroyo formation. For collecting field data, I used Gaia GPS for tracking LWD that was surveyed in May 2021, and for tagging and tracking new recruitment of LWD during the December 2022 site visit. I used the pebble count method and sieve analysis to measure the river's natural bed material and the riprap

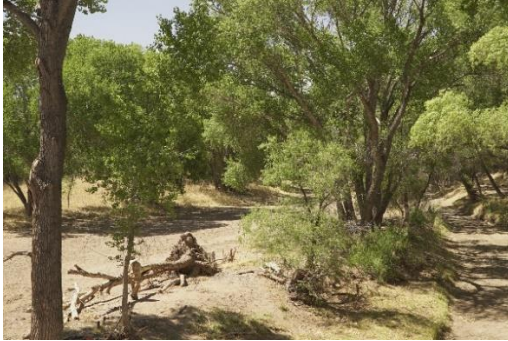
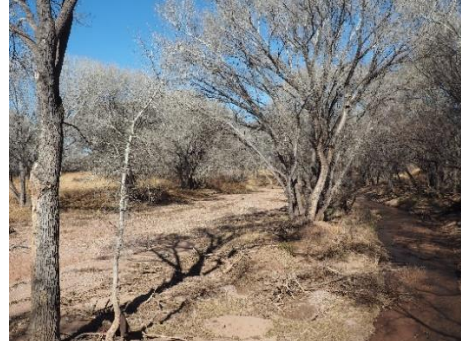
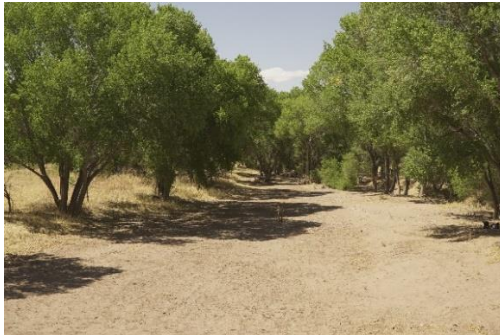
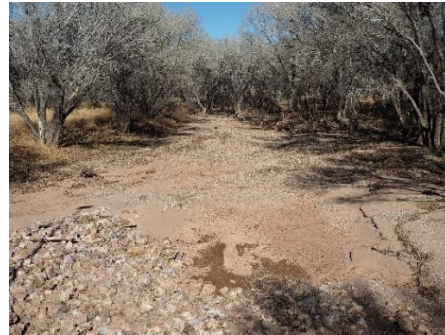
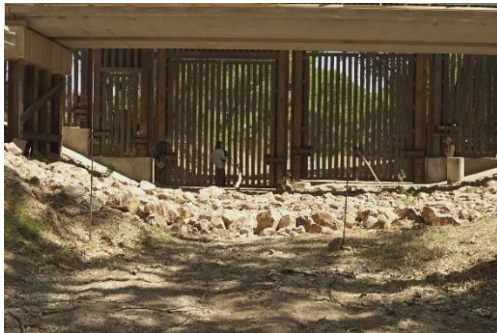
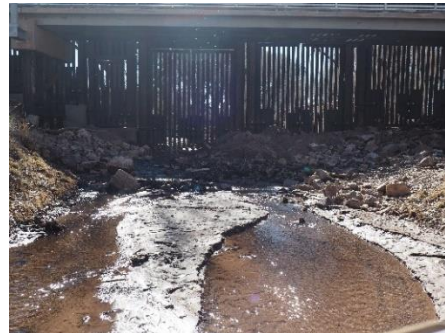
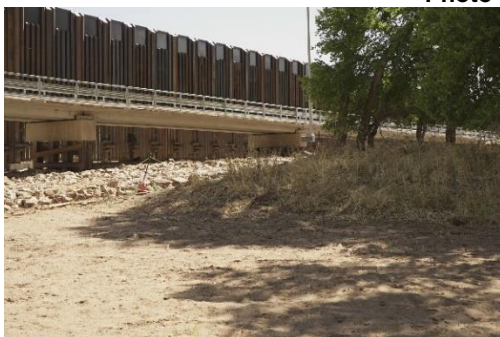
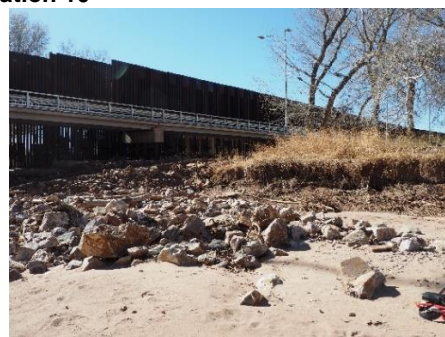
Figure 15: Select photo station results (May 2021 and December 2022 site visits).

feet downstream by December 2022. The repeat photos from station 7 indicate that LWD #110 was moved downstream between May 2021 and December 2022. Changes to the channel's morphology are solidified in cross section 1 (Figure 16), which indicates an approximately 4-foot mound of riprap in the center of the channel (station 90) and that the left bank has incised (station 55). Additionally, cross section 3 (Figure 16) captures a pile of LWD approximately 5 feet in height accumulated upstream of a stand of cottonwoods near the center of the channel (station 87). The December 2022 survey results indicate that what was a flat channel composed primarily of sand has been converted to a more topographically complex channel with scour pools and piles of riprap transported downstream of the border wall. These changes—along with the transport of 8 of 9 of the LWD tagged in 2021, and an increase in woody debris accumulation—occurred with a peak streamflow of 5,640 cfs having occurred between the May 2021 and December 2022 site visits. Further monitoring following monsoon season that includes the reach upstream of the border will be beneficial to understanding how the floodgate system interacts with the river's flood and debris transport regimes.

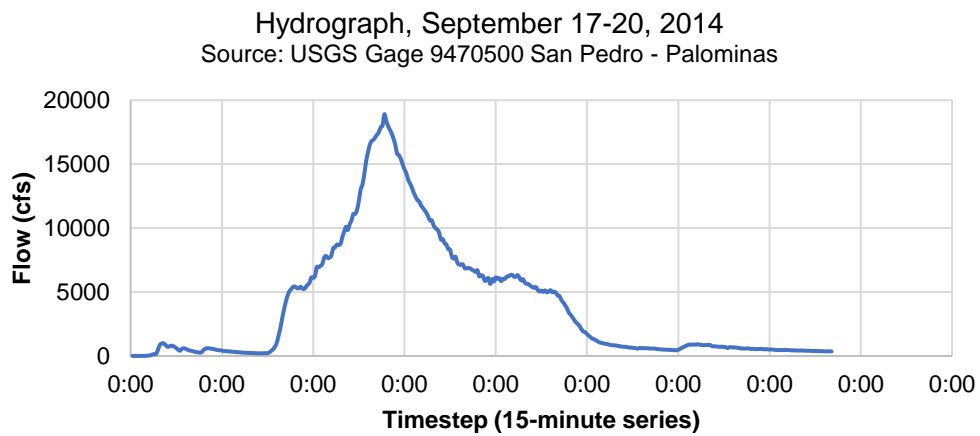
Figure 20: Hydrograph from September 17, 2014, event.

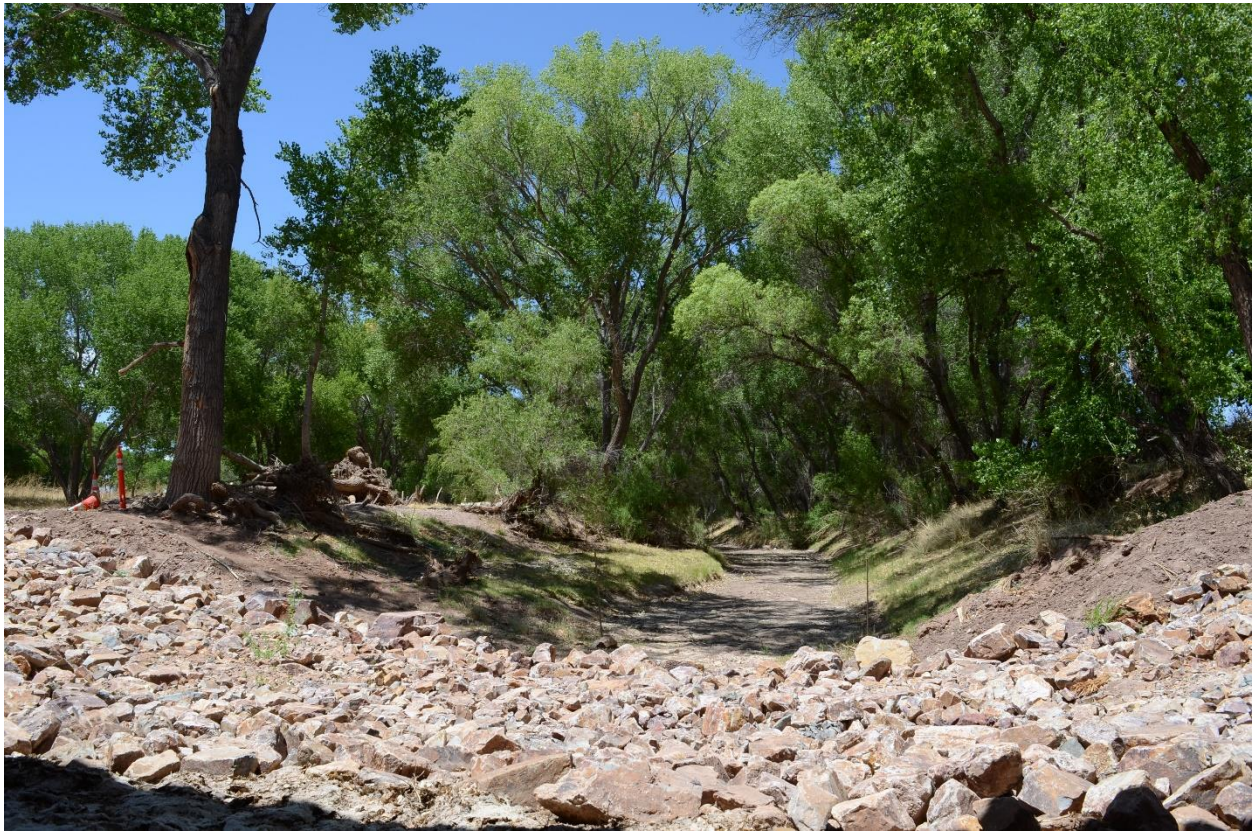
The San Pedro River looking downstream into the channel from the border wall (May 2021).

No. 770 upstream from section 3, Provo River near  
Hailstone, Utah.

*Roughness Characteristics of Natural Channels* (Barnes, 1937), page 137.
