Accelerated Traffic Load Testing of Expansion Joints for the Self-anchored Suspension Section of the New San Francisco-Oakland Bay Bridge East Span

# **Accelerated Traffic Load Testing of Expansion Joints for the Self- Anchored Suspension Section of the New San Francisco–Oakland Bay Bridge East Span**

Partnered Pavement Research Center (PPRC) Contract Strategic Plan Element 3.16:  
Bay Bridge Expansion Joint Testing Study

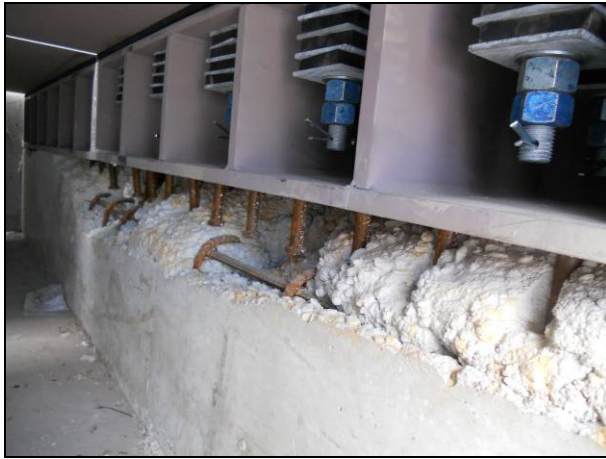
**Figure 2.10: Concrete pour problem on channel assembly structure.**

(Concrete was repaired prior to HVS testing.)

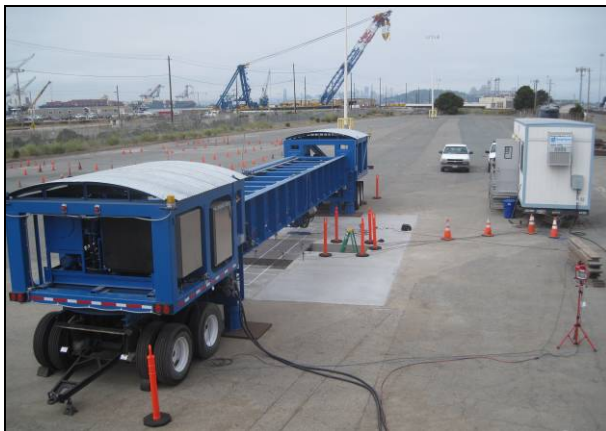
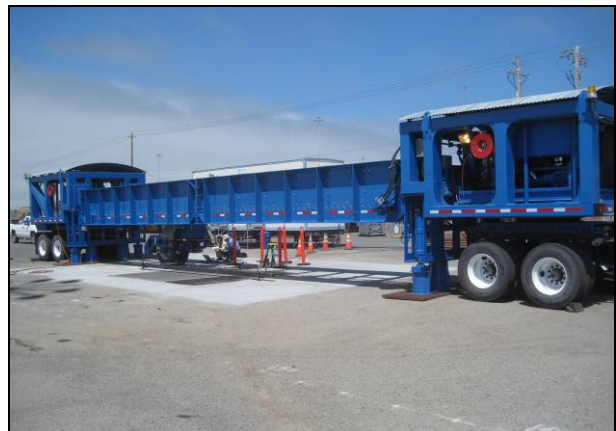
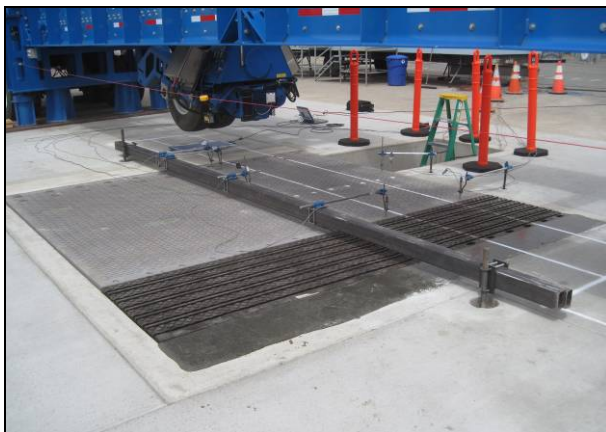
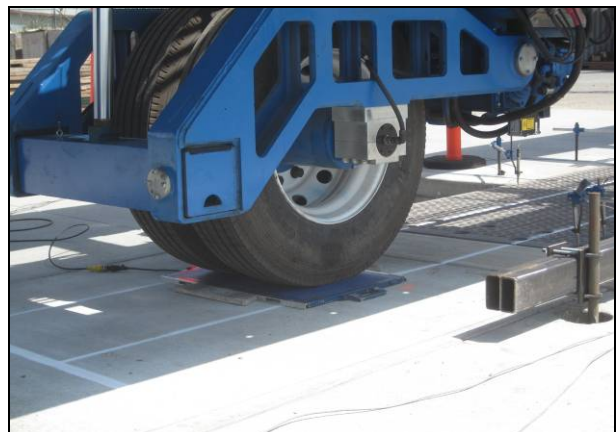
**Figure 2.12: HVS on test structure prior to start of testing.**

The test structure was built by Caltrans. Construction was started in March 2011, and completed in July 2011. Photographs of the construction are provided in Figure 2.4 through Figure 2.9. Problems were encountered with the concrete pour around the channel assembly structure (Figure 2.10), but this was repaired prior to installation of the instruments and the start of testing (Figure 2.11). However, this problem resulted in a gap between the steel plate and the channel assembly on the west side of the structure (Figure 2.11). This gap could not be repaired without dismantling and reconstruction, which prevented testing on this edge of the steel plate, since loading would have led to unrealistic responses being recorded. The completed project with the HVS in place is shown in Figure 2.12.

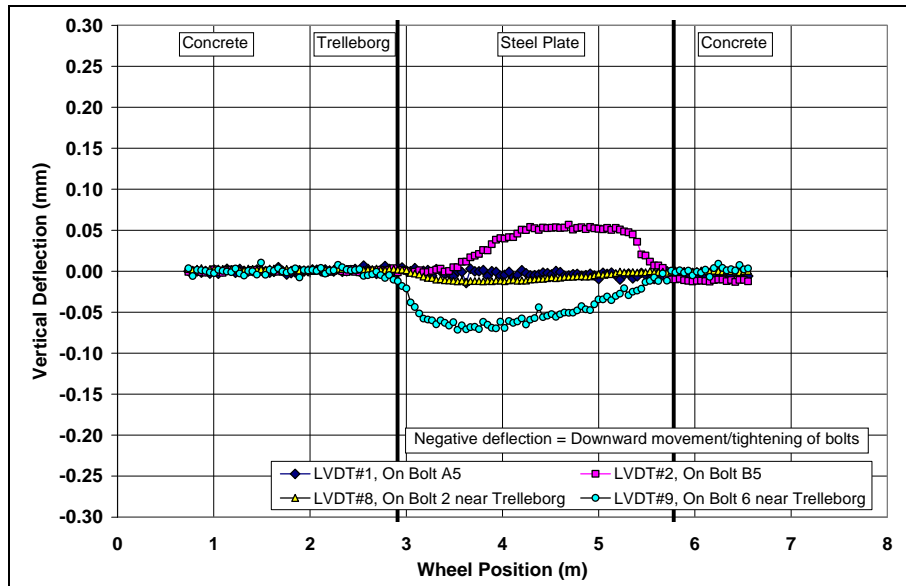
**Figure 4.2: Phase 1.1: Influence lines of vertical deflection for LVDTs on bolts.**  
(Repetition #500,000, wheel load at 40 kN)

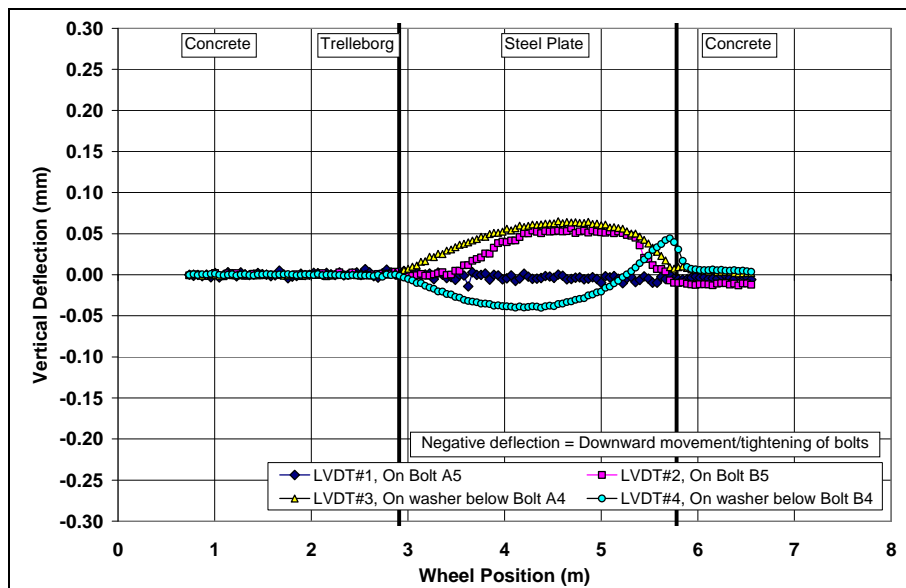
**Figure 4.3: Phase 1.1: Influence lines of vertical deflection for LVDTs on bolts and washers.**  
(Repetition #500,000, wheel load at 40 kN)

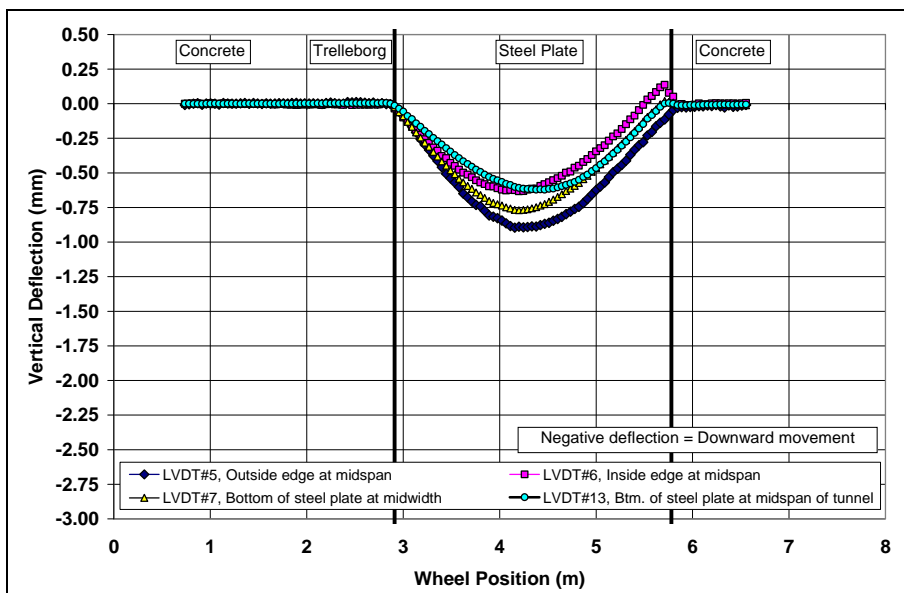
**Figure 4.4: Phase 1.1: Influence lines of vertical deflection for LVDTs on steel plate.**  
 (Repetition #500,000, wheel load at 40 kN)

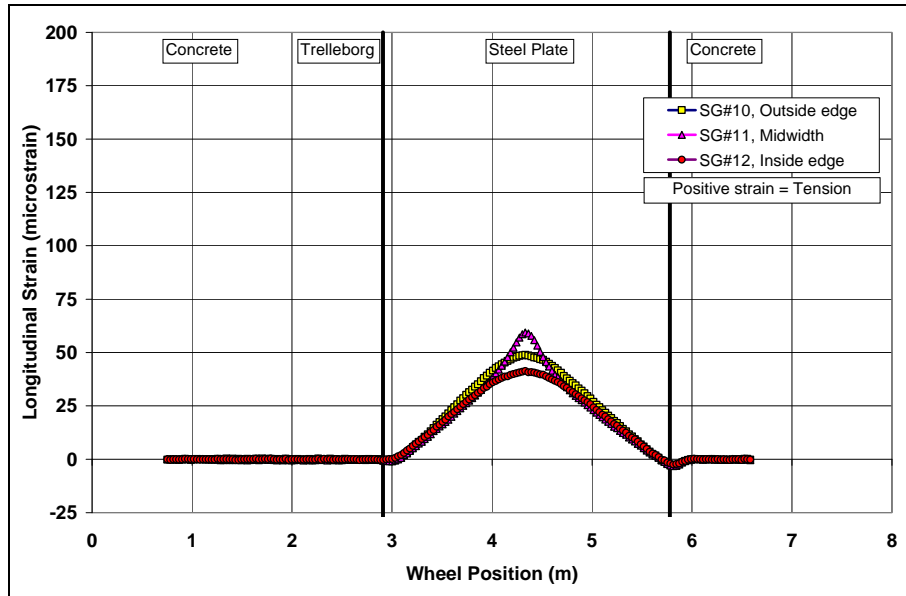
Influence lines (or strain bowls) from a single pass of the 40 kN wheel load (repetition #500,000) for the strain gauges at the midpoints of the inside and outside edge and midpoint of the steel plate are shown in Figure 4.8. Strains were very similar and ranged between 40 and 60 microstrain, with highest strain recorded at the midpoint of the steel plate.

**Figure 4.8: Phase 1.1: Influence lines of longitudinal strain at bottom of steel plate.**  
(Repetition #500,000, wheel load at 40 kN)

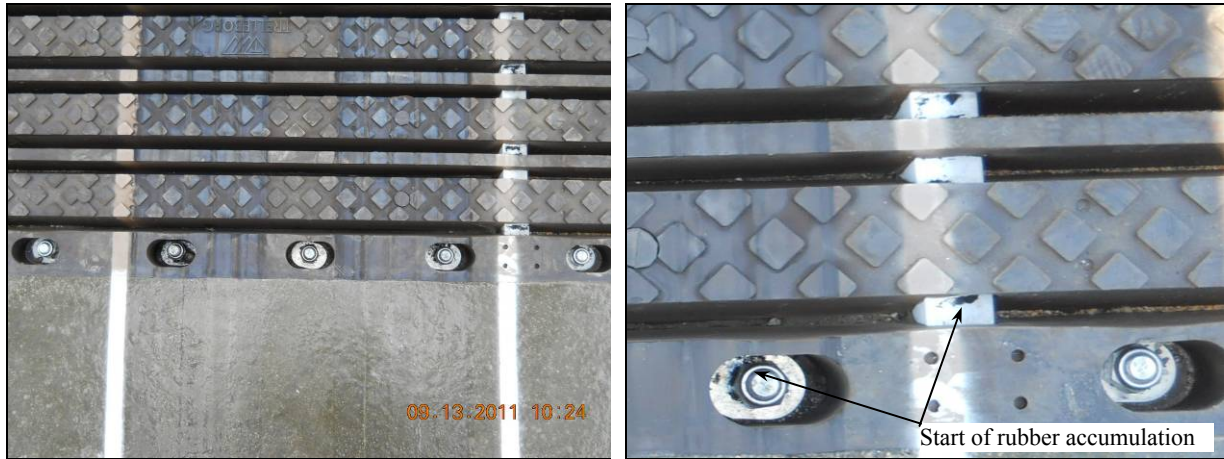
No visual damage was observed on the concrete structure, steel plate, bolts, or washers. However, some wear, in the form of tire abrasion on the rubber sections, was observed on the Trelleborg unit after about 100,000 load repetitions. Small rubber particles started to accumulate on the steel ribs and in the bolt recesses (Figure 4.10). Apart from some slight deformation ( $< 2.0$  mm) on the rubber in the wheelpaths, no other damage was observed on the Trelleborg unit. No rotation of the bolts or washers was observed.

**Figure 4.10: Phase 1.1: Rubber abrasion on Trelleborg unit after 100,000 load repetitions.**

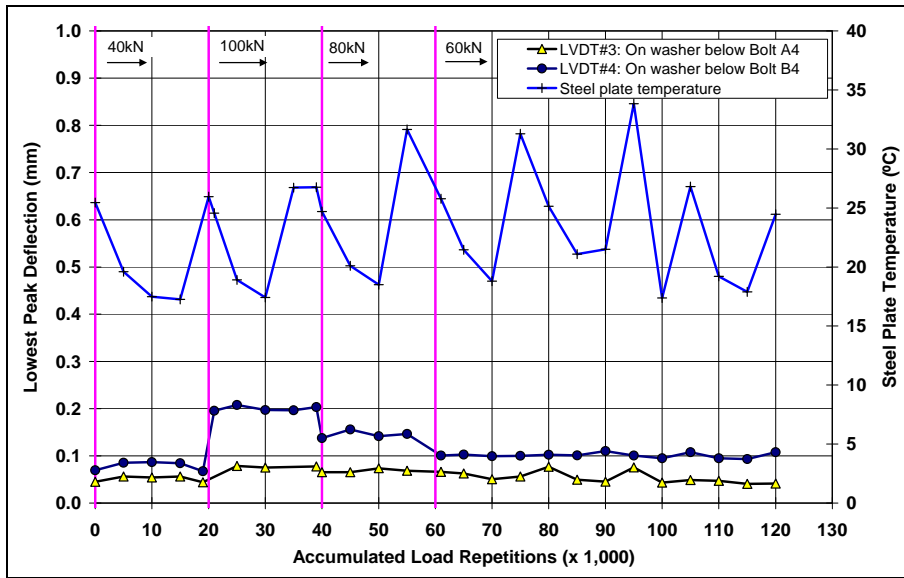
Figure 4.21: Phase 1.3: Lowest peak deflections recorded on washers during traffic wander.

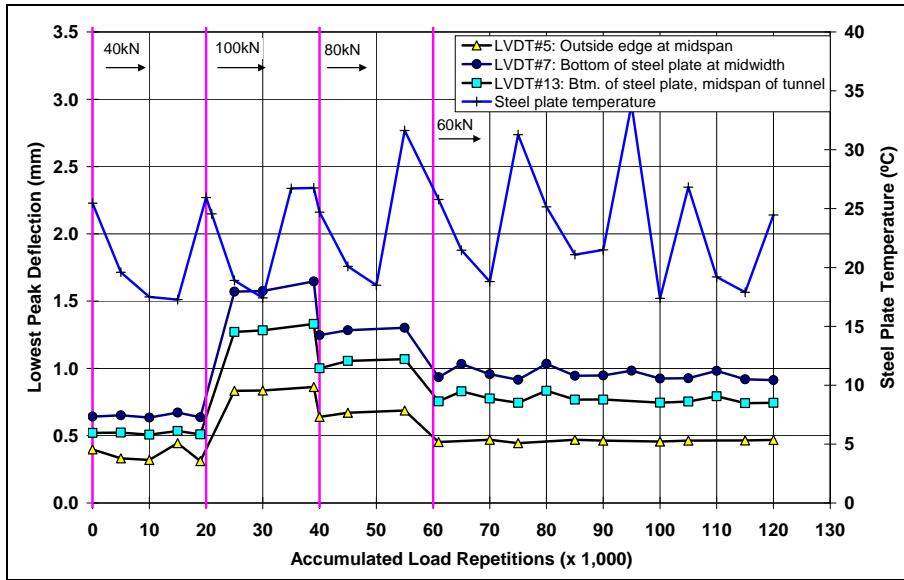
Figure 4.23: Phase 1.3: Lowest peak deflections on steel plate during traffic wander.

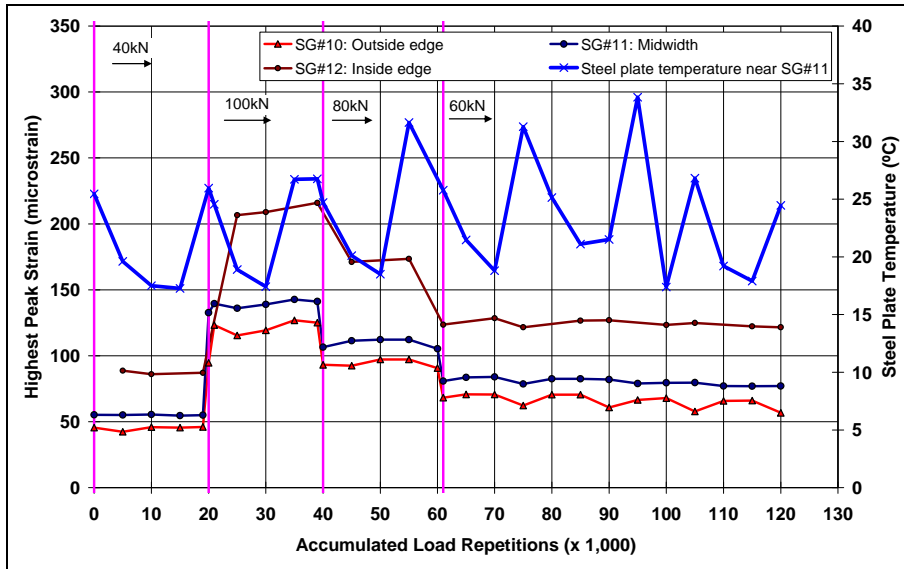
Plots of the lowest (wheel wander point furthest from the sensor) and highest (wheel wander point closest to the sensor) peak strains measured on the steel plate for the duration of Phase 1.3 are shown in Figure 4.25 and Figure 4.26, respectively. Average strains are also summarized in Table 4.5 together with a ratio between the highest and lowest peak strain recorded on each sensor at each wheel load. Changes in strain at different wheel loads and different wheel positions were consistent with the changes observed in

Figure 4.26: Phase 1.3: Highest peak longitudinal strains on steel plate during traffic wander.

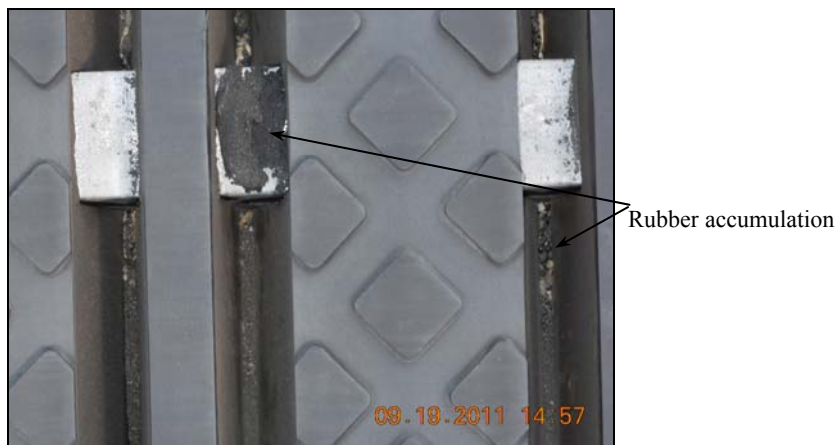
No visual damage was observed on the concrete structure, steel plate, bolts, or washers at the end of this phase. Tire abrasion wear on the Trelleborg unit continued with additional accumulations of rubber particles (Figure 4.27). No further deformation or other damage was observed on the Trelleborg unit. No rotation of the bolts or washers was observed.

Figure 4.27: Phase 1.3: Rubber particle accumulation on Trelleborg unit after 740,000 repetitions.

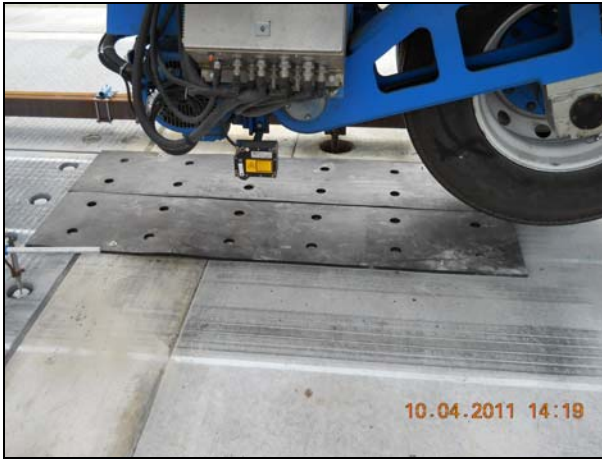
The objective of Phase 3.1 was to determine whether impact loads on the steel plate had any influence on the response trends observed during earlier phases. Testing was carried out on the edge of the expansion joints in the same wheelpath used in Phase 2.1. On the first day, a 13 mm (0.5 in.) neoprene mat (Figure 4.41) was used to cause the impact and thereafter a 19 mm (0.75 in.) hardwood board (Figure 4.42). Larger steps could not be used as these would have caused a system error and consequent shut down of the HVS hydraulic operating unit. The test ran for three days with a 60 kN wheel load in a unidirectional (i.e., one-way traffic only) channelized mode. Wheel direction travelled from the channel assembly toward the Trelleborg unit, with impact applied to the channel assembly on the first day (i.e., from the 13 mm neoprene mat) and then the midpoint of the steel plate thereafter (i.e., from the 19 mm hardwood board). See Figure 4.41 and Figure 4.42 for relative positions of the steps). The influence of the two steps on actual load applied to the steel plate was not determined.

**Figure 4.41: Phase 3.1: Impact load from neoprene step.**

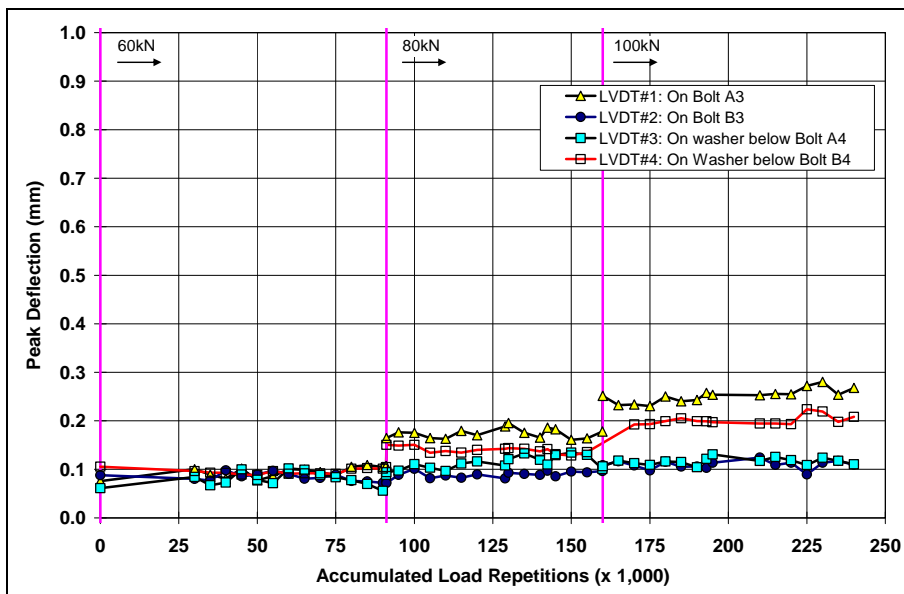
**Figure 4.52: Phase 3.2: History of peak deflections on bolts and washers.**

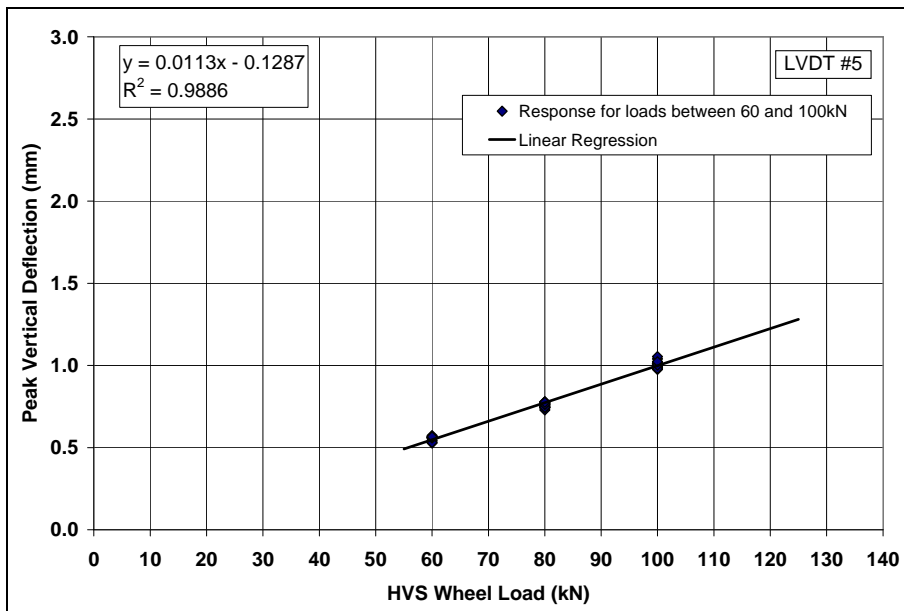
Figure 4.54: Phase 3.2: Relationship between peak deflection and wheel load.

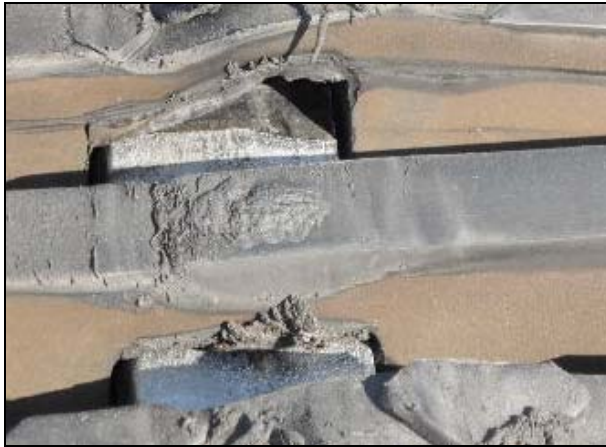
**Figure 4.66: Phase 3.3: Damage to steel rib of Trelleborg unit.**

A total of 1.36 million load repetitions, equating to about 46 million equivalent standard axle loads on a highway pavement, were applied in seven phases during the three-month test. On completion of this testing, no structural damage was recorded by any of the Linear Variable Differential Transducers (LVDTs) or strain gauges installed on the steel plates, steel frames, bolts, and washers. There was also no visible damage on any of these components. Excessive overloading with a 150 kN half-axle load (approximately four times the standard axle load) on an aircraft tire in the last phase of the test caused some damage to the Trelleborg unit in the joint. The damage included abrasion, tearing, shoving and permanent deformation of the rubber inserts, and deformation and shearing of one of the steel supports directly under the wheel load.

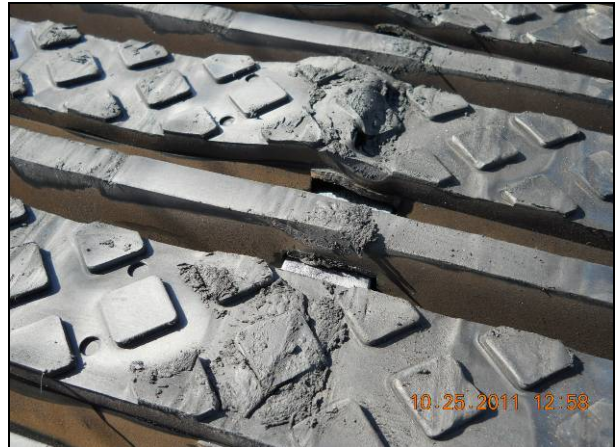
**Figure 4.67: Phase 3.3: Deformation and shoving of rubber on Trelleborg unit.**

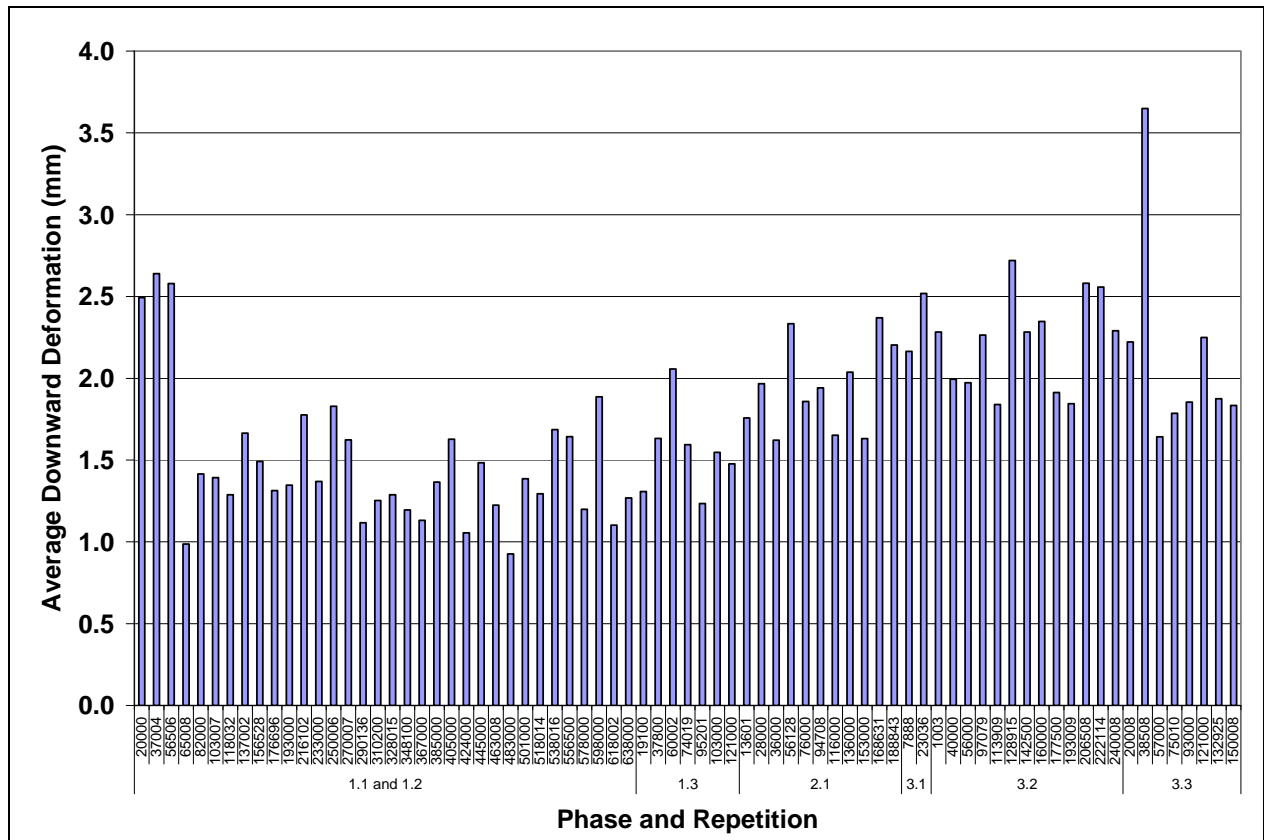
Figure 4.77: Average maximum downward permanent deformation of Trelleborg unit.
