Validation of the thermal effect of roof with the Spraying and green plants in an insulated building

# VALIDATION OF THE THERMAL EFFECT OF ROOF-SPRAYING AND GREEN PLANTS IN AN INSULATED BUILDING

Nan Zhou<sup>1</sup>, Weijun Gao<sup>2</sup>, Chris Marnay<sup>1</sup>, Masaru Nishida<sup>3</sup>, and Toshio Ojima<sup>4</sup>

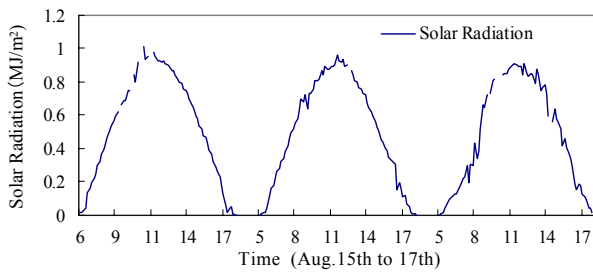
Figure 6 Solar radiation during the survey period

As shown in Figure 6, the quantity of solar radiation from August 15th to 17th was greatest from 12:00 to 13:00, and the quantity on 15th exceeds  $1\text{MJ/m}^2$ , exceeds  $0.96\text{MJ/m}^2$  on 16th, exceeds  $0.88\text{MJ/m}^2$  on 17th. All days were almost clear throughout the survey period.

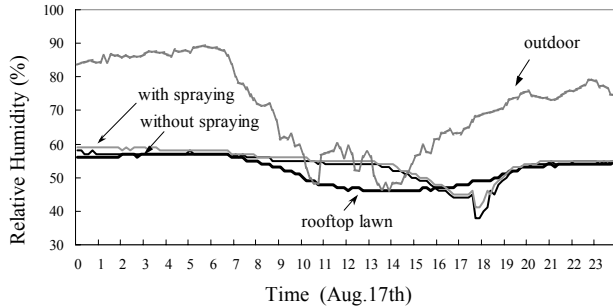
Figure 9 Indoor relative humidity

Figure 9 shows the relative humidity. Regarding the

relative humidity of rooms with a rooftop lawn (E305) on the 17th, it was kept at 57% from 0:00 to 7:00, and became lower from 7:00, the lowest reading was 46% from 13:00 to 14:00. The daily range was about 11%. The room without Roof Spraying was kept at 57% from 0:00 to 6:00 and became lower from 7:00, the lowest reading was 38% at 17:40. The daily range was from 15% to 19%. The relative humidity of the room with roof spraying above kept at 59% from 0:00 to 6:00 and became lower from 7:00, the lowest value was 41% at 17:40. The daily range was 16% to 18%.

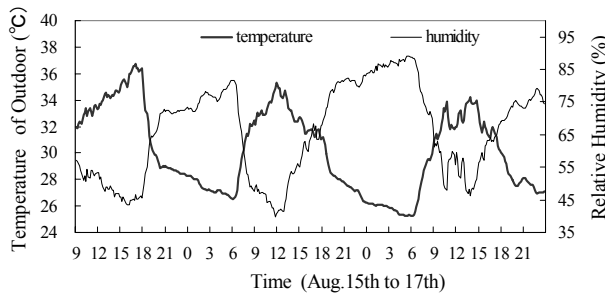
Figure 7 Outdoor temperature and relative humidity

Figure 7 shows the air temperature and the relative humidity. It was a typical summer day in Kitakyushu.

On the 15th, the outdoor air temperature peaked at 17:00, and the temperature was  $36.8^\circ\text{C}$ . On the 16th, the lowest temperature was  $26.5^\circ\text{C}$  at 6:00, the highest temperature was  $35.3^\circ\text{C}$  at 12:00, and the daily temperature range was  $8.8^\circ\text{C}$ . On the 17th, the lowest temperature was  $25.2^\circ\text{C}$  at 6:00, the highest temperature was  $34.2^\circ\text{C}$  at 14:00 and the daily range was  $9^\circ\text{C}$ .

On the other hand, the lowest relative humidity was 43.6% at around 17:00 on 15th, the highest relative humidity on 16th was 81.6% at around 6:00, when the lowest relative humidity occurring at 12:00 at about 39.8%. The highest relative humidity on 17th was 89.2% at around 6:00, with the lowest relative humidity occurring at 13:30 at about 46.8%. The daily range was 41.8% on 16th, 42.4% on 17th.

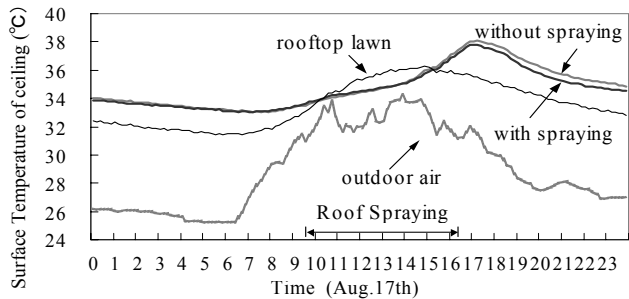
Figure 11 Ceiling surface temperatures

Figure11 and Table 4 shows the results for the three rooms.

The surface temperature of the ceiling of the room with the rooftop lawn remained stable compared with the other two rooms, and its maximum temperature was

3.5°C less than in the other two rooms.

The fluctuation of the ceiling surface temperature resembles the indoor air temperature; the room with rooftop lawn remains stable compared with the other two rooms. In the case of the two rooms without rooftop lawns, west wing temperature fluctuated sharply.

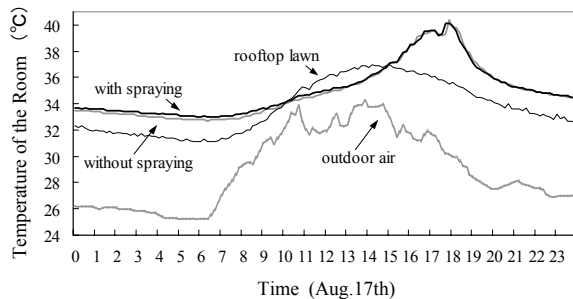
Figure 8 The indoor air temperature

As shown as Figure 8, compared with the other two rooms, the temperature of the room with the rooftop lawn was relatively stable. Also, it continued low during the afternoon, although the temperature is higher than the other two rooms in the morning. The highest temperature appears early, but it became constant and fluctuation became gradual during daylight. On the other hand, in the room without a rooftop lawn the temperature goes up sharply during the afternoon, the highest temperature was 3-4°C higher than the room with a rooftop lawn. The peak temperature is delayed as long as 4 hours in the room with the rooftop lawn until it reaches the highest temperature, and it was observed that the temperature went up sharply under the influence of the afternoon sun.

There was little temperature difference between the room with the spraying and the room without the spraying, i.e. spraying water did not affect room temperature. This result from RC building seems to be dependent on the room's ceiling insulation material.

The analysis of temperature and relative humidity of the indoors was collected from the center of the room. Figure 8 shows each room's temperature, Figure 10 shows the temperature of the corridor. Table 3 shows the comparison of the daily temperature range, lowest temperature and the highest temperature on 17th.

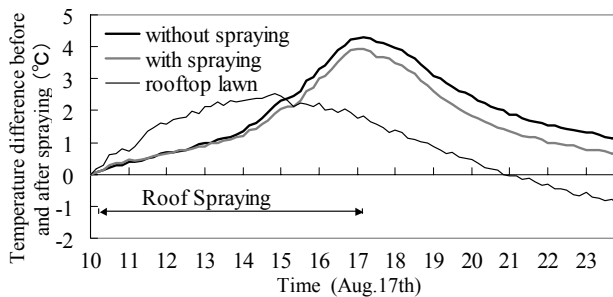
Figure 12 Difference between before and after spraying

On the other hand, in the case of the two rooms without a rooftop lawn covering (temperature, as shown as the Figure12), the average ceiling surface temperature of the sprayed roof room was 0.3°C less than the non-sprayed roof room.

And also, the difference increases gradually on the third day of spraying. This resulted from the heat capacity effect of the roof, suggesting that the effect of the spraying increased little by little.
