A systems approach to retrofitting residential HVAC systems

A Systems Approach to Retrofitting Residential HVAC Systems

J.A. McWilliams and I.S. Walker

May 2004

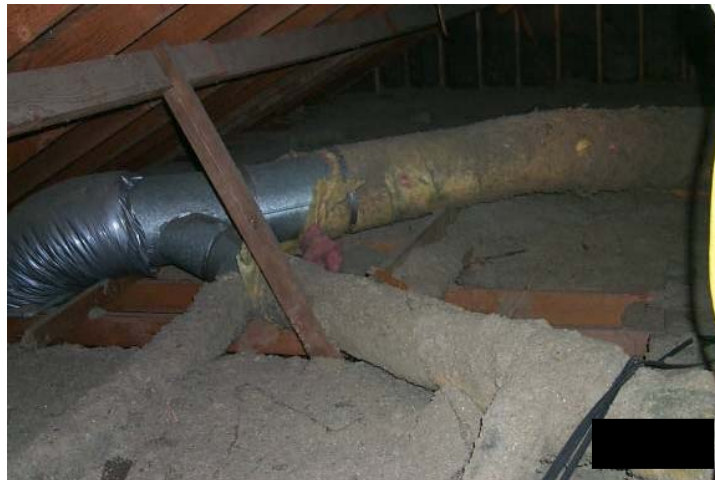
Figure 2. Poorly insulated sheet metal ducts and blown-in insulation in the attic before retrofit

attic, with RSI 4.5 (R-26) glass fiber insulation between the 50 mm by 200 mm (2 by 8 inch joists) on 40 cm (16 inch) centers. The house had the following combination of problems: low-efficiency heating and cooling equipment, leaky (see Figure 1) and poorly insulated ducts (see Figure 2), low air handler flow, low refrigerant charge, and a leaky exterior envelope. In addition, the air handler, furnace, cooling coils and most of the duct system were located outside the conditioned space in the garage and attic. A few major components of the shell leakage were easily identified in this house: several large mechanical chases were open to the attic, and a building cavity return was open to the garage and the attic. The HVAC system was undercharged and operating at only two-thirds of its rated capacity. Lastly, the homeowner reported problems in cooling the upstairs of the house.

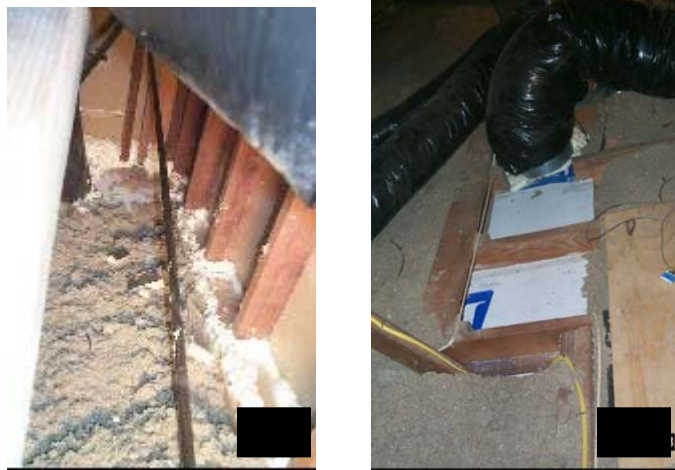
Figure 3. Sealing cavities connecting the house to the attic. Foam was used for sealing small holes and cracks at building component intersections (left). Duct board insulation was used to block off large open areas (right)

The sealing of the envelope was very successful – mostly because this particular house had significant large leaks that we were able to access. We sealed over 570 L/s (1200 cfm) of leakage at 50 Pa (0.2 in. water) - about one-quarter of the total leakage. The sealing included: air-sealing the attic floor plane (2 large chases) as shown in Figure 3, leaks between the old cavity return (which communicated with the garage) and the conditioned space, and plumbing penetrations in the conditioned space.

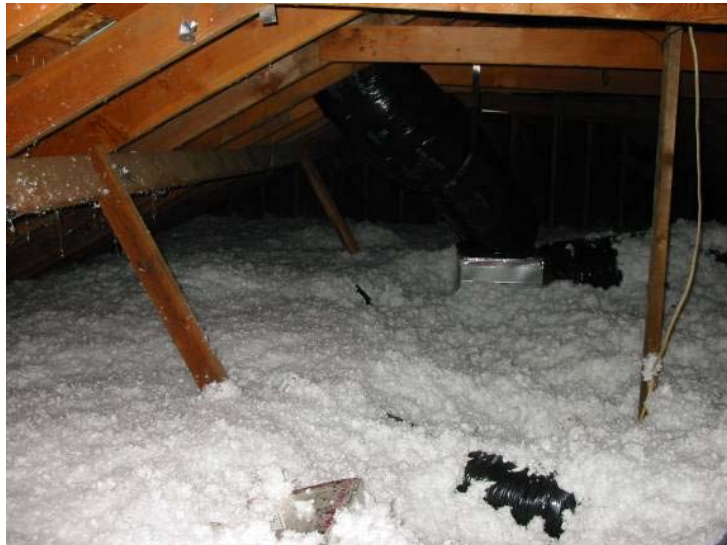
Figure 4. New flex ducts in attic covered by additional blown-in insulation.

Because the ducts, furnace, and air handler were located in the attic, the original retrofit plan was to seal and insulate the attic to bring the system inside conditioned space. Unfortunately, it was not possible to obtain code approval for this retrofit in the available time. As an alternative, it was decided to place the ducts on the attic floor and cover them with blown-in insulation (as illustrated in Figure 4), thus increasing the effective insulation of the ducts and protecting them from the radiation from the underside of the roof deck. Thus, the added attic insulation served two purposes: it increased the envelope insulation and improved the distribution system performance. With sufficient time and resources, it may have been possible to persuade the code authorities to allow a sealed attic. However, as in most real retrofit situations, limits of time meant that the vented attic was retained and the ducts were buried in additional ceiling insulation. Given the strict conservatism of code officials, it is unlikely that these issues can be dealt with on an individual project basis without extensive advance planning. Hopefully, research projects like the current study will mean that innovative building changes will become more widely accepted.

- The metal ducts in the attic were replaced with new R-4 flexible ducts (despite clear and repeated instruction to retain the original ducts) because the contractor thought they were undersized. Initially the contractor hung the flex-ducts from the attic ceiling with smooth bends. However, to allow covering the ducts with insulation the contractor then placed the new ducts on the floor, but unfortunately did not take the time to lay the ducts with smooth bends.
