CHEMICAL STABILITY OF SODIUM BETA"-ALUMINA ELECTROLYTE IN SULFUR/SODIUM POLYSULFIDE MELTS

Submitted to Journal of the Electrochemical Society

M. Liu and L.C. De Jonghe

June 1986

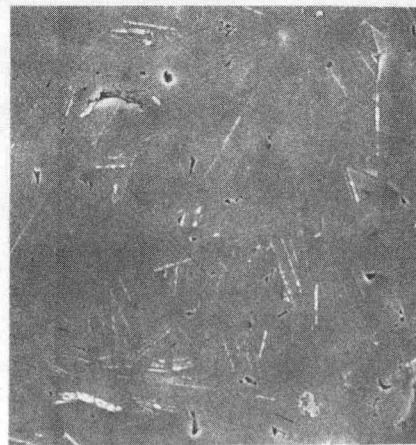
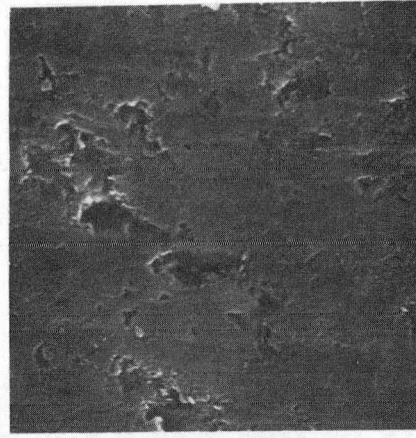
The surfaces of polished specimens are shown in Fig 1. Very little has happened to the polished surface immersed in  $Na_2S_2$  and  $Na_2S_3$  melts. However, on the polished surface in  $Na_2S_4$  melt, some compounds formed on areas containing defects such as microcracks, pores,

etc, which were introduced by mechanical polishing. On the polished surface immersed in  $Na_2S_5$ , a non-uniform and discontinuous, thin surface layer was formed and more corrosion products were evident at areas containing flaws or irregularities (Fig 1e). The changes in surface morphology were even more pronounced for the samples immersed in pure sulfur, where a thick corrosion layer formed on the whole surface (Fig 1f).

Fig 1 Scanning electron micrographs of the polished surface of the electrolyte before and after 5-week immersion in sodium polysulfide melts with different compositions.

- (a) as-polished before immersion.
- (b) immersed in  $Na_2S_2$  ( $350^\circ C$ ).
- (c) in  $Na_2S_3$  ( $400^\circ C$ ).
- (d) in  $Na_2S_4$  ( $400^\circ C$ ).
- (e) in  $Na_2S_5$  ( $400^\circ C$ ).
- (f) immersed in pure sulfur ( $350^\circ C$ ).

It appears, see Fig 1 and 2, that more chemical reactions, deposition and or recrystallization of corrosion products occurred in sulfur-rich melts, i.e.,  $Na_2S_5$  and pure sulfur, and that more dissolution of corrosion products occurred in sulfur-poor melt, i.e.,  $Na_2S_2$ . This is perhaps due to the changes of the solubility of the sulfates in the sulfide melts as the composition of the sulfides changes.

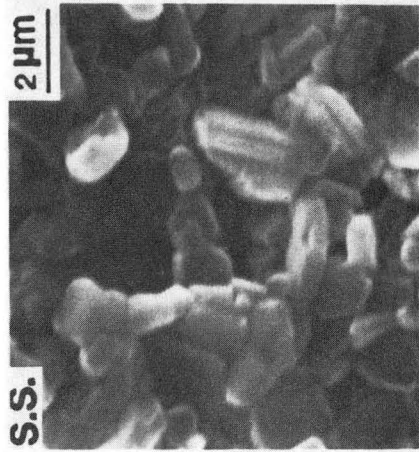
The surfaces of sintered electrolyte are shown in Fig 2. After immersion, the surfaces were covered with a thin product layer, while some compounds had accumulated in the surface pores. The extent of the reactions apparently increased from  $Na_2S_2$  to  $Na_2S_3$  to pure sulfur.

Fig 2 Sintered surfaces of the electrolyte (same experimental conditions and arrangement as in Fig 1)

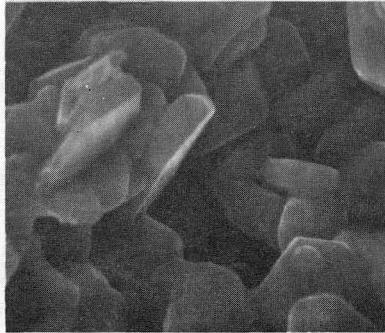
Figs 3 and 4 show the changes in morphology of polished and sintered surfaces before and after immersion at  $400^\circ C$  for 5 weeks in  $Na_2S_3$  with the presence of oxygen, water, moist air, or stainless steel (Fe-Ni-Cr) plus graphite felt (C). An  $Na_2S_3$  melt was chosen because, without impurities, this melt was among the least reactive ones, as shown in Figs 3b and 4b. However, in the presence of impurities, the change in surface morphology and chemistry can be dramatic.

(1). **Steel + Carbon (Figs 3c and 4c):** The presence of transition metals and graphite felt considerably affected the interaction between the  $Na_2S_3$  melt and the electrolyte. A corrosion product layer covered the entirety of the surface, and some octahedrally shaped crystals had formed.

(2). **Oxygen (Figs 3d and 4d):** The effects of the presence of oxygen contamination on the  $Na_2S_3$ /electrolyte system are: (i) creation of a corrosion layer on most of the areas of the polished surfaces (Fig 3d); (ii) considerable acceleration of the reactions and increase of the deposition of the corrosion products, and formation of the flower-shaped crystals on the electrolyte surface; and (iii) recrystallization of some crystals on the sintered surface in addition to the overall thin product layer that formed without oxygen present.

(3). **Water (Figs 3e and 4e):** In the case of absorption of water in electrolytes, there is an obvious etching effect: the grain boundaries are clearly revealed and some material appeared missing. Some corrosion products had deposited between grains.

(4). **Moist Air (Figs 3f and 4f):** The exposure of the electrolyte to moist air ( $H_2O$ ,  $O_2$ ,  $CO_2$ , etc) had the combined effects of water and oxygen contamination.

Fig 4 Sintered surfaces of the electrolyte (same experimental conditions and arrangement as in Fig 3).

Obviously, these reactions are much more favorable thermodynamically in the presence of oxygen, since they have a large, negative  $\Delta_r G^\circ$ , as shown in Table 3. Experimental results agreed very well with this calculation. A heavy reaction, deposition of corrosion products, and recrystallization were found on the electrolyte surfaces when some free oxygen had been introduced into test tubes before sealing (see Figs 3d and 4d).

Coupled with oxygen or even carbon dioxide, which could come from the absorption of moist air on the electrolyte surface during cell construction, water does make the polysulfides more susceptible to corrosion. The possible reaction products now include  $NaHSO_4$  and  $Na(OH)$ , whose melting points are  $320^\circ C$  and  $317^\circ C$ , respectively. Thus, the presence of water can lead to increased reaction of the electrolyte in the polysulfide melts at about  $350^\circ C$  (see Figs 3e and 4e).

An important aspect of sulfur side-degradation in practical Na/S cells is deposition of metal sulfides originating from container corrosion. The deposits formed on the electrolyte surface, as shown in Figs 3c and 4c, have been identified as  $FeS_2$ ,  $Cr_2S_3$ ,  $Ni_3S_2$ ,  $NiS_2$ ,  $(Ni,Fe)S$  and  $NaCrS_2$ , etc., and are similar to those reported by Park [8] and Battles [9]. The possible reactions can be written as follows:
