Results from Visual Inspection and Laboratory Testing for ASR in Existing Concrete Cores from Bridges and Pavements in California

Partnered Pavement Research Center (PPRC) Strategic Plan Project Task 3.34:
Improved Screening Tests for ASR

1. REPORT NUMBER UCPRC-RR-2015-07	2. GOVERNMENT ASSOCIATION NUMBER	3. RECIPIENT'S CATALOG NUMBER
4. TITLE AND SUBTITLE Results from Visual Inspection and Laboratory Testing for ASR in Existing Concrete Cores from Bridges and Pavements in California		5. REPORT PUBLICATION DATE March 2017

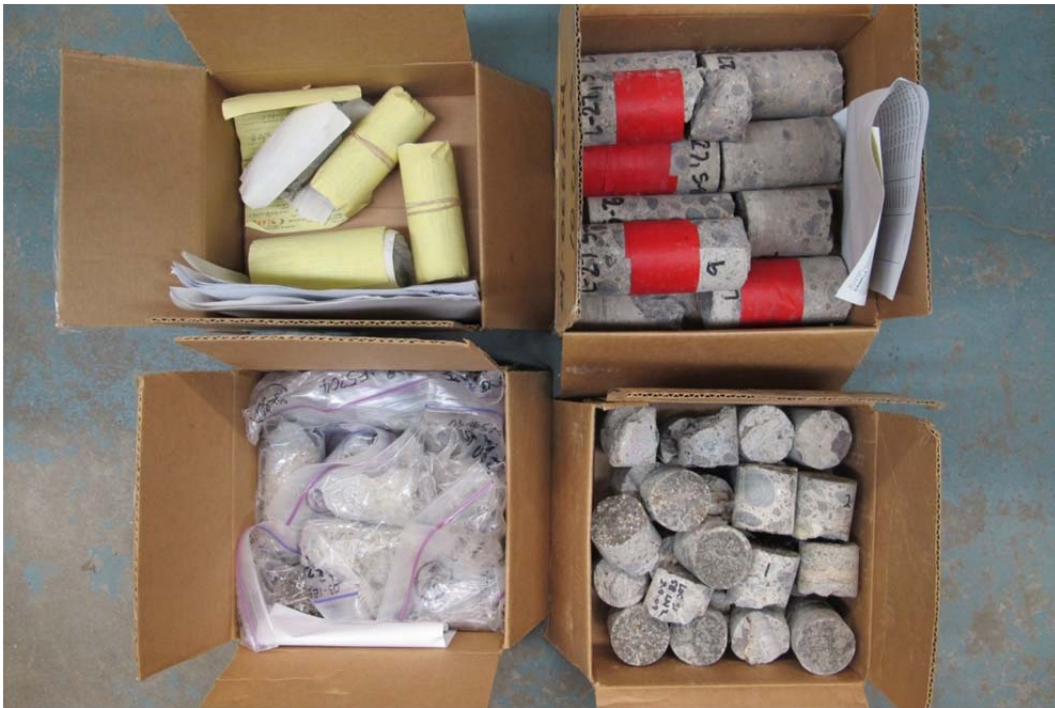
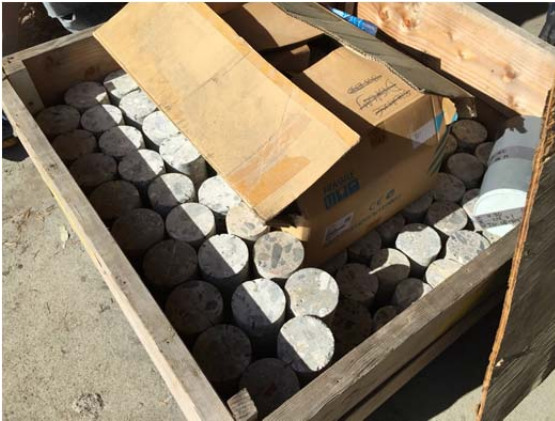
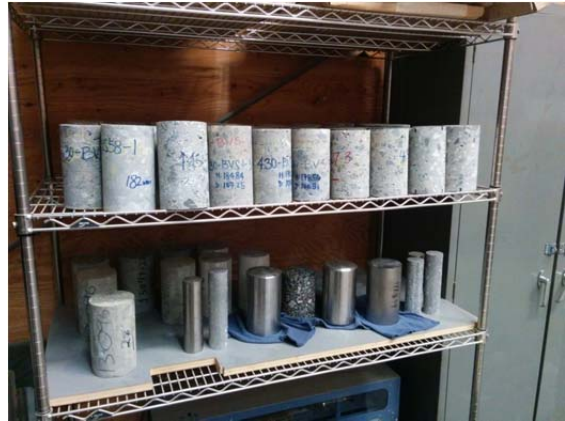
Figure 2.1: Pavement cores, including 150 cores that had been soaked in lime water for CTE testing.

The 265 pavement cores (Figure 2.1), of which 131 had been soaked briefly in lime water for the CTE testing, and 311 bridge cores were prepared for examination for ASR. For this investigation the petrographic consultant advised selecting bridge cores that had a minimum length of 3 inches (75 mm), so that the required amount of surface area for the examination on each would be available, and a preferred length of 4 inches (100 mm); this resulted in the selection of 102 cores to process before the examination (Figure 2.2). The pavement cores had sufficient surface area for examination because of their greater width (4 inches [102 mm]) and length.

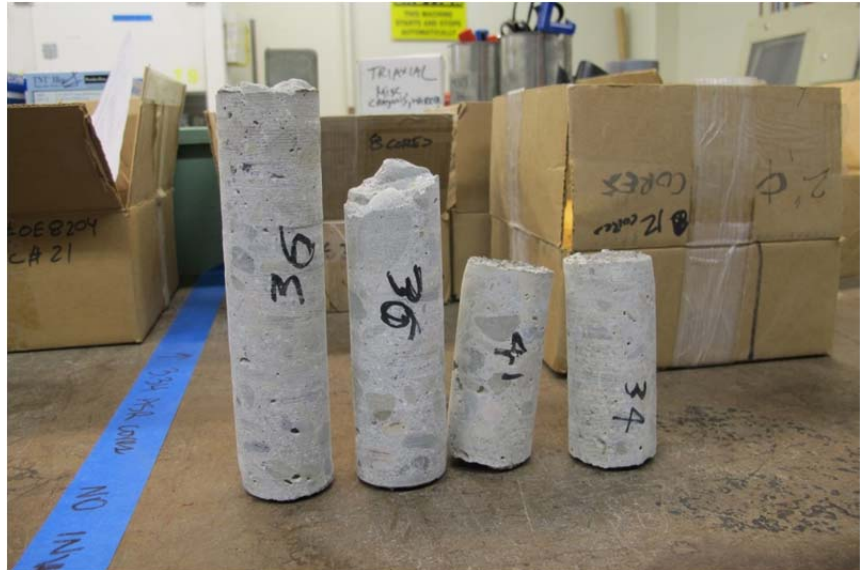
Figure 2.2: Bridge cores; cores equal to or longer than 3 inches were used for ASR visual inspection.

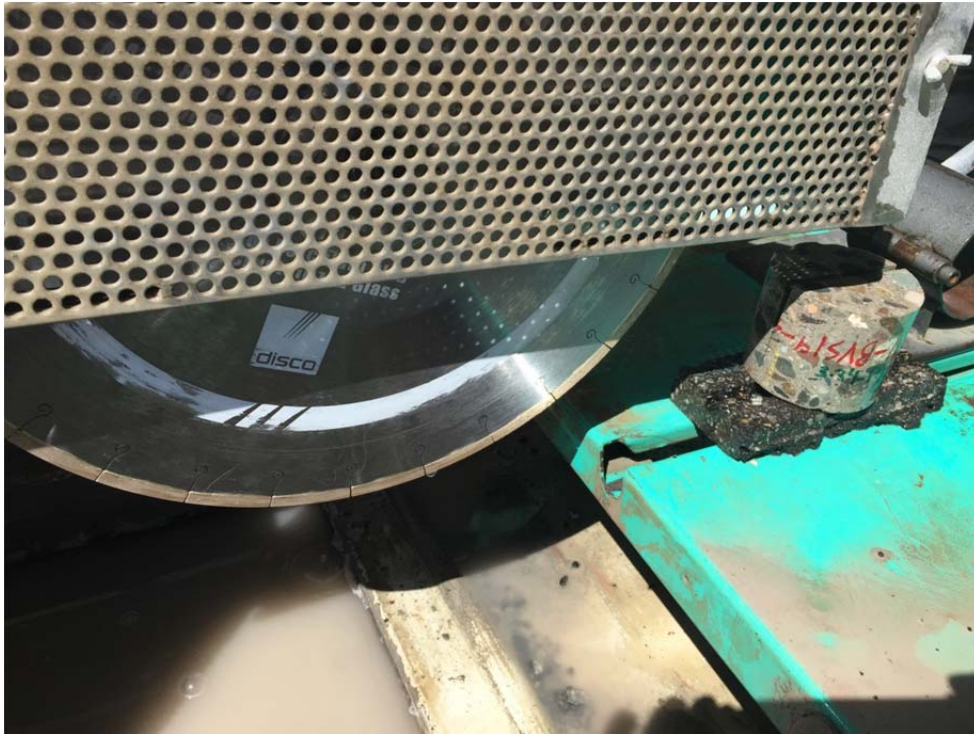
After the cores were inventoried and measured, they were cut for testing and examination. As shown in Figure 2.7, the cores were cut using J-slot continuous diamond blades, which are commonly used to cut marble and tile.

Figure 2.7: J-slot continuous diamond blades for concrete core cutting.

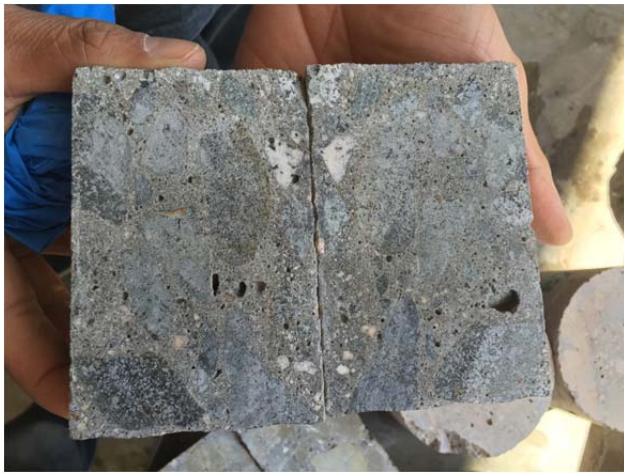
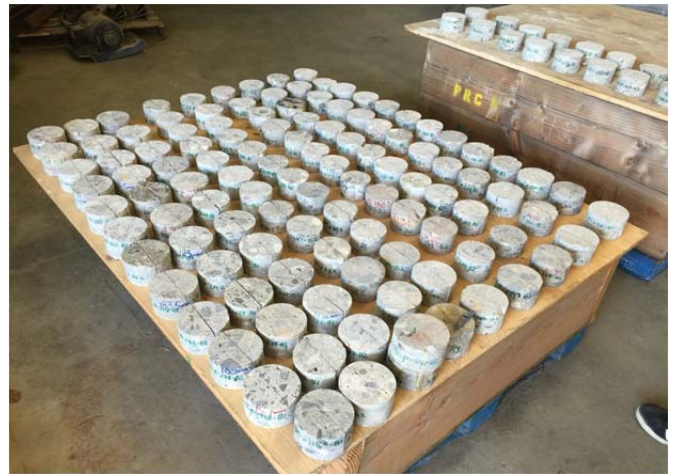
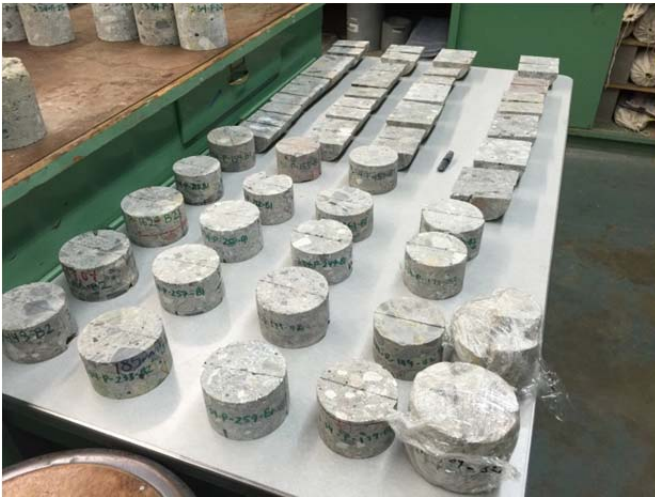
Figure 2.9: Concrete cores for visual inspection.

All the pavement cores used for CTE testing had been cut to a length of 6 inches (152 mm), but the pavement cores and bridge cores from the GPR study were of varying lengths. For this study, bridge cores that were equal to or longer than 3 inches were cut vertically into two parts for the ASR visual inspection (Figure 2.8 and Figure 2.9).

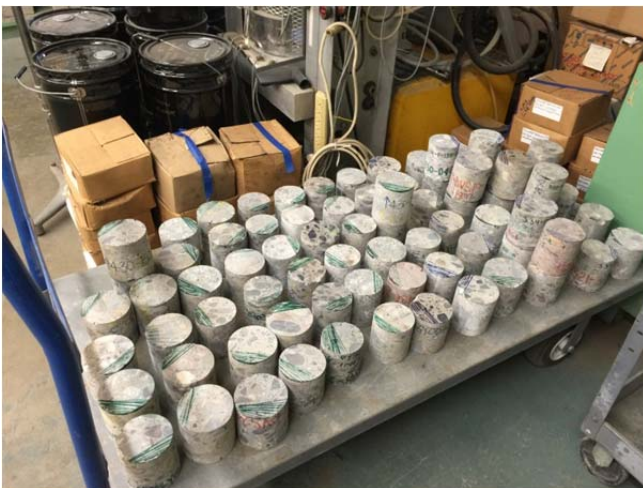
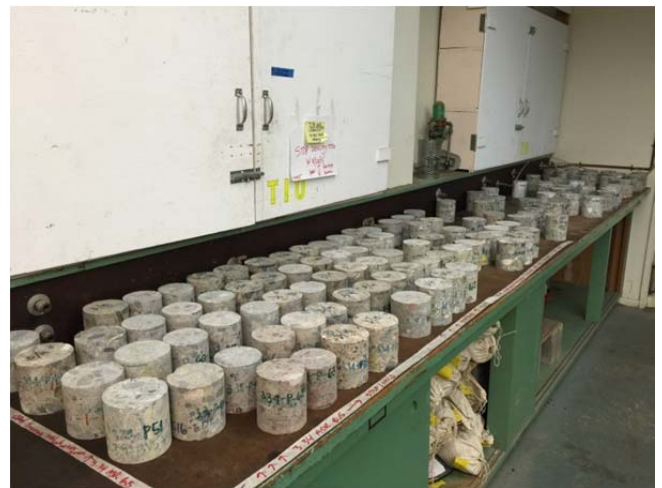
Figure 2.10: Concrete pavement cores after cutting and leveling for strength testing.

Pavement core pieces cut for strength testing were ground to ensure that the top and bottom surfaces were parallel to each other and perpendicular to the core sides (Figure 2.10). All the bridge cores were too small for strength testing.

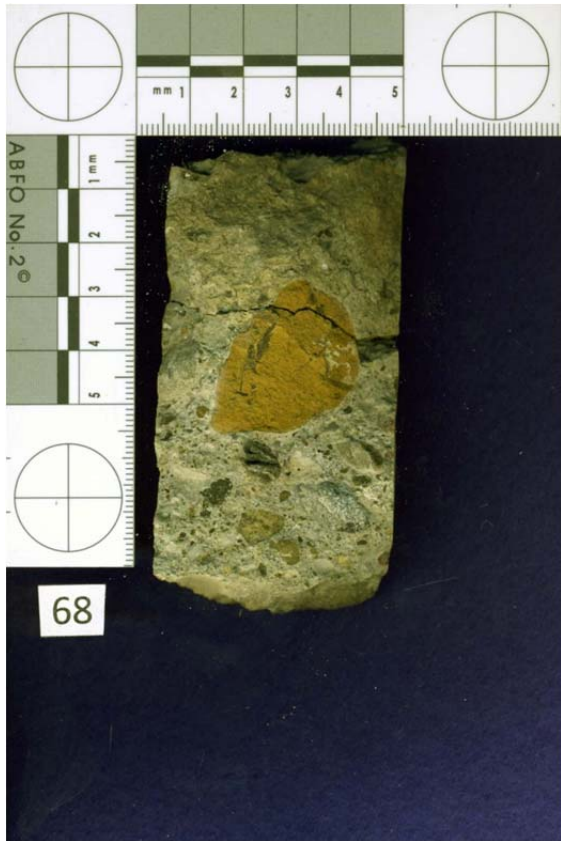
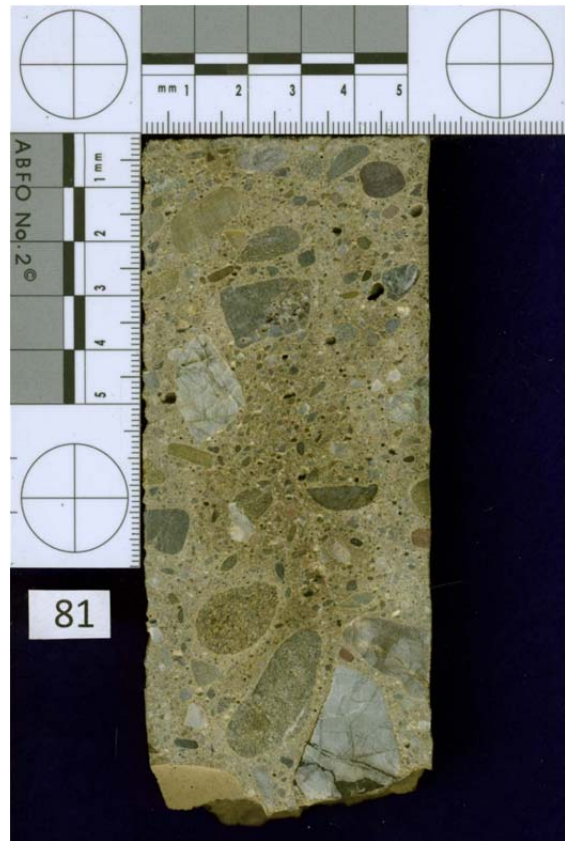
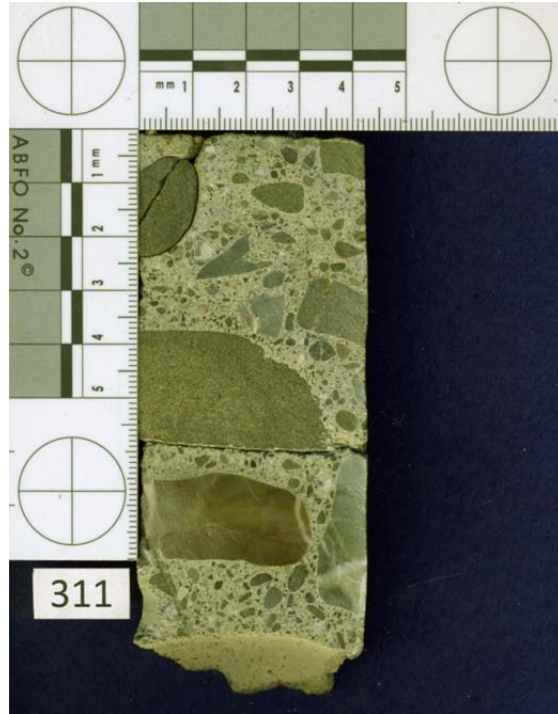
Figure 3.4: Example scans of the cut surfaces of three bridge cores.

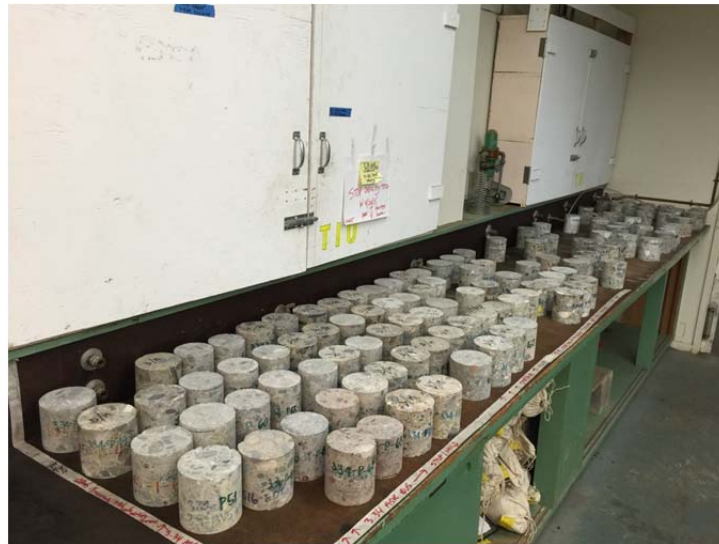
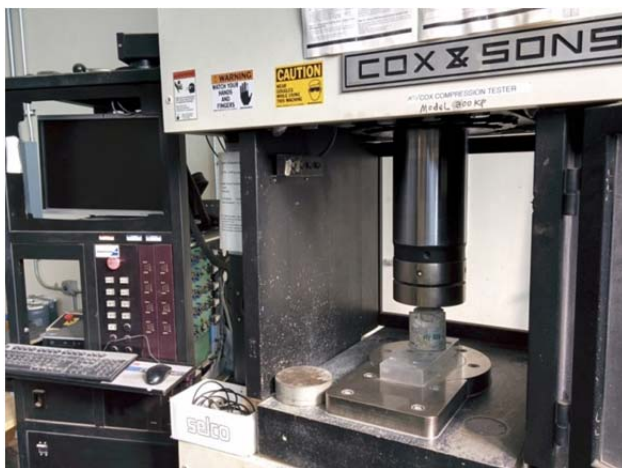
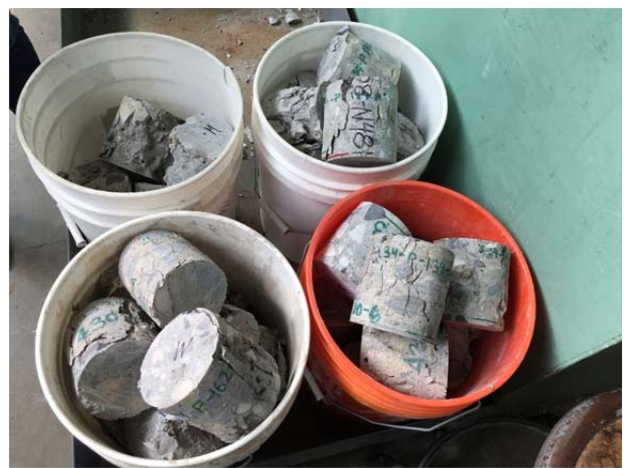
Figure 4.1: Pavement cores and strength testing.

In Task 3 of this project, 206 of the pavement cores were subjected to compressive strength testing (Figure 4.1) following ASTM C39/C39M-14a (Standard Test Method for Compressive Strength of Cylindrical Concrete Specimens) to help assess the condition of the concrete. Low strength due to microcracking is a potential indicator of ASR damage. The density of the pavement cores used for strength testing was also measured following ASTM C642-13 (Standard Test Method for Density, Absorption, and Voids in Hardened Concrete) to help determine whether any low strength values were attributable to low-density aggregate or high voids contents. The compressive strengths were also compared with those expected for concrete pavement strength based on data provided by the Caltrans Office of Structural Materials.

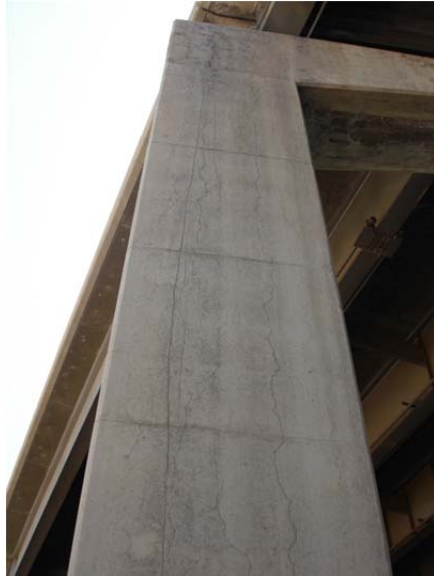
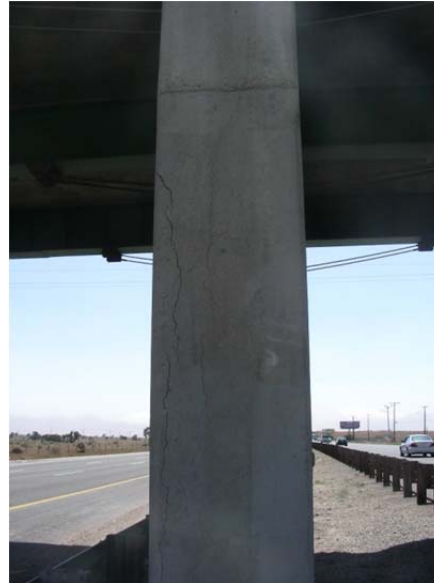
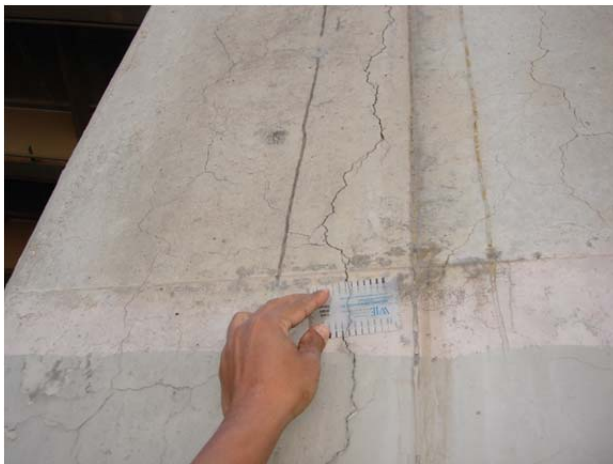
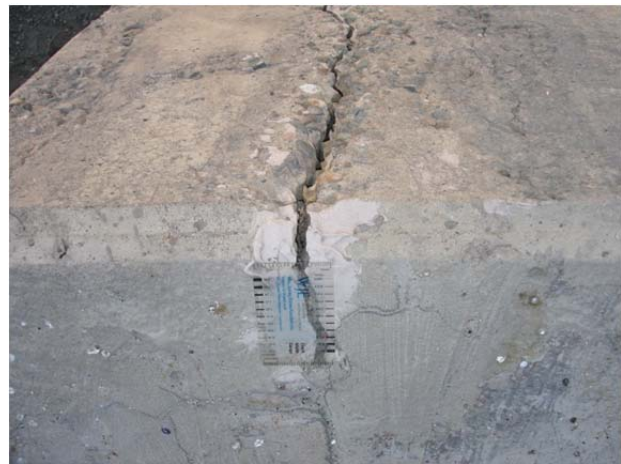
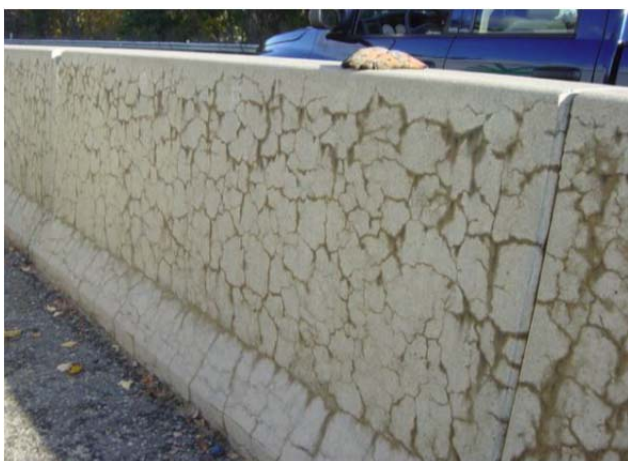
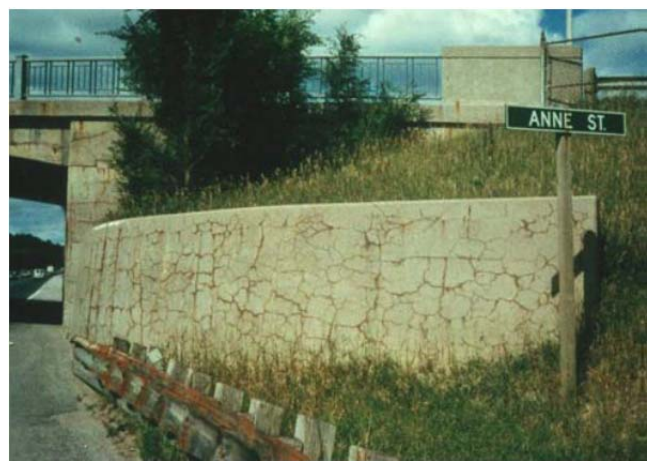
Figure A.2: Example photos showing some of the common petrographic features of ASR.

gel, and voids lined or filled with gel. Each feature should be given a weighing factor based on its association to ASR. Photos in Figure A.2 show some of the common petrographic features of ASR. The weighted features should be summed and normalized to the area examined, which will give a Damage Rating Index (DRI) value for the core slice. Additional information should be gathered regarding the presence of reacted aggregate (but not showing signs of distress), the presence of secondary mineral deposits other than ASR gel, and the physical characteristics of the concrete, such as consolidation and segregation.

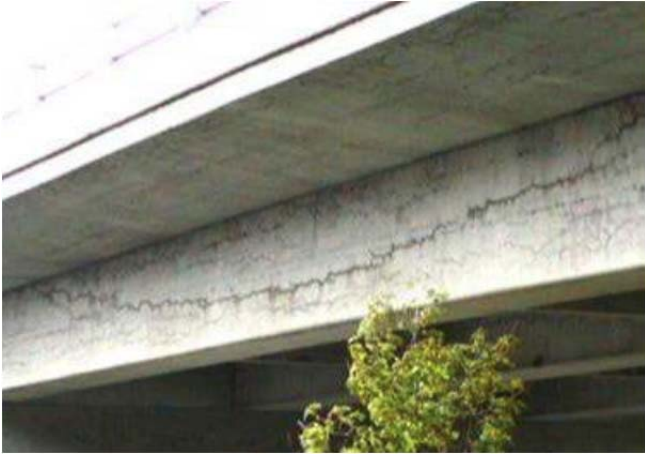
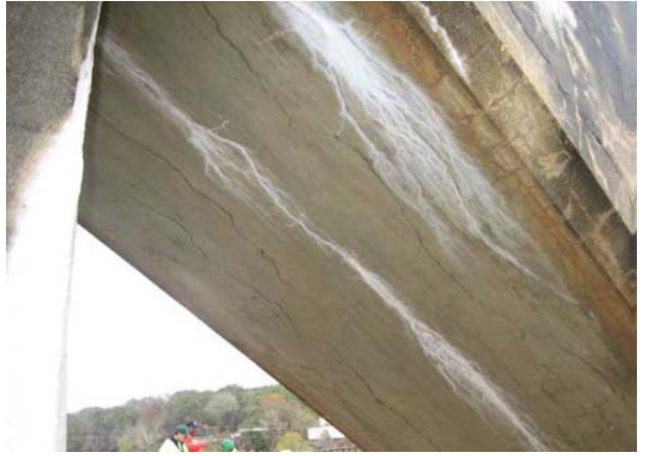
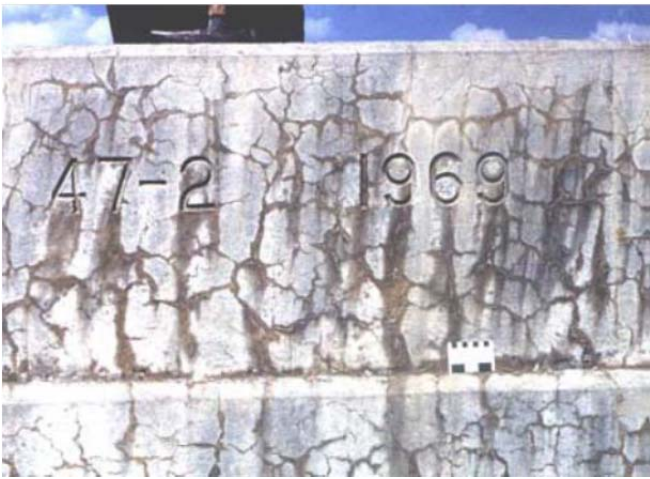
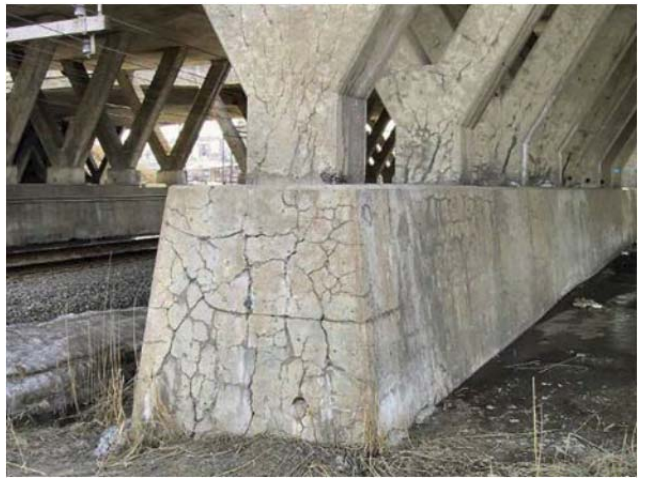
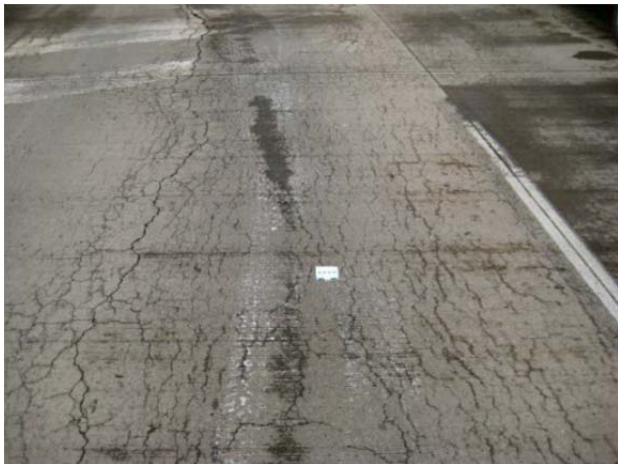
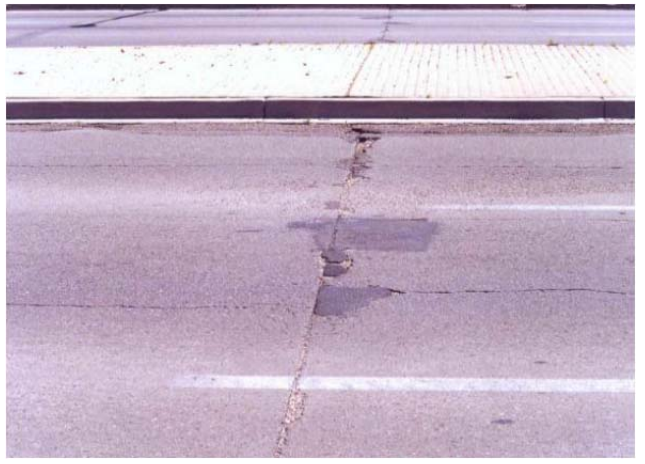
Figure A.2: Example photos showing some of the common petrographic features of ASR (*cont'd*).

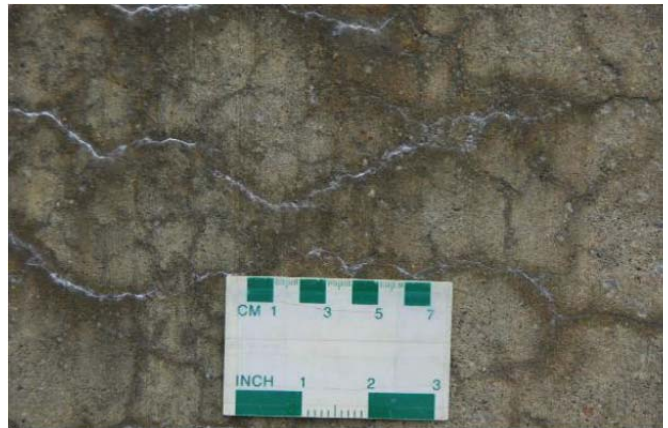
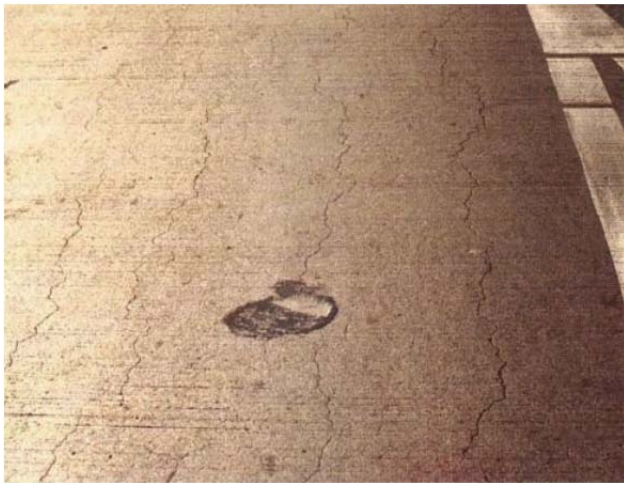
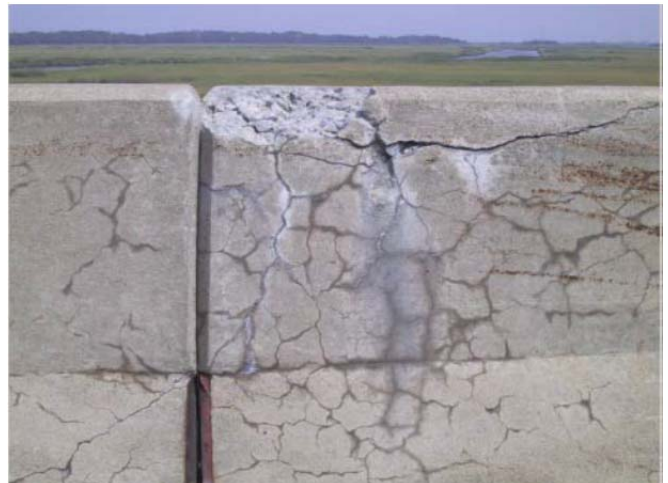
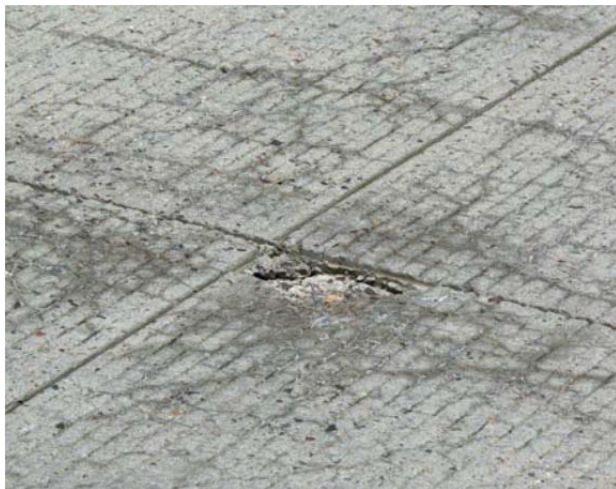
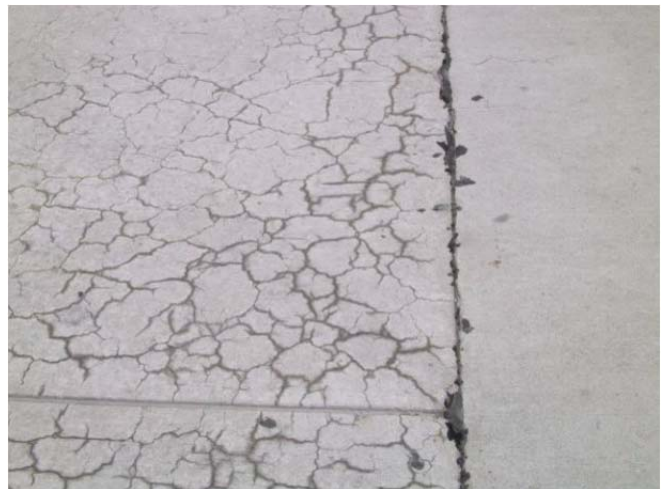
Figure A.2. Example photos showing some of the common petrographic features of ASR (cont'd).
(Some of the photos are from the reference: Thomas, M.D.A., B. Fournier, and K.J. Folliard. *Alkali-aggregate Reactivity (AAR) Facts Book*. No. FHWA-HIF-13-019. 2013.)
