Excavation and Conservation of the Early Christian Basilica, Sanctuary of Zeus, Ancient Nemea

EXCAVATION AND CONSERVATION OF THE EARLY CHRISTIAN BASILICA, SANCTUARY OF ZEUS, ANCIENT NEMEA

Stahl Research Report #40

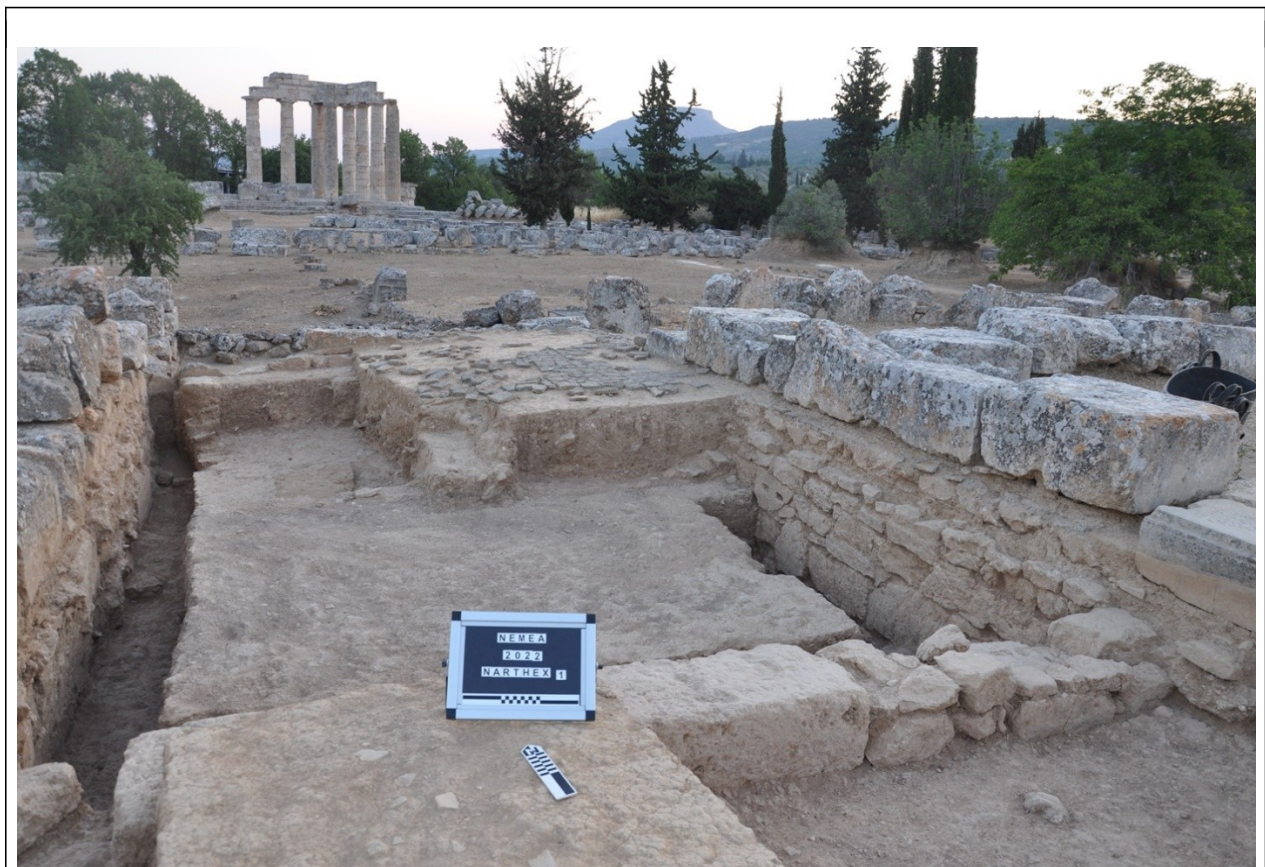
Figure 1. Architectural Features of the Early Christian Basilica

We cleared and fully documented areas that had been excavated in the 1920s by Blegen and Hill, in the 1960s by Williams, and in 1980 by Miller. We revealed the building's foundation walls, floor surfaces, and other architectural features (column/pilaster bases), including previously unrecorded interior walls belonging to the 4thc. BCE *Xenon* building on which the east wall of the narthex was founded. The ashlar temple blocks were set on a leveling course of clay and mortar, a course of small stones, and other clay level over the 4thc. masonry. The east-west central wall of the *Xenon* (so-called Telestas wall) is preserved here to a significant height as well, passing just under the threshold to the nave.

All of the foundations were digitally recorded, and the Xenon foundations were planned and drawn for the first time. Interestingly, just as the basilica walls were built of blocks “quarried” from the 4thc. temple, the interior walls of the Xenon were built using fragmentary blocks from the 6thc. temple, the foundations of which remain under the later temple. So, the 5thc. CE basilica was not simply built over the ruins of the Xenon but specifically founded on visible and well-preserved walls belonging to the 4thc. BCE building.

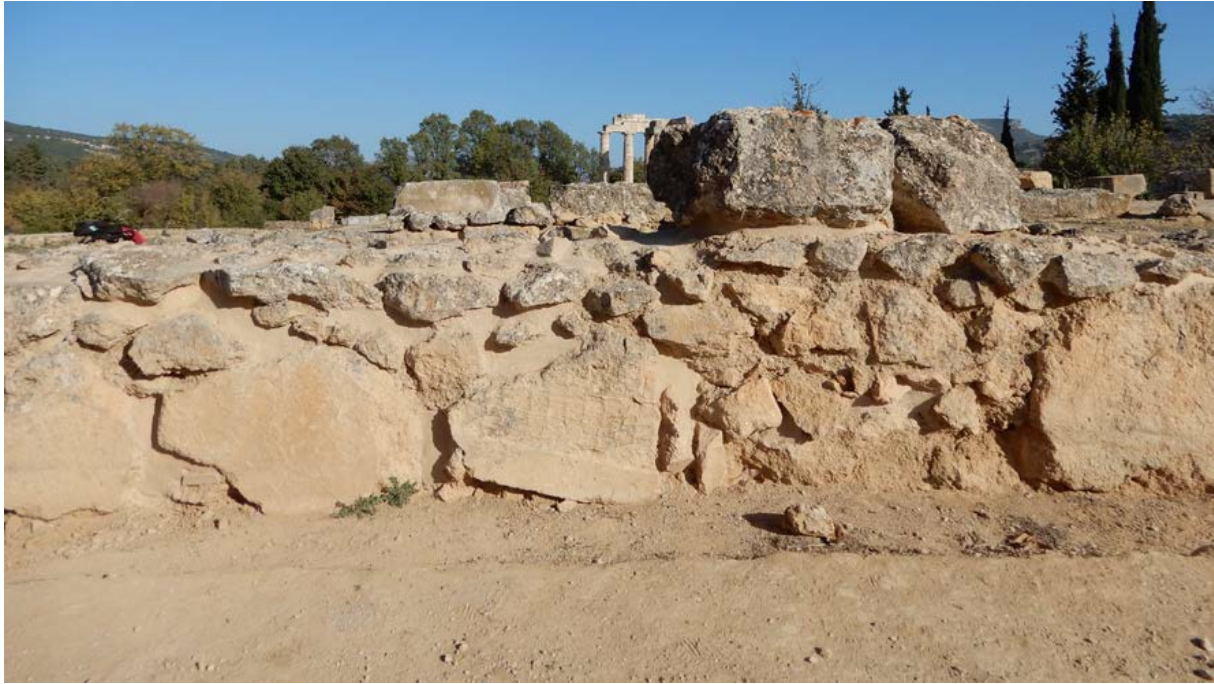
Figure 2. Basilica, S façade, post conservation

The basilica trenches were partially backfilled again at the end of the season, except where wall conservation was necessary and pending. In October, the conservation team from Lithou Syndyrisi, who had completed the study, came to Nemea. The conservation consisted of cleaning and replacing the ancient mortar in the sub-foundations, especially on the west and south facades (Figure 2), with a modern formula that will strengthen the stones and their carrying capacity. Work was completed on the interior and exterior of the NW corner, the W narthex wall, the S façade and the interior walls of Rooms 1 and 3. Once the mortar had set and dried, we backfilled the remaining open trenches in the narthex to protect the unexcavated portions and remaining tile floors of the basilica. Wherever possible, the tops of the 4thc. BCE walls were left visible along with the road surface and drain in Room 1. Those walls were stabilized also with sandbags. The remainder of the building will be reinvestigated, cleaned, and the masonry conserved in the coming seasons.
