Flat Composite Panel Impact Testing and Characterization by Ultrasonic Non-Destructive Evaluation

A Thesis submitted in partial satisfaction of the requirements
for the degree Master of Science

Structural Engineering

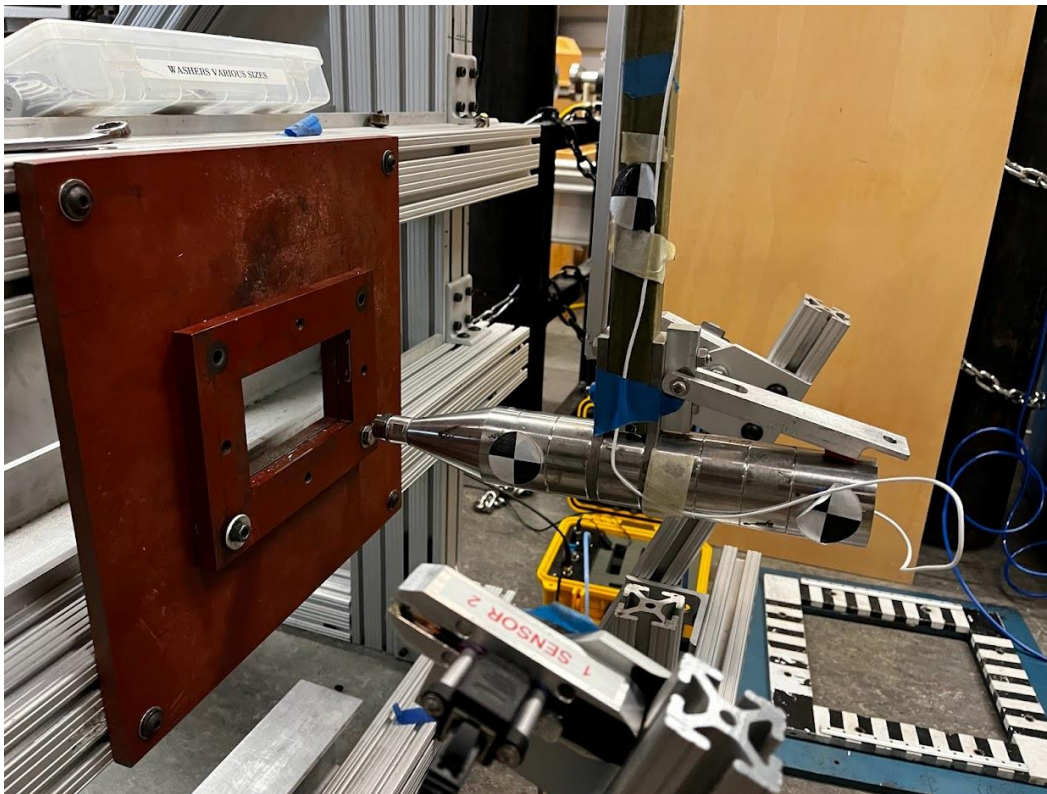
Figure 2.2: Pendulum Impactor System Set-up

impacting mass. The fixture plates, as well as the laser photogate, pendulum tip mass, and the end of the pendulum arm can be seen in Figure 2.2.

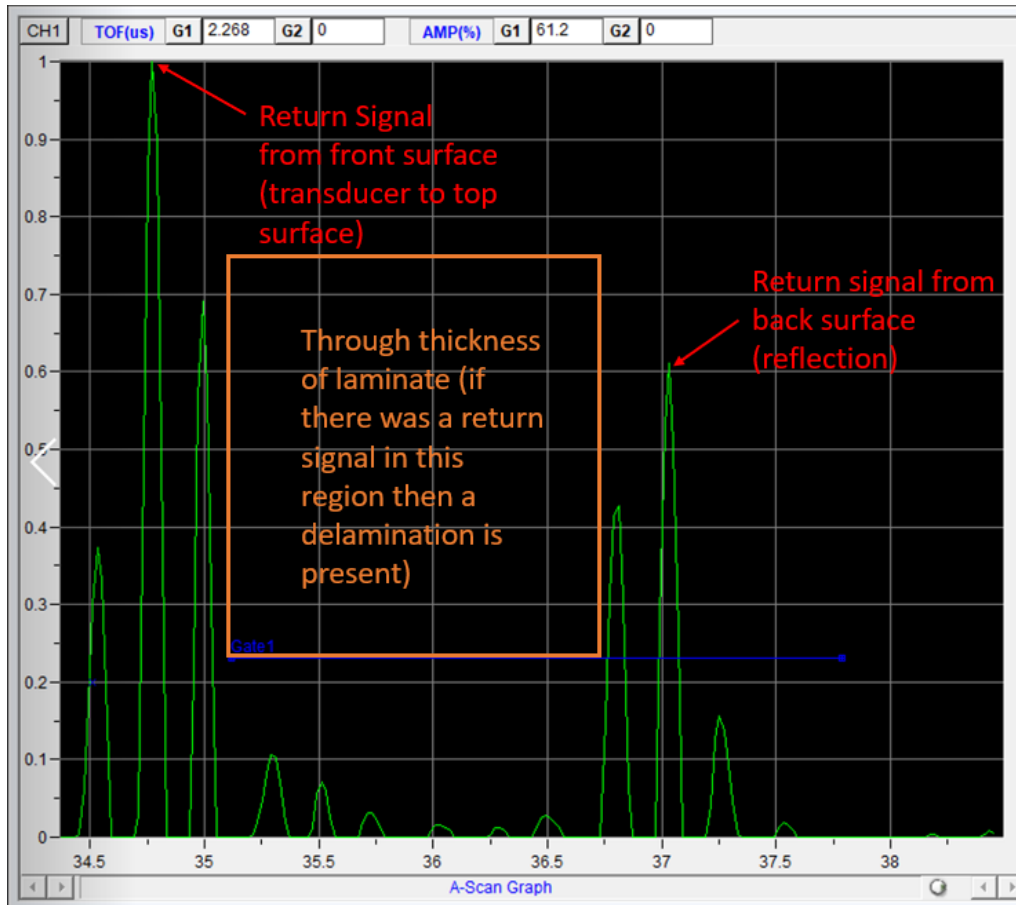
Figure 2.7: Reference Waveform from A-scan, the gate alerts the user (and the software) if there is a significant (>50%) signal return earlier than the reference return peak. If a reflection returns within the orange boxed area and has an amplitude greater than 50% of the pristine region reflection, then this is a location of damage.

The ability to detect the damage perimeter was due to the signal from the transducer returning at an earlier time of flight (TOF) than in the reference waveform. The user would mark the point on the specimen where this damage perimeter was observed and then shift to a different section of the specimen to characterize the shape of the damage. Once enough damage perimeter dots had been marked onto a single specimen to properly identify the overall shape of the delamination zone, the dots were connected. Figure 2.8 shows an example of a specimen that had been A-scanned with the method described. The in depth A-scan procedure can be found in the Appendix II.

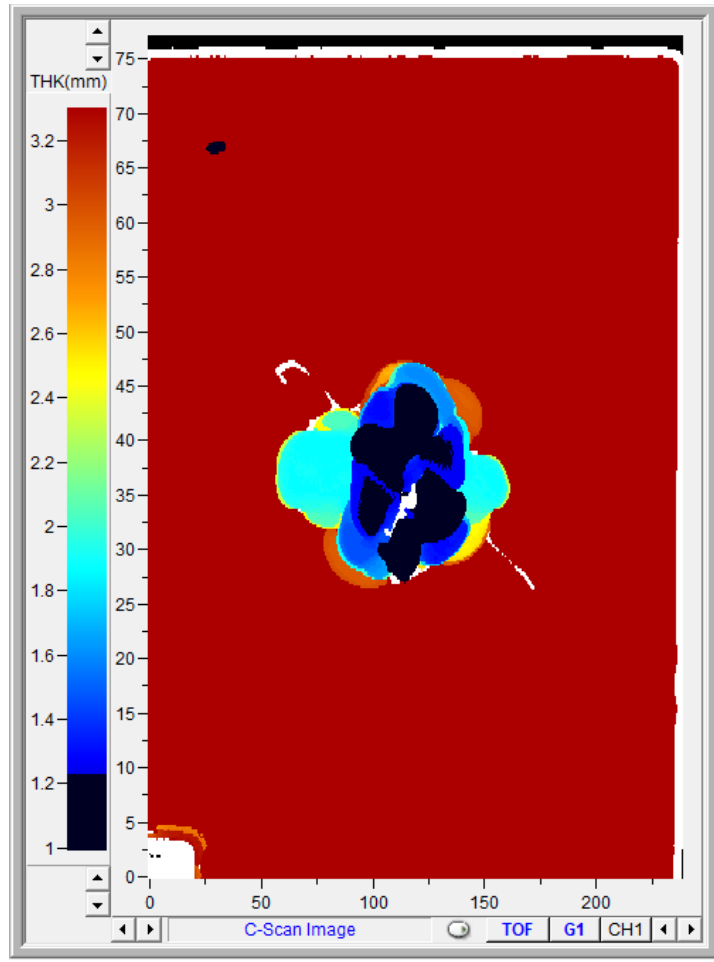
Figure 2.17: C-Scan Image of a 20 J Impacted Hard Laminate.

With the material velocity known, and the scan set up completed, a C-scan like that seen in Figure 2.17 could be obtained for each specimen. Figure 2.17 shows the C-scan of the specimen shown in Figure 2.8, the A-scan and C-scan can be seen to have similar characteristics on the perimeter, but with the C-scan contour plot is much more useful for understanding the extent of the damage through the thickness of the specimen since the color scale shown provides information about the depth of the delaminations (note: background dark red is 3.3 mm panel thickness in undamaged zones).

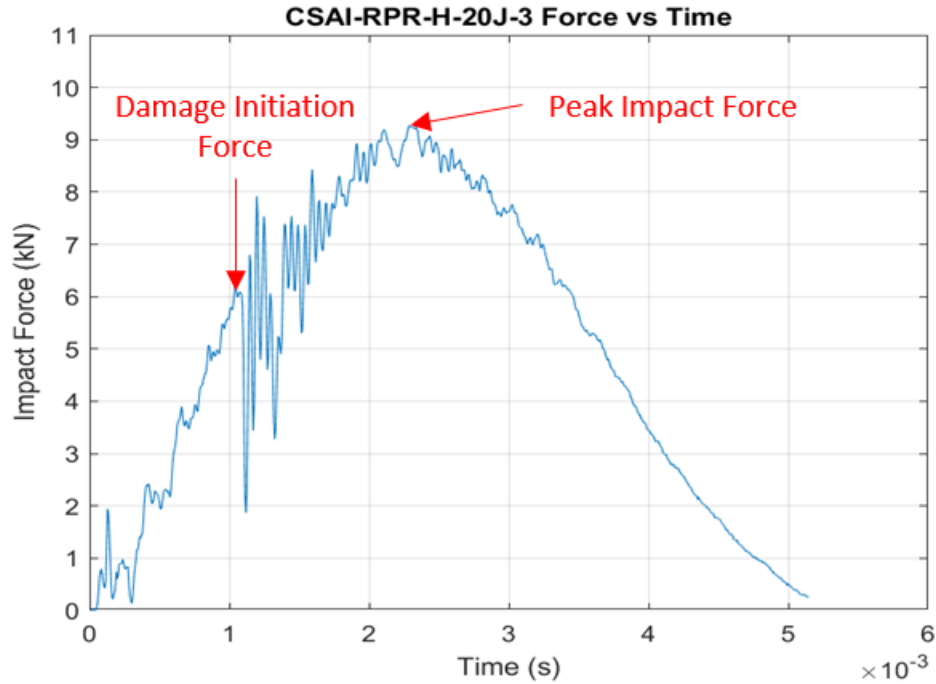
Figure 3.1: Location of Damage Initiation Force and Peak Impact Force Magnitude.

As discussed in Section 2.1, the 81 specimens were impacted at varying energy levels using a pendulum impactor system. The data from the impact event was recorded with a Picoscope data acquisition system (DAQ). The data that the Picoscope DAQ collected included the impact force data from a force sensor equipped on the pendulum arm tip mass, as well as the time data of the impact event from a laser photogate that recorded the pendulum arm swinging into and bouncing back from the impact event. From this data, force versus time plots were created for each impact event. Figure 3.1 shows the force versus time plot for one of the specimens. This plot has been annotated to call out the location where damage is initiated in the specimen, as well as the peak impact force. The damage initiation is identified as the highest force value developed before a major drop in the force magnitude occurs, which is then followed by significant oscillations (noise/ringing of the sensor). This drop is due to the specimen becoming damaged (delamination, cracking, etc.) which causes a loss in force magnitude as the specimen deforms locally and complies with the impactor.

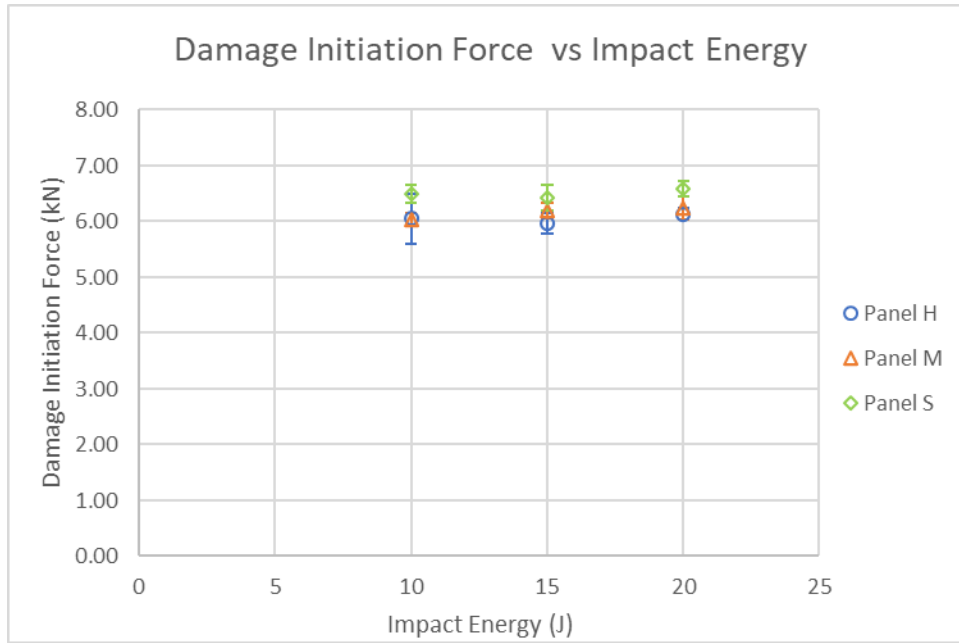
Figure 3.8: Damage Initiation Force Versus Impact Energy Level for all Specimens.

higher in Panel S than it is in panels M and H. Interestingly, it can be seen that there is an inverse relationship between damage initiation force and peak impact force for Panel S. Panel S, as previously stated, has a higher damage initiation force when compared to the other panel types. The difference in damage initiation force can be attributed to the difference in fiber orientation that the panel types have. Panel S is comprised of 16% 0° plies, 64% ±45° plies, and 20% 90° plies. The amount of 90° plies present in the Panel S layup greatly exceeds those found in the Panel H and Panel M layups (both contain only 4% 90° plies). This large difference in 90° plies is the main driver in why Panel S has a higher damage initiation force. Since the impact event occurs in the center of the specimen, and the specimen is constrained along each edge, the increase in 90° plies gives Panel S increased stiffness in the short direction of the specimen (the long edge of each specimen is the 0° direction). By having 16% more 90° plies, the loading from the impact event is able to transfer to the clamped constraints that are on the short edge following the load path of the 90° plies, thus Panel S has the advantage of utilizing the boundary conditions that are closer to the impact epicenter more effectively than Panel M and Panel H. The average damage initiation force with error bars for each panel and impact energy are plotted in Figure 3.8. The damage initiation force is found to be mostly insensitive to impact energy, as the forces developed during the impact event reaches the critical level for all energies investigated. This figure further shows that Panel S has the highest damage initiation force across all 27 specimens at each energy level. The plot also shows that Panels H and M are very similar but Panel H has slightly lower damage initiation forces than Panel M.

An additional reason for the higher damage initiation force in Panel S is that the interlaminar shear strength (ILSS) of Panel S is higher than that of Panel H and Panel M due to the stacking sequence of the plies around the midplane of the laminate. It has been found that as the fiber orientation directly surrounding the midplane of the laminate varies from 0° to 90° there is a decrease in ILSS in the laminate [14]. In all three panel types, the midplane ply has a fiber orientation of 90° . The midplane is the location of maximum shear stress in the laminate, since the midplane fiber direction is 90° and that corresponds with the shortest path to the edge constraints, this 90° direction can be characterized as our primary load path in the laminates during impact. The midplane ply as well as the plies directly above and below that ply, are the critical plies in the laminate for shear stress related failures. Looking at the fiber orientations of the ply at the midplane of the laminate, as well as the plies above and below it, the following three-ply stack sequences are attained for each panel (H, M, and S): $[0/90/0]$, $[-45/90/-45]$, and $[90/90/90]$, respectively. Panel S has a 0° change in fiber orientation from midplane to the

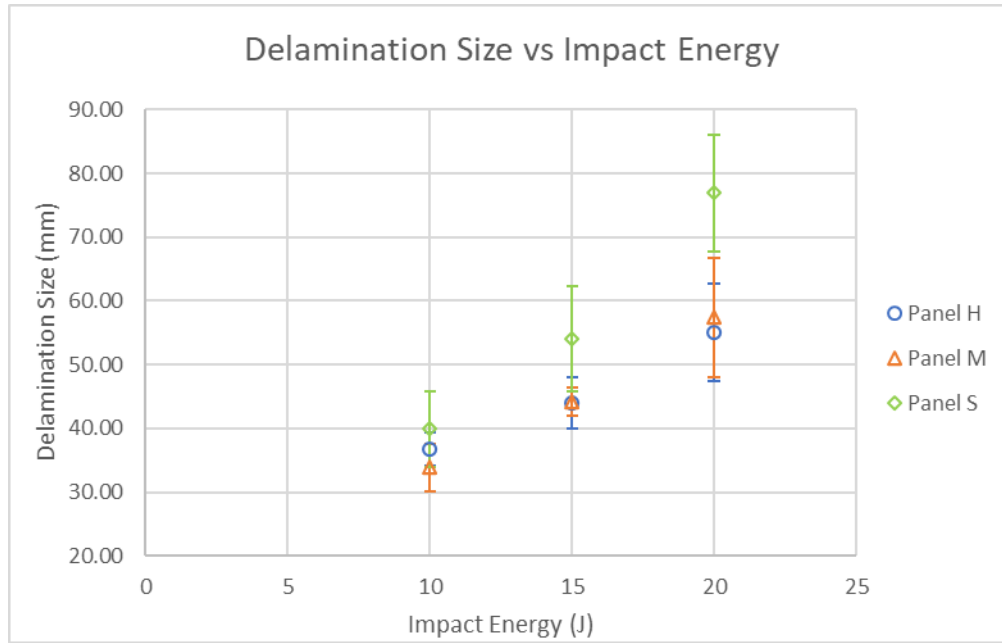
Figure 3.9: Delamination Size Versus Impact Energy Level for all Specimens.

The force required to initiate damage was highest in Panel S, due to this the damage size of the internal delaminations were also largest in Panel S. As seen in Figure 3.9, across the three impact energy levels Panel S has the largest damage sizes, with Panel M and Panel H competing for smallest delamination size. The delamination size of each specimen was determined by measuring the longest length between edges of the delamination perimeter per the hand-mapped ultrasonic A-scan, as discussed in Chapter 2.

The delamination sizes of Panels H, M, and S seem to follow a similar trend as the damage initiation for each, the damage size is related to the damage initiation force magnitude. Panel S has the largest delamination sizes because of the damage initiation force being larger in that Panel than the other panels. This causes larger delaminations because there is more strain energy stored in the panel before damage occurs which causes a more catastrophic delamination once damage is initiated because there is more strain energy in the system to be released. The normalized amount of energy absorbed in the three panels across the three energy levels can be seen in Figure 3.10. Normalization is done by dividing the absorbed energy by the incoming projectile impact energy. It can be seen for all three impact energies that the amount of energy absorbed from the impact is about half of the incoming energy. This energy is absorbed into the panel via the damage spreading through the specimen during impact. Similar to the delamination size plot, Panel S has the most energy absorbed in the impact event, with panel M and Panel H once again having very similar results.

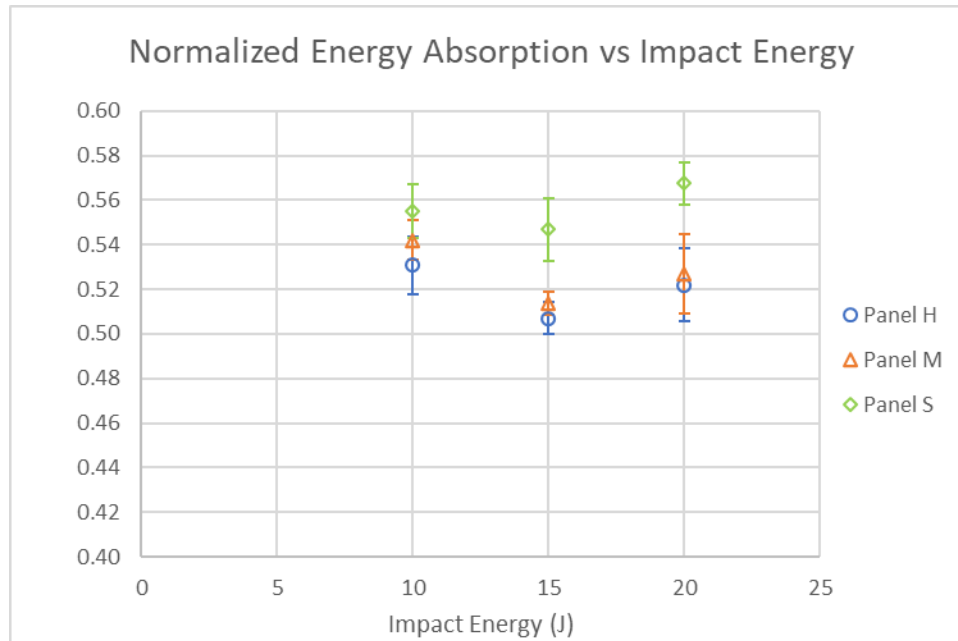
Figure 3.10: Normalized Energy Absorption Versus Impact Energy Level for all Specimens.

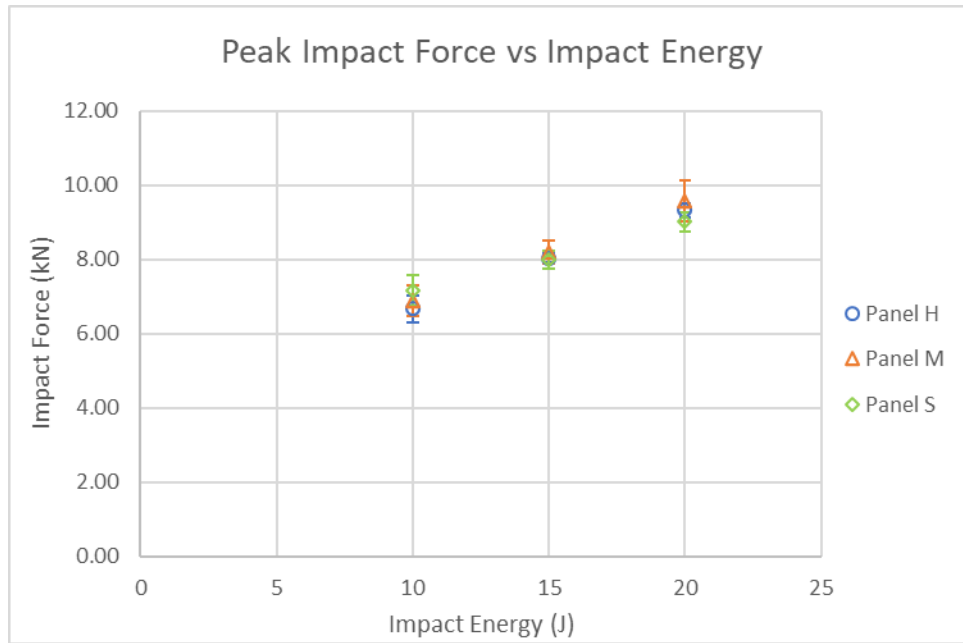
Figure 3.11: Peak Impact Force Versus Impact Energy Level for all Specimens.

Along with the force magnitude at the point of damage initiation being recorded, the peak impact force for each specimen was also recorded. Surprisingly, Panel S had the lowest peak impact force of the three panels in the 15 and 20 J impacts. While this seems unanticipated since Panel S had the highest damage initiation force across all panel types, as well as the largest delamination sizes and most energy absorption, it actually makes sense that the peak force drops when compared to Panels M and H. The peak force in Panel S drops in the 15 and 20 J impacts because once the damage is initiated the laminate experiences more extensive damage than the other two panel types, this extensive spread of damage does not allow the force to climb as high as is seen in Panels M and H.

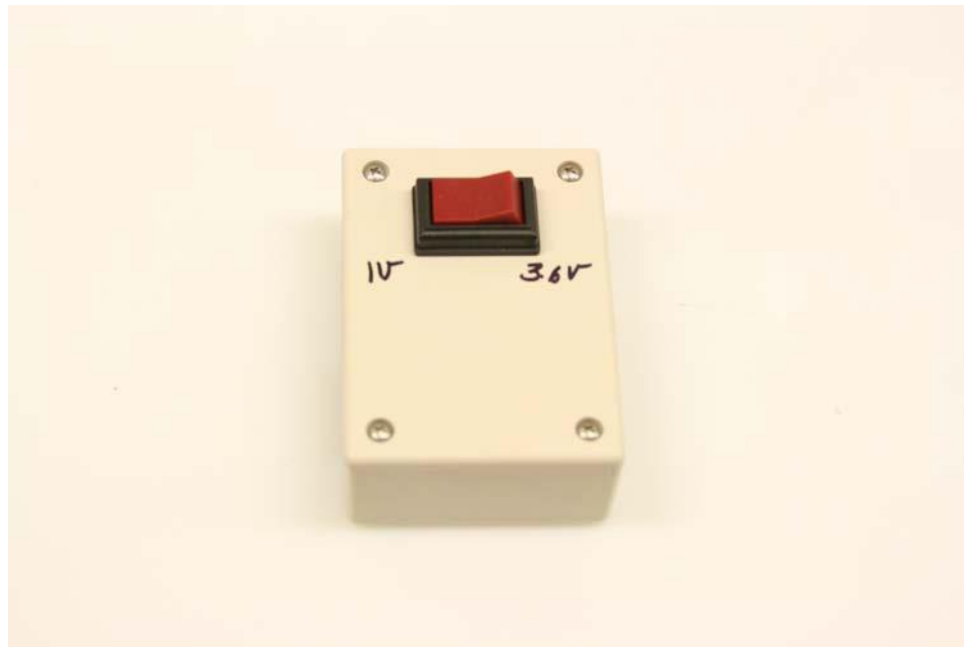
Figure A.1: Position Output Voltage Switch.

1. Set position output switch to “1V”
