**SEISMIC RESPONSE OF LIGHTWEIGHT CONCRETE PANELS
WITH FRICTION-BASED ENERGY DISSIPATORS**

**Report No. UCB/SEMM-97/17
Structural Engineering, Mechanics and Materials
Department of Civil & Environmental Engineering
University of California at Berkeley**

December 1997

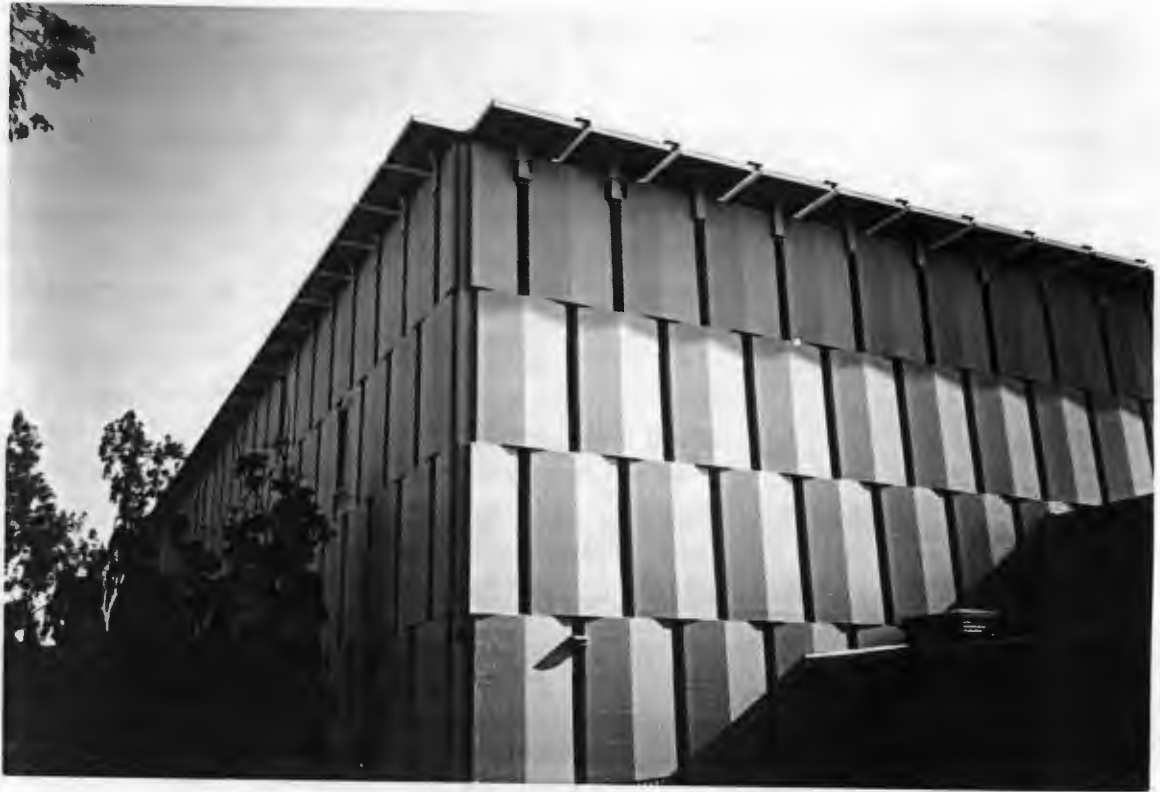
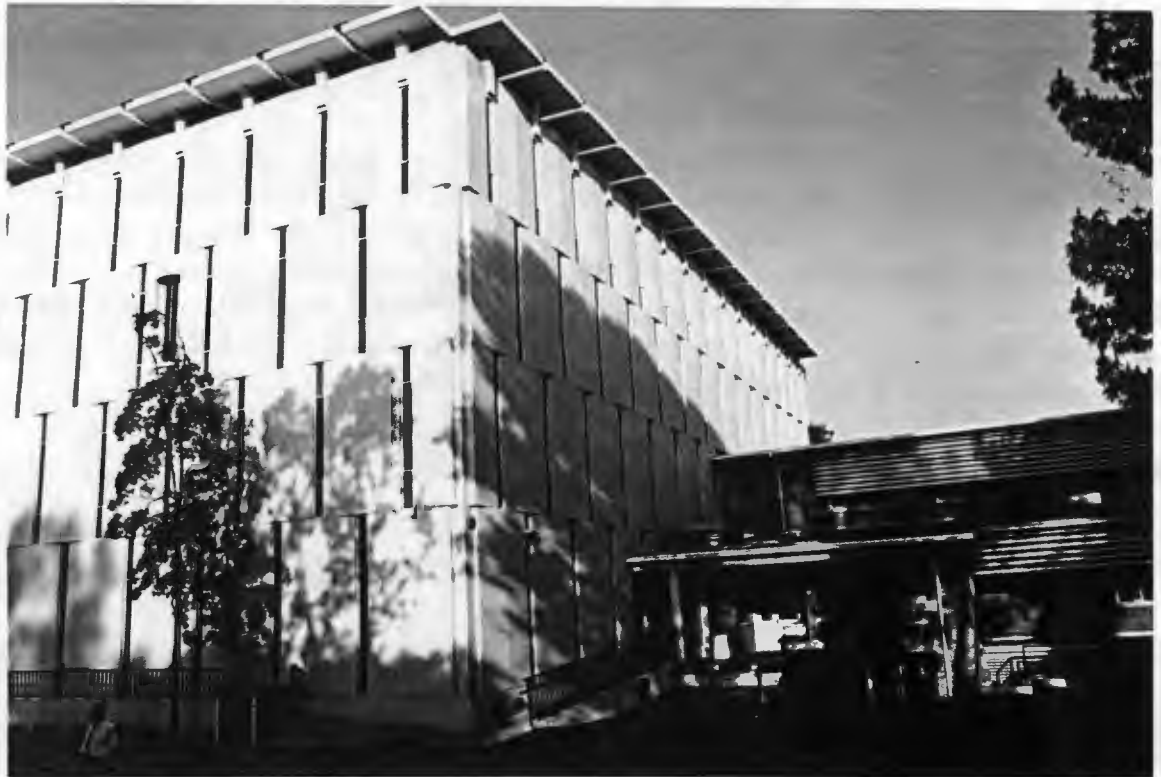
Figure 1.1. Pictures of the Rivera Library of the University of California at Riverside (UCR)

The UCR Rivera Library is a 4-story building clad with precast lightweight concrete panels (Fig. 1.1). As part of the seismic retrofit program of the library, it is proposed that the exterior panels be connected to the structure with friction-based energy dissipating. These dissipators, also known as slotted bolted connections, have shown in the laboratory excellent energy dissipation characteristics [1]. Figure 1.2 presents drawings prepared by Nabih Youssef and Associates showing the main features of the proposed system. Each precast panel will be connected to the bottom floor with bolted steel connectors. Three energy dissipators will be bolted near the top of each panel and to the beam of the corresponding top floor. It is expected that the relative motion between adjacent floors due to seismic excitations will activate the dissipators.

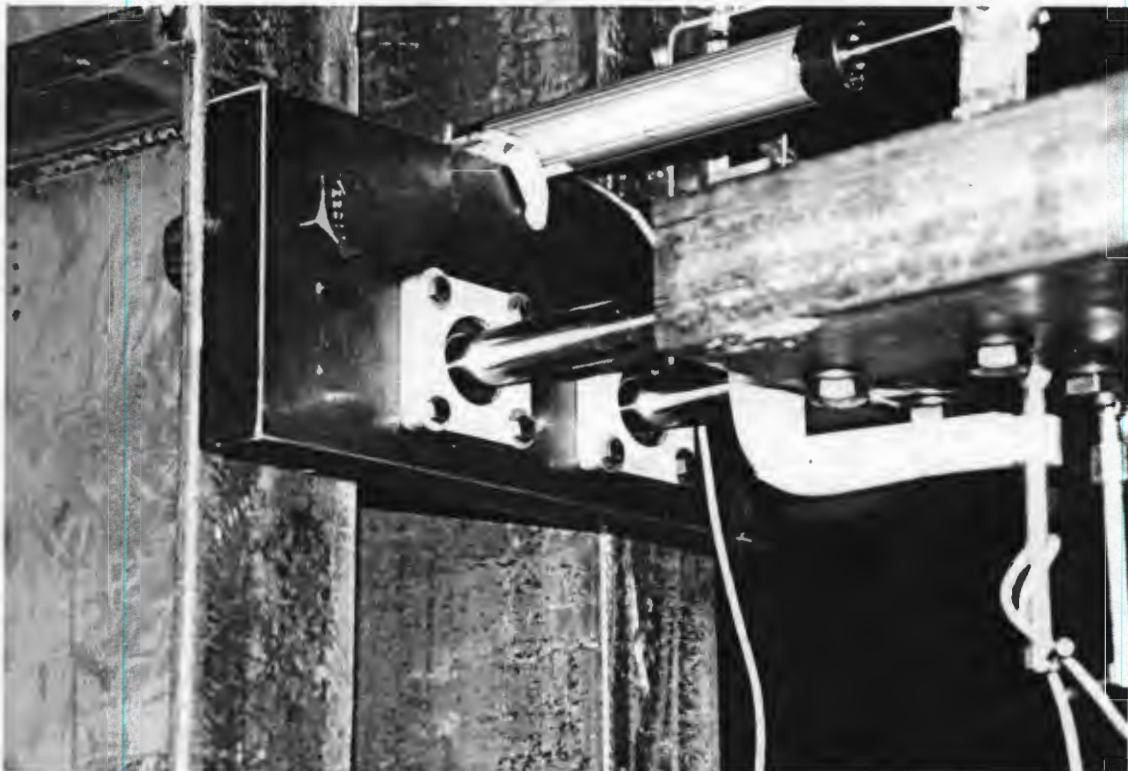
Figure 2.3. (a) Dynamic actuator, (b) Low friction linear bearings

A servohydraulic dynamic actuator applied the simulated seismic motions to the system. The actuator was connected to a steel loading carriage, which represented the top beam of the building (Fig. 2.3-a). The carriage was restricted to move only horizontally, parallel to the panel. This was achieved by installing two steel shafts at each end of the carriage, which ran through low friction linear bearings (Fig. 2.3-b). The loading thus provided significant excitation to the panel-dissipation system only along its main horizontal relative motion direction.

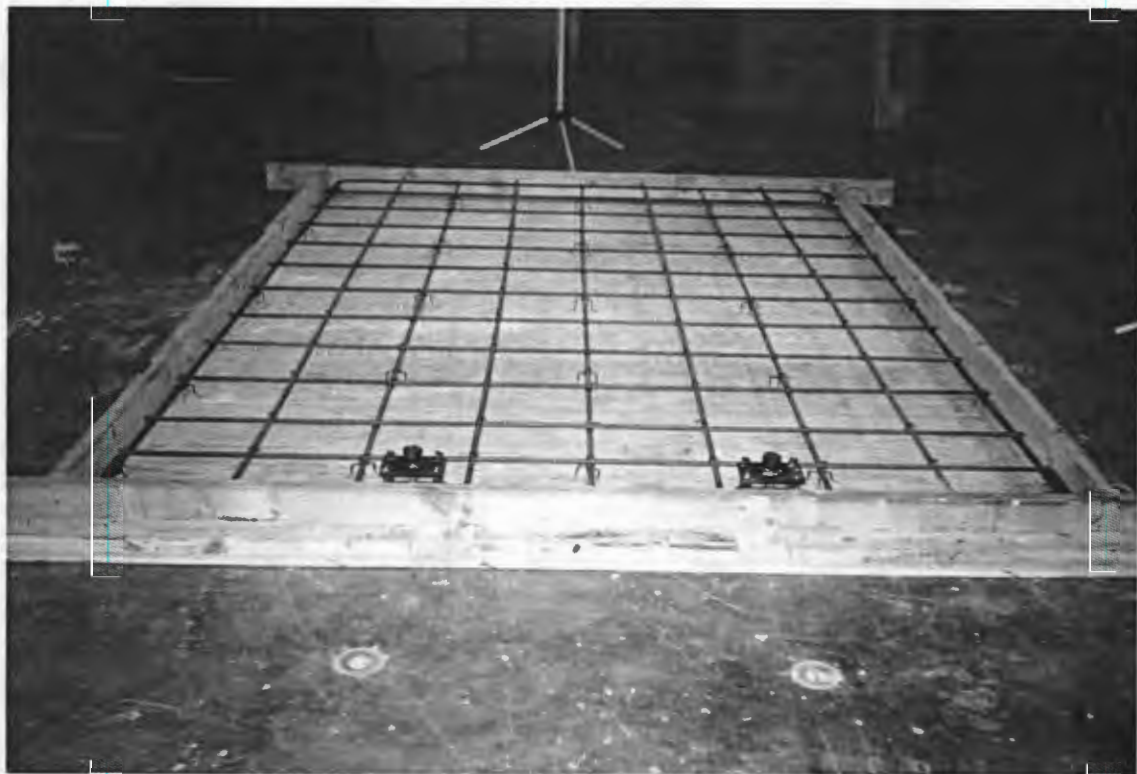
Figure 3.2. Panel formwork and reinforcement

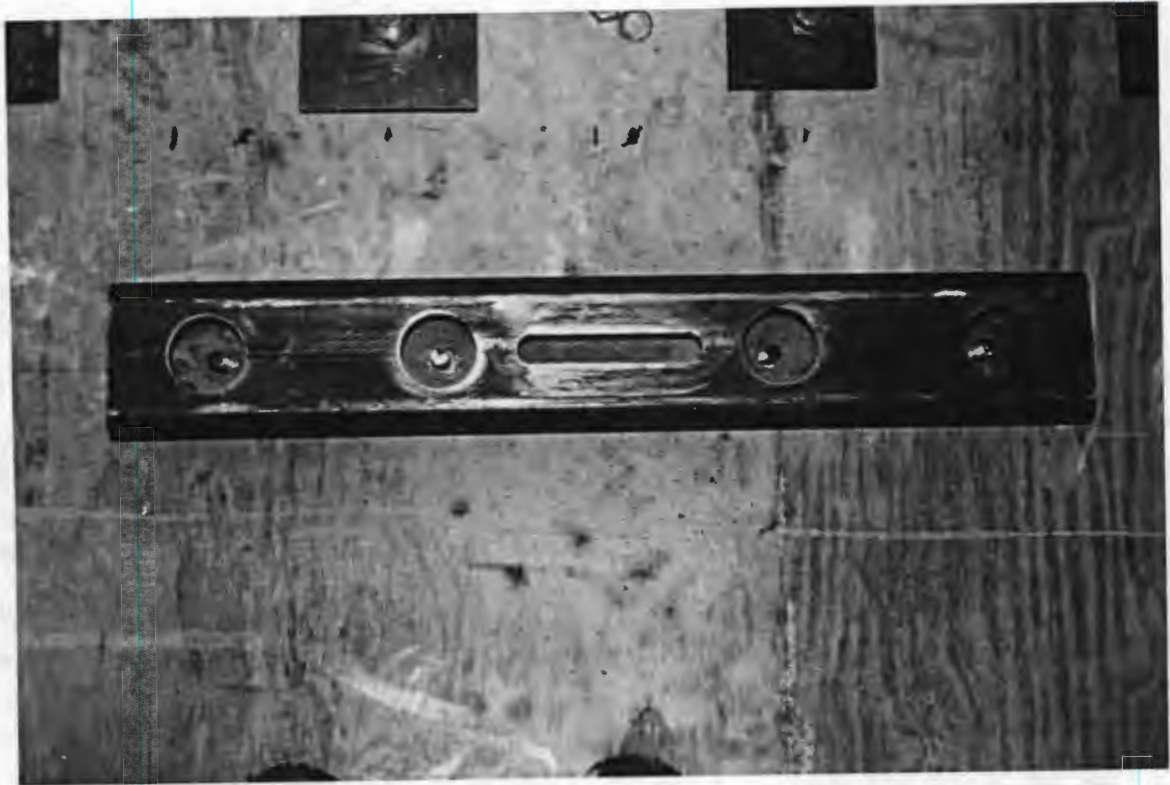
Figure 4.4 (a) Steel tube, (b) Steel angel

Figure 4.4-a shows the slotted steel tube mounted on the panel. Notice the access slots. An assembled dissipator is shown in Fig. 4.4-b. A displacement transducer is also shown.

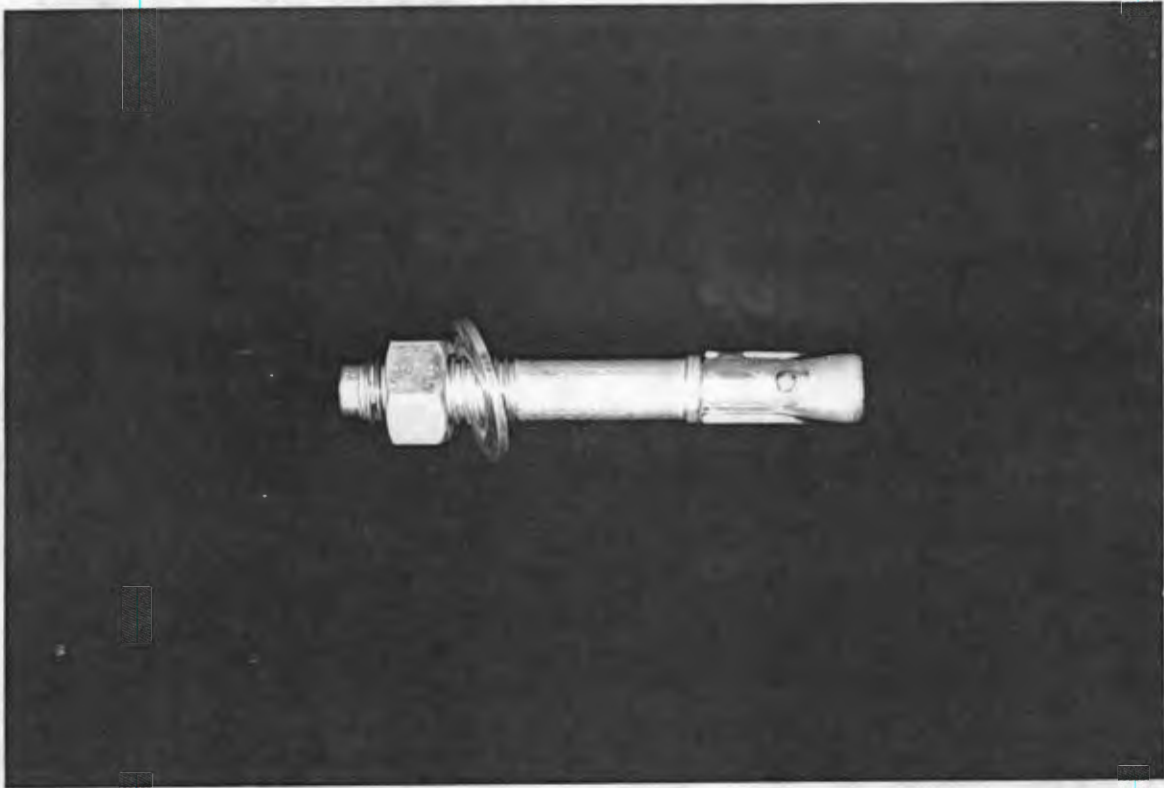
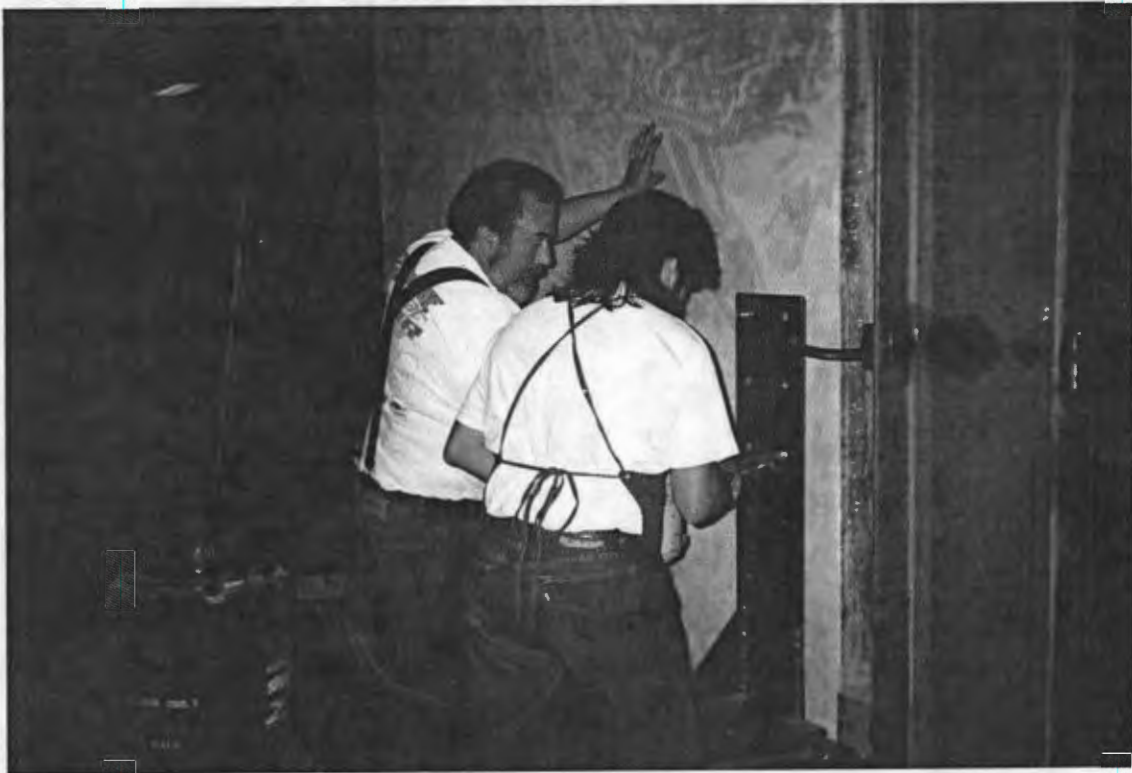
Figure 5.1. (a) Hilti Kwik Anchor Bolt, (b) Bolt installation at the bottom support

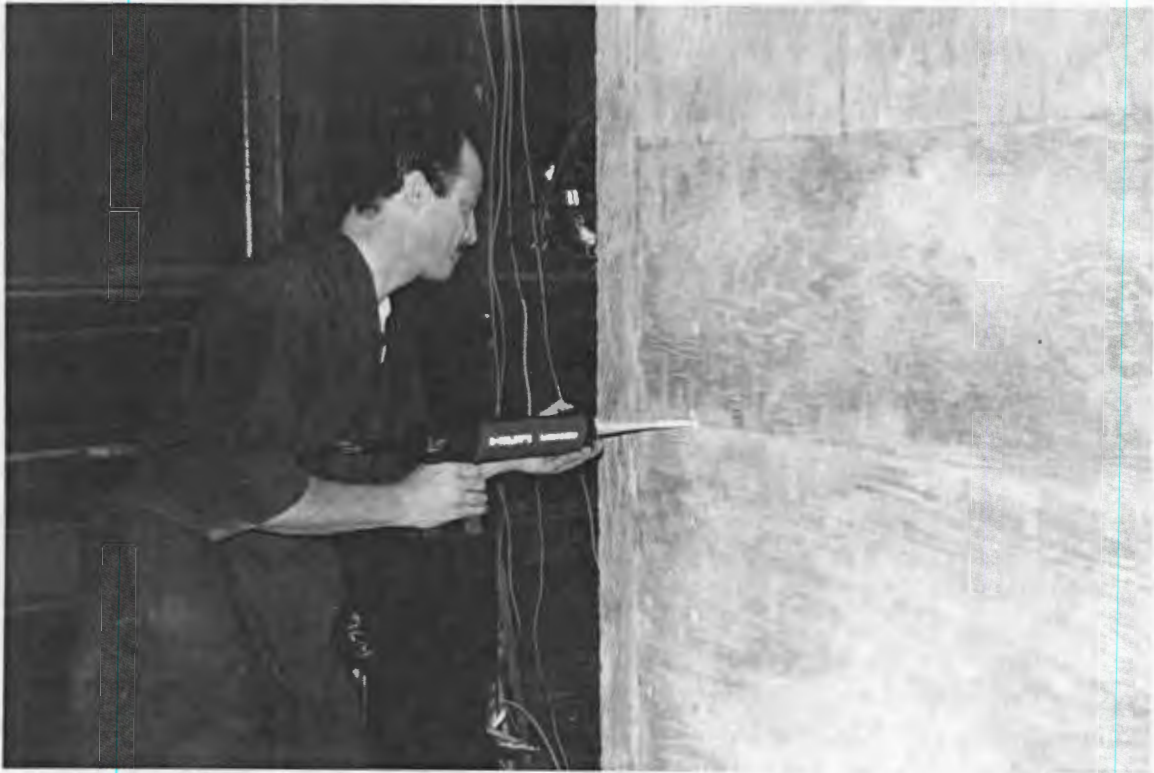
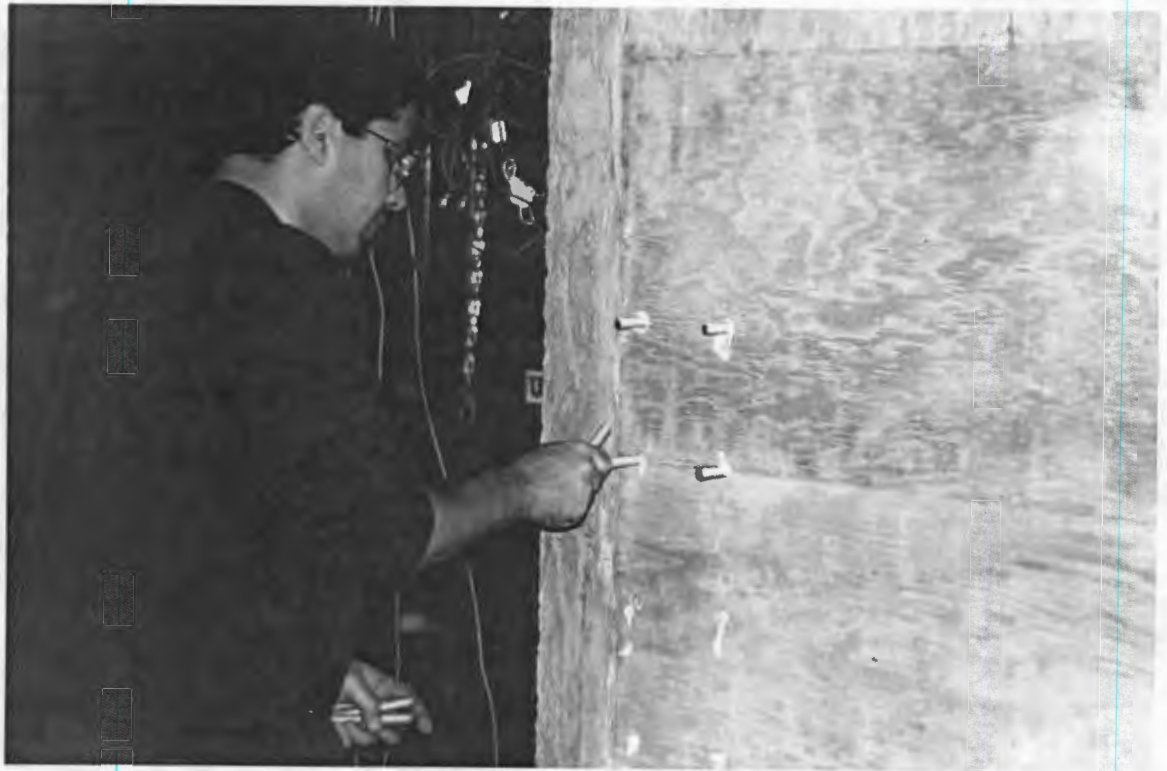
Figure 5.3. Installation of Hilti Hit HY-150 at the bottom support:
(a) injection of the epoxy, (b) installation of the studs

To limit the rocking response, a new type of anchorage, Hilti Hit HY-150 Adhesive Anchor System, was used. These bolts, shown in Fig. 5.2-a, also require a hole to be pre-drilled in the concrete. Epoxy is injected inside the hole with a special tool, and then the bolts are inserted in the holes. The energy dissipating devices were anchored to the panel while the panel was in a horizontal position, lying down on the floor (Fig. 5.2-b). The base supports were connected to the panel while the panel was in place in a vertical position. Since the anchor bolt heads could not go through the over-sized holes provided in the steel supports, the studs were epoxied in the pre-drilled holes and then the supports were fit in place. (The diameter of the studs was $\frac{1}{2}$ " and the holes were $\frac{9}{16}$ " in diameter.) To do this process fast enough to prevent hardening of the epoxy before adjusting the supports, one person filled the holes with the epoxy and another person installed the anchor bolts (Figs. 5.3-a and 5.3-b).

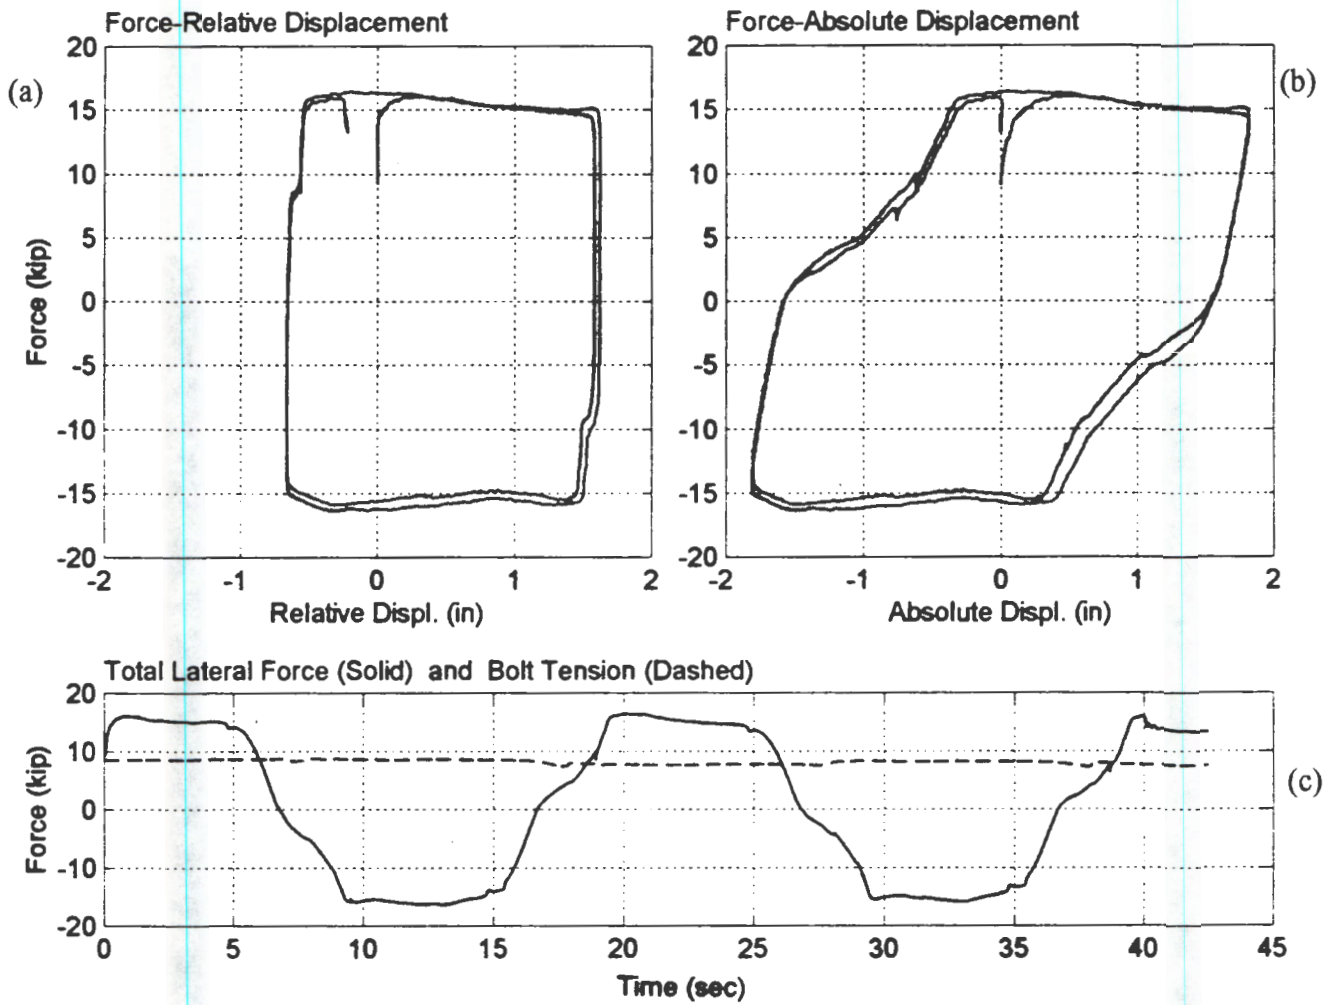
UCR Rivera Library--Test No. 9 Anchorage A Three Devices (T=150 ft-lbs)
Harmonic Motion (0.05 Hz, 1.8 in) File: 06041214.txt

Figure 7.6 Test results

To increase the sliding load of the connectors, the bolts were tightened with a torque of 150 ft-lbs, and the system was tested again (Test No. 9). The lateral load was increased to about 17 kips, as shown in Fig. 7.6. The tension in the bolts was 8.5 kips; therefore the coefficient of friction was now about 0.35. This increase in the coefficient of friction was probably due to wear in the washers and the steel contact surfaces. During this test the panel cracked due to the high shear load applied by the energy dissipators (Fig. 7.7).

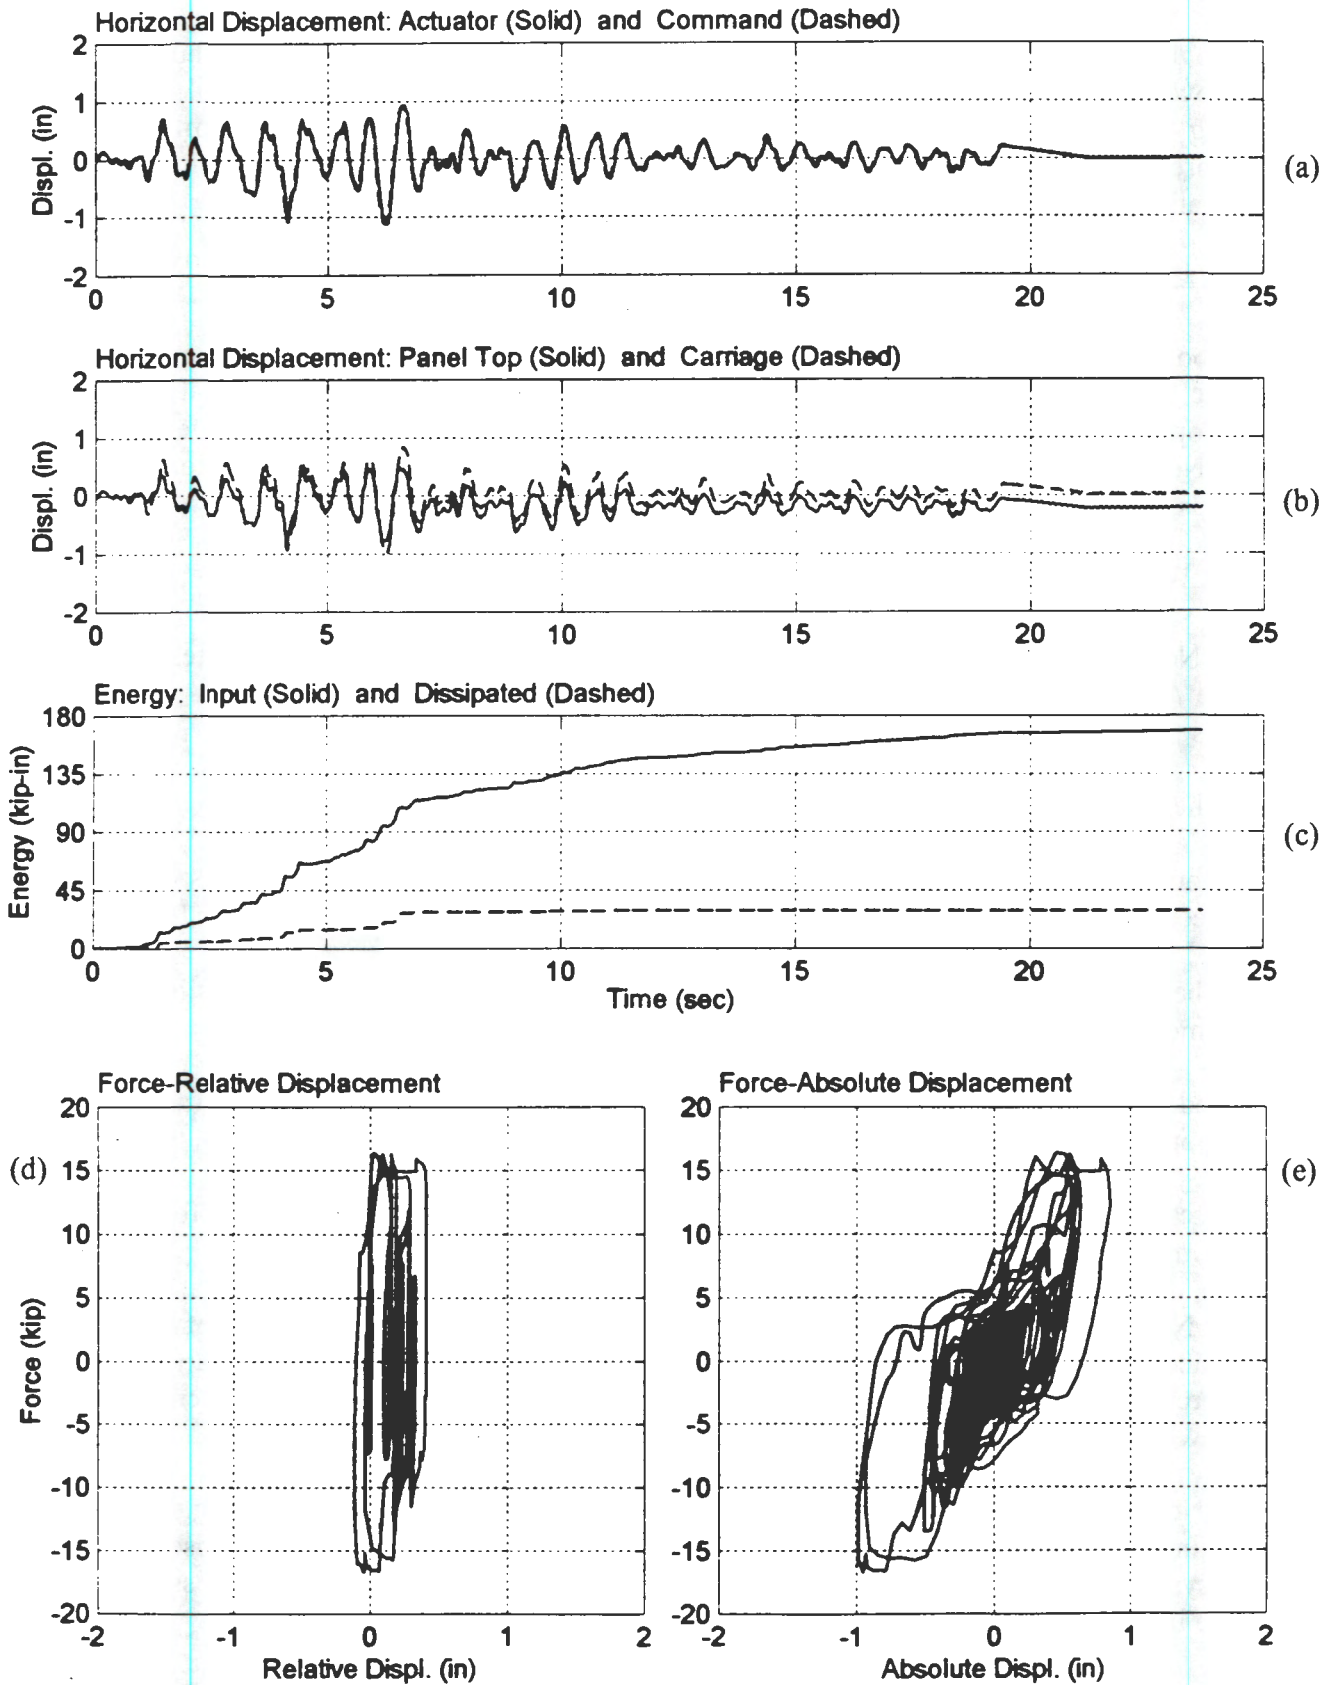
UCR Rivera Library—Test No. 11 Anchorage A Three Devices (T=100 ft-lbs)
 Seismic Motion (Max. Ampl.=1.1 in) File: 06101117.txt

Figure 7.9 Test results

Test No. 11 was a simulated earthquake motion with amplitude of 1.11 inches. Significant rocking of the panel was observed during the test. Figure 7.9 summarizes the results obtained:

The main reason for the limited energy dissipation performance of the system was the excessive rocking of the panel due to the flexibility of the connections between the base supports and the panel. Looking at Fig. 7-9-b, the max top displacement of the panel is about 0.8", while the maximum input displacement is only 1.1". This top displacement was mainly caused by the rocking of the panel, i.e. by the relative displacement between the panel and the bottom supports. This rocking motion prevented the effective sliding motion of the moving components of the dissipator. The contribution of the panel to the lateral top displacement is insignificant. Therefore it was concluded that the anchorage system needed to be redesigned.

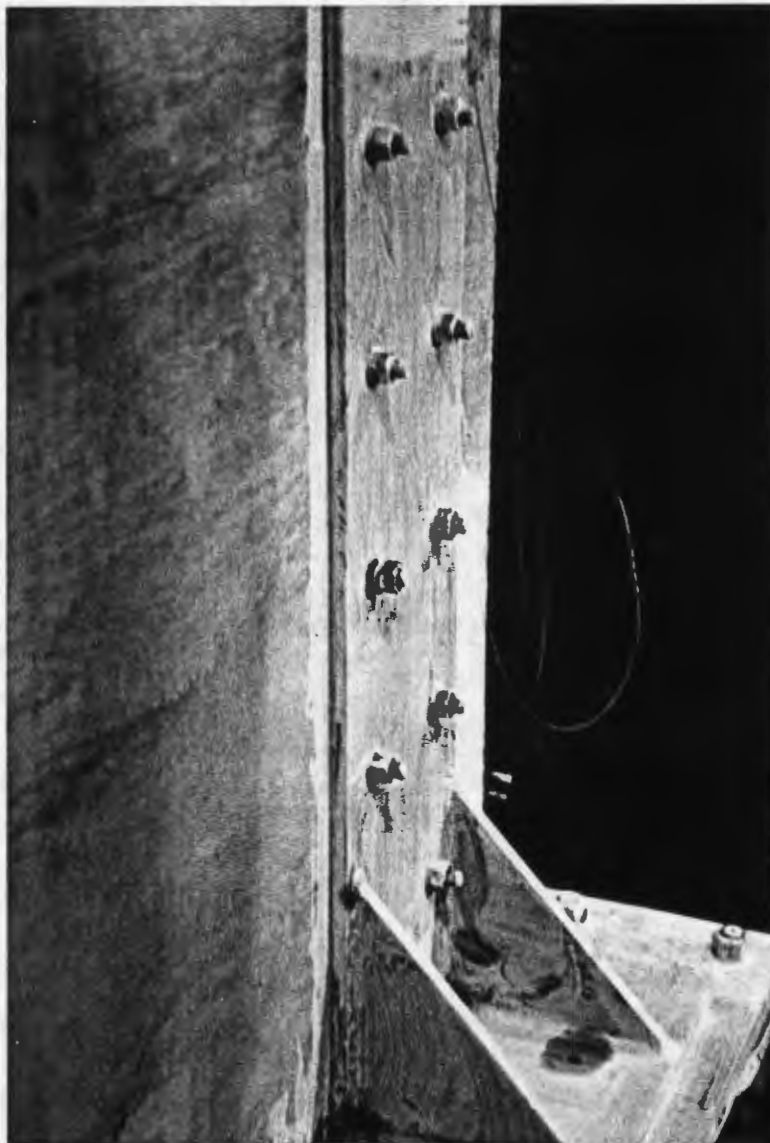
Figure 7.14. Some nuts loosened up after test no. 18

Test No. 18 was a severe harmonic motion, with eleven 1.8-in cycles at 1.5 Hz (Fig. 7.13). Panel cracking increased significantly and some nuts from the base support became loose (Fig. 7.14). The system showed excellent energy dissipation characteristics during this test, dissipating 90% of the input energy.

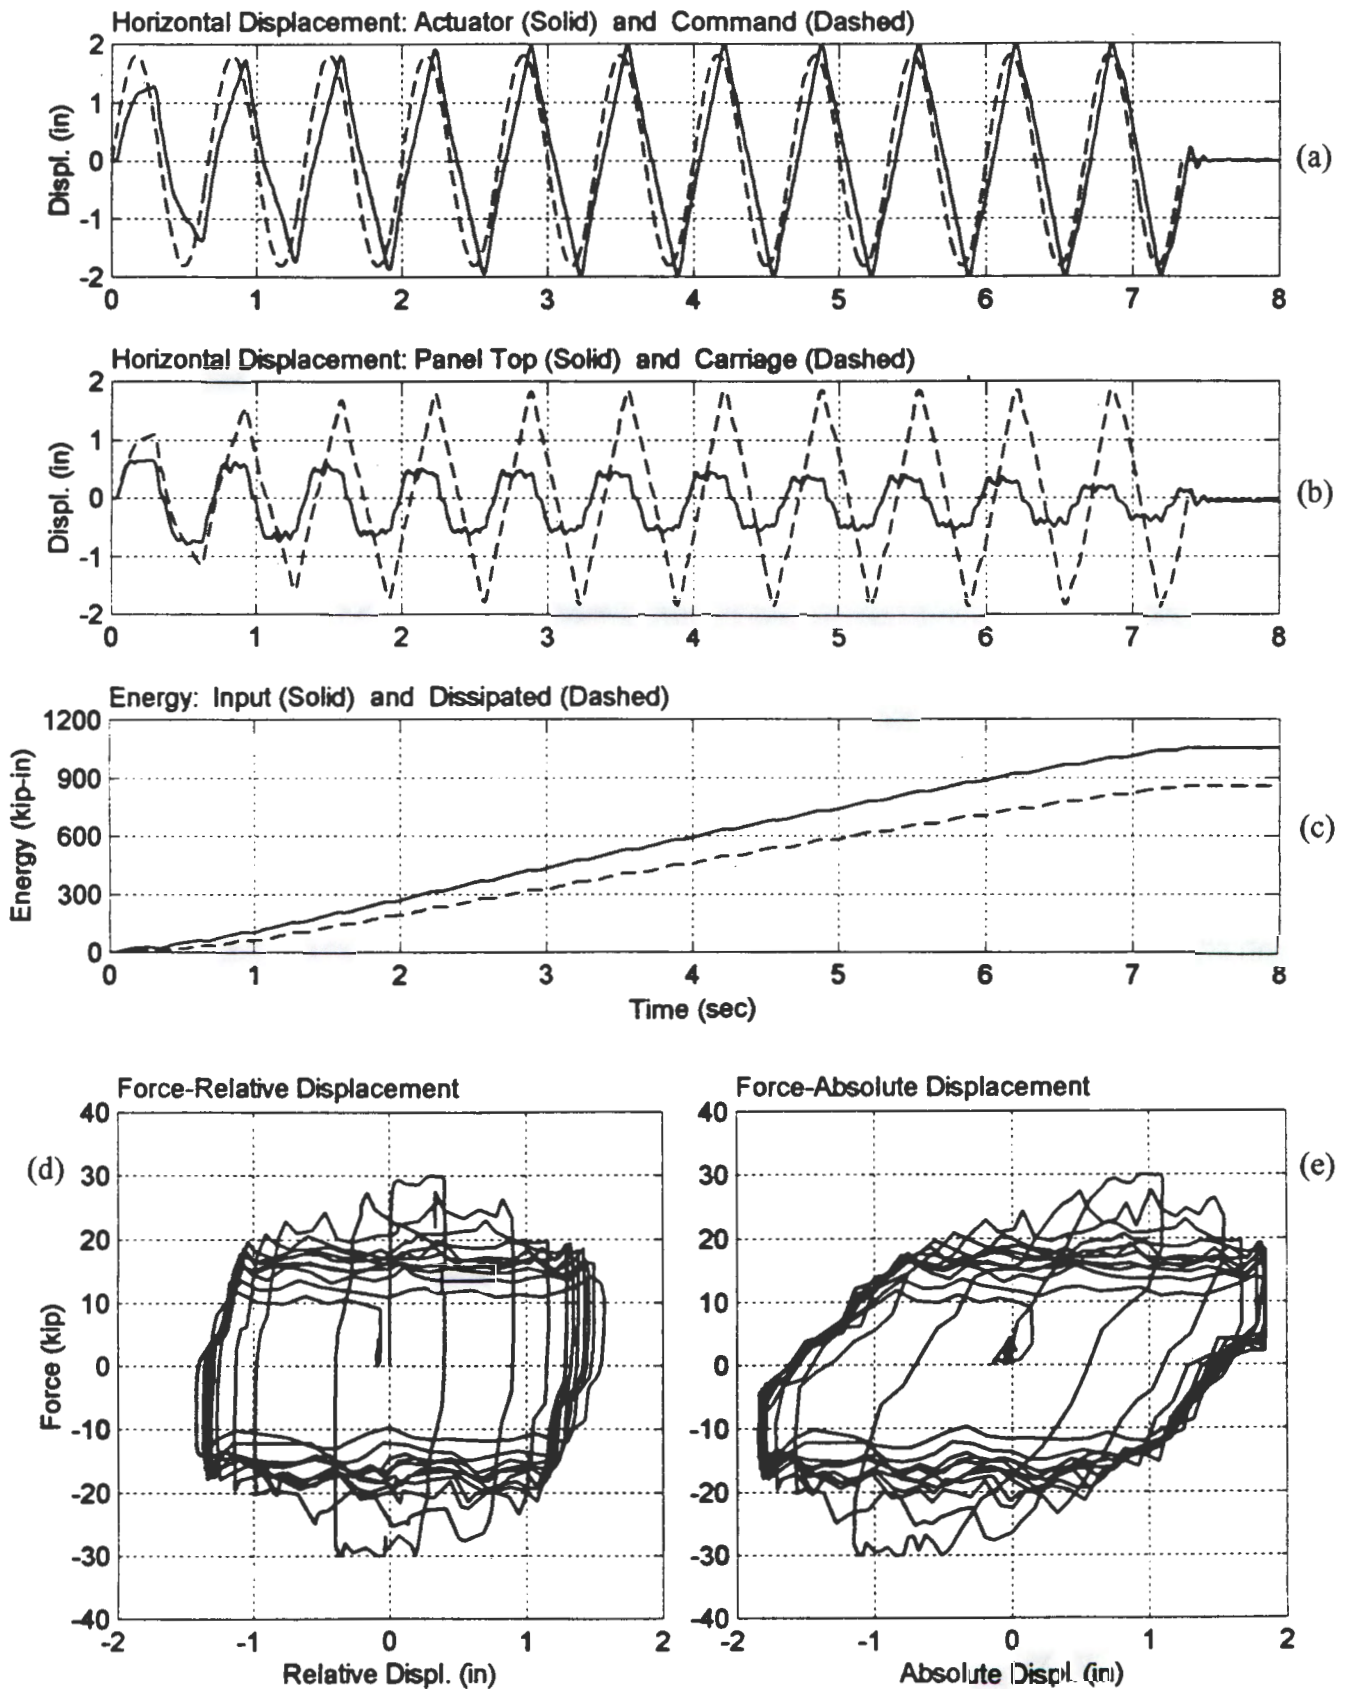
UCR Rivera Library—Test No. 22 Anchorage B Three Devices (T=150 ft-lbs)
Harmonic Motion (1.5 Hz, 1.8 in) File: 06271531.txt

Figure 7.16 Test results

The effect of increasing the tension in the bolts was studied during Tests Nos. 22 and 23. For Test No. 22, bolt tension increased to 150 ft-lb. Sliding started at about 30 kips and reduced slowly with shaking, perhaps because of wearing of the sliding surfaces. Bolt tension was reasonably stable. (Figure 7.16.)

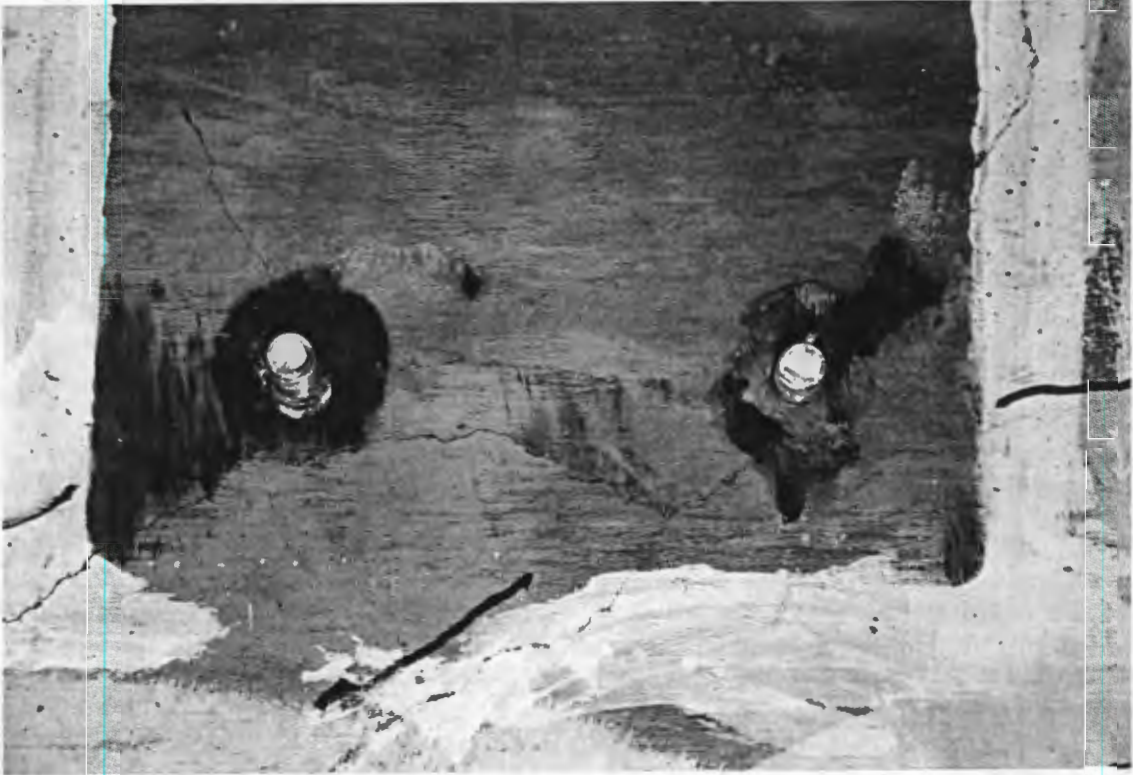
Figure 7.21. Close-up of the epoxy around the studs after the last test

For Test No. 23, the tightening torque was increased to 200 lb-ft. The resulting bolt tension was about 10 kips. Figure 7.17 shows the test results. There was very little relative motion between the panel and the carriage, indicating that the dissipators were locked most of the time because of the high tension in the bolt (plot b). Consequently, the hysteresis loops were quite thin, and the amount of energy dissipated very small, as seen in plots c and e, respectively. Figure 7.18 shows the crack pattern after this test. The state of one of the brass and teflon washers can be appreciated from Figure 7.19; it can be seen that the teflon washer was completely crushed. Finally, Figs. 7.20 and 7.21 show the studs after the last test. Looking carefully, it can be seen that the epoxy around the studs is almost intact.

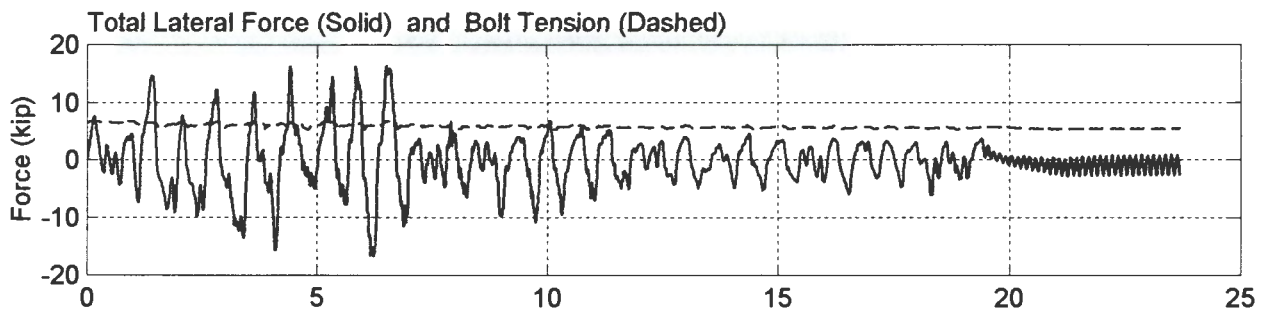
UCR Rivera Library--Test No. 12 Anchorage A Three Devices (T=100 ft-lbs)
Seismic Motion (Max. Ampl.=1.65 in) File: 06101134.txt

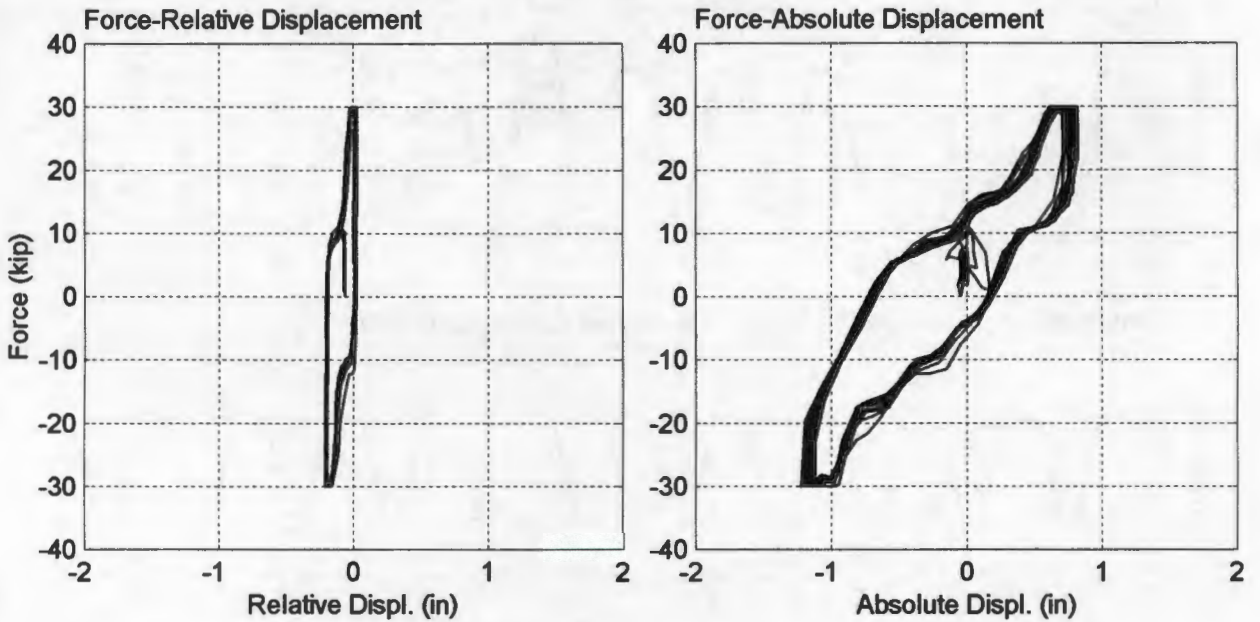
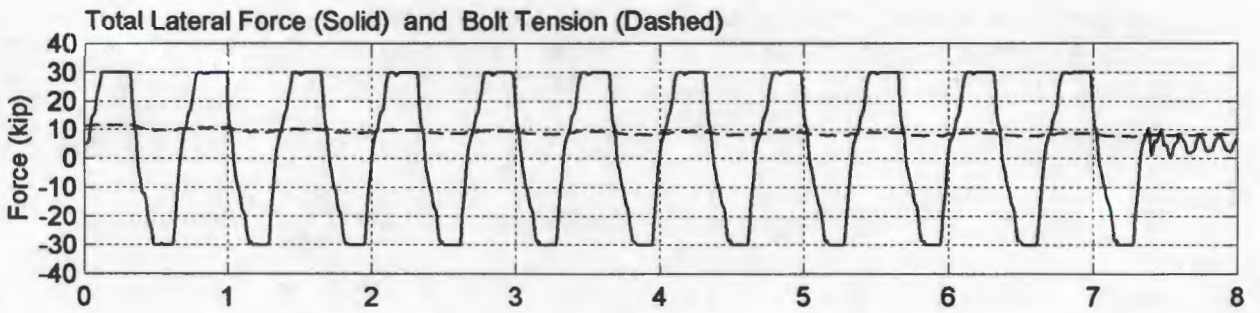
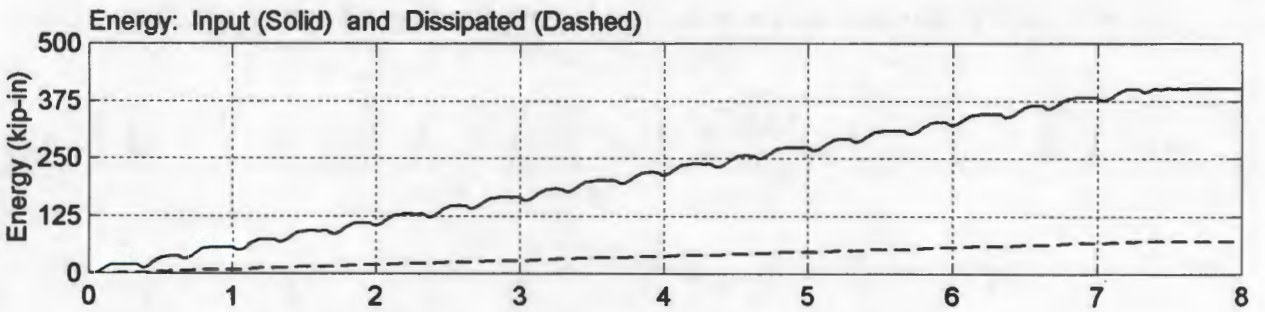
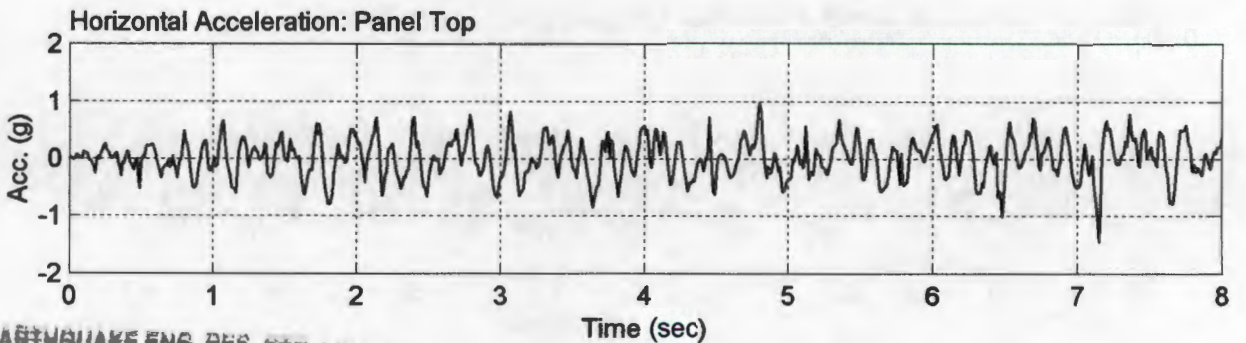
UCR Rivera Library—Test No. 23 Anchorage B Three Devices (T=200 ft-lbs)
Harmonic Motion (1.5 Hz, 1.8 in) File: 06271553.txt
