Construction constraints for geomorphic-unit rehabilitation on regulated gravel-bed rivers

River Research and Applications, 25(4)

Sawyer, April M  
Pasternack, Gregory B  
Merz, Joseph E  
[et al.](#)

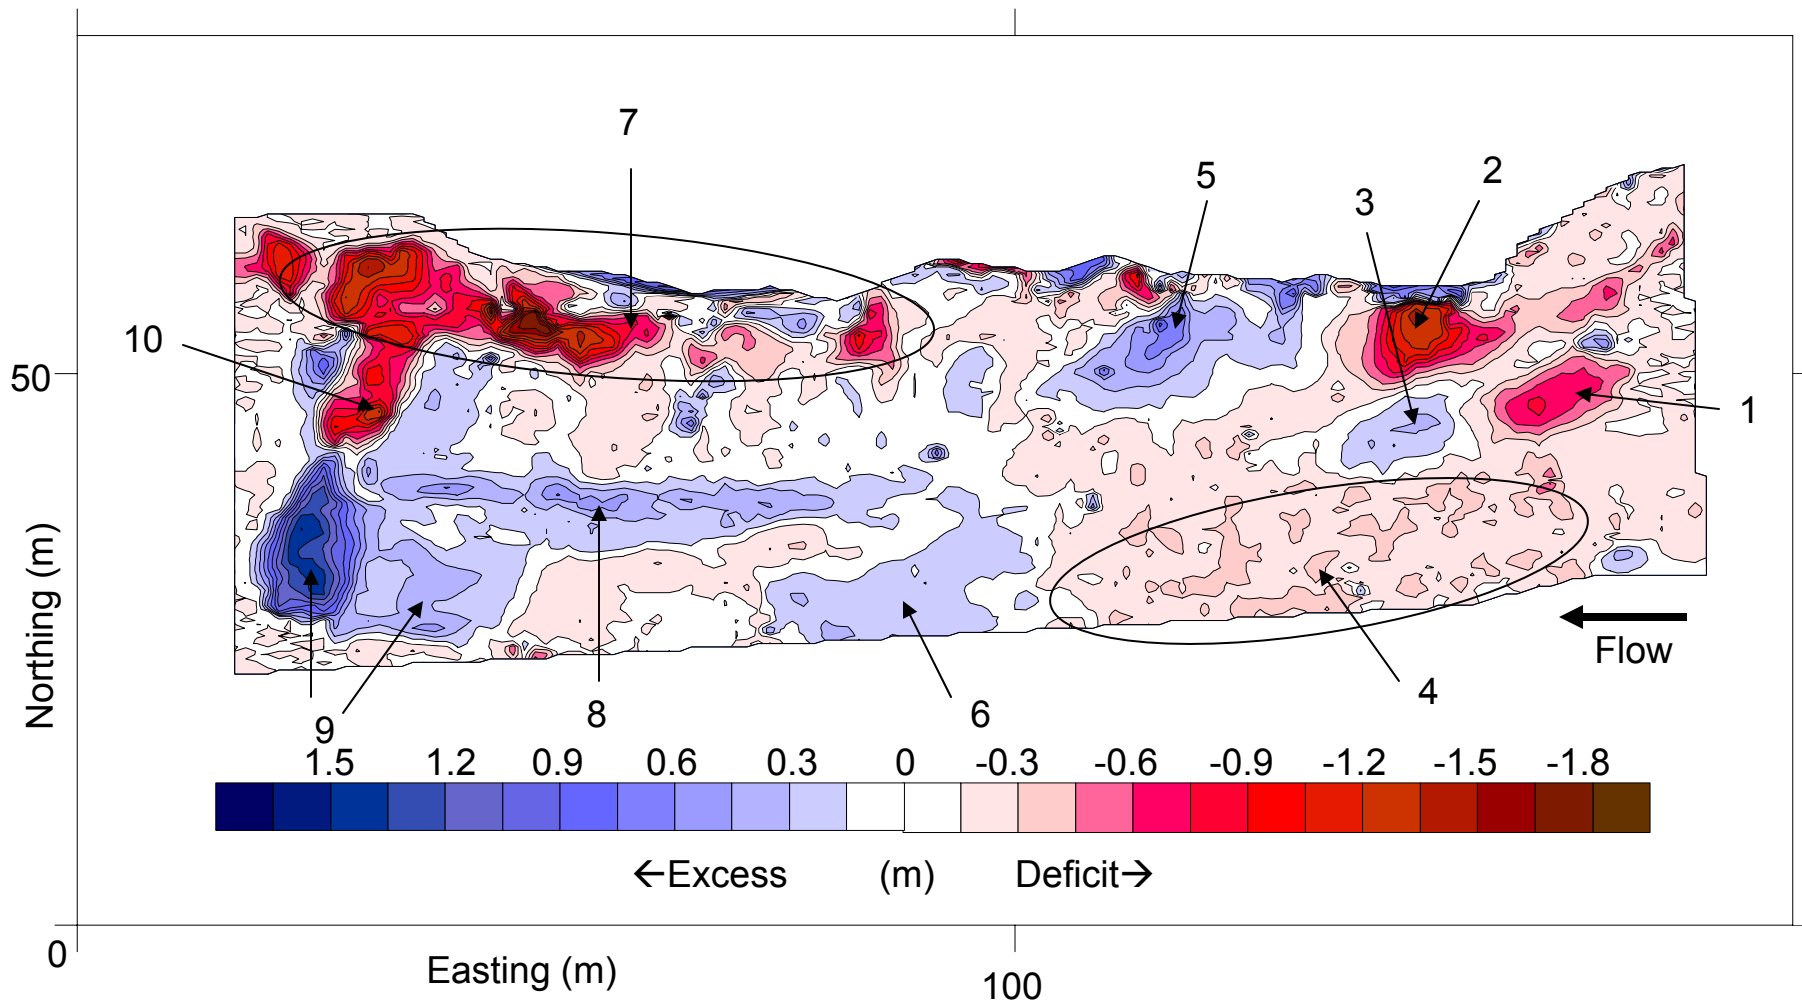
1 Figure 13. Contour map with 0.15 m elevation change intervals between as-built and design for  
2 the 2005 project. Note that deep areas along river right were underfilled due to vegetation  
3 obstructions (areas 2 and 7). Also, note the overfilled thalweg (area 8) and downstream end of  
4 the site (area 9). See Table 4 for sources of error by area number.  
5

22 Ten areas of significant deviation (Fig. 13) were found in the DEM comparison of design  
23 versus as-built topography for 2005. Intentional on-site design changes to accommodate wood  
24 placement caused an overfill in area 5. Area 8, the designed thalweg, was accidentally

4 Operator gravel placement methods caused most of the 2005 site's errors. Like the 2004  
5 project, there was a gravel surplus in 2005. However, unlike 2001-2004, the design of entrance  
6 and exit slopes for 2005 explicitly accounted for front-loader fording-depth capability and the  
7 unwillingness of the 2004 operator to risk damage to the front loader. As a result of this  
8 adjustment, it was easier to ascribe the relatively minor design deviations in areas 3, 4, 5 and 6 to  
9 poor elevation estimation by the operator, who turned out to be the same individual as from  
10 2004. A surveyor periodically checked elevations referencing a grid with corresponding stakes  
11 at 6.1 m (20') intervals along the bank to aid the operator. The surveyor could guide the operator  
12 to improve grading but the front loader's tire tracks 0.15-0.3 m deep were unavoidable.  
13 Although tracks were observed in previous years, the 2005 project relied most heavily of all on
