Reflective Cracking Study: First-level Report on HVS Testing on Section 586RF - 45 mm MB15-GOverlay

Reflective Cracking Study: First-Level Report on HVS Testing on Section 586RF — 45 mm MB15-G Overlay

Authors:
D. Jones, R Wu and J. Harvey

Partnered Pavement Research Program (PPRC) Contract Strategic Plan Element 4.10:
Development of Improved Rehabilitation Designs for Reflective Cracking

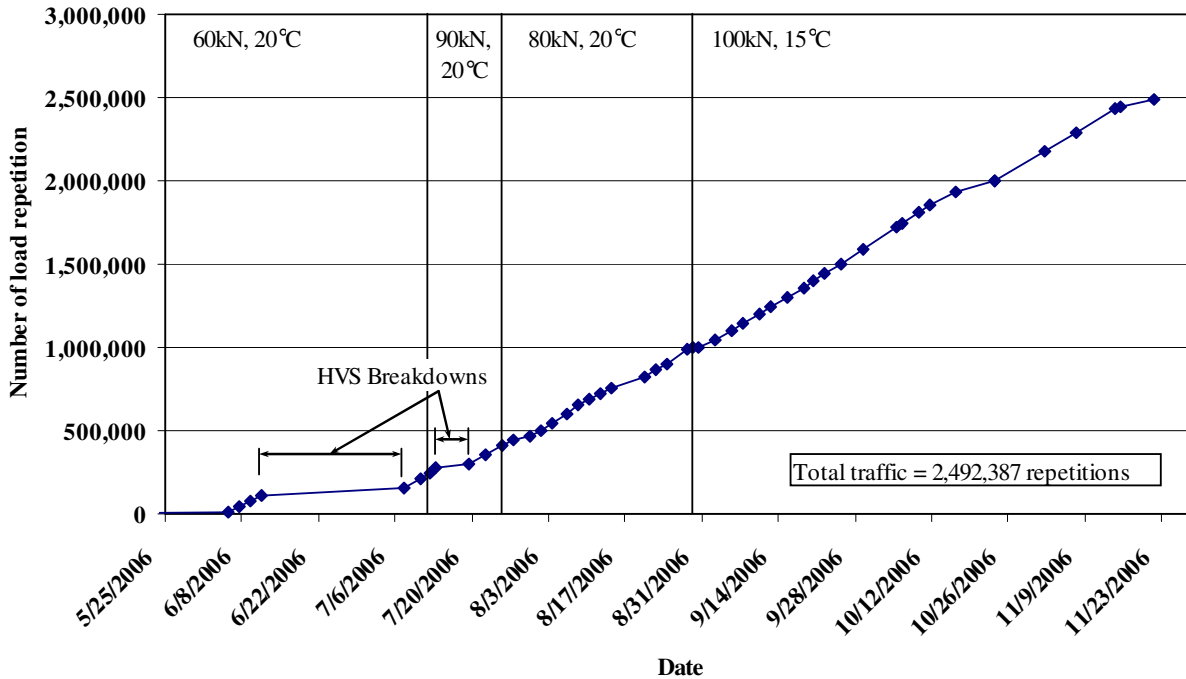
Figure 2.6: Cumulative traffic applications and loading history.

- 215,000 repetitions of a 60 kN (13,500 lb) load
- 195,000 repetitions of a 90 kN (20,250 lb) load
- 590,000 repetitions of an 80 kN (18,000 lb) load, and
- 1,492,387 repetitions of a 100 kN (22,500 lb) load.

This loading equates to approximately 87.9 million equivalent standard axles (ESALs), using the Caltrans conversion of $(\text{axle load}/18000)^{4.2}$, which in turn equates to a Traffic Index of 15.3.

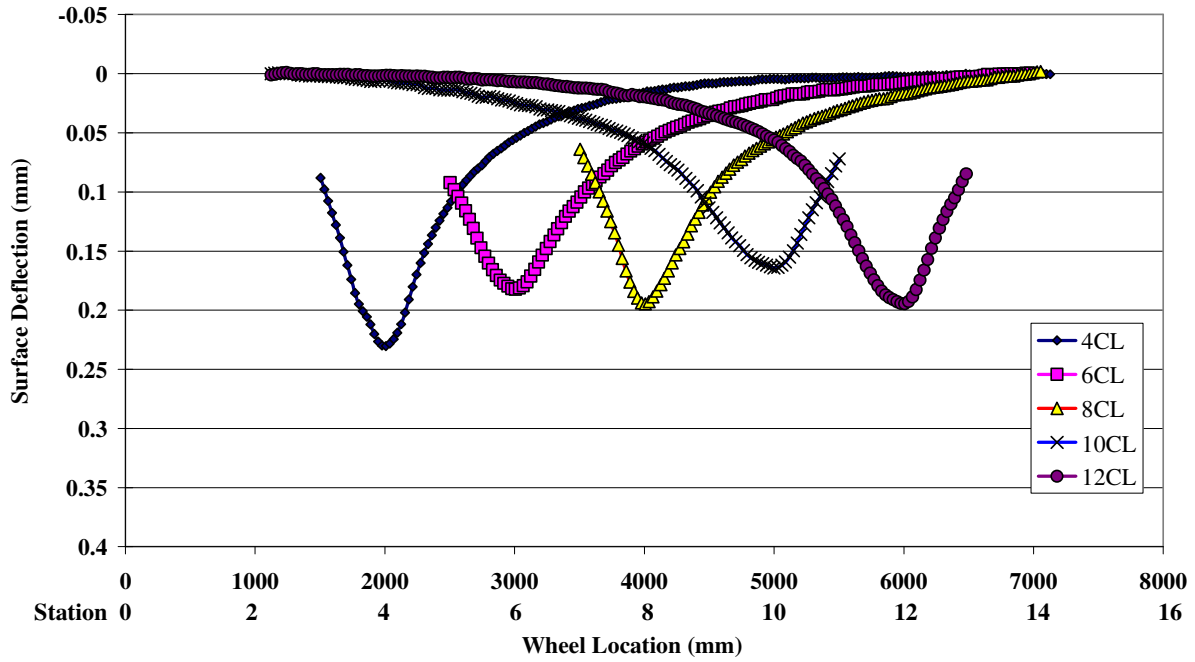
Deflections and damage rates both increased with increase in load. Figures 3.6 to 3.10 compare the deflection bowls at the same locations at test start, at load change intervals, and at test completion. The same scale is used on all figures, and the increasing deflection in the early part of the test is clear. However, deflections do not increase when the load is increased to 100 kN (Figure 3.9). This is partly attributed to drying back of the base material. The higher deflections at Stations 4CL, 6CL, and 12CL over the more densely cracked underlying DGAC can be observed in Figures 3.8 to 3.10.

Figure 3.6: RSD deflections at CL locations with 60 kN test load at test start.

Figure 3.7: RSD deflections at CL locations with 60 kN test load after 215,000 repetitions. (90 kN load change)

Figure 3.8: RSD deflections at CL locations with 60 kN test load after 410,000 repetitions. (80 kN load change)

Figure 3.9: RSD deflections at CL locations with 60 kN test load after 1,000,000 repetitions. (100 kN load change)

Figure 3.10: RSD deflections at CL locations with 60 kN test load at test completion.

At the start of the test, initial deflections were all within 0.1 mm of each other, with the lowest deflection (i.e., stronger pavement) recorded at Station 10CL, overlying that part of the DGAC with the lowest density of cracking. During the course of the test, relatively little damage (considering the loading applied) occurred on the overlay over the entire section under HVS trafficking, with the highest values at Station 4CL. This is confirmed by the ratio of final-to-initial deflections for all RSD locations, which show that surface deflections increased by between 1.4 and 1.9 times along the length of the test section, indicating relatively minor damage in the pavement structure in terms of loss of stiffness. Although the ratio of final-to-initial deflections was fairly consistent across the section, when the results are considered in conjunction with Figure 2.4, lower deflections (Stations 8CL and 10CL) were recorded in the part of the section that had a slightly less dense cracking pattern in the underlying pavement (stiffer pavement), while those with the highest deflections (Stations 4CL, 6CL, and 12CL) were over the more severely cracked area (weaker pavement).

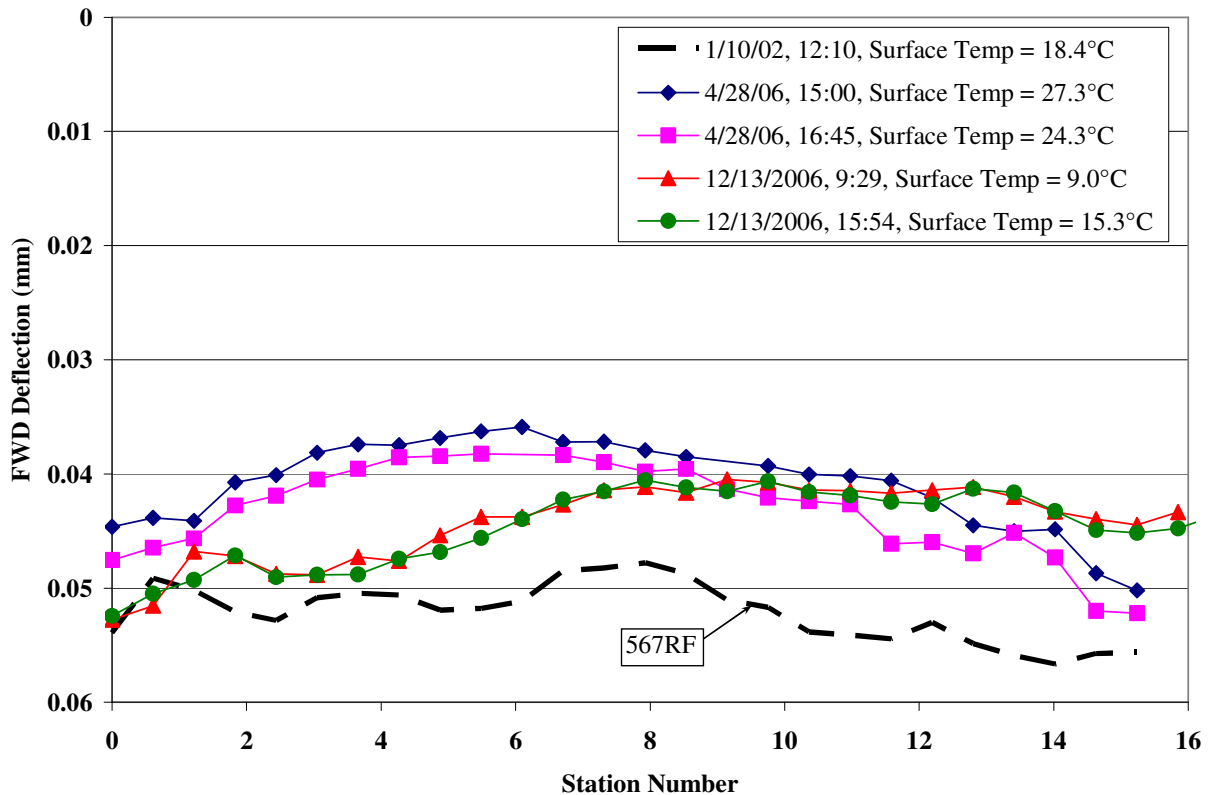
Figure 3.14: Subgrade pavement stiffness (FWD Sensor 6) on section centerline.

Figure 3.14 shows deflections in the subgrade before and after the test. These measurements indicate that there was no significant change (<0.02 mm) during the course of the experiment. The overlay did not provide any significant structural improvement to the overall pavement structure in terms of protection of the subgrade. Some temperature sensitivity was noted in the measurements prior to trafficking.

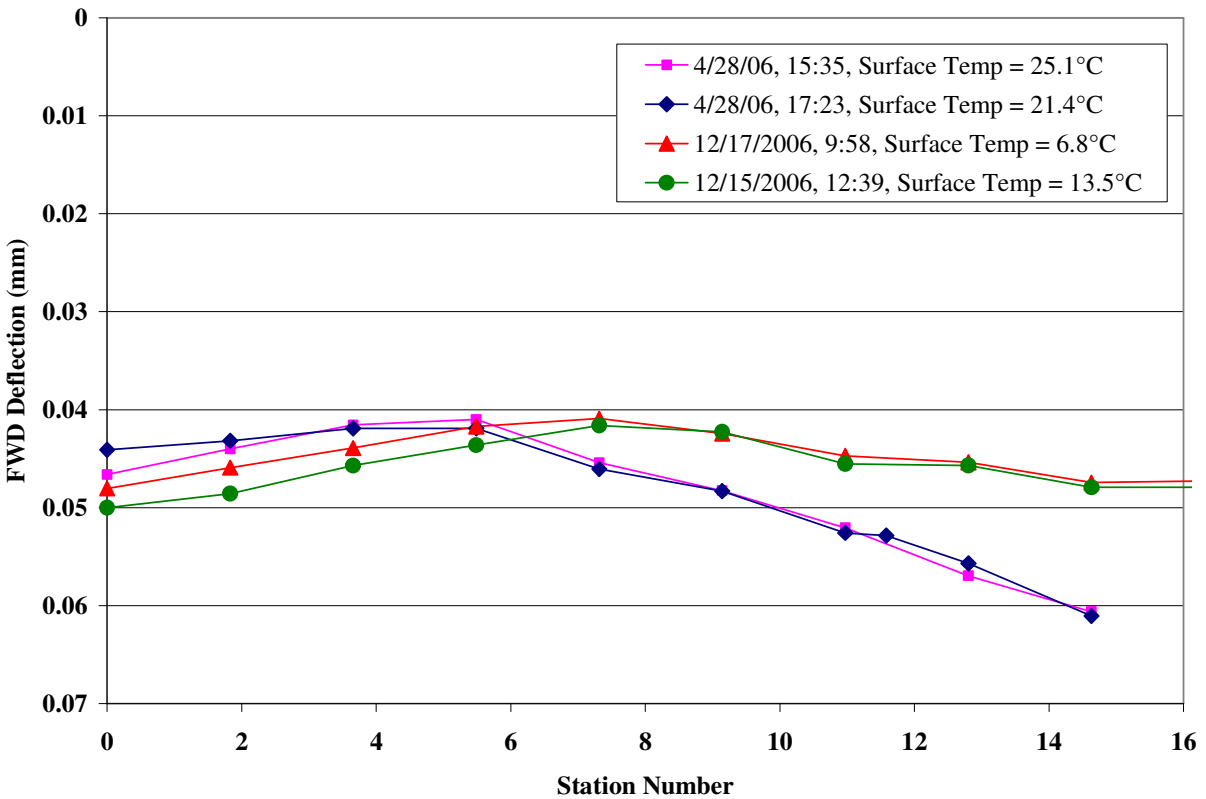
Figures 3.15 and 3.16 show FWD deflections taken along the side of the HVS test section but outside the trafficked area (i.e., the area tested did not have traffic damage). The figures can be used to understand the influence of environmental conditions on the performance of the section. The figures generally show slightly lower deflections after completion of testing compared to before testing. This is attributed to the drying out of the subgrade and lower base. The off-section deflections did not appear to be significantly influenced by temperature.

Figure 3.15: Composite pavement stiffness (FWD Sensor 1) outside trafficked area.

Figure 3.16: Subgrade pavement stiffness (FWD Sensor 6) outside trafficked area.

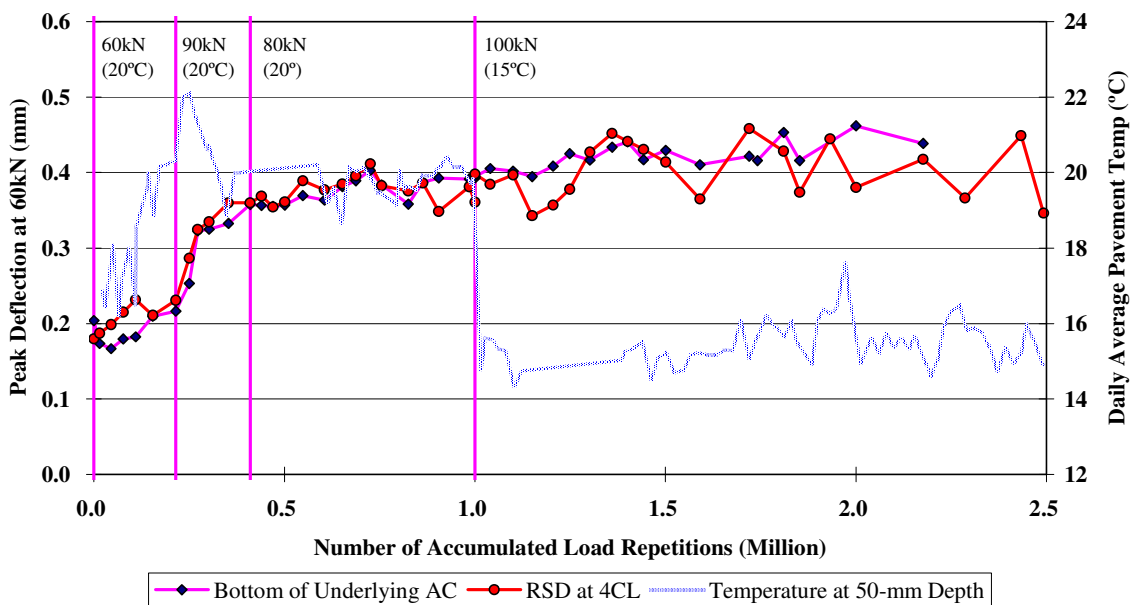
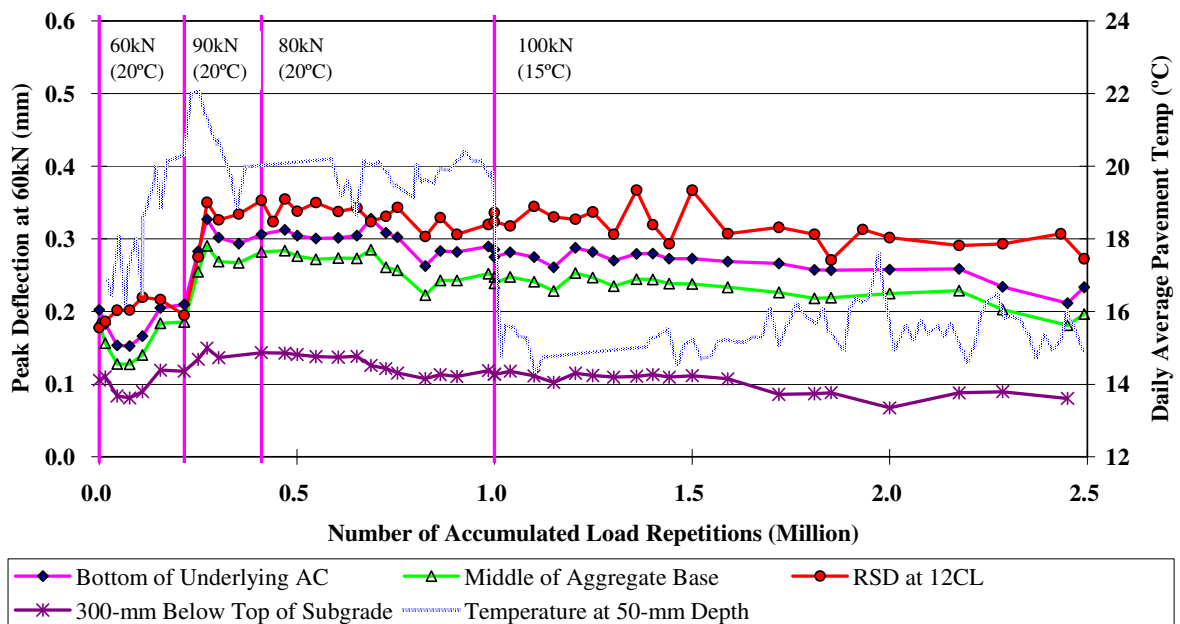
Figure 3.17: Elastic deflections at MDD4 with 60 kN test load.

Figure 3.18: Elastic deflections at MDD7 with 60 kN test load.

Figure 3.19: Elastic deflections at MDD12 with 60 kN test load.

Depth (mm)	Layer	Elastic Deflection (microns)		
		Before Trafficking	After Trafficking	Ratio of Final/Initial
MDD4				
0	Surface (from RSD)	180	346	1.92
122	Bottom of cracked DGAC	204	438	2.15
300	Middle of aggregate base	N/A	N/A	-
480	Bottom of aggregate base	N/A	N/A	-
MDD7				
0	Surface (from RSD)	184	273	1.48
132	Bottom of cracked DGAC	196	288	1.47
550	Middle of aggregate base	141	201	1.43
778	Bottom of aggregate base	114	153	1.34
MDD12				
0	Surface (from RSD)	177	273	1.54
120	Bottom of cracked DGAC	202	233	1.15
287	Middle of aggregate base	184	196	1.07
766	Bottom of aggregate base	106	80	0.75

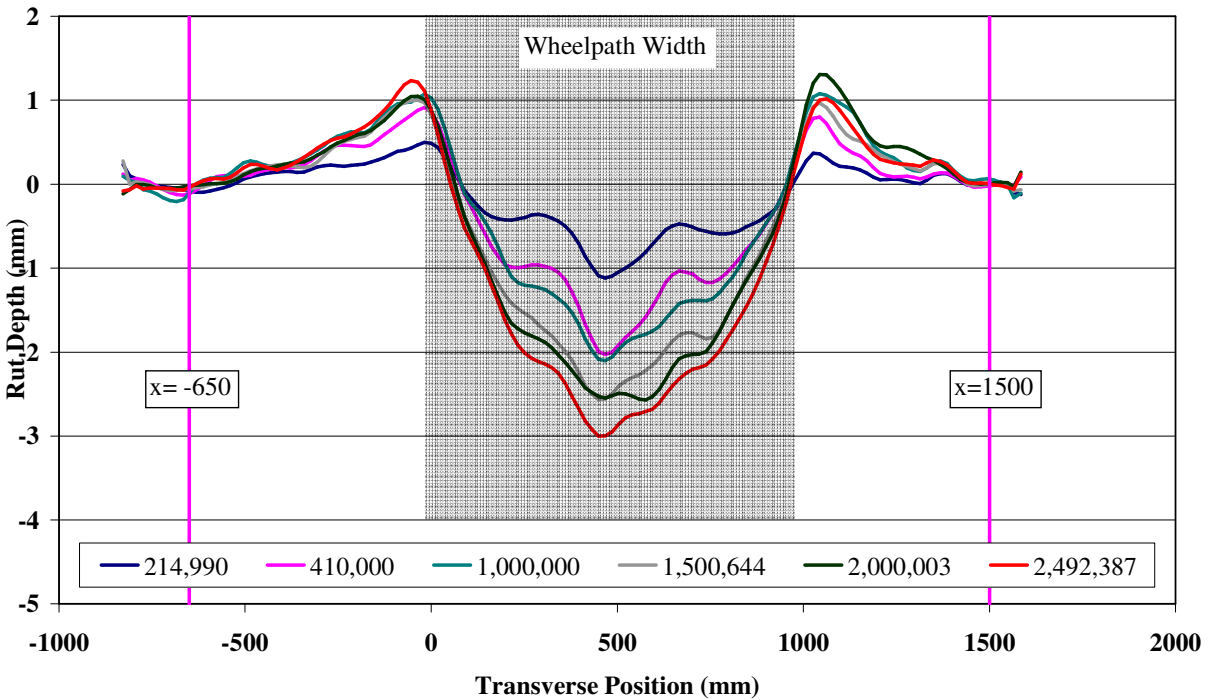
Figure 3.21: Laser profilometer cross section at various stages of trafficking.

Figure 3.21 shows the average transverse cross section measured with the Profilometer at various stages of the test. This plot clearly shows the increase in rutting and deformation over the duration of the test.

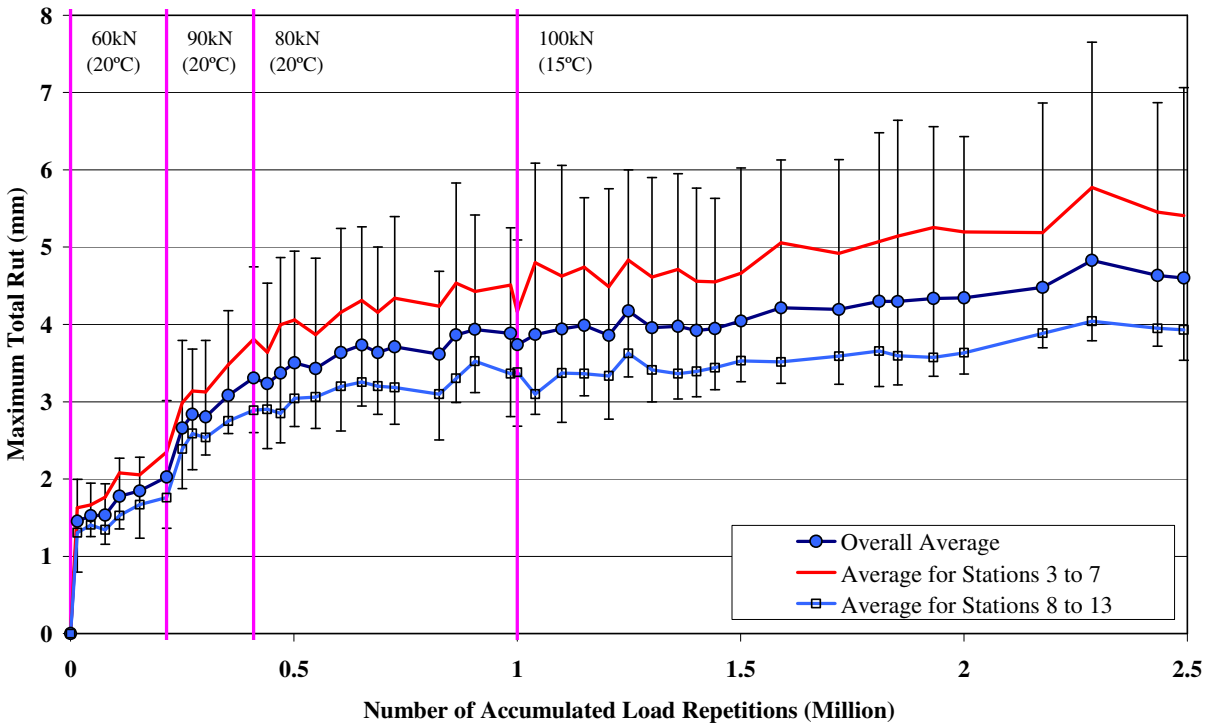
During HVS testing, rutting usually occurs at a high rate initially, then typically diminishes as trafficking progresses until reaching a steady state. If the load level is subsequently increased, the pavement will undergo another phase of rapid rutting development until a steady phase for that new load level is reached. This initial phase is referred to as the “embedment” phase. Figures 3.22 and 3.23 show the development of permanent deformation (average deformation and maximum rut, respectively) with load repetitions as determined by the Laser Profilometer for the test section. *Note that the scales in the figures are different.* Embedment phases are apparent at the beginning of the experiment and at the 90 kN load change. Error bars on the average reading indicate variation along the length of the section and show a marginal difference (1.5 mm in maximum rut) between one end of the section and the other at the end of the test. The figures also show average deformation and average maximum rut for Stations 3 to 7 and 8 to 13. There is very little difference between the two ends, which corresponds to the relatively even cracking in the underlying layer. The rate of deformation decreased after the 100 kN load change. This was attributed to the lower pavement temperature after the load change (15°C).

Figure 3.22: Average deformation determined from Laser Profilometer data.

Figure 3.23: Average maximum rut determined from Laser Profilometer data.

After completion of trafficking, the average deformation and the average maximum rut depth were just 1.7 mm and 4.6 mm respectively. The maximum rut depth measured on the section was 7.7 mm, at Station 3. The average maximum rut depth at the end of the test was significantly less than the failure criterion of 12.5 mm. However, in the interest of completing the reflective cracking study trafficking was stopped after discussion with Caltrans (6). The final surface rutting pattern of the overlay generally corresponds with the fatigue cracking pattern of the cracked DGAC layer, as shown in Figure 3.29, with the deepest rut occurring in the area over the area with slightly more severe cracking in the underlying layer.

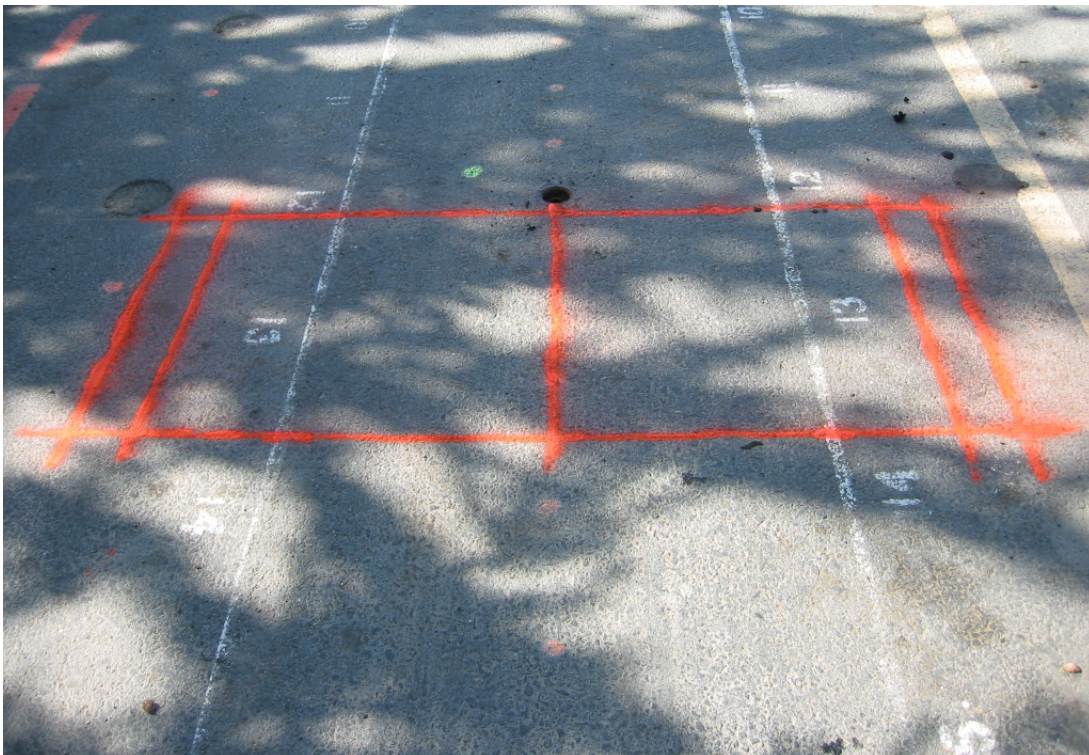
Figure 3.34: Section surface between Stations 12 and 15 at end of test.

After 2,492,387 repetitions with increasing wheel loads (from 60 kN to 100 kN) under controlled pavement temperatures (20°C for the first one million repetitions and 15°C thereafter), no surface cracking was observed. The MB15-G overlay thus appeared to successfully prevent any reflective cracking from the underlying layer from appearing on the surface, despite calculated ratios of final-to-initial deflections indicating that damage had occurred in the asphalt layers during the course of trafficking. A photograph of the section after trafficking is shown in Figure 3.34.
