First-Level Analysis of Heavy Vehicle Simulator Testing on Three RHMA-G Mixes to Investigate Performance with Reclaimed Asphalt Pavement Aggregate Replacement

Authors:
D. Jones and S. Louw

1. REPORT NUMBER UCPRC-TM-2020-04	2. GOVERNMENT ASSOCIATION NUMBER	3. RECIPIENT'S CATALOG NUMBER
4. TITLE AND SUBTITLE First-Level Analysis of Heavy Vehicle Simulator Testing on Three RHMA-G Mixes to Investigate Performance with Reclaimed Asphalt Pavement Aggregate Replacement		5. REPORT PUBLICATION DATE December 2020

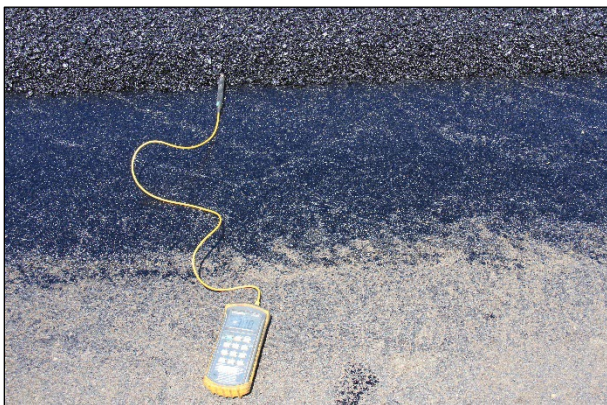
Temperatures were systematically recorded throughout the placement of the RHMA-G using thermocouples (Figure 3.13) and an infrared camera fixed to the paver (Figure 3.14).

Figure 3.13: Temperature measurement with thermocouple.

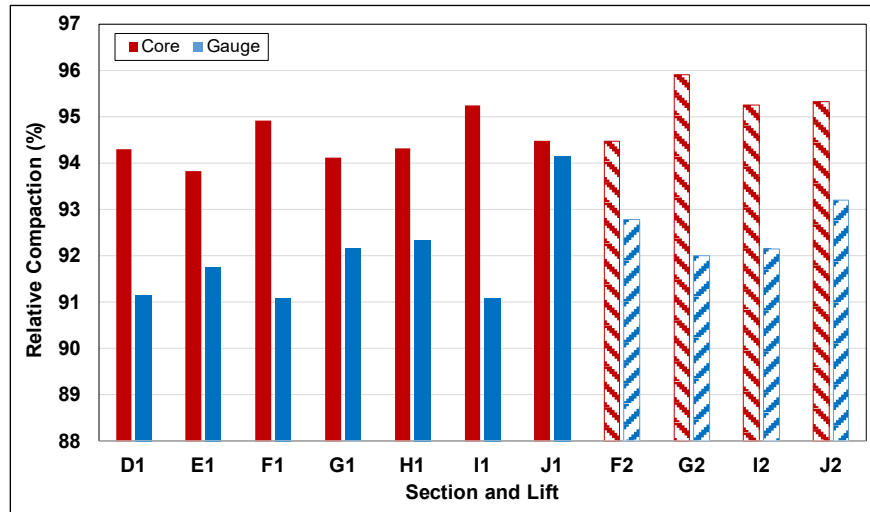
Figure 3.15: Summary of relative density measurements.

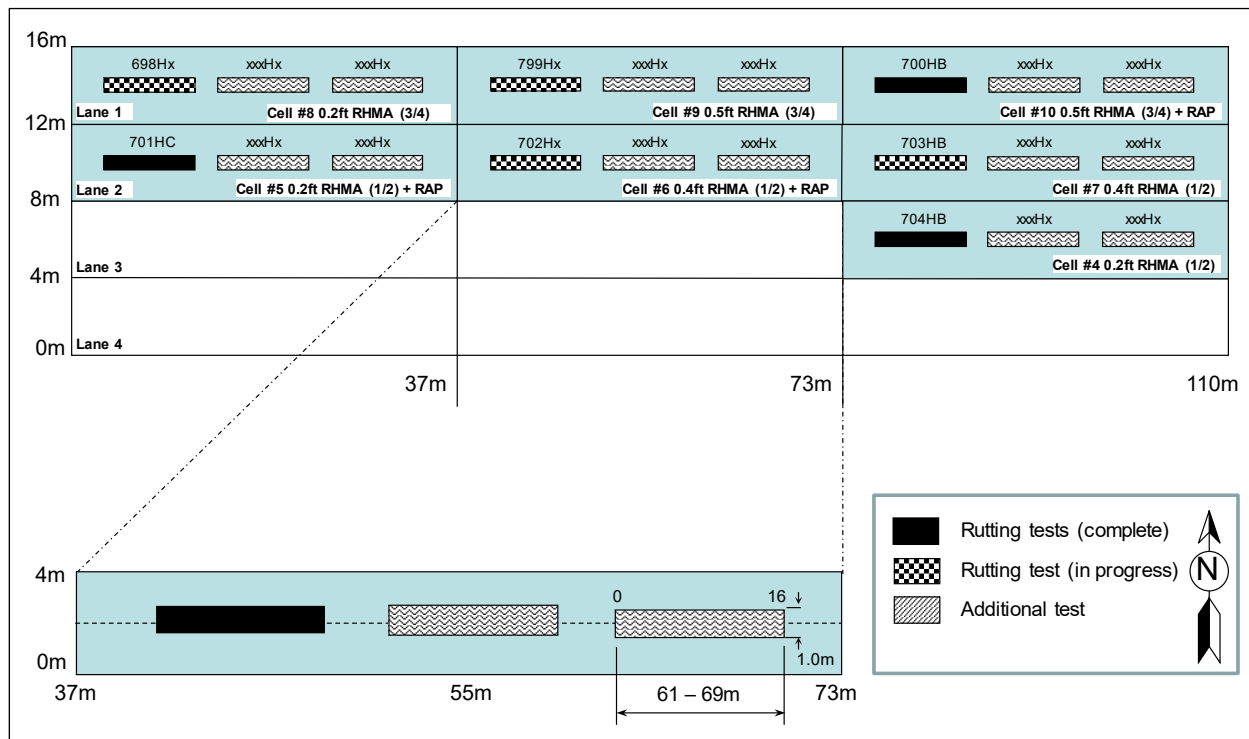
The test track layout for this project is shown in Figure 4.1. Falling weight deflectometer (FWD) test results were used to identify three uniform HVS test sections in each mix cell, the first for assessing rutting performance under high pavement temperature conditions (Phase 1), and the second and third for potential additional testing (e.g., fatigue cracking performance). Additional testing, if justified, will be identified and motivated based on the results of the first round of testing and associated laboratory testing.

Figure 4.1: Test track layout.

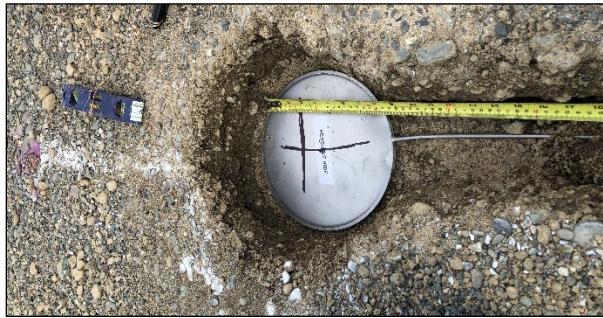
- One *RST LPTPC09-S* pressure cell was installed at mid-depth in the aggregate base layer (Figure 4.3) on each Phase 1 test section to measure vertical pressure (stress) under the moving wheel.

Figure 4.3: Pressure cell installation.

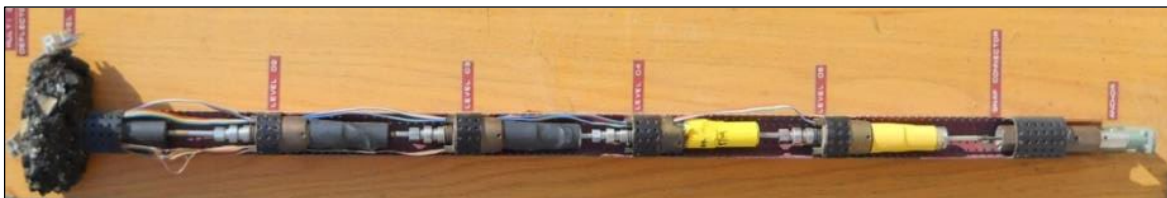
- One multi-depth deflectometer (MDD) was installed on each Phase 1 test section. An MDD is essentially a stack of linear variable differential transformer (LVDT) modules fixed at different depths in a single borehole. The LVDT modules have non-spring-loaded core slugs that are linked together into one long rod that is anchored at the bottom of a 3.3 m (\approx 10.8 ft.) borehole. The LVDT modules are fixed to the pavement layer, which allows permanent vertical deformations at various depths to be recorded, in addition to measurement of the elastic deformation caused by the passage of the HVS wheels. The borehole is 38 mm (\approx 1.5 in.) in diameter. A model MDD with five modules is shown in Figure 4.4. In this project, MDDs were installed between the two wheelpaths of the dual-wheel configuration because of cable limitations that prevented installation in one of the wheelpaths.

Figure 4.4: A model multi-depth deflectometer (MDD), showing five modules.

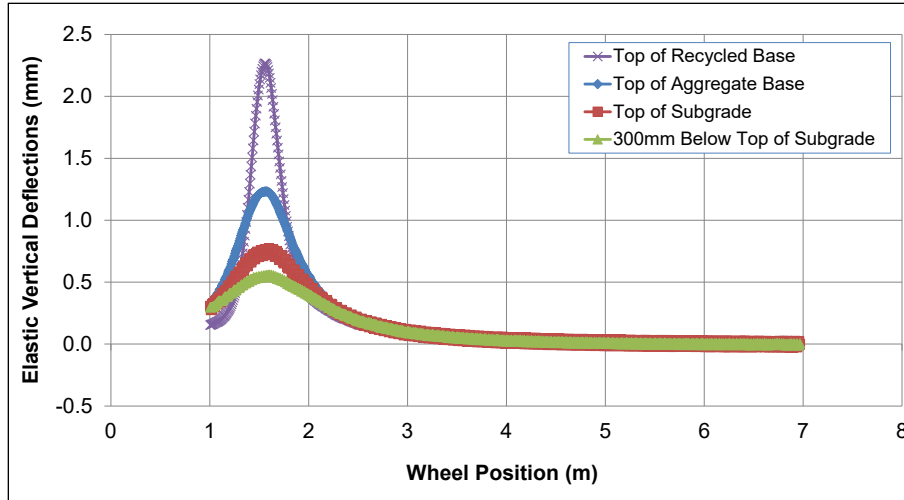
An example set of MDD data is presented in Figure 4.7, which shows the variation of the elastic vertical deflections measured at different depths versus wheel position as the wheel travels from one end of the test section to the other. The elastic vertical deflection is the difference between the total vertical deflection and the reference value, which is the measurement recorded when the wheel is at the far end of the test section. The peak values are the maximum elastic vertical deflection for each individual MDD module.

Figure 4.7: Example elastic vertical deflection measured with MDD.

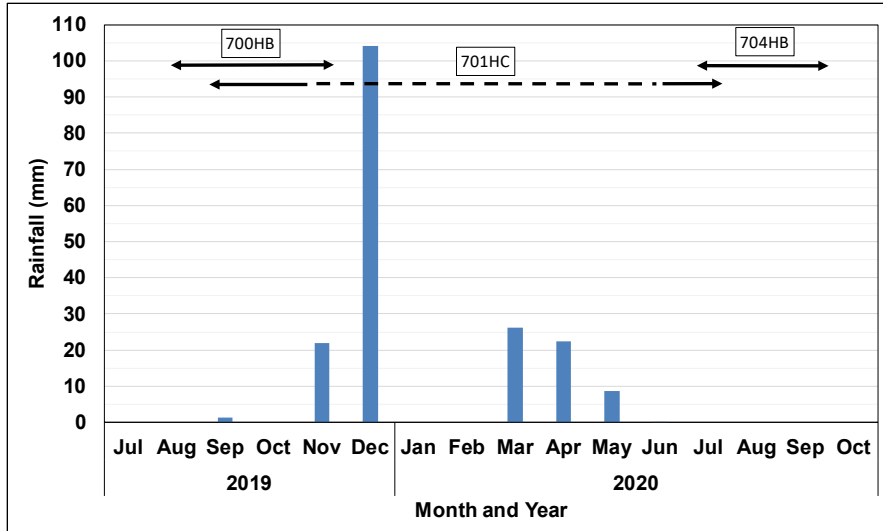
Figure 5.1 shows the monthly rainfall data from July 1, 2019, through October 31, 2020, as measured at the weather station next to the test track. Some rainfall was recorded during testing on 700HB and 701HC, with five 24-hour rainfall events greater than 12.5 mm (≈ 0.5 in.), two of which were greater than 25 mm (≈ 1 in.). No rainfall was recorded during testing on 704HB.

Figure 5.1: Measured rainfall during Phase 1a HVS testing.

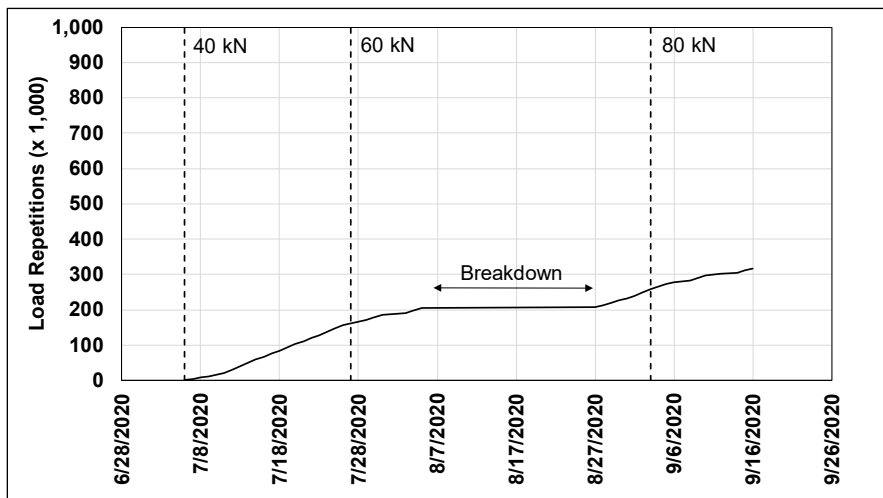
Loading commenced with a 40 kN half-axle load on July 6, 2020, and ended with an 80 kN load on September 18, 2020. A total of 320,000 load repetitions were applied and 36 datasets were collected. Load was increased from 40 kN to 60 kN after 160,000 load repetitions, and then to 80 kN after 260,000 load repetitions. The HVS loading history for Section 704HB is shown in Figure 5.2. A 21-day breakdown resulting from a hydraulic system failure occurred between August 6 and August 26.

Figure 5.2: 704HB: HVS loading history.

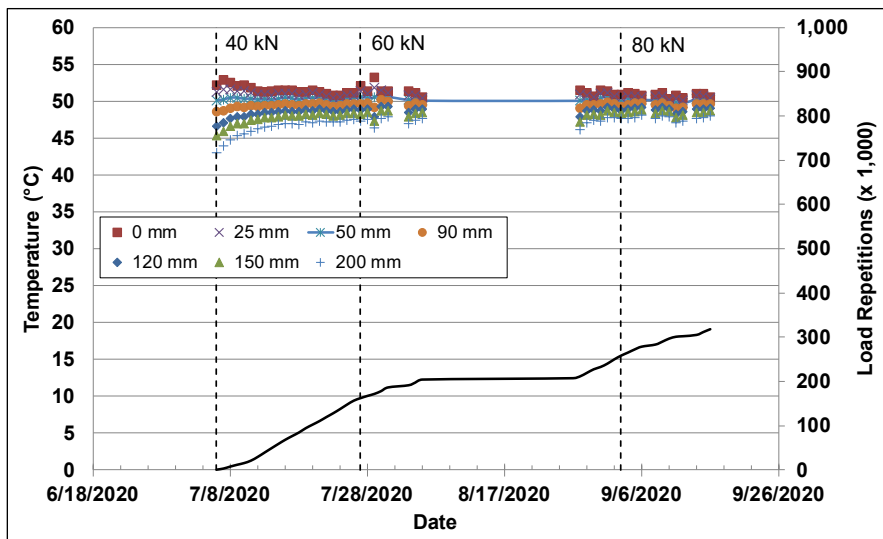
Daily 24-hour averages of the air, surface, and in-depth temperatures of the RHMA-G and recycled layers are shown in Figure 5.5 and listed in Table 5.1. Pavement temperatures were constant and in the target range ($50 \pm 2^\circ\text{C}$ at a pavement depth of 50 mm) in the RHMA-G layer. Temperatures decreased with increasing depth in the underlying layers, as expected.

Figure 5.5: 704HB: Daily average pavement temperatures.

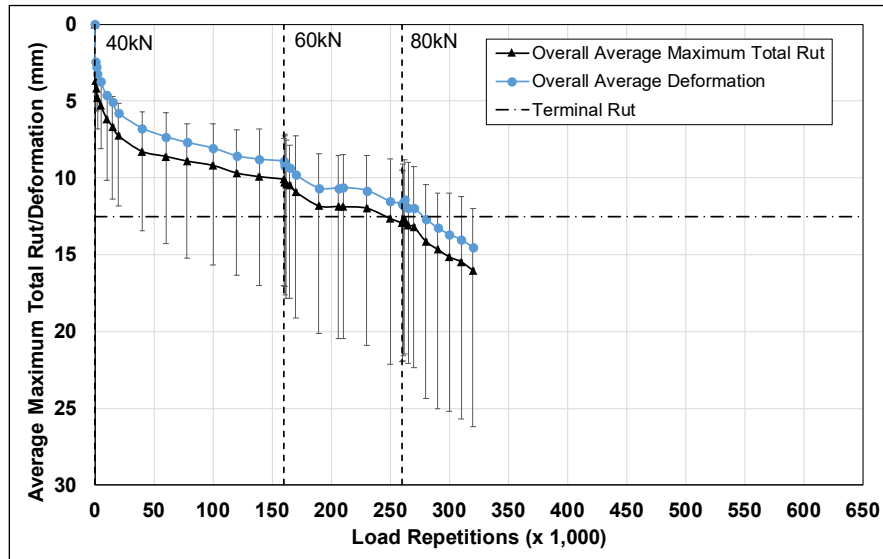
Figure 5.7 shows the development of permanent deformation (average maximum total rut and average deformation) with load repetitions. Error bars on the plot indicate lowest and highest measurement along the section. These error bars show that there was considerable variation in rut depth along the length of the section. The cause of this variation cannot be determined from

the data alone and will be investigated during the forensic investigation upon completion of all testing and as part the laboratory testing phase.

Figure 5.7: 704HB: Average maximum total rut and average deformation.

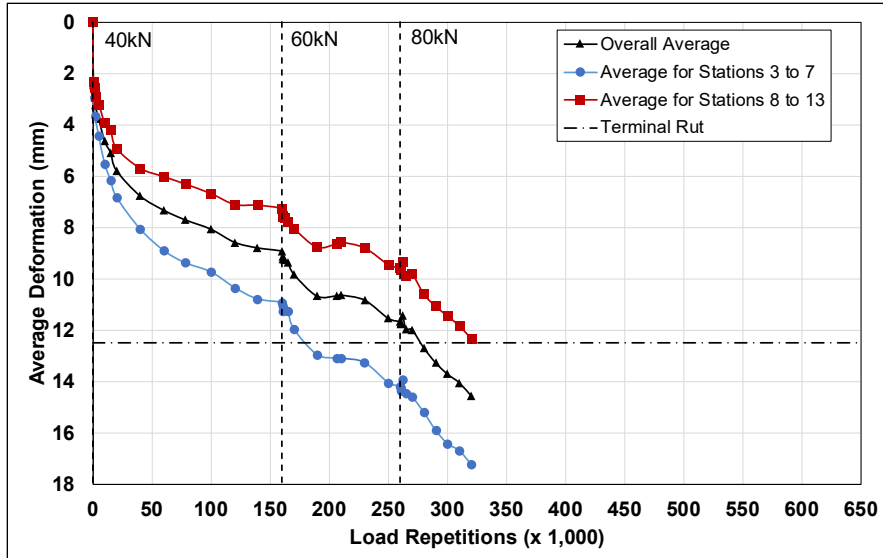
Figure 5.8: 704HB: Average deformation.

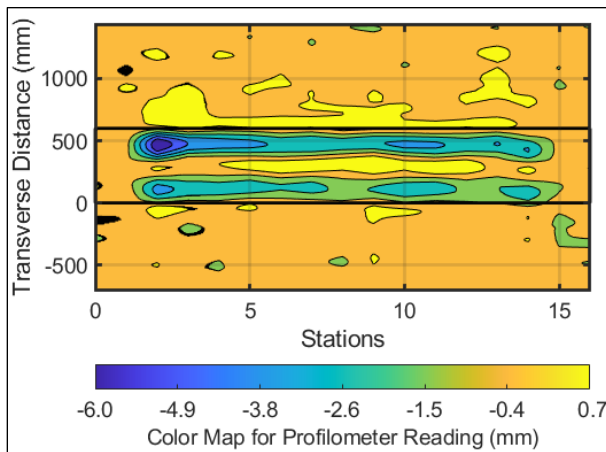
Figure 5.9 and Figure 5.10 show contour plots of the pavement surface at the start and end of the test (320,000 load repetitions). The end-of-test plot clearly shows the deeper rut at one end of the section.

Figure 5.9: 704HB: Contour plot of permanent surface deformation at start of test.

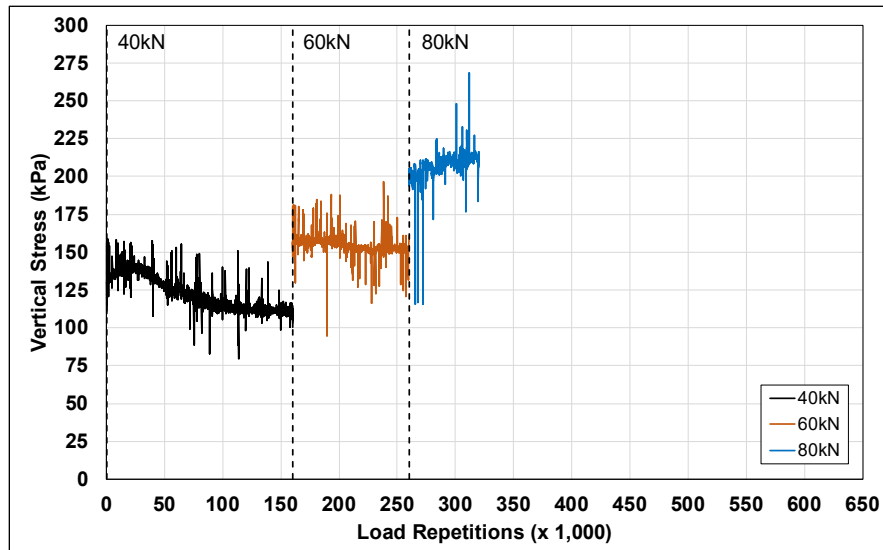
Pressure readings were stable after some initial embedment, but sensitive to load change, for the duration of the test. Increases in recorded pressures occurred after the load changes, as expected.

Figure 5.12: 704HB: Vertical pressure in the middle of the aggregate base layer.

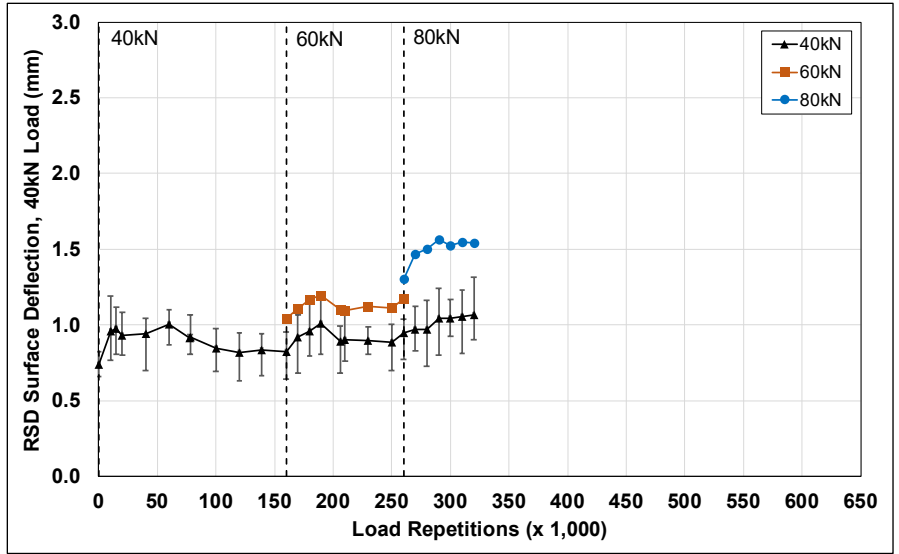
Figure 5.13 compares elastic surface deflections measured with a road surface deflectometer (RSD) under a 40 kN half-axle load. Deflections under the 60 kN and 80 kN half-axle loads are also shown. Error bars on the 40 kN load measurements indicate lowest and highest measurements along the section for that load. Deflections increased during the embedment phase of each load, as expected, but appeared to stabilize after embedment under the 40 kN and 60 kN loads, indicating that no significant permanent damage occurred in the pavement for the duration of this part of the testing. After the 80 kN load change, deflections under a 40 kN load continued to increase slowly, indicating that some permanent damage was occurring in the pavement under the higher load at the time when testing was halted. Increases in absolute surface deflection were recorded on the section under the 60 kN and 80 kN loads, as expected. The error bars show that there was limited variability in stiffness along the section.

Figure 5.13: 704HB: Surface deflection (RSD).

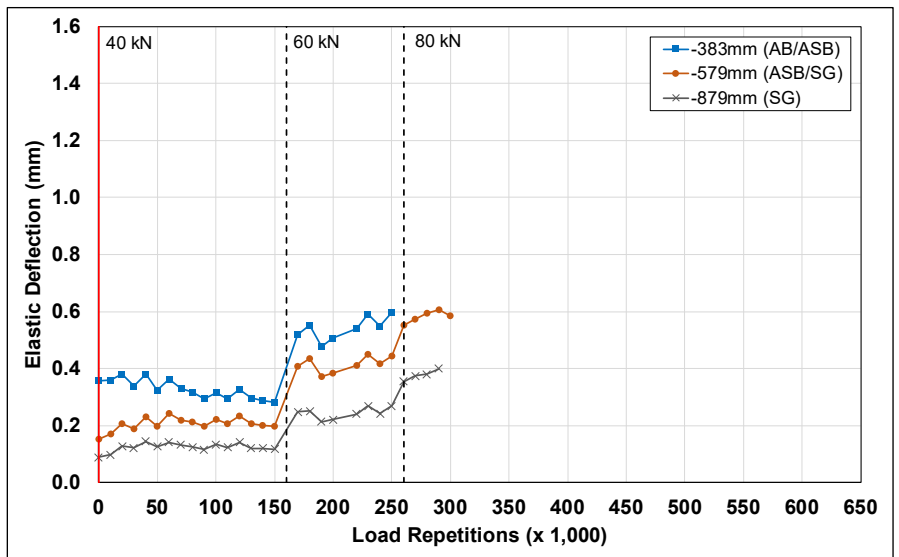
Figure 5.14 shows the history of in-depth elastic deflections measured by the LVDTs in the multi-depth deflectometer. These readings are consistent with the surface deflections measured with the RSD shown in Figure 5.13. Deflections remained stable for the duration of testing under a 40 kN wheel load.

Figure 5.14: 704HB: Elastic deflection in the underlying layers.

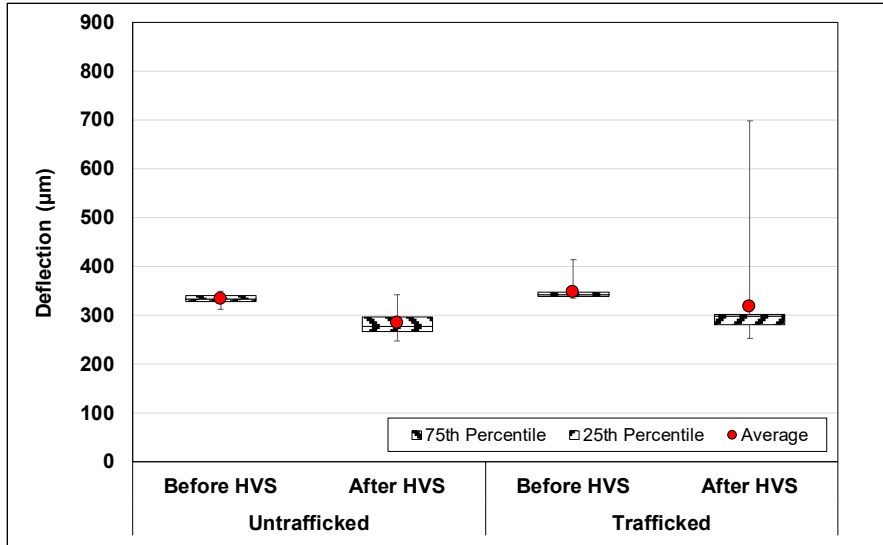
Figure 5.15: 704HB: Surface deflection (FWD).

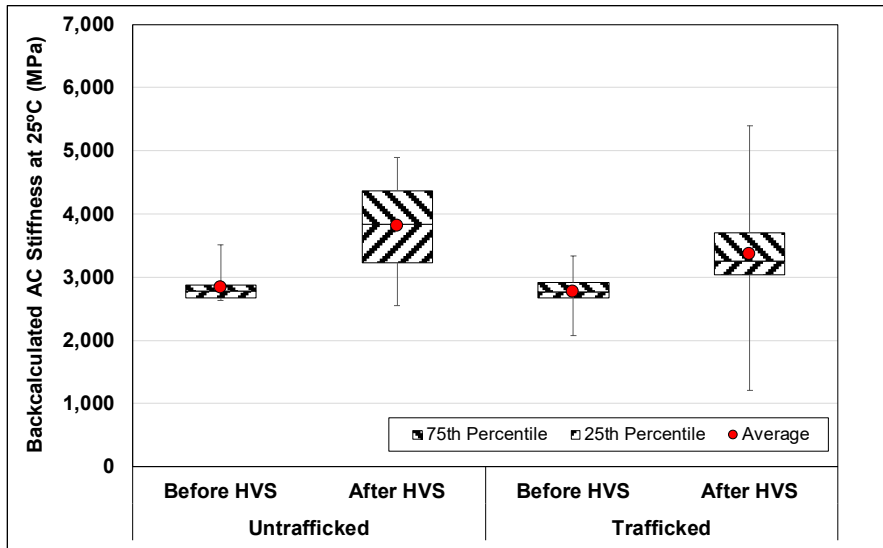
The recycled layer stiffness was backcalculated from the deflection measurements using the *CalBack* software package, and the results are summarized in Figure 5.16. Error bars represent the lowest and highest values. The average backcalculated stiffness of the RHMA-G layer (2,770 MPa) at the start of testing was lower than those of RHMA-G layers tested in previous projects (around 4,300 MPa). Average stiffness increased (about 590 MPa) after HVS trafficking, with a notable difference along the length of the section (1,200 MPa to 5,400 MPa), confirming the damage at the one end. The average stiffness of the untrafficked areas at either end of the test section also increased, consistent with the deflection measurements.

Figure 5.16: 704HB: Backcalculated stiffness of the RHMA-G layer (FWD).

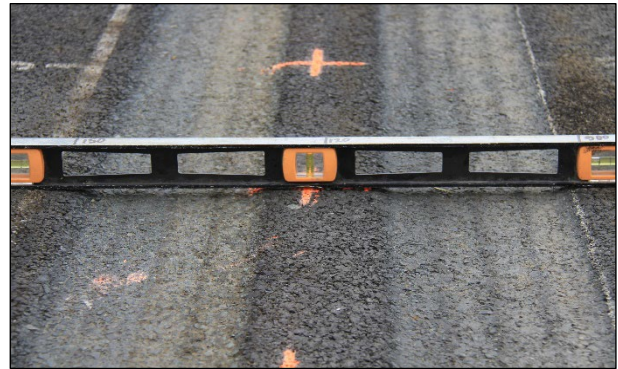
Figure 5.20: 704HB: Close-up view of surface at Station 8.

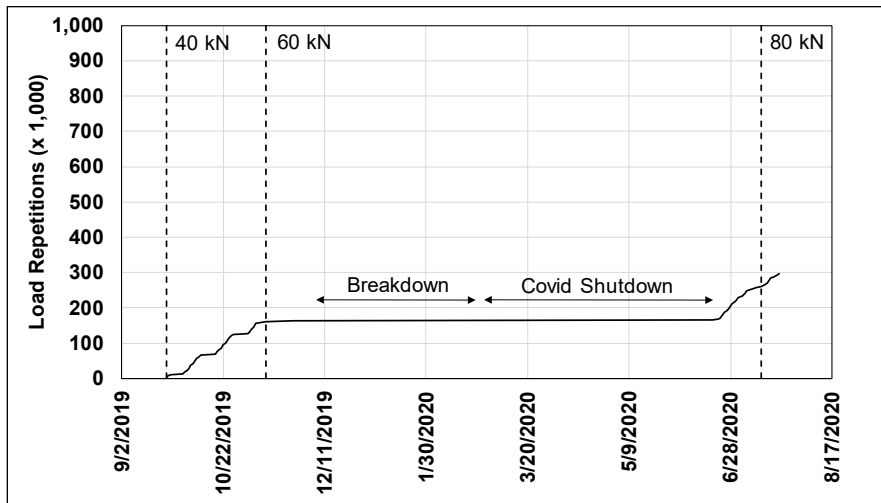
Loading commenced with a 40 kN half-axle load on September 23, 2019, and ended with an 80 kN load on July 23, 2020. A total of 300,000 load repetitions were applied and 39 datasets were collected. Load was increased from 40 kN to 60 kN after 160,000 load repetitions, and then to 80 kN after 260,000 load repetitions. The HVS loading history for Section 701HC is shown in Figure 5.23. Trafficking on this section was severely impacted, first because of a three-month breakdown resulting from a major hydraulic system failure, followed by a mandated four-month COVID-19 shutdown. It is not clear if this extended shutdown, coupled with a hydraulic oil spill, influenced the performance of the section. The test will be repeated on a new section if deemed appropriate based on an analysis of the data collected from the tests on all seven sections.

Figure 5.23: 701HC: HVS loading history.

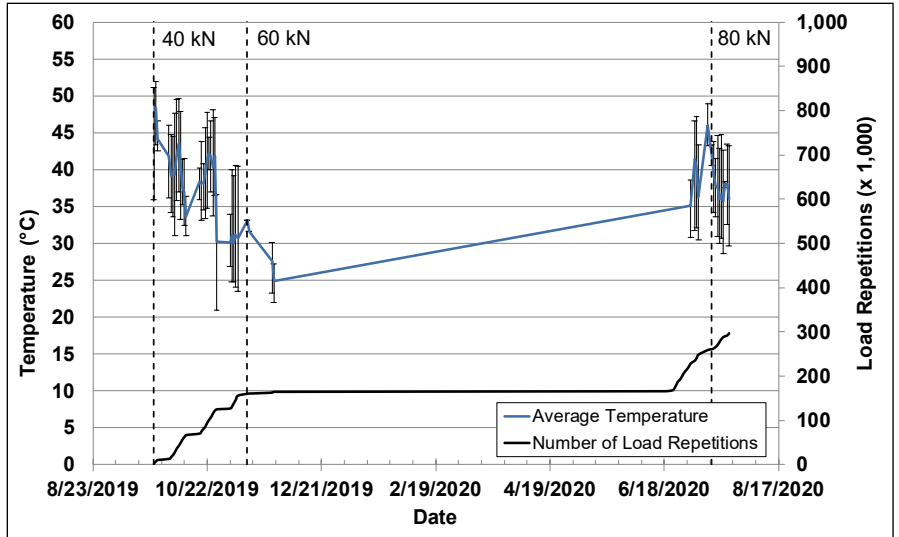
The daily 24-hour average air temperatures, measured with thermocouples attached to either side of the HVS environmental chamber above the heaters and calculated from the hourly temperatures recorded during HVS operations, are shown in Figure 5.25. Vertical error bars on each point on the graph show the daily temperature range. During the test, air temperatures inside the environmental chamber ranged from 21.0°C to 52.0°C (≈70°F to 126°F) with an average of 38.1°C (≈100.6°F) and a standard deviation of 5.7°C (≈10.3°F). Air temperature was automatically adjusted with heater settings to maintain a pavement temperature of 50±2°C at a pavement depth of 50 mm. The recorded pavement temperatures discussed in Section 5.4.3 indicate that the inside air temperatures were adjusted appropriately to maintain the required pavement temperature.

Figure 5.25: 701HC: Daily average air temperatures inside the environmental chamber.

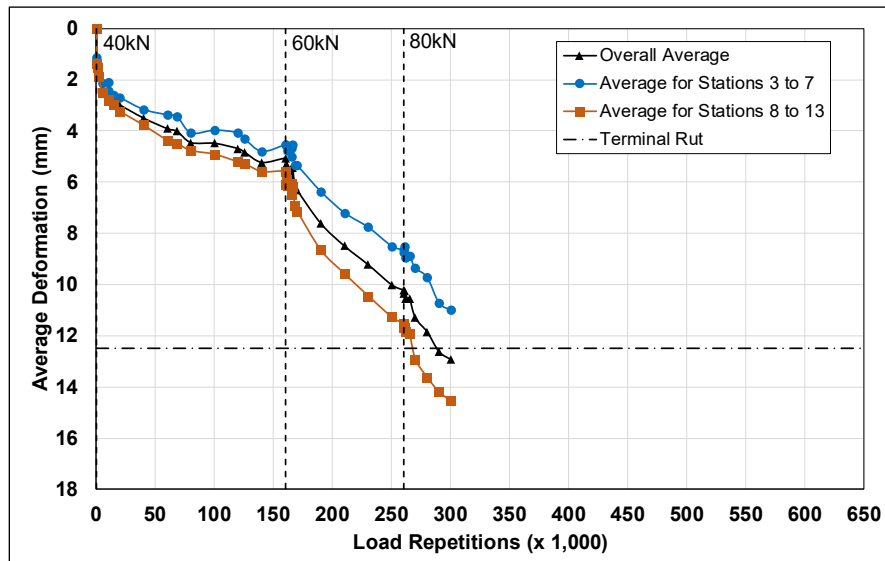
Figure 5.29: 701HC: Average deformation.

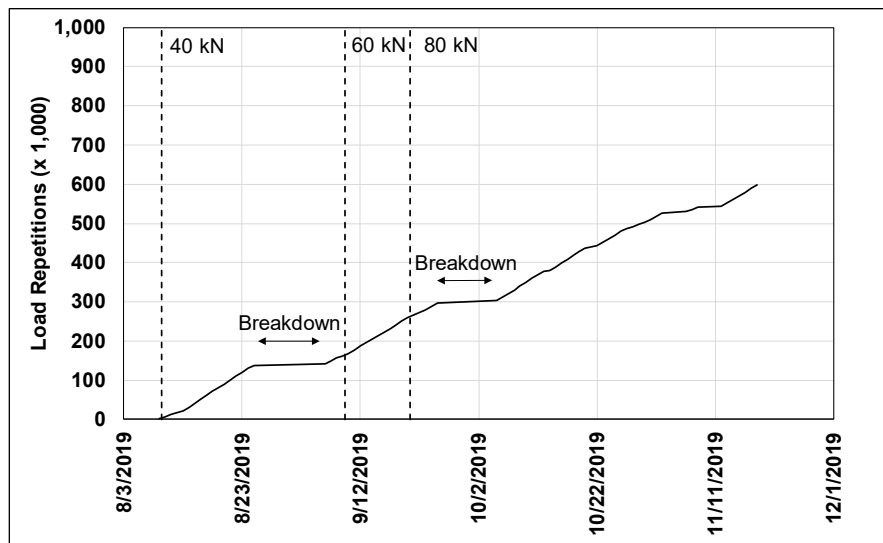
Figure 5.44: 700HB: HVS loading history.

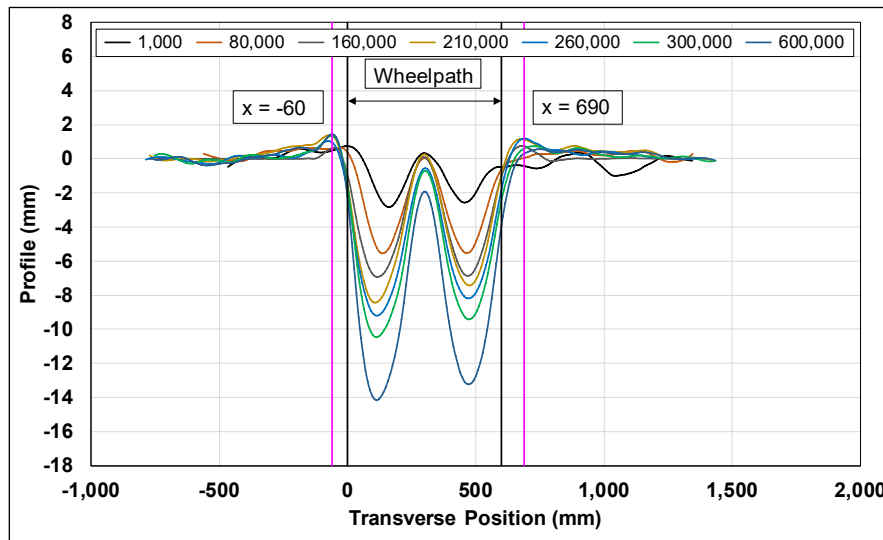
Figure 5.48: 700HB: Profilometer cross section at various load repetitions.

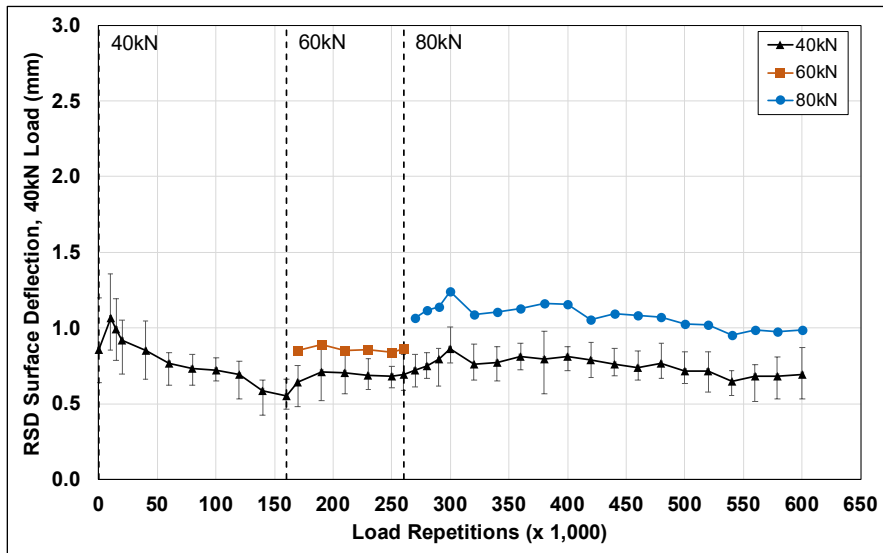
Figure 5.55: 700HB: Surface deflection (RSD).

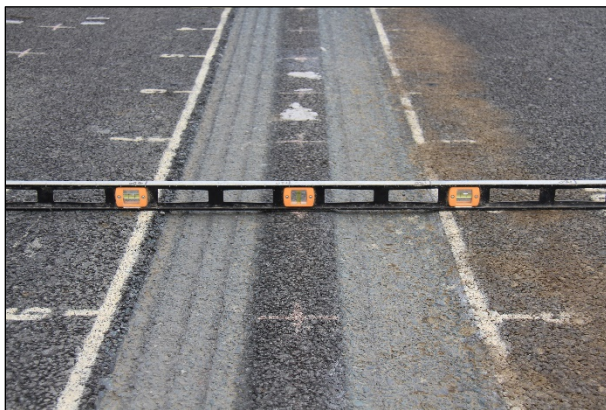
Figure 5.61: 700HB: View of rut at Station 8.

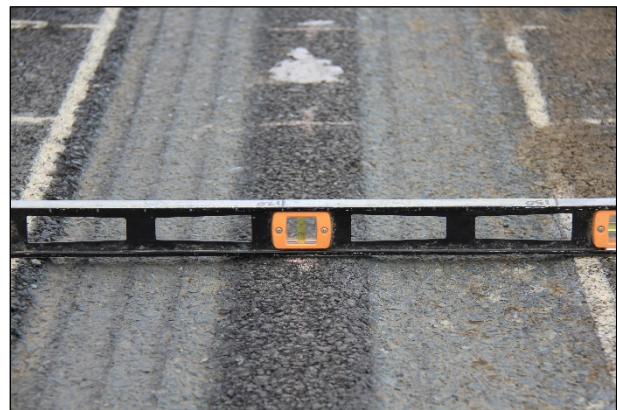
Figure 5.62: 700HB: Close-up view of test section surface at Station 8.
