FRACTURE TOUGHNESS OF PRECIPITATION HARDENING ALUMINUM ALLOYS

David Eugene Porter
(Ph. D. Thesis)

April 1969

LAWRENCE RADIATION LABORATORY
UNIVERSITY of CALIFORNIA BERKELEY

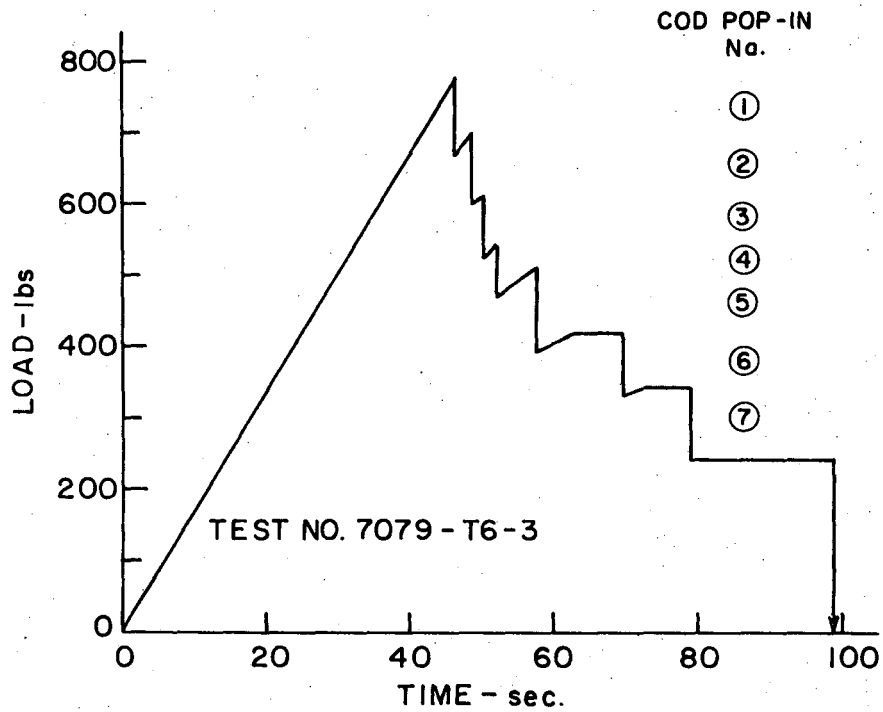
XBL 691-121

Fig. 2 The crack opening displacement gage output and load versus time records for .071 in. thick 7079-T6 aluminum large SEN fracture specimen.

The results of an instrumented fracture tests of commercial 7079-T6 aluminum are given first to illustrate how a commercial material behaves. These results are shown in Figs. 2 and 3, and Table 2. In Fig. 3, and all similar figures, the vertical lines are timing lines that are 1 second apart. The numbers along side the timing lines at the top of the oscillogram refer to the approximate total number of seconds from the start of the tests. Once the time of an event is established, then the properties corresponding to the event can be found by referring to the appropriate figure or table. The first pop-in (No. 1) of Fig. 2 is a good example to illustrate the properties corresponding to an event. The pop-in occurred at 46.5 seconds. This corresponded to a stress wave in Fig. 3 which has saturated the recording system. The saturation condition

was evident because of the absence of the normal exponential decay of the wave and the fineness of the line following the wave. Table 2 shows that the stress intensity (K) for the initiation of the crack growth was 40.6 ksi $\sqrt{\text{in}}$. The crack had jumped 0.130 in. during the pop-in.

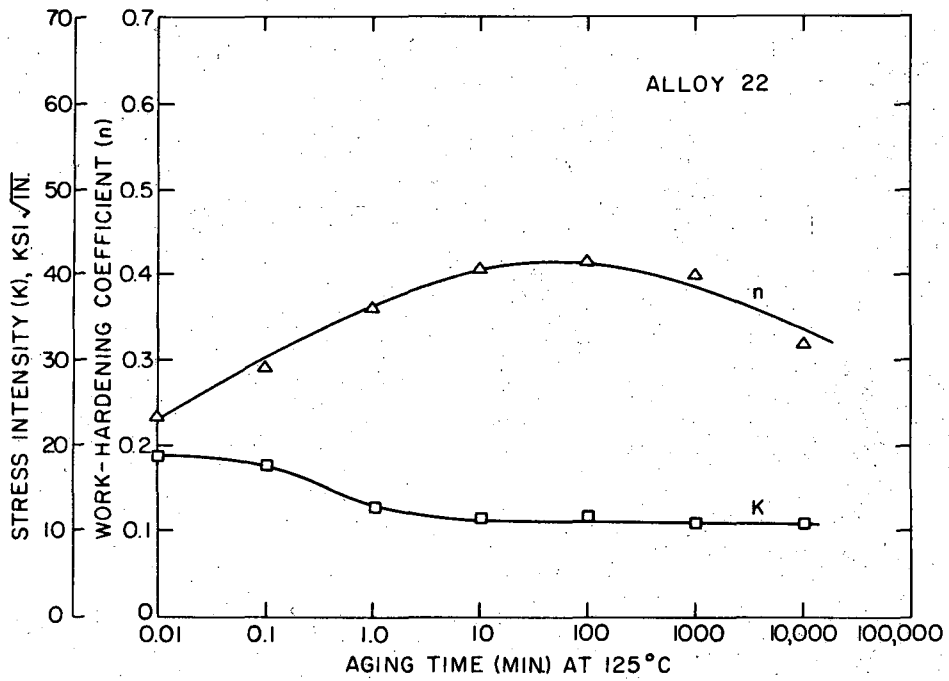
XBL 693-345

Fig. 4 The mechanical properties of alloy 22 (Al-6.8% Zn) as a function of aging time at 125°C.

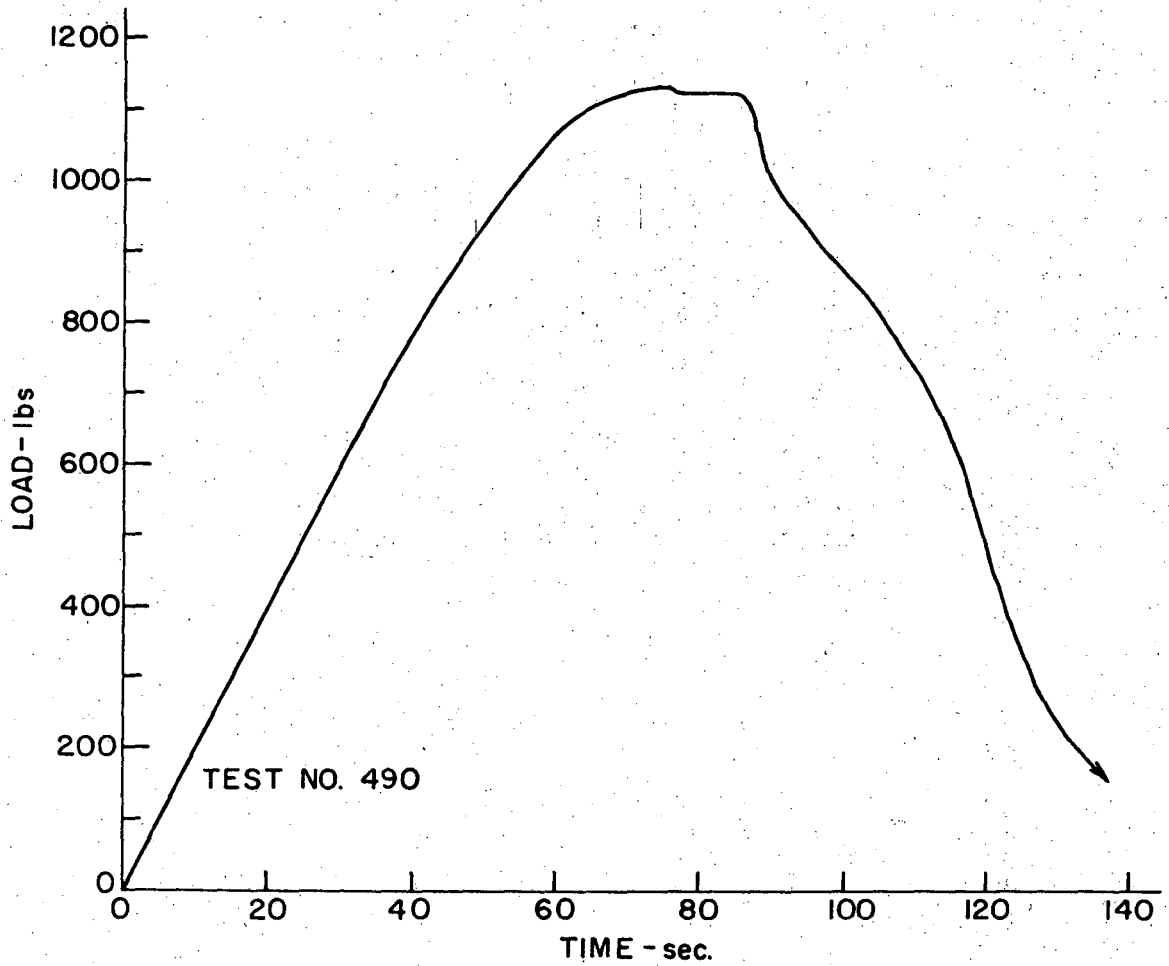
XBL 691-120

Fig. 7 Load versus time curve for a large SEN fracture specimen of alloy 24, solution treated and aged at room temperature for 30 min. Tested at 0.039 in./min.

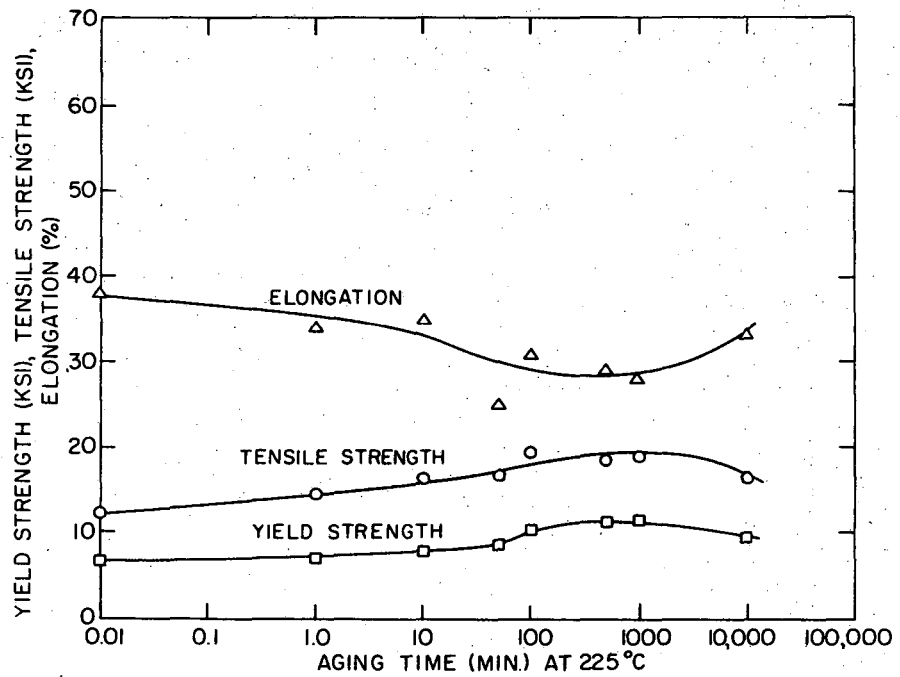
XBL 693-350

Fig. 18 The mechanical properties of alloy 27 (Al-4.76% Ag) as a function of aging time at 225°C.

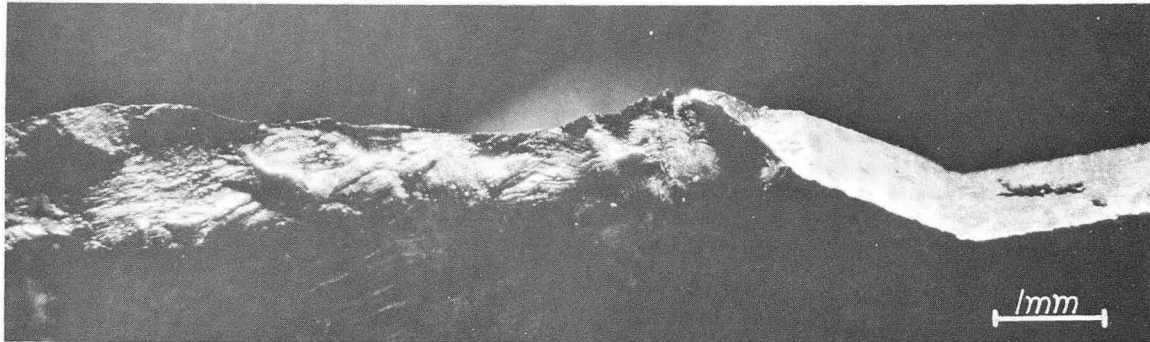
Fig. 59 Scanning electron fractographs of alloy 26, solution treated and aged:

- (a) to (f) 30 min. at room temperature, (c) same areas as (b),
- (e) and (f) same area as (d).
- (g) to (i) 1000 min. at 125°C.

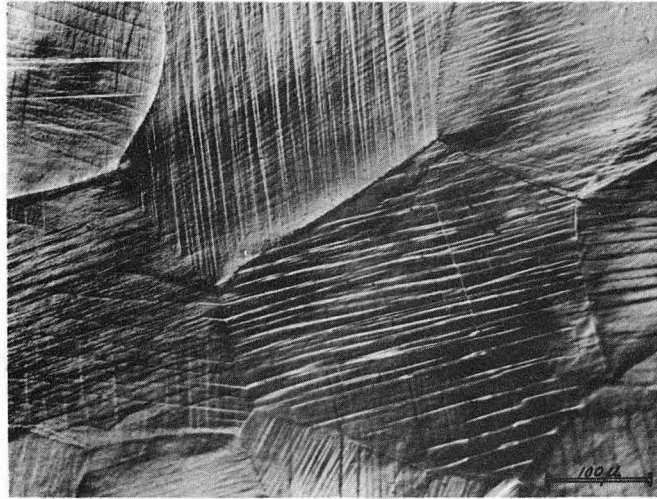
Fig. 77 Micrographs showing the plastic zone for alloy 29, solution treated and aged 100 min. at 225°C . The optical micrograph (b) and the scanning electron micrographs (c) and (d) are taken from plastic zone shown in (a).

comparing distribution of slip lines in neighboring grains, Figs. 76(a) and 78(a). The plastic zone size of the Al-Zn alloy in peak aged and overaged condition (Fig. 74) may be compared to that found in alloy 29 in the peak aged condition (Fig. 77). (Scanning electron micrographs of the first plastic zone in Fig. 74(a) are shown in Fig. 74.) The calculated plastic zone size for the overaged Al-Zn and the peak aged Al-Ag specimens is the same (0.35 in.) and nearly equal to the measured size for peak aged Al-Ag alloy (0.37 1/2 in.).* The micrographs show that the deformation is more uniformly distributed in the case of Al-Ag alloys and as a result these alloys should be expected to be much tougher. (Note: the grain rotation in Fig. 75(c) and the crack at the interface of the plastic zone in Figs. 75(a) and (e).)
