In situ crack mapping of large-scale self-sensing concrete pavements using electrical resistance tomography

# In Situ Crack Mapping of Large-Scale Self-Sensing Concrete Pavements using Electrical **Resistance** Tomography

Sumit Gupta<sup>1</sup>, Yun-An Lin<sup>1</sup>, Han-Joo Lee<sup>2</sup>, Jeff Buscheck<sup>3</sup>, Rongzong Wu<sup>3</sup>, Jerome P. Lynch<sup>4</sup>, Navneet Garg<sup>5</sup>, and Kenneth J. Loh<sup>1,2,\*</sup>

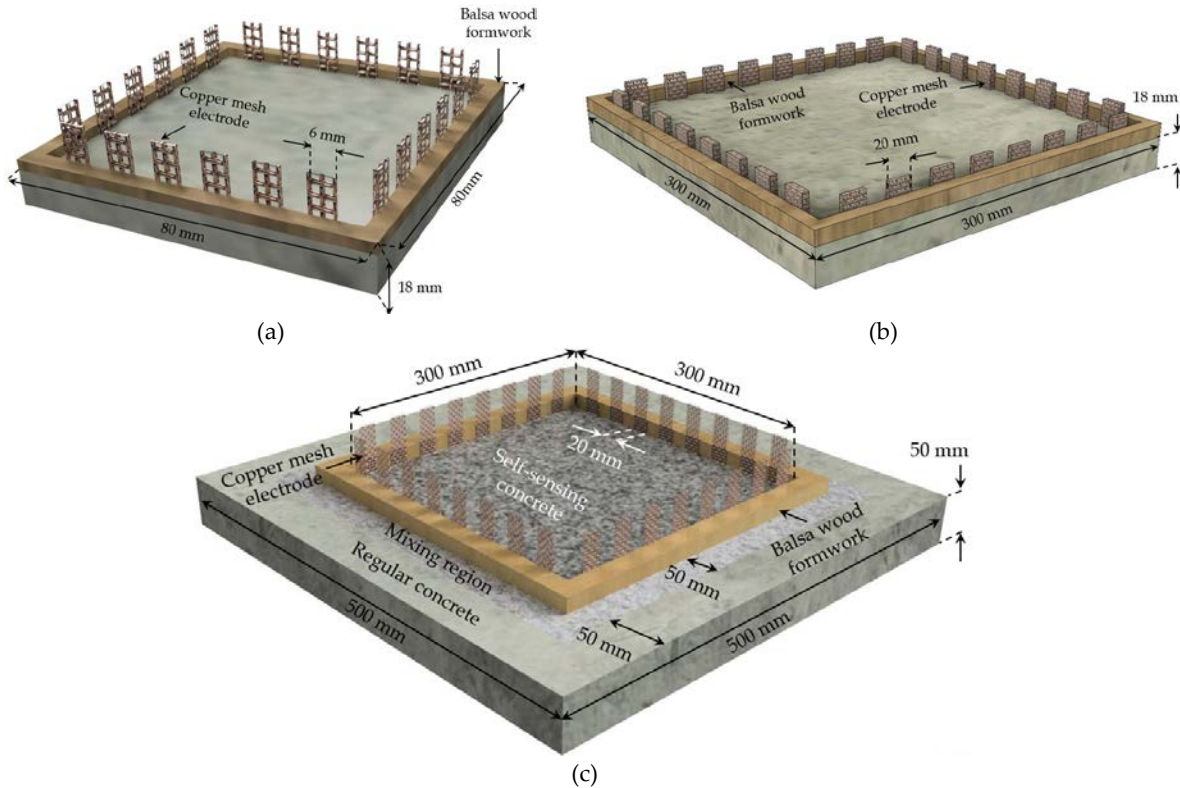
Figure 1. Concrete specimens of different sizes were cast for validating spatial damage detection in the laboratory. Schematics of self-sensing concrete specimens of sizes (a)  $80 \times 80 \times 18 \text{ mm}^3$  with 24 boundary electrodes (Type A) and (b)  $300 \times 300 \times 18 \text{ mm}^3$  with 32 boundary electrodes (Type B) are shown. (c) A  $500 \times 500 \times 50 \text{ mm}^3$  concrete specimen with a  $300 \times 300 \text{ mm}^2$  sensing area at the center was also cast to simulate embedding self-sensing concrete regions in plain concrete.

Plate specimens were cast in customized poly(vinyl chloride) (PVC) molds for laboratory validation of spatial damage detection. Three sample sets of different sizes were made: Type A,  $\sim 3.15 \times 3.15 \times 0.7$  in<sup>3</sup> (80×80×18 mm<sup>3</sup>) (Fig. 1a); Type B,  $\sim 12 \times 12 \times 0.7$  in<sup>3</sup> (300×300×18 mm<sup>3</sup>) (Fig. 1b); and Type C,  $\sim 20 \times 20 \times 2$  in<sup>3</sup> (500×500×50 mm<sup>3</sup>) (Fig. 1c). Type A specimens were instrumented with 24 equidistantly spaced boundary electrodes, while the others used 32 boundary electrodes arranged in 6×6 and 8×8 square patterns, respectively. The electrodes were copper mesh strips, which were arranged accordingly on balsa wood formworks to hold them in place during casting (Fig. 1). The length of the electrodes was slightly longer than the specimen's thickness for measurement purposes. Then, the formwork with the electrodes was placed in the PVC mold, while the inner walls of the mold were oiled with WD-40 so that the specimens could be easily removed after casting. The joints of the mold were sealed with white petrolatum.

Casting began by pouring the concrete mix into molds (with the balsa wood formwork and electrodes). Types A and B specimens were cast using only the self-sensing concrete mix. Type C specimens were cast with plain concrete (*i.e.*, without coated aggregates) surrounding self-sensing concrete, which simulated the embedment of a self-sensing region within a large pavement section in the field (Fig. 1c). Fabricating these Type C specimens required using an extra temporary mold for containing the inner self-sensing concrete region, which was a 2-mm-thick hollow metal sheet box. After simultaneously pouring the self-sensing concrete mix in the inner region and plain concrete around it, the inner mold was removed after  $\sim 5$  min after pouring; doing so allowed both types of concrete to mix at the interface. For all the sample sets, the specimens were wrapped with plastic (to minimize water evaporation and microcracks) and kept in the lab

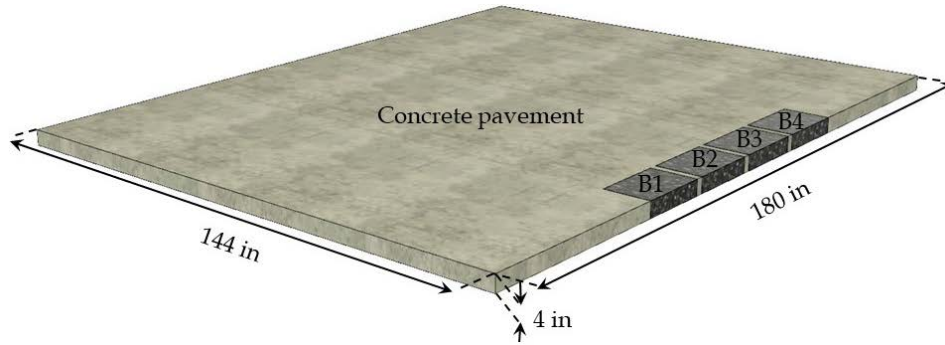
Figure 2. A  $15 \times 12 \text{ ft}^2$  ( $4.6 \times 3.7 \text{ m}^2$ ) concrete airport pavement slab was cast for accelerated pavement testing. B1, B2, B3, and B4 are the four self-sensing concrete regions located along one of the longitudinal edges of the slab.

A  $15 \times 12 \text{ ft}^2$  ( $4.6 \times 3.7 \text{ m}^2$ ) concrete pavement slab (Fig. 2) was cast at the University of California Pavement Research Center (Davis, California) for HVS accelerated pavement testing (APT). Four  $18 \times 12 \times 4 \text{ in}^3$  ( $0.46 \times 0.30 \times 0.10 \text{ m}^3$ ) self-sensing concrete regions (*i.e.*, B1, B2, B3, and B4) were cast along a longitudinal edge of the slab as shown in Fig. 2, while the remainder of the slab was normal concrete. The locations of B1 to B4 were selected according to where damage would most likely occur. The same mix design described in Section 3.1 was used.

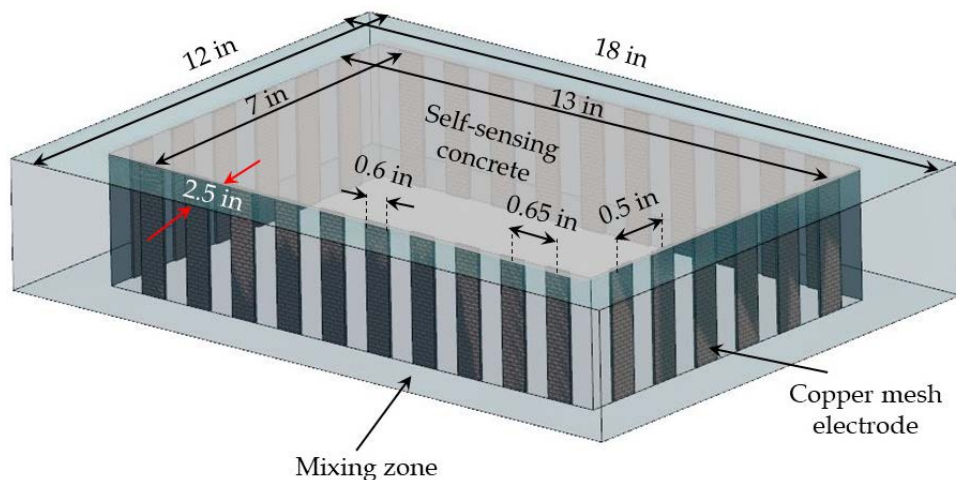
Figure 3. An illustration and the dimensions of the self-sensing concrete block casted as part of the full-scale airport pavement slab are shown. The electrodes were arranged in a  $10 \times 6$  rectangular pattern in the wooden mold.

Prior to casting, each self-sensing concrete regions was separated from its surrounding using a rectangular wooden mold of size  $18 \times 12 \times 4 \text{ in}^3$  ( $\sim 450 \times 300 \times 100 \text{ mm}^3$ ). Fishing wires were routed in the mold for facilitating electrode placement and for securing their position during casting. These wires were slightly displaced from the edges of the mold to provide room for normal and self-sensing concrete to mix during casting, similar to the procedure used when casting Type C specimens. As in Section 3.3.1, electrodes were prepared by cutting copper mesh to form  $0.6 \times 3 \text{ in}^2$  ( $15 \times 75 \text{ mm}^2$ ) rectangular strips. They were arranged in a  $10 \times 6$  rectangular pattern and mounted onto fishing wires (Fig. 3). The electrodes were slightly shorter than the thickness of the pavement so that they could be completely embedded in concrete. Shielded multi-strand electrical wires (22 American Wire Gauge) were soldered to the bottom of the copper

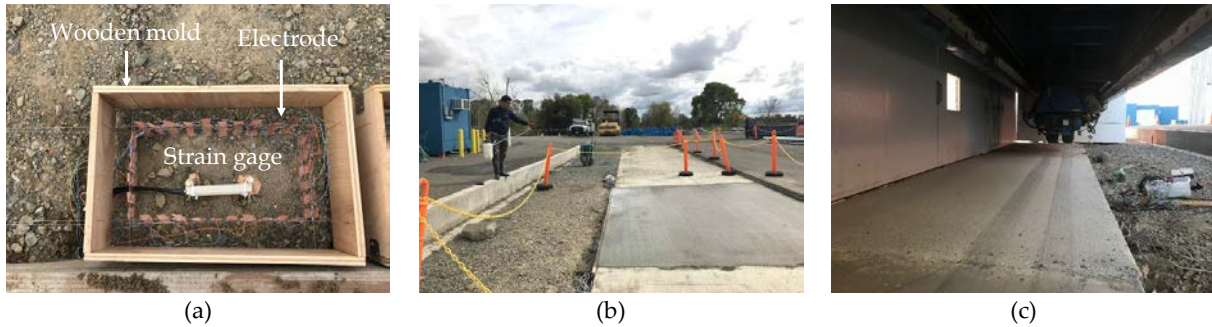
Figure 4. (a) The wooden mold for casting the self-sensing concrete regions, along with the electrodes mounted on fishing wires and strain gages, are shown. The picture of concrete slab (b) immediately after casting and (c) after 28 days of curing are shown.

After the molds, electrodes, and strain gages were prepared, the entire concrete slab was cast. First, self-sensing concrete was mixed on-site with a  $9 \text{ ft}^3$  ( $0.25 \text{ m}^3$ ) Multiquip mixer. The self-sensing concrete mix was poured into the wooden molds and consolidated with a poker vibrator. Second, and at the same time, plain concrete (Syar Concrete LLC.) was poured directly from a cement mixer truck in the remaining area and consolidated. Then, the wooden molds around the self-sensing concrete regions were removed, where the two different concrete mixes were allowed to naturally mix at the interface. The final step entailed smoothing the slab surface followed by spraying of a curing compound to minimize water evaporation and subsequent microcracks. A picture of the slab immediately after casting is shown in Fig. 4b. The concrete was cured for 28 days; Fig. 4c shows a picture of the cured slab.

slab during trafficking. As a result, one of the wheels passed right over the self-sensing concrete blocks during trafficking (Fig. 4c). The HVS was commanded to apply a total of 17,000 cycles of loading on the pavement, with the applied carriage load gradually increasing from 25 kN to 100 kN based on the schedule listed in Table 2. After every 1,000 cycles of loading, the HVS was paused, and **ERT** measurements of all four self-sensing concrete regions were acquired. The locations of surface cracks, if any, were also manually marked after every 1,000 cycles. It should be mentioned that the **ERT** measurements were recorded during sunny and dry weather so that the effect of moisture on the **ERT** results could be minimized.

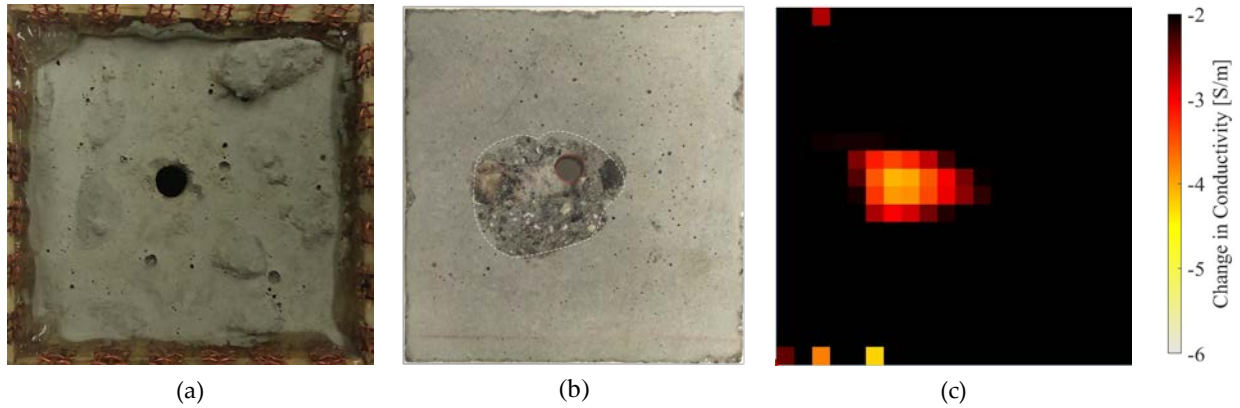
Figure 5. (a) Damage was introduced in an  $80 \times 80 \times 18$  mm<sup>3</sup> Type A self-sensing concrete specimen by drilling a 6.25-mm-diameter hole near the center. (b) Spalling has occurred on the back-side of the concrete specimen. (c) The change in conductivity distribution with respect to its undamaged state was calculated using ERT.

First, as mentioned in Section 3.4.1, a 6.25-mm-diameter hole was drilled at the center of Type A specimens (Fig. 5a). **The FEM for **ERT** conductivity reconstruction of Type A specimens used 400 bilinear quadrilateral elements.** The hole was drilled through the specimen's thickness starting from its front-side (*i.e.*, the face with access to the electrodes). During drilling, minor spalling of concrete occurred on the **backside** near the drilled location, as is highlighted in Fig. 5b. Fig. 5c shows the corresponding **ERT**-estimated change in spatial conductivity distribution (with respect to the undamaged baseline), and a negative change in conductivity was observed at the center. This was expected since the drilled hole removed material, which reduced conductivity at the damaged region. The shifting of the predicted damage spot towards the left was due to spalling of self-sensing concrete at the **backside** of the specimen. Overall, the shape of the damage as indicated by the **ERT** conductivity map (Fig. 5c) closely resembled the actual shape of the damage shown in Fig. 5b. Low SNR observed in Fig. 5c was probably due to the lowest damage sensitivity of the central region of the **ERT** specimen caused by the diffusive nature of the injected current. In addition to validating the proposed system's damage detection capability, this result demonstrated its potential to identify a subsurface defect that was not visible from the front-side of the concrete specimen.

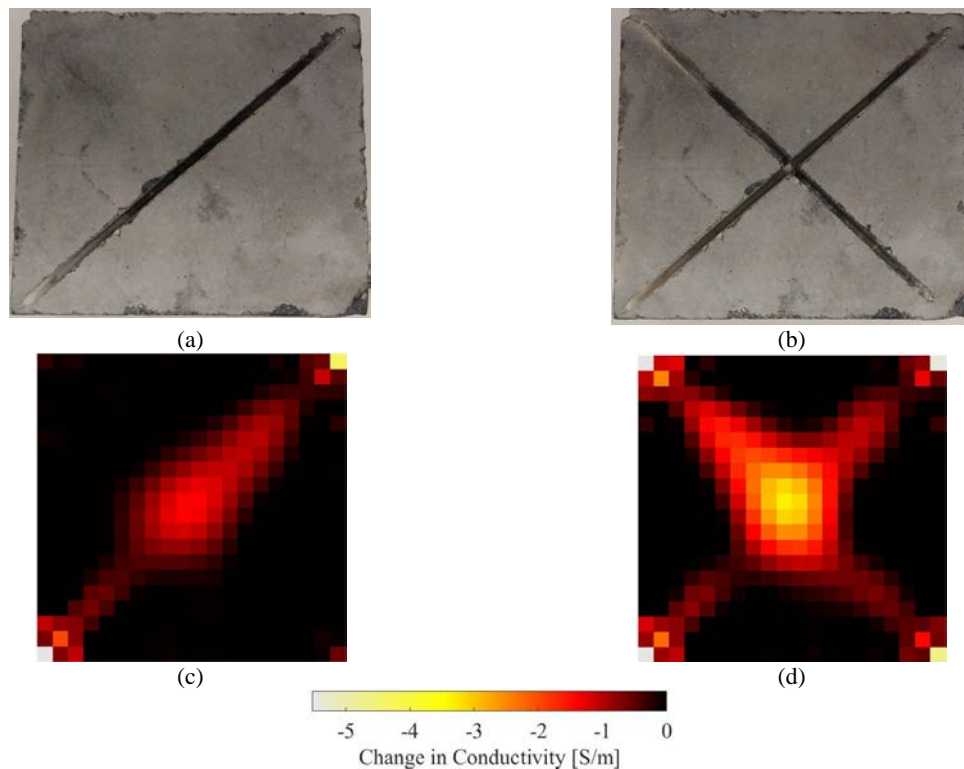
Figure 6. (a) A diagonal cut was made on the backside of a  $80 \times 80 \times 18$  mm<sup>3</sup> Type A self-sensing concrete specimen to create the first damage state, (b) followed by another orthogonal cut to create the second damage state. The ERT results successfully characterized the (c) single and (d) double diagonal cuts.

Another experiment was performed on Type A specimens to validate crack detection using **ERT**. The specimen was subjected to damage by cutting grooves along its diagonals (Figs. 6a and 6b). Their corresponding changes in spatial conductivity are shown in Figs. 6c and 6d, respectively. Similar to Fig. 5, a decrease in conductivity was observed along the region of the diagonal cuts. The shapes and orientation of the cuts were also successfully captured in the reconstructed conductivity maps. As mentioned in Section 3.4.1, the depth of the cut was not uniform along its length and was  $\sim 0.52$  in ( $\sim 13$  mm) near the center and  $\sim 0.20$  in ( $\sim 5$  mm) near the corners, with an average width was  $\sim 0.28$  in ( $\sim 4.5$  mm). As a result, the magnitude of conductivity change (decrease) was greatest at the center and gradually lessened toward the ends of the diagonals. Despite identifying the location, shape, size, and severity of the cracks, blurriness in the reconstructed conductivity maps was observed. This could have resulted as the electrical current could not thoroughly propagate between two opposite electrodes due to the closely-spaced cracks [50]. The sharpness of the **ERT** images can be enhanced by increasing the number of boundary electrodes, thereby collecting more voltage measurements at the boundary.

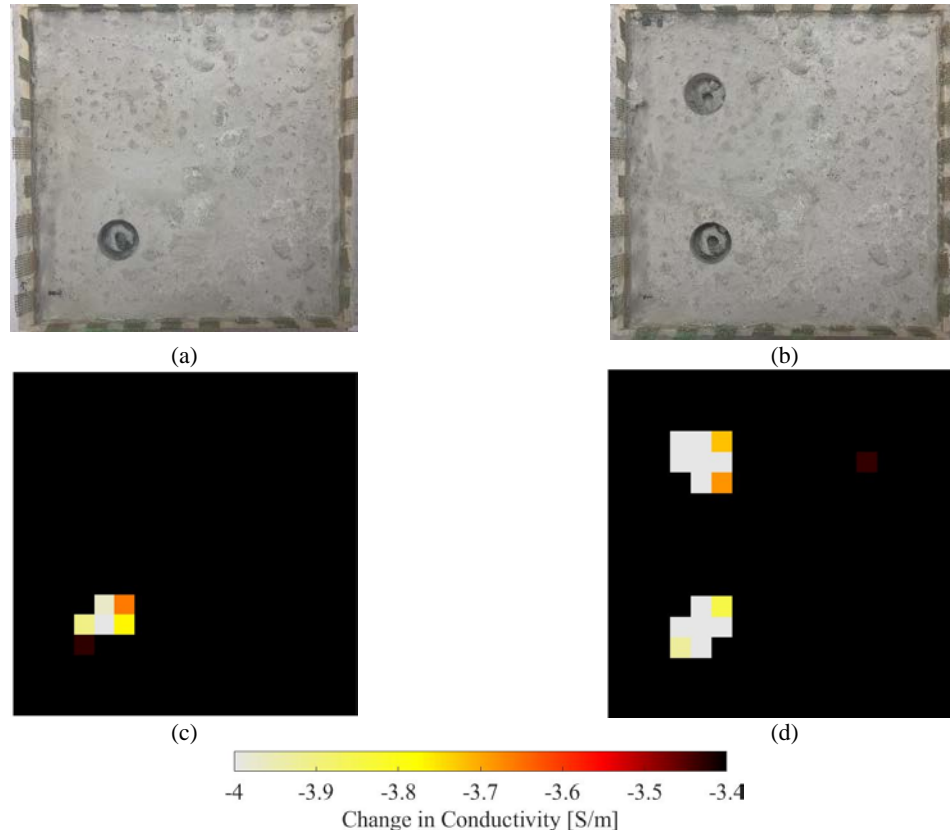
Figure 7. Two 25-mm-diameter holes were drilled at the (a) bottom-left and (b) top-left corner of the Type B specimen. The corresponding changes in conductivity are shown in (c) and (d) respectively.

Second, holes were drilled near the bottom-left and top-left corners of Type B specimens, while ERT datasets were acquired after each new damage state. The FEM for ERT conductivity reconstruction of Type B specimens used 289 bilinear quadrilateral elements. Figs. 7a and 7b show pictures of the same specimen after each hole was drilled. The corresponding changes in conductivity obtained by solving the ERT inverse algorithm are presented in Figs. 7c and 7d, respectively. Like the previous cases, ERT successfully identified the sizes and locations of these damage features. Significant decreases in electrical conductivity at the locations of drilled holes were observed due to the severity of damage (*i.e.*, through-holes). In principle, these through-holes have zero conductivity or an infinite change in resistivity with respect to the pristine state. However, infinite resistivity cannot be mathematically represented nor could an extremely

large value be estimated by **ERT** due to regularization. Nevertheless, these results demonstrate that **ERT** can be implemented on self-sensing concrete specimens as large as  $1 \times 1 \text{ ft}^2$ .

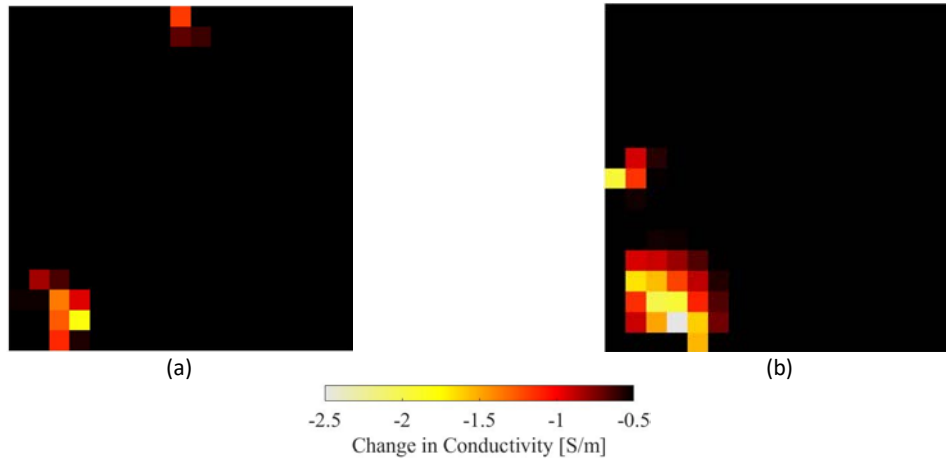
Figure 8. (a) A partial hole was drilled at the bottom-left corner of a Type C specimen, and its corresponding change in conductivity distribution relative to its undamaged state is shown. (b) The hole was then completely drilled through the thickness, and the ERT result shows a greater change (decrease) in conductivity where the hole was drilled.

The last laboratory experiment was performed using a Type C specimen, and the purpose was to validate detection of progressive damage. First, a hole was drilled at the bottom-left corner of the specimen to only half the specimen thickness (*i.e.*,  $\sim 25\text{-mm}$ -deep). **The FEM for ERT conductivity reconstruction of Type C specimens used 1,092 bilinear quadrilateral elements.** The corresponding **ERT** result is shown in Fig. 8a. Next, hole depth was extended by drilling through the entire thickness. **ERT** measurements were again acquired for conductivity reconstruction. The **ERT** conductivity map of Fig. 8b not only correctly showed the location of the damage but also an appropriate greater change in conductivity. This result was expected since conductivity changes would be greater with increasing damage severity. Overall, the results of Fig. 8 validate that **ERT** could characterize progressive damage in larger self-sensing concrete specimens.

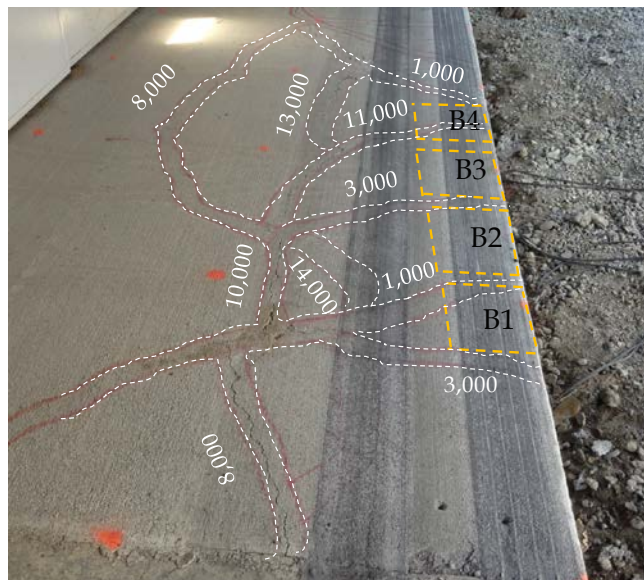
Figure 9. The picture of the damaged concrete pavement slab after 17,000 cycles of HVS testing shows the locations of the four self-sensing concrete regions. Cracks were marked at the end of each 1,000-cycle period as they appeared.

As mentioned in Section 3.2, HVS accelerated pavement tests were conducted on a full-scale concrete airport pavement slab with four embedded self-sensing concrete regions. A final picture of the damaged pavement slab after 17,000 cycles of loading is shown in Fig. 9. The locations of the self-sensing concrete regions B1 to B4 are also outlined. Cracks were also manually marked on the slab after every 1,000 cycles of loading (Fig. 9), during which ERT tests were also performed. The number of cycles after when these cracks appeared are also indicated in Fig. 9.

shown in Figs. 10a to 10h. This location coincides with the first crack that appeared after 1,000 cycles of loading, as is also marked in Fig. 9. The similarity of the conductivity maps in Figs. 10a to 10h suggests that this crack did not propagate significantly during the first 8,000 cycles of loading.

Although no surface cracks passed through B2 and B3 (Fig. 9), some conductivity changes were recorded in these regions, as shown in Figs. 11 and 12. However, the locations of these conductivity changes were slightly inconsistent between consecutive loading stages. It was also observed that the magnitude of the conductivity changes shown in Figs. 11 and 12 were much lower than those in Fig. 10. Such low-magnitude conductivity changes could occur due to measurement noise.

It can be seen from Fig. 9 that a surface crack appeared after 11,000 loading cycles in the middle of the bottom edge of B4. The location of the crack coincided with the conductivity changes shown in the corresponding **ERT** conductivity maps (Fig. 14k). In fact, the crack appeared immediately after significant

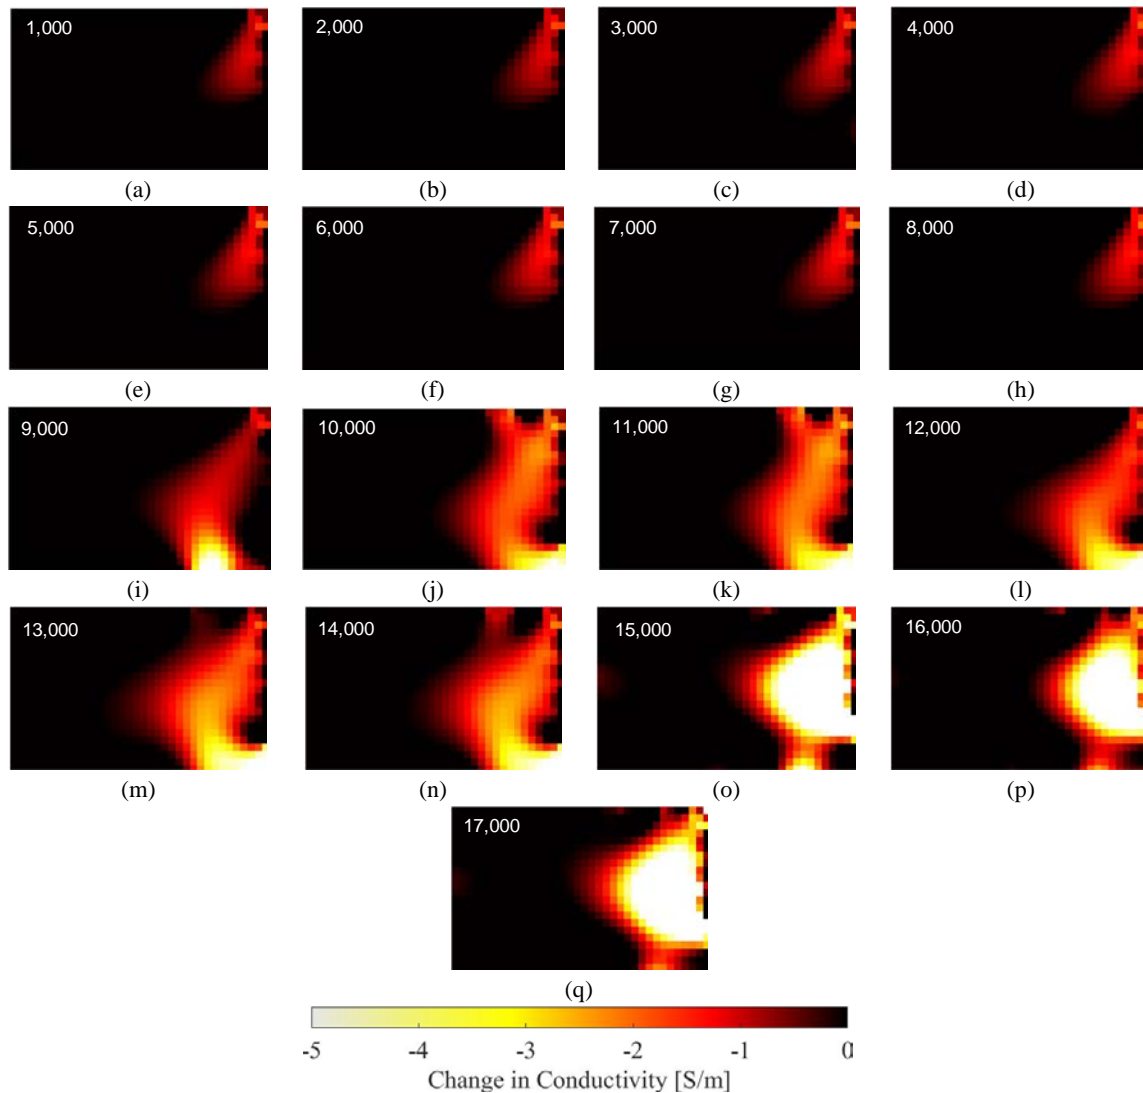
Figure 10. (a) to (q) The **ERT** results show the change in conductivity distribution (with respect to its undamaged baseline) of self-sensing concrete region B1 after the HVST testing to different loading cycles (as highlighted in each image).

Fig. 10 presents the reconstructed change in electrical conductivity distributions of self-sensing concrete region B1 after every 1,000 loading cycles of HVS APT. The number at the top left corner of each image corresponds to the number of cycles applied. A negative change in conductivity was observed near the top-right corner of B1 early in the tests, and it remained approximately the same size and magnitude as

However, further decreases in conductivity at the damaged location was captured by **ERT** with additional loading cycles, as are shown in Figs. 10i to 10q. As mentioned in Table 2, the load was increased to 80 kN after 9,000 cycles. It can be inferred that the crack propagated and widened from 8,000 to 17,000 cycles due to fatigue and the higher intensity of loads applied, which resulted in more significant changes in electrical conductivity in that region. Unfortunately, **ERT** was unable to capture the final shape of the crack marked on the surface of B1 (Fig. 9). Rather, an intense change in conductivity was observed near the right edge. This phenomenon can be potentially attributed to the presence of another severe subsurface crack near this region (as suggested by the **ERT** results from Figs. 10o to 10q) that masked the surface crack observed in Fig. 9.

In all the results described above (*i.e.*, Figs. 10, 11, 12, and 14), amplified conductivity changes near the boundaries were observed, especially during high intensity loading. For example, instead of capturing the observed crack's correct shape and path, the ERT results shown in Fig. 10 indicated an intensified change in conductivity near the right edge (Figs. 10i to 10q). In Figs. 11 and 12, some conductivity changes were observed only near the electrodes, although no such defects were observed on the concrete surface. In the case of B4, from 15,000 to 17,000 cycles, ERT failed to produce any meaningful results (Figs. 14o to 14q). It is possible that all such conductivity changes were observed due to the failure of certain electrodes inside the self-sensing concrete regions, thus producing spurious voltage measurements and inaccurate reconstructed conductivity maps. This hypothesis warrants future testing explicitly focusing on the

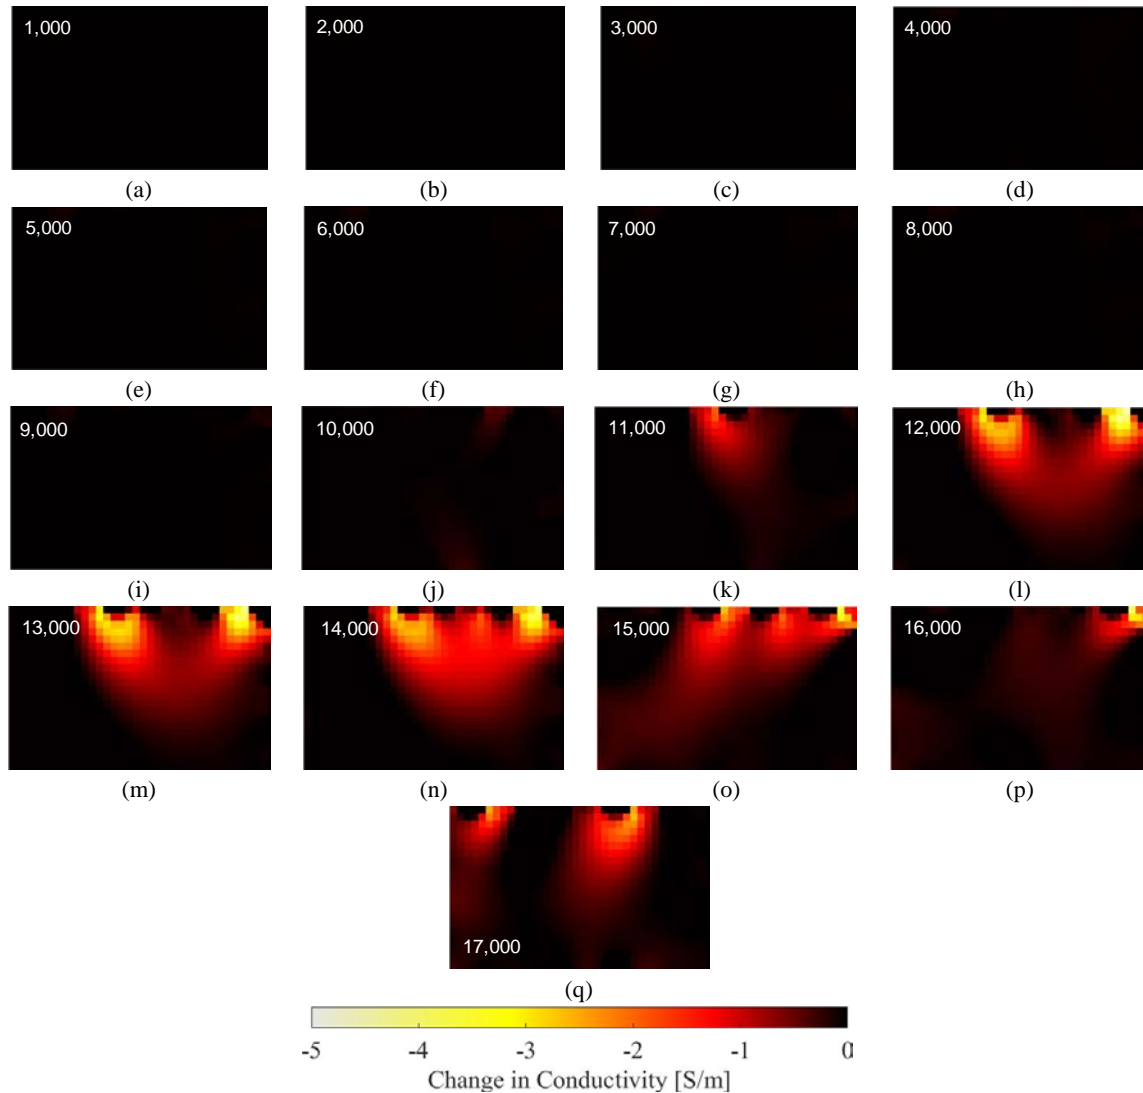
Figure 11. (a) to (q) These ERT results present the conductivity changes experienced by B2 at after different cycles of loading.

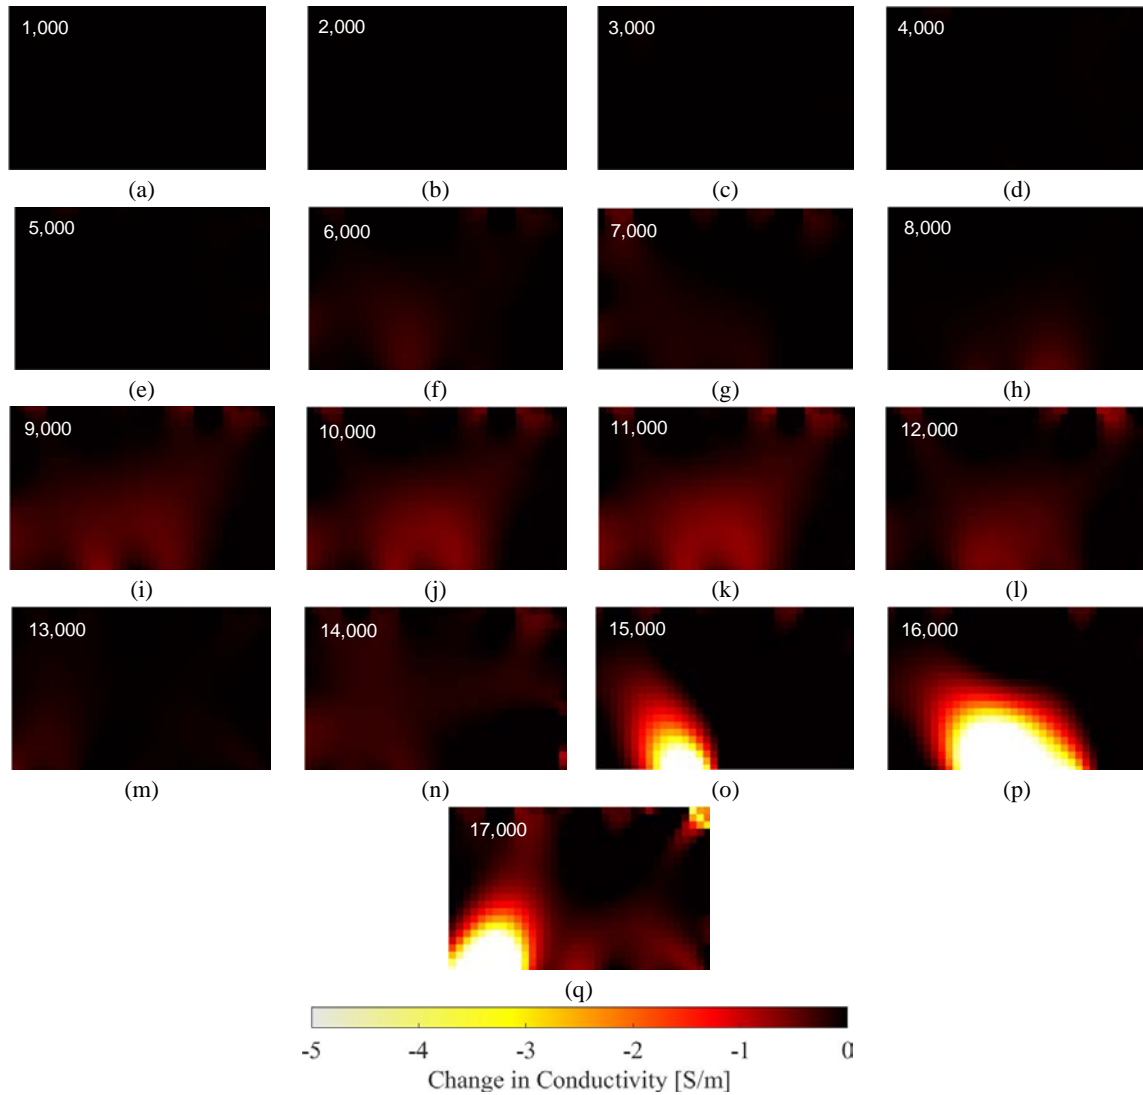
Figure 12. (a) to (q) The **ERT** results present the conductivity changes experienced by B3 after different stages of loading.

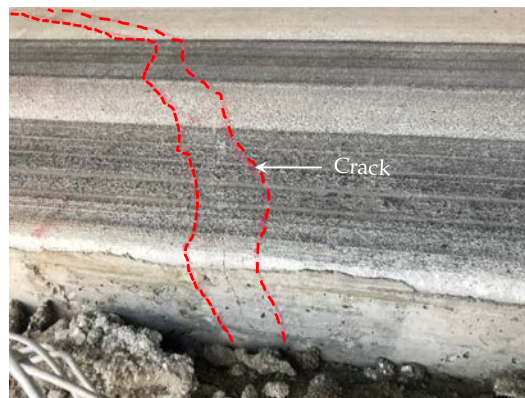
Figure 13. A zoomed-in view of B4 after 11,000 cycles of loading. The observed crack location is highlighted in red.

Fig. 13 shows a picture of self-sensing concrete region B4 after 11,000 cycles of loading, where a crack appeared and then traversed through the middle of its bottom edge. Fig. 14 shows the changes in conductivity distribution of B4 corresponding to different loading stages from 1,000 to 17,000 cycles. From 1,000 to 4,000 cycles, a minor change in conductivity was observed near the middle of the bottom edge (Figs. 14a to 14d), yet no damage was observed on the surface. Continued loading from 5,000 to 10,000 cycles still revealed no damage on the surface, but the ERT results showed a continued progression of greater conductivity changes (Figs. 14e to 14j). This localized conductivity change was potentially the result of a subsurface crack that formed at  $\sim 3,000$  cycles and had slowly but not yet fully propagated to the surface until it was visually identifiable at 10,000 cycles.
