Engineering Evaluation of Post-Liquefaction Strength

Joseph Patrick Weber

Doctor of Philosophy

University of California, Berkeley

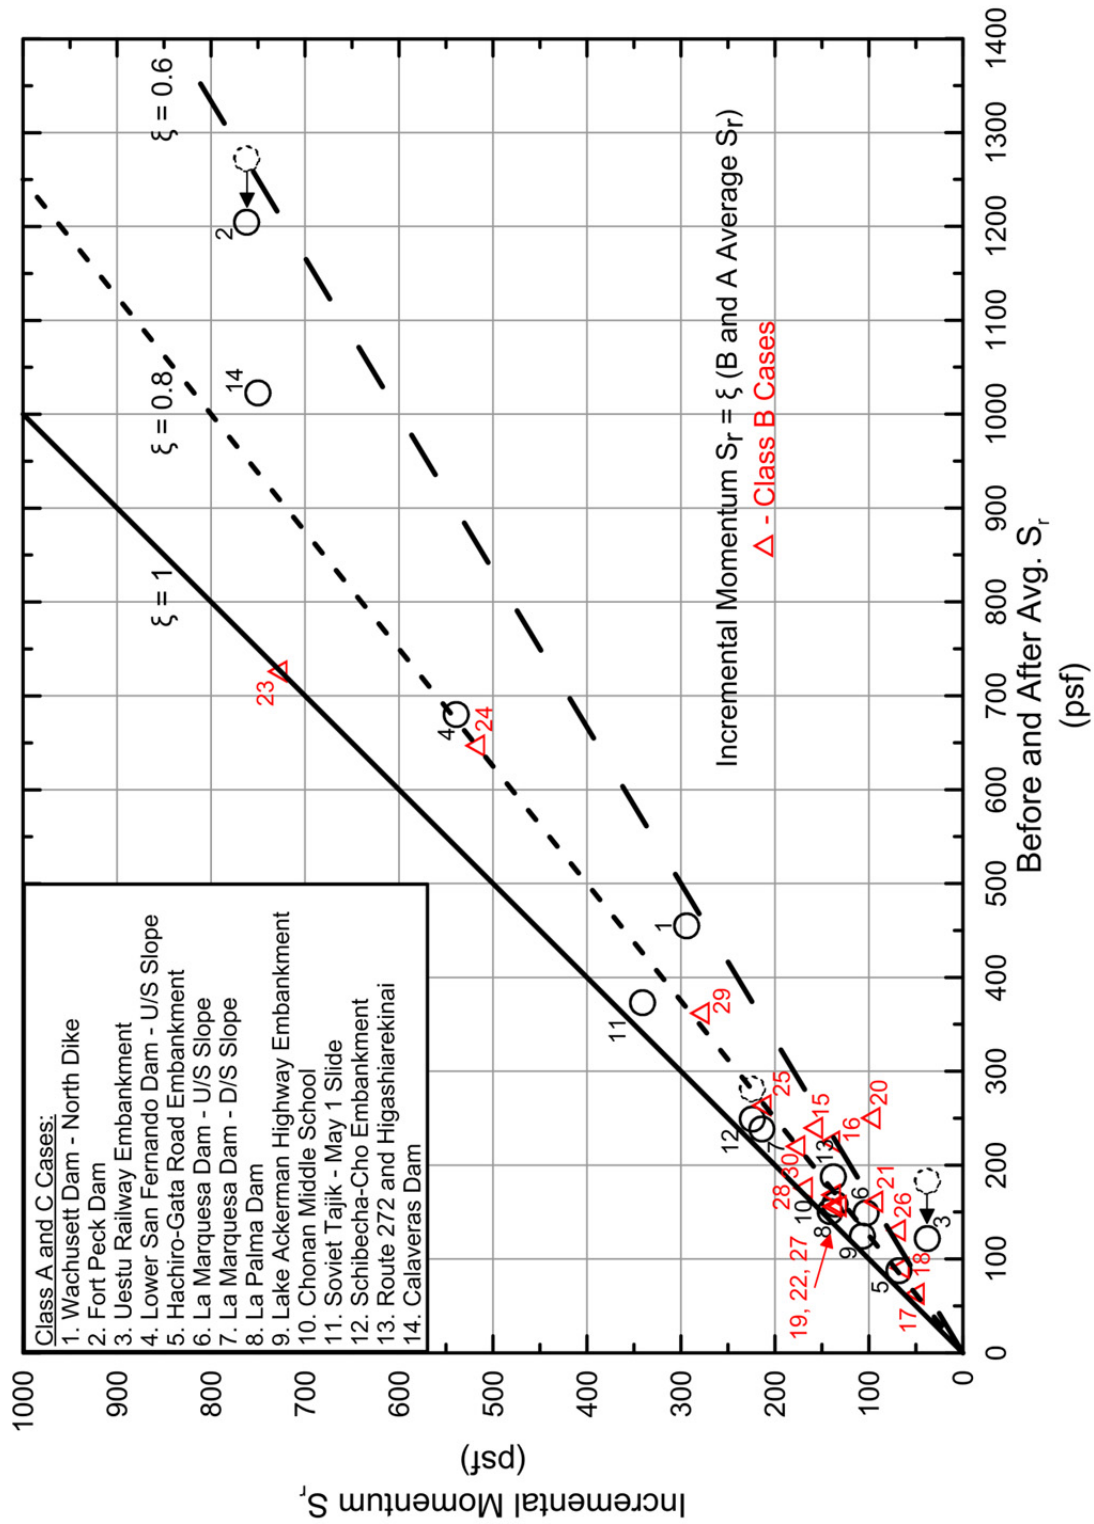
Figure 4.10: Figure 4.6 repeated, this time adding the back-analyzed Class B failure case histories (red triangles).

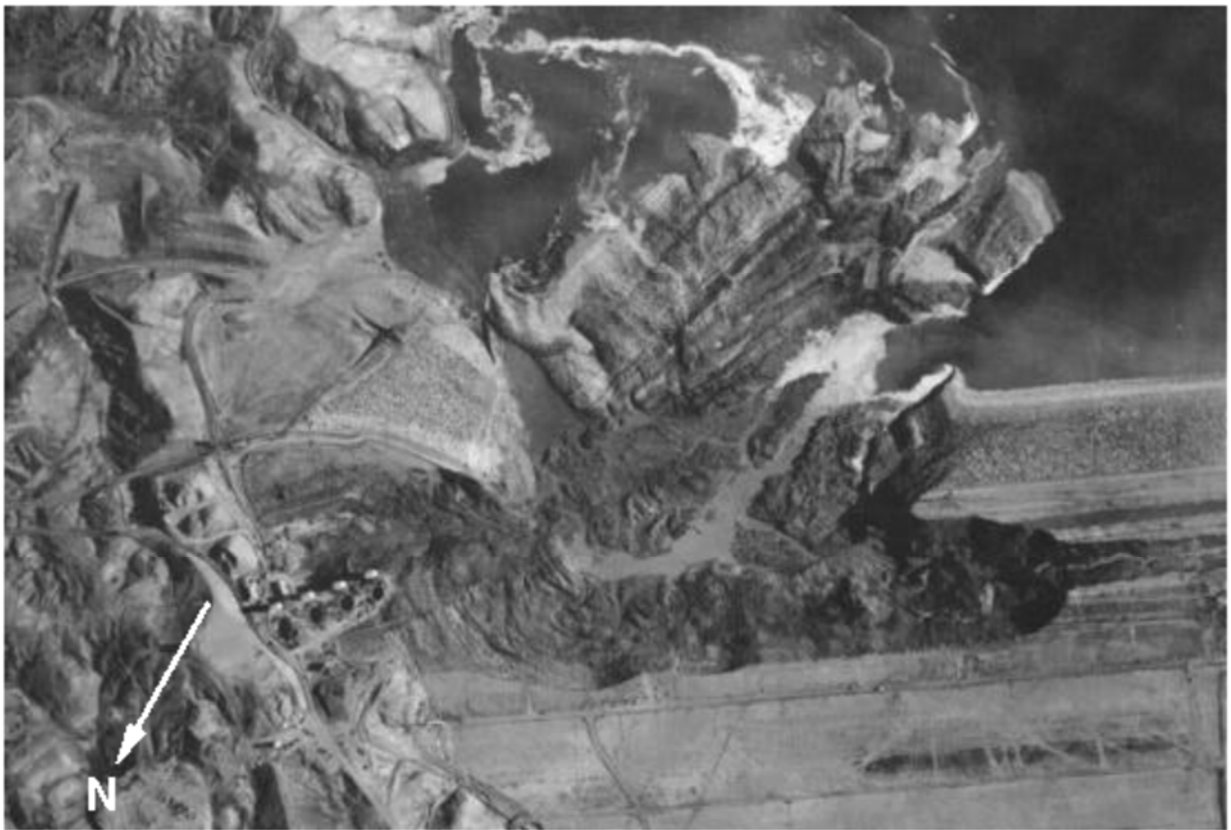
Figure A.2.2: Enlarged aerial photo from Figure A.2.1 showing failure at the east end of the dam. (from <http://www.midrivers.com/~rafter/lake/>)

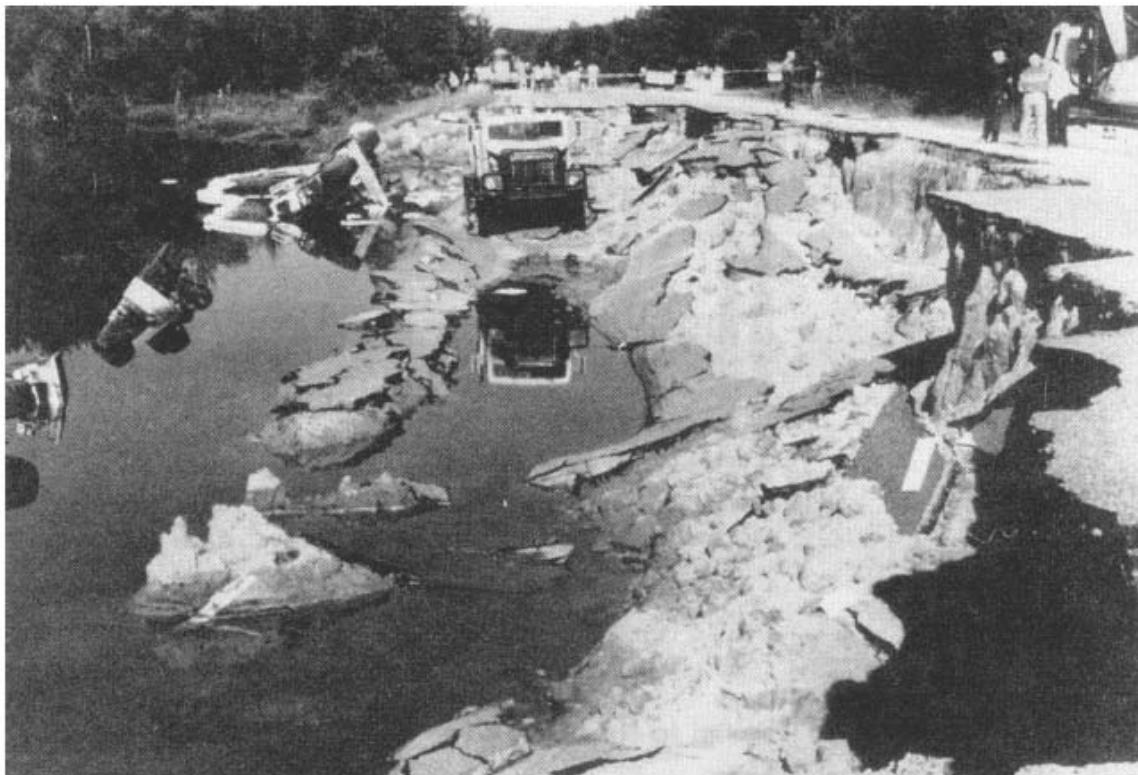
Figure A.9.2: Photograph showing the failed embankment (looking towards the west), showing crest loss and the positions of four of the large geophysical exploration trucks. (Hryciw et al., 1990).

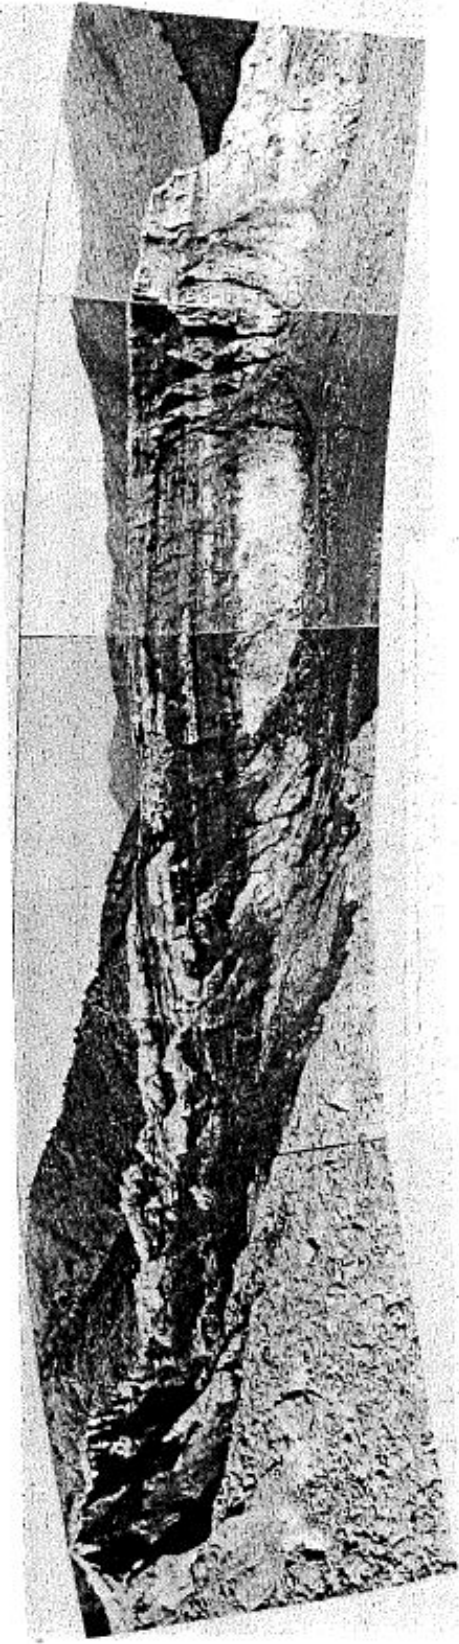
Figure B.6.3(a): Photograph showing post-failure conditions at the Old Dam; photo taken looking upstream towards the back edge and the "horseshoe shaped" scarp (Dobry and Alvarez, 1967).

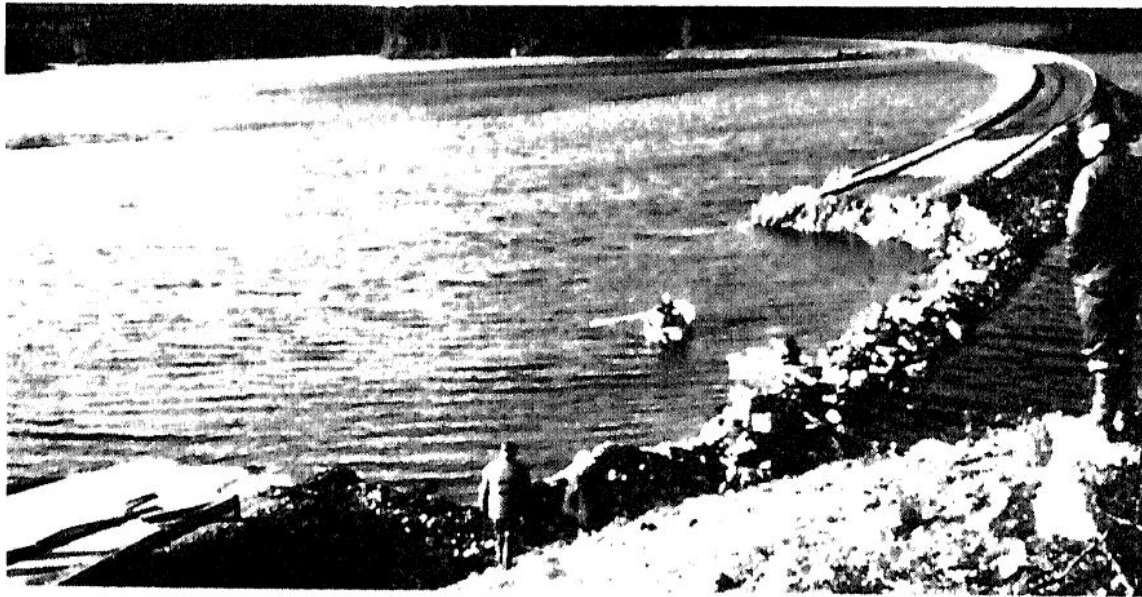
Fig. 1 View of the failure, October 4th 1983.

Figure B.13.1: Photograph of the Asele Road Embankment failure scarp and the remaining embankment on October 4, 1983 (Ekstrom and Olofsson, 1985).

Figure B.13.1 presents a photograph (from Ekstrom and Olofsson, 1985) showing the scarp after the failure, and Figure B.13.2 shows a cross-section through the failed road embankment section (from Konrad and Watts, 1995, based on Ekstrom and Olofsson, 1985).

The failure was attributed by Ekstrom and Olofsson (1985) to cyclically initiated liquefaction of the loose embankment fill due to the shaking applied by the vibratory roller. Ekstrom and Olofsson attributed the loose nature of the fill material to the use of a “wet fill” method during winter months which reportedly left the fill susceptible to freezing, which in turn defeated efforts at compaction of the fill when the embankment was under construction.

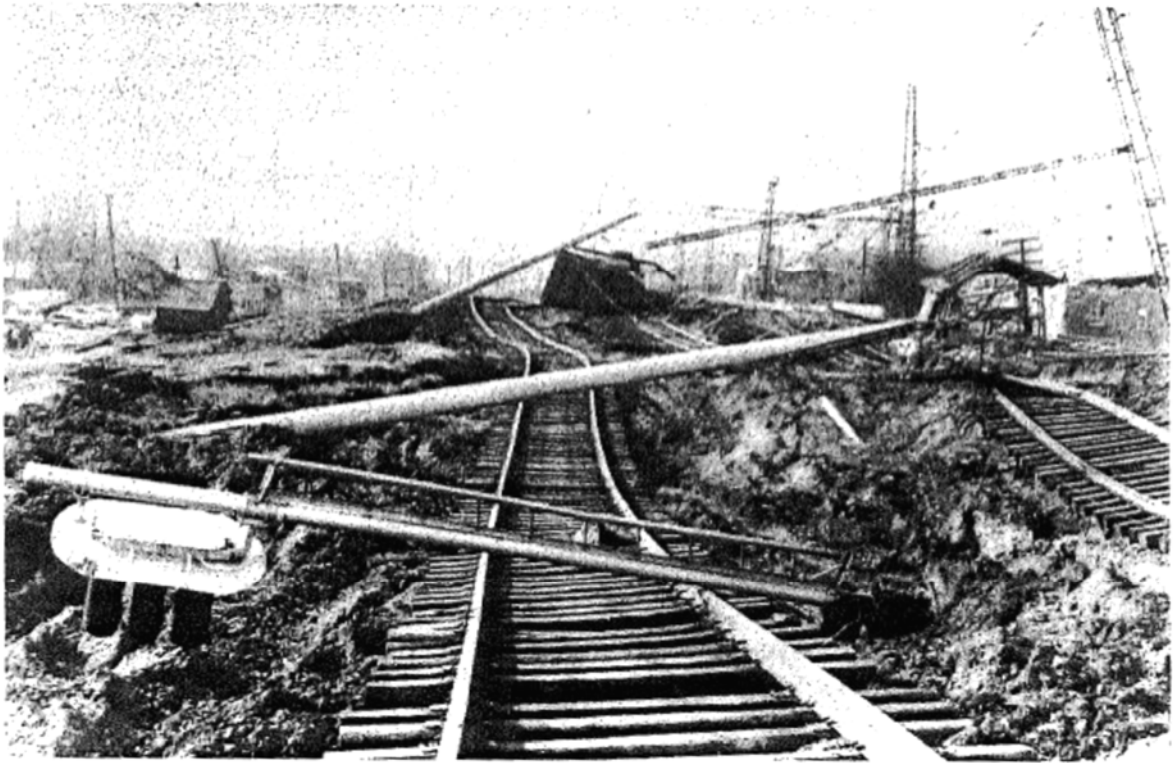
**FIG. 13. Photograph of Failed Embankment at Railway Station in Nalband (Site 3) (Photo Courtesy of A. Karakhanian, 1989)**

Figure B.14.1: Photo of the failure of the railway embankment near Nalband (from Yegian et al., 1994)
