Reflective Cracking Study: Initial Construction, Phase 1 HVS Testing, and Overlay Construction

Partnered Pavement Research Program (PPRC) Contract Strategic Plan Element 4.10:  
Development of Improved Rehabilitation Designs for Reflective Cracking

California Department of Transportation  
Division of Research and Innovation  
Office of Roadway Research

University of California  
Pavement Research Center  
UC Davis, UC Berkeley

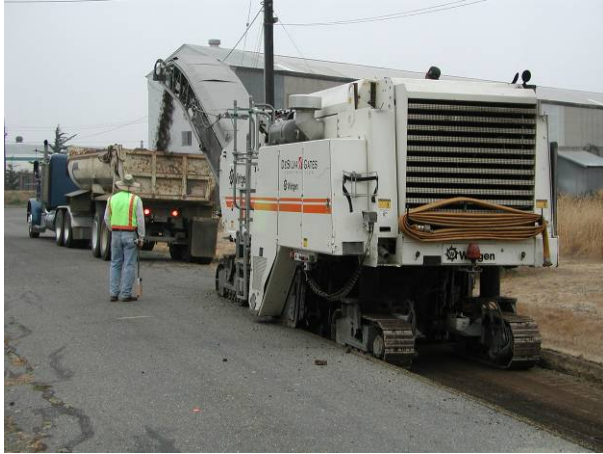
**Figure 2.5: Milling of existing roadway**

The existing aggregate base and asphalt concrete layer were milled to a depth of 250 mm (10 in), which removed all material to the surface of the subgrade (Figures 2.5 and 2.6). The ends of the pavement (25 m [82 ft] in length) were tapered to a thickness of 100 mm (4 in) to remove the existing asphalt concrete, leaving the existing aggregate base and subgrade in place.

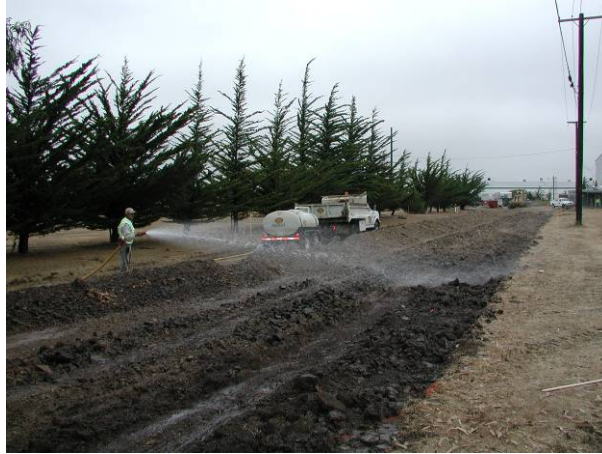
**Figure 2.7: Subgrade preparation**

The test results indicated that the relative compaction did not meet the Caltrans specification of 95 percent of laboratory determined maximum dry density (6). This was likely due to the water content being approximately 2.5 percent below the optimum according to CTM 216. To improve the degree of compaction, the subgrade moisture content was adjusted, and the material reworked to a depth of 200 mm (8 in) before being recompacted. This resulted in relative compaction of 97 percent. To limit hauling of in-situ material, the cross slope of the subgrade was increased to 2.25 percent.

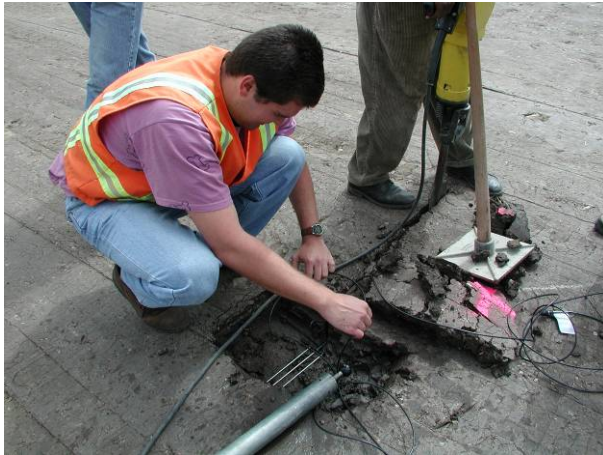
**Figure 2.8: Installation of Time Domain Reflectometer**

Six TDRs were placed horizontally at a depth of 50 mm (2 in) below the subgrade surface while one TDR was positioned vertically at a depth of 200 mm (8 in) below the subgrade surface. The TDRs were compacted in-place using a hand tamper and the wires taken to the edge of the shoulder, and then buried in the subgrade layer to protect them from damage by the aggregate trucks and the larger aggregate particles of the compacted base material.

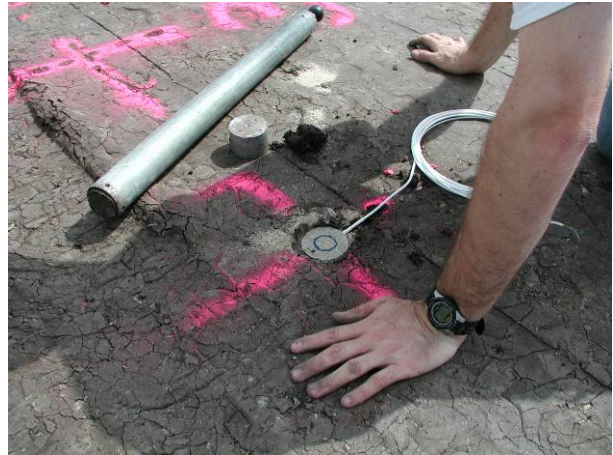
**Figure 2.9: Installation of pressure cell**

Following compaction of the subgrade soil, seven Time Domain Reflectometers (TDRs) and five pressure cells were installed in the subgrade (Figures 2.8 and 2.9). The description and locations of these instruments within the test pavement are provided in Appendix B.

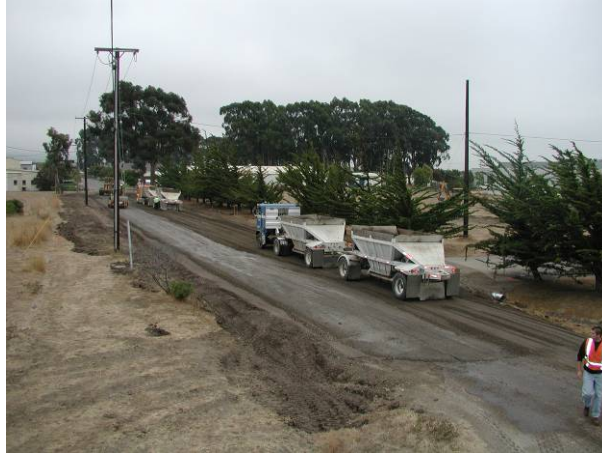
**Figure 2.10: Base construction**

The aggregate base was constructed from material supplied by the Dutra Materials plant in San Rafael, California in a uniform thickness of 410 mm (16 in) along the 80-m (262 ft) length of the test sections. The base was placed in three lifts of 150 mm (6 in), 150 mm, and 110 mm (4.3 in) to achieve a relatively uniform material (Figure 2.10). Base thickness was varied in the taper sections in order to link the test pavement elevation with the existing pavement elevations.

The base material was compacted at the optimum water content for the maximum wet density according to CTM 216 using a steel drum vibratory roller. Nuclear density testing (CTM 231) was performed on the second and final lifts in order to ensure that Caltrans compaction requirements for Class 2 aggregate base were met. The resulting average relative compaction of the aggregate base was 97.0 percent in the second lift and 98.6 percent in the third lift.

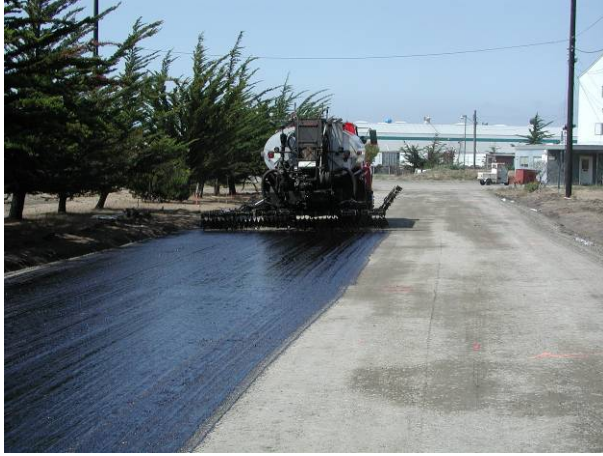
**Figure 2.11: Base priming**

The aggregate base was primed two days prior to paving using a CS-70 binder (Figure 2.11). The road was closed to traffic during this application and until the asphalt concrete was placed. After priming, asphalt concrete strain gages were installed in their respective positions using the method specified by the instrument manufacturers (Figure 2.12). A sand asphalt hot mix was used to secure the strain gages in position and the leads were run to the edge of the shoulder where they were bagged and buried in a similar method to that used in the installation of the pressure cells and TDRs.

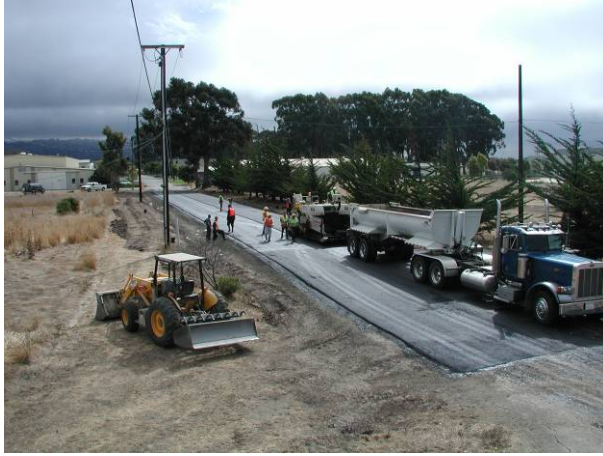
**Figure 2.13: Asphalt concrete placement**

During the paving of the first lift, asphalt concrete was removed from the skip of the paver and spread evenly in a thickness of approximately 20 mm (0.8 in) over the strain gages and tamped in place using a hand tamper. The leads of the strain gages were also covered with asphalt concrete to prevent damage by the paver.

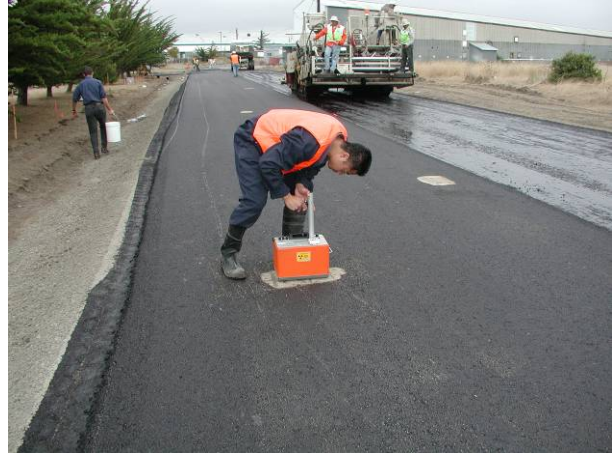
**Figure 2.14: Nuclear density testing**

The asphalt concrete was placed in two lifts of 45 mm (1.8 in) each with a paving width of 3.7 m (12 ft). Each lift was compacted using a steel drum roller. Density was controlled by means of nuclear density testing (Figures 2.13 and 2.14). As stated in the bid documentation, the degree of compaction was required to be in the range 92 to 95 percent (air-void content of 5 to 8 percent) of the theoretical maximum density (CT 309).

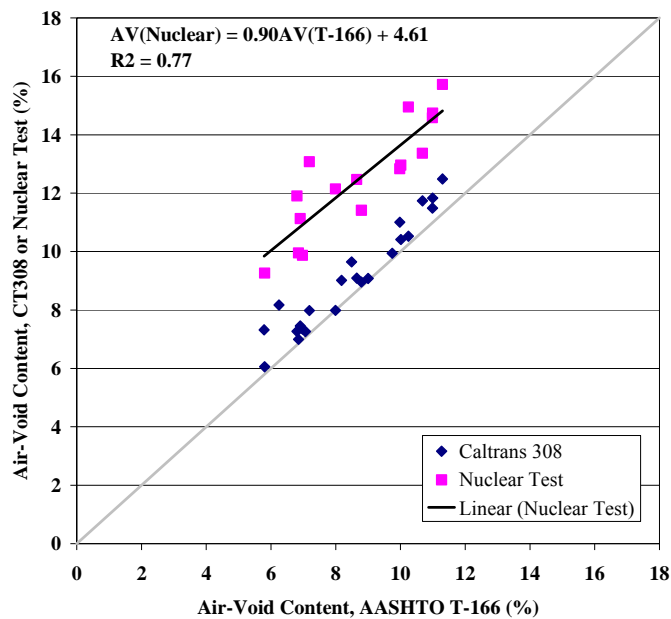
**Figure 3.1: Relationship between air-void content measurements.**

Nuclear density measurements and extracted cores were obtained to determine the air-void content distribution in the asphalt content layer after construction. The data were also used to establish a relationship between the nuclear test and laboratory test air-void contents. Laboratory air-void contents were determined on extracted cores according to Caltrans CT308 and AASHTO T-166 test procedures at locations where nuclear readings were obtained. Acceptance was based on AASHTO T-166 test results. Figure 3.1 shows the relation between Caltrans CT308, the nuclear device air void data, and AASHTO T-166 air void data. As shown in the figure, the average measured air-void content difference between AASHTO T-166 and the nuclear device was 4.6 percent.

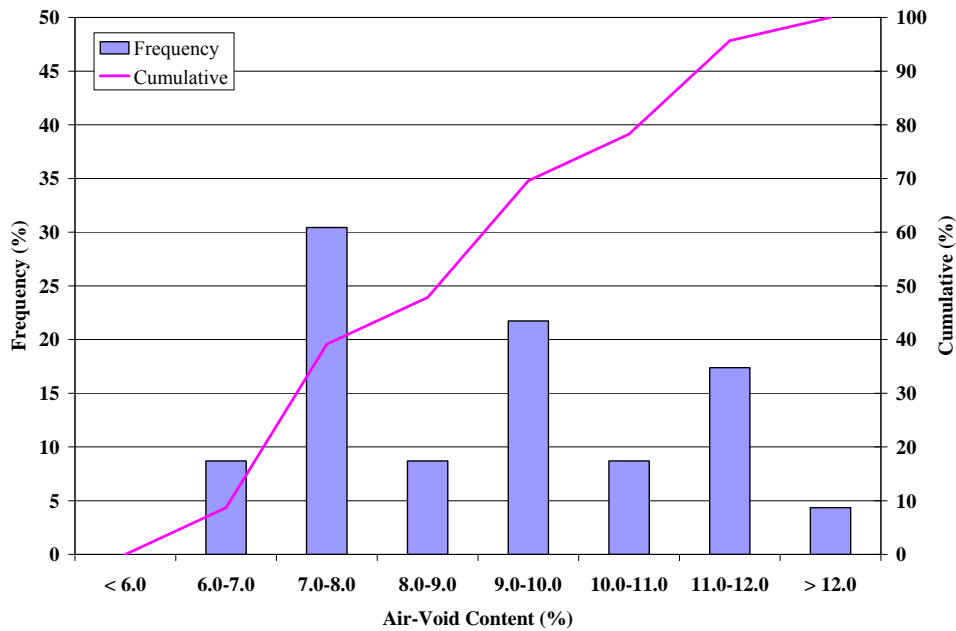
**Figure 3.2: Air-void content relative frequency and cumulative histogram.**

Figure 3.2 shows a relative frequency and cumulative histogram for the air-void content in the dense-graded asphalt concrete. A wide range of air voids with more than one peak value is evident. More than one data distribution can be found over the range of measured air voids. This may be due to the presence of segregated areas on the asphalt concrete mat observed during construction. These areas were primarily

caused by the asphalt mix in the hopper of the paver cooling while waiting for the next truck to deliver mix to the site. Because the cooled mix in the paver was not completely remixed with the new hot mix, proper compaction of the cooled mix was not possible. As a result, some areas had higher air voids. These segregated areas were excluded from consideration when selecting the sub-sections for accelerated pavement testing.

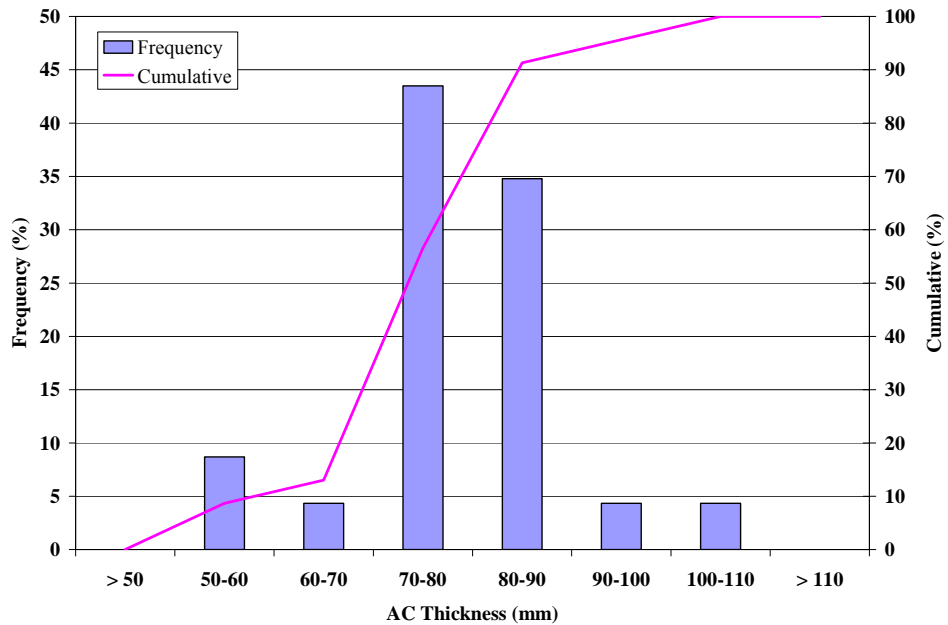
**Figure 3.4: Relative frequency and cumulative histogram for asphalt concrete thickness.**

Extracted cores were also used to determine the distribution of asphalt concrete thickness along the test section. Figure 3.4 shows the relative frequency and cumulative histogram for the asphalt concrete thickness. The data show that about 76 percent of the asphalt concrete cores were between 70 and 90 mm thick. The average thickness along the pavement section was 79.0 mm with a standard deviation of 9.9 mm. The design thickness for this project was 90 mm.

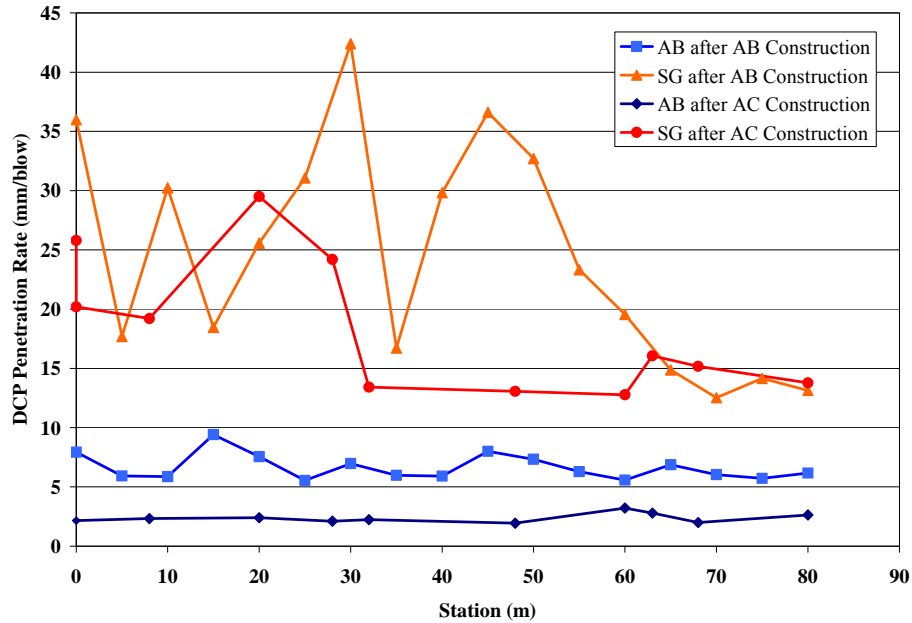
Figure 3.7: DCP data for unbound materials.

Figure 3.7 summarizes Dynamic Cone Penetrometer (DCP) tests in terms of penetration rates in the aggregate base and subgrade along the pavement section. These were obtained after construction of the aggregate base and asphalt concrete layers. DCP tests were performed at the same 17 locations where asphalt concrete cores were extracted. Average penetration rates for the aggregate base and subgrade before placing the asphalt concrete were 6.4 mm/blow and 23.4 mm/blow, respectively with standard deviations of 1.0 mm/blow and 9.0 mm/blow, respectively. After placing the asphalt concrete layer, the average penetration rates in the aggregate base and subgrade were 2.4 mm/blow and 17.8 mm/blow, respectively with standard deviations of 0.4 mm/blow and 5.4 mm/blow, respectively.

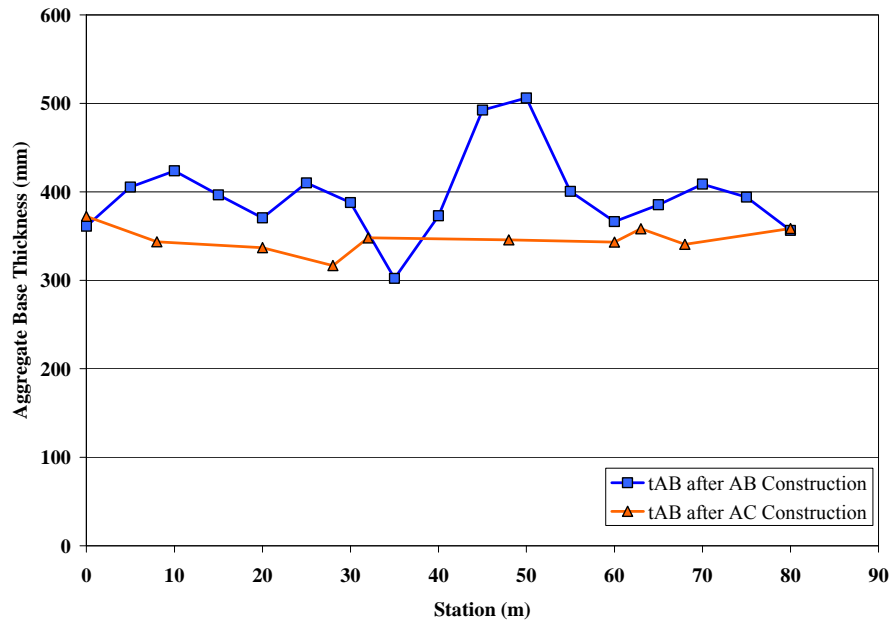
Figure 3.8: Thickness of aggregate base estimated from DCP measurements.

Aggregate base thicknesses along the pavement section were estimated from DCP data at the point where the slopes of the penetration rates of the aggregate base and subgrade intersect. The average thickness of the aggregate base was 375 mm with a standard deviation of 47 mm (design thickness was 410 mm). Figure 3.8 shows aggregate base thickness along the pavement section. The data indicate a difference between the thickness obtained before and after placing the asphalt concrete. The results are not conclusive at this point because they were obtained at different locations.

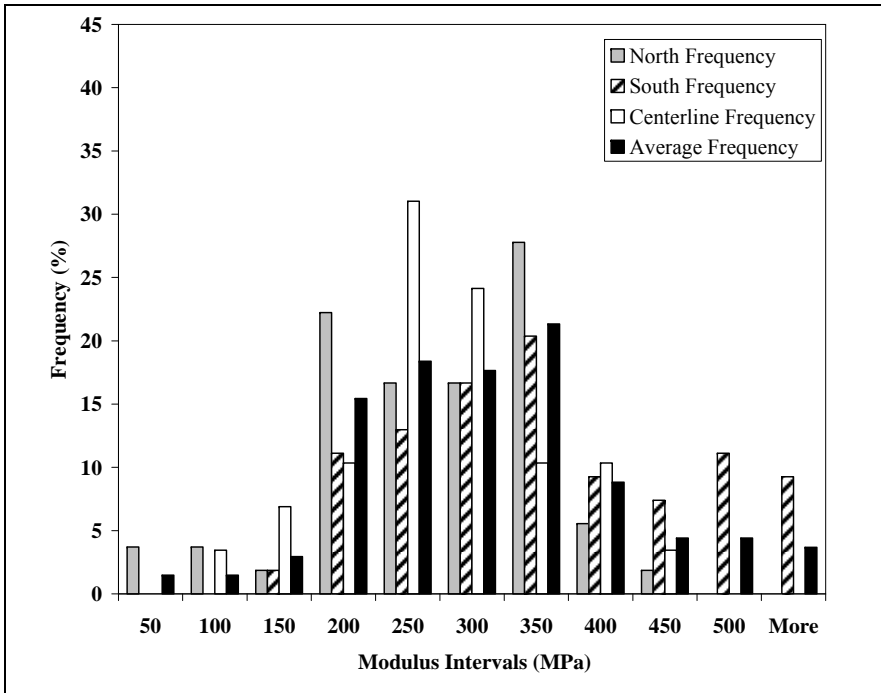
Figures 3.19 and 3.20 show the relative frequency and cumulative histogram, respectively of aggregate base moduli along the pavement section obtained from backcalculation of the FWD data. Results suggest that the first area may consist of two populations of moduli with values of approximately 250 MPa and 350 MPa, with the high modulus values on the northbound lane between stations 0.0 m and 30 m. Figure 3.21 shows the distribution of aggregate base modulus along the pavement section. In the figure, darker color indicates higher aggregate base modulus.

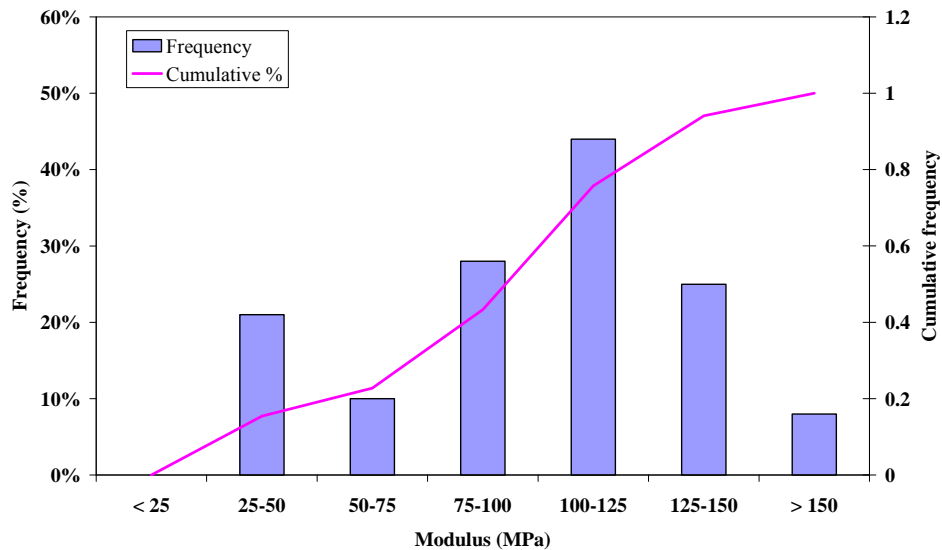
**Figure 3.22: Relative frequency and cumulative histogram of subgrade modulus.**

The average modulus of the subgrade was 98 MPa with a standard deviation of 37 MPa. Relative frequency and cumulative histogram are shown in Figure 3.22, while Figure 3.23 shows the distribution of subgrade modulus along the pavement section. In the figure, darker color indicates higher modulus. A weak subgrade (lower modulus) was observed between Stations 20 m and 50 m in the southbound lane (test lines 1.3 and 2.3 m). While the reason for the low subgrade modulus in this area is not clear, based on observations during construction the subgrade in this area was compacted at high moisture content (to the right of the line of optimum). Compaction in this moisture region induces dispersed particle orientation in this type of soil. This, in turn, results in higher resilient deformations (low resilient modulus) than if compaction occurs to the left of the line of optimum (lower moisture content).

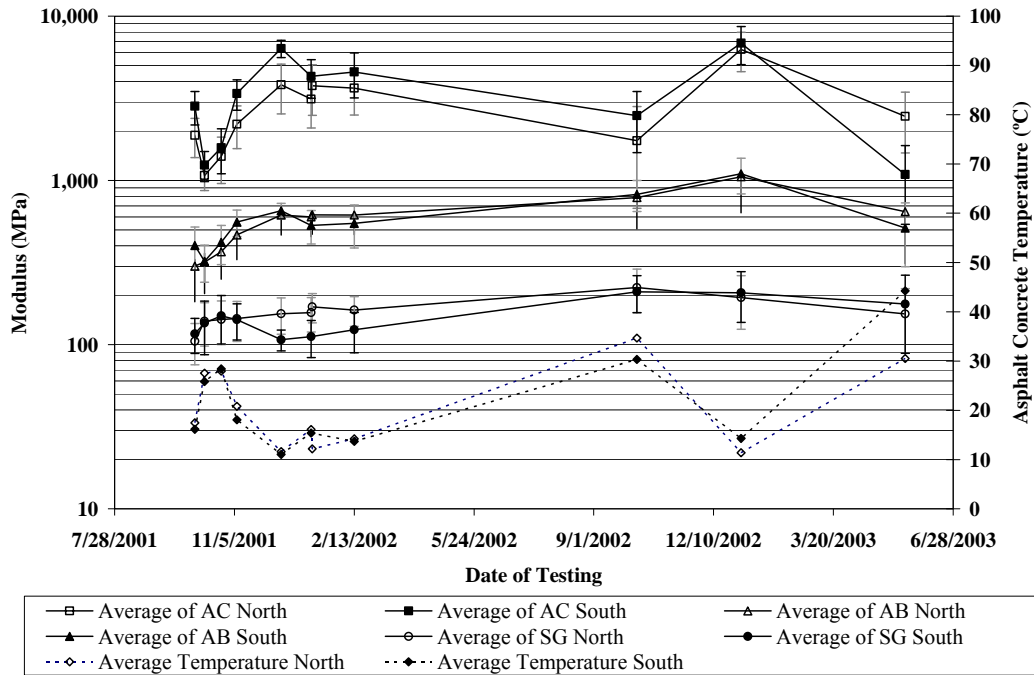
**Figure 3.26: Summary of back-calculated moduli for pavement section.**

Moduli were calculated from FWD deflections using the computer program ELMOD 5.0 (7). A non-linear subgrade and no bedrock were assumed in the back-calculations. Results of the back-calculations are summarized in Figure 3.26 for average layer moduli along the north and south lanes. Y-bar errors indicate one standard deviation from the average value.

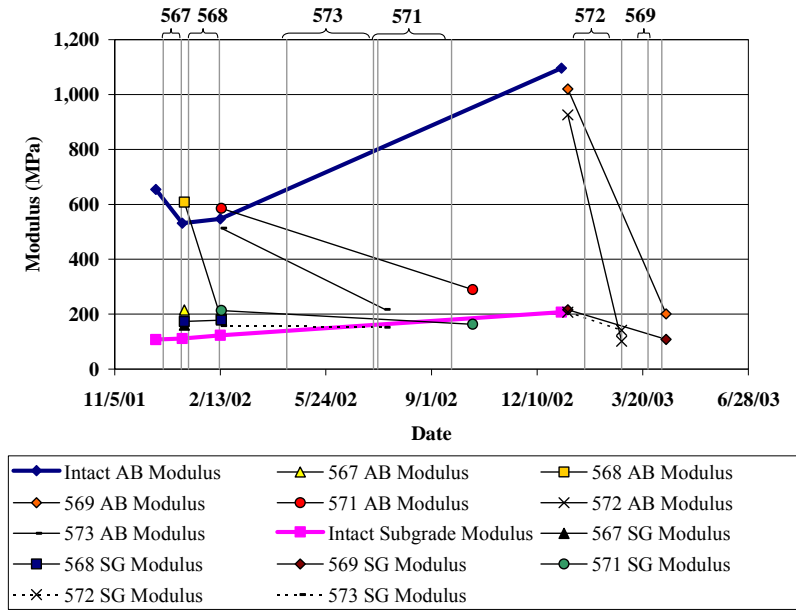
**Figure 4.6: Backcalculated aggregate base and subgrade moduli for HVS sections.**

Modulus values for the aggregate base are shown in Figure 4.6. The data show a clear reduction in aggregate base modulus over time for all sections. Values were in the range of 500 MPa to 1,100 MPa before HVS testing and between 100 MPa and 300 MPa after HVS testing. The agreement between intact modulus and modulus before HVS testing for each of the sections appeared reasonable.

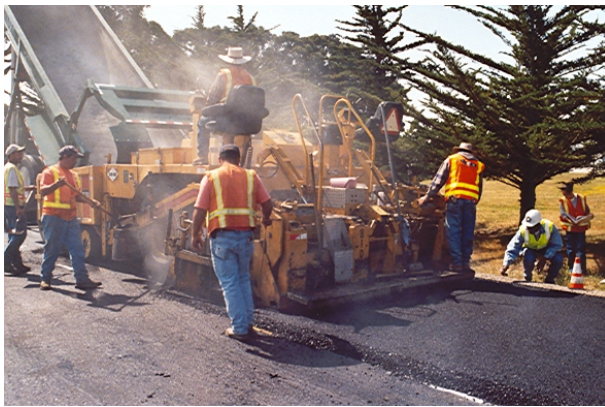
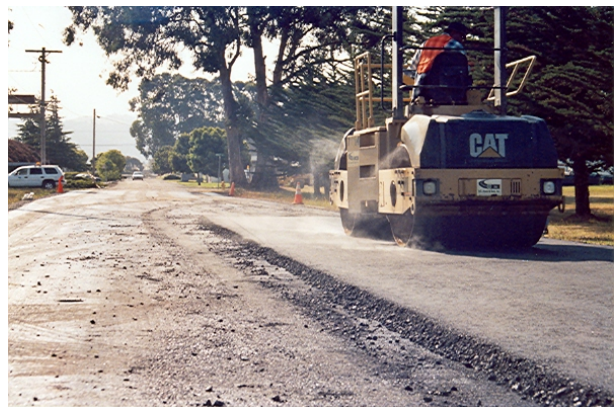
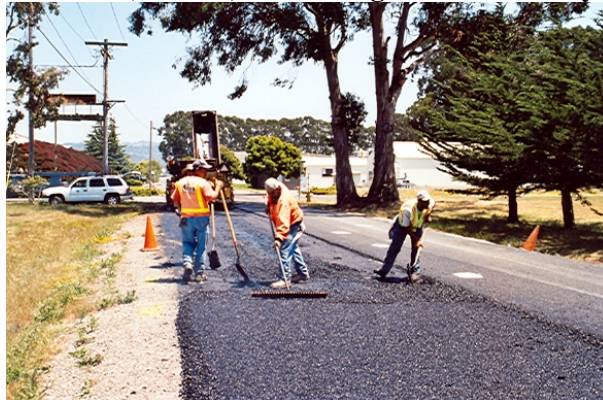
The overlays were placed on the same day, within a few hours of each other. A tack coat (rapid-setting emulsion) was applied prior to placement at a rate of  $0.3 \text{ l/m}^2$ . The 90 mm layers were placed in two lifts of 45 mm and a tack coat was applied between lifts at a rate of  $0.3 \text{ l/m}^2$ . The overlays were compacted with steel drum roller (Figures 5.1 through 5.3).

Figure 5.1: Overlay placement (RAC-G).

Figure 5.2: Overlay compaction (AR4000-D).

Figure 5.3: Overlay placement (MB4-G).
