A brief overview of climatization strategies of historic houses in the Netherlands: From “one size fits all” to “a process of deliberation”

Parks Stewardship Forum, 38(3)

Bart Ankersmit and Marc Stappers

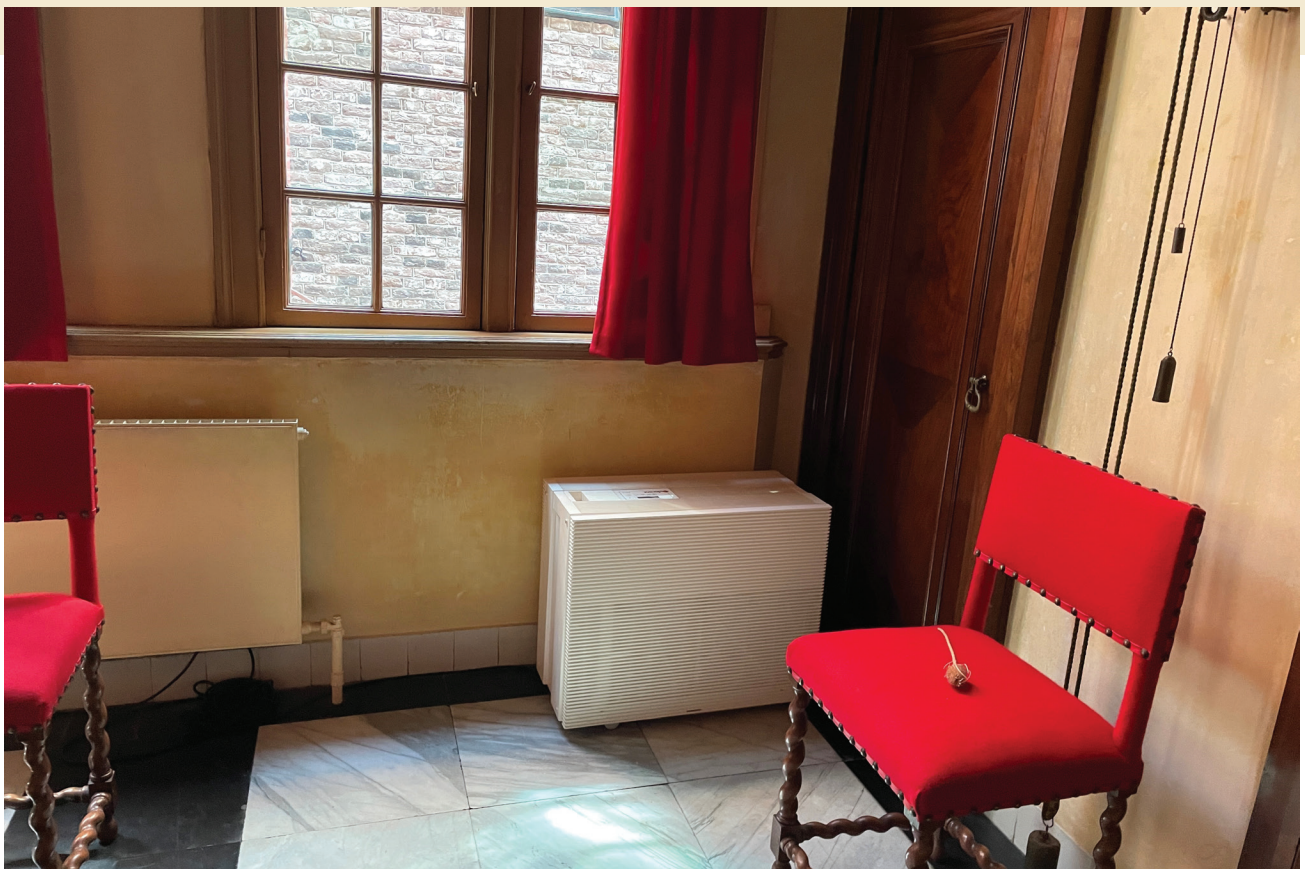
IMAGE 9 (top). Climate control in the historic building is by a small number of radiators and an occasional humidifier in some of the rooms, while the entrance building is fully climatized using HVAC systems. MARC STAPPERS **IMAGE 10 (bottom).** Climate control in the historic building is by a small number of radiators in only a few rooms, while the entrance building is fully climatized using HVAC systems. BART ANKERSMIT

winter temperature of 17–18°C (62.6–64.4 °F) and expand the museum volume with an extra adjacent building (Images 9 and 10).

The two buildings, separated by a small alley, are connected by an underground passage. The renovated building became the new entrance and presented the valuable and susceptible objects in display cases.

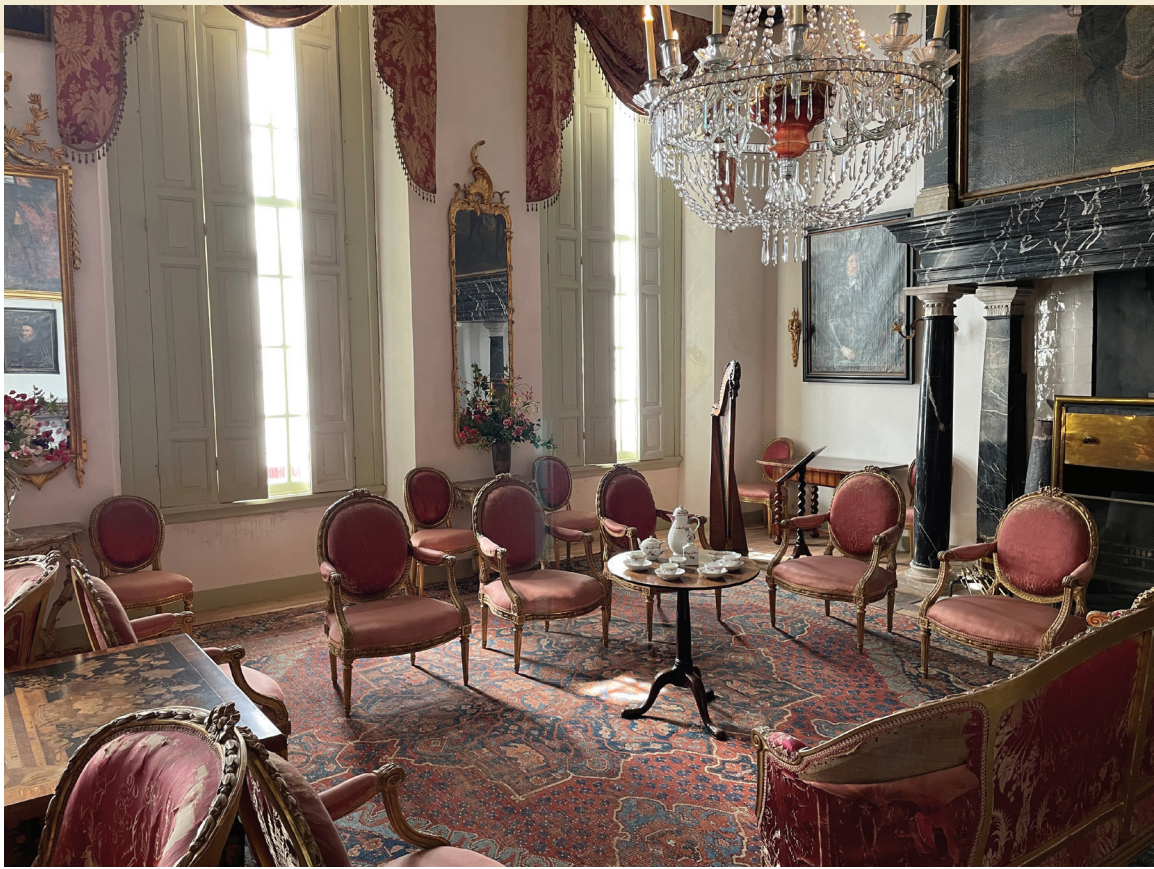
IMAGE 12 (top). Che Grand Salon on the belle etage (main floor). MARC STAPPERS **IMAGE 13 (bottom).** Amerongen Castle with the floor heating on two levels, the basement and the hallways on the ground floor. The former living apartments, now office spaces, are heated by radiators. The unheated historic rooms will be minimally heated by the adjacent heated spaces. BART ANKERSMIT

The floor heating in the souterrain resulted in an increase of the annual minimum temperature from 3–5°C to around 10°C. On the belle etage, one of the most important rooms in the house is located: the Grand Salon (Image 12). It contains very valuable moveable collections and is not heated directly, instead receiving warmth from the floor-heated hallway. The annual average temperature in the salon slightly increased. Although the yearly average relative humidity remained around 60–65%, the house was experienced as being less moist and damp. Careful inspection of a selection of susceptible objects showed that no new mechanical damage due to relative humidity fluctuations occurred between 2009 and 2018.

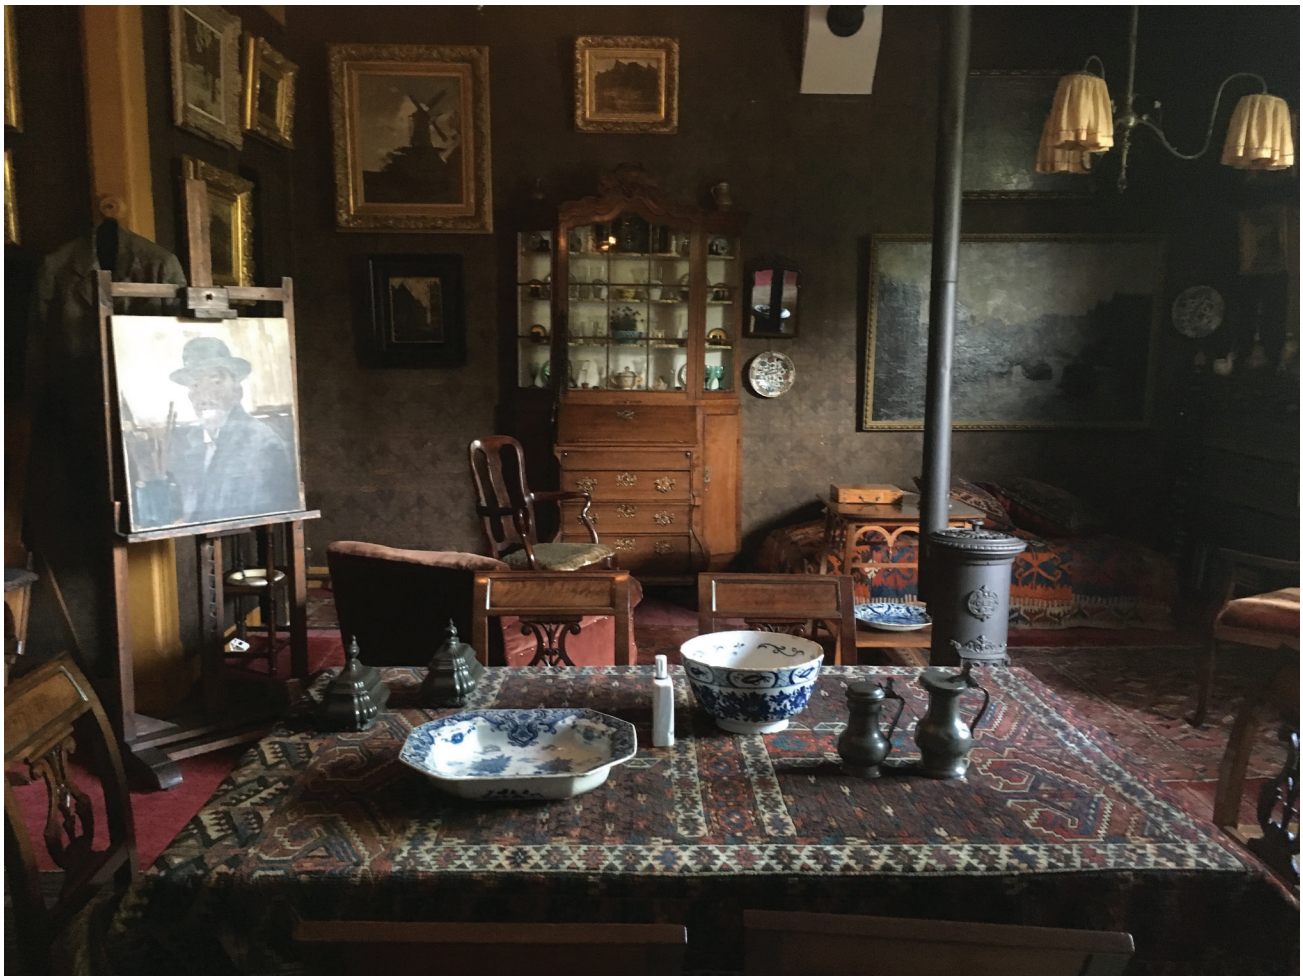
IMAGE 20. The interior of the Witsenchamber with a datalogger on the table and the furnace for a small amount of heat on the right. BART ANKERSMIT

The apartment can be visited by appointment (Image 20). The apartment has very limited climate control: a little heating but no moisture control. In 2020, the small organization of volunteers who check the condition of the collection regularly and give tours to visitors noticed signs of mold on the book collection. It was decided not to
