Forced Vibration Testing of a Four-Story Reinforced Concrete Building Utilizing the *nees@UCLA* Mobile Field Laboratory

Eunjong Yu,^{a)} Derek Skolnik,^{b)} Daniel H. Whang,^{c)}
M.EERI, and John W. Wallace,^{b)} M.EERI

The *nees@UCLA* mobile field laboratory was utilized to collect forced and ambient vibration data from a four-story reinforced concrete (RC) building damaged in the 1994 Northridge earthquake. Both low amplitude broadband and moderate amplitude harmonic excitation were applied using a linear shaker and two eccentric mass shakers, respectively. Floor accelerations, interstory displacements, and column and slab curvature distributions were monitored during the tests using accelerometers, linear variable differential transformers (LVDTs) and concrete strain gauges. The use of dense instrumentation enabled verification of common modeling assumptions related to rigid diaphragms and soil-structure-interaction. The first six or seven natural frequencies, mode shapes, and damping ratios were identified. Significant decreases in frequency corresponded to increases in shaking amplitude, most notably in the N-S direction of the building, most likely due to preexisting diagon

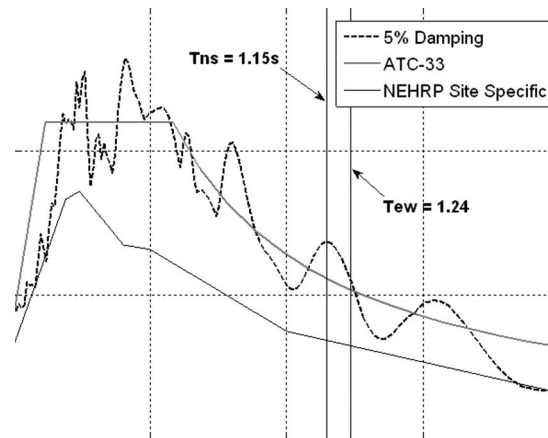
Figure 3. Response spectra obtained from N-S component of recorded acceleration during Northridge at basement floor of nearby 13-story building (CSMIP 24322). Also included are the site specific spectra provided by NEHRP as reported in Aschheim and Moehle (1995) and the derived ATC-33 spectrum. Finally, the fundamental NS and EW periods identified during EMS shaking are marked.

No ground motions were recorded at the site during the earthquake; however, a record was obtained in the basement of a 13-story RC building (CSMIP station No. 24322) approximately 0.3 miles south of the site. Figure 3 displays the response spectra derived from the NS component. Recorded horizontal peak ground accelerations in the basement of the nearby building were 0.45 g and 0.23 g in the north-south and east-west directions, respectively. Although the ground motions at the test building may vary from

those recorded at the nearby building, the recorded peak accelerations indicate that relatively strong shaking occurred nearby the test structure. Additionally, site specific motions (also shown in Figure 3) for the test building were derived as part of the Building Seismic Safety Council funded case studies for the 50% draft of ATC-33 (Aschheim and Moehle 1995) and also indicate that strong shaking occurred at the test building site.

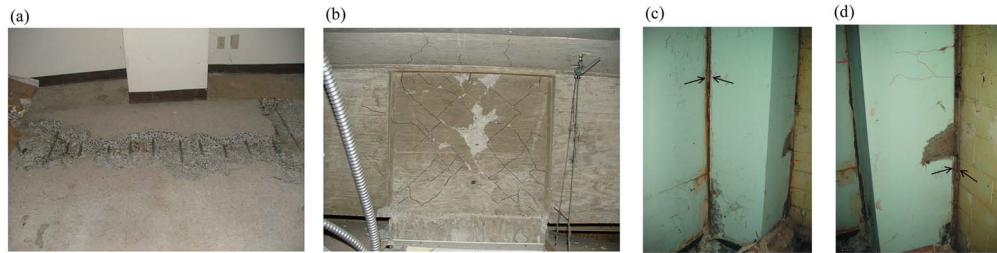
Figure 4. Earthquake damage to the building: (a) punching shear failure (Column B6 at the third floor level), and (b) diagonal crack on beam-column joint (Column A4 at the third floor level) (c) & (d) detachment of partition and infill wall from column (Column A1 at the first floor level).

Detailed visual inspections of the building were performed prior to forced-vibration testing to document the existing structural condition. Particularly severe damage was observed at slab-column connections due to slab punching shear failure around the perimeter of the drop panels. The most dramatic failures were observed at the south end of the second floor level (column B2) and the north end of the third floor level (column B6, Figure 4a).

Diagonal cracks were observed within the beam-column joint regions (Figure 4b) along the east and west perimeter frames, primarily at the third floor level between columns A4 to A6 and columns D4 to D6. Minor concrete cover spalling were the cracks crossed at the middle of some joints, and the diagonal cracks often extended up to the floor slab. No joint cracks were noted in the north and south perimeter frames except for column C7 at the roof level. The damage survey also indicated that a majority of the perimeter girders in both directions had minor to moderate concrete crushing at the joint interface, and most of the perimeter columns had flexural cracks

Partition walls (metal studs and wallboard) and masonry walls at the ground floor were detached and separated from adjacent structural members Figure 4c and 4d, indicating that the building experienced substantial lateral deformations during the earthquake. These observations indicate that non-structural partitions were unlikely to contribute to the lateral strength and stiffness of the building during the subsequent forced vibration tests conducted as part of this study.

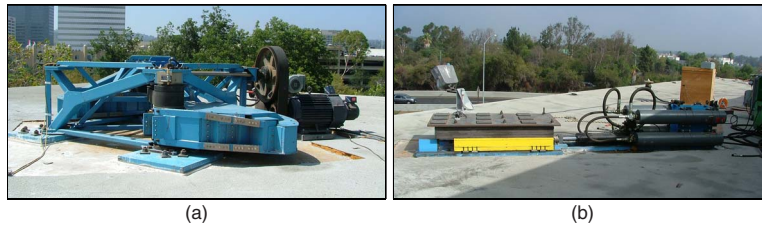
Figure 5. Field shakers: (a) eccentric mass shaker (EMS) and (b) linear mass shaker (LMS).

Two, large capacity, eccentric mass shakers (EMS) (ANCO Model MK-15) and a modest-capacity linear mass shaker (LMS) were anchored to the roof of the building as vibration sources (Figure 5). A single MK-15 shaker develops unidirectional harmonic forces with a peak force output of 100 kips with two counter-rotating baskets. The force generated by each EMS, P , is expressed as:

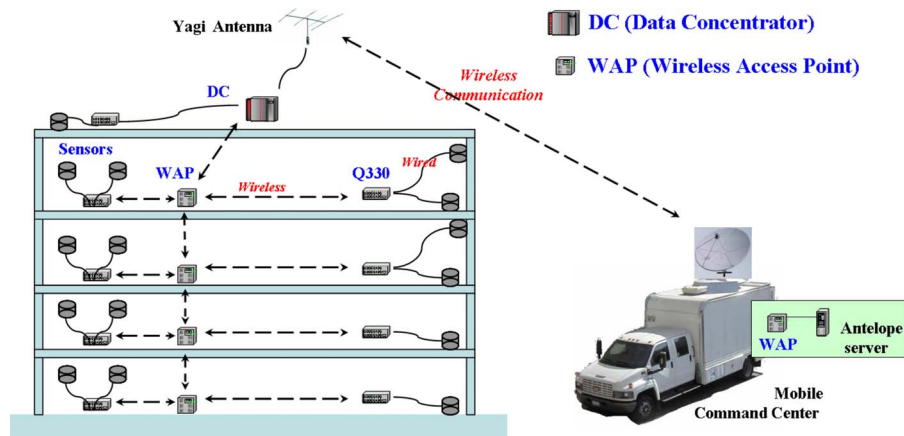
Figure 8. A schematic drawing of Kinometrics DAQ system.

Data acquisition was performed using two separate systems, one for the accelerometers and LVDTs and the other for the concrete strain gauges. Data from both systems were GPS time-stamped to ensure synchronization. Figure 8 shows a schematic of the data acquisition system for accelerometers and LVDTs. These sensors were connected to 19 units of 24-bit, 6-channel Kinometrics Q330 dataloggers, where analog signals were digitized, time-stamped and stored to a local memory buffer as data packets. The data packets were transmitted using 802.11b wireless networking technology to a Data Concentrator (DC) located on the roof floor via four Wireless Access Point (WAP) modules distributed throughout the building. The DC houses a UNIX workstation running Antelope (data acquisition software for Kinometrics system) and wireless networking equipment. The DC consolidates and broadcasts collected data and video streams wirelessly to the mobile command center (MCC) which is a truck with integrated mobile computing facilities and satellite communication systems. The data transfer from the DC to the MCC located near the test building (~ 300 ft) was accomplished via standard 802.11b

wireless and TCP/IP networking protocols, using a Yagi (unidirectional, high-gain antenna) at the penthouse roof and a parabola antenna attached to the MCC.

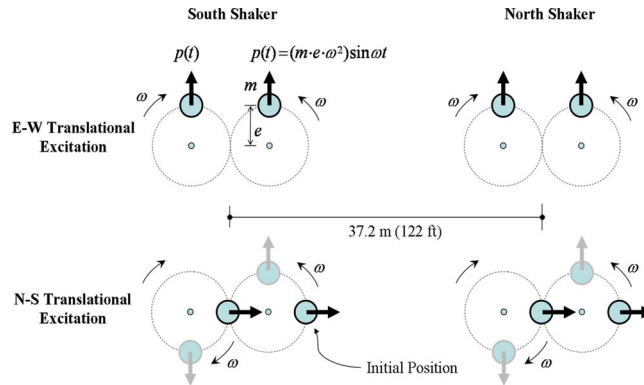
Figure 10. Initial positions of shaker baskets for E-W and N-S translational excitation.

component of the inertial force generated by one basket was cancelled by the E-W component of the other basket, producing a resultant force in the N-S direction (Figure 10).

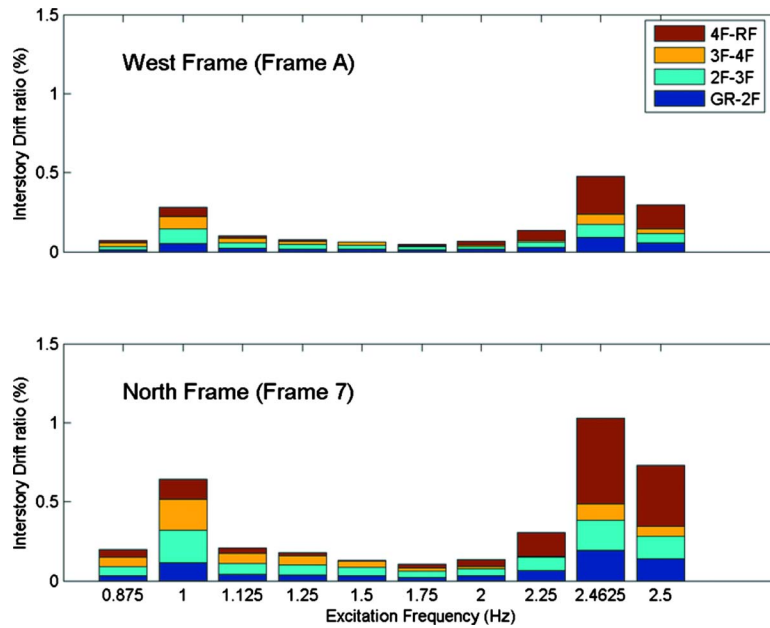
Figure 12. Interstory drift distribution during torsional EMS excitation with half-full baskets.

Figure 12 shows the typical variation of interstory drifts (during torsional EMS test with half-full baskets), calculated from the peak displacements and phase angles for each floor obtained from the story accelerations, at selected excitation frequencies. Because the floor displacements may be out of phase, except at resonance, the interstory drift is taken as the absolute value of the difference between two displacement vectors, normalized by the story height. Interstory drifts obtained from LVDT measurements were consistent with those obtained using this approach. However, due to dynamic interaction of the sensor mounts, LVDTs mounted with a spring support system, Figure 7e, the direct measurements were of poorer quality (e.g., clipping of data peaks occurred) than the acceleration data (Yu 2005). As shown in Figure 12, at frequencies less than about 2 Hz, interstory drifts are almost evenly distributed throughout the first to fourth stories; however, for higher frequencies, drifts at the roof and penthouse levels are substantially larger than those for lower stories. For all tests with the EMS, the maximum interstory displacement was 0.7 in. (0.43%) which was achieved at the north frame (Line 7 of Figure 1) between the fourth floor and roof under 2.4625 Hz torsional excitation with half-full baskets. It is important to note that, while substantial, this interstory

drift is insufficient to produce yielding given the relatively flexible moment frame system (e.g., see Wallace et al. 1998), as interstory drifts of roughly 1.0% to 1.5% are typically required to achieve yielding within moment frame systems.

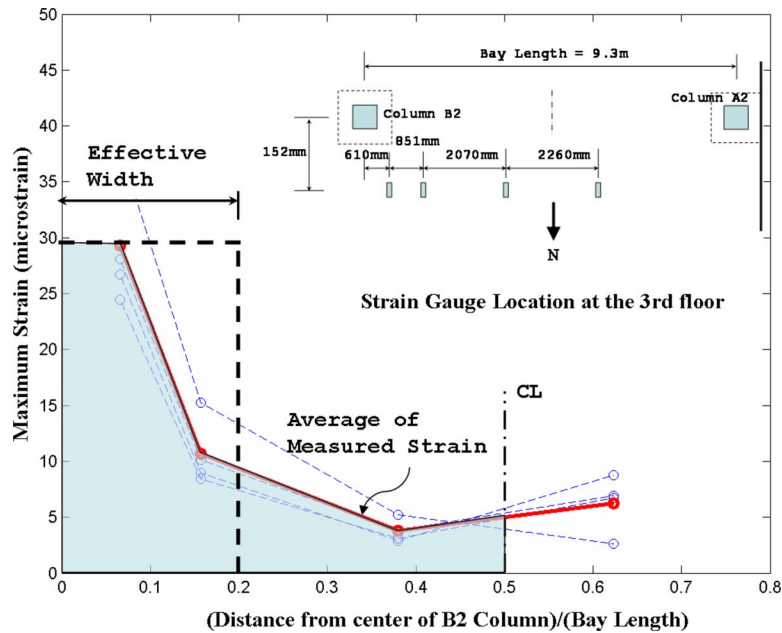
Figure 13. Maximum compressive strain distribution profile along the fourth floor slab at the B2 column during N-S translational excitation with half-full baskets.

where c_1 is the column dimension in the direction of framing (24 inches), β is a factor used to represent the impact of cracking, α is commonly referred to as the effective slab width (without consideration of cracking), and t_{slab} is the overall slab thickness. The effective slab width α for the building tested, obtained using Equation 5, is 0.43. For post-tensioned slabs β values are typically between $2/3$ and 1.0, resulting in $\alpha\beta$ values be-

tween 0.29 and 0.43. Kang and Wallace (2005) determined an effective width value of 0.47 ($\alpha=0.7$, $\beta=2/3$) using data obtained in shake table tests of an approximately 1/3-scale, two-story, post-tensioned flat plate by tuning the natural frequency of an analytical model to the results obtained from the tests. The cracked effective slab width of 0.4 obtained from Figure 13 is within the range of previously proposed and reported values, and would be a reasonable value to use in subsequent, detailed analytical studies of this building.

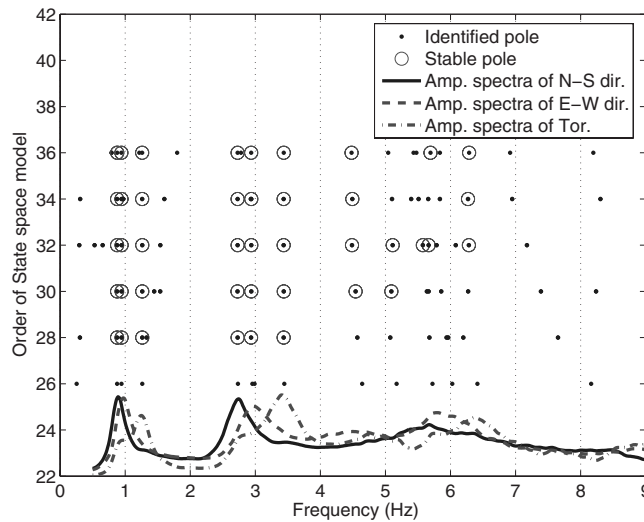
Figure 15. Stability plot.

From the input and output, the N4SID estimates a state space model, via linear least squares, given the model order specified by the user. A state space model of order 30 should be sufficient to identify the 30 poles corresponding to the modal properties of the 15 modes. However, due to measurement noise and numerical round-off errors, not all of the identified modes from the system identification process have physical meaning. To distinguish the physical and non-physical (spurious) modes, a stability plot (Bodeux and Golinval 2001), which represents variations of identified natural frequencies, damping ratios, and mode shapes due to a change of model order, was employed. Figure 15 shows the stability plot for the LMS test run2, indicating all identified modes and their stability as the model order is increased from 28 to 36. In the figure, a robust mode is chosen as the mode satisfying the following stability conditions; the difference in results between the current and prior model should be: (1) less than 1.5% for natural frequency, (2) less than 5% for damping ratio, and (3) more than 98% for the Modal Assurance Criterion (MAC) (Allemang and Brown 1982). The first six or seven modes could be identified from each of the LMS test data and ambient vibration measurements. Despite the earthquake damage to the interior, slab-column connections, the cyclic response of the building frame is effectively linear given the low-to-moderate amplitude vibrations imposed during the tests (no element yield) and the light damage to the perimeter moment frame. That is, reloading, despite the modest damage resulting from the Northridge earthquake, is essentially linear with changes in observed frequencies expected due to concrete

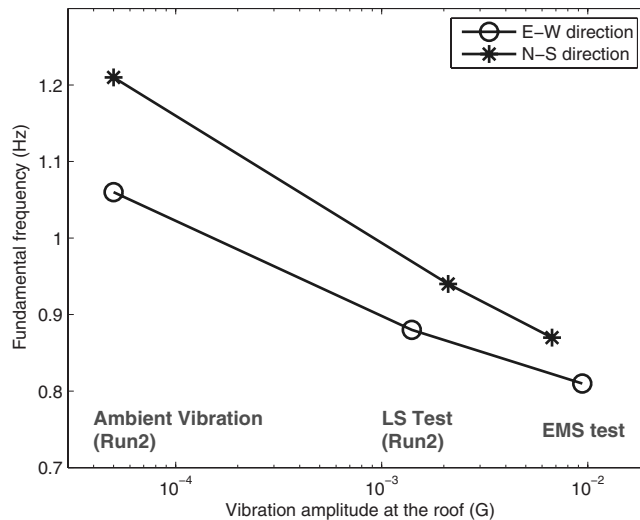
Figure 17. Change of natural frequencies with vibration amplitude.

sequent studies further validate the earlier findings, e.g., Celebi et al. (1993). In the current tests, the peak values of the roof accelerations around the fundamental frequencies, obtained by filtering data with a very narrow bandpass filter (fifth-order Butterworth filter with cutoff frequencies of 95% and 105% of the fundamental frequencies in each test), are 5×10^{-5} g, 0.0015 g to 0.002 g, and 0.007 g to 0.009 g for the ambient, LMS tests, and EMS tests, respectively. The relationship between shaking amplitude and fundamental frequency is shown in Figure 17. The decrease in fundamental frequencies appears to be proportional to the logarithm of the (filtered) vibration amplitude increase.
