Modeling riparian geomorphology and vegetation on a regulated river to assess change, prioritize ecological restoration areas, and inform restoration design

CLANCY ROBERT MCCONNELL  
DISSERTATION

Geography

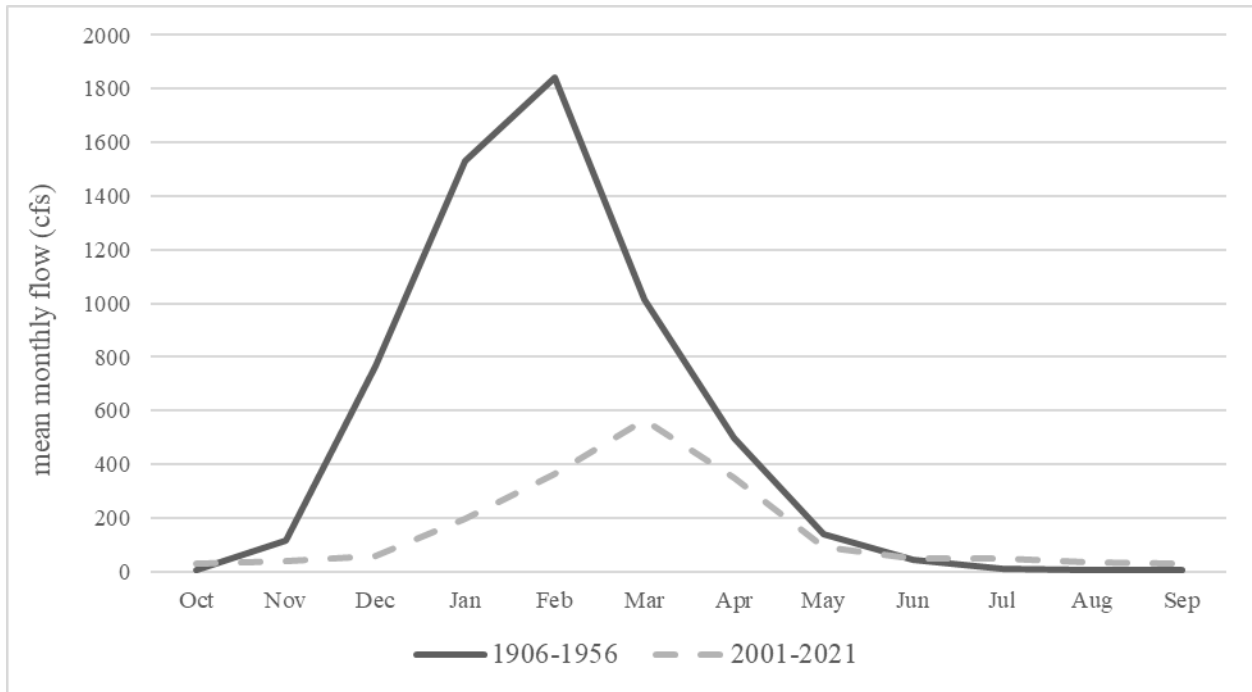
**Figure 1.2.** Pre- and post-dam average annual hydrographs for Lower Putah Creek. There was a major reduction in winter flows, minor increase in summer flows, and total average reduction in flow of 69%. Monthly average post-dam flow data was only available after 2000 (Bureau of Reclamation, 2023).

completed (**Figure 1.2**). The largest flow recorded pre-dam, in 1940, was 81,000 cubic feet per second (cfs), and was the last flood from Putah Creek to submerge the city of Davis (Larkey, 1969). The largest flow since 1957 has been just 18,700 cfs, and occurred in 1983.

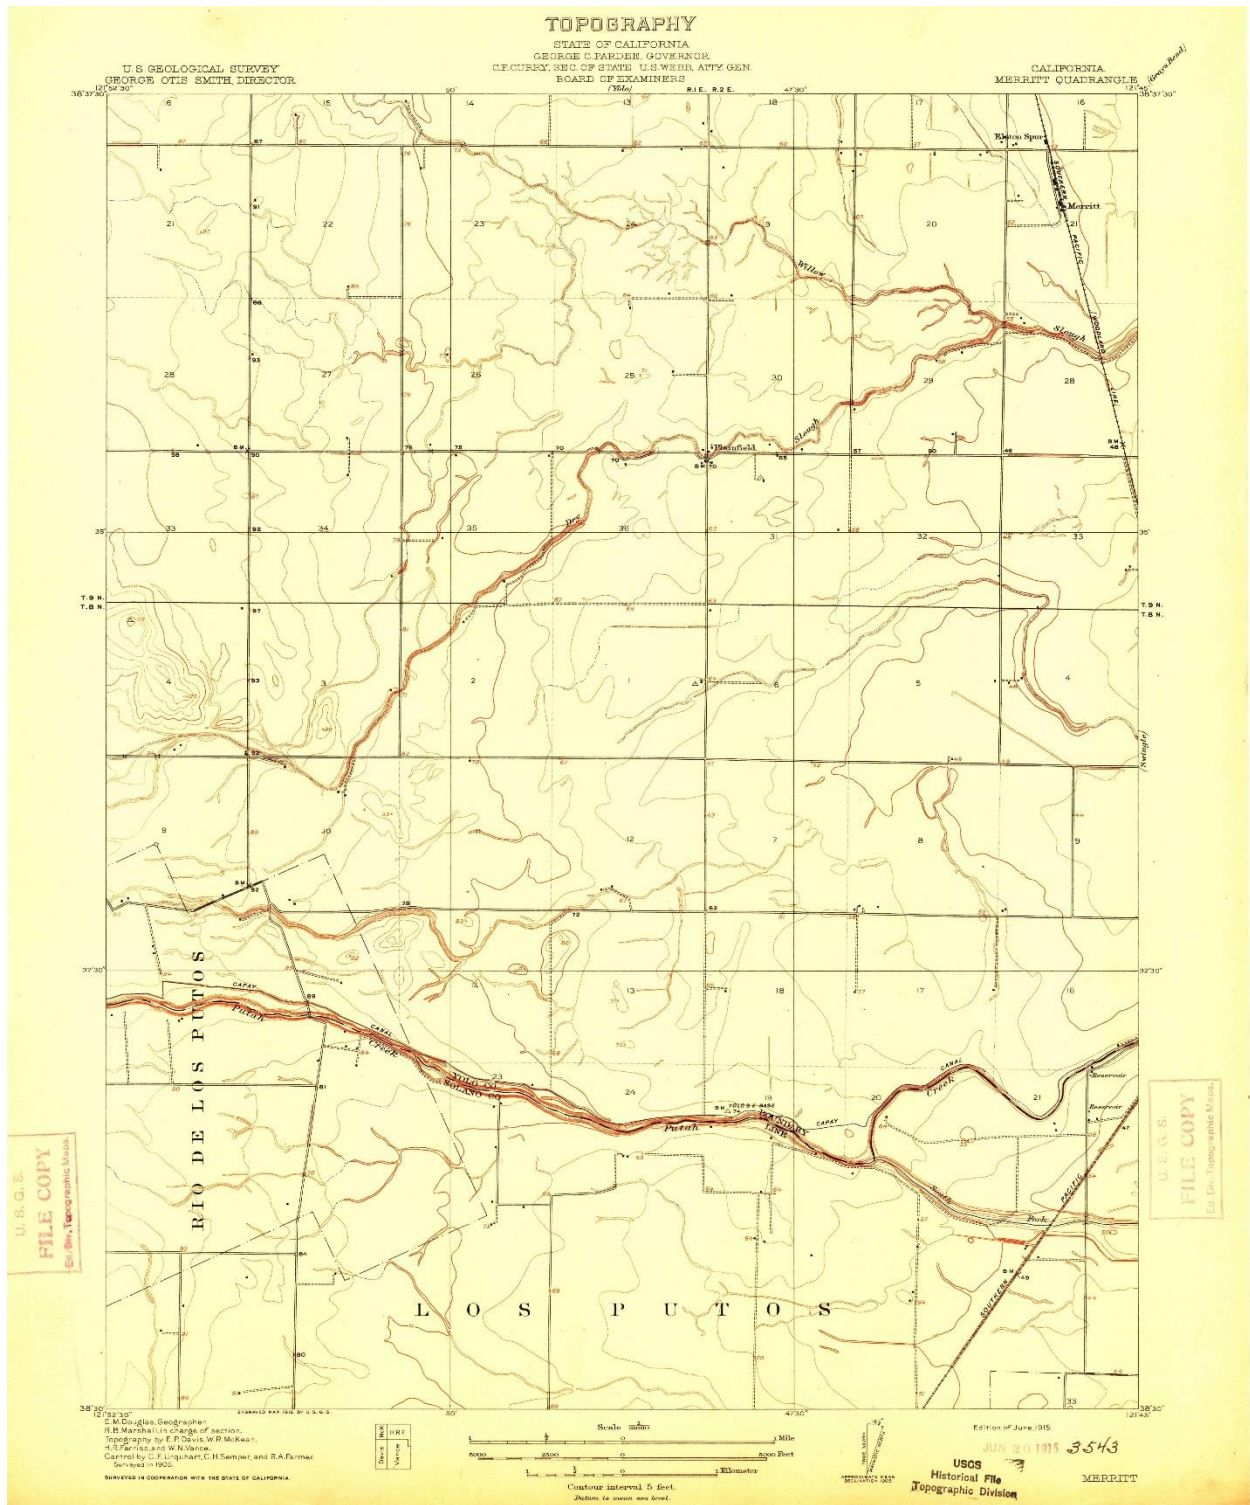
**Figure 1.4.** A 1905 USGS topographic quadrangle, Merritt, used in the study. Putah Creek is in the lower half of the map, and the Putah Creek fork is in the bottom right, showing the new channel (South Fork) breaking off from the old channel (North Fork), which bends north at a 90-degree angle. The contour interval is five feet.

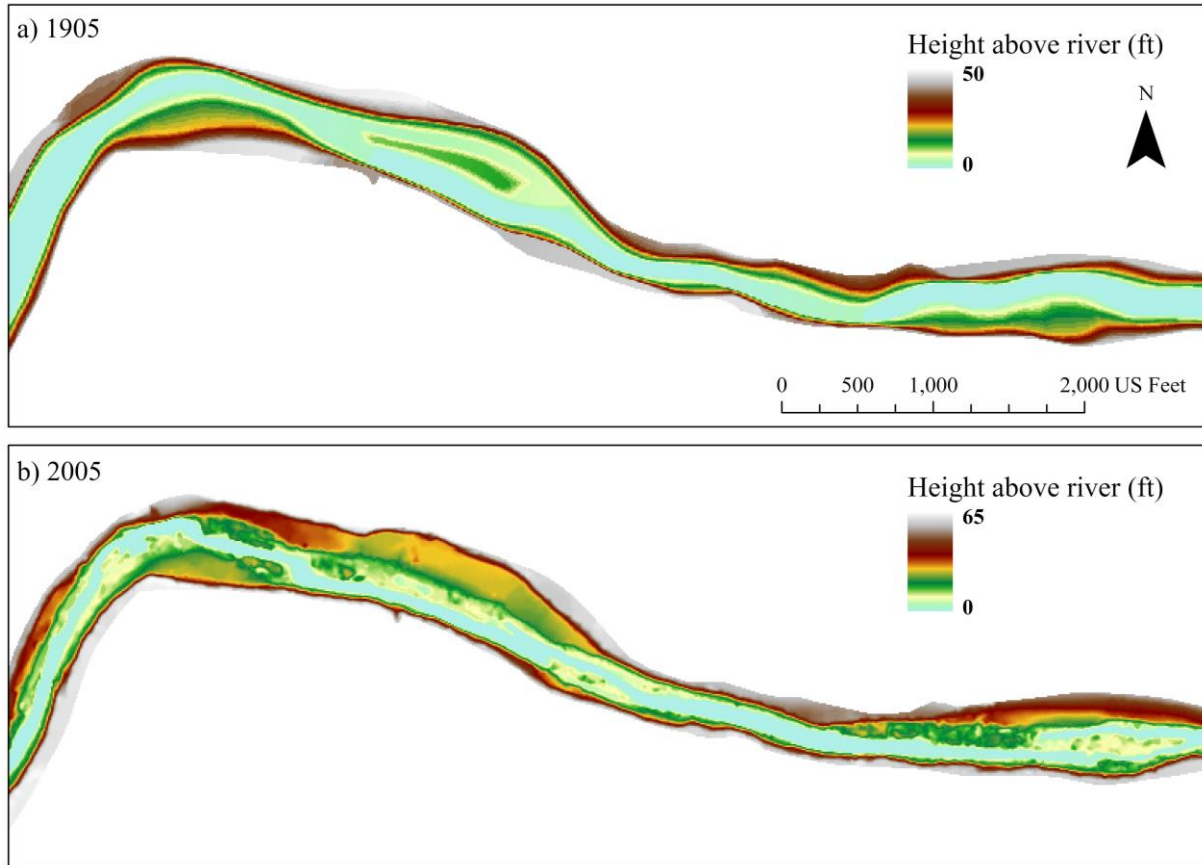
**Figure 1.5.** An example of the HAR maps. These show the HAR models at river-mile 17, just downstream of El Rio Villa, for (a) 1905 and (b) 2005. This comparison demonstrates that, between 1905 and 2005, the baseflow channel narrowed significantly.

DEM to create the HAR map. This method can produce negative grid cells, which may or may not be real, depending on the study site. In this area, the negligible number of negative-value cells were converted to 0-ft relative elevation using the ArcGIS Con tool (conditional statement). The resulting rasters were then clipped to the study boundary. A sample of the HAR maps are shown in **Figure 1.5**.

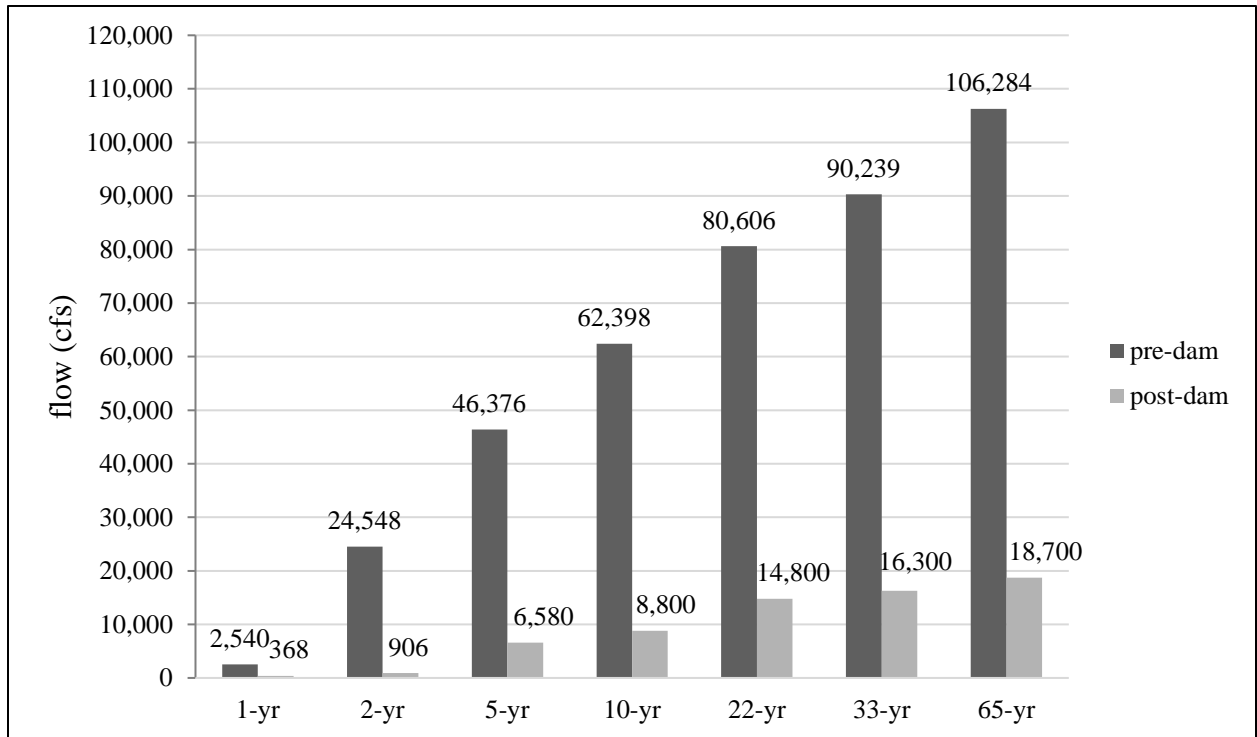
**Figure 1.6.** Flow frequency values for selected recurrence intervals in pre-dam and post-dam. Post-dam peak flows are between five and twenty-five times smaller than pre-dam flows.

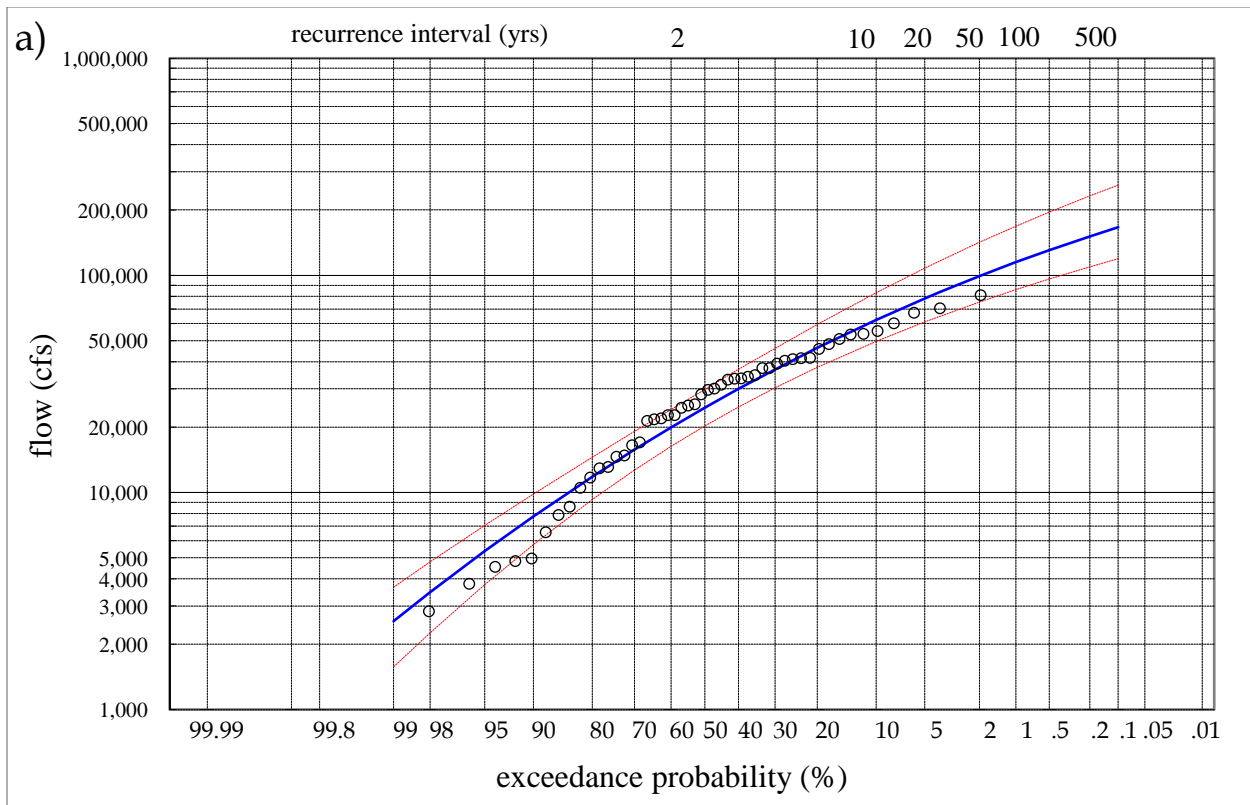
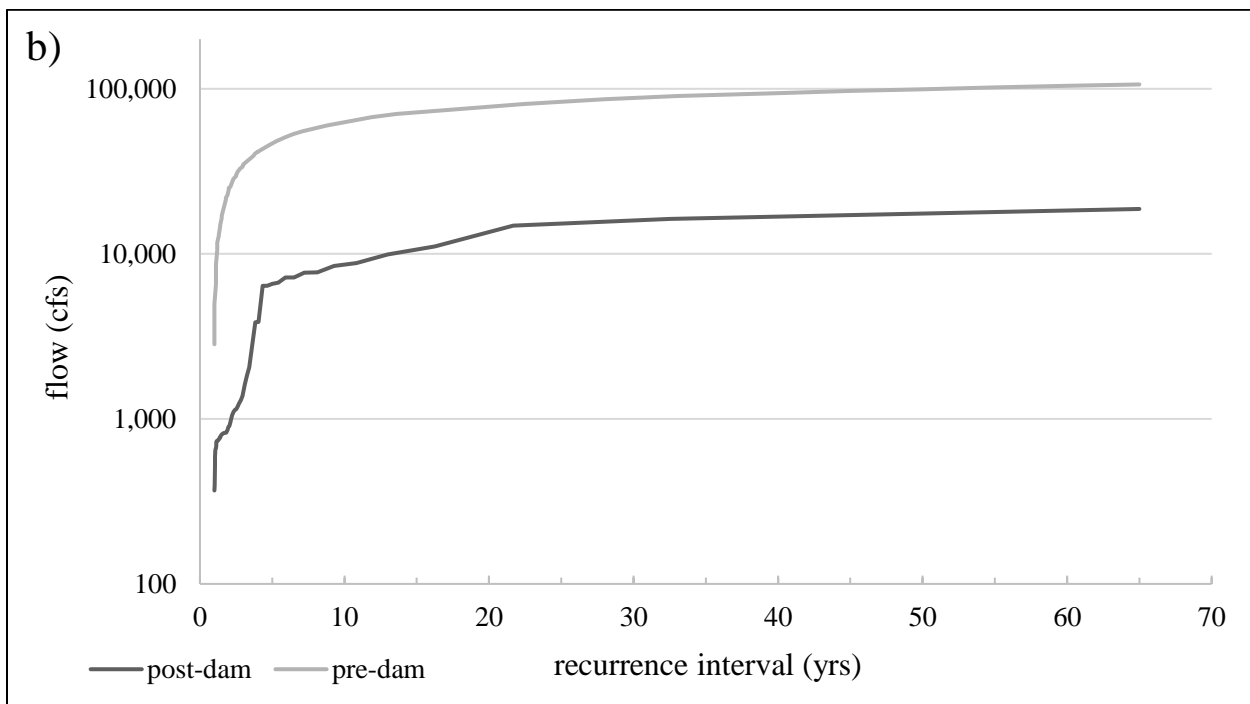
**Figure 1.7.** Flow frequency curves for pre-dam and post-dam. (a) Log-Pearson Type III flow frequency curve for pre-dam, created using the outputs from the NRCS worksheet; and (b) comparison of flow frequency curves for the pre-dam flow regime, created using the Log-Pearson Type III formula, and post-dam flow regime, created using the Weibull plotting formula.

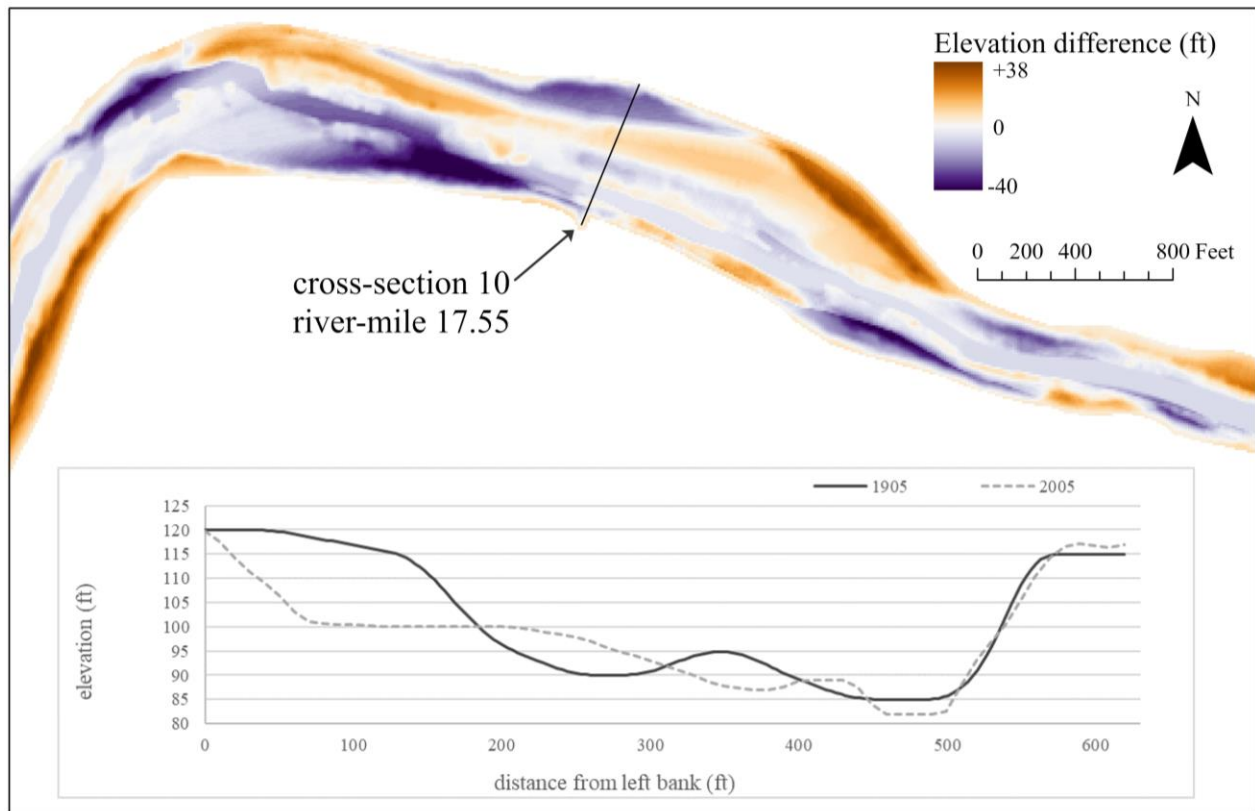
**Figure 1.8.** DEM subtraction map and accompanying 1905 and 2005 cross-sections at river-mile 17. Purple indicates material lost from 1905 to 2005; orange indicates material gained from 1905 to 2005. The cross-section shows exaggeration in the z dimension to characterize local topographic change.

banks (Vaught, 2007). This can be observed in not only the significant increase in area above 32 ft HAR compared to pre-dam, but also in the DEM subtraction in areas shown in orange along the upper banks in **Figure 1.8**, and in most of the cross-sections, as indicated by small mounds in the elevation profile at the top-of-bank in 2005 but not 1905 (**Figure 1.10, Appendix Figure A.1**). It is possible that the net change in channel material was influenced by not only the geomorphic effects of the dam and dredging, but also by creek-side landowner operations, which have been extensive throughout the agricultural development of the area from the 1840s to the present (Grismer, 2018; Lower Putah Creek Coordinating Committee, 2005; Rubin, 1988; Vaught, 2007).

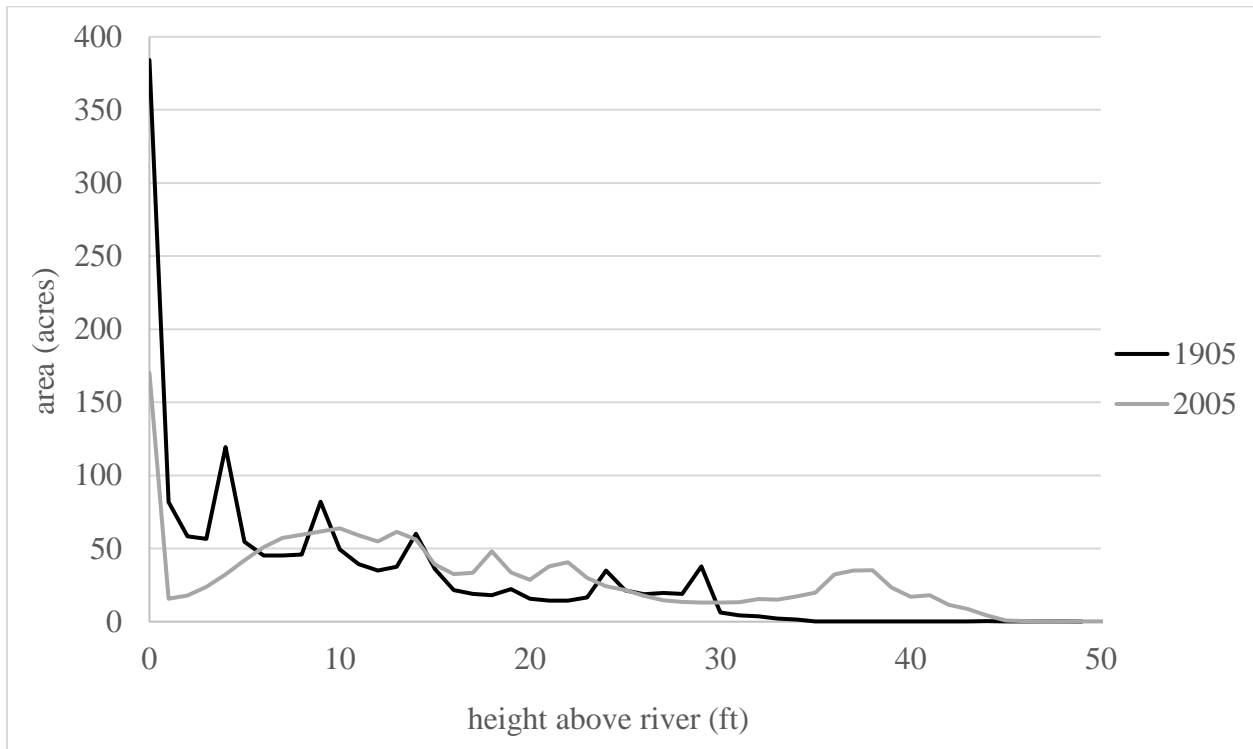
**Figure 1.9.** The distribution of area by HAR for 1905 and 2005. Two significant findings are visible: (1) the 2005 channel has significantly more area above 35-ft HAR, indicating the 1905 channel was much shallower than the 2005 channel; and (2) there is significantly more low-HAR area in 1905 than in 2005, indicating the 1905 channel had a flatter, wider channel bottom. These results indicate significant downward incision and baseflow narrowing.

bottom-of-channel along most of the length of the creek (**Figure 1.9**). This finding is corroborated by the cross-sections (**Figure 1.10**), which show that the 2005 channel is more V-shaped and contains a narrow, deeper baseflow channel, whereas the U-shaped 1905 channel bottom was flat and wide.

However, the HAR histogram (**Figure 1.9**) shows a more complicated change in geomorphology than system-wide channel degradation. While bottom-of-channel changes, including deepening and a narrower baseflow channel, are the result of incision and dredging, there is a consistent pattern indicating gained material along the top-of-bank that is most likely the result of agricultural landowners pushing material into the channel to extend field size or create small levees, although it is also possible that dredging or scraping of the channel in the early 1900s (but after 1905) moved material from the bottom of the channel to the top of the

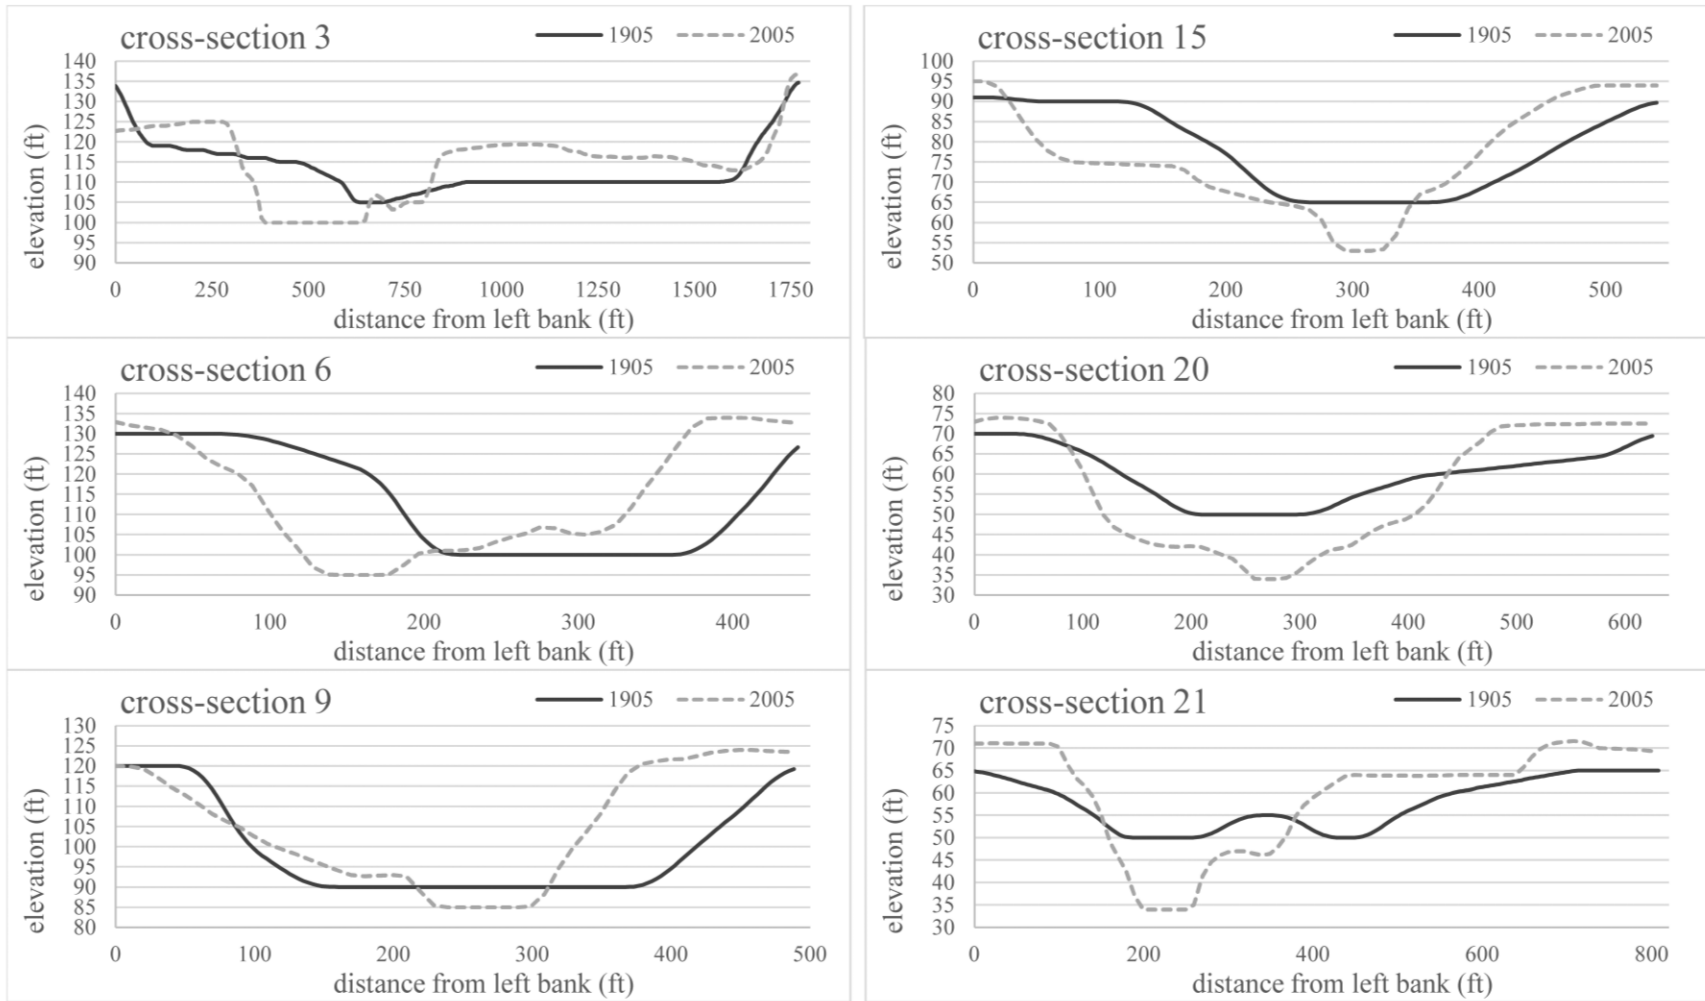
**Figure 1.10.** Cross-sections sampled from the 41 representative cross-sections in **Appendix Figure A.1**. These plots show incision of the baseflow channel along the entire creek, with variable magnitude by location. In general, the 2005 channel banks are steeper and the baseflow channel has narrowed. Figure continued on next page as **Figure 1.10b**.

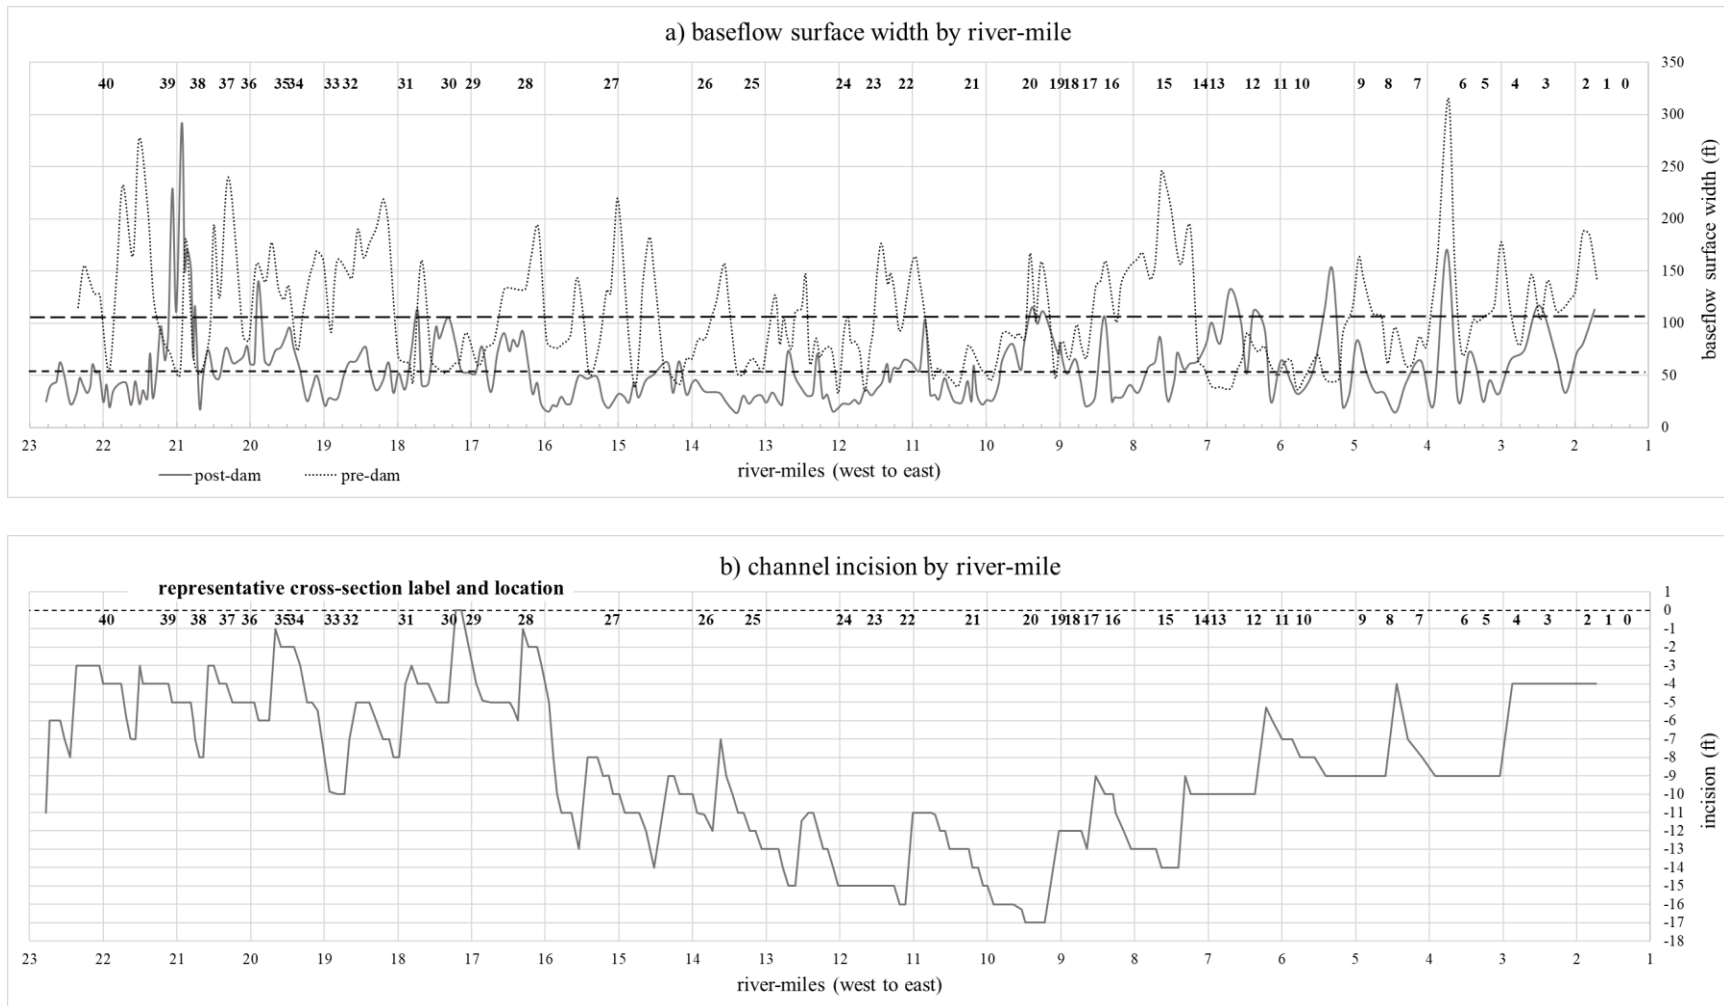
**Figure 1.11.** Longitudinal plots by river-mile. The 41 representative cross-sections are labeled at the top of each plot for reference, indicating: (a) baseflow river surface width for pre-dam and post-dam, as well as mean values for width (dashed lines), and (b) maximum channel incision between pre-dam and post-dam (dotted line indicates zero incision); the dashed line here indicates zero incision.

Some areas of the baseflow inundation surface (river-miles 3.5-4, 4.5-5.2, 7.5-8.8, 9.5-10.7, 18.5-19.9) seem to have narrowed in a pattern consistent with even degradation laterally across the channel; we hypothesize that this pattern indicates narrowing by flow incision rather

than dredging (**Figure 1.11**). Areas of the surface that widened (river-miles 5.2-5.6, 6.2-7.2, 17.3-17.6, 20.8-21.2), which are inconsistent with the channel becoming V-shaped, we hypothesize indicates a dredged morphology. However, areas of the greatest incision could more strongly indicate dredging, especially since incision was highly variable. When comparing the entire longitudinal incision plot to the entire baseflow surface plot, the reach with the greatest incision (river-miles 7.5-15.5) aligns with the reach where the baseflow surface showed the least change (river-miles 8.5-13.5) (**Figure 1.11**), suggesting an artificial vertical removal of sediment, rather than a more even lateral downcutting. This reach was also known to have been dredged extensively by UC Davis to mine aggregate to construct campus roads and buildings as late as the 1970s (P. Moyle, personal communication, 2018). A more in-depth examination of longitudinal plots and all 257 post-dam cross-sections could identify reaches that might serve as appropriate reference sites for geomorphic restoration or rehabilitation. In rivers of the Central Valley, restoration of the channel and vegetation would likely utilize a topo-sequence of riparian vegetation (e.g. Conard et al., 1980) according to HAR and modeled flow inundation surfaces. On Lower Putah Creek, these would be reaches with shallow sloped channel banks and a wide floodplain, which under the regulated flow regime would increase the riparian zone and be better able to support a more dynamic riparian ecosystem (**Figure 1.13**).

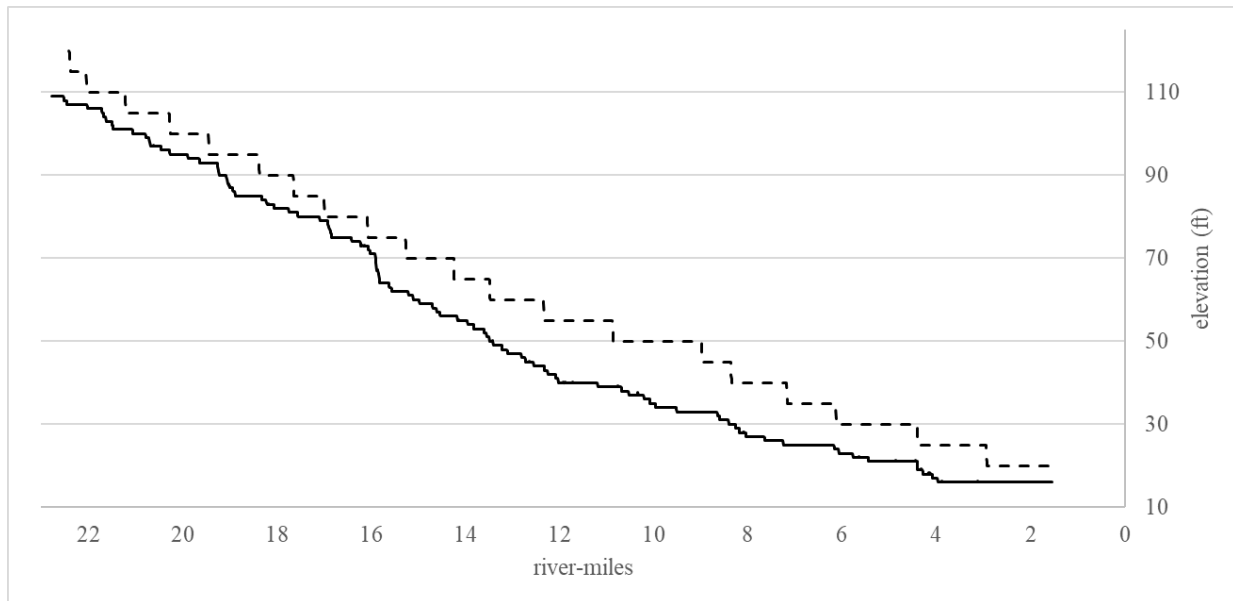
**Figure 1.12.** Thalweg elevation profiles for 1905 (dashed line) and 2005 (solid line). There was incision along the entire creek except for a very short section at river-mile 17.14, where the incision was 0 ft. The staircase pattern in the 1905 profile is an artefact of the 1905 five-foot contour interval.

maximum of 17 ft, with incision occurring along the entire channel except for a short section from river-mi 17.14 to river-mi 17.21, where the incision was 0 ft (**Figure 1.11b**). Incision was highly variable but patterned by reach, as indicated by local changes in slope, which differed between 1905 and 2005 (**Figure 1.12**). Incision was greatest from approximately river-mi 7.5 to river-mi 15.5, and in general, incision was much greater downstream of river-mi 16 than upstream of that point. The regularly-spaced peaks and valleys in **Figure 1.11b** are explained by the stairstep pattern of the 1905 DEM, an artefact of the 1905 five-foot contour interval (**Figure 1.12**).

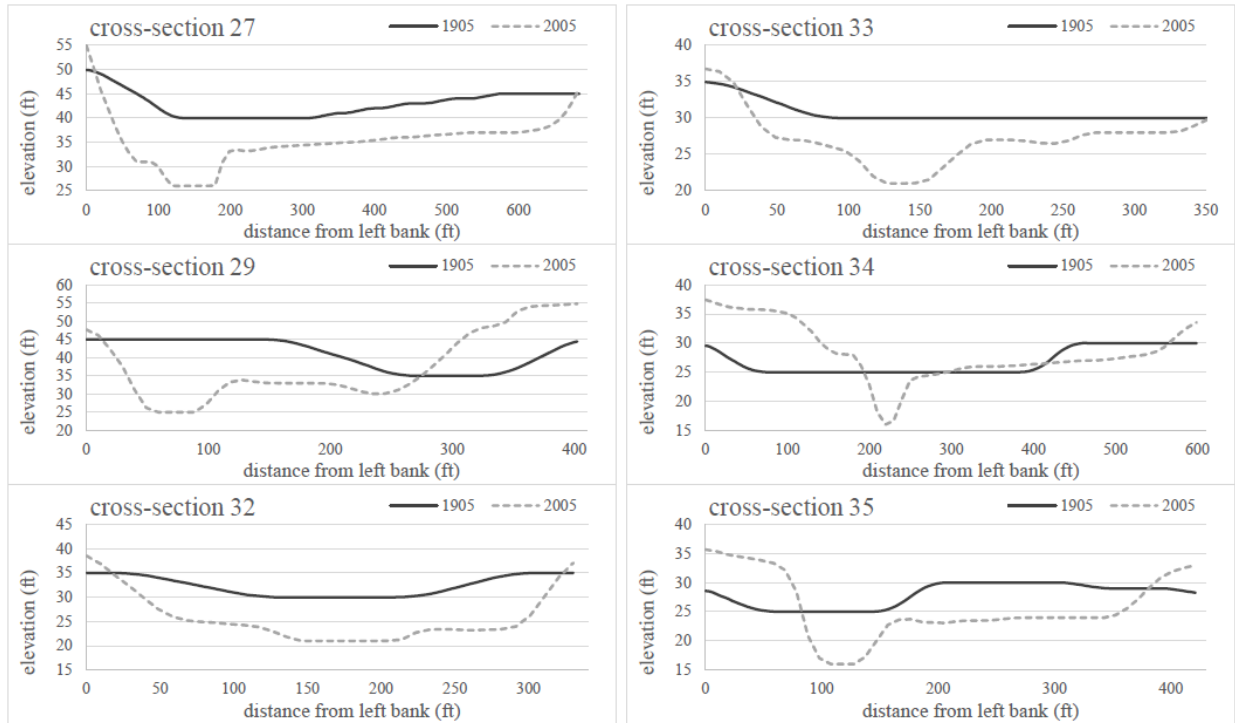
**Figure 1.13.** Cross-sections that could serve as reference sites for geomorphic restoration. While there is significant incision in these cross-sections, they have a relatively narrow (<50 ft.) and shallow (<7 ft.) baseflow channel as well as relatively wide floodplains with gentle gradients, requiring only minor geomorphic modification for restoration compared to other areas.

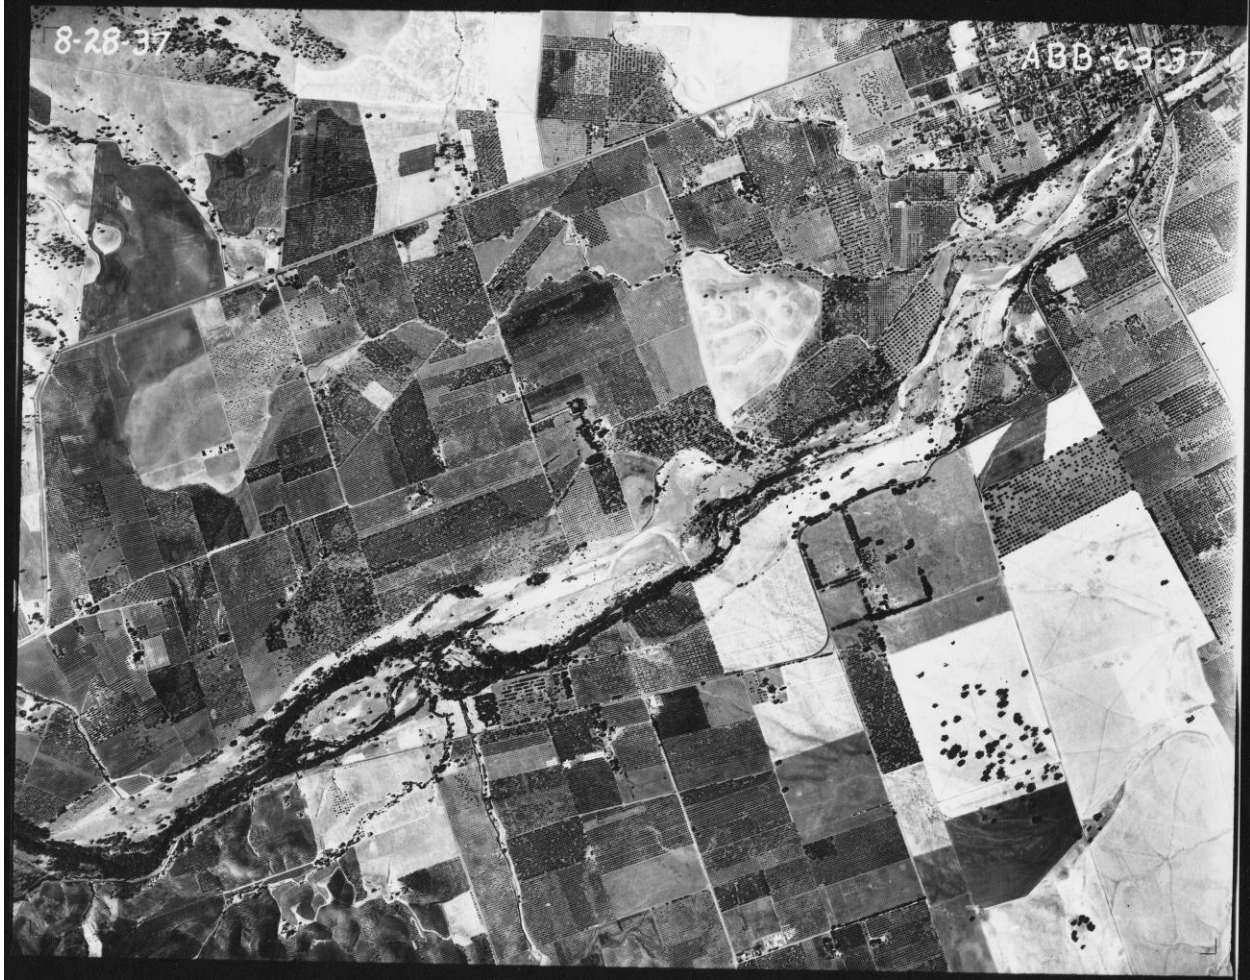
**Figure 2.1.** Black and white 1937 aerial photograph for a section of Lower Putah Creek. Here, the river flows freely through the area in the lower left that in 1957 would become impounded by Putah Diversion Dam. The city of Winters, CA, is in the upper right. Surface water is visible in some areas of the channel, including in the mid-lower center and mid-lower center-left of the image, appearing as smooth-edged, dark objects against bright, barren material and more textured, woody vegetation. While surface water was often not visible in the driest months of the year pre-dam, complex connections with groundwater may have helped maintain flow in dry reaches during these months (Grismer, 2018).

Historical aerial photographs for the 1937 flight (**Figure 2.1**) were downloaded from the FrameFinder tool on the University of California, Santa Barbara, library website. This flight took place from August 20-28, 1937, at an altitude of 13,750 ft and a scale of 1:20,000, with front overlap of 60% and side overlap of 20%. Each photograph's scanned resolution is 0.7 cm/pixel. This aerial photography, which documented more than 90% of the agricultural land in the U.S. from 1937-1941, was done by the Works Progress Administration and USDA Farm Service Agency to verify compliance with the way New Deal funds were spent (Monmonier, 2002). Since then, it has been used for land-use and conservation planning (Monmonier, 2002), environmental health assessment (Maxwell et al., 2010), and historical ecology and environmental history research (Ma et al., 2020; Weems, 2011).

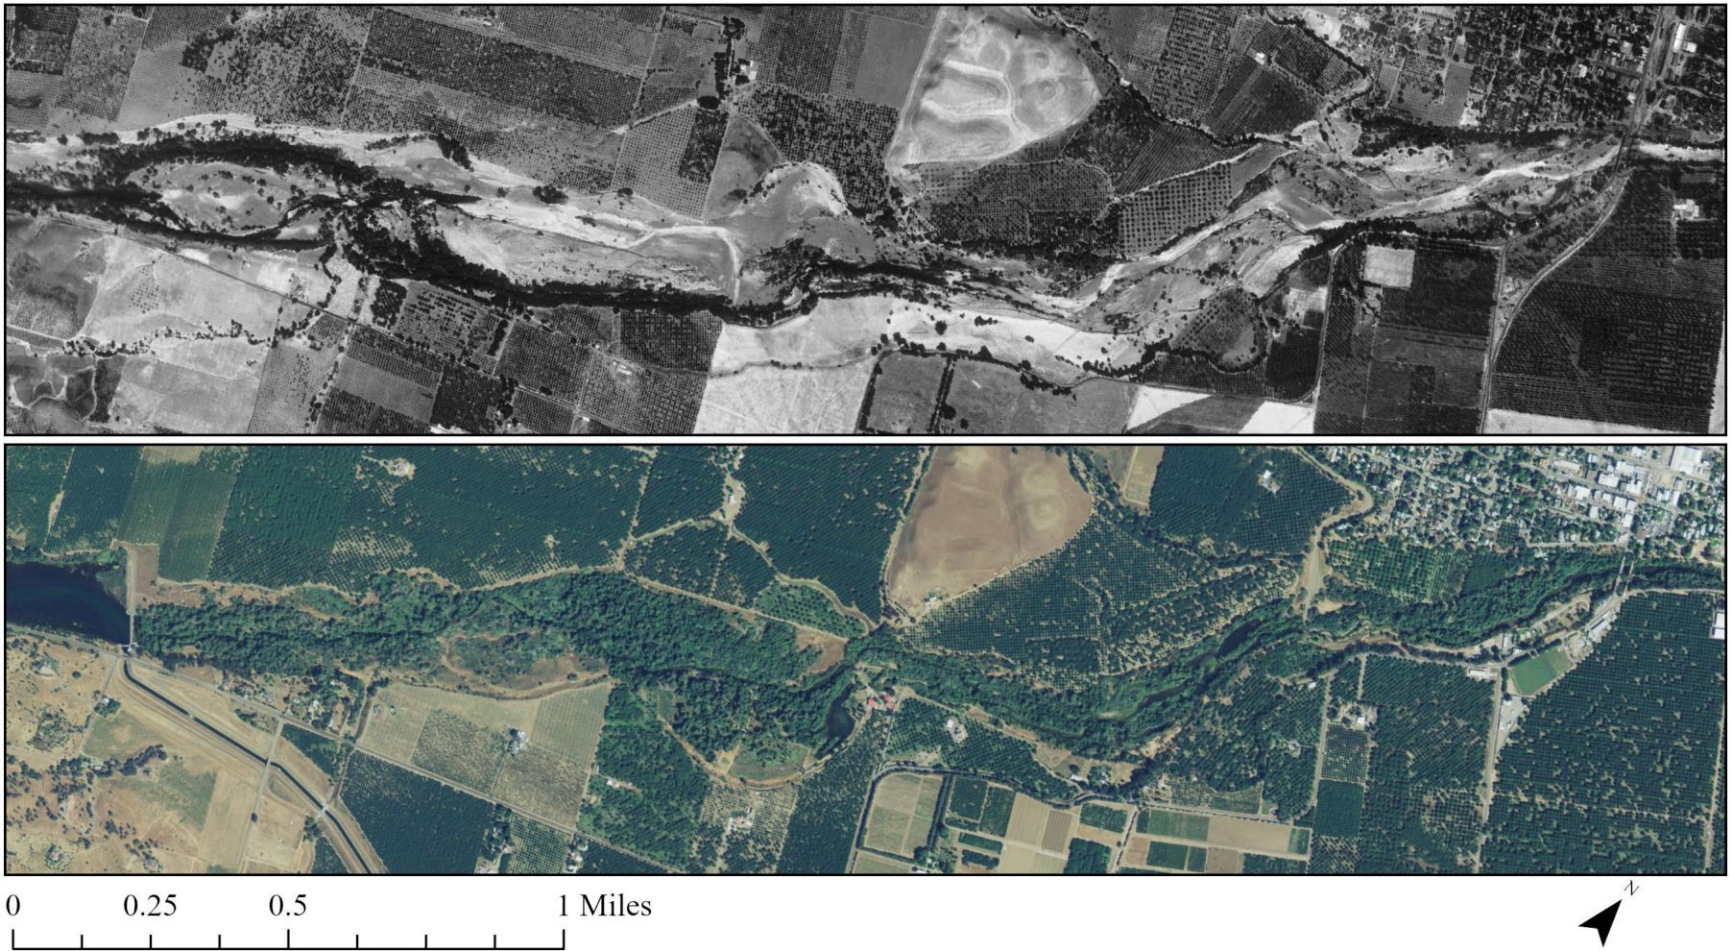
**Figure 2.2.** Mosaicked aerial imagery for 1937 (top) and 2009 (bottom). These maps show the 1937 and 2009 mosaics for the same reach of creek shown in **Figure 2.1**. For the purposes of this study, cover types clipped out of each dataset include: crops, developed areas, and water.

merged in remote sensing software ENVI 5.0, then georeferenced in ArcGIS Pro again as one orthomosaic. To georeference the file, link points were chosen based on common features between the 1937 mosaic and current aerial imagery (basemap), such as old building corners, the center of signature oak trees, old bridges, street corners, and town monuments. The spline method was used for rectification in order to allow the greatest degree of alignment (Tobias et al., 2021). Approximately 100 control points were used in each of two georeferencing processes. The output georeferenced orthomosaic has a pixel resolution of 8.8 ft (**Figure 2.2**) and was clipped to the study area boundary.

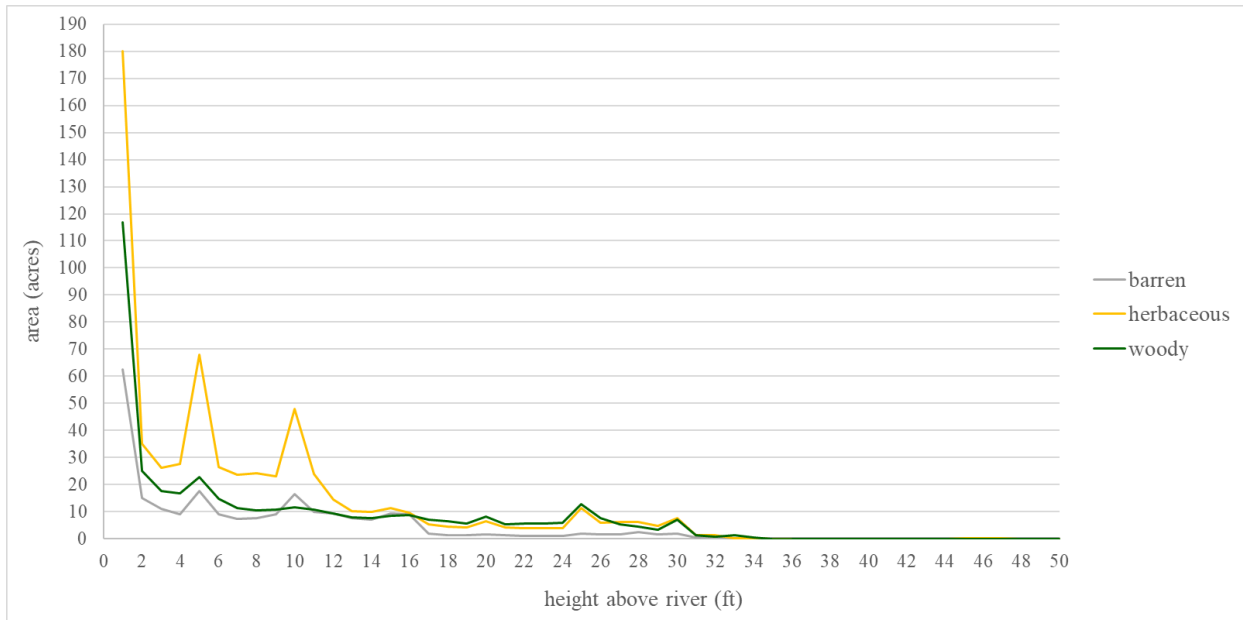
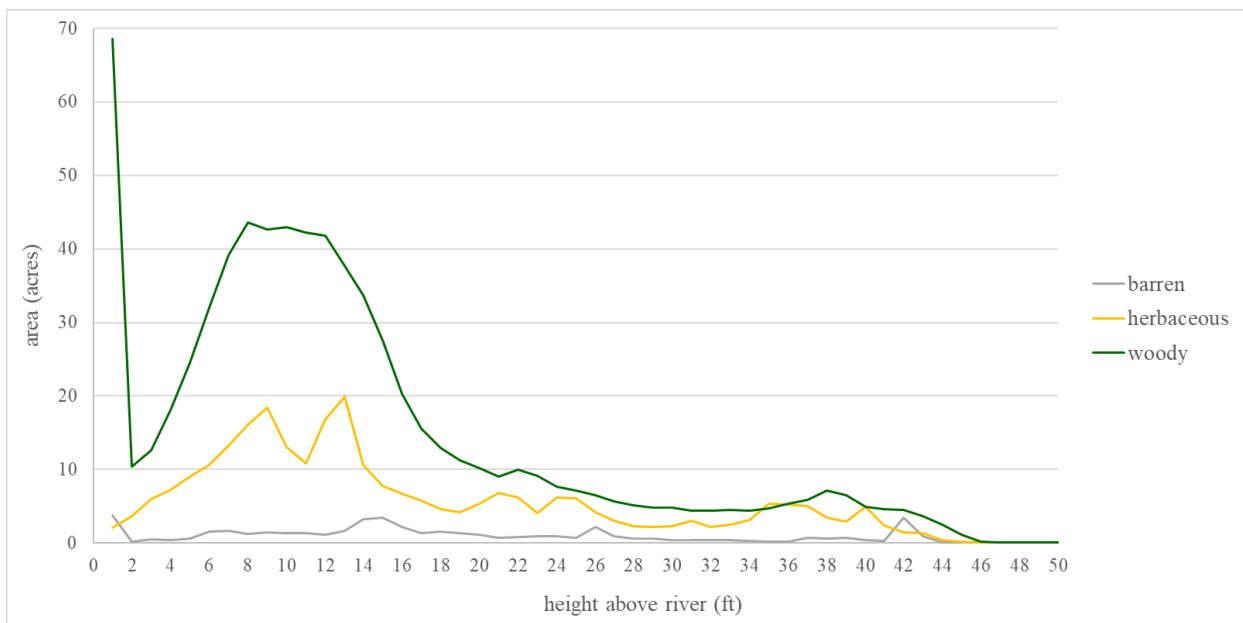
**Figure 2.4.** The distribution of land cover type by HAR for 1937 (top) and 2009 (bottom). In 1937, note that the cover drops to near zero above 30 ft HAR; this is because the channel was much shallower in 1905 than in 2005 (Chapter 1). The distribution of values changes significantly between time periods, with the peak in 1937 at 0 ft HAR and the peak in 2009 around 6-14 ft HAR.

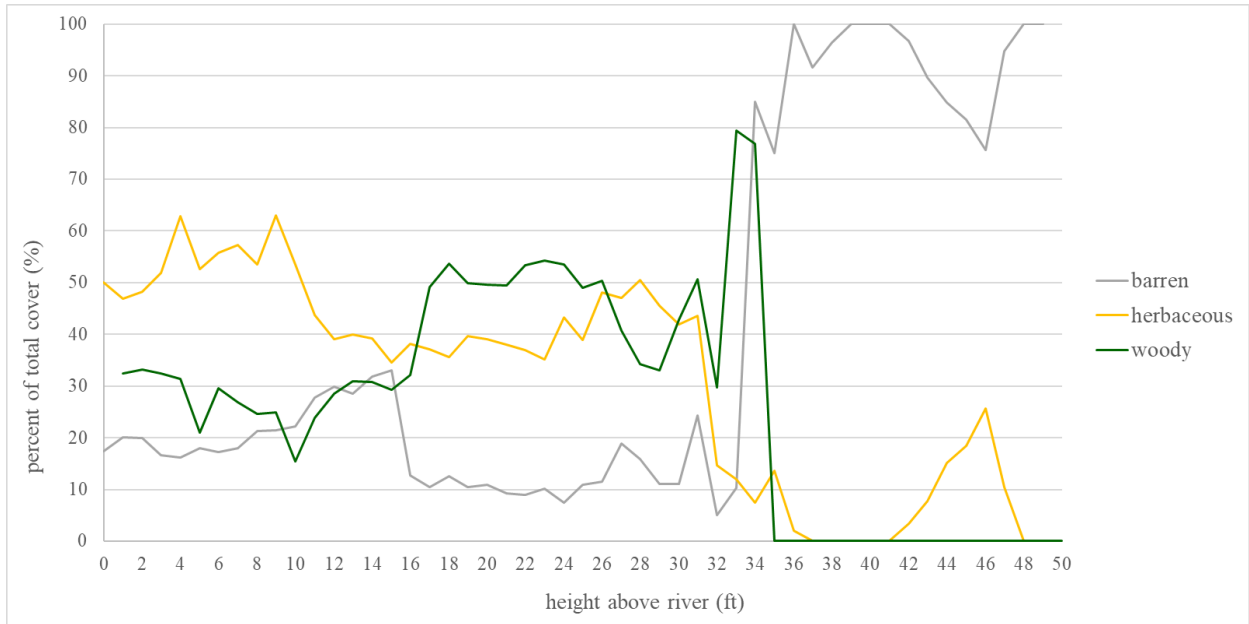
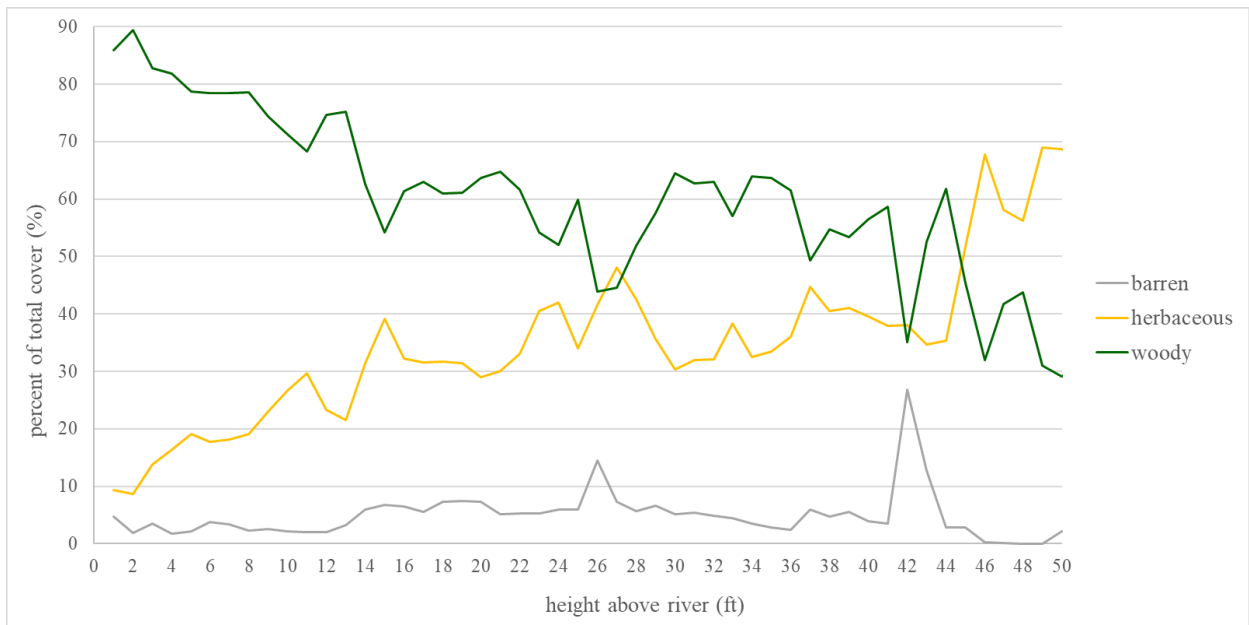
**Figure 2.5.** Proportional cover of each class by HAR in 1937 (top) and 2009 (bottom). In 1937, values become skewed above 30 ft HAR due to the shallower channel in 1905. Again, there is a significant change in the distribution of land cover type, with herbaceous dominating low HAR in 1937 and woody dominating low HAR (and nearly all the entire study area) in 2009.
