Modeling riparian geomorphology and vegetation on a regulated river to assess change, prioritize ecological restoration areas, and inform restoration design

CLANCY ROBERT MCCONNELL  
DISSERTATION

Geography

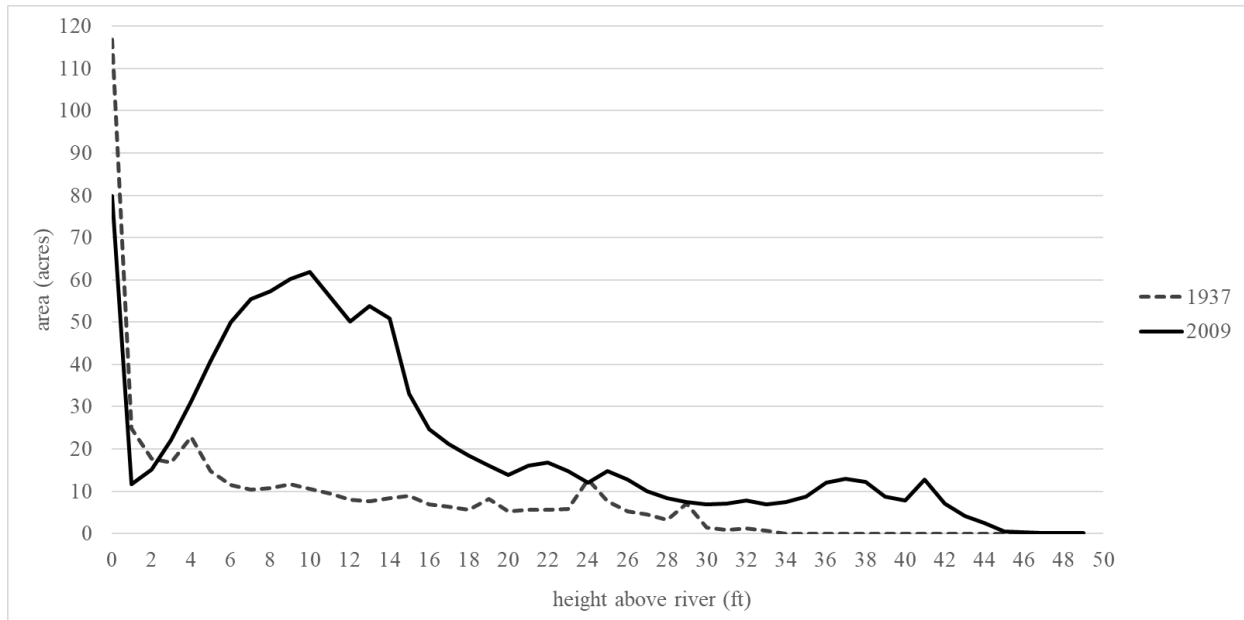
**Figure 2.6.** Distribution of woody vegetation by HAR in 1937 and 2009. This plot demonstrates well both the change in distribution of woody vegetation and the change in dominance of woody vegetation between 1937 (dashed line) and 2009 (solid line).

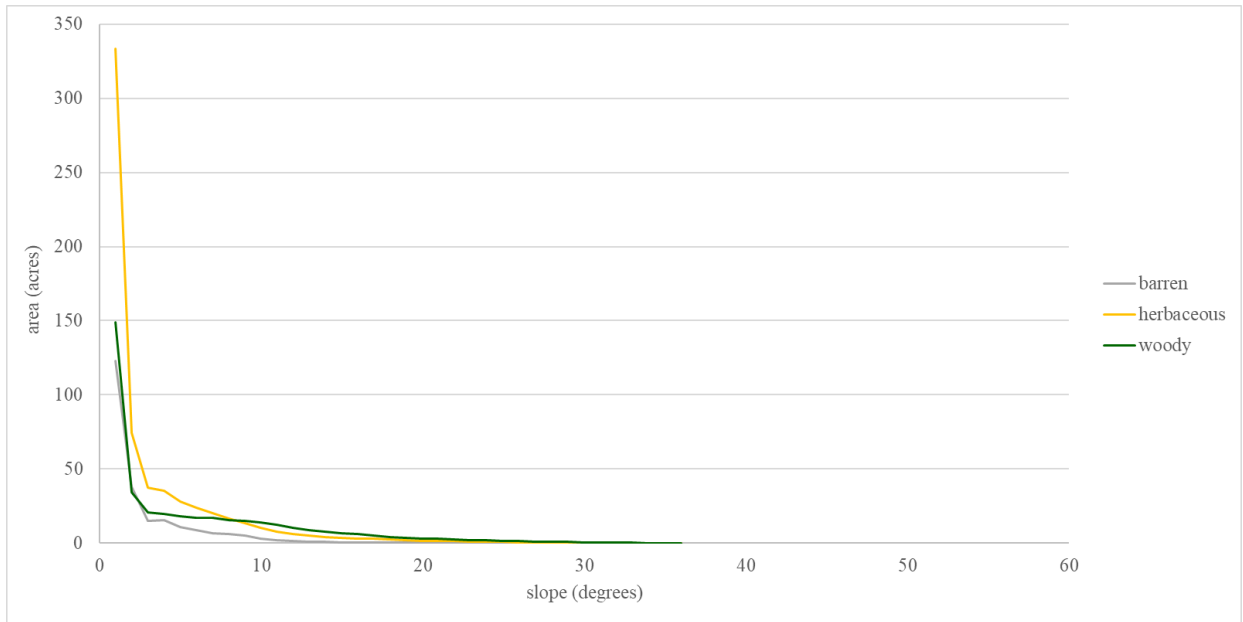
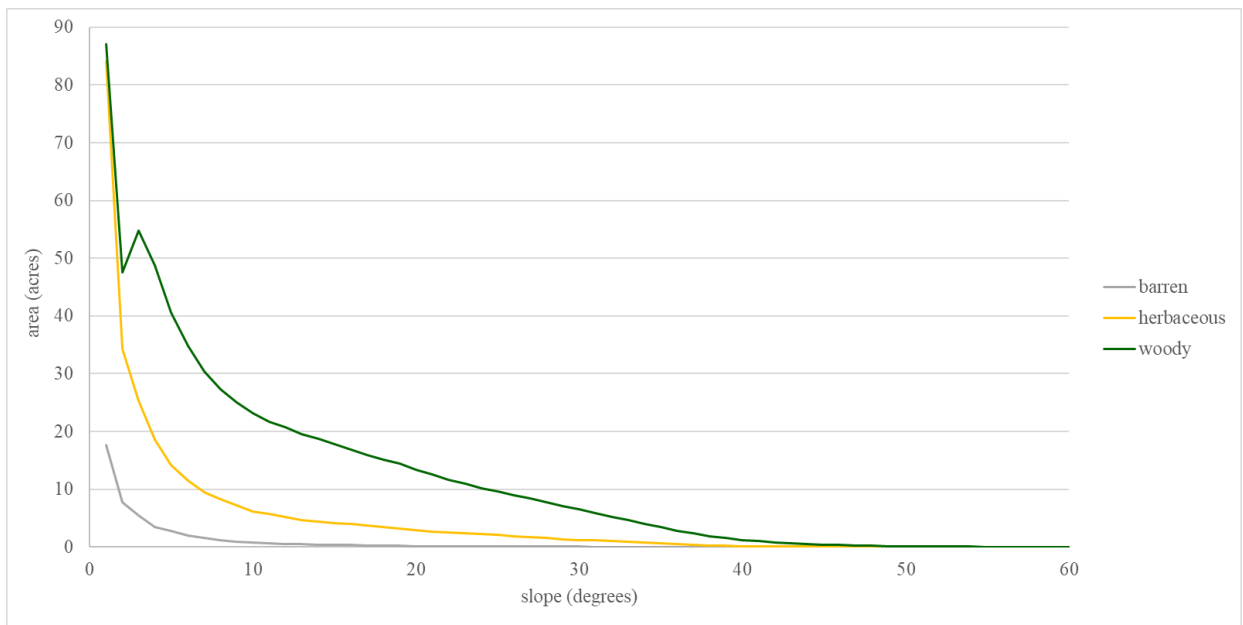
**Figure 2.7.** The distribution of land cover type by bank slope for 1937 (top) and 2009 (bottom). The 1937 plot shows in general much shallower slopes than the 2009 plot. Also, in 1937 herbaceous cover dominated the shallowest slopes (<8 degrees), whereas in 2009 woody cover dominated all slopes, and the distribution across slope values was relatively even compared to the distribution in 1937.

The amount of steep bank slopes increased between 1937 and 2009 across the study area due to channel deepening and narrowing (i.e., incision; Chapter 1), and the distribution of all three cover types by bank slope reflects that finding (**Figure 2.7**). In 1937, very little cover of any kind was found on bank slopes steeper than 26.8% (15 degrees), and the vast majority of the vegetated area was found on bank slopes shallower than 17.6% (10 degrees). In 2009, around half of the study area has a bank slope greater than 17.6% (10 degrees), steep slopes (those greater than 14.1-17.6% (8-10 degrees)) are dominated by woody cover, and barren cover is only found on the shallowest slopes.

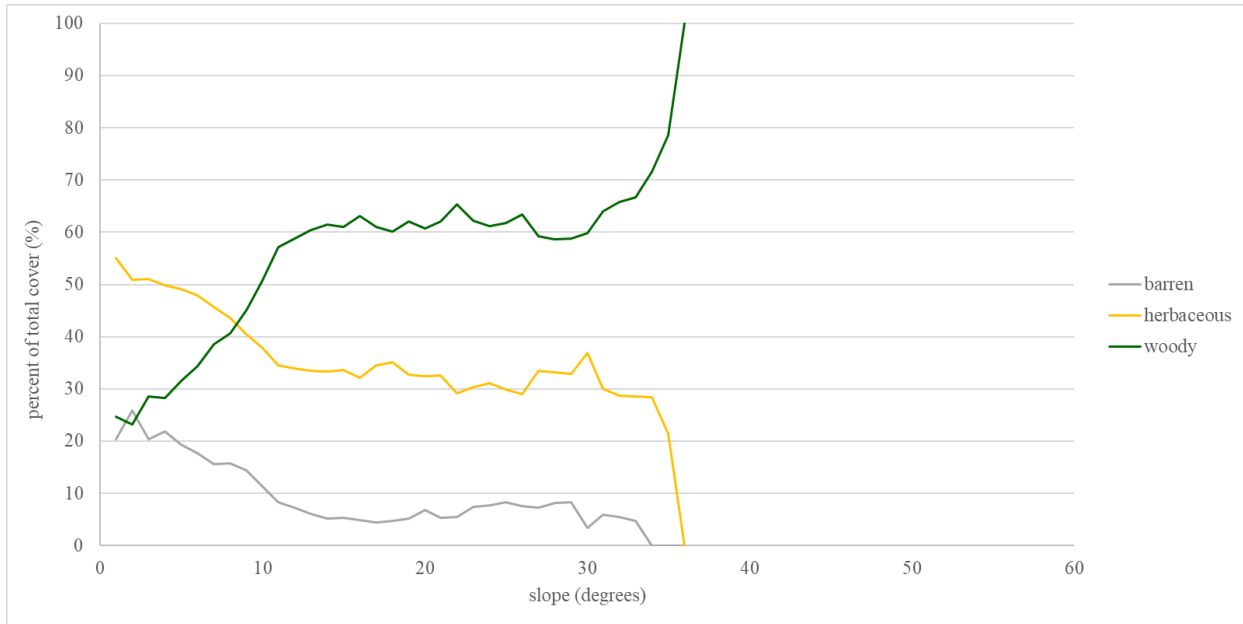
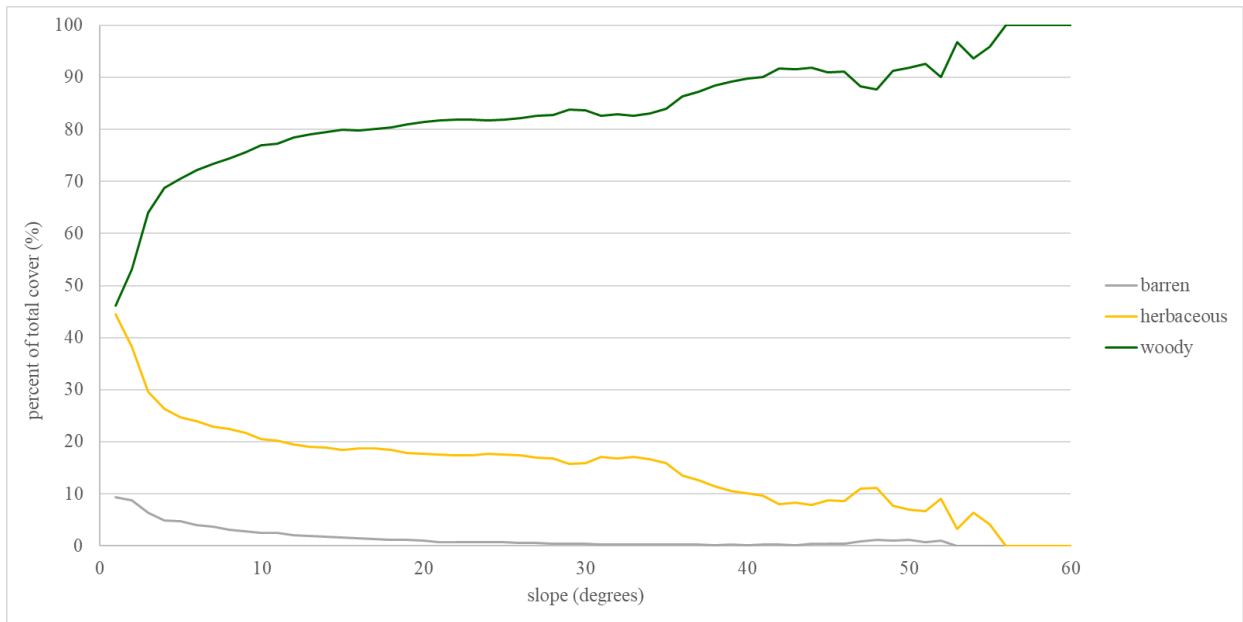
**Figure 2.8.** Proportional cover of each class by bank slope in 1937 (top) and 2009 (bottom). Comparing the maximum bank slope values in 1937 and 2009, it is clear that the 2009 channel is significantly deeper than the 1937 channel, due to the steeper banks. The skew of the 1937 curve above 35 degrees and the skew of the 2009 curve above 53 degrees are due to the low number of cells with that steepness.

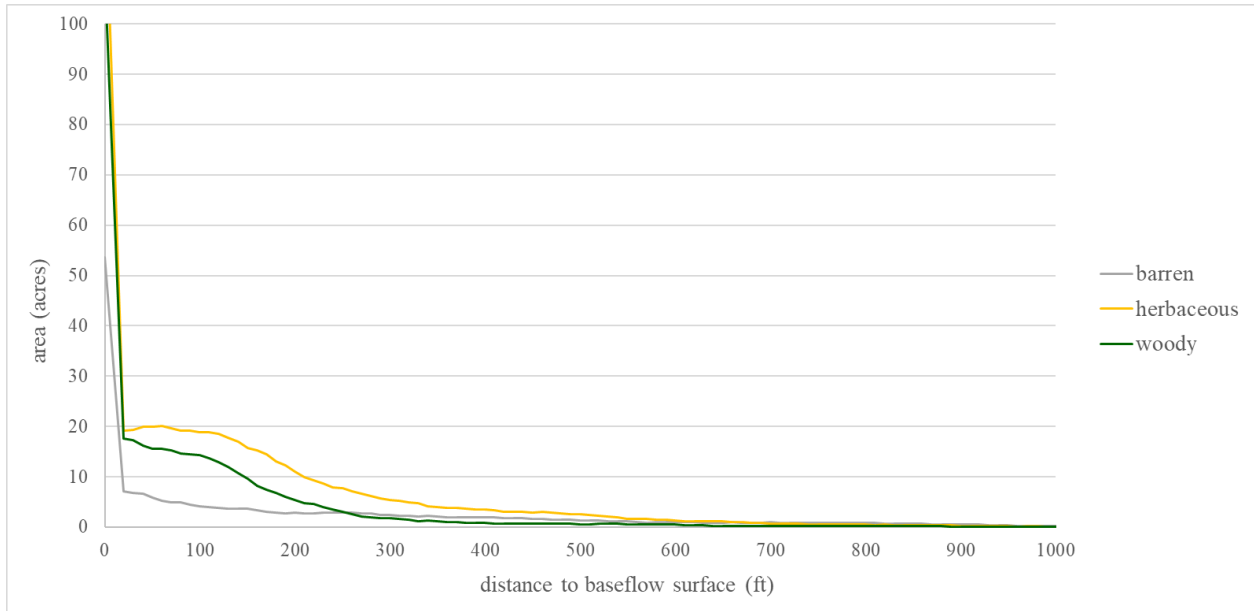
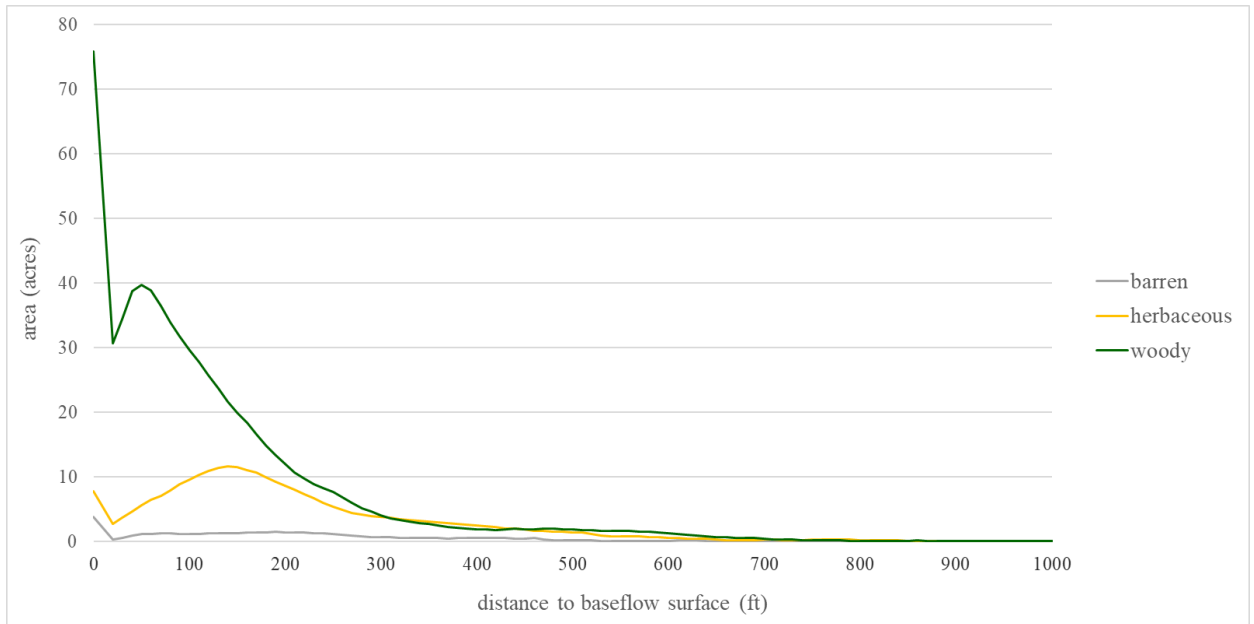
**Figure 2.9.** Distribution of cover type by distance to baseflow surface for 1937 (top) and 2009 (bottom). In 1937, herbaceous cover dominates almost all values, whereas in 2009, woody cover dominates almost all values. There is also a shift in the peak distribution of all cover types between time periods: in 1937, there are more values at zero ft from the baseflow surface because the channel bottom was wider and flatter than in 2009.

Charts of the distance to baseflow surface values for each cover class show significant changes to vegetation distribution (**Figure 2.9**). Woody cover and herbaceous cover both peak farther from the baseflow surface in post-dam than in pre-dam. Woody cover, which forms the vast majority of cover in post-dam, shifted from consistently decreasing cover away from the water to a peak around 50 ft from the water, and values overhanging the water surface decreased. All three land cover types showed similar pre-dam distribution. Post-dam, herbaceous cover was found in only small amounts near the baseflow surface, peaking about 150 ft from the water. Barren cover in the post-dam was found in small extents throughout the study area, and peaked around 210 feet from the water.

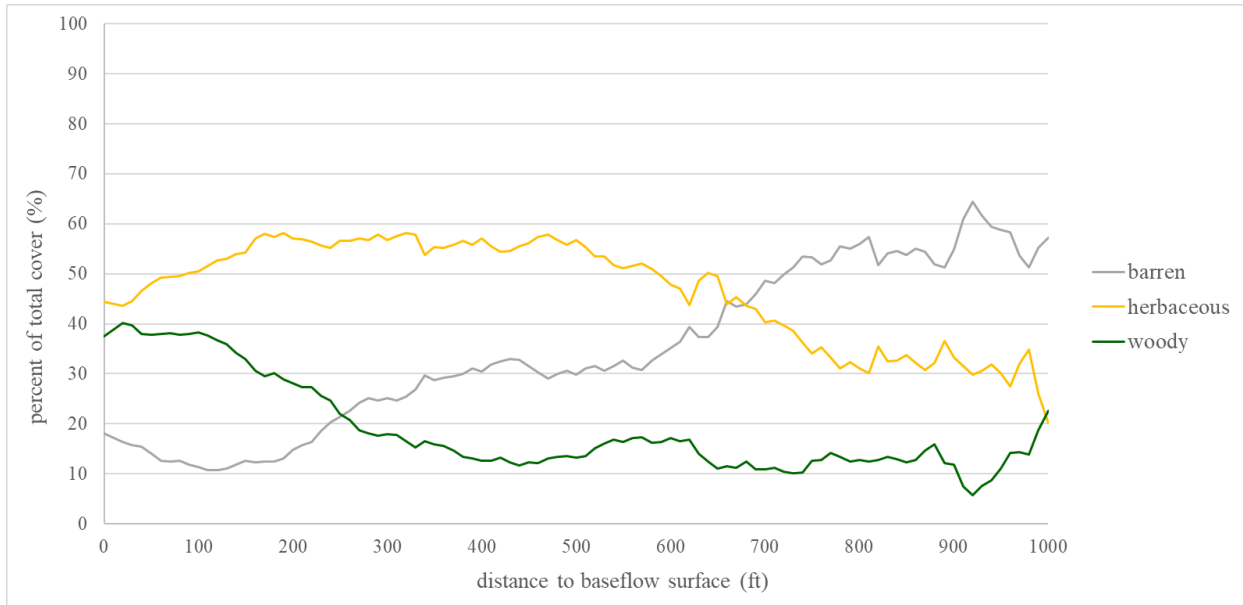
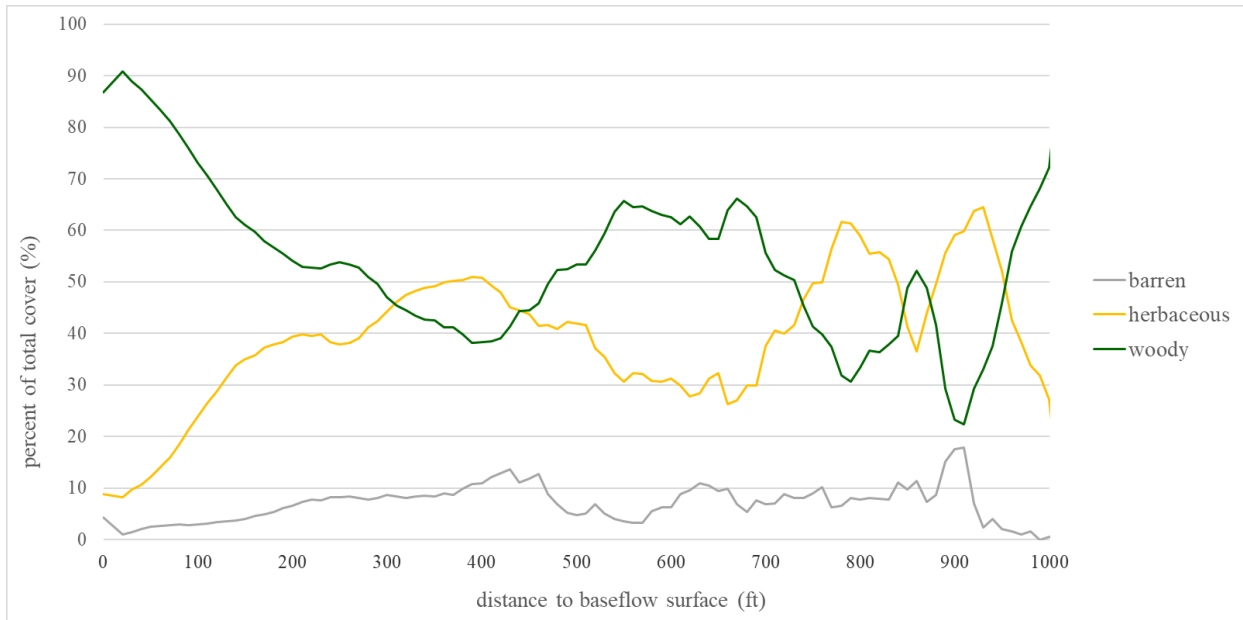
**Figure 2.10.** Proportional cover of each class by distance to baseflow surface in 1937 (top) and 2009 (bottom). In 1937, herbaceous cover dominates all but the farthest areas from the channel, but in 2009 (bottom), woody cover dominates in most areas, especially in areas within 300 ft of the baseflow surface; this indicates filling in of woody vegetation across the study area but especially in the riparian zone.

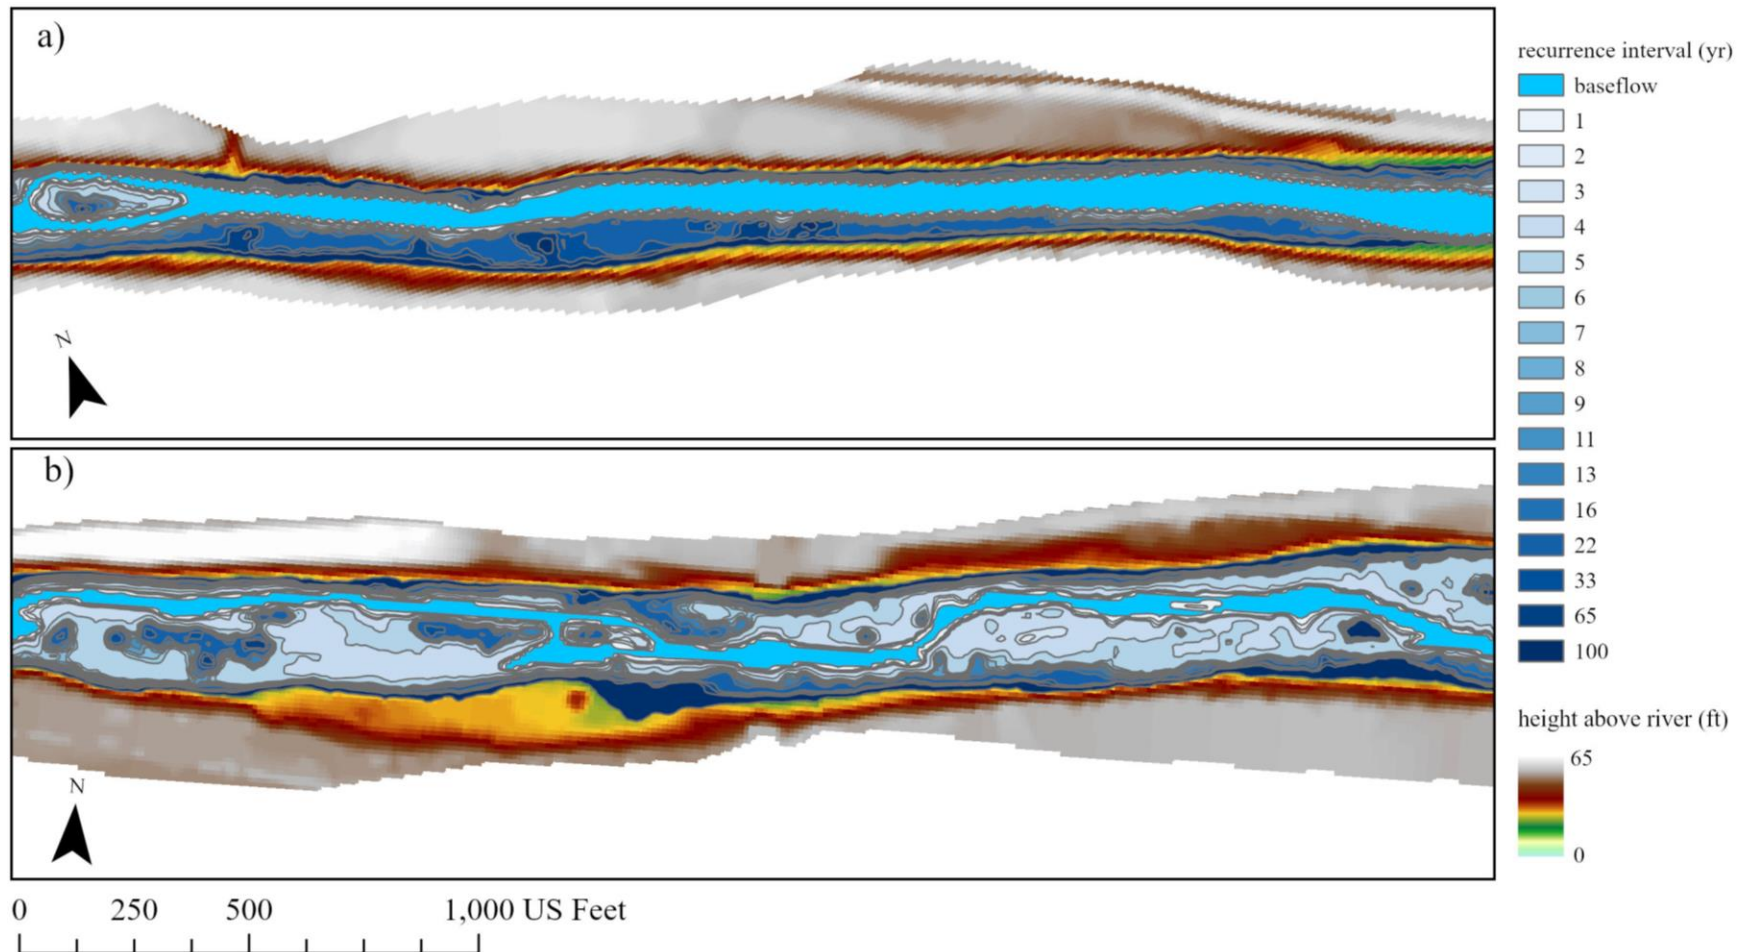
**Figure 3.3.** Inundation areas for all modeled recurrence intervals, overlaid on the HAR (ft) raster. (a) River-miles 11 and (b) 10 experience very different flow dynamics due to their geomorphology; the steep banks and wide baseflow channel at river-mile 11 has essentially no regularly active floodplain, whereas the shallower banks and narrow baseflow channel at river-mile 10 supports a large and frequently-inundated floodplain.

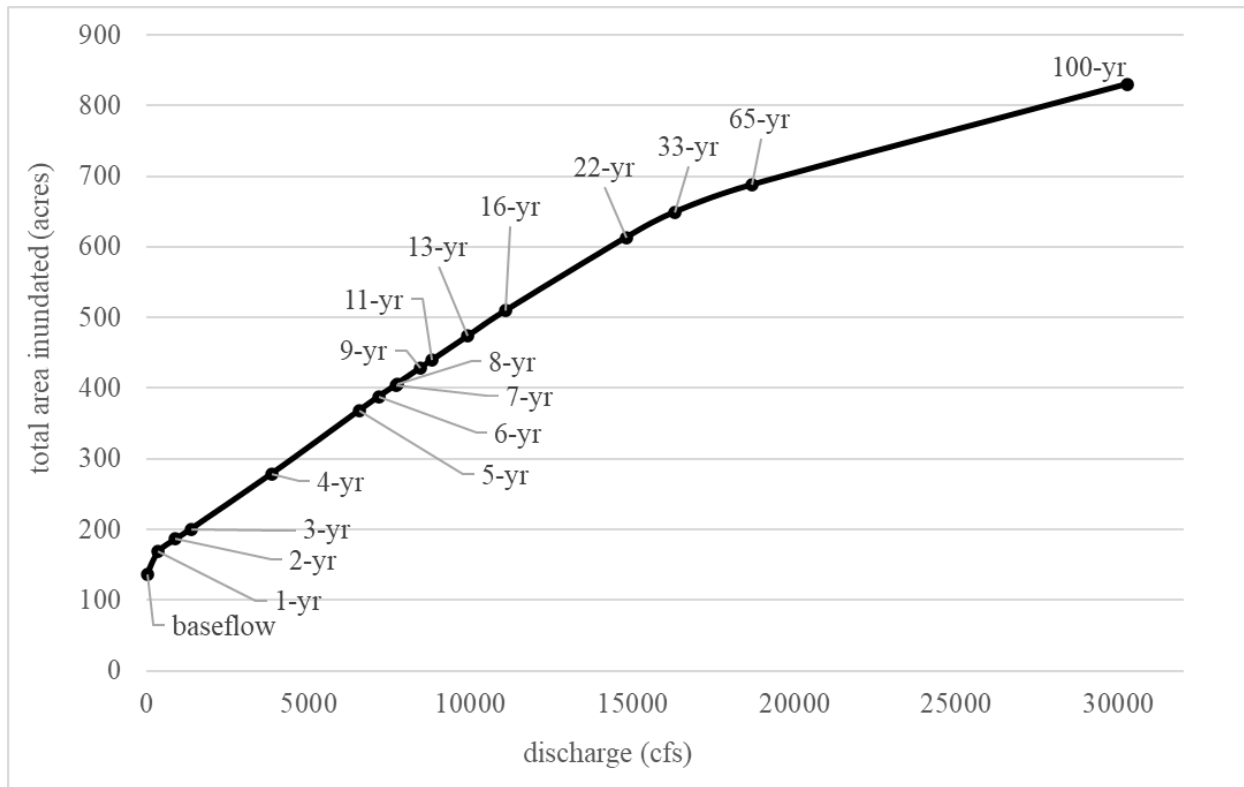
**Figure 3.4.** Total inundated area by discharge. Modeled recurrence interval flows are indicated with leader lines. Across the study area, channel surface area is inundated in a predictable way according to discharge, but not according to recurrence interval.

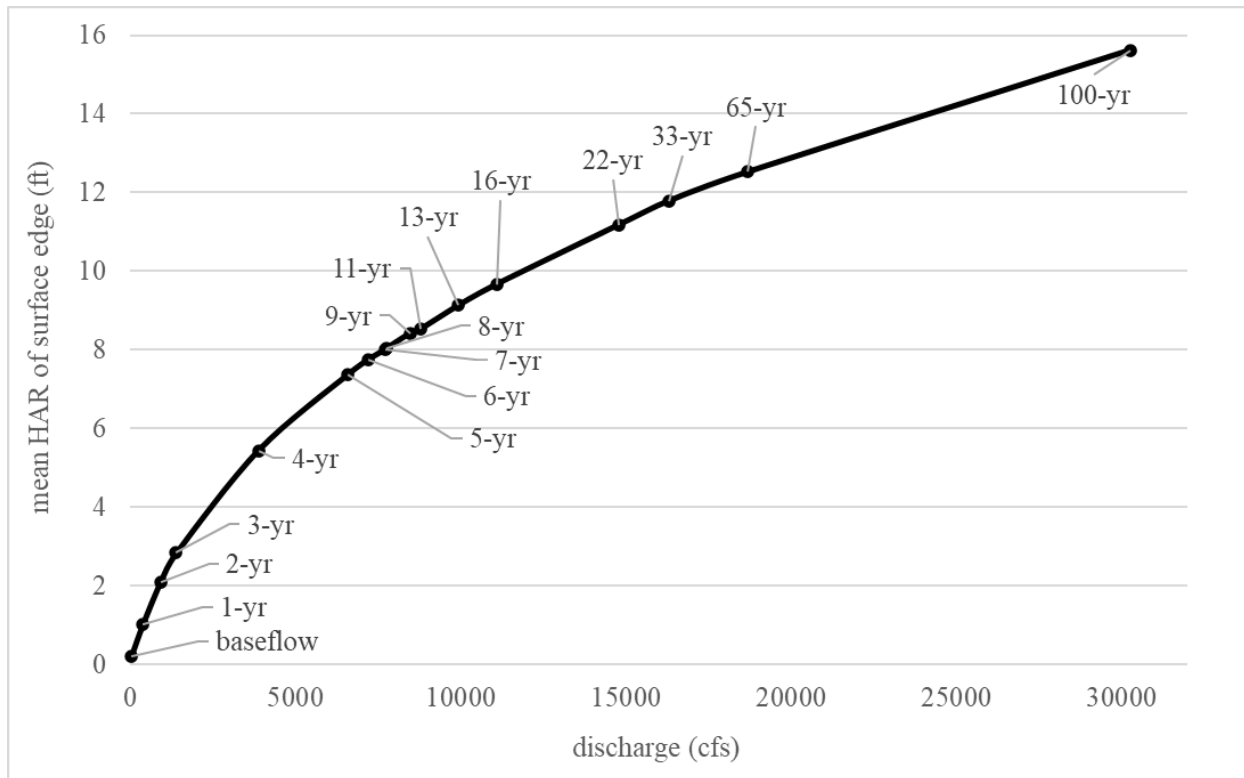
**Figure 3.5.** Mean HAR of inundation surface edge by discharge. Recurrence interval flows are indicated with leader lines. Across the study area, the HAR value of discharge is predictable according to the size of the flow, and vice versa.

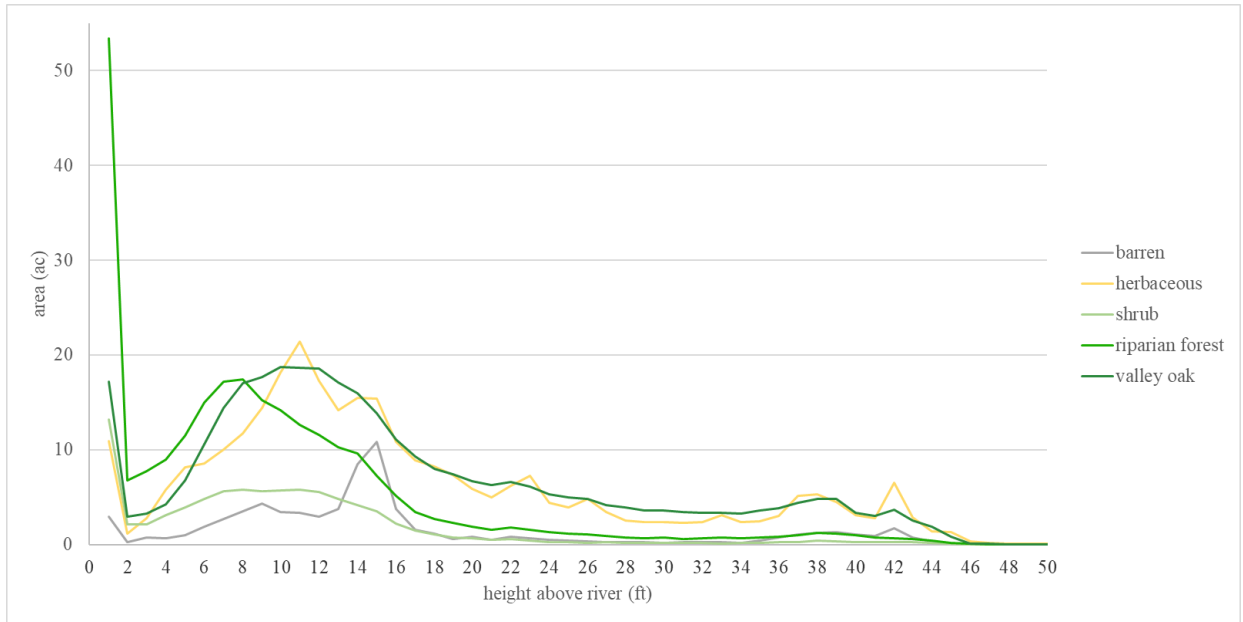
**Figure 3.7.** Distribution of each SVM-classified cover type by HAR. There is significant variation between cover types: riparian forest dominates, and peaks in, the lowest HAR areas. Shrub peaks higher than riparian forest, but tapers to near-zero around 19-ft HAR. Valley oak and herbaceous have similar distributions, although valley oak is found in higher density below 10 ft HAR.

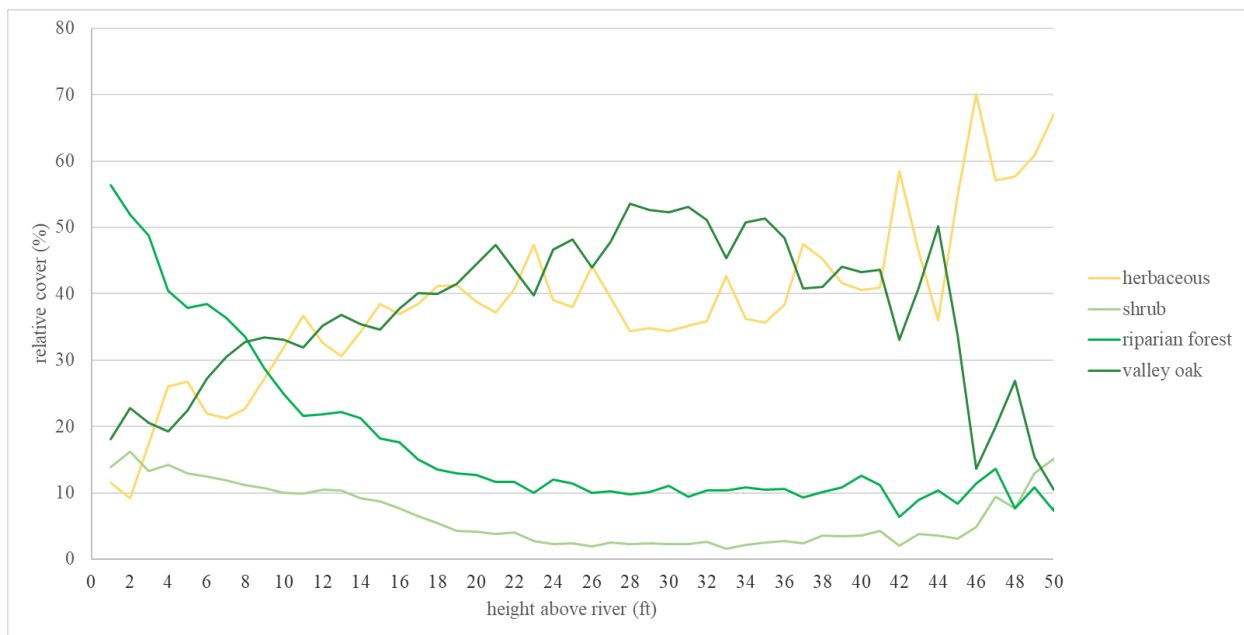
**Figure 3.8.** Relative cover of each vegetation cover type by HAR. Relative cover excludes barren and water from the total area. Riparian forest dominates below 8-ft HAR, and shrub follows a very similar distribution to riparian forest. Valley oak and herbaceous follow similar distributions. Values above 44 ft HAR are skewed due to the small amount of area of that relative elevation.

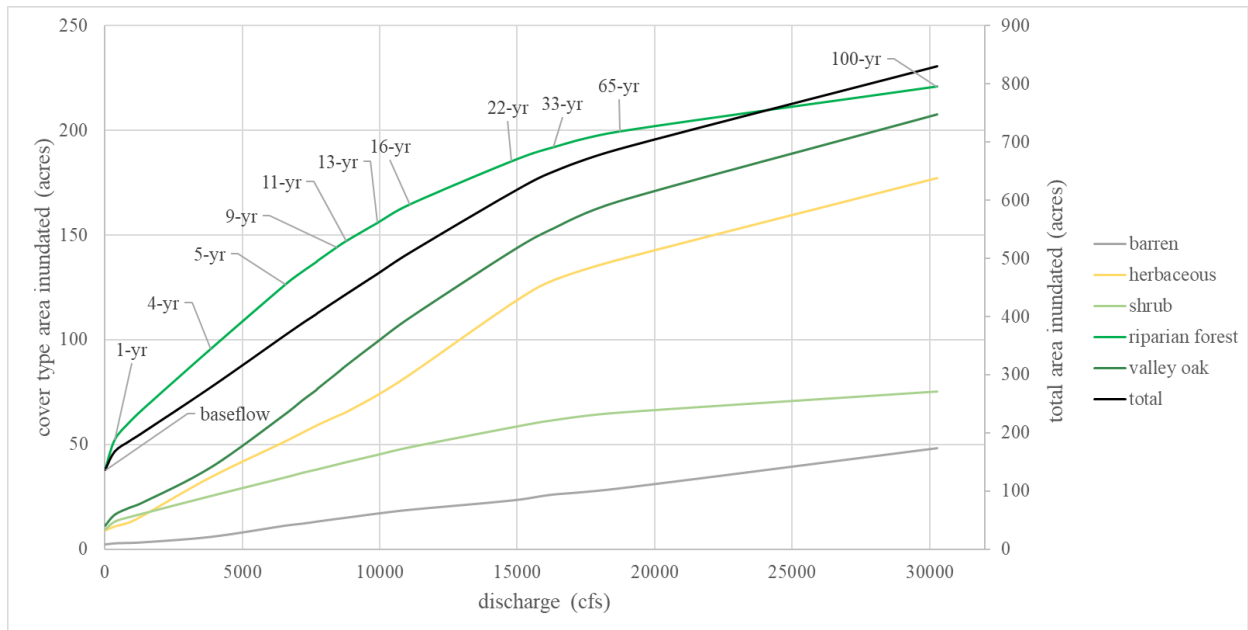
**Figure 3.9.** Inundated area of each cover type by discharge (cfs). Total inundated acreage of the study area (black line) is plotted on the secondary (right-hand) y-axis. Riparian forest and shrub follow markedly different curves than valley oak and herbaceous. Riparian forest dominates the smallest discharges but tapers off quickly in distribution starting around 9,000 cfs, more quickly than valley oak and herbaceous, whose curves continue rising in accordance with total available area. Shrub is somewhat less tied to the lowest discharges, beginning its taper around 15,000 cfs, but adds very little acreage above roughly 17,000 cfs.

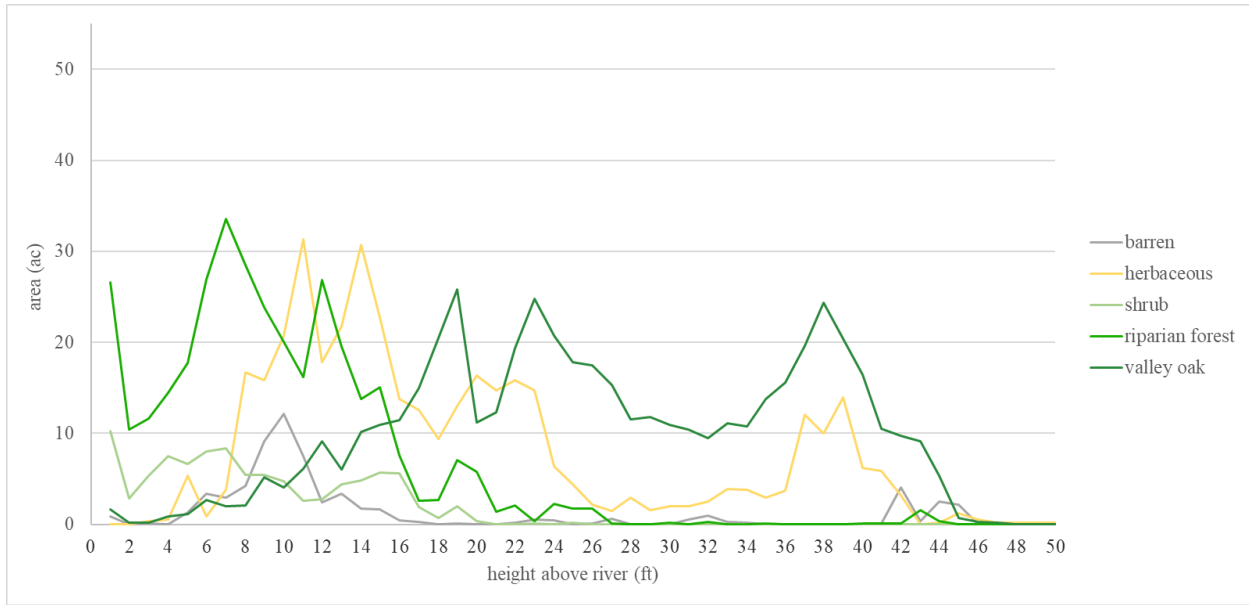
**Figure 3.11.** Distribution of each cover type by HAR in the random forest classification. In this model, riparian forest very strongly dominates the lowest HAR zones, in alliance with shrub. Valley oak slowly increases in density to around 17-ft HAR, above which it dominates in cover. Herbaceous distribution is variable, peaking at 10-14-ft HAR, but does not clearly dominate any one area. Barren cover peaks at relatively low HAR and tapers to near zero around 16-ft HAR.

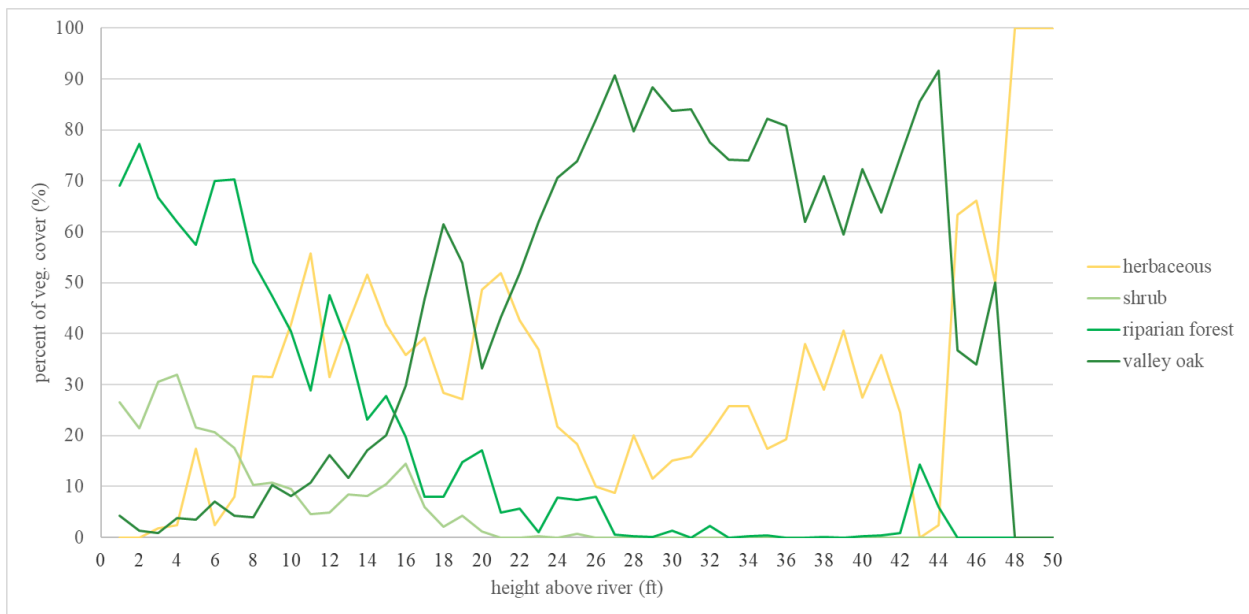
**Figure 3.12.** Relative cover of each vegetative type by HAR in the random forest classification. Here, the dominance of each cover type is even clearer than in **Figure 3.9**. Riparian forest and shrub dominate the lowest HAR zones, and valley oak dominates the high HAR zones. Herbaceous more clearly peaks in this graph at moderate HAR elevations (transition zone), where neither riparian forest nor valley oak clearly dominate. The distributions become erratic above 44 ft HAR because there are so few cells with values greater than 44 ft HAR.
