Advantages and Limitations of Bio-polymer Treatments for Remediation of Wildfire Burned Slopes and Prevention of Post-wildfire Mudflows

A Thesis submitted in partial satisfaction of the requirements
for the degree Master of Science

Structural Engineering

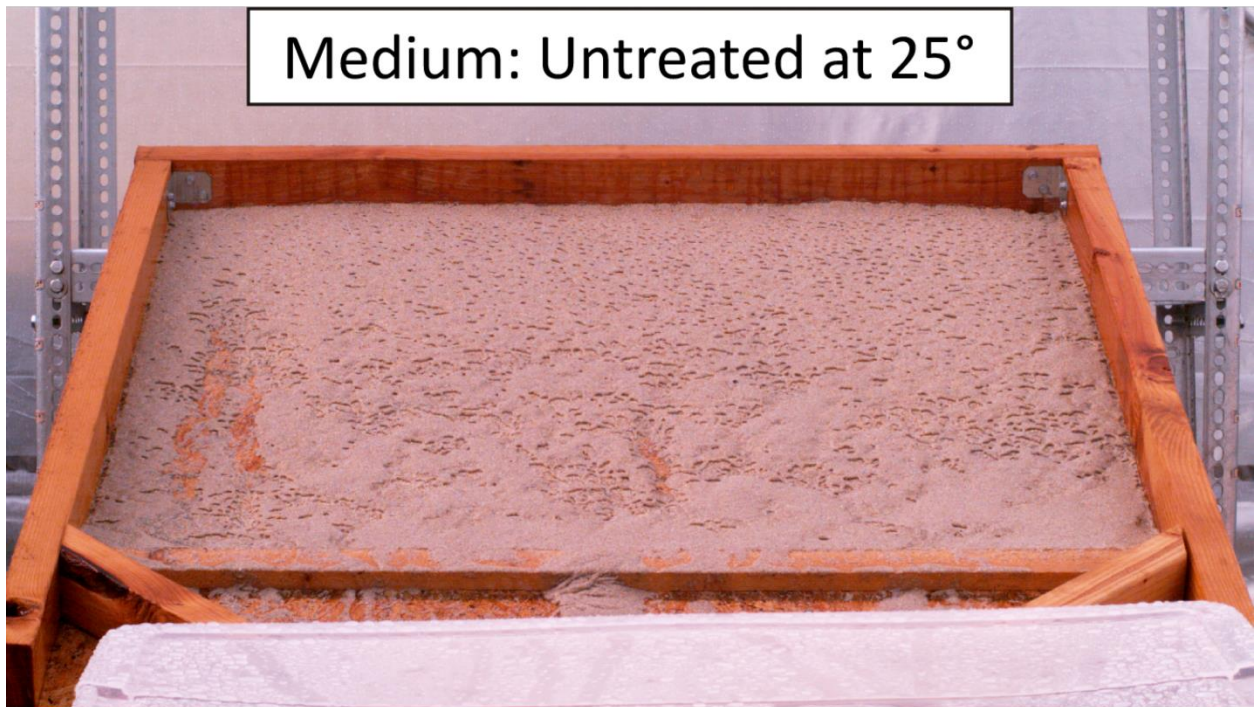
Figure 1.7: Detail views of Figure 1.6a and Figure 1.6b

a. Erosion

b. Vertical channels

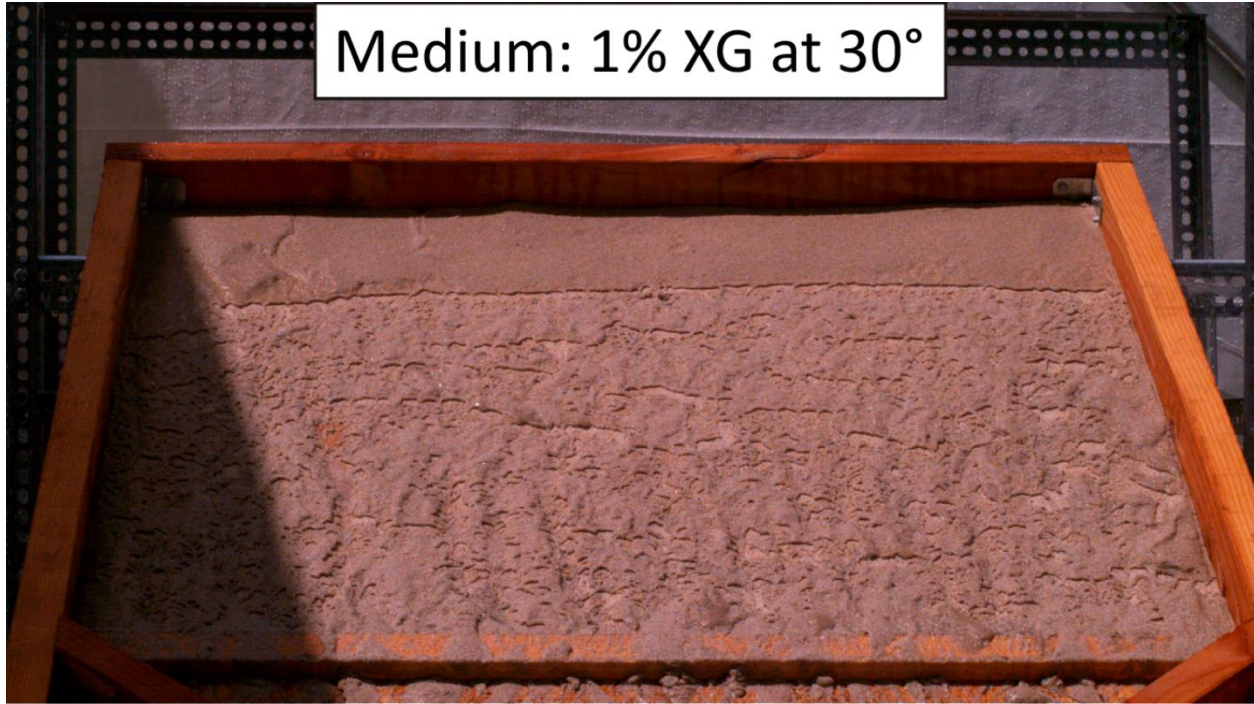
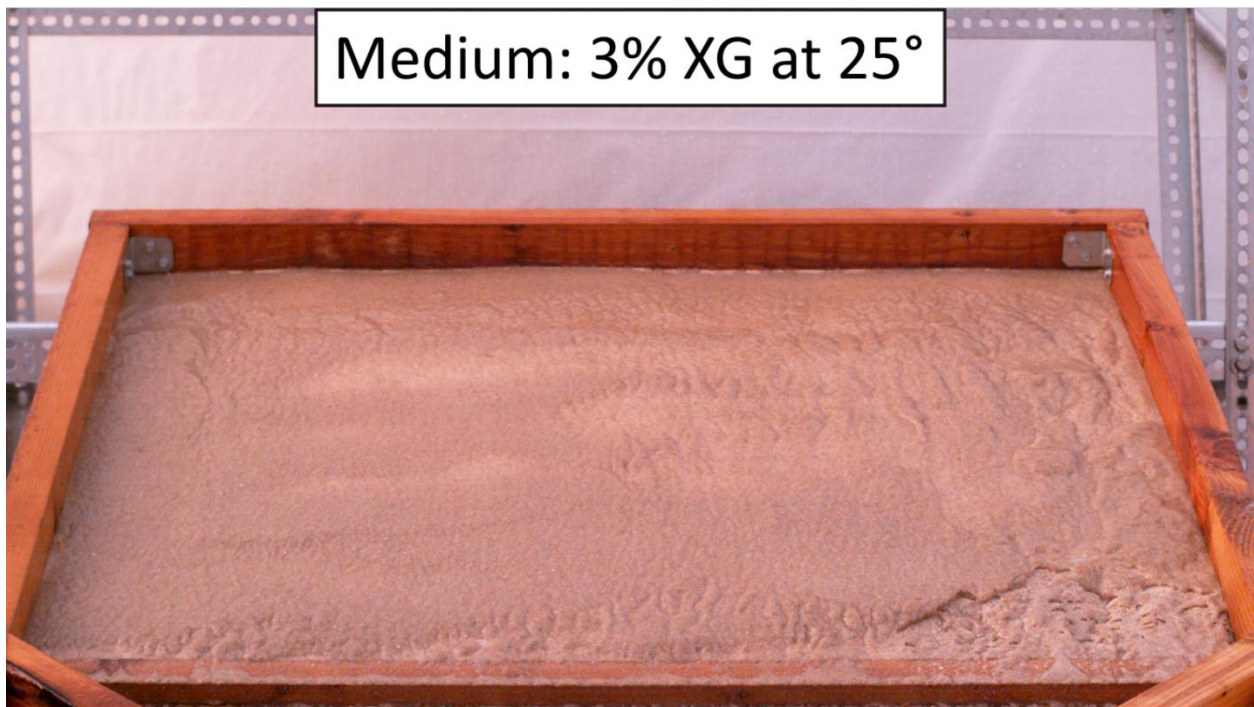
Figure 1.8: Detail views of Figure 1.6c and Figure 1.6d

c. Horizontal and vertical channels

d. Horizontal erosion

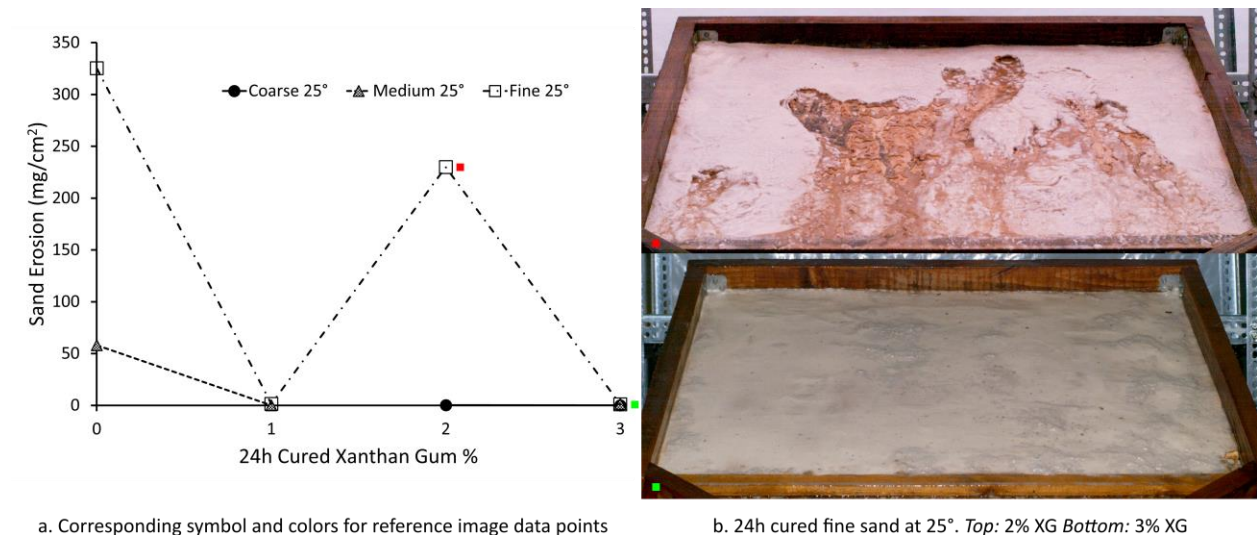
Figure 1.10: Sand erosion vs. the cured XG-sand mix for varying slope angles for 50 mm/hr rain intensities

The amounts of collected sand normalized by the experiment surface area are plotted against the XG percentage in the mix and the slope angle in Figures 1.10 and 1.11 to understand erosion better. The overall trend indicates that XG percentage increase better stabilizes slopes, and more XG is needed at higher angles and finer sands. Furthermore, erosion susceptibility in treated fine sands is problematic due to the random development of unfavorable surface morphologies. For example, Figure 1.10a shows that although most experiments at 1% to 3% XG-sand mix cured for 24 hours develop different levels of sliding ridges, the measured erosion is still significantly reduced compared to the pure hydrophobic sand experiments. However, fine sand with 24 h cured

2% XG at 25° performs poorly (Figure 1.10b). Top Figure 1.10b shows how the cured protective layer above the pure hydrophobic sand is being compromised as a piece of the crust breaks away. The water that continuously rains and flows down the slope chips away pieces at the exposed location, increasing the size of the sliding patches.

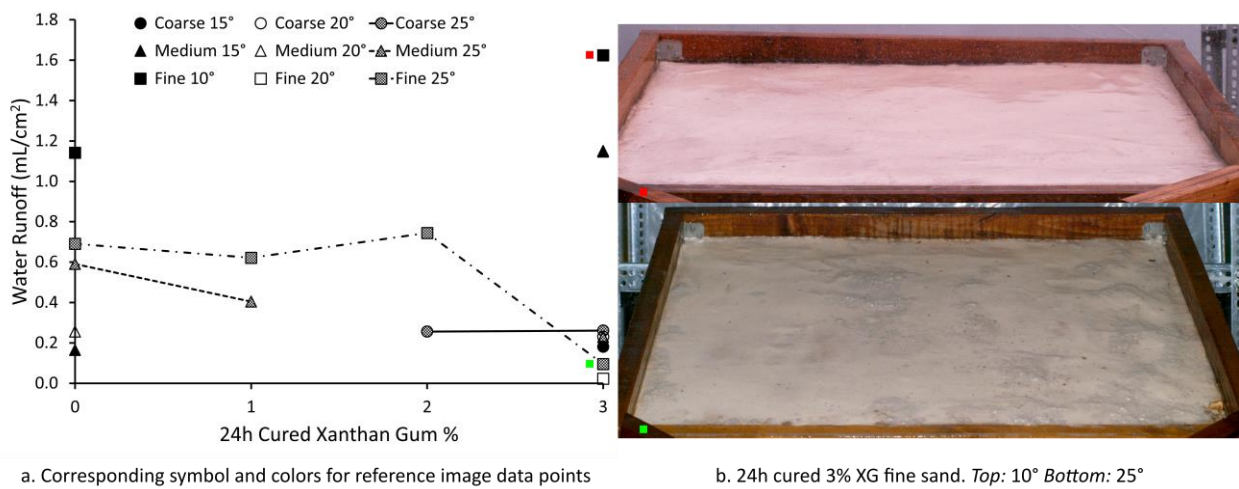
Figure 1.12: Water runoff v. 24h cured XG percentage for varying slope angles

Figure 1.12a shows conclusive results at highest slopes of 25° for all sand types and percentages of XG, and relatively inconclusive results at less steep angles. At 25° and cured 3% XG sand mix, the water runoff is highest over coarse, then medium, and then fine sand slopes.

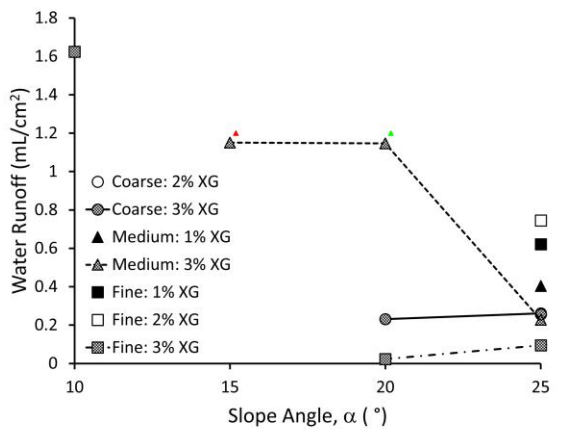
a. Corresponding symbol and colors for reference image data points

b. 24h cured 3% XG medium sand. Top: 15° Bottom: 20°

Figure 1.13: Water runoff v. slope angle for varying 24h cured XG percentages

Figure 1.13 shows an inverse relationship between the water runoff and the sand erosion for slopes covered with medium cured 3% XG-sand mix. When the medium sand erosion is lower for the shallower slopes, around 0.3 mg/cm², the water runoff is 1.15 mL/cm². However, once the medium sand erosion increases to 0.95 mg/cm², the water runoff significantly decreases to 0.23 mL/cm².

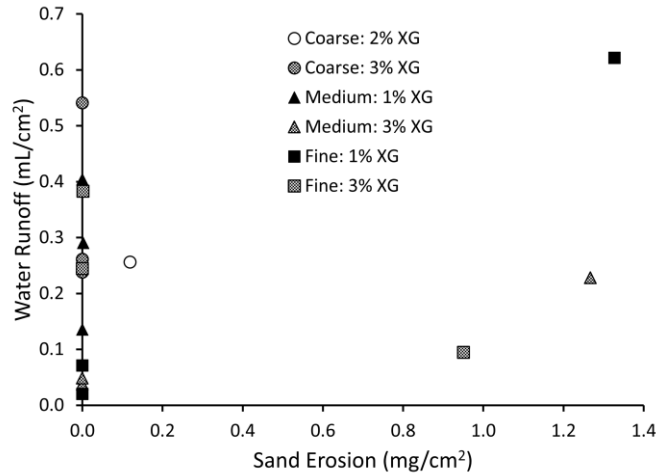
Figure 1.14: Water runoff v. sand runoff for 24h cured XG percentages at a 25° angle

Coarse and fine sand experiments show a slight water runoff increase with an increasing slope, regardless of sand erosion. This idea is depicted in Figure 1.14, which when looking at a 25° slope, there were coarse, medium, and fine sand trials with cured XG percentages where there was no or little erosion and a water runoff range of 0.02 mL/cm² to 0.73 mL/cm². A majority of these no erosion data points are below 0.30 mL/cm². To conclude, although the water runoff can be high without erosion, both water and sand runoff increase exponentially once the erosion starts.

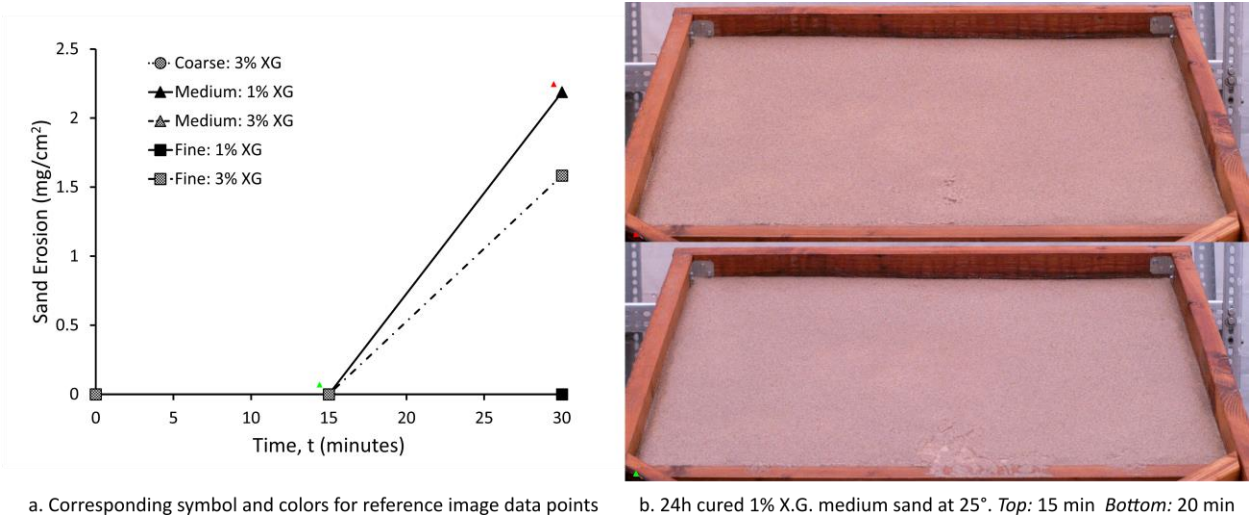
Figure 1.16: Sand runoff v. time for rain intensities of 15 mm/hr at a 25° angle

Time of raining changes surface morphology, erosion, and water runoff. Looking at Figure 1.16, at the lower intensity of 20 mm/hr, there was no erosion collected after the initial 15 minutes, but between 15 and 30 minutes, there was erosion and some sliding patch failures in both the 1% medium and the 3% fine, but the 1% fine and 3% coarse and medium continued to work during this raining time. Figure 1.16b shows an example of how the surface morphology could change as the rain duration increases. The example shows that the erosion stems from the developed ridge, even though it is small. Much like seen in the previous section, when the surface morphology type changes from ridges to another kind, there is an increase in sand runoff. On the contrary, Figure 1.17 shows that the water runoff for the lower rain intensity of 15 mm/hr stayed consistent with little change in slopes for the duration of the experiment. The higher the XG percentage, the lower the water runoff for cured medium sand. For cured fine sand, the higher the XG percentage, the

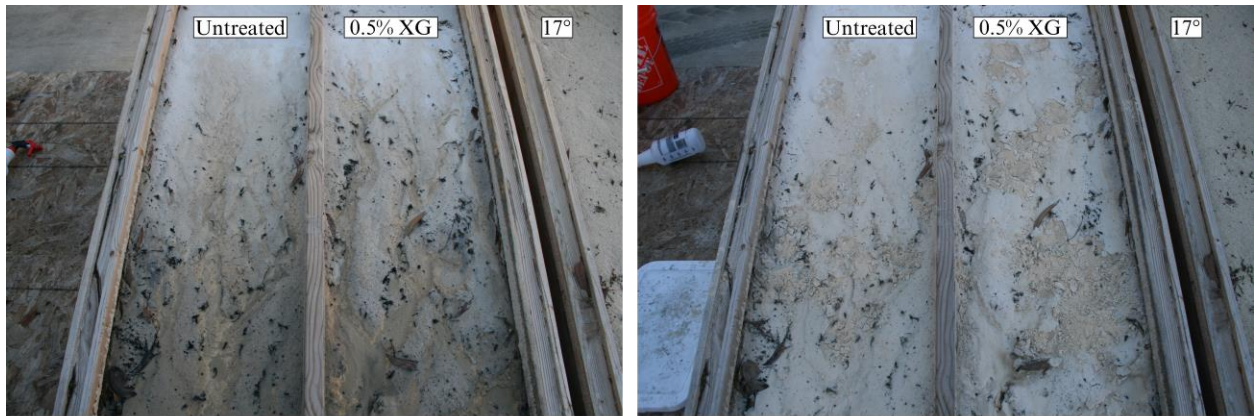
a. Fine sand morphology after RE 7

b. Raccoon prints prior to re-covering the slopes

Figure 2.4: Extreme channels formed in the fine sand slope with subsequent animal activity

RE 3 with a max. 15-min rain intensity of 9.14 mm/hr caused the first significant change in surface morphology, leading to a larger erosion yield for each slope and sand type. Figures 2.3a, 2.3b, and 2.3c depict the increase in surface morphology when comparing the sand types, with the least change being in the coarse slopes, some channels beginning to form on the medium slopes, and deep channels already formed on the fine slopes. As the rain events continued, the channels seen in the fine sand slopes became more prevalent, with extremely large channels (Figure 2.4a). With a cured layer from the XG after continuous raining, more raccoon activity broke apart the surface layer and created more drastic surface conditions exposing the hydrophobic layers susceptible to mudflows (Figure 2.4b).

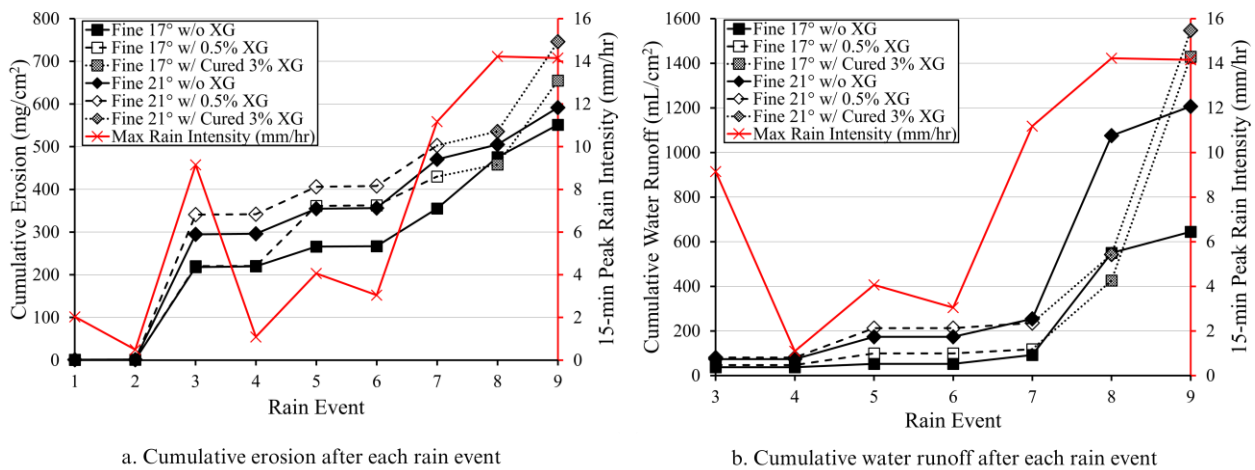
Figure 2.12: Fine sand cumulative erosion and water runoff with the 15-min peak rain intensities

Figures 2.12, 2.13, and 2.14 all compare the cumulative erosion and water runoff for each angle and treatment type for fine, medium, and coarse sand respectively. Focusing on the cumulative erosion for each sand type, the most erosion with the 0.5% XG treatment for fine sand occurred during RE 3, and during RE 5 for medium and coarse sand. As seen with the data collected each RE, the cumulative erosion shows the similarities in erosion trends when XG is used. For all sand types and both angles, the XG treated slopes follow the same trends but at different values, with the fine sand slopes eroding the most with a cumulative erosion of 700.35 mg/cm² (7003.5 g/m²) averaged between the angles, coarse sand slopes the least with 16.63 mg/cm² (166.3 g/m²), and medium sand slopes eroding in-between the two with 261.50 mg/cm²
