The Over-Prediction of Seismically Induced Soil Liquefaction during the 2016 Kumamoto, Japan Earthquake Sequence

Geosciences, 13(1)

**Abstract:** Following the M7.0 strike-slip earthquake near Kumamoto, Japan, in April of 2016, most geotechnical engineering experts believed that there would be significant soil liquefaction and liquefaction-induced infrastructure damage observed in the densely populated city of Kumamoto during the post-event engineering reconnaissance. This belief was driven by several factors including the young geologic environment, alluvially deposited soils, a predominance of loose sandy soils documented in publicly available boring logs throughout the region, and the high intensity ground motions observed from the earthquake. To the surprise of many of the researchers, soil liquefaction occurred both less frequently and less severely than expected. This paper summarizes findings from our field, laboratory, and simplified analytical studies common to engineering practice to assess the lower occurrence of liquefaction. Measured in situ SPT and CPT resistance values were evaluated with current liquefaction triggering procedures. Minimally disturbed samples were

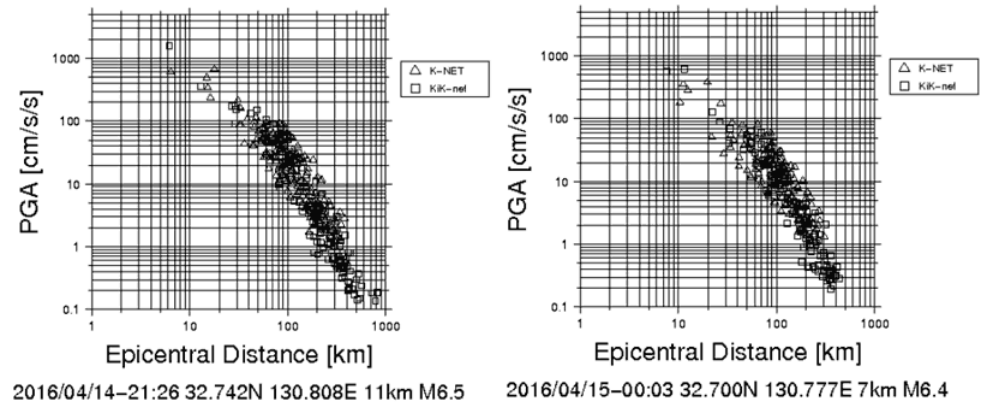
Figure 2. Attenuation trends of the recorded foreshock events on 14 and 15 April 2016.

PGA of 1.08 g. The focus of the second foreshock was at 32.70 N 130.78 E at a depths of 7 km below the ground surface [1]. The faulting mechanism of the second foreshock was also a right-lateral strike-slip mechanism with maximum recorded PGA of 0.81 g. Figure 2 presents the attenuation trends of the recorded motions for the two foreshock events.

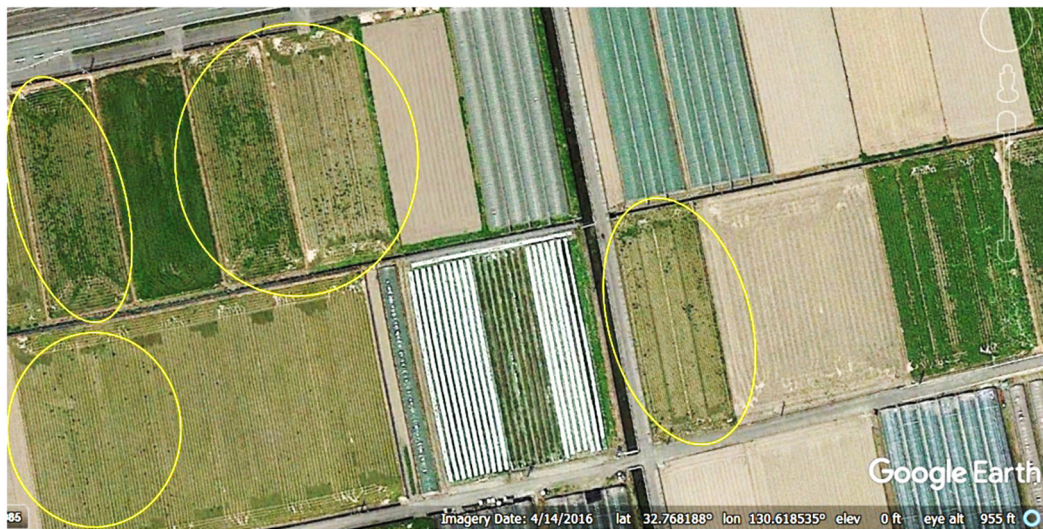
**Figure 6.** Example satellite imagery showing the small black circles and darkened areas that were originally thought by many researchers to possibly be sand boils and water from liquefaction but were later identified to be bundled and burned rice stalks.

Once the GEER reconnaissance team was on the ground in Kumamoto, it was surprised to find very little visible evidence of soil liquefaction [1]. Other reconnaissance groups were also surprised to find less evidence of soil liquefaction than they anticipated based on their preliminary investigation [17,38]. Even in Mashiki Town, which is located near ground motion station KMMH16 in Figure 4 and that felt the largest recorded ground motions from the KES mainshock, very few surficial manifestations of liquefaction were observed—mostly limited to areas of backfilled pipelines and manholes [39]. Mukunoki et al. identified several locations of possible liquefaction based on aerial photographs following the KES mainshock [17]. However, field reconnaissance by their group confirmed liquefaction evidence and damage at the ground surface at only a small fraction of their identified locations (Figure 7). The field locations where liquefaction was confirmed are shown as red dots in Figure 7.

- Misclassification of burned rice stalks from satellite and aerial imagery as possible liquefaction sand boils was also another reason for the over-prediction of liquefaction following the 2016 KES.

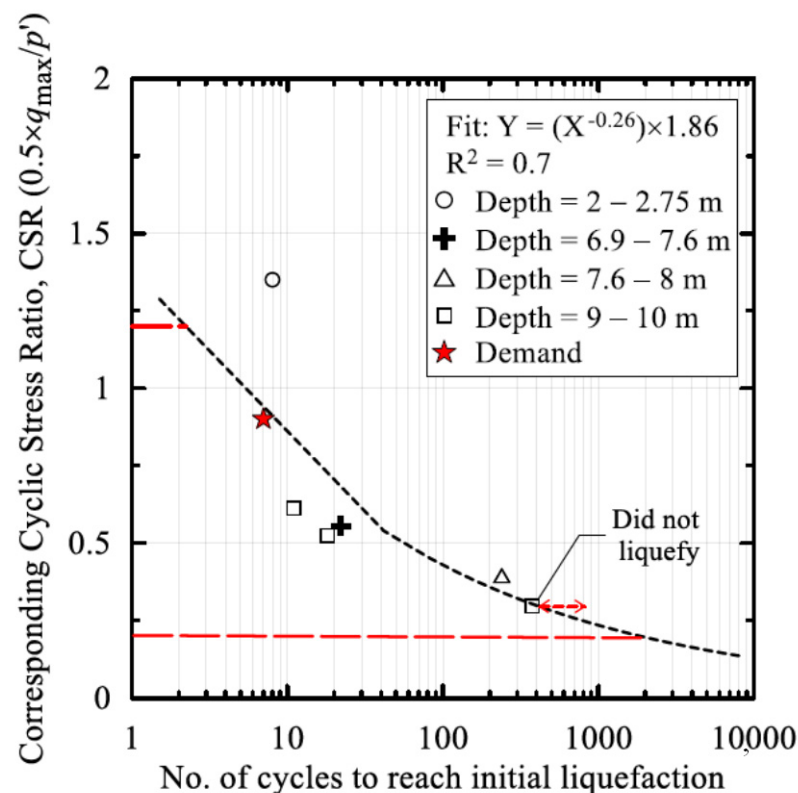
**Figure 13.** Undrained cyclic triaxial shear strength test results for soil specimens from Site 2-1 (after Anderson et al. [46]).

All cyclic triaxial tests were conducted in strain-controlled mode because (1) strain-controlled tests cause less water content redistribution in soil samples before initial liquefaction occurs and provides more realistic predictions of in situ pore pressures than those obtained from stress-controlled tests; and (2) stress-controlled triaxial tests are less accurate due to the development of different strains during compression and extension phases. They

The results of the triaxial cyclic shear tests from Site 2-1 are presented in Figure 13. The star in the figure represents our best estimate of the peak cyclic stress ratio (CSR) that the native soil was exposed to during the 2016 KES. The line in the figure represents the best-fit trendline for approximating the liquefaction triggering boundary. Based on our interpretation of the test, the native soil is located very near to the regressed liquefaction triggering boundary, further providing laboratory evidence that the majority of the soils at Site 2-1 either liquefied or were very close to liquefying. Additional undrained cyclic shear tests from Site 2-1 could be performed in future research to further test our observations made here based on our minimally disturbed samples. Ideally, frozen and cored samples of soil should be tested in future research.

observed in our study to have medium-to-high fines content, moderate to high plasticity, and high organic content. These properties likely contributed to the increased resistance to soil liquefaction. Likewise, the crushable nature of the volcanic soils may have led to artificially low penetration resistance readings for the SPT and CPT. The crushability and metastable structure of the volcanic soils also certainly would have contributed (perhaps even dominated) the resistance of the soil to liquefaction triggering as has been observed in previous studies by other researchers. The less volcanic soils of the southern half of the Kumamoto Plain experienced much more sporadic minor liquefaction. Volcanically derived sands in general also showed a higher resistance to liquefaction based on our cyclic triaxial results on minimally disturbed samples.

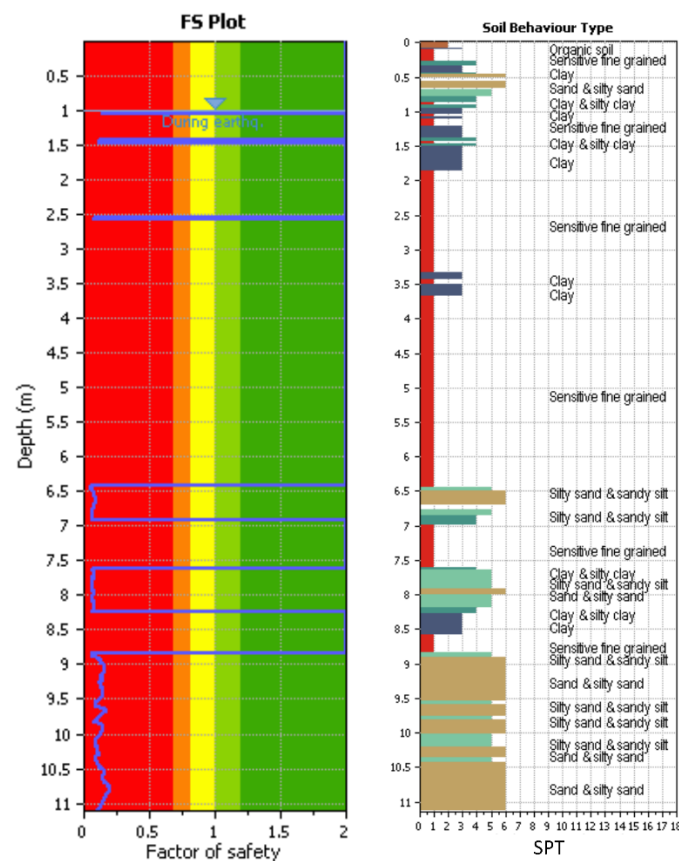
Figure 18. CPT liquefaction triggering results and SBT plot for Site 1 (modified from Anderson [40]).

Evaluation of susceptibility and triggering using the CPT sounding from Site 1 yielded a different outcome. Layers predicted to have been susceptible to liquefaction and triggered are shown in the factor of safety (FS) plot in Figure 18. The corresponding SBT plot from the CPT sounding is also shown for reference of the soil layering. As is shown in Figure 18, little liquefaction is predicted in the clayey and sensitive fine-grained soils at depths shallower than 6 m. However, significant liquefaction triggering is predicted for depths greater than 6 m. No surface manifestations of liquefaction were observed at Site 1, and the site was therefore classified as a “No Liquefaction” site. However, it is possible that liquefaction occurred at depths greater than 6 m, but no surface manifestations were observed due to the thick and plastic non-liquefied soil cap. Assessment of the site using the Ishihara surface manifestation prediction method [54] predicted no surface manifestations of liquefaction at the site.

The result of this assessment of conventional methods for predicting susceptibility and triggering therefore showed the predictions match the observed surface behavior related to liquefaction manifestation at Site 1.

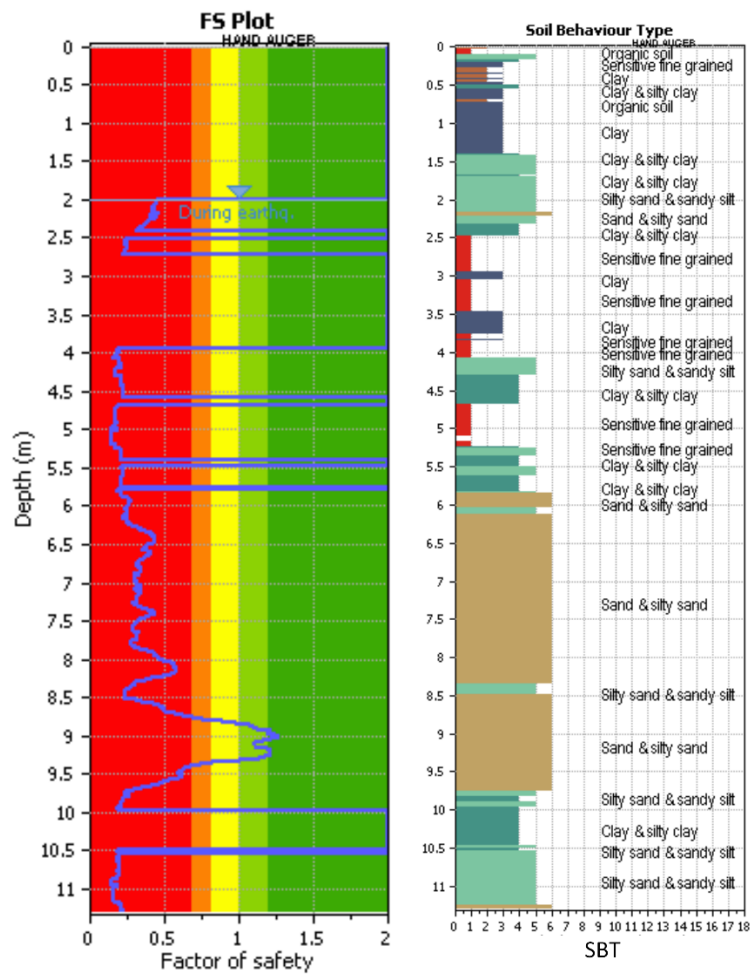
Figure 20. CPT liquefaction triggering results and SBT plot for Site 2-2 (modified from Anderson [40]).

Susceptibility and triggering results from the CPT sounding from Site 2-2 are shown in Figure 20. The results show a good match with the SPT results below a depth of 6 m below the ground surface but show more predicted liquefaction in the upper crust of soil in the thinner lenses of silty sand and silty clay.

The deeper soil layers above the Aso-4 flows and Ariake Bay clay sediments at Site 2-2 are composed of 4 m of silty sand mixed with some gravel. Above this is a layer of clayey sand about 2 m thick. This site is also located on a natural levee. Recall that Site 2-2 is nearby to Site 2-1, which showed substantial surface liquefaction effects. The same poorly graded sand/silty sand layer is observable at both sites, but it is slightly thinner and approximately 4 m deeper at Site 2-2. Therefore, it is very possible that the same layer liquefied at Site 2-2 but was sufficiently deep to not show evidence of surface manifestation.
