Full-Depth Recycling Study: Test Track Construction and First Level Analysis of Phase 1 HVS and Laboratory Testing

Partnered Pavement Research Center (PPRC) Contract Strategic Plan Element 4.36:
Recycling of Rubberized HMA in RAP and FDR Projects

University of California
Pavement Research Center
UC Davis, UC Berkeley

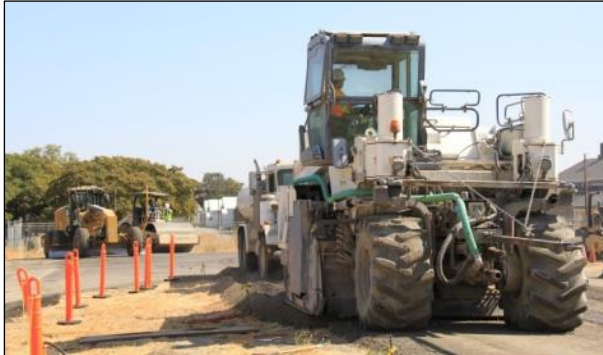
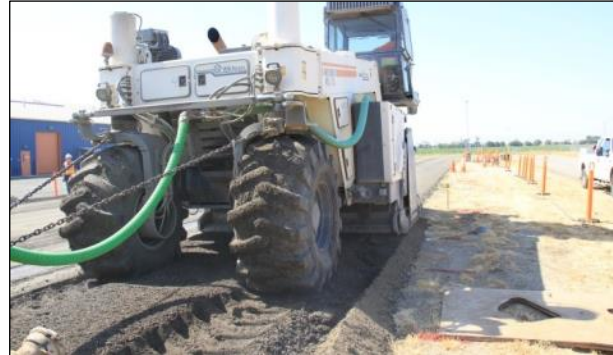
Figure 3.5: FDR-NS: Test track recycling.

layers (Figure 3.7). This was attributed to the relatively unaged state of the rubberized asphalt surfacing. On completion of the recycling pass, the pulverized material appeared to have a consistent grading and uniform moisture content with very little oversized material (Figure 3.8). Recycling depth was well controlled, with an average depth of 8 in. (250 mm) maintained over the full length of the test section. Initial rolling was completed with a padfoot roller (Figure 3.9), followed by a vibrating smooth drum roller (Figure 3.10). Final levels were achieved with a grader after compaction with the smooth drum roller (Figure 3.11) and final compaction was completed with a rubber-tired roller (Figure 3.12).

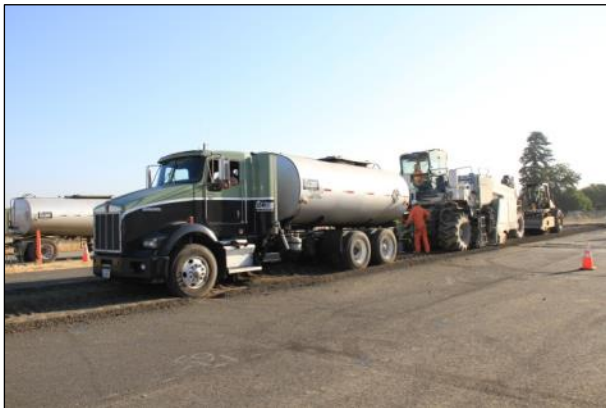
Figure 3.14: FDR-EE: Recycling train.

backed up to the start, and then a third pass was made to add binder to the untreated strip. Despite adjustments to the settings, the spray rate still appeared to be too high and there was some overlap with the previous application, resulting in excess emulsion being injected into the material (Figure 3.16). After completion of this third pass on the first 90 ft (30 m), the recycler was stopped and flow rates readjusted. After this change, the emulsion application rate appeared to be more consistent for the next approximately 90 ft (30 m), although more binder was still being applied on the right-hand side of the lane compared to the rest of the lane based on observations of the color and consistency of the recycled material, and on material adhering to the right rear tire of the recycler.

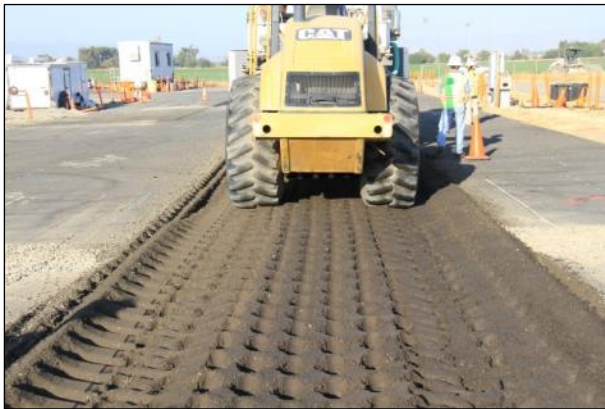
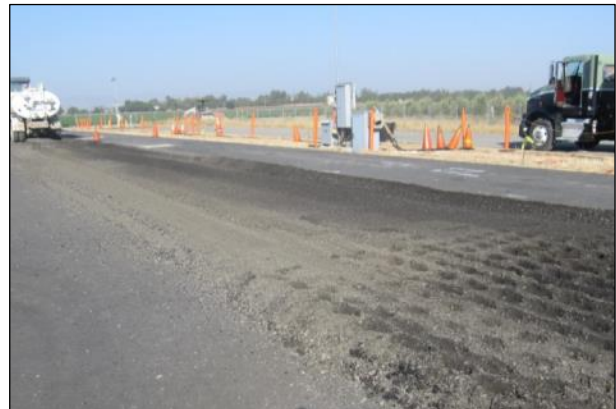
Figure 3.17: FDR-EE: Compaction with padfoot roller.
(Note untreated areas and emulsion adhering to tire).

The FDR-EE lane was compacted following the same sequence as that described for the FDR-NS lane. During compaction with the padfoot roller, the strip down the left side of the lane where no binder had been applied (Figure 3.17) was clearly visible. After completion of rolling with the smooth drum roller, the areas with excess fluid content in the recycled material in the first half of the lane was clearly visible in the form of puddles on the surface (Figure 3.18 and Figure 3.19). Excavation of the pulverized material in the adjacent FDR-FA lane clearly showed the high moisture content in the FDR-EE layer after compaction (Figure 3.20). Subsequent passes with the smooth drum roller caused additional water puddles to appear on the test track surface.

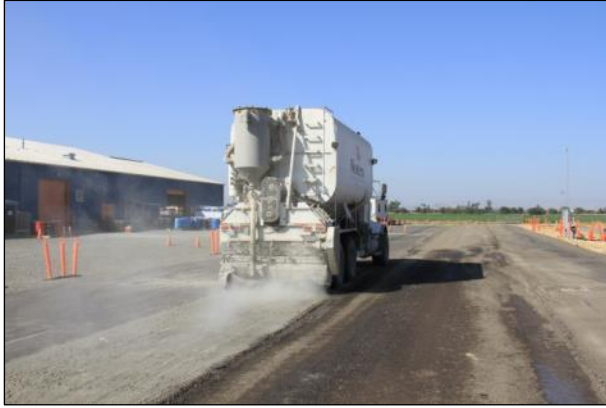
Figure 3.21: FDR-FA: Spreading cement on old asphalt surface.

The lane was recycled in a single pass of the recycling train, which consisted of the asphalt binder and water tankers coupled to the front and rear of the recycler respectively (Figure 3.22). Foamed asphalt appeared to be evenly injected across the width of the test track and none of the problems experienced on the FDR-EE test section were observed. Recycling depth was consistent at 10 in. (250 mm) and the recycled material appeared to be uniformly mixed (Figure 3.23 and Figure 3.24). Compaction and leveling followed the same procedure as that used on the FDR-NS section (Figure 3.25 and Figure 3.26). Additional water was sprayed onto the surface prior to rolling with the rubber tired roller. The compacted surface was tightly bound and no wet spots were observed.

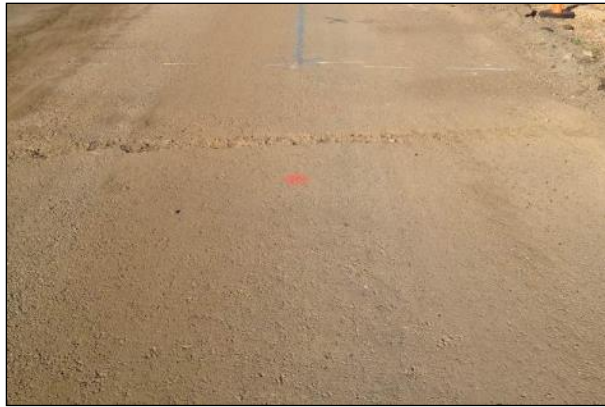
Figure 3.34: Broomed surface of FDR-NS layer.

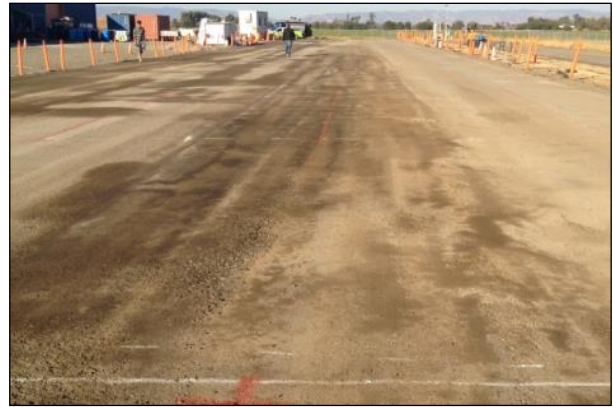
Figure 3.35: Broomed surface of FDR-EE layer showing dark, moist surface.

section appeared darker and to have a higher moisture content than the other sections (Figure 3.35), and the surface was easily dented with a hammer blow.

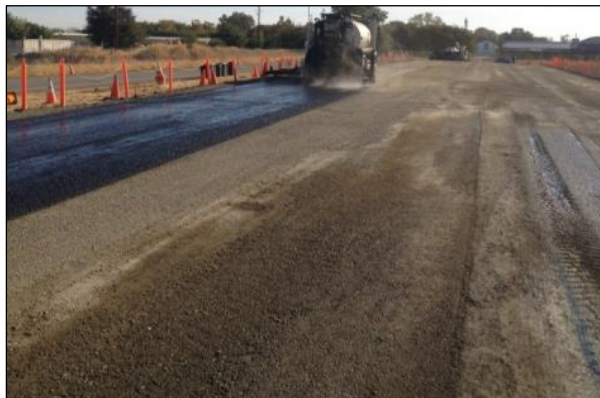
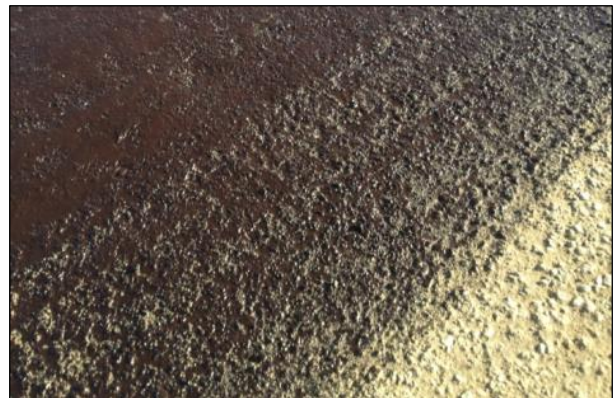
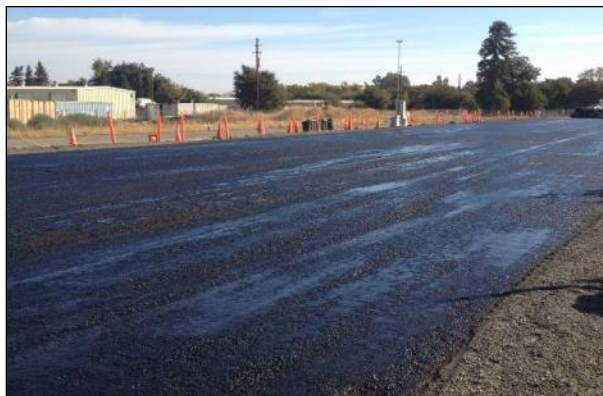
Figure 3.36: Prime coat application.

An SS-1H asphalt emulsion prime coat was applied to the surface at a rate of 0.15 gal/yd² (0.68 L/m²). Although a consistent application was achieved (Figure 3.36), some differential penetration was observed, which was attributed to patches of near-surface moisture.

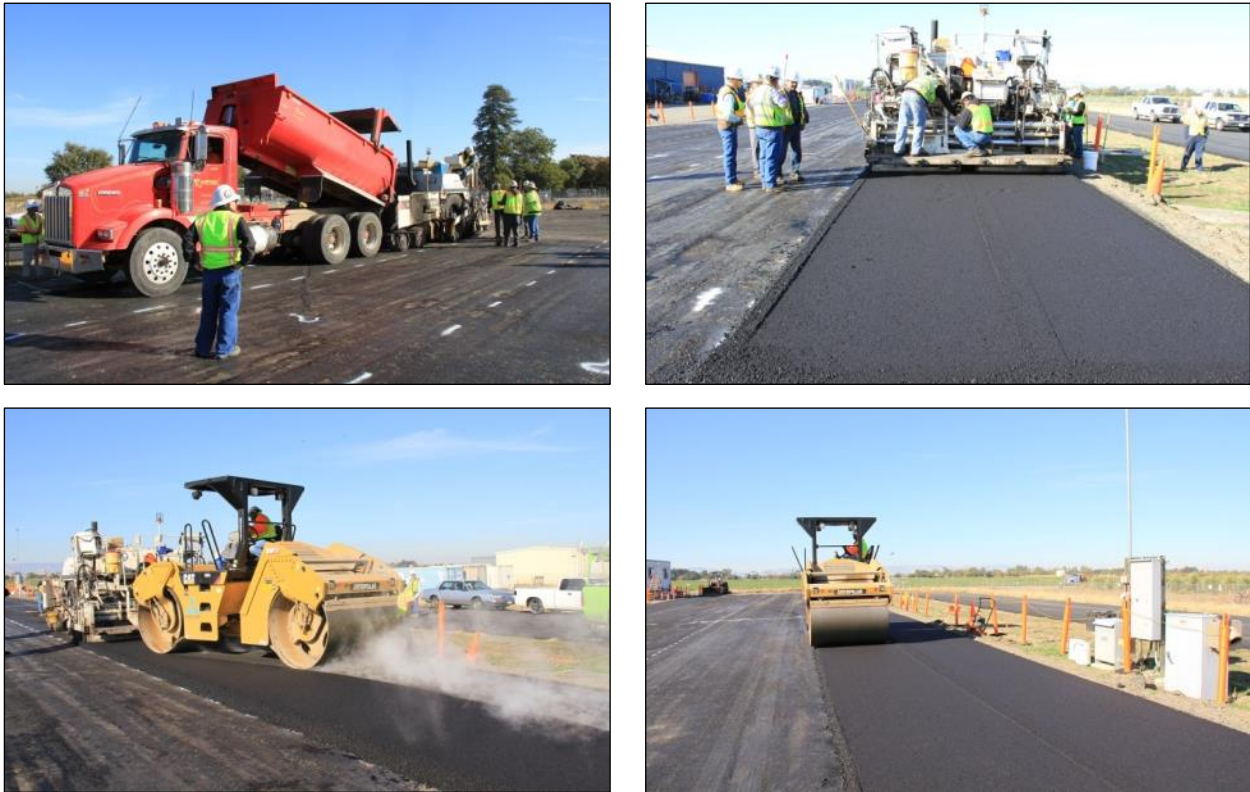
Figure 3.37: Asphalt concrete placement.

Mix was transported using end-dump trucks. Paving was carried out in a west-east direction and followed conventional procedures (Figure 3.37). Work started in Lane #1, followed by Lanes #2, #3, and #4. The second lift on Lane #1 (Cell #2) was placed after completion of the first lift on the other lanes. A breakdown roller closely followed the paver, applying about four passes. A single pass was made with an intermediate rubber-tired roller, followed by another four passes with a finish roller. Compaction of the lower lift appeared to be consistent and no problems were noted (Figure 3.38). On the second lift placed in Cell #2, the mix appeared tender and some shearing was noted (Figure 3.39) in the vicinity of the instrumentation cables (discussed in Section 4.4).

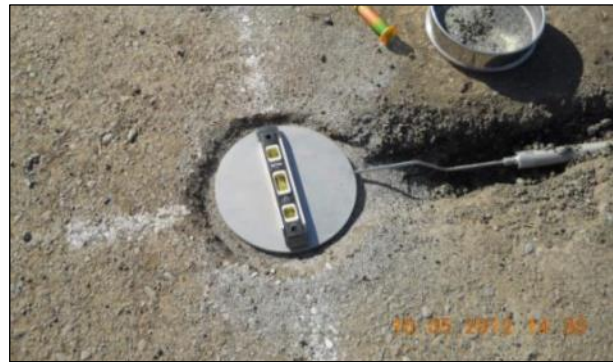
Figure 4.4: Pressure cell installation.

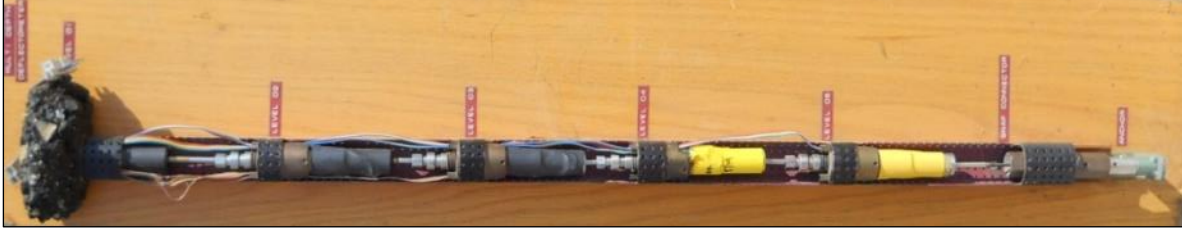
Figure 4.5: A model multi-depth deflectometer (MDD), showing five modules.

- One multi-depth deflectometer (MDD), which is essentially a stack of linear variable differential transformer (LVDT) modules fixed at different depths in a single borehole, was installed on each test section. The LVDT modules have nonspring-loaded core slugs that are linked together into one long rod that is fixed at the bottom of a 10 ft (3.3 m) borehole. The LVDT modules are fixed to the pavement, which allows permanent vertical deformations at various depths to be recorded, in addition to measurement of the elastic deformation caused by the passage of the HVS wheels. The borehole is 1.5 in. (38 mm) in diameter. A model MDD with five modules is shown in Figure 4.5.

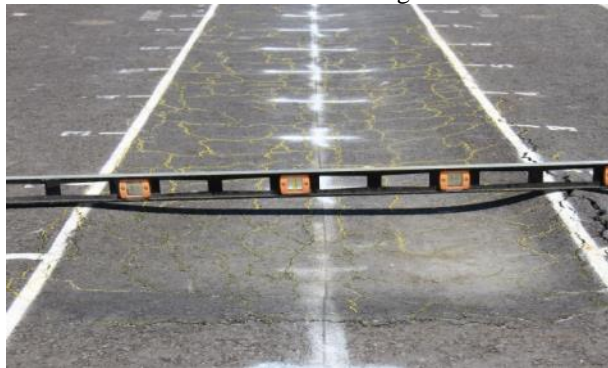
Cracking and deformation at end of test section
