AN INVESTIGATION OF METALLURGICAL FACTORS WHICH AFFECT THE FRACTURE TOUGHNESS OF ULTRA HIGH STRENGTH STEELS

William E. Wood, Earl R. Parker and Victor F. Zackay

May 1973

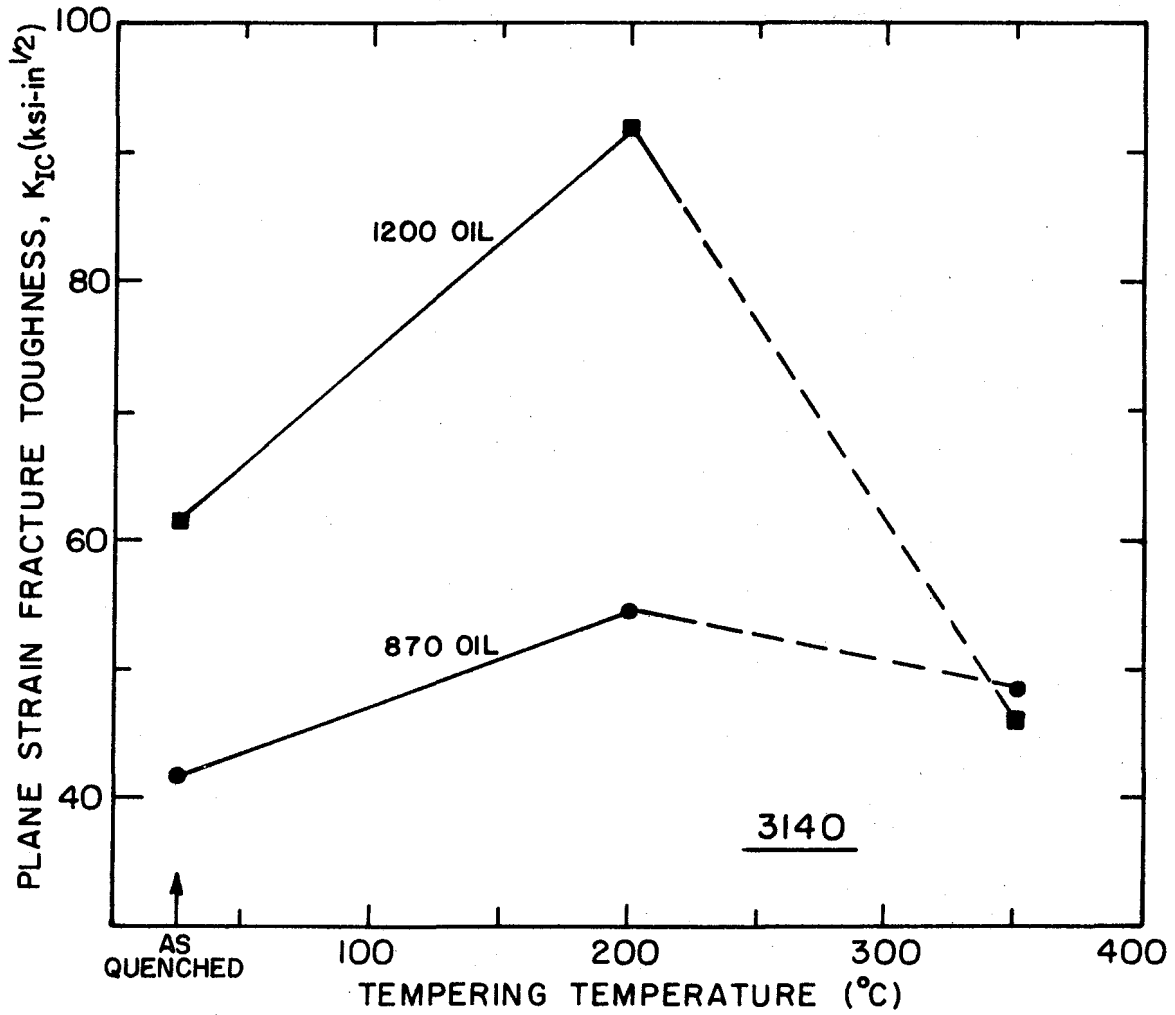
A limited amount of data has been obtained for alloy 3140 and is given in Table XII. The fracture toughness for both the (1200, Oil) and (870, Oil) heat treatments are graphed as a function of tempering temperature in Fig. 21. While the information is not complete, the results in Table XII and Fig. 21 show that this alloy does respond significantly to the (1200, Oil) heat treatment and that as for several other alloys the step quench heat treatment does not result in as high a fracture toughness as the direct (1200, Oil) heat treatment. Finally, this alloy does show an abrupt drop in toughness when the direct (1200, Oil) heat treatment is tempered above 200°C.

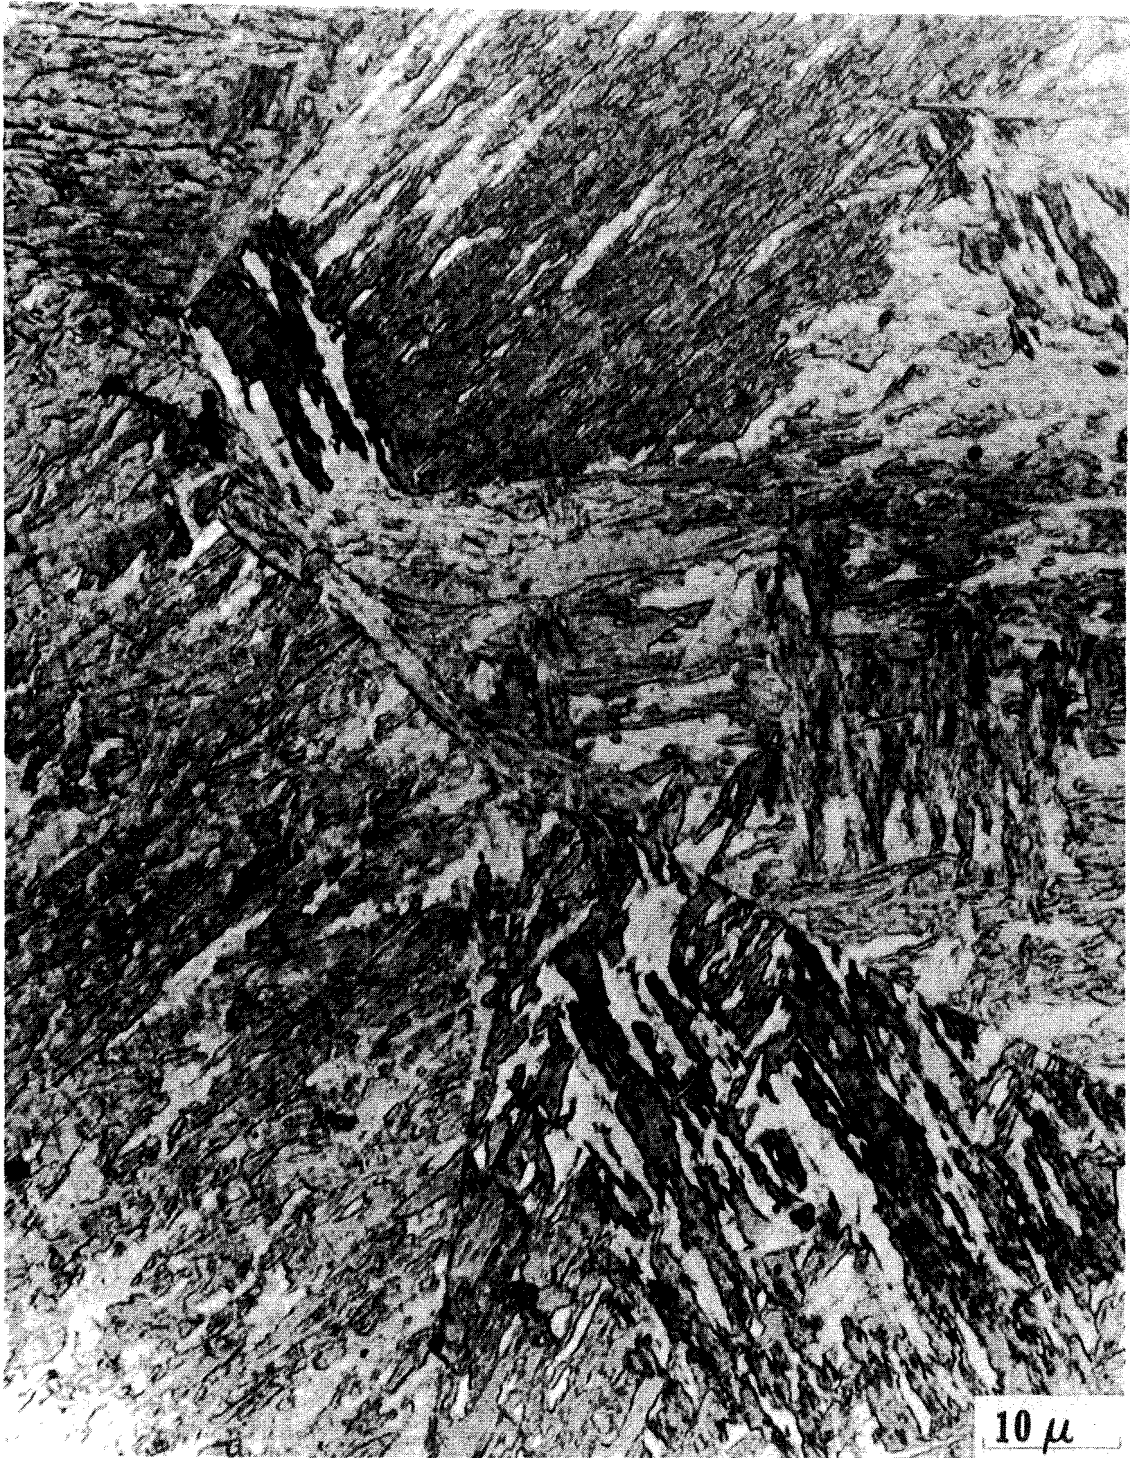
Fig. 33

The as-quenched microstructure for a (1200°C, IBQLN) heat treated section of 4340, 0.027 in. thick is shown in Fig. 33. This structure is fully martensitic without any trace of a decomposition product visible.

4340 (1200, IBQLN) AQ, 0.027 in. thick

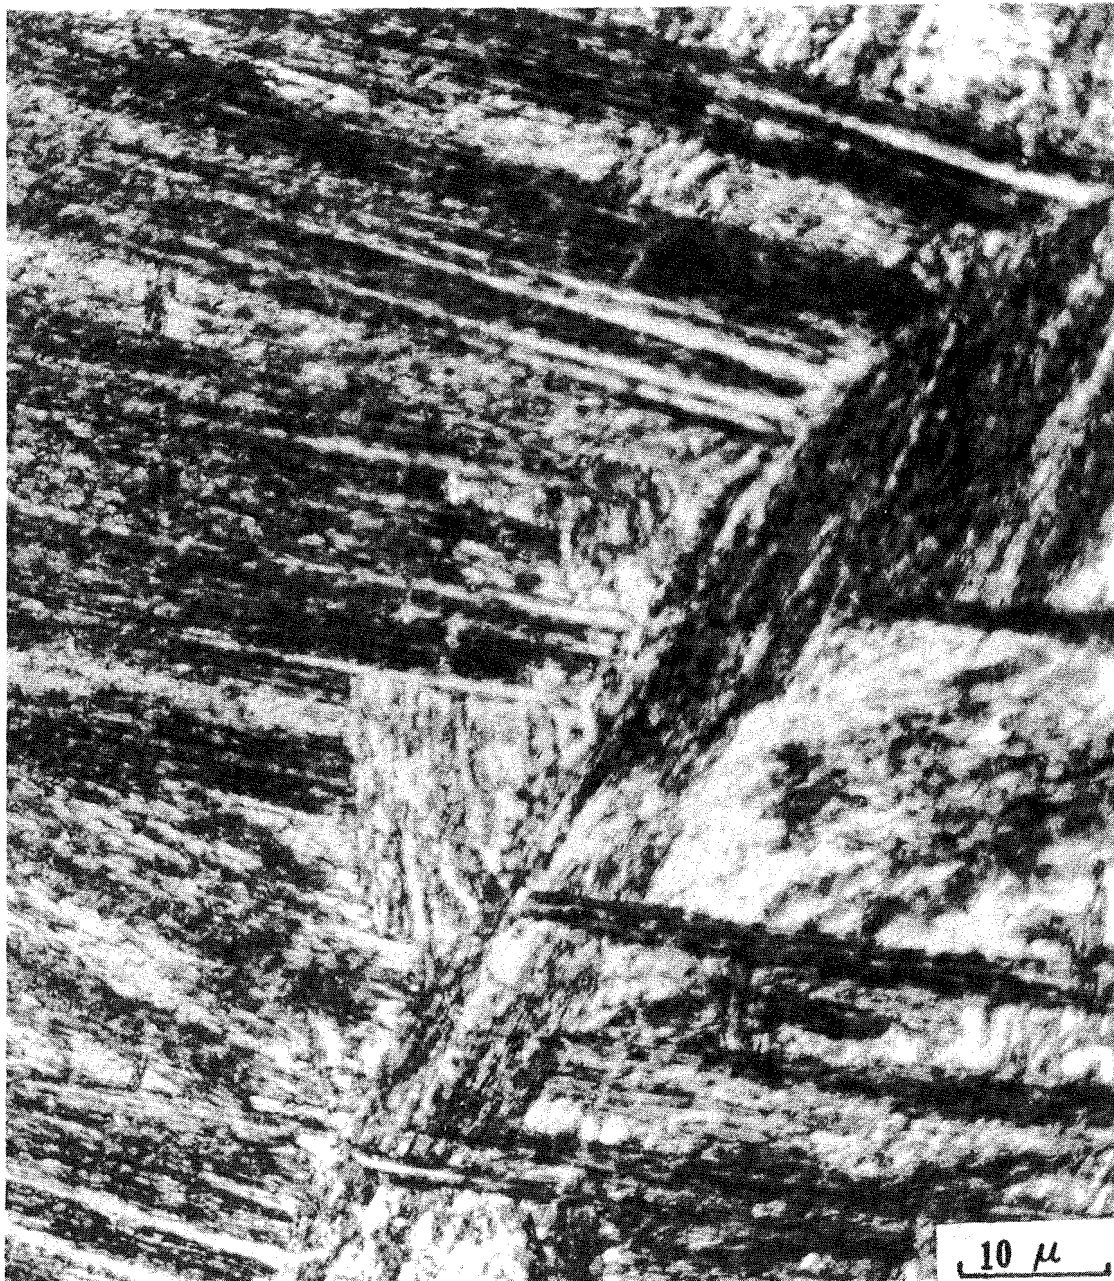
Using a step quench into oil, (1200→870, Oil) does not produce a change in the microstructure. Upper bainite is visible again originating from grain boundaries (Figs. 43 and 44).

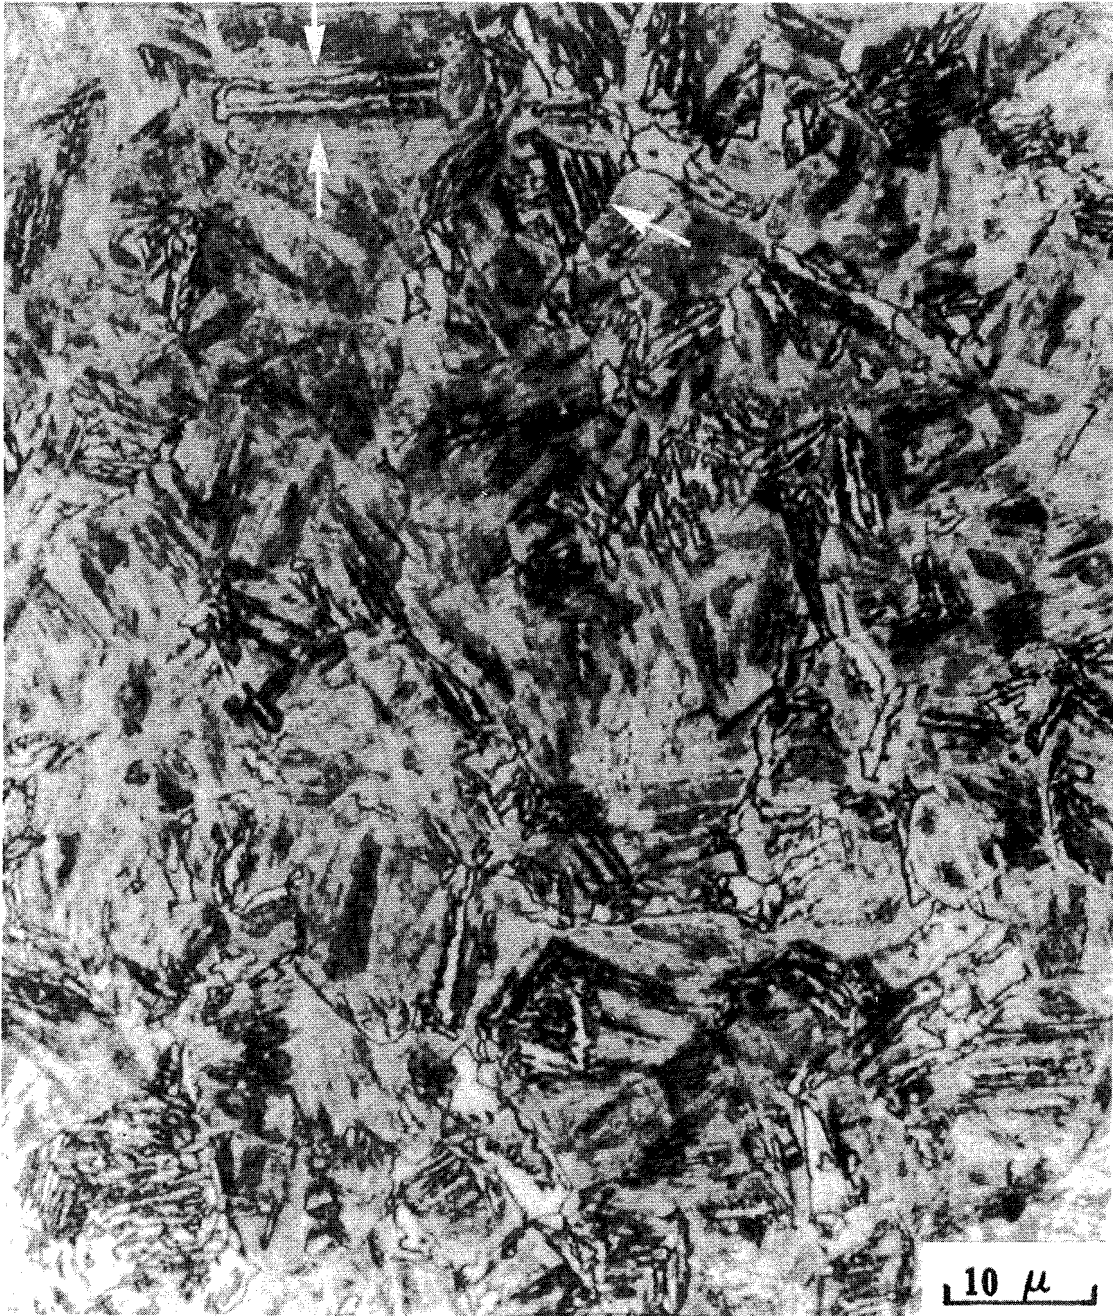
The microstructure which results from the commercial 870°C austenitization followed by an oil quench is shown in Figs. 49 and 50. Figure 50 reveals that this heat treatment results in the formation of ferrite and very coarse upper bainite in which the ferrite laths

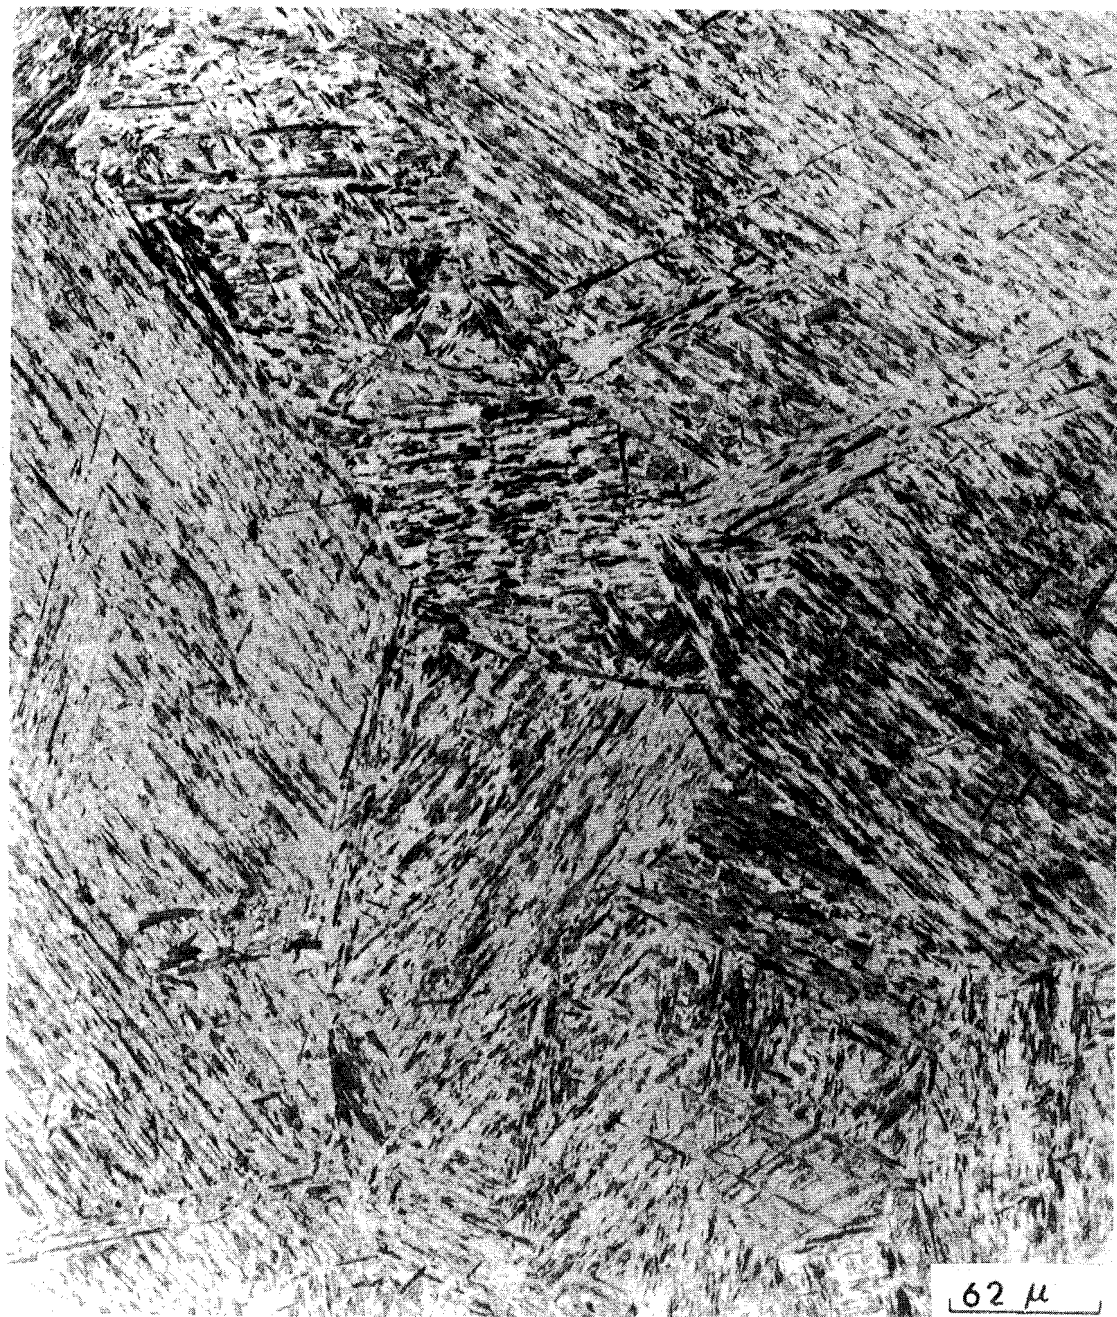
Fig. 51

The microstructure of the (1200, IBQLN) heat treated fracture toughness specimen is very similar to that of alloy 4130. The general appearance of the microstructure of this alloy for this heat treatment is shown in Fig. 51. It is difficult to identify without transmission electron microscopy whether this heat treatment results in a fully martensitic or mixed martensitic and bainitic structure. However, a decomposition product can be seen along the sites of prior austenite grain boundaries. For the (1200, Oil) heat treatment though, there are small regions of upper bainite found occasionally along prior austenite grain boundaries. An interference contrast micrograph (Fig. 52) in which the dark etching region, marked by arrows, can actually be seen to consist of many very finely spaced parallel plates originating from the grain boundary. The long dark etching plates radiating outward from the grain boundaries in the (1200, Oil) heat treatment (Fig. 53) are actually made up of several parallel units characteristic of bainite. Finally, a very fine film of ferrite outlines the grain boundary in Fig. 54 for the (1200, Oil) heat treatment. All the features identified in Figs. 52 through 54 for the (1200, Oil) heat treatment can also be found in the specimen given a (1200 -870, Oil) heat treatment (Fig. 55).

4330 (1200, IBQLN) AQ
