Alternative Weld Details and Design for Continuity Plates and Doubler Plates for Applications in Special Moment Frames

A dissertation submitted in partial satisfaction of the requirements for the degree

Structural Engineering

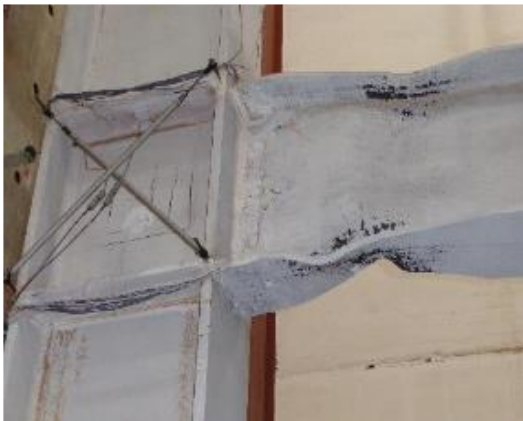
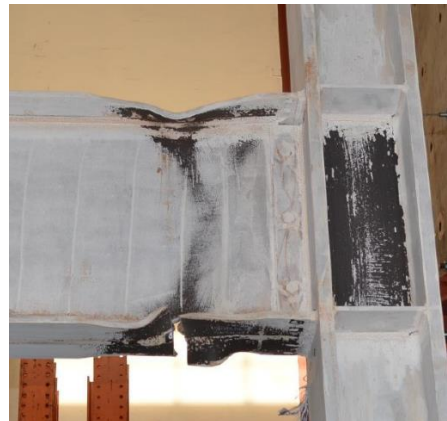
Figure 1.7 Flexibility Method Verification (Mashayekh and Uang 2018)

(a) Specimen C1

(b) Specimen C2

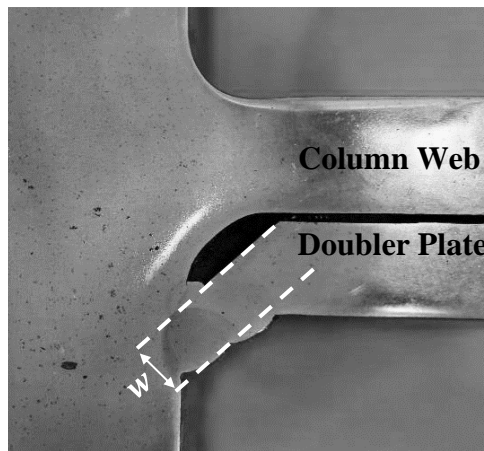
Figure 2.5 Doubler Plate Vertical Fillet Welds

(b) Specimen C7

An additional complication to using fillet welds as the vertical weld to fasten the doubler plate to the column is maintaining the effective throat of the weld through the beveled portion of the doubler plate [see Figure 2.5(a)]. The commentary of §E3.6e.3 in AISC 341 (2016b) discusses the issue and recommends that the fillet weld size should be increased to accommodate any reductions in the effective throat due to the bevel of the doubler plate. For Specimen C7, a bevel angle of 45° was specified to circumvent this issue [see Figure 2.5(b)]. No fit-up issues of the 5/8-in. doubler plate on the W24×192 column was reported.

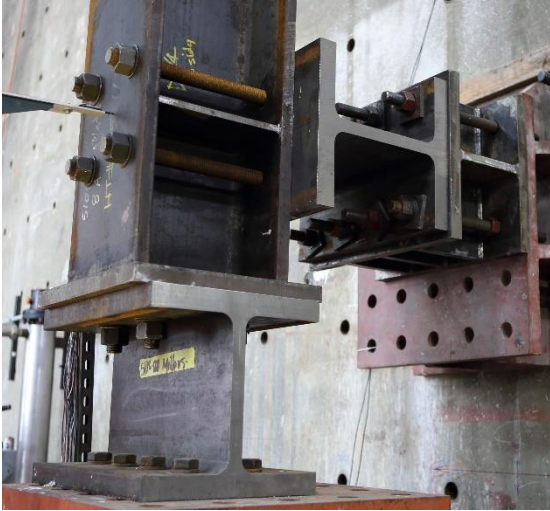
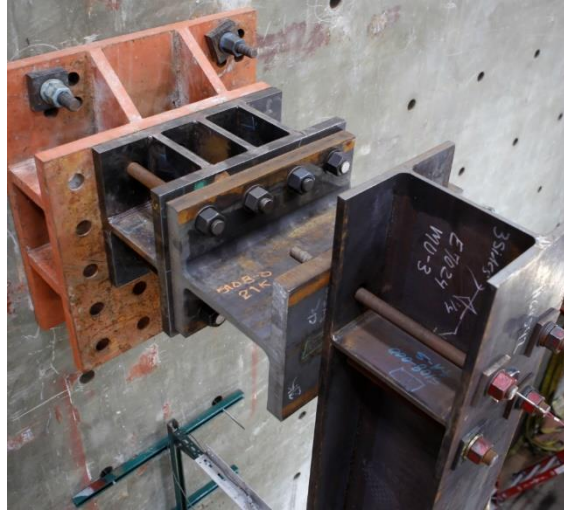
Figure 3.2 Column Support (Phase 1)

(a) Lower End

(b) Upper End

The Phase 1 test setup is shown in Figure 3.1; each specimen was tested in the upright position. Frame inflection points are assumed to exist at the mid-height of each story, which are simulated by using three W14×257 hinge supports. The W14 shapes were mounted under the column and at the top and bottom as shown in Figure 3.2. The beam length represents half of the bay width, assuming an inflection point at the midspan of the beam. The loading end (south end of the specimen) is loaded through a 220-kip hydraulic actuator with an inline load cell. The load from the actuator is delivered to the free end of the beam through a loading corbel (see Figure 3.3). An intermediate top flange lateral restraint placed about 18 in. away from the RBS cut used for Specimens C3 and C5 is seen Figure 3.4. The top-flange lateral bracing outside of the RBS simulates the lateral restraint provided by a composite concrete slab in a real application. To

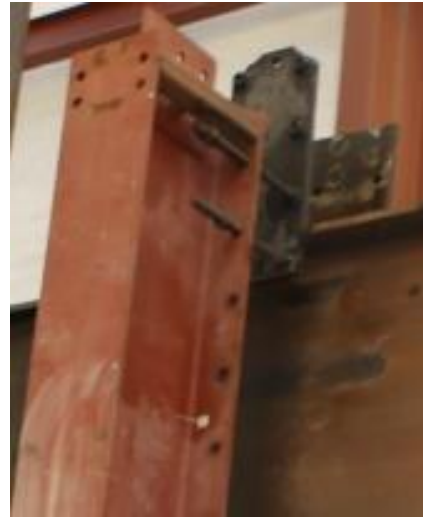
Figure 3.4 Top Flange Intermediate Lateral Restraint (Specimens C3 and C5)

(b) Detail

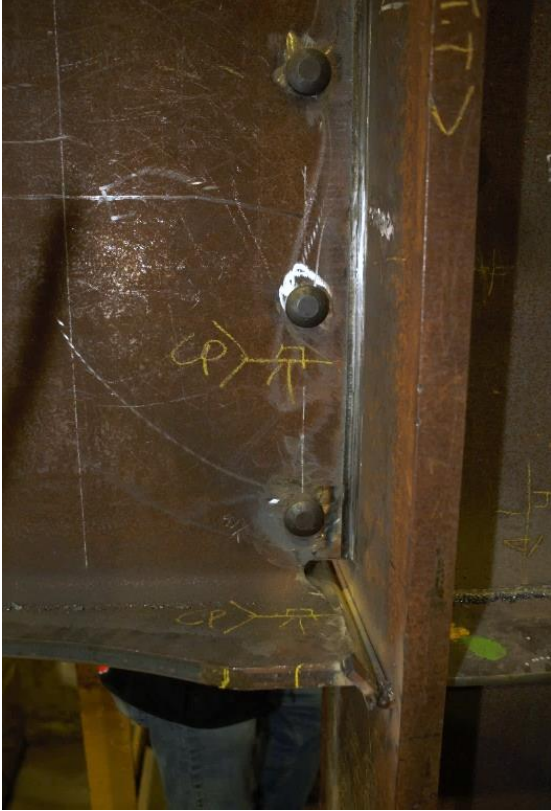
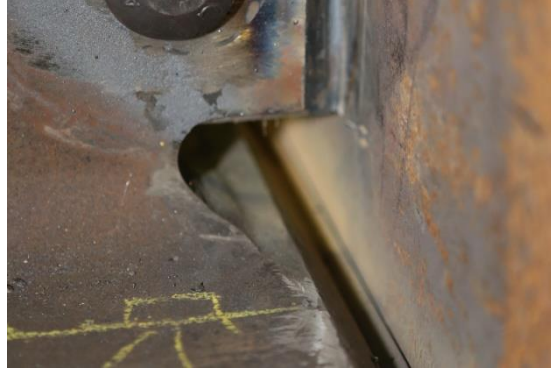
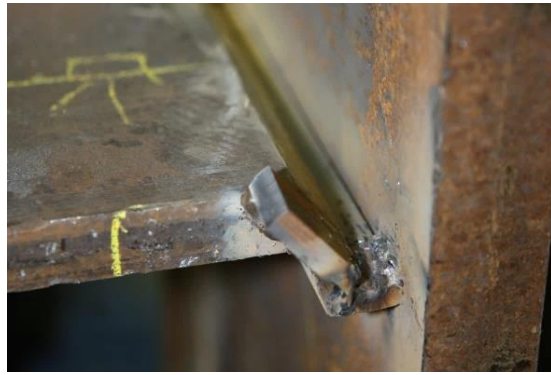
Figure 3.10 Beam Bottom Flange and Web CJP Weld Preparation (Specimen C5)

(a) Overview

(b) Weld Access Hole

(c) Run off Tab

The San Bernardino location (San Bernardino Steel) of The Herrick Corporation fabricated the test specimens. For reasons of economy, the field welding was simulated at Herrick's shop. The simulated field welding of Specimen C5 was observed on October 25 of 2018. Figure 3.10 to Figure 3.16 show the observed simulated field welding. At the time of welding, a visual inspection was performed by West Coast Inspection Services. After a 24-hour cool-down period, UT and magnetic particle testing were also performed by West Coast Inspection Services. Weld inspection of the Phase 2 specimens was completed by the Smith & Emery Company. See Reynolds and Uang (2019) for all Weld Inspection Reports. The inspections did not reveal any actionable flaws in the welding.

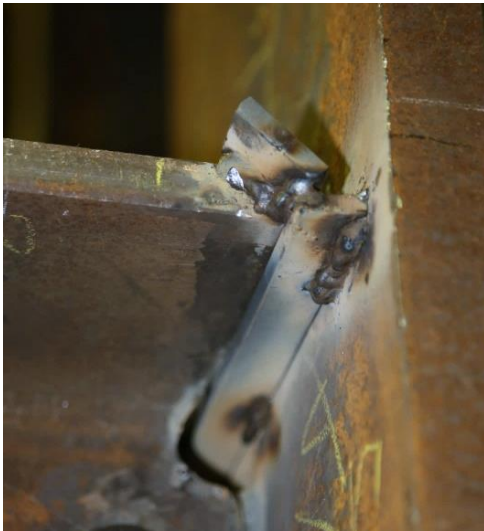
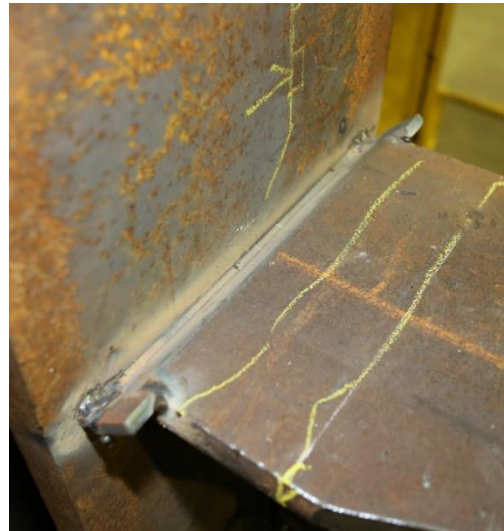
Figure 3.11 Beam Top Flange CJP Weld Preparation (Specimen C5)

(a) Backing Bar

(b) Groove

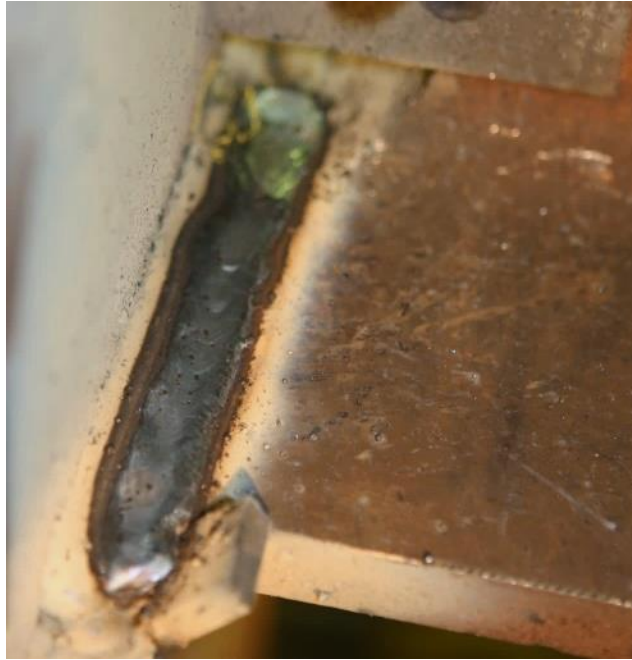
Figure 3.12 Beam Flange CJP Weld during Groove Welding (Specimen C5)

(a) Beam Bottom Flange

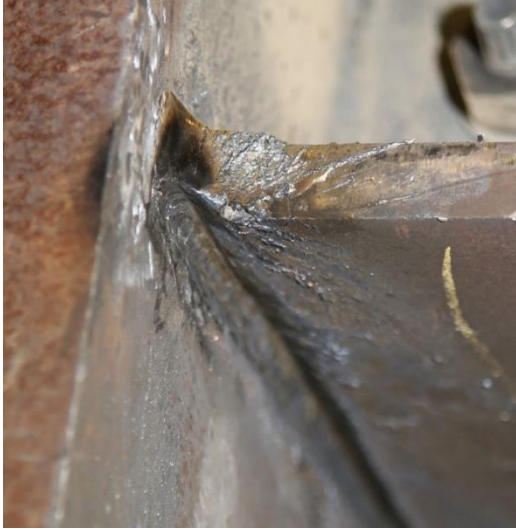
Figure 3.13 Beam Bottom Flange Underside CJP Weld Treatment (Specimen C5)

(a) Backgouging

(b) Reinforcing Fillet

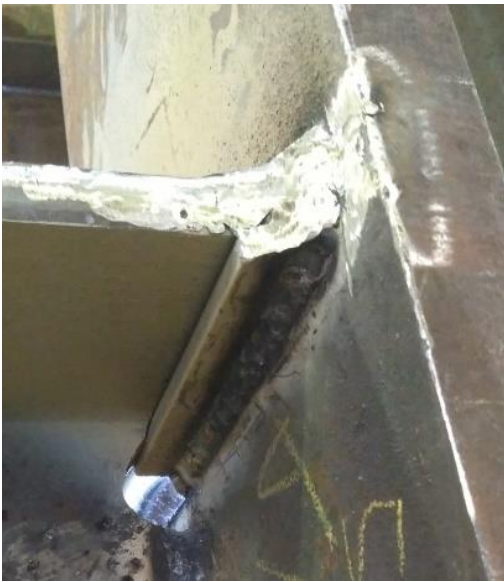
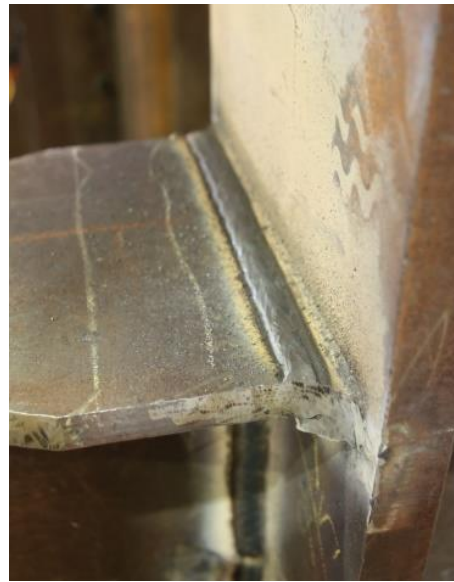
Figure 3.14 Beam Top Flange Underside CJP Weld Treatment (Specimen C5)

(a) Reinforcing Fillet

(b) after Cleanup

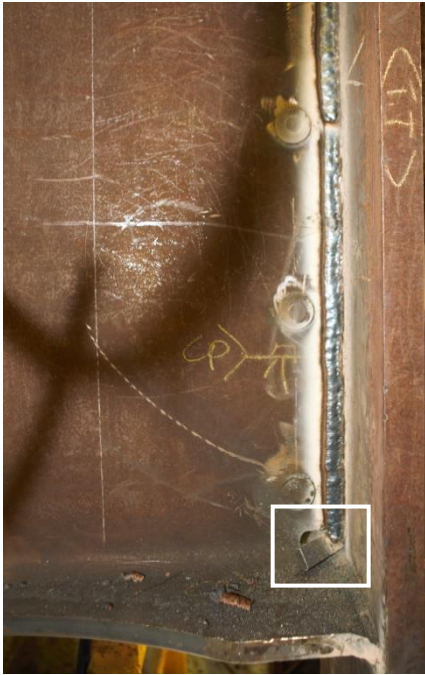
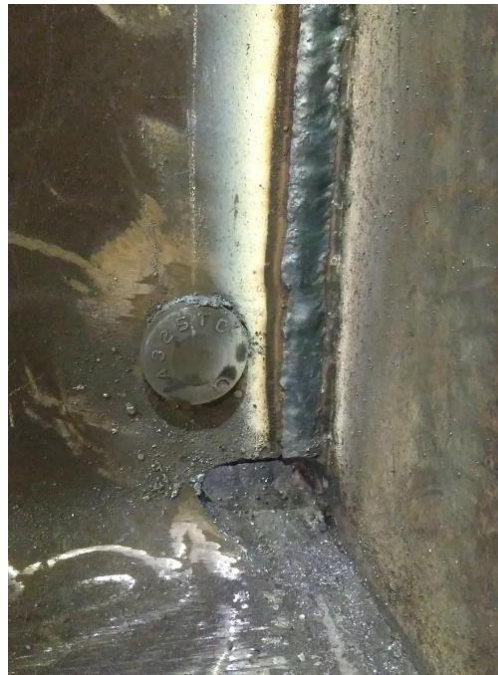
Figure 3.15 Beam Web Weld (Specimen C5)

(a) Completed Weld

(b) after Cleanup

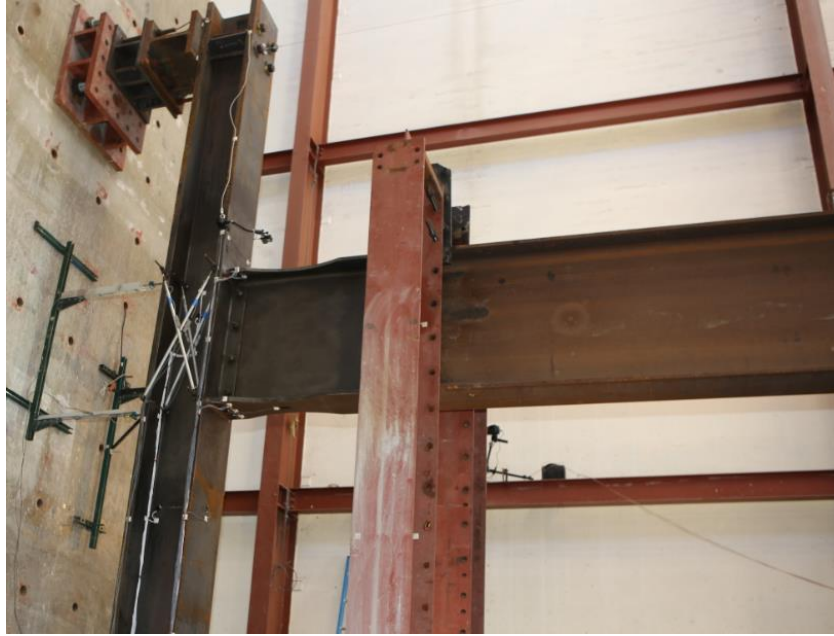
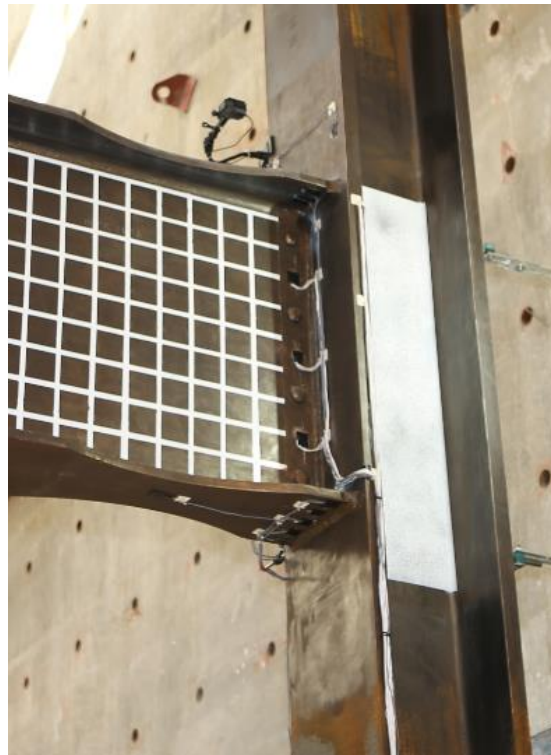
Figure 4.1 Specimen C3: Specimen before Testing

(a) West Side

(b) East Side

Specimen C3 was designed to challenge the Lehigh Criterion. This was the only requirement of AISC 341 (2016) that would necessitate a continuity plate in this specimen; the flange force computed from AISC 358 (2016) for this connection does not exceed any column limit state of AISC 360 §J10 (2016). The specimen also closely matches Specimen C2 tested during the verification of the flexibility method, except that Specimen C2 used a 5/8-in. continuity plate. The panel zone of Specimen C3 has a high DCR of 0.94. Figure 4.1 shows the specimen before testing. The specimen failed by a complete fracture of the beam top flange CJP weld during the second cycle of 0.05 rad drift.

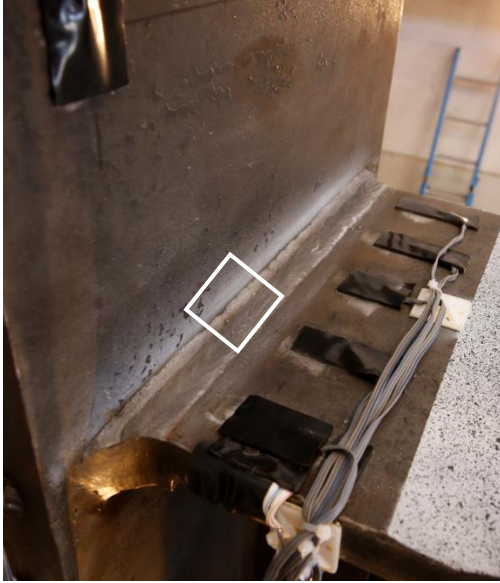
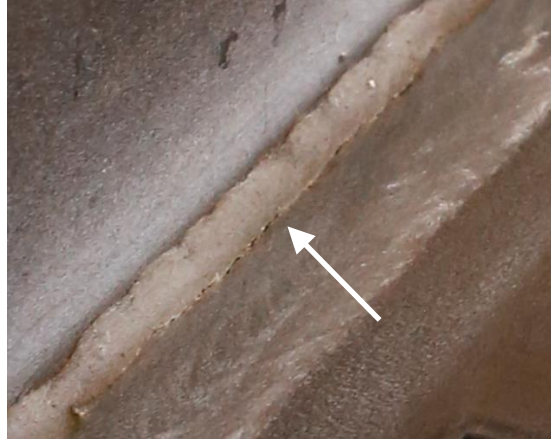
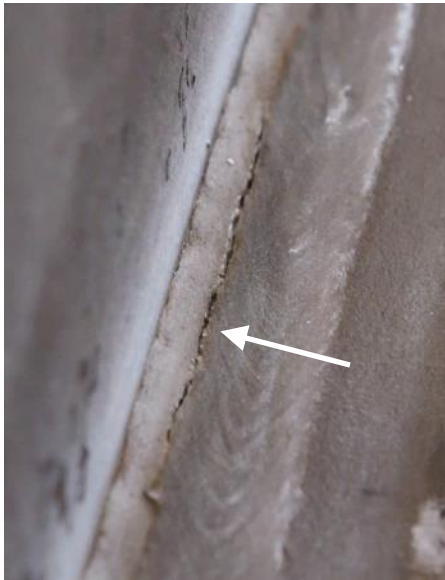
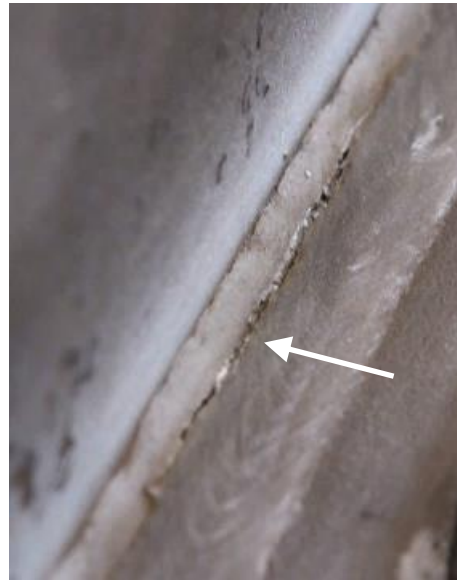
Figure 4.3 Specimen C3: Beam Top Flange Weld Tearing

(b) Tearing at -0.03 rad (2nd Cycle)

(c) -0.04 rad (1st Cycle)

(d) -0.04 rad (2nd Cycle)

- Figure 4.3 shows ductile tearing of the beam top flange CJP weld that was first observed during the 2nd negative excursion of 0.03 rad drift. Minor growth of this fracture occurred during the 0.04 rad cycles occurred during testing.

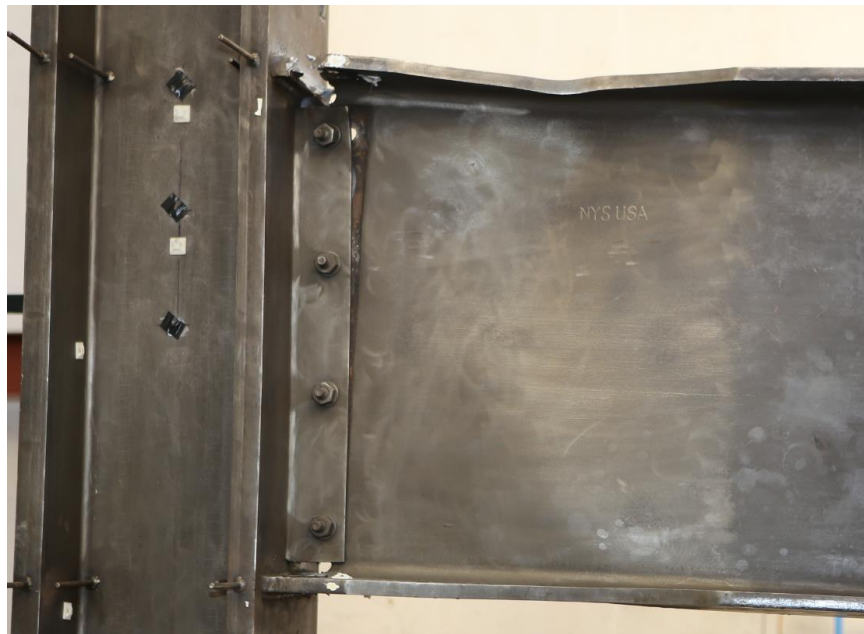
Figure 4.6 Specimen C3: Connection at End of Test

(b) West Side

- Figure 4.6 shows the connection after testing. The top flange CJP weld fractured at -0.013 rad of the second cycle of 0.05 rad drift. Tearing of the web through the erection bolts occurred during continued negative excursion. Figure 4.7 shows the beam lateral-torsional buckling at the end of testing. The buckling was most pronounced in the unbraced bottom flange of the beam.

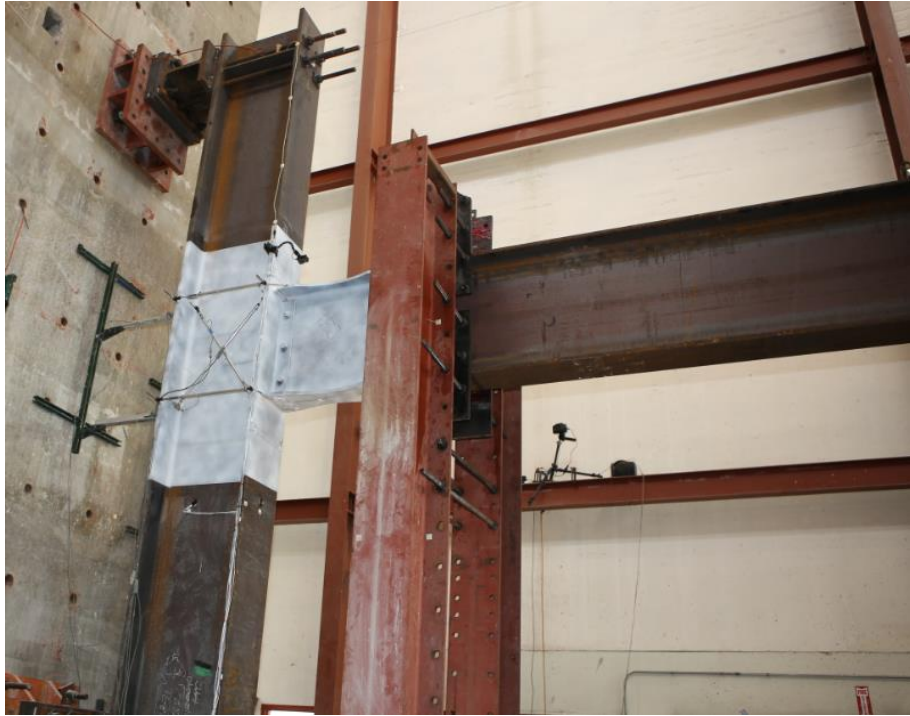
Figure 4.15 Specimen C4: Specimen before Testing

(a) West Side

(b) East Side

Specimen C4 was similar to Specimen C3 as it was designed to challenge the Lehigh Criterion. This was the only requirement of AISC 341 (2016) that would necessitate a continuity plate in this specimen; the flange force computed from AISC 358 (2016) for this connection does not exceed any column limit state of AISC 360 §J10 (2016). In contrast to Specimen C3, Specimen C4 uses a deep column to reflect a modern practice in SMFs to control drift. Figure 4.15 shows the specimen before testing. The specimen ultimately failed by low-cycle fatigue of the beam bottom flange in the plastic hinge location during the second cycle of 0.06 rad drift.

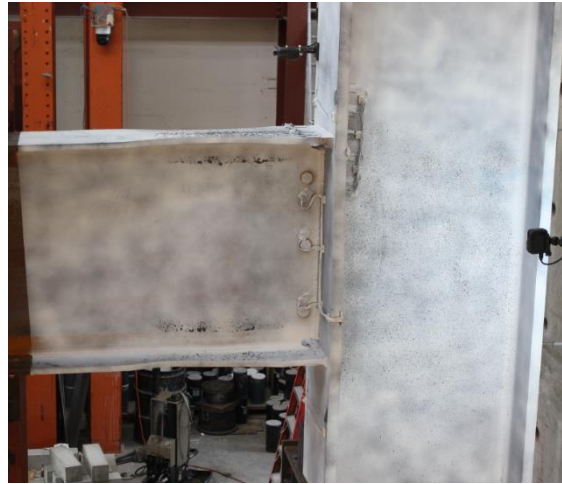
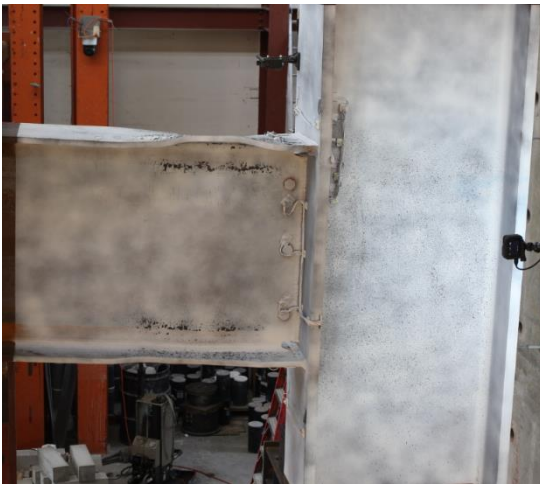
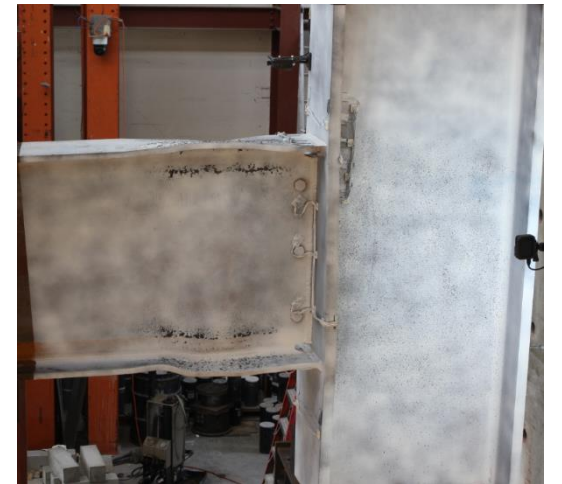
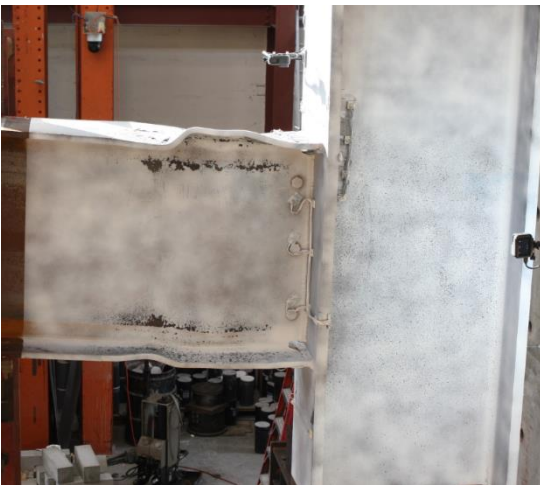
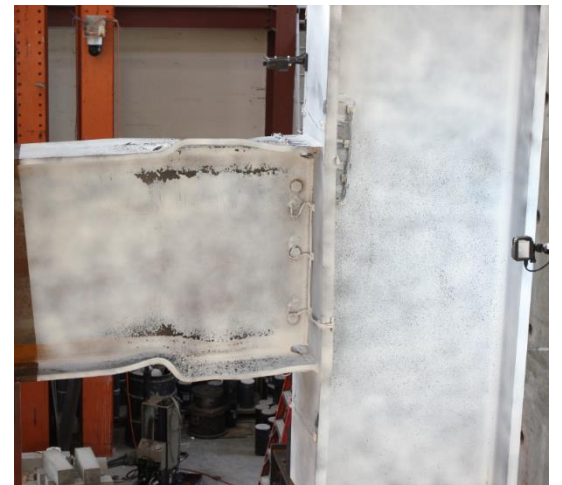
Figure 4.16 Specimen C4: East Side of Connection

(b) -0.03 rad (2nd Cycle)

(c) +0.04 rad (2nd Cycle)

(d) -0.04 rad (2nd Cycle)

(e) +0.05 rad (1st Cycle)

(f) -0.05 rad (1st Cycle)

- Figure 4.16 shows the east side of the specimen at the peak excursions during the later cycles of the loading protocol. The specimen met the AISC acceptance criteria by completing one complete cycle at 0.04 rad drift while the flexural strength at the column face did not degrade below 80% of the beam nominal flexural strength. Local buckling of the web and flange initiated during the second cycle of 0.03 rad drift. This progressed to result in modest flange local buckling during the 0.04 rad and 0.05 rad drift cycles.

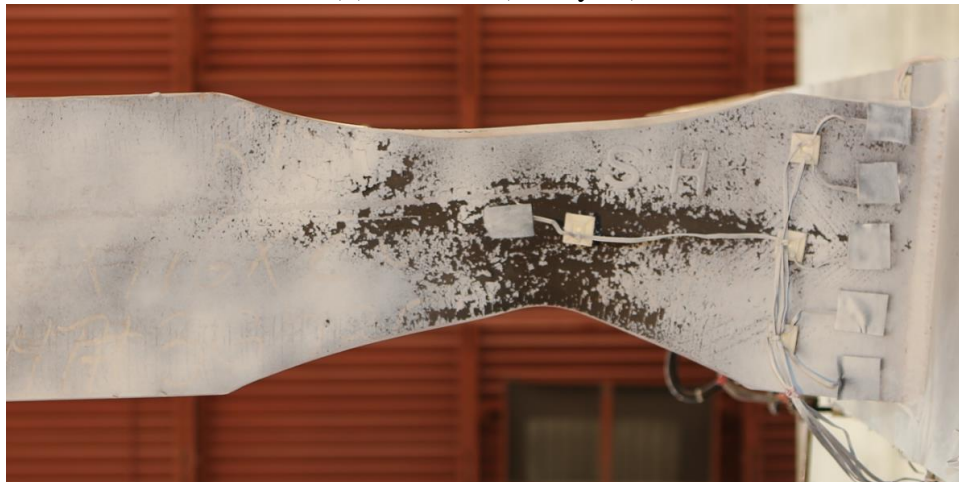
(c) -0.04 rad (2nd Cycle)

Figure 4.17 Specimen C4: Beam Bottom Flange Yielding and Buckling

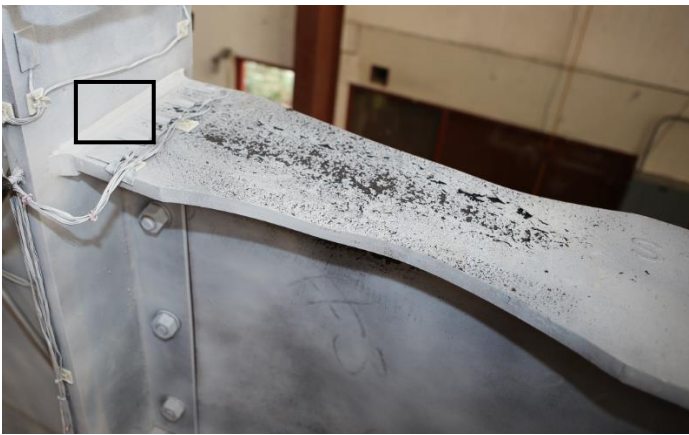
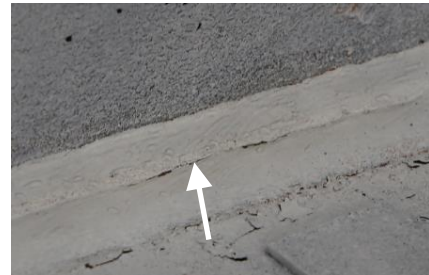
(a) Overview

(b) CJP Weld

Figure 4.19 Specimen C4: Beam Top Flange at -0.04 rad (1st Cycle)

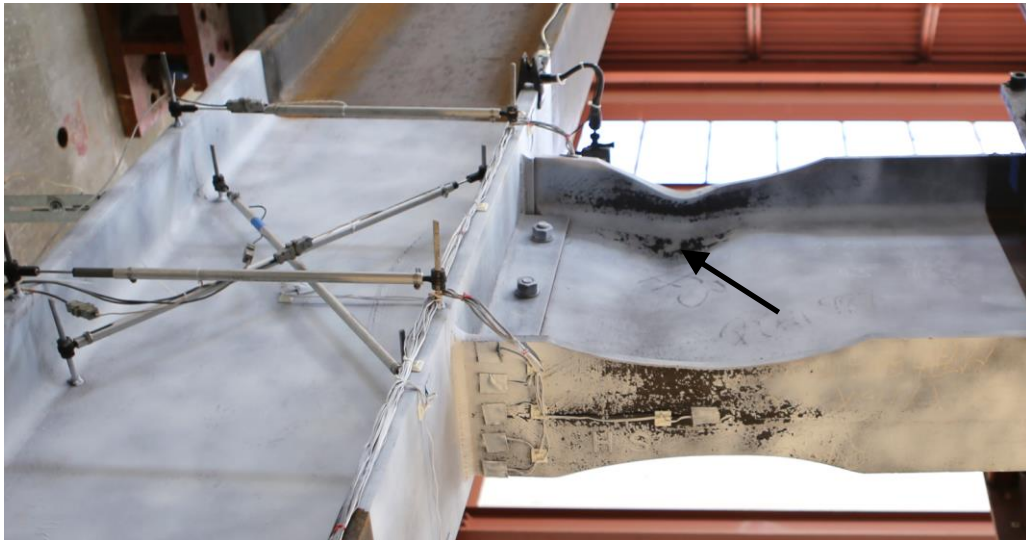
Figure 4.21 Specimen C4: Beam Web Buckling at -0.04 rad (1st Cycle)

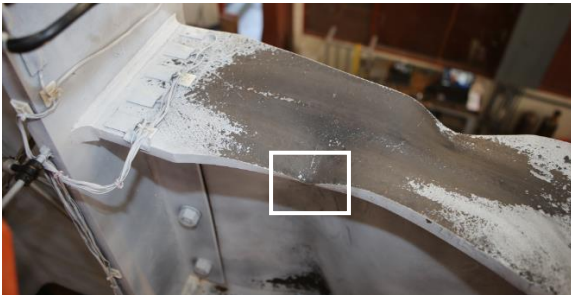
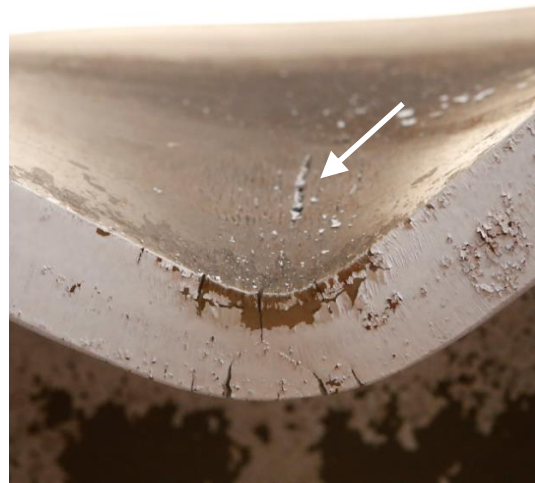
(a) Overview

(b) Ductile Tearing

Figure 4.23 Specimen C4: Beam Top Flange at -0.06 rad (2nd Cycle)

- Figure 4.23 shows ductile tearing of the beam top flange similar to the condition of the beam bottom flange prior to fracture. It was observed that significant tearing occurs in the ‘compression’ side of the local buckling during load reversals.

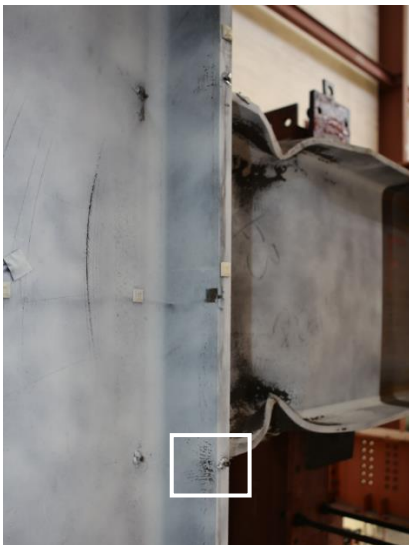
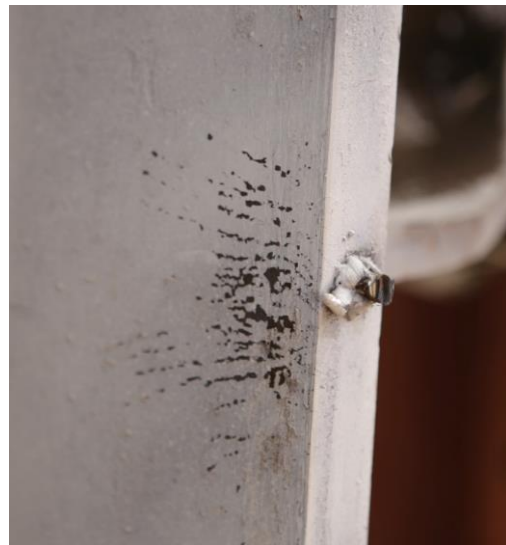
(a) Overview

(b) Flange Local Bending

Figure 4.26 Specimen C4: Column Flange (End of Test)

- The complete bottom flange tear was accompanied with a 4-in. propagation into the web (see Figure 4.25). Most of the fracture surface consists of cleavage fracture with shear fracture surfaces at the peripheral edges of the flange.
- Column flange yielding behind the beam flanges, similar to a flange local bending phenomenon, was observed during the 0.05 rad cycles. Figure 4.26 shows the yielding of the column flanges at the end of the test.

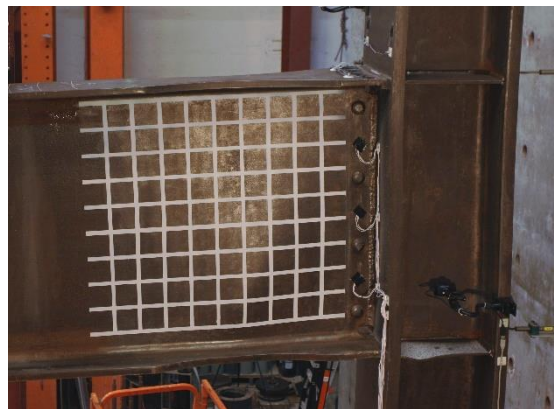
(f) -0.05 rad (1st Cycle)

Figure 4.34 Specimen C5: East Side of Connection

- Figure 4.34 shows the east side of the specimens at the peak excursions during the later cycles of the loading protocol. The specimen met the AISC acceptance criteria. It was observed that beam web buckling initiated during the first cycle of 0.04 rad drift. Flange local buckling initiated at the beam bottom flange within the RBS cut during the second cycle of 0.04 rad drift. By 0.05 rad drift flange local buckling was observed in both flanges.

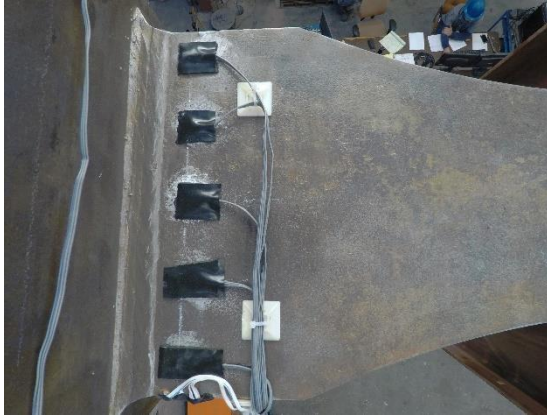
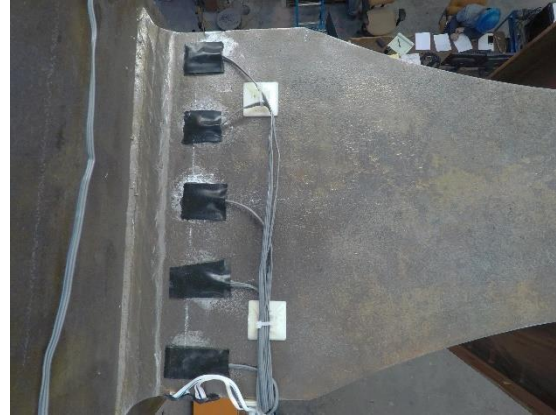
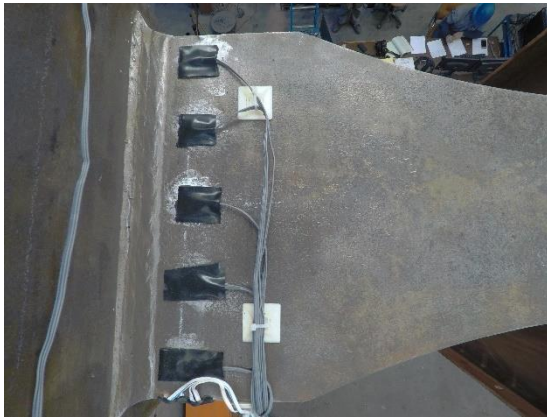
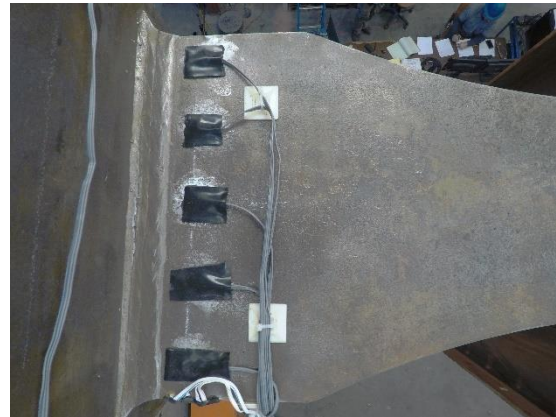
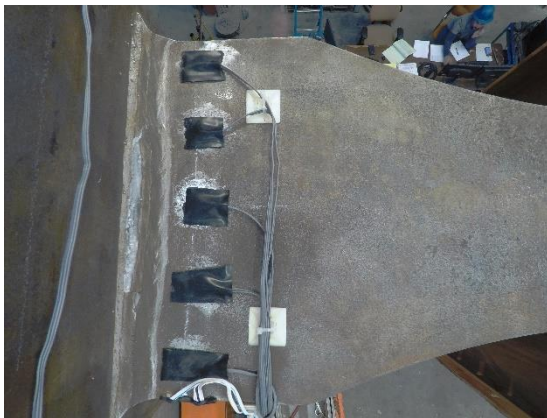
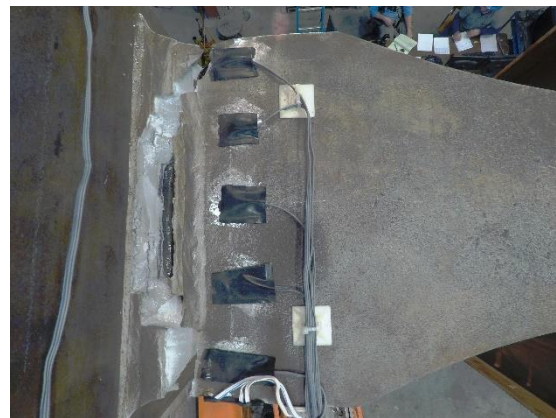
Figure 4.35 Specimen C5: Beam Top Flange

- Figure 4.35 shows ductile tearing of the beam top flange CJP weld that was first observed during the 2nd negative excursion of 0.03 rad drift. Minor growth of this fracture occurred during the 0.04 rad cycles during testing.

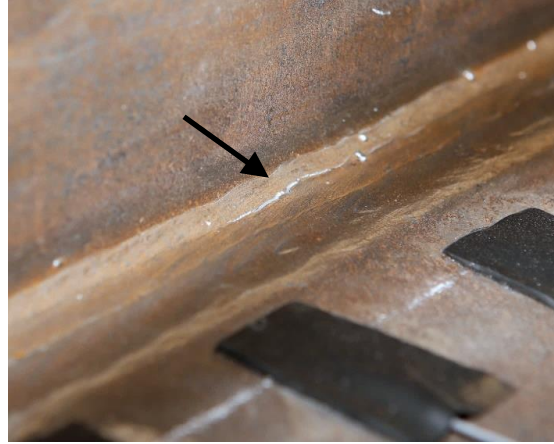
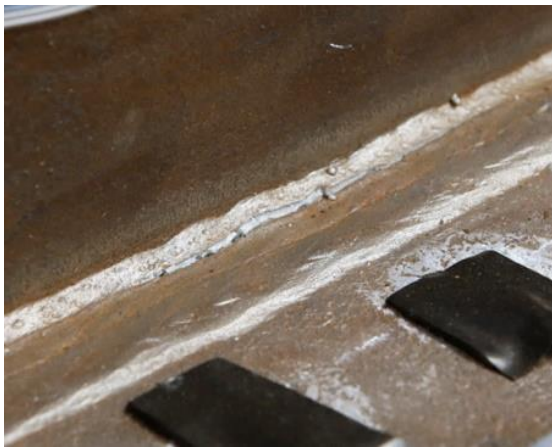
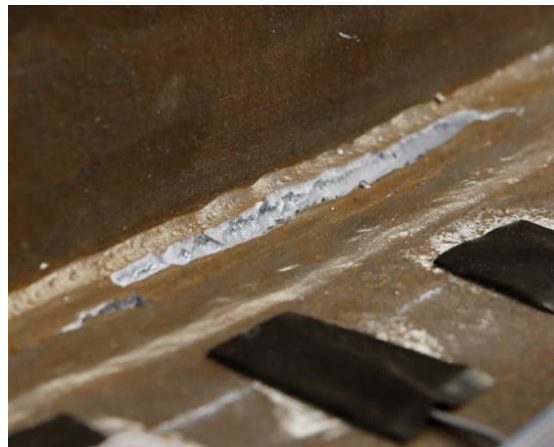
(b) -0.03 rad (2nd Cycle)

(c) -0.04 rad (2nd Cycle)

(d) -0.05 rad (1st Cycle)

Figure 4.36 Specimen C5: Beam Top Flange CJP Weld Fracture Progression

- Figure 4.36 shows gradual progression of tearing of the beam top flange CJP weld. Figure 4.36(e) shows the complete beam top flange fracture. This shear type fracture originated at a toe of the prominent weld pass against the column and propagated through the flange at

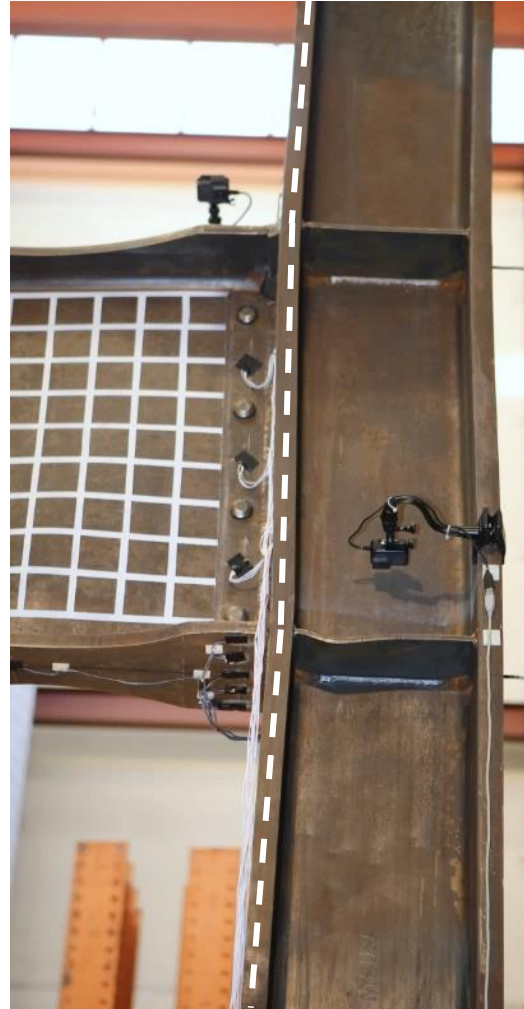
(b) -0.05 rad (2nd Cycle)

Figure 4.37 Specimen C5: Column Kinking due to Panel Zone Deformation

- Significant column kinking was observed during the testing of the specimen (see Figure 4.37).
- Minor web buckling was evident at the end of testing [see Figure 4.38(a)]. Continued negative excursion after fracturing the beam top flange produced a fracture of the beam web [see Figure 4.38(b)]. This fracture originated in the weld access hole and propagated down through the erection bolt holes. Local necking was observed near this fracture.

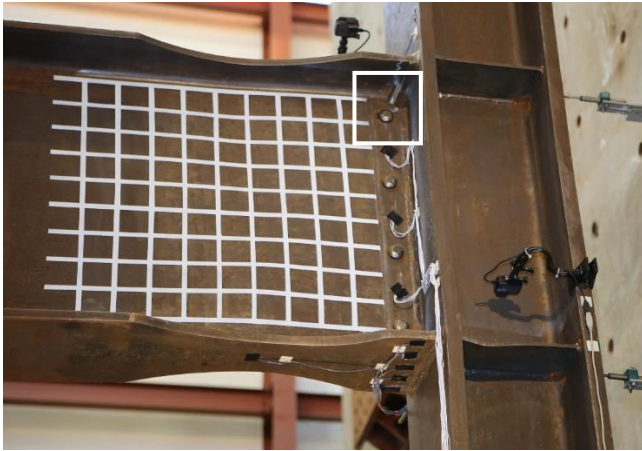
(a) Beam Web Buckling

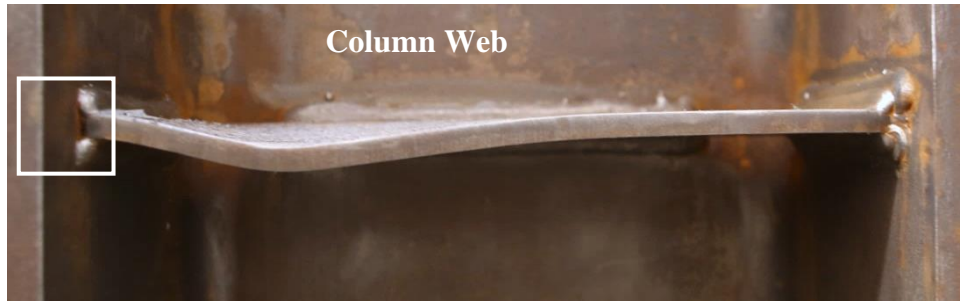
(a) East Bottom Flange Continuity Plate

(b) Enlarged View of Weld

- Figure 4.39 shows the slight beam lateral-torsional buckling at the end of testing.
- At the end of testing no damage was observed in any of the fillet welds fastening the continuity plates to the column. Figure 4.40 shows the continuity plates after testing. The east bottom flange and west top flange continuity plate experienced local plate buckling. The east bottom flange continuity plate started developed local buckling during the first negative excursion of 0.04 rad drift. At the time of failure, the specimen was experiencing a negative excursion which pulled the west top flange continuity plate straight with minor residual deformation. The east bottom flange shows the full extent of the buckling as this plate was in compression at the point of failure. Despite the significant plate buckling and column flange kinking, the continuity plate to column flange welds have remained intact [see Figure 4.40(b)].

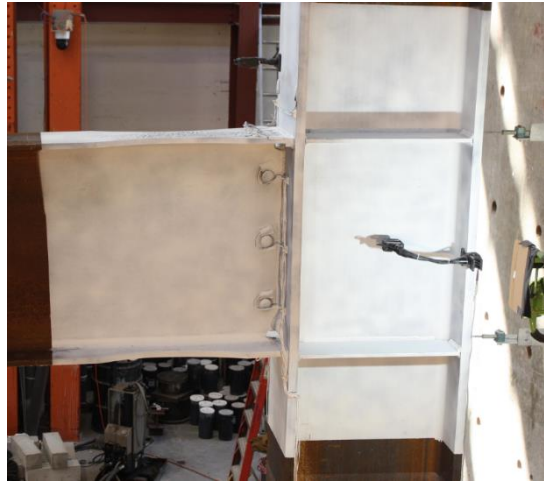
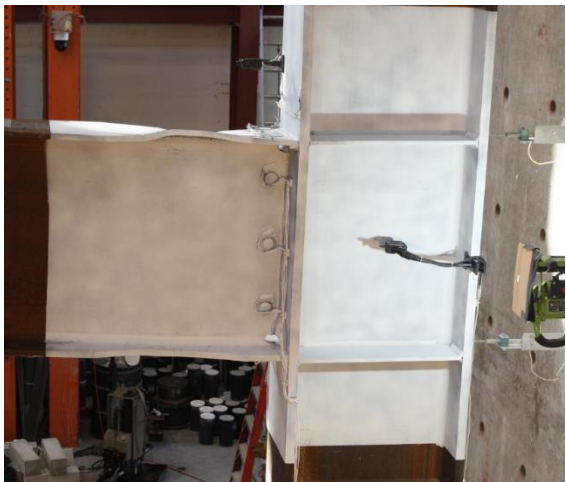
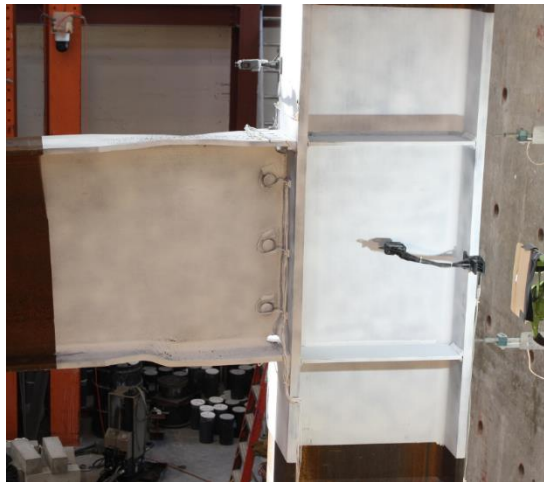
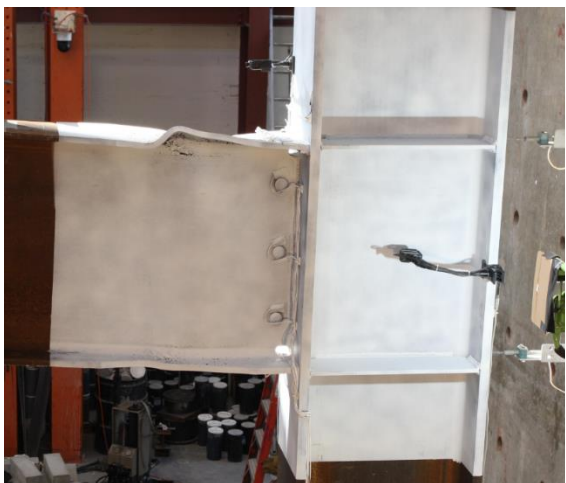
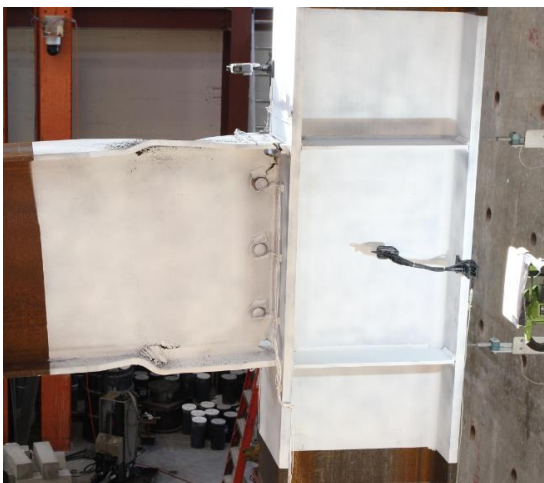
Figure 4.48 Specimen C6: East Side of Connection

- Figure 4.48 shows the east side of the specimen at the peak excursions during the later cycles of the loading protocol. The specimen met the AISC acceptance criteria. It was observed that beam web buckling and beam flange local buckling both initiated during the first cycle of 0.04 rad drift. Flange local buckling initiated at the beam bottom flange within the RBS cut during the second cycle of 0.04 rad drift. At 0.05 rad drift modest beam flange and beam web local buckling was observed.
- Figure 4.49 shows the progressive tearing of the beam top flange CJP weld. At the first negative excursion to 0.03 rad drift a minor crack was observed at the toe of prominent weld pass on the outward surface of the CJP weld. This crack progressed until -0.037 rad of the first negative excursion of 0.05 rad drift when a sudden fracture of the flange

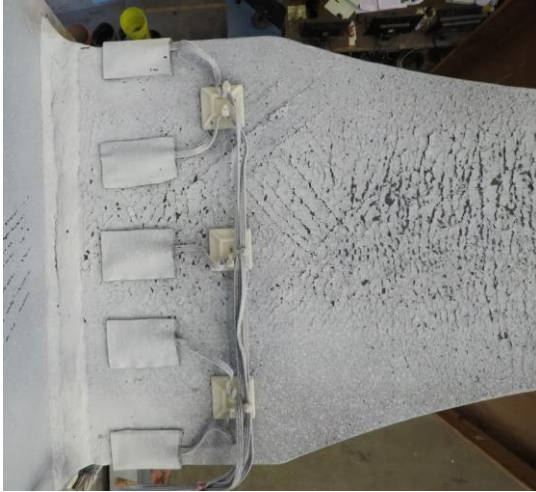
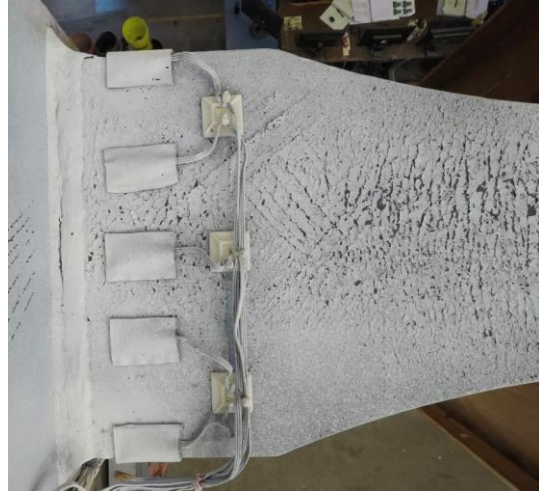
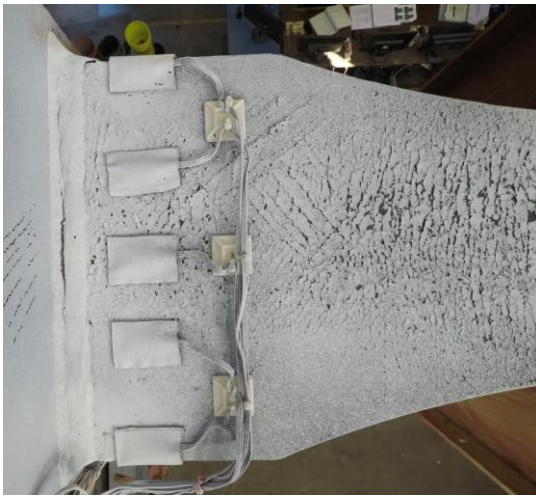
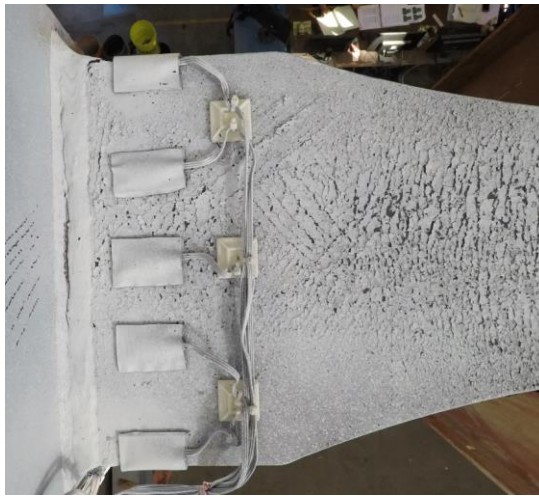
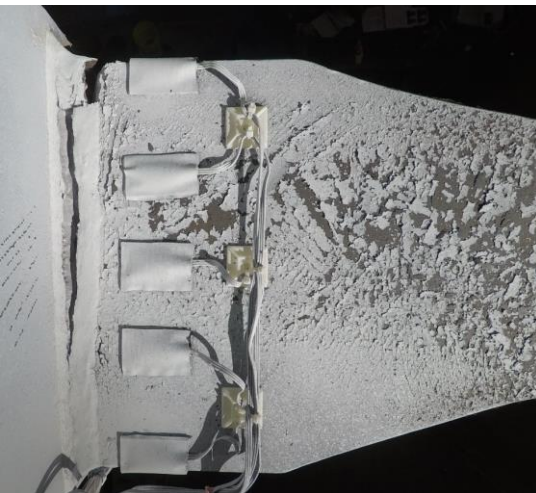
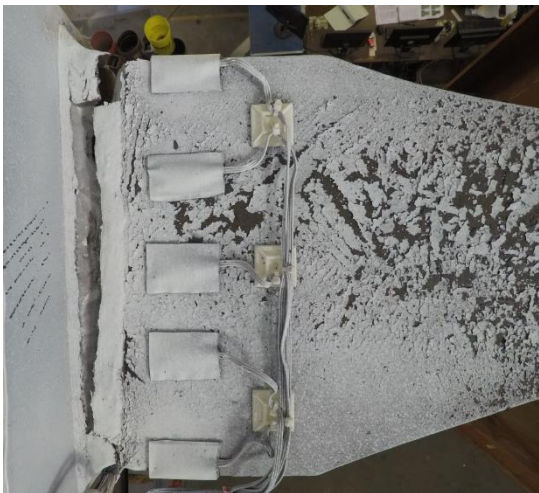
Figure 4.49 Specimen C6: Beam Top Flange

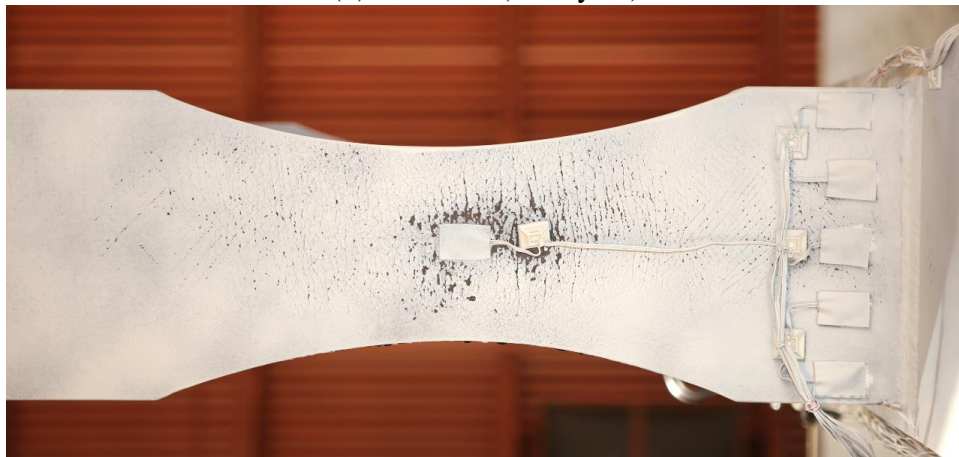
(c) +0.04 rad (2nd Cycle)

Figure 4.51 Specimen C6: Beam Bottom Flange Yielding

- Beam bottom flange yielding started during the 0.01 rad cycles within the reduced beam section and near the column flange (see Figure 4.51). This yielding progresses through testing. Minor lateral-torsional buckling was observed during testing.

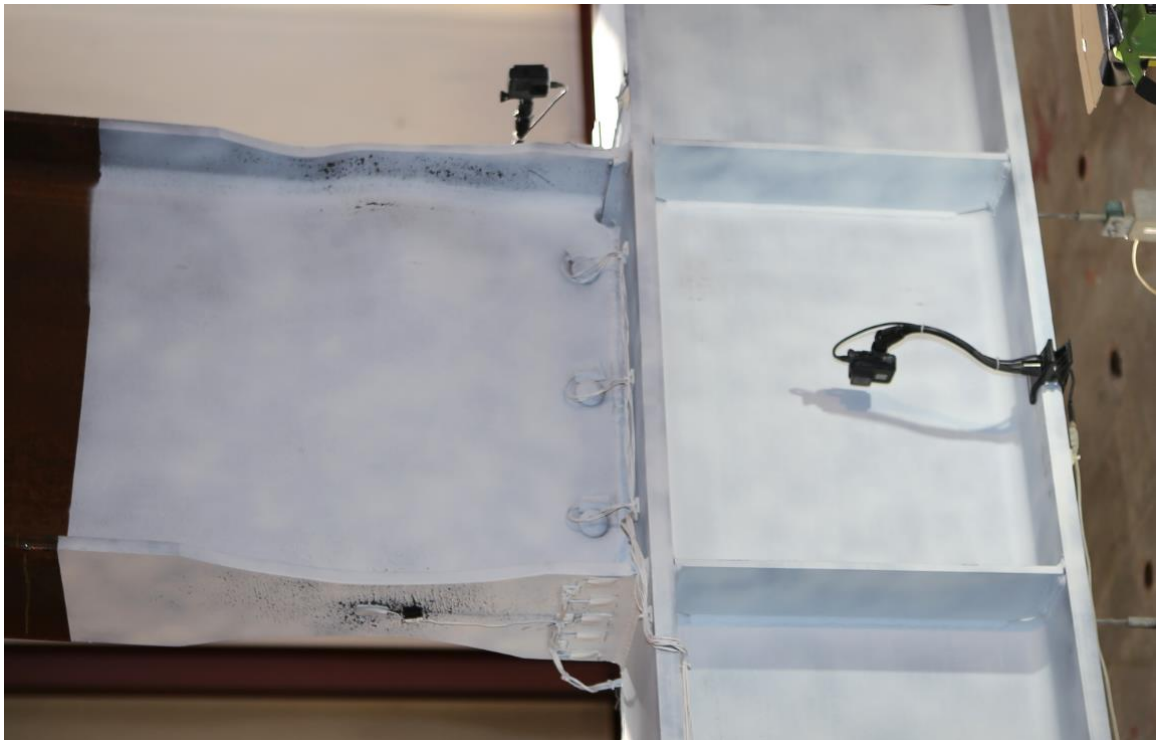
Figure 4.53 Specimen C6: Beam Web and Flange Local Buckling at +0.04 rad (2nd Cycle)

- Figure 4.52 shows panel zone yielding on the west side of the specimen. This yielding commenced during the 0.015 rad drift cycles and progressed through testing. Figure 4.53 shows the beam flange and beam web local buckling.

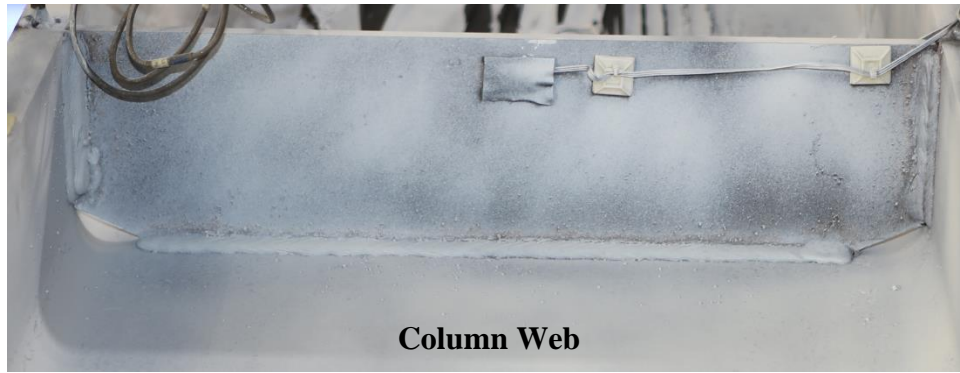
(a) West Bottom Flange Continuity Plate
