Alternative Weld Details and Design for Continuity Plates and Doubler Plates for Applications in Special Moment Frames

A dissertation submitted in partial satisfaction of the requirements for the degree

Structural Engineering

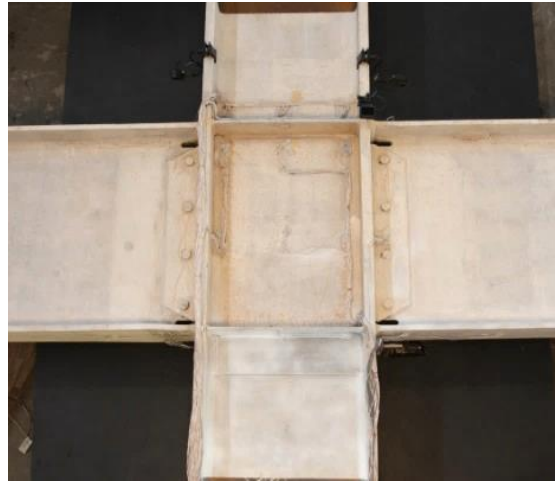
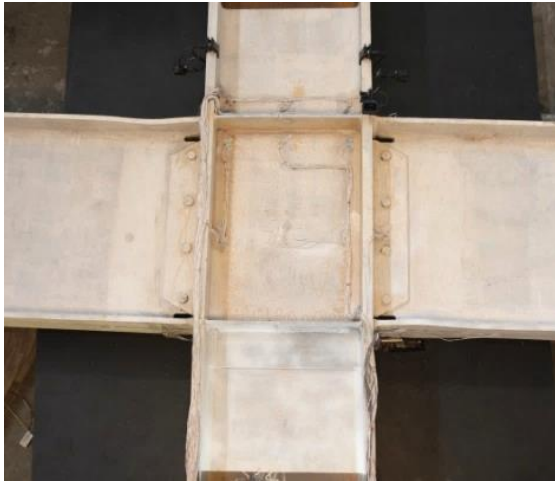
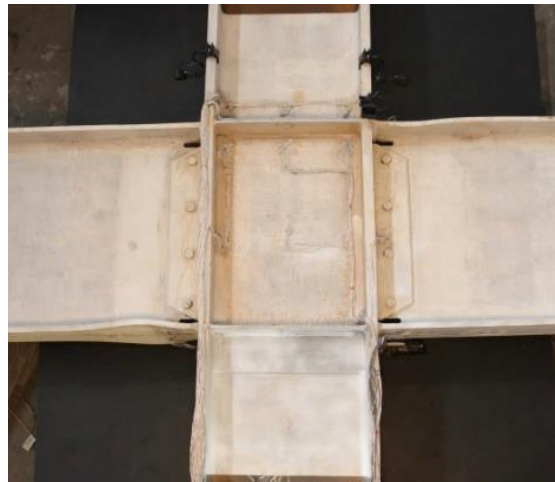
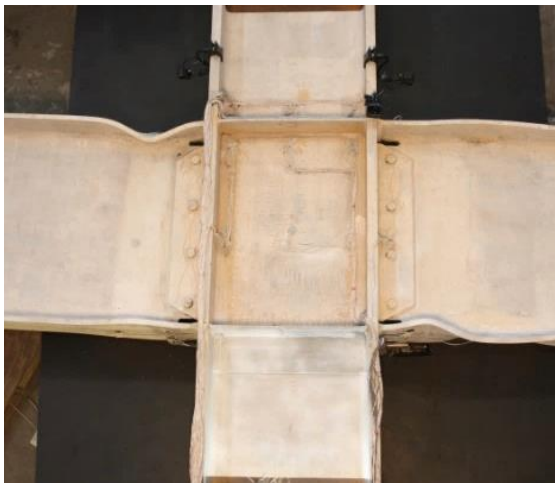
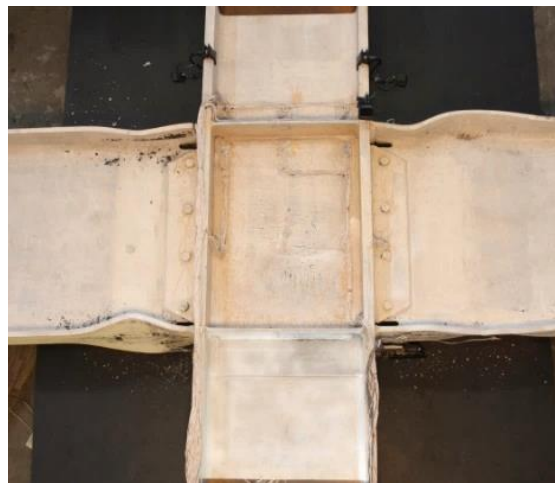
Figure 4.97 Specimen W1: Connection during Testing

- Figure 4.97 shows the connection during testing. The loading protocol was applied symmetrically such that a clockwise rotation is a positive excursion on the east beam and a negative excursion on the west beam. The response is described such that a positive excursion refers to a clockwise rotation of the joint. The specimen met the AISC acceptance criteria by completing one complete cycle at 0.04 rad drift while the flexural strength at either column face did not degrade below 80% of the beam nominal flexural strength. Beam flange and web local buckling initiated at 0.03 rad drift and progressed throughout testing.
- Figure 4.98 and Figure 4.99 show the progressive beam yielding during testing. Yielding starts adjacent to the column flange and propagates outward, concentrating down the center of the beam.

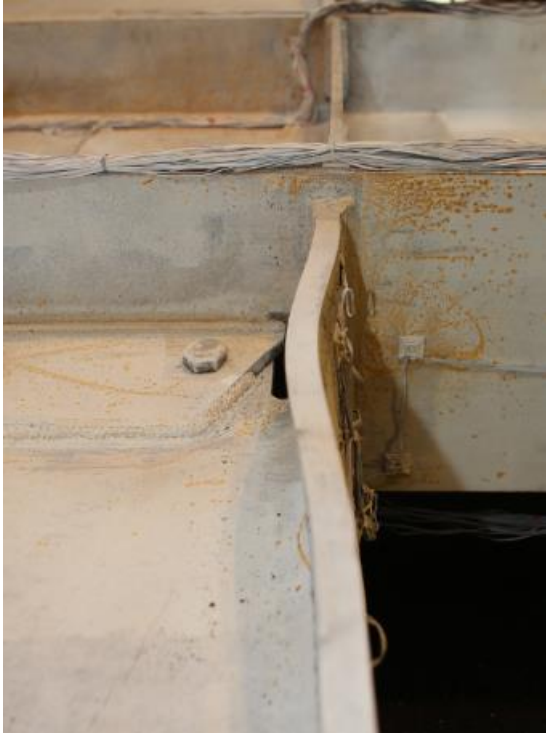
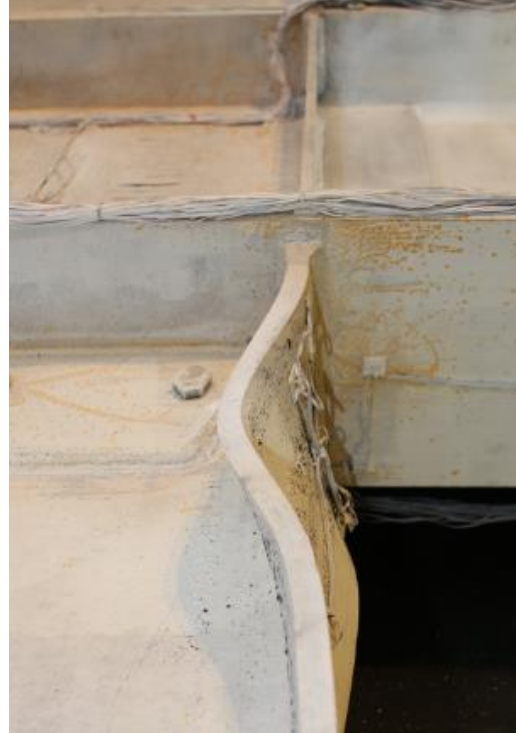
Figure 4.100 Specimen W1: East Beam Bottom Flange Local Buckling

- Figure 4.100 shows the progression of flange local buckling that developed in the east beam bottom flange. The local buckling develops in a opposite sense between the east and west beams depending on which flange of the beam was in compression.

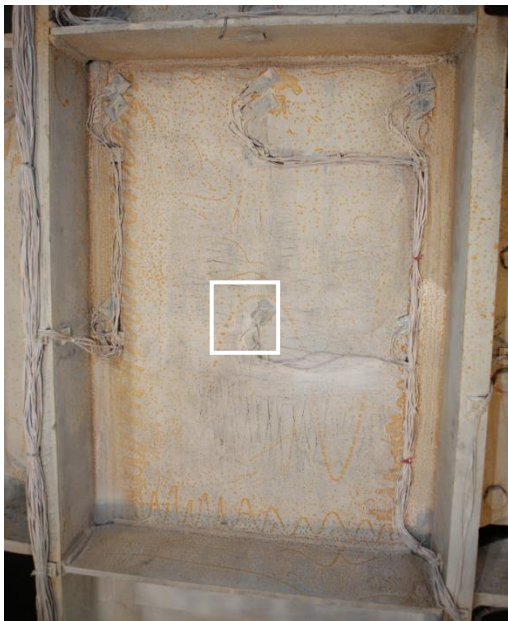
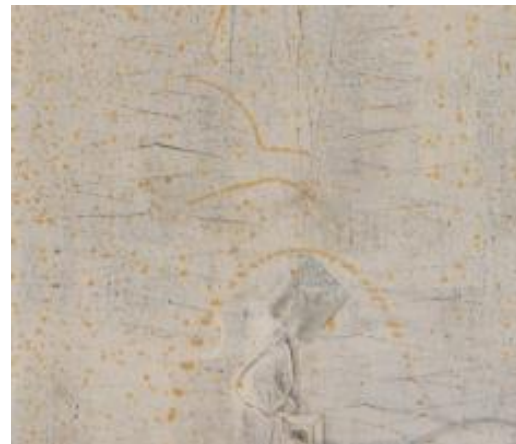
Figure 4.101 Specimen W1: Panel Zone Yielding at +0.03 rad (2nd Cycle)

- Figure 4.101 shows yielding in the panel zone observed at a at 0.03 rad drift. The yielding did not progress significantly further by the end of testing.

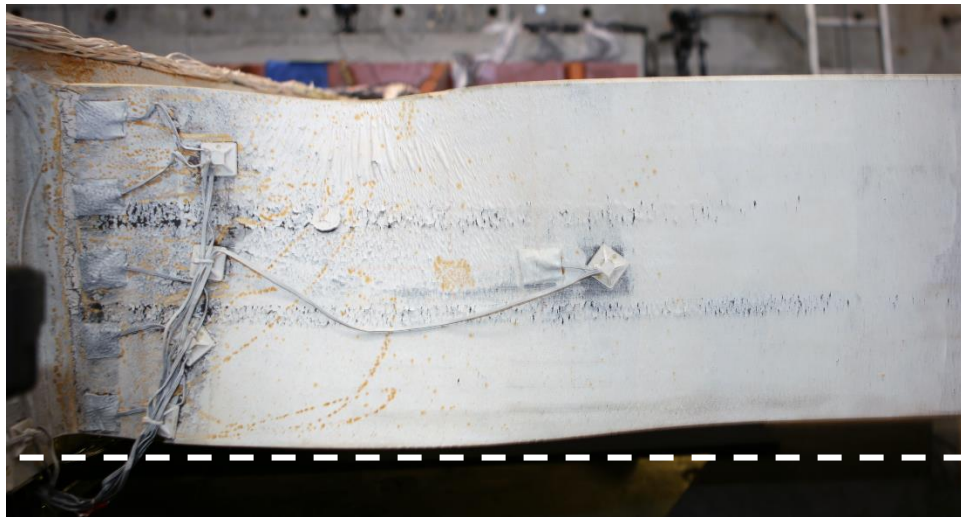
Figure 4.102 Specimen W1: Lateral-Torsional Buckling

- Figure 4.102 shows the minor lateral-torsional buckling that developed in beam top flanges during the 0.04 rad drift cycles. The buckling was mirrored between positive and negative joint rotations, reflecting when the top flange experienced compression.

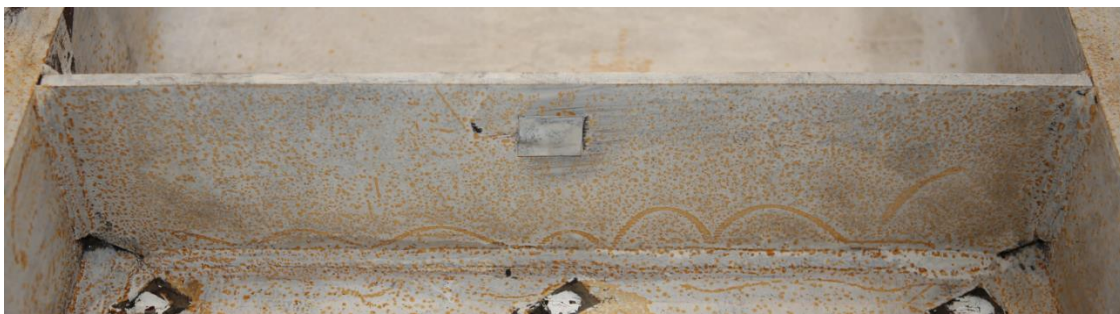
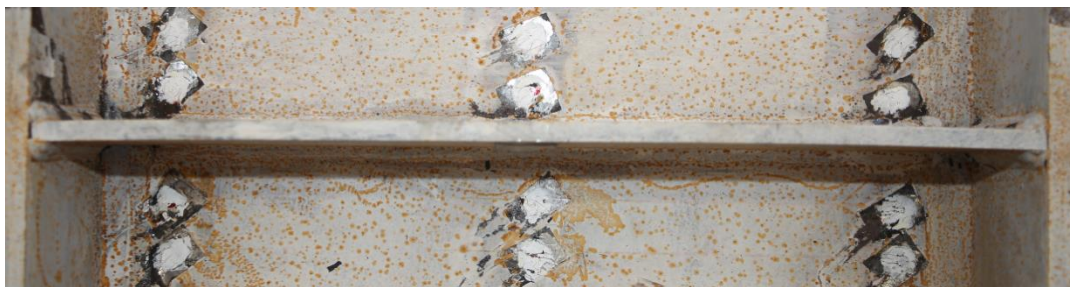
Figure 4.107 Specimen W1: Top Flange Continuity Plate (End of Test)

- Continuity plates did not demonstrate yielding nor damage to any of the fillet welds during testing (see Figure 4.107 to Figure 4.109). A slight bow present in the continuity plates occurred before testing of the specimen and was not due to local buckling of the plate.

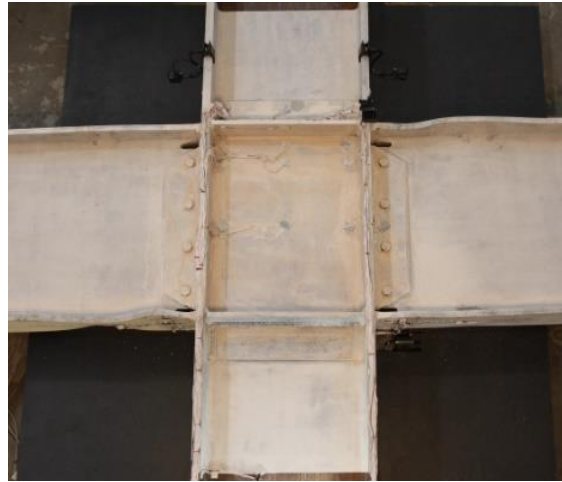
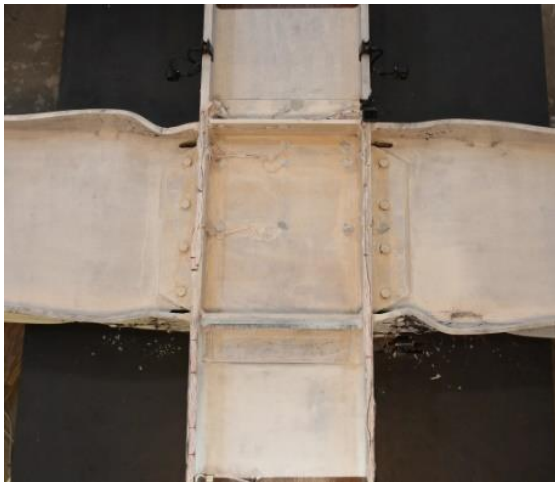
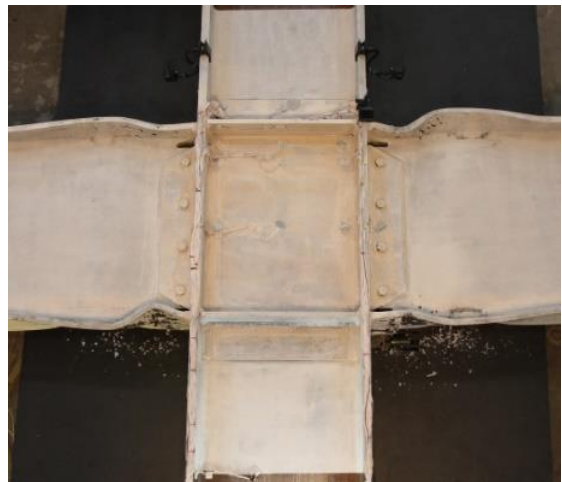
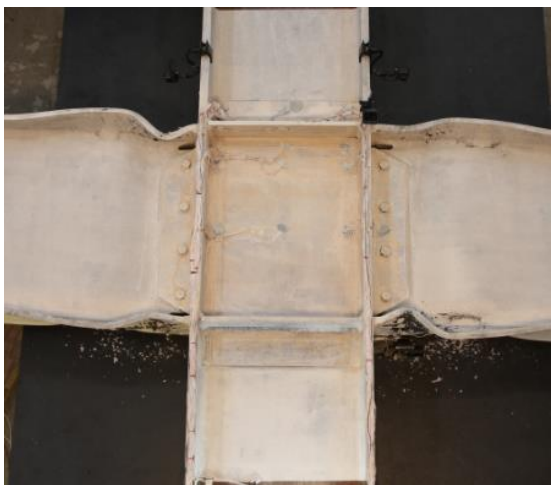
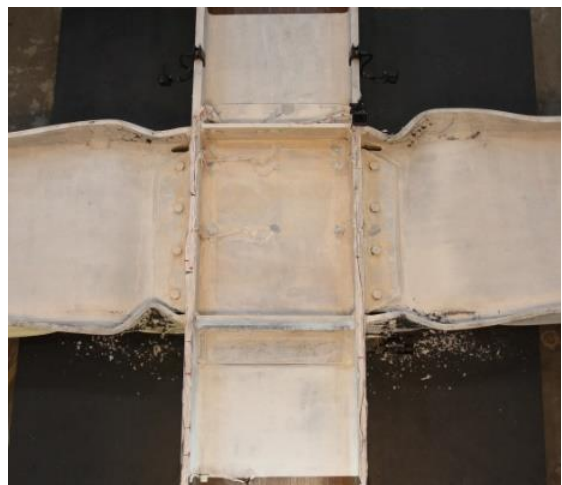
Figure 4.118 Specimen W2: Connection during Testing

- Figure 4.118 shows the connection during testing. The specimen met the AISC acceptance criteria by completing one complete cycle at 0.04 rad drift while the flexural strength at either column face did not degrade below 80% of the beam nominal flexural strength. Beam flange and web local buckling initiated at 0.03 rad drift and progressed throughout testing.
- Figure 4.119 and Figure 4.120 shows the bottom flange yielding and buckling of the east and west beams. The yielding of the flanges initiated during the 0.0075 rad drift cycles. It was observed that significant lateral-torsional buckling initiates at 0.04 rad drift and progresses in the later drift cycles.

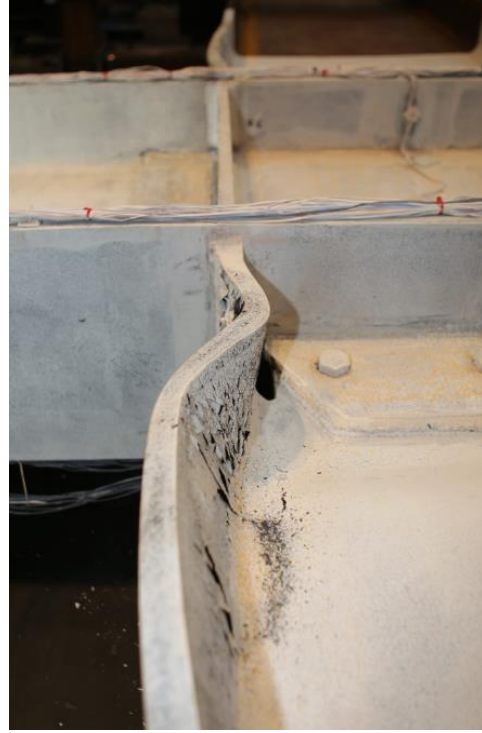
Figure 4.121 Specimen W2: East Beam Top Flange Local Buckling

- Figure 4.121 shows the progression of flange local buckling that developed in the east beam top flange. The local buckling develops in the flange of the beam in compression during that excursion and then is pulled relatively straight during the tension excursions.

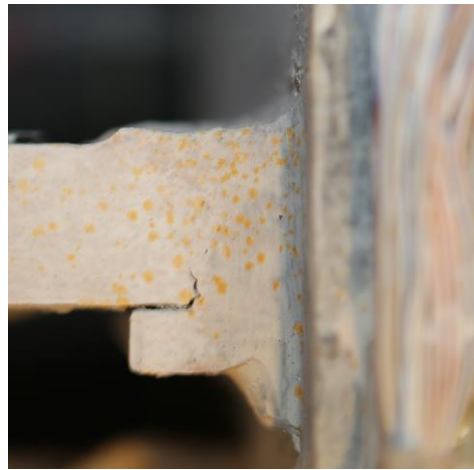
Figure 4.122 Specimen W2: East Beam Top Flange CJP Weld Tear at -0.03 rad (2nd Cycle)

- Figure 4.122 shows the initiation of a weld fracture during the second cycle of 0.03 rad drift. The fracture originates at the fusion face of the CJP weld and backing bar on the flange bevel side. Figure 4.123 shows the progression of this tear during the 0.04 rad and 0.05 rad drift cycles. At 0.05 rad drift cycles a weld tear on the top side of the west beam bottom flange CJP weld was observed (see Figure 4.124). A similar fracture was observed in the east beam bottom flange CJP weld at 0.06 rad drift (see Figure 4.125).

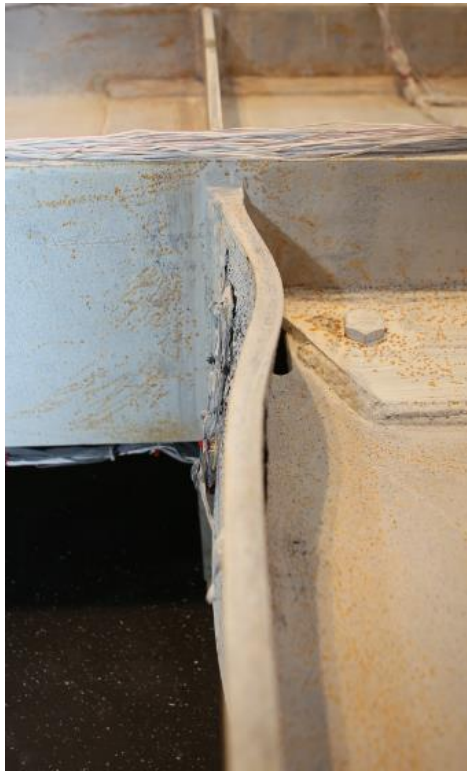
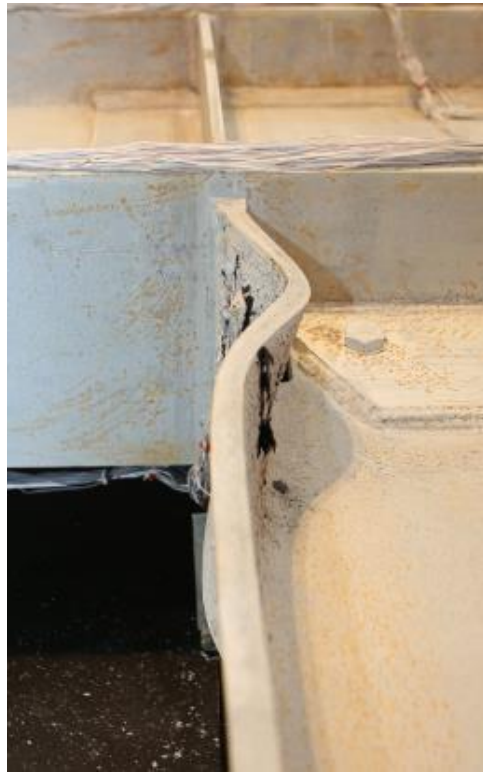
Figure 4.144 Specimen W3: East Beam Top Flange Local Buckling

- Figure 4.141 shows the connection during testing. The specimen met the AISC acceptance criteria by completing one complete cycle at 0.04 rad drift while the flexural strength at either column face did not degrade below 80% of the beam nominal flexural strength. Beam flange and web local buckling initiated at 0.03 rad drift and progressed throughout testing.
- Figure 4.142 and Figure 4.143 show the east beam bottom flange and west beam bottom flange during testing. The gradual progression of yielding, flange local buckling, and lateral-torsional buckling is observed. The progression of flange local buckling between the second cycle of 0.03 rad and the first cycle of 0.04 rad is shown in Figure 4.144.

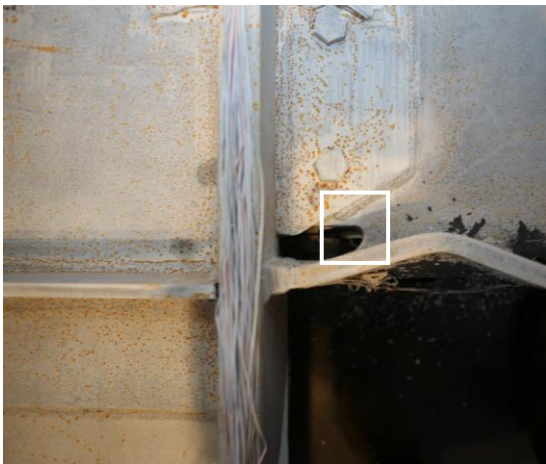
Figure 4.145 Specimen W3: East Beam Top Flange Weld Access Hole Tearing at -0.05 rad (1st Cycle)

- Figure 4.145 shows the initiation of tearing in the weld access holes. All four weld access holes show a similar behavior.
- Severe web buckling develops in both beams during the 0.05 rad drift cycles (see Figure 4.146). Figure 4.147 shows a similar severity of flange local buckling during the 0.05 rad drift cycles.

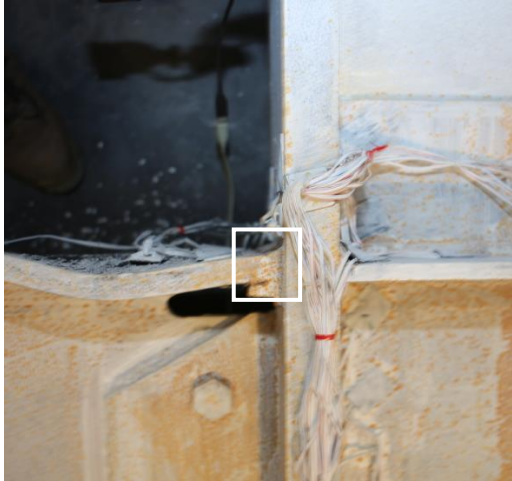
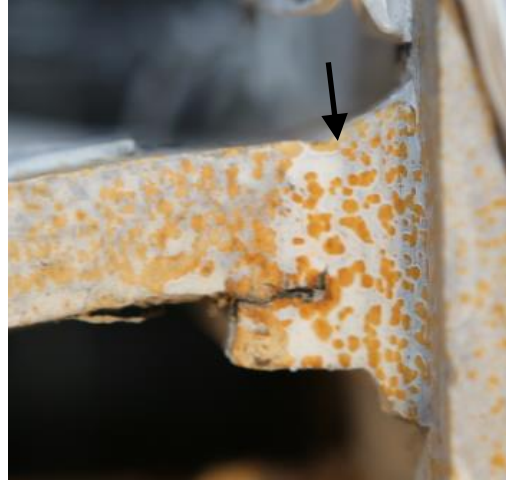
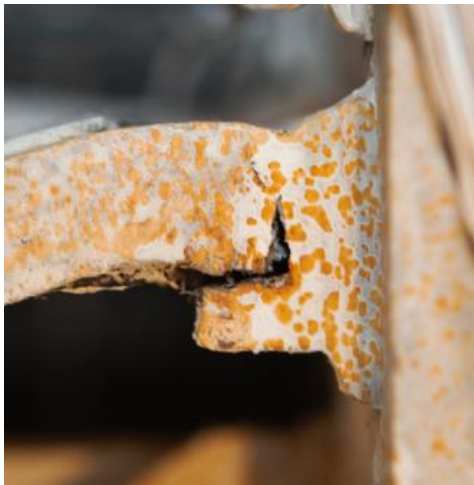
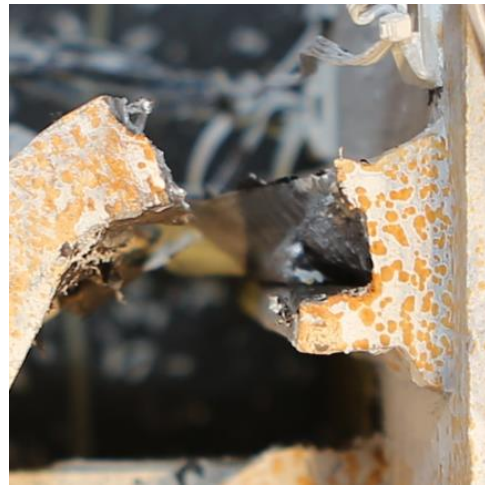
Figure 4.148 Specimen W3: East Beam Top Flange CJP Weld Tear Progression

- Figure 4.148 shows the gradual progression of tearing in the east beam top flange CJP weld. The tear initiated at the CJP weld root during the second cycle of 0.04 rad drift. A similar tear was observed in the west beam top flange CJP weld (not pictured). During the first negative excursion to 0.06 rad drift the east beam top flange fractured through 60% of the width of the flange. The tear of the top flange was accompanied with a 5-in. tear of the beam web extending outward from the radius of the weld access hole (see Figure 4.149).

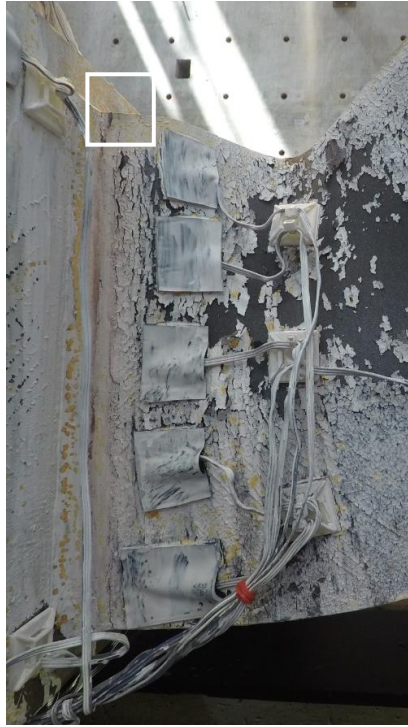
Figure 4.150 Specimen W3: East Beam Top Flange Fracture at +0.06 rad (1st Cycle)

- Although the root of the CJP weld started to tear during earlier cycles the propagation of the tear to the top surface of the CJP weld occurred when the beam was under global compression during the first positive excursion of 0.06 rad drift (see Figure 4.150). This occurs due to the high local curvature of the flange local buckling. During the first negative excursion of 0.06 rad drift the fracture propagates to 60% of the beam flange width (see Figure 4.151). During the second negative excursion of 0.06 rad drift the east beam top flange fractures completely.

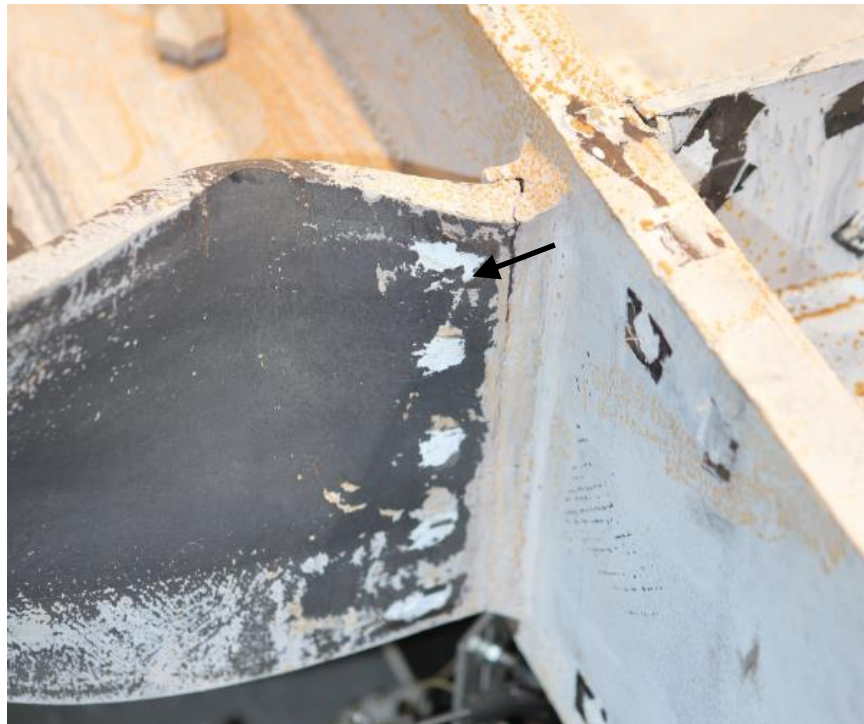
Figure 4.153 Specimen W3: West Beam Top Flange (End of Test)

- Figure 4.152 shows the connection at the end of testing.
- Figure 4.153 shows a partial fracture of the west beam top flange at the end of testing. Also observed in this photo is minor column yielding above the beam flange.

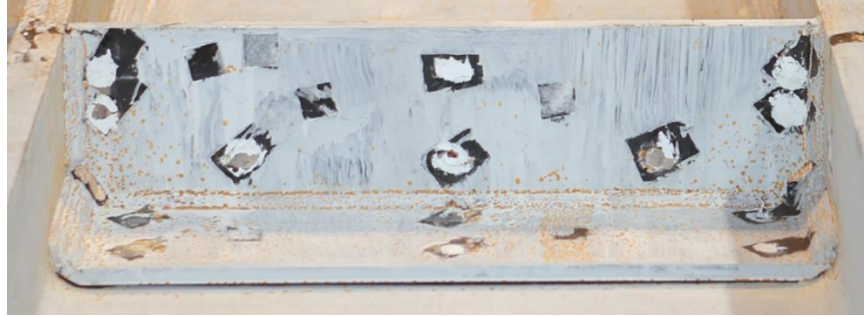
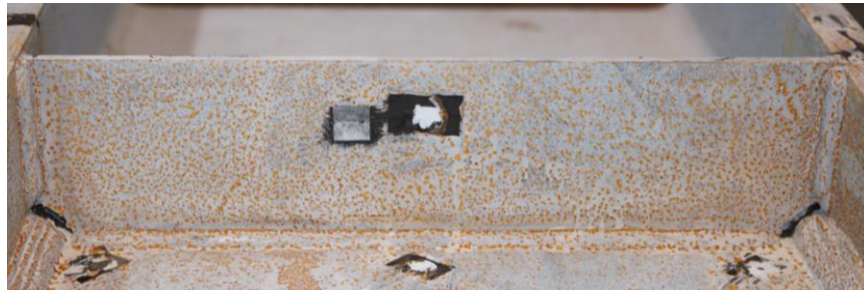
Figure 4.154 Specimen W3: Top Flange Continuity Plate (End of Test)

- No yielding or damage to the continuity plate fillet welds was observed during testing (see Figure 4.154 and Figure 4.155). A detailed view of four of the continuity plate fillet welds

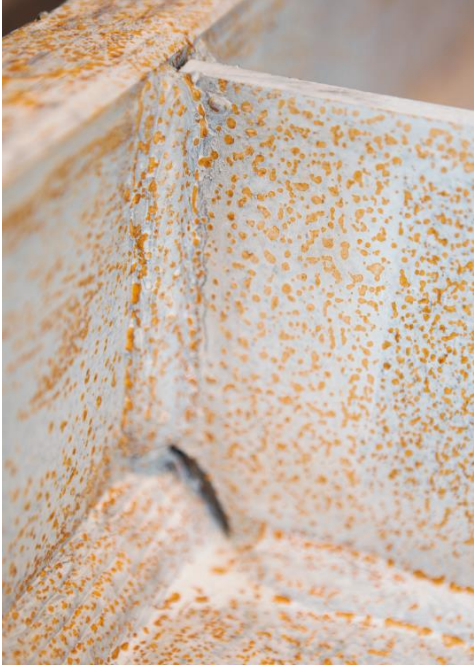
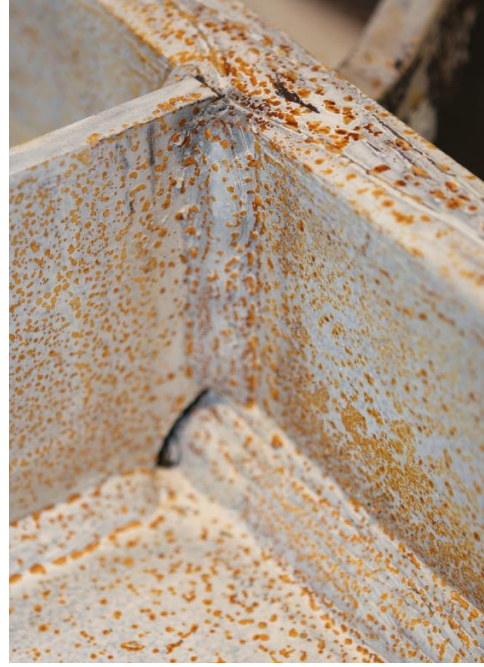
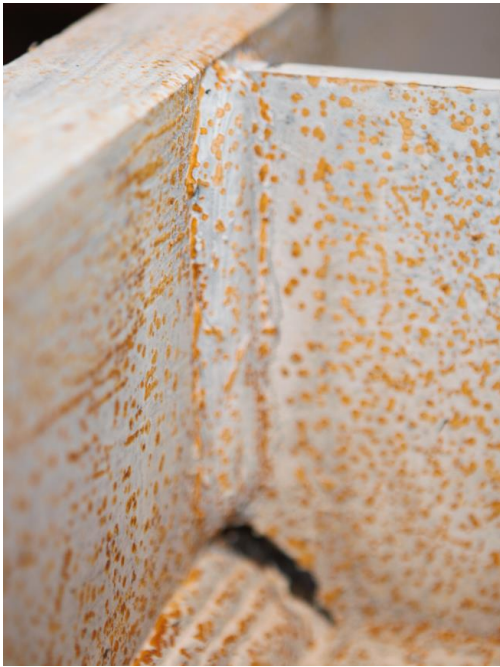
is shown in Figure 4.156. Similarly, no damage was observed to the doubler plate fillet weld.

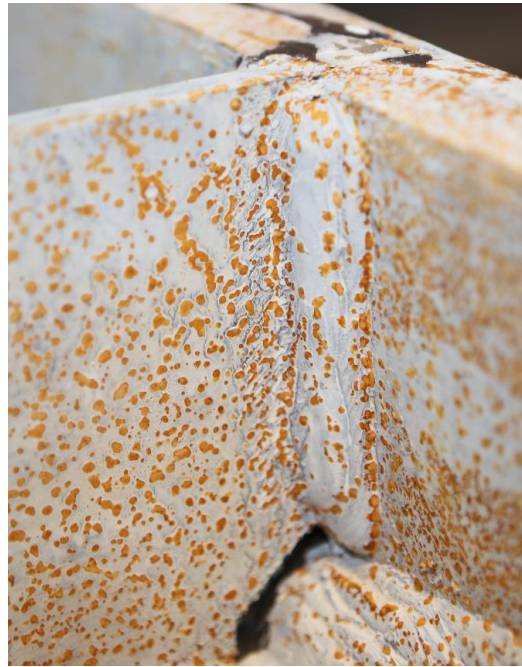
Figure 4.156 Specimen W3: Continuity Plate Fillet Welds (End of Test)

(d) East Bottom Flange

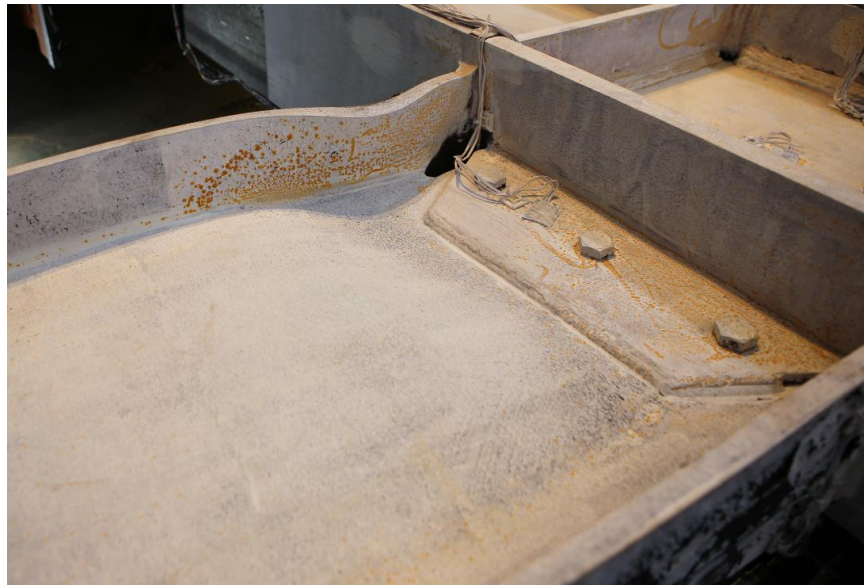
Figure 4.169 Specimen W4: West Beam Web Buckling at +0.04 rad (1st Cycle)

- Figure 4.165 shows the connection during testing. The specimen met the AISC acceptance criteria by completing one complete cycle at 0.04 rad drift while the flexural strength at either column face did not degrade below 80% of the beam nominal flexural strength.
- Figure 4.166 and Figure 4.167 show the east beam bottom flange and west beam bottom flange during testing. The progression of flange local buckling between the second cycle of 0.04 rad and the first cycle of 0.05 rad is shown in Figure 4.168.
- Figure 4.169 shows the initiation of web buckling during the first negative excursion of 0.04 rad drift.

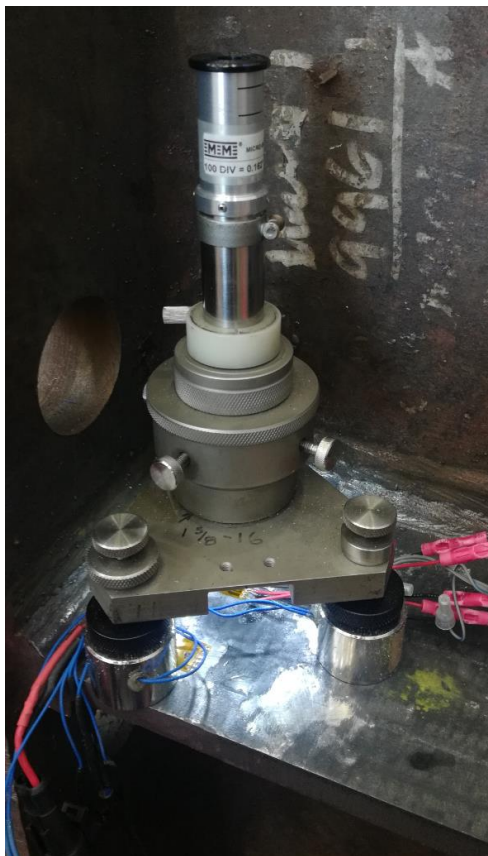
Figure 6.4 Hole-Drilling Method: Drill Positioning

D , of 0.202 in. is used. A drill holder is centered above the strain gauge using a microscope with the same bore diameter as the drill and securely held in place using three electromagnets (see Figure 6.4). The microscope is replaced with the pneumatic drill which was preconfigured to orbit the cutter to produce a hole diameter of $0.5D_0$ —the maximum permitted hole diameter. This diameter was chosen to maximize the strain response of the strain gauge rosette. The cutter is lowered into contact with the strain gauge surface [see Figure 6.5(a)]. The cutter is then advanced until the bare metal is exposed under the gauge [see Figure 6.5(b)]. The drill is then advanced slowly and paused every 100 microns before recording the strains from all three strain gauges. Once the target depth is achieved of $0.4D$ (2.05 mm), the drill is removed from the holder [see Figure 6.6(a)]. Graduations on the microscope verify the diameter of the hole [see Figure 6.6(b)].

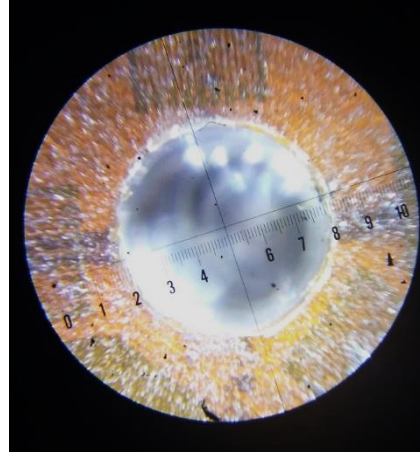
Figure 6.6 Hole-Drilling Method: Completed Drilling

(b) Diameter Verification

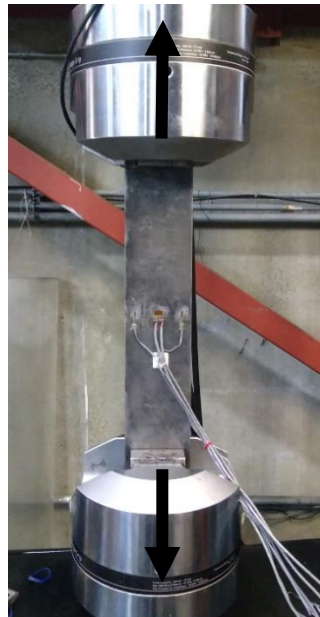
Figure 6.7 Hole-Drilling Method: Verification Setup

(b) Experimental Setup

A verification of the hole-drilling method was performed by elastically loading a plate cut from the web of an W30×116 beam of A992 steel. A 36-in. long plate was used to mitigate boundary condition effects from the uniaxial load frame. Two uniaxial strain gauges and a strain gauge rosette was installed on each side of the plate at the mid length [see Figure 6.7(a)]. Uniaxial strain gauges placed on each quadrant of the plate allows correction of unintentional bending stresses in the plate. The plate was loaded uniaxially before (Case A) and after drilling a hole through one of the rosette gauges (Case B). To simplify the verification process, the final hole depth of $0.4D$ was drilled in a single session. Figure 6.8 shows the recorded strains before and after drilling the hole in the longitudinal and transverse directions.

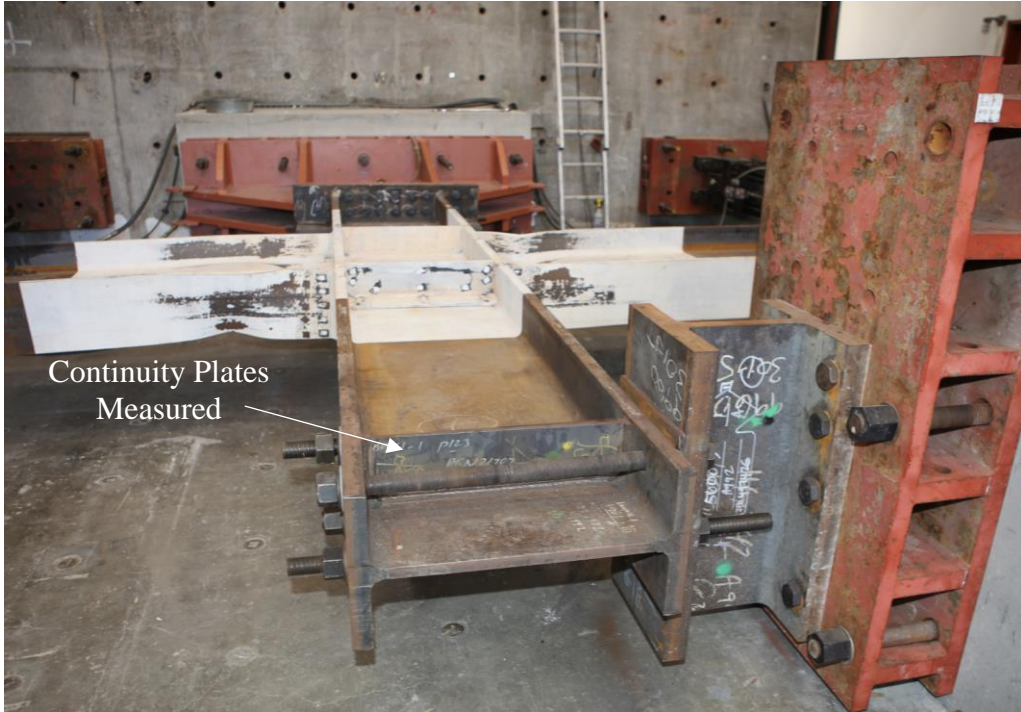
Figure 6.10 Specimen W1: Column Top-End Continuity Plates

In order to evaluate the residual stresses in a continuity plate, the column top end of Specimen W1 was detailed such that one web side of the column's continuity plate conformed to the requirements of AISC 341 (2016b) with CJP groove welds to fasten the continuity plate to the column flange. The other web side of the column used fillet welds complying with the proposed fillet weld size of $(3/4)t$. Figure 6.10 shows the top end of the column of Specimen W1 after testing. It is anticipated that the top end of the column remained elastic during testing. Figure 6.11 shows the detailing used for the continuity plates at the top end of Specimen W1. Each continuity plate was sampled with 12 strain gauge rosettes placed within one-half of the continuity plate for residual stress measurements (see Figure 6.12).
