Segmentation of X-ray CT and Ultrasonic Scans of Impacted Composite Structures
for Damage State Interpretation and Model Generation

A dissertation submitted in partial satisfaction of the

Structural Engineering

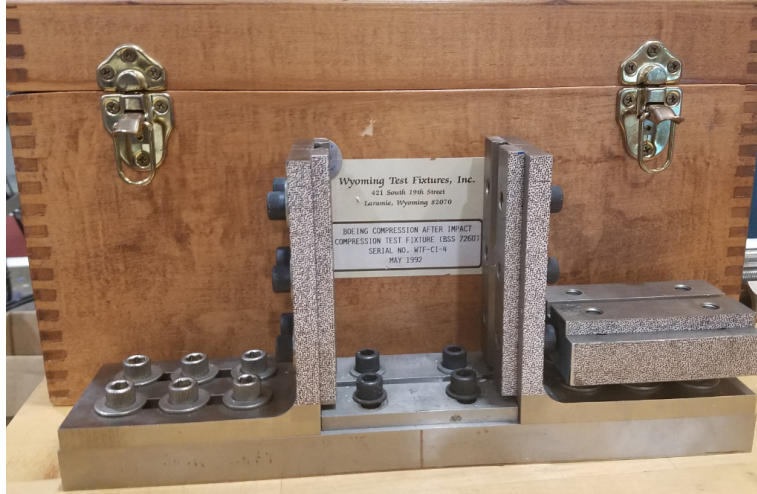
Figure 2.6. Flat panel compression after impact test fixture.

Specimens were compression after impact (CAI) tested according to ASTM D7137 [13] using a Boeing/Wyoming CAI fixture as shown in Figure 2.5. This fixture features out-of plane constrained boundary conditions on all four sides to prevent global buckling and promote compression failure due to impact damage as the failure mechanism. Compression was conducted at an end shortening rate of 0.25 mm per minute. 3D digital image correlation (DIC) images were collected for both sides of the specimen with two camera pairs for the front and back and an additional camera pair to characterize the boundary movement. Additionally four direct current deformation transducers (DCDT) measurements were taken between the loading platens to verify the crosshead displacement. The test configuration is shown in Figure 2.6.

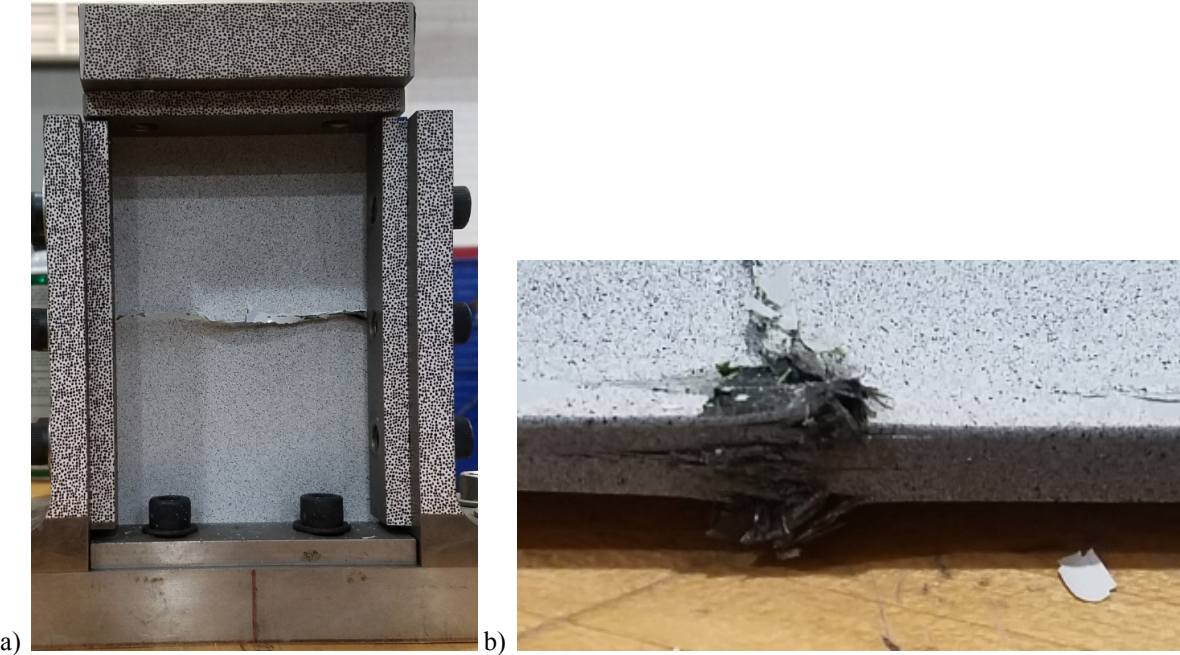
Figure 2.8. a) Specimen TC-24-31-1 in fixture post-failure. b) Image of brooming failure-

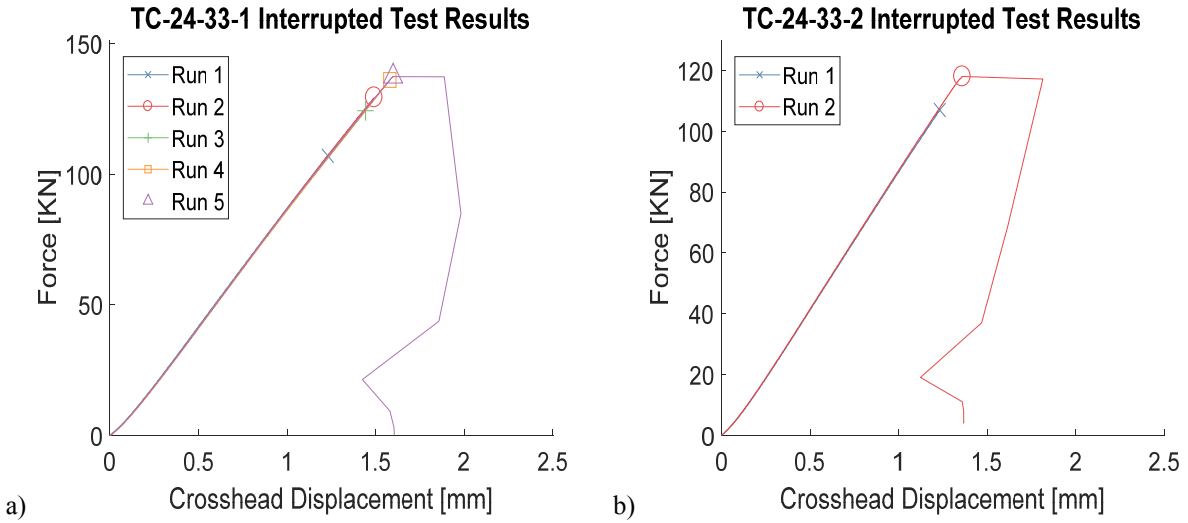
Figure 2.14. Interrupted testing force-history curves for a) specimen TC-24-33-1 and b) specimen TC-24-33-2. Plotting symbols indicate the peak load reached in each test run.

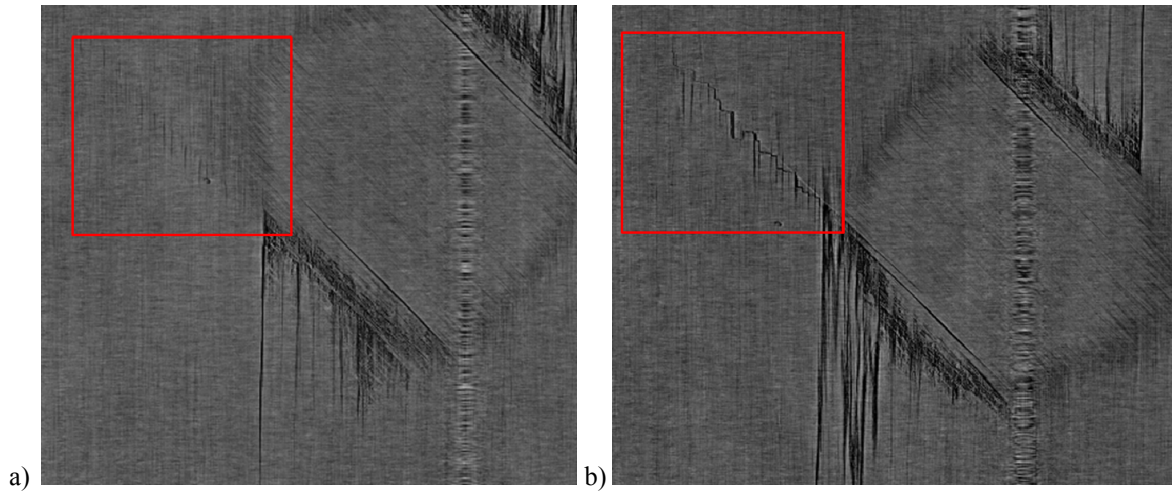
Figure 2.15. CT scan slices for specimen TC-24-33-1 after interrupted test a) run 1 and b) run 4. The major progression of a series matrix cracks into fiber breakage is highlighted.

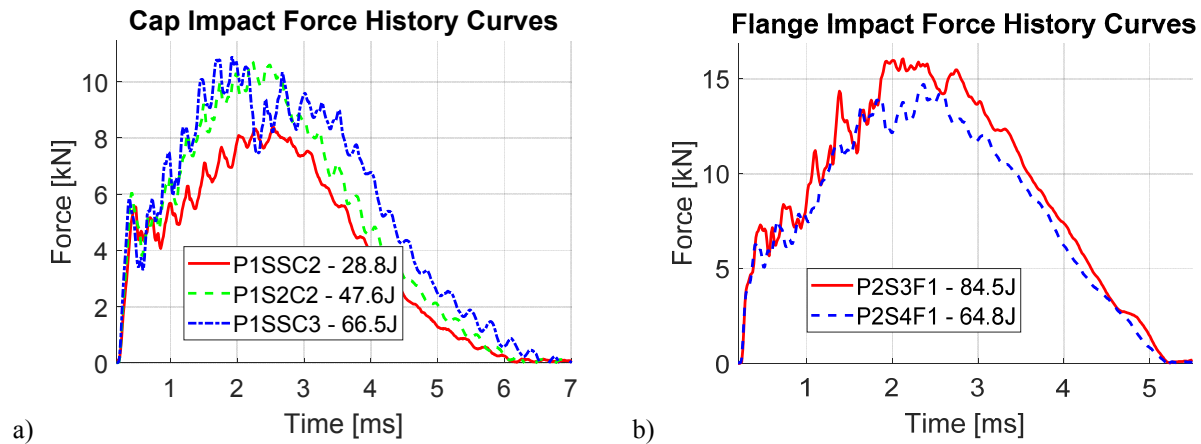
Figure 3.5. a) Example impact force histories for the three cap impact energy levels. b) Example impact force histories for the two flange impact energy levels

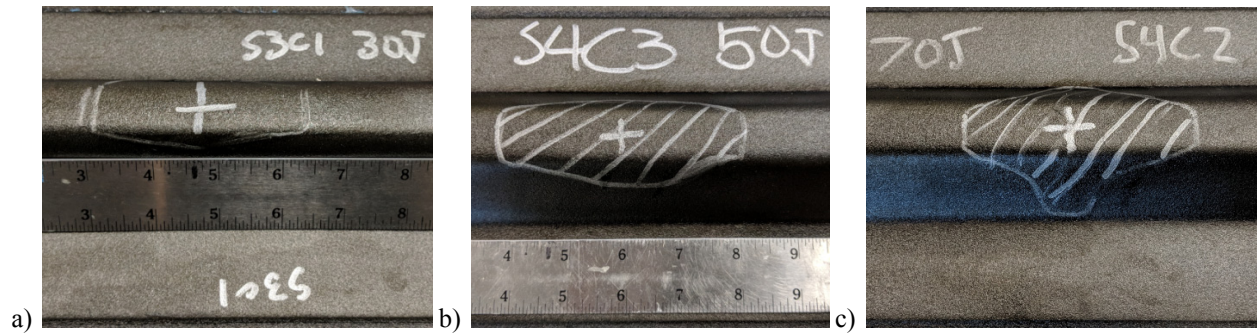
Figure 3.6. Handheld A-scan measurement of impact damage extent for cap impact case. a) Specimen S3C1, 28.5 J impact case. b) Specimen S4C3, 47.1 J impact case. c) Specimen S4C2, 66.7 J impact case.

After impact, handheld A-scan mapping was performed to capture the approximate damage area such as shown for cap type impacts in Figure 3.6 and Figure 3.7 and flange type impacts in Figure 3.8. Damage length as approximated from these A-scans is given in Table 3.1. Figure 3.8 shows the impact damage for the three cap impact energy levels (~28, 47, 66 J). Impact damage for the 28 J case (Figure 3.6a) is contained within the stringer crown region, with a small amount of damage in the radius region. Impact damage for the 47 J case (Figure 3.6b) shows a similar shape for this specimen (S4C3) with damage in the crown and radius, and with somewhat more significant radius damage. However, for the 47 J case, some asymmetry of the damage state has been observed in other specimens (S2C2 and S3C2) as shown in Figure 3.7 for specimen S2C2. Figure 3.7a shows the side of the cap with damage traveling into the web and Figure 3.7b shows the side of the cap with damage contained by the radius. This asymmetry may have been caused by slight misalignment of the impact location, skewed towards one web. Impact damage for the 66 J case (Figure 3.8c) shows damage traveling down the web on both sides of the stringer cap. This damage in the stringer web has been observed as a band of fiber breakage in most plies and some delamination, and this damage is likely associated with the second load drop event observed in the 66 J impact force-histories. Flange damage for both energy levels (Figure 3.8) show a roughly trapezoidal shape where the wider base of the trapezoid is at the end of the stringer flange and the thinner base is near the inside of the stringer.

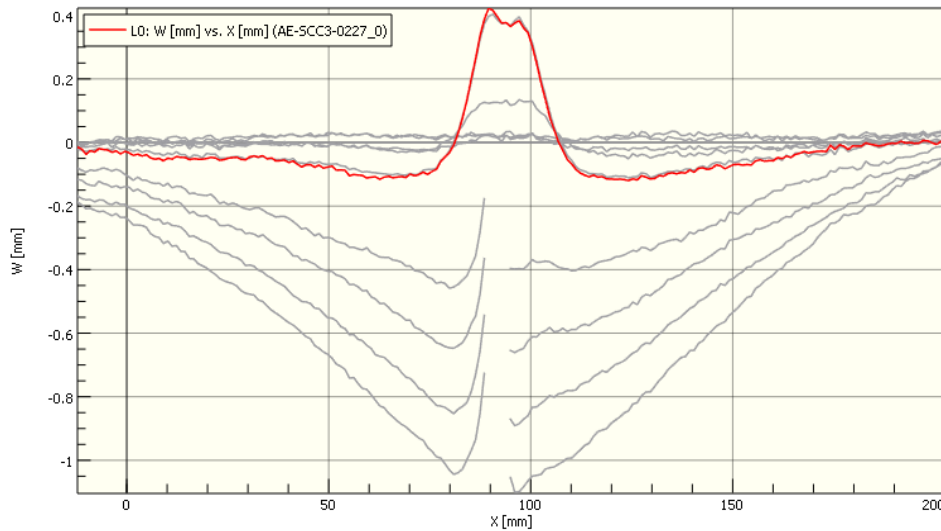
Figure 3.19. Line plot showing progression of the out-of-plane displacement shape throughout testing of specimen SSC3, Red highlights the displacement shape before failure and negative lines represent the shape after cap crippling.

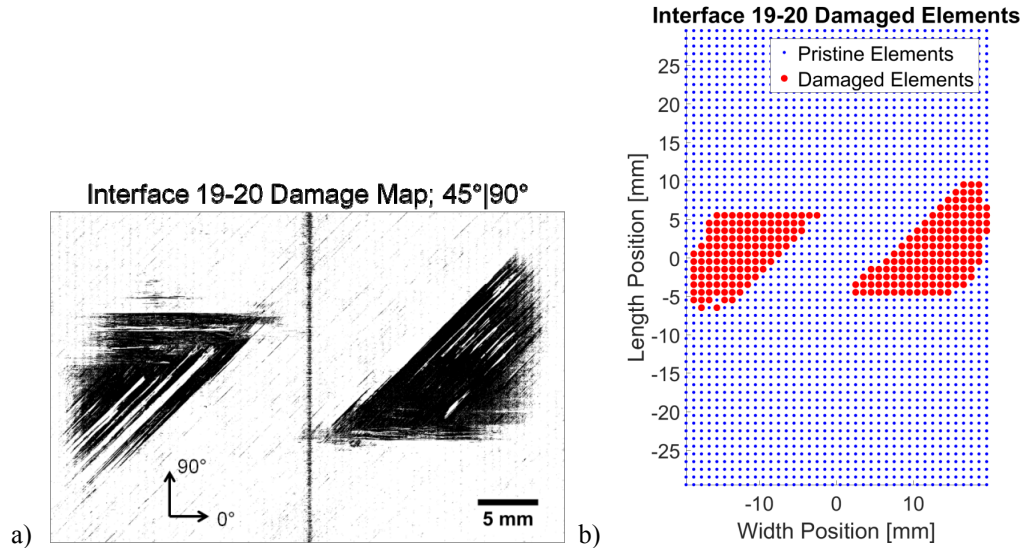
Figure 5.5. a) Delamination at an example interface from the TC-24-32-1 specimen scan, b) delamination mapping to a set of damaged elements shown as larger red markers for a representative mesh of cohesive elements.

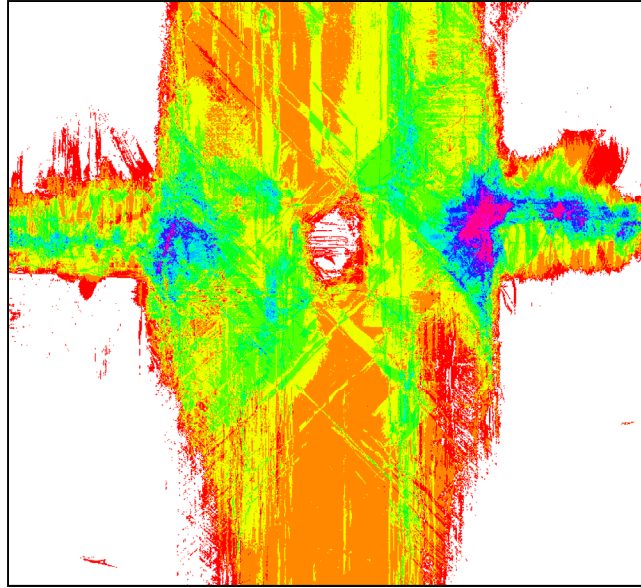
Figure 5.24. Map of delaminations and ply damage for specimen S4C2 color coded by the number of damage features in that region. The horizontal band of damage observed here is strongly associated with fiber damage and delamination traveling down the web.

Ply damage such as fiber breakage and matrix cracking was also simplified based on the impact case modeled. For the high energy impacted specimens where damage traveled into the web on both sides of the cap, this damage feature was taken to be the most critical to model. A color coded map of the 2D projected delaminations can be seen in Figure 5.24 showing a horizontal band of damage near the impact center. Additionally, an example of this damage feature broken down by ply and interface can be seen in Chapter 4. To simplify this feature, fiber damage was applied to the entire laminate in a 5 mm wide strip to both the radius and web near the impact center, except in 90° plies where the direction of this feature corresponds with matrix damage instead of fiber breakage.

In order to streamline model development, a general script to generate models with varying levels of damage and delamination was created in Python for use with Abaqus. To prevent the computational costs associated with full ply-by-ply modeling, the script was designed to utilize user selected ply grouping to model delamination at a reduced number of interfaces. Ply groups were chosen based on modeling the most critical delaminations. Additionally, to model initial fiber damage and delamination, elements were assigned damaged material properties based on the reference sections shown in Figure 5.25. In the case of long delaminations in the crown, cohesive elements in regions 4, 5, and 6 were marked as initially damaged, and in the case of fiber damage travelling into the stringer web sections 3, 4, 6, and 7 were marked with reduced fiber compression strength properties.

To model the asymmetric web damage observed in specimen S2C2, the fiber damage model was adapted to a one sided initial damage zone of sections 6 and 7 as indicated in Figure 5.24 as shown in the highlighted region in Figure 5.32. Similarly to the experiment, this model had an initial failure mode where only the side of the cap with web fiber damage failed following the first damage event. The displacement field in the model post-initial failure is shown in Figure 5.33a. This displacement field is similar to the displacement field observed in the DIC results for S2C2 after the first load drop as seen in Figure 5.33b-c. The initial progression of the damage into the crown region seems well captured by the modeling approach of initial fiber damage in one side of the stringer web. Model force-displacement is compared with experimental results in Figure 5.34. Unlike specimen S2C2, only one major load drop was observed in the model, but
