*An Assessment of Stream Flow and Habitat Quality
for Steelhead Trout in San Pablo Creek, Contra Costa County*

Shannah Anderson and Lorraine Maldague
Department of Landscape Architecture and Environmental Planning
University of California at Berkeley
May, 2004

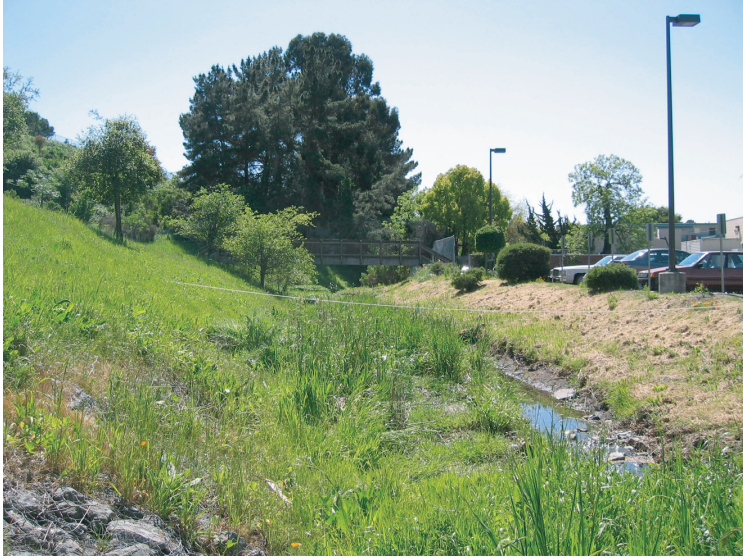
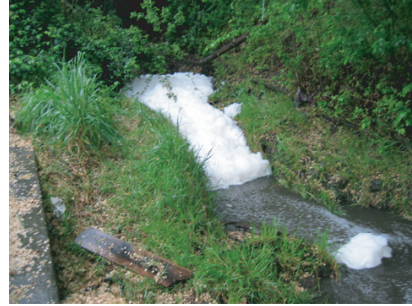
Cross-section survey site

Site area during rainfall

Cross-section field sketch

We surveyed Appian Creek just off of Appian Way in El Sobrante, adjacent to the El Sobrante Boys and Girls Club (Figure 4). Our flow calculations for this site involved the estimation of the Manning coefficient ('n') using Chow's *Open Channel Hydraulics*' table and our field observations (Table 1) (Chow, 1959). We based the calculation of the Manning coefficient on observations of silt and earthen dirt bed, minor, irregular channel form, gradual channel variations, negligible-minor obstructions, little vegetation, and a minor level of meandering. We determined the HWM as a visible trash line, which was consistent over two hundred feet.

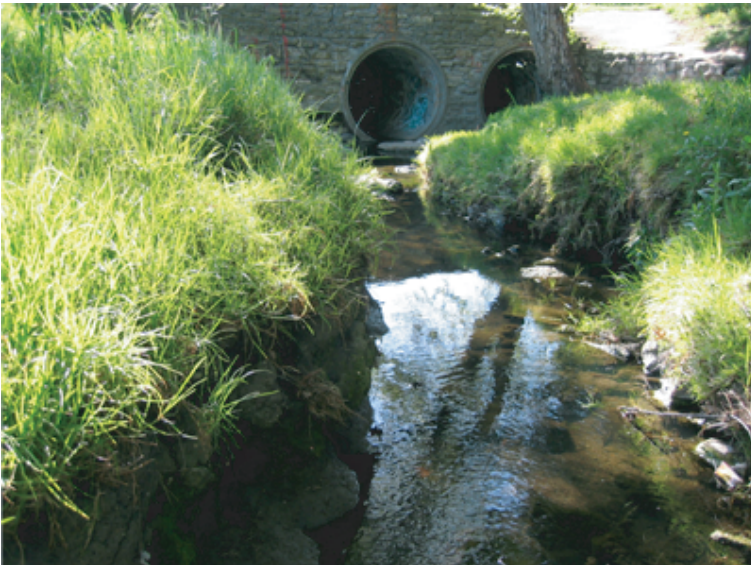
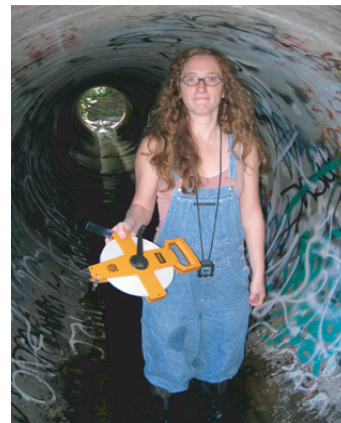
Cross-section survey site

Left-bank culvert

Cross-section field sketch

Our field survey for Wilkie Creek took place near the intersection of Santa Rita Road and May Road, near DeAnza High School in Richmond, California (Figure 4). We based the calculation of the Manning coefficient on a silt dirt bed, slightly irregular channel form, gradual channel variations, minor obstructions, limited encroaching vegetation, and a minor level of meandering. For the HWM, we sighted flattened, dead grasses and woody debris. We also received additional information from a neighbor with property adjacent to the creek, who informed us that the water level reached the level of a footpath during the February 25th storm.

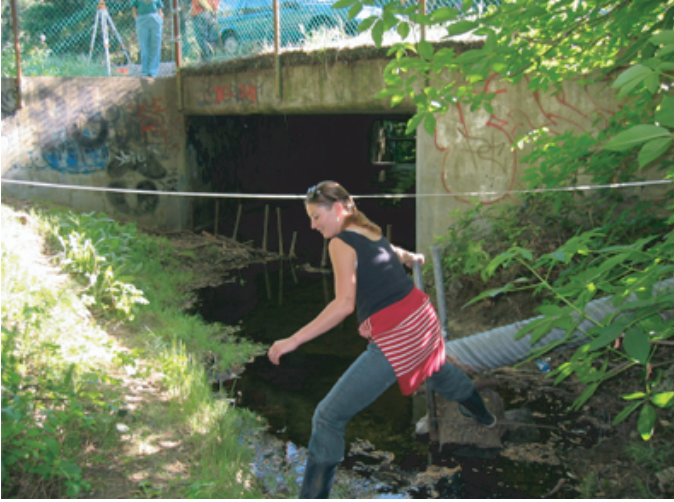
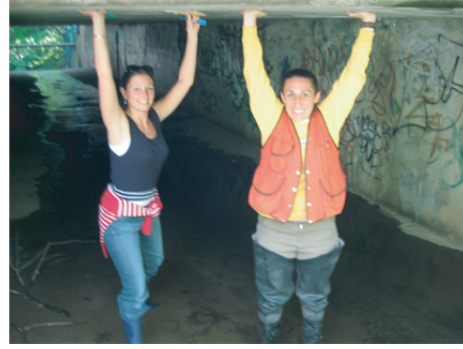
Cross-section Survey Site

Lorraine and Sarah hold up the culvert leading to 8-ft cement steps

Cross-section field sketch

We surveyed Castro Creek at the intersection of Hillside Drive and Castro Ranch Road in El Sobrante, California (Figure 5). We calculated the Manning's n based on a silt bed, irregular channel form and variations, large amount of obstructions, encroaching vegetation, and a medium level of meandering. The only visible piece of trash that we could find at Castro Creek was a white cloth at an outfall, which we used as the HWM.

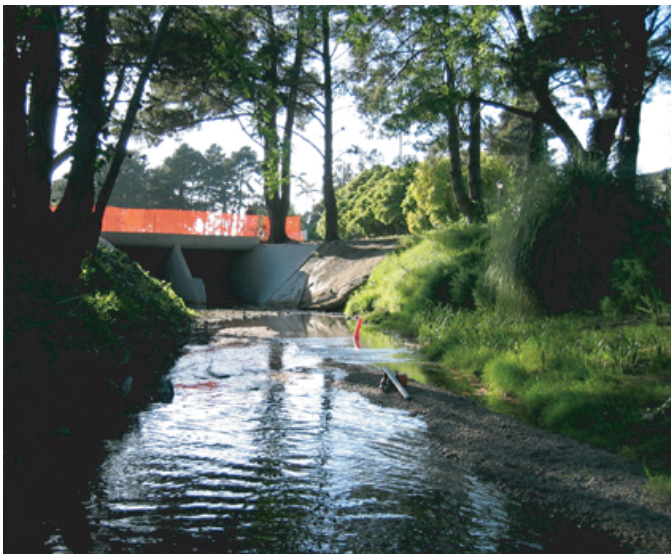
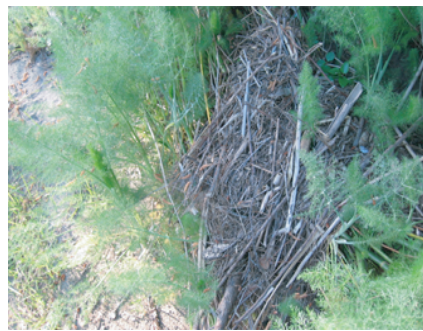
Cross-section Survey Site

High Water Mark

Cross-section field sketch

To set a reference and baseline for peak flow and unit runoff of the tributaries, we referred to the nearest stream with United States Geological Survey (USGS) surface water data – Wildcat Creek. We surveyed a cross section at Wildcat Creek in Davis Park to derive the flow for the peak storm flow of 2004 (Figure 5). Our observed HWM consisted of debris with piled sticks 6 feet above the creek bed on the left and right banks.

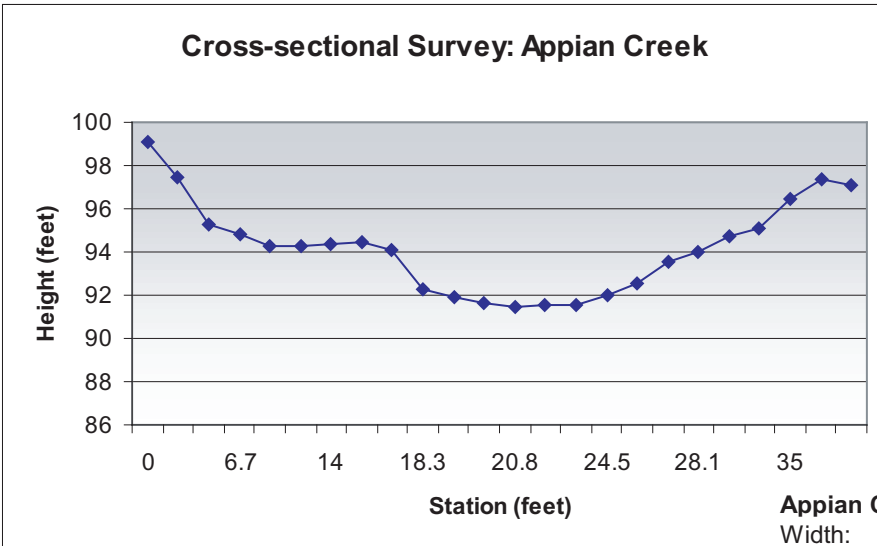
Appian Calculation for 2004 HWM based on cross-sectional data

Width: 25.7-18 7.7 (off grid from cross-section)
 Depth: 94.75-91.51 3.25 feet
 Area: 1.5*6 (for left 34.025 S=0.003

Wetted Perimeter: 28.5
 R: 1.19 n: 0.04888
 n0: 0.02
 V: 1.49*1.12*.054/0.048 n1: 0.005
 V: 1.88f/s n2: 0.004
For Last Probable storm event: n3: 0.008
Q: 63.87cfs n4: 0.01
 m5: 1.04

Our corresponding roughness coefficient using the Manning Equation and Chow's Table was 0.049 (Figure 7). Using the cross-sectional measurements from the HWMs, we found an area of 34.03sq ft and a

velocity of 1.88ft/s. The HWM-based flow calculations using the Manning Equation indicated a flow of 63.87cfs, with a unit runoff of 80.85 cfs/sq mi. This ratio gives a flow of about 900 cfs, which corresponds on the Wildcat Creek Flood Frequency Curve as a flood with a 4.6 year return interval (Table 3).

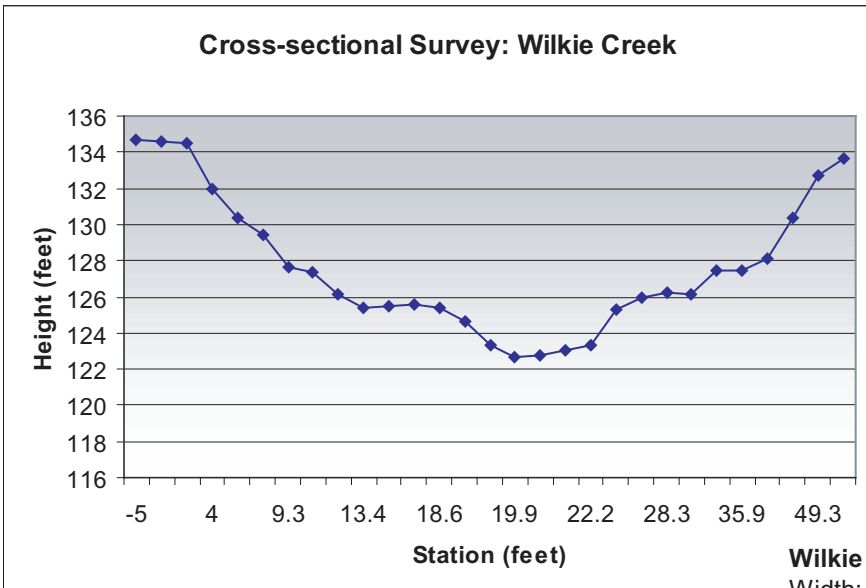
Wilkie Calculation for 2004 HWM based on cross-sectional data

Width: 28.3-15.6 8.7 (off grid from cross-section)
 Depth: 127.3-122.8 4.54
 Area: 1.5*6 (for left 39.498 S=0.01

For Wilkie Creek, we found a roughness coefficient of 0.058 (Figure 7). The HWM was 5 ft above the thalweg for a total area of 39.5 sq ft and a velocity of 3.23 f/s. These HWMs indicated a flow of 126 cfs, with a unit runoff of 217.24 cfs/sq mi. That same ratio applied to Wildcat Creek corresponds to the 50-year flood (Table 3).

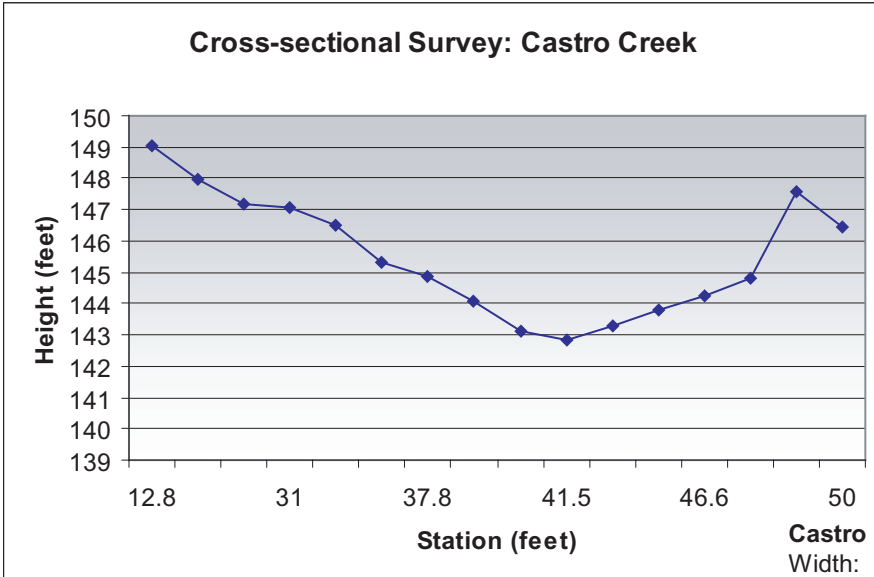
Castro Calculation for 2004 HWM based on cross-sectional data

Width:	<u>12.5</u>	(off grid from cross-section)
Depth:	<u>4.73</u>	
Area:	<u>59.125</u>	S=0.04
Wetted Perimeter:	<u>25</u>	
R:	<u>2.365</u>	n: <u>0.09592</u>
V:	<u>1.49*1.78*2/0.096</u>	n0: 0.02
V:	<u>5.53ft/s</u>	n1: 0.01
For Last Probable storm event:		n2: 0.007
Q:	<u>326.0cfs</u>	n3: 0.03
		n4: 0.021
		m5: 1.09

Our result was a roughness coefficient value of 0.096 (Figure 8). The area corresponding to our HWM came to 59.13 ft, with a velocity of 5.53 ft/s. These HWMs corresponded to a flow of 326 cfs, and a unit runoff index of 534 cfs/sq mi. That same ratio applied to Wildcat Creek gives us a flow beyond the estimate of the 100-year flood (Table 3).

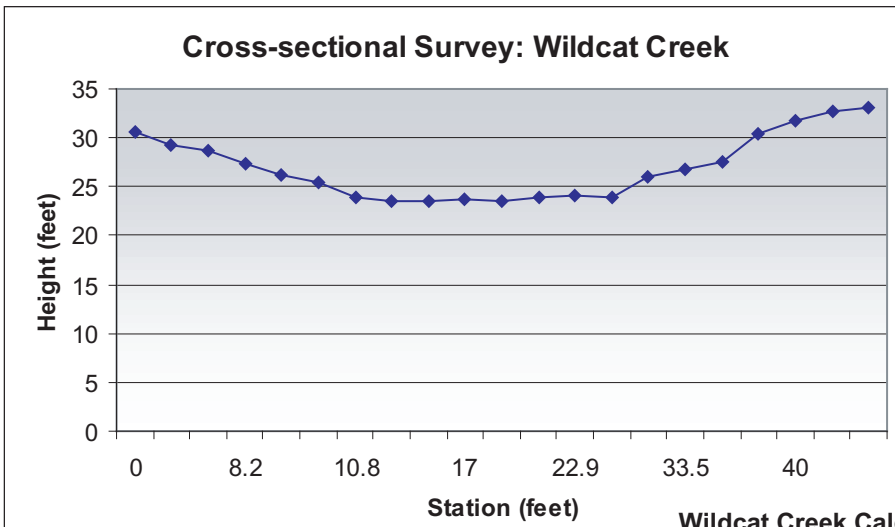
Wildcat Creek Calculation for 2004 HWM based on cross-sectional data

Width (34.5-11.7):	<u>22.8</u>	(off grid from cross-section)
Depth:	<u>4 feet</u>	
Area:	<u>91.2</u>	S=13.82-13.42/100
Wetted Perimeter:	<u>28</u>	Slope: <u>0.004</u>
R:	<u>3.26</u>	n: <u>0.055</u>
V:	<u>1.49*2.21*.063/0.055</u>	n0: 0.022
V:	<u>3.77f/s</u>	n1: 0.004
For Last Probable storm event:		n2: 0.005
Q:	<u>343.82cfs</u>	n3: 0.012
RI: 1.65 years		n4: 0.01
probability of occurring any given year is 60%		m5: 1.04

We estimated the roughness coefficient as 0.055 based on the channel characteristics observed in the field and applying them to Chow's Table of roughness coefficient values. With the use of the Manning Equation, these points correspond to an area of 91.2 ft and a velocity of 3.77 ft/s, leading to a value for flow of 343.82 cfs. Using the Flood Frequency Curve, we found that this flood had a return interval of 1.65 years and a 60 percent chance of occurring in any given year (Figure 8). We then compared these values with other Bay Area Watersheds, including Alameda Creek, Arroyo Valle, and the Guadalupe River. The return interval for the year's peak storm (February 25) on other streams ranged from 1.2 to 2.0 years, very close to the value we derived for Wildcat Creek (Appendix B).

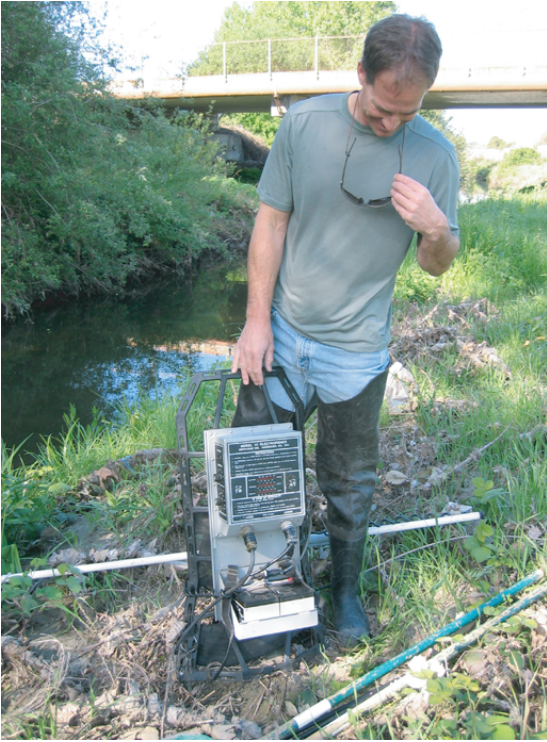
Rob Leidy from the EPA with the electro-shock box: this equipment provides the voltage needed to shock fish for two seconds, just enough time to net, bucket, and measure them.

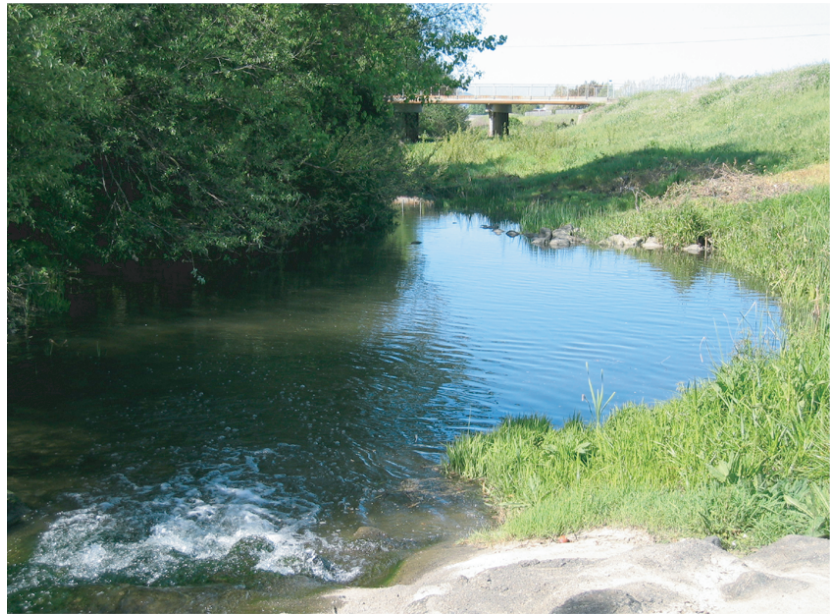
Site 1: San Pablo Creek
between Parr and Third St.

Lateral scour occurs beneath the vegetation along the left-bank, with exposed roots from willows and cottonwoods.

We characterized Site 1 by analyzing the presence pools and riffles. The site had a mid-channel pool that was 199 feet long and 15 foot wide, below which was a low-gradient riffle (45.5-foot long and 12.8 feet wide). Below the riffle was a deeper plunge pool(65-feet long and 38-feet wide). This plunge pool was followed by another mid-channel pool (283-feet long and 22.8-feet wide (Figure 17). Using these numbers we found the percentage of habitat by occurrence was 7.7 percent riffle and 92.3 percent pools.

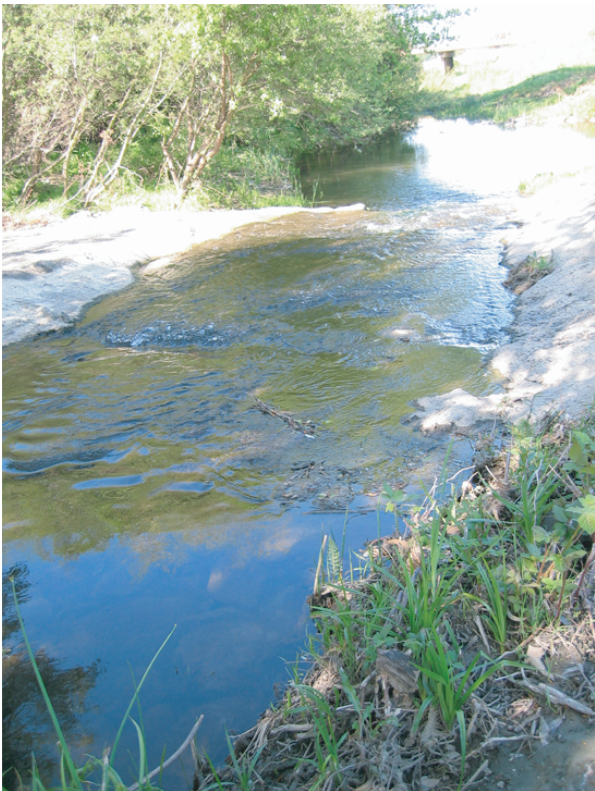
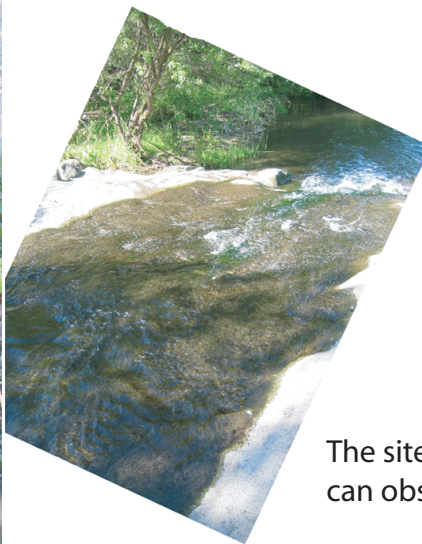
The site has an upstream bedrock sheet which can obstruct fish passage at high flows.

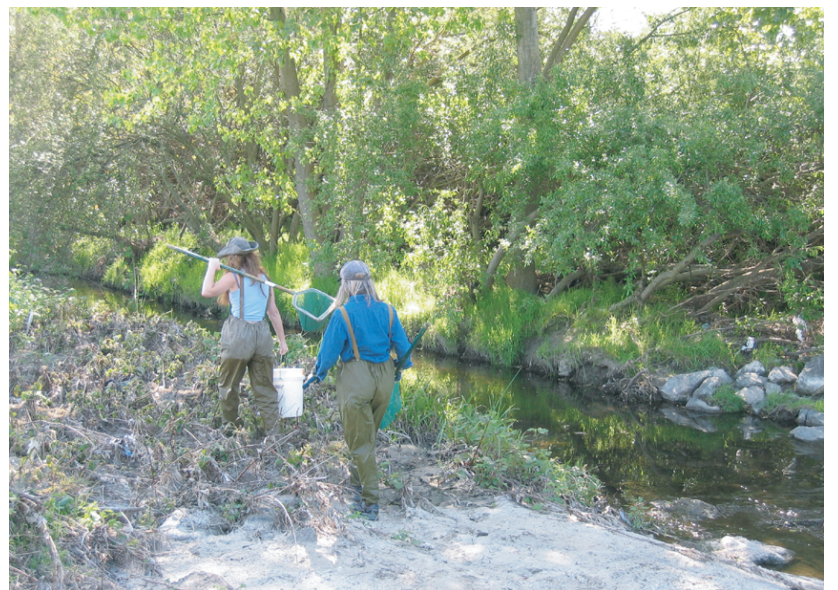
The site is composed mainly of a mid-channel pool.

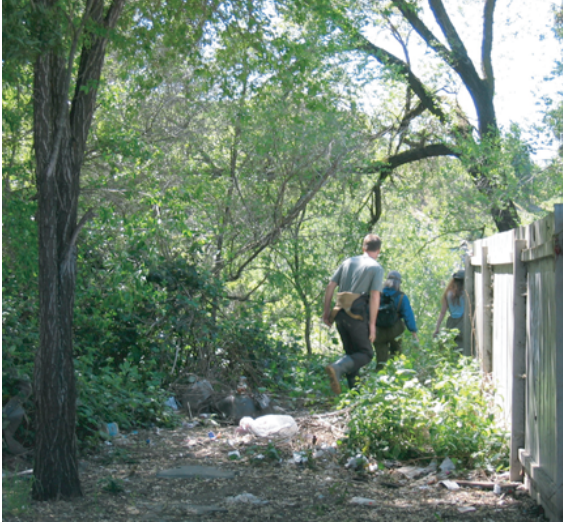
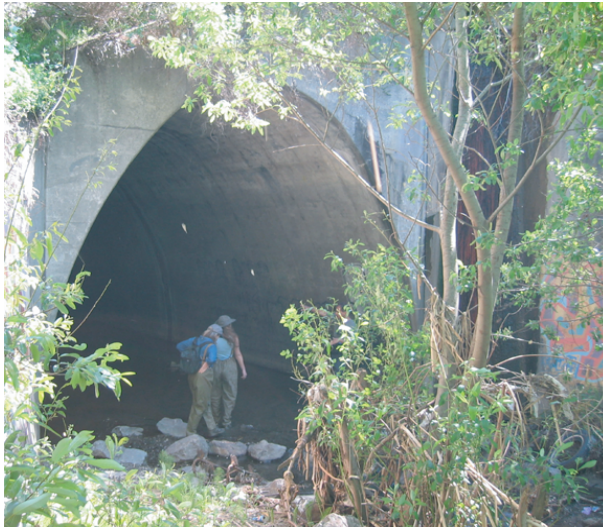
Site 2: San Pablo Creek at Interstate 80

This site was assessed as the single largest obstruction to fish passage along San Pablo Creek. The I-80 culvert is 200 feet long and bends, though its gradient is low enough for the fish to swim upstream (Rob Leidy, EPA).

San Pablo Creek flows primarily above ground, only culverted under the I-80 freeway near the border of San Pablo and El Sobrante. This culvert is split into three sections with lengths ranging from 440 to 673 feet each (Figure 14). With the assistance of Rob Leidy, we walked the length of the culvert, observed the culvert's slope, width and height, and concluded that the culvert would be passable by an anadromous fish.

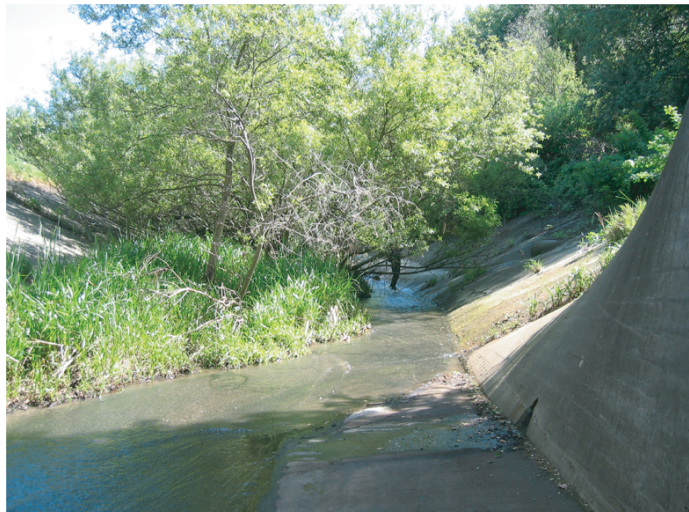
Just downslope from the highway, we found a large leak -possibly an EBMUD waterpipe- draining into the San Pablo creek below.

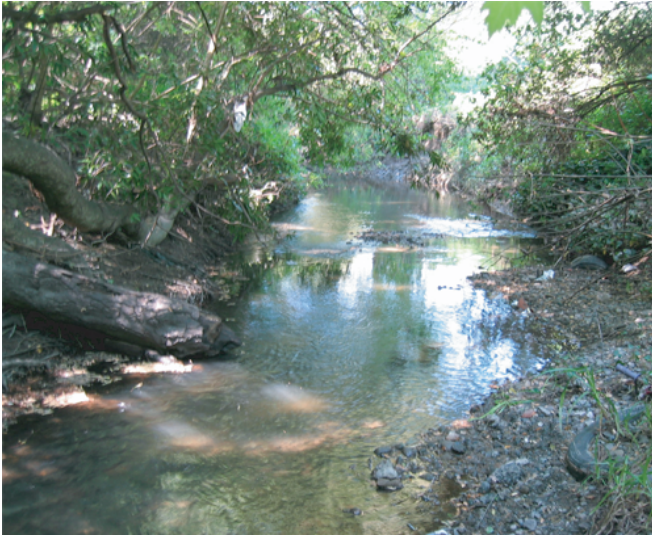
Site 3: San Pablo Creek at Via Verde

This site has an extremely silty bed and many pools and riffles, but has formerly been surveyed for fish habitat. After an initial ocular assessment, we decided not to pursue fish counting in this area, as it was an unlikely spawning habitat.

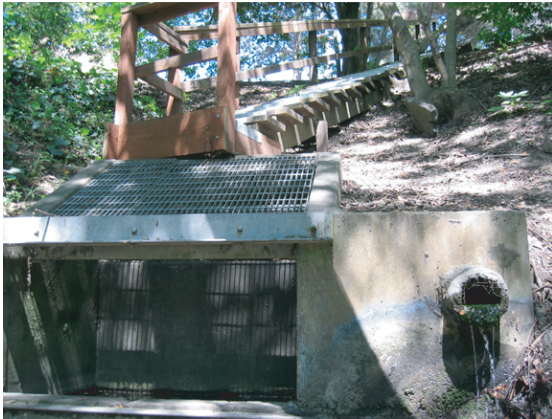
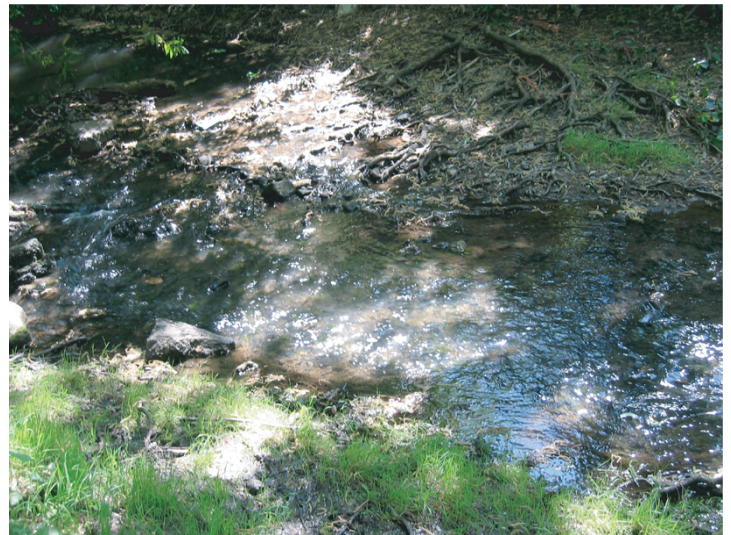
Site 4: San Pablo Creek between D'Avilla and La Honda (EBMUD Treatment Plant)

This site has low-gradient riffles in combination with plunge pools.

At Site 4, we found a long plunge pool (30-feet long and 16-feet wide) formed by the presence of large woody debris. Downstream of this pool was a low-gradient riffle (34-feet long and 8 feet wide).

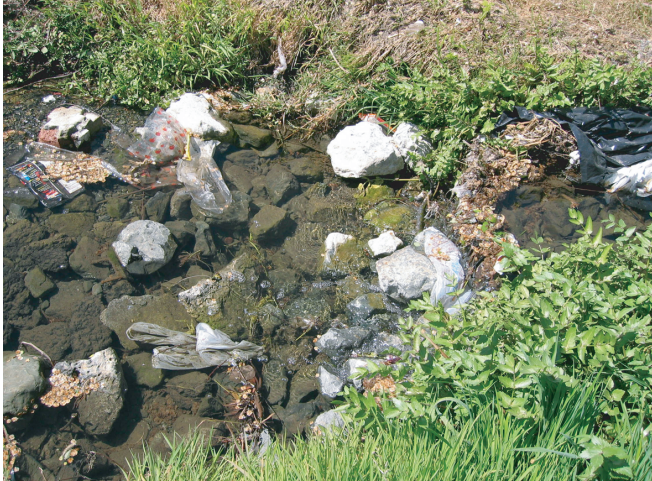
Appian Creek
*70% embeddedness, 30%fines

At Appian Creek, embeddedness totaled 70 percent with 30 percent fines at our cross section survey site. At Wilkie Creek, we found an embeddedness factor of 10-20 percent with 20 percent fine-grained bed material.

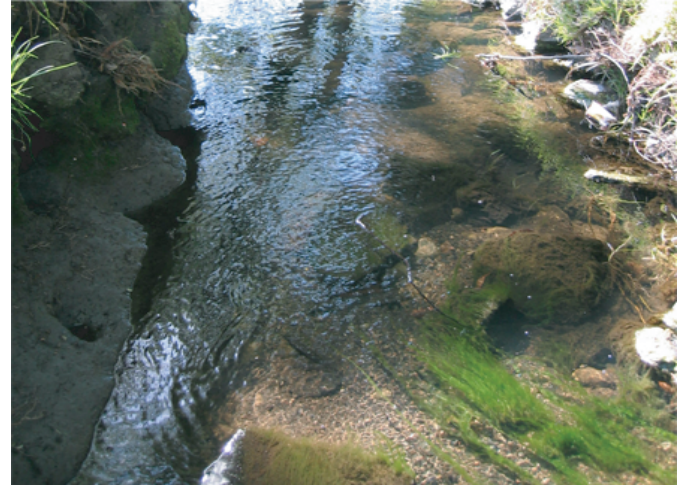
Wilkie Creek
*10-20% embeddedness, 20% fines

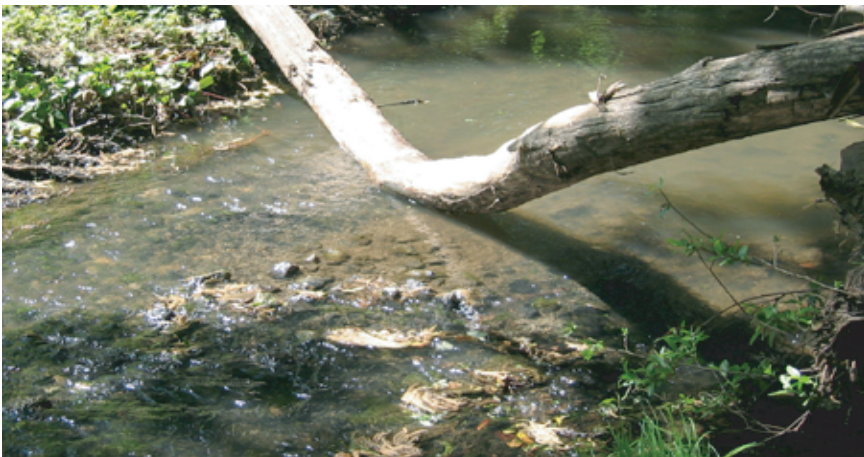
Site 4
San Pablo Creek at EBMUD Plant
*50%-80% embeddedness,
60% fines

At Site 4, we found gravel of appropriate size for spawning habitat. However, the embeddedness factor was 50-80 percent, and fine-grained bed sediment totaled 60 percent.
