Post-Project Appraisal of Santa Rosa Creek Restoration

LDARCH 227 : River and Stream Restoration

Final Draft

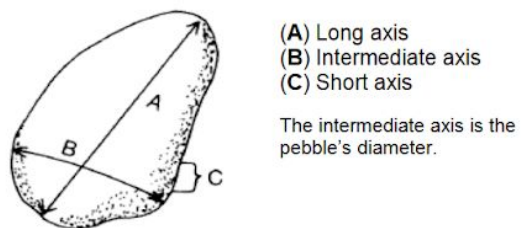
Figure 2.1 (Harrelson, et al, 1994)

Figure 2.1. Pebble count measurement breakdown

The Wolman pebble count was used to evaluate the riverbed of the project. This is completed by randomly picking rocks from one spot in each section and measuring the intermediate length of the rock as identified in Figure 2.1. Twenty-five specimens were measured in each section due to time constraint even though 100 specimens is typically the minimum number of measurements required at a creek cross section. Embedded rocks were also measured at when applicable in the

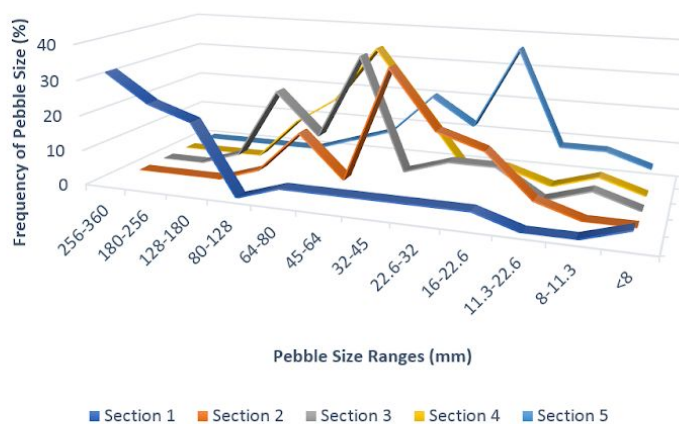
Figure 3.1

Figure 3.1. Pebble count distribution in each section of the reach

The pebble count data is reported in Tables 3.4, 3.5, 3.6, 3.7, and 3.8 respectively for each section of our reach that was analyzed. Overall, the data shows there is a noticeable difference in the pebble size ranges that are prominent in each section of the reach as displayed in Figure 3.1. In section one of the reach, a significant number of large boulders were recorded. All of the boulders were embedded in concrete. In section two of the reach there were slightly more pebbles in the smaller size ranges in comparison to the third and fourth reach. Section three had a mix of medium-large sized pebbles in the riverbed. Section four of the reach indicated a high frequency of medium sized rocks. Lastly, section five of the reach had peak frequency of pebbles with relatively smaller intermediate lengths.

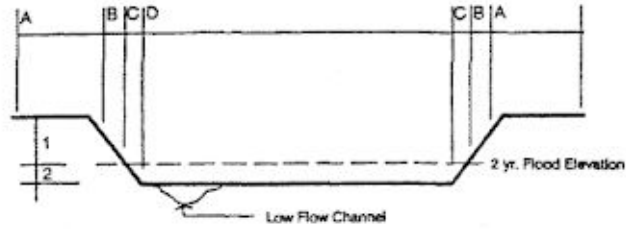
Figure 4.1 (The City of Santa Rosa, et al., 2013)

Typical Revegetation Scheme for Urban Reaches “C”, “D”, and “E”

<u>PLANTING ZONES</u>		<u>MOISTURE REGIME</u>	<u>PRINCIPAL PLANT SPECIES</u>
A	Top of Bank	Xeric (dry)	Live Oak, Valley Oak, Madrone, Bay, Manzanita, Cenothus, Native Bunch Grasses and Wildflowers
B	Mid-Bank	Mesic (intermediate)	Valley Oak, Black Oak, Buckeye, Maple, Elderberry, California Rose, California Blackberry, California Grape, Snowberry, Native Grasses and Wildflowers
C	Lower-Bank	Hydric (seasonally wet)	Alder, Cottonwood, Willow, Ash, Boxelder, Elderberry, Maple, Snowberry, California Rose, California Blackberry, California Grape, Native Herbs
D	Channel Bottom	Hydric (perennially wet)	Elderberry, California Blackberry, California Grape, California Rose, Snowberry, Sapping Willows, Native Wetland Grasses, Sedges, Tules, Rushes, Cattails, and Bur reed
<u>HYDRAULIC PLANTING ZONES</u>			<u>PRINCIPAL PLANT SPECIES</u>
1	Above 2 yr. Floodplain		Elderberry, California Blackberry, California Grape, California Rose, Snowberry

2	Below 2 yr. Floodplain		Grasses, Tules, Cattails, Snowberry, California Rose, California Blackberry, and Fishery Enhancement

The Santa Rosa Citywide Creek Master Plan stated that there were particular native plants typically planted in urban environment river restorations as shown in Figure 4.1. Comparing the plants recorded in Table 4.1 with those listed in Figure 4.1, it was found that nearly 79% of the suggested plant species from the Santa Rosa Creek Restoration guidelines (The City of Santa Rosa, et al., 2013) were present in Santa Rosa creek. Plants not observed in the creek were the California rose, blackberry, and grape, bur reeds, and bay trees. In addition, several invasive species were found including the common fig, ivy, the himalayan blackberry, and watercress. Of these, ivy was noted to be most invasive, stretching along all parts of reach four. Even though

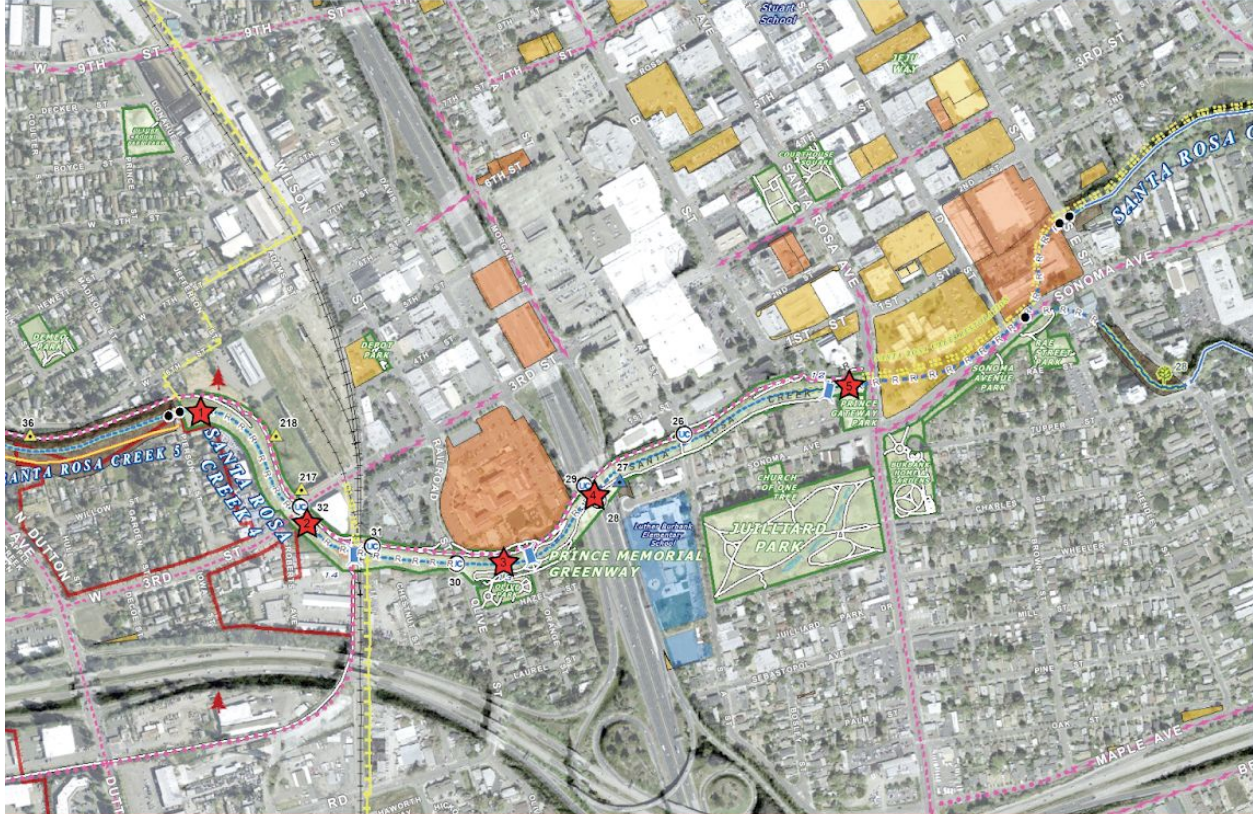
[Map of Pierson Reach from Pierson Street to E Street. The five red stars indicate the different locations the reach was analyzed at in the post-restoration study]

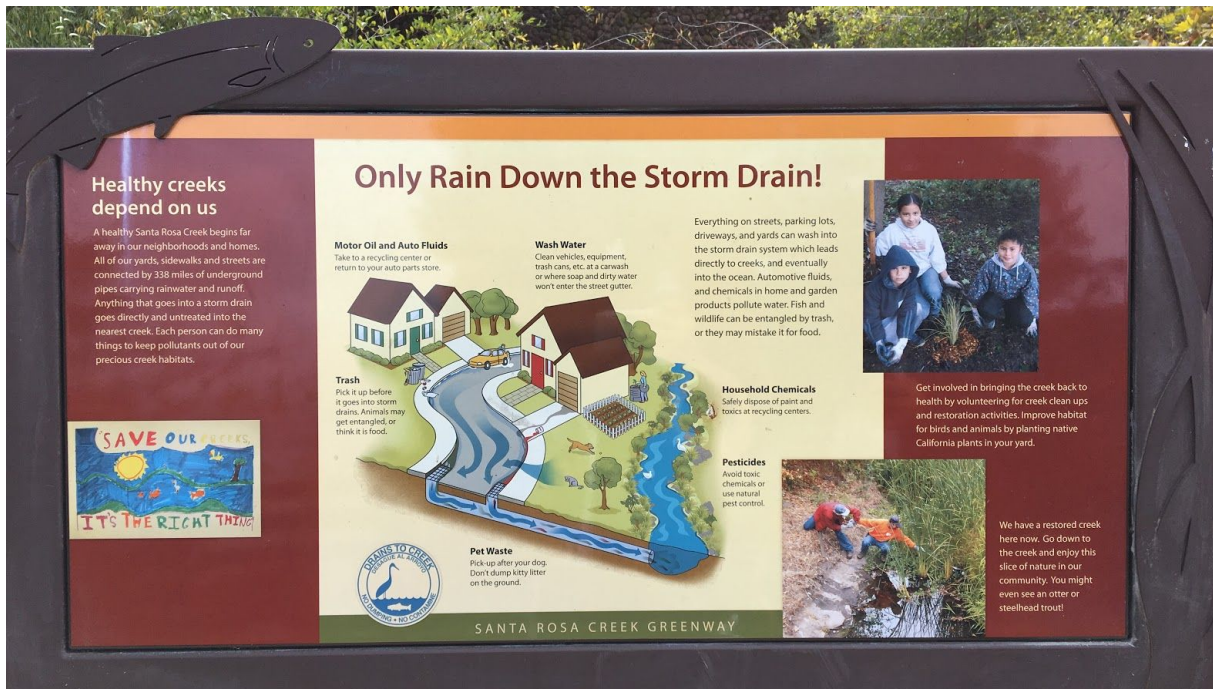
Educational interaction was bolstered with several informational signs (shown in Appendix C) describing the creek restoration with some example topics expanding on why the restoration occurred, how it benefits the creek habitat, and what that habitat should include.

Photo 2: Example of one of the several educational boards erected along the creek

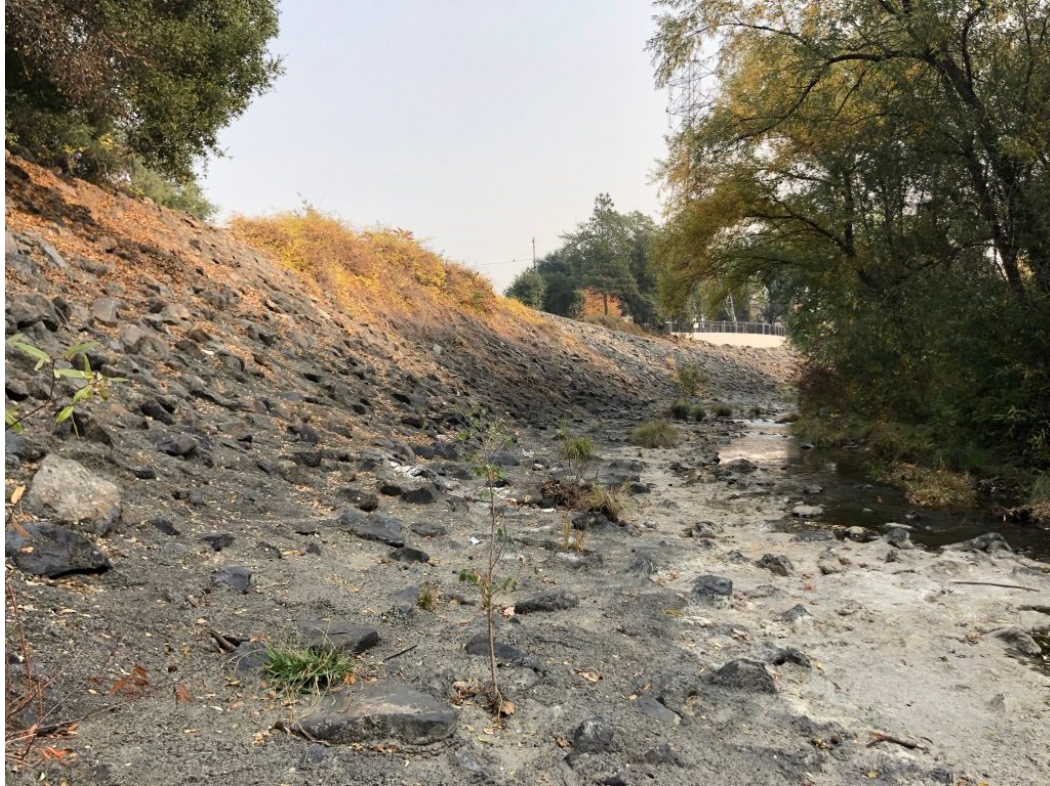
Photo 3: Location 1, evidence of only embedded rock and shallow creek.

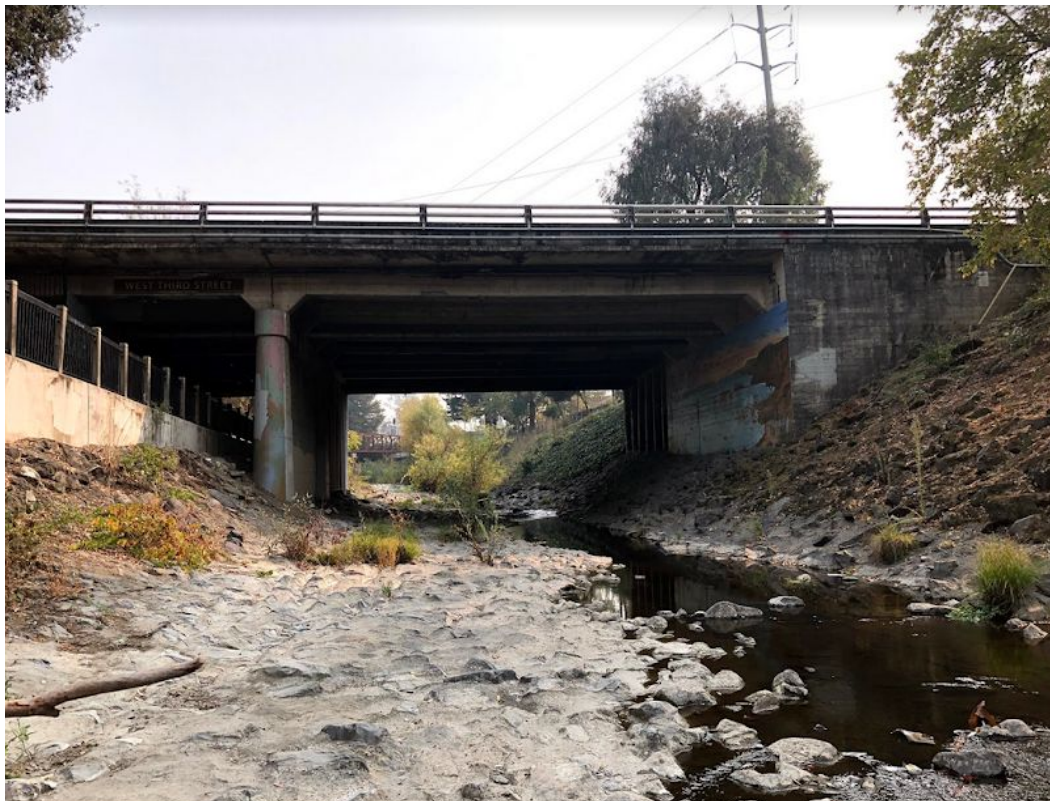
Photo 4: Location 2, evidence of large embedded rock

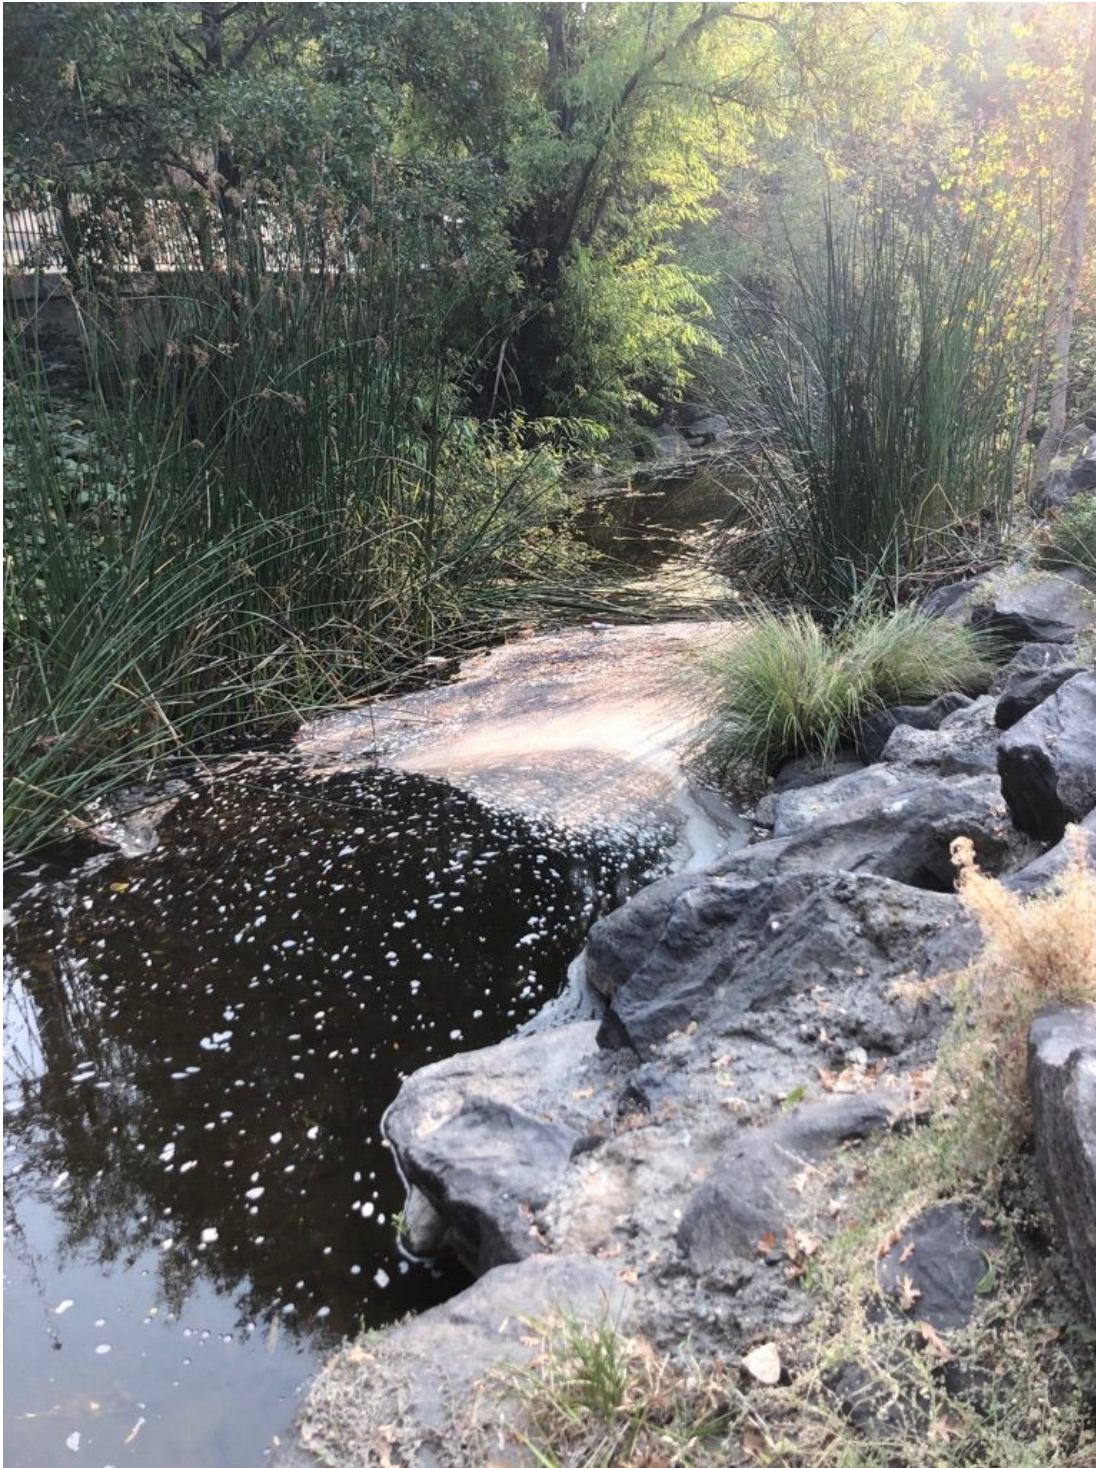
Photo 5: Location 4, indicates unhealthy water quality.

We recommend a community clean up of the river: a day in which the community volunteers to pick up litter and learn about the wildlife at the creek. A further water quality analysis is also recommended because of the nutrient build up at location 4 (shown in Photo 5 of Appendix C). Dissolved oxygen, pH, biological oxygen demand, and turbidity should be measured. As mentioned earlier, the main goal that is not met is the health and safety goal. In the past year there have been reported incidents of vandalism, disorderly conduct, and assault along the creek (the crime data is in Figure 3.6). More surveillance should be added along the creek. Another important social issue involves the high numbers of homeless individuals which frequent the area or claim spots along the creek as their residence. To maintain important health and safety standards, it is critical this population is educated in necessary and proper procedures.

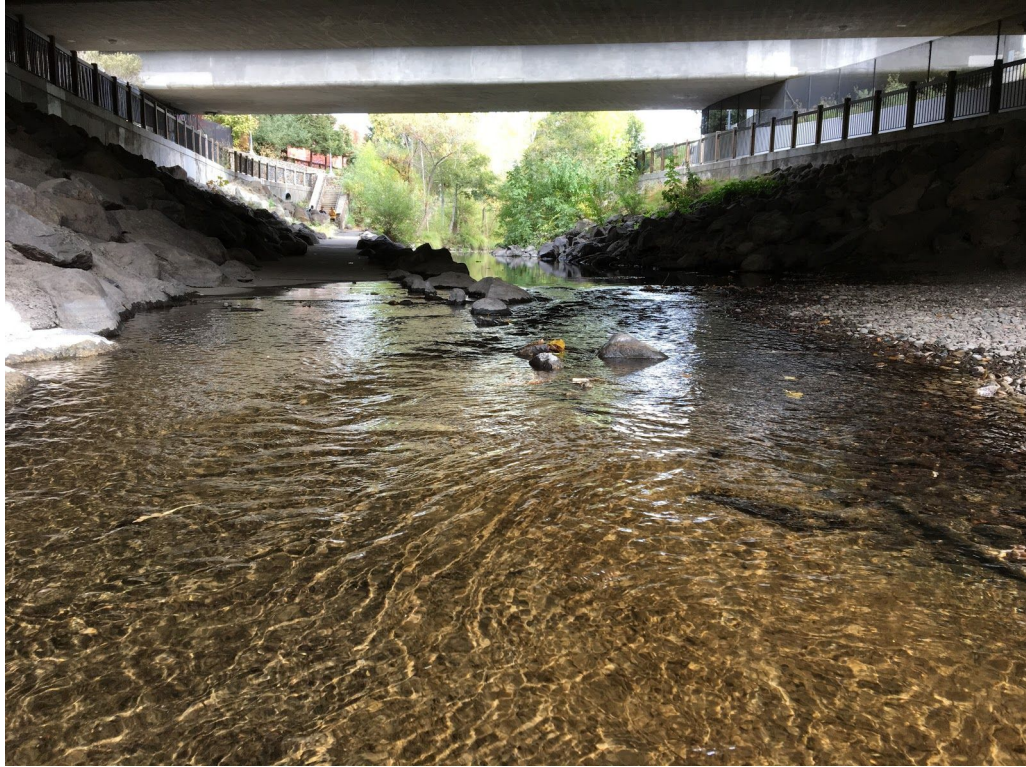
Photo 6: Location 4, shows shallow water flowing over sidewalk underneath Santa Ana Ave.

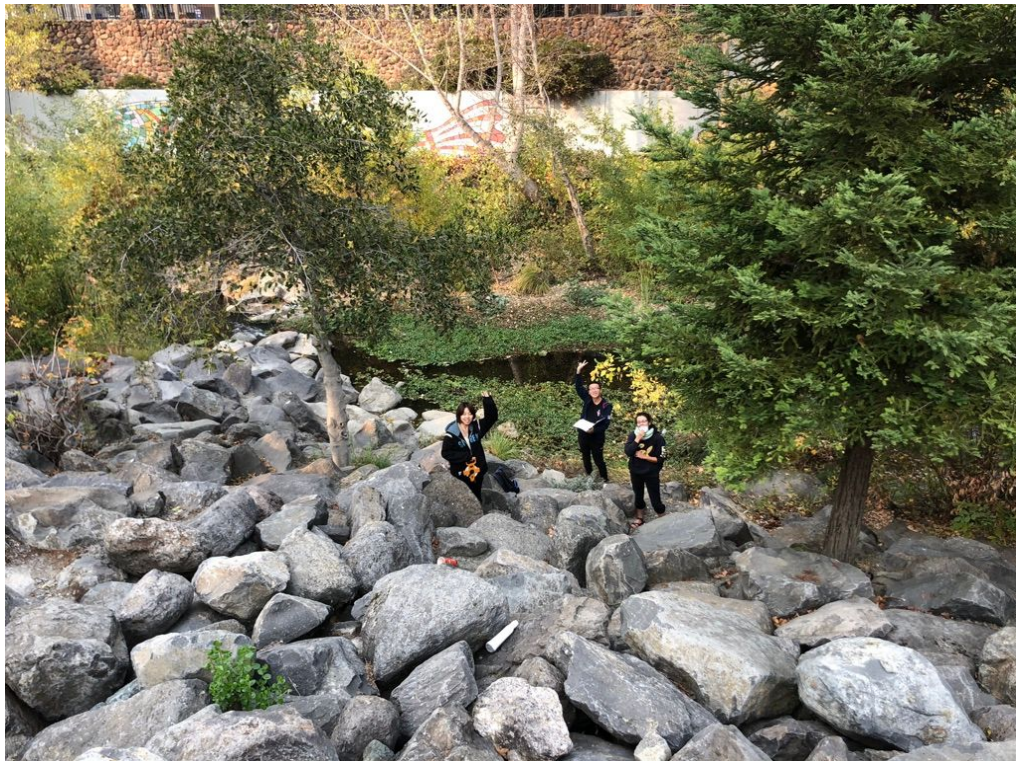
Photo 7: Location 5, lots of vegetation and large walls on either side of creek.

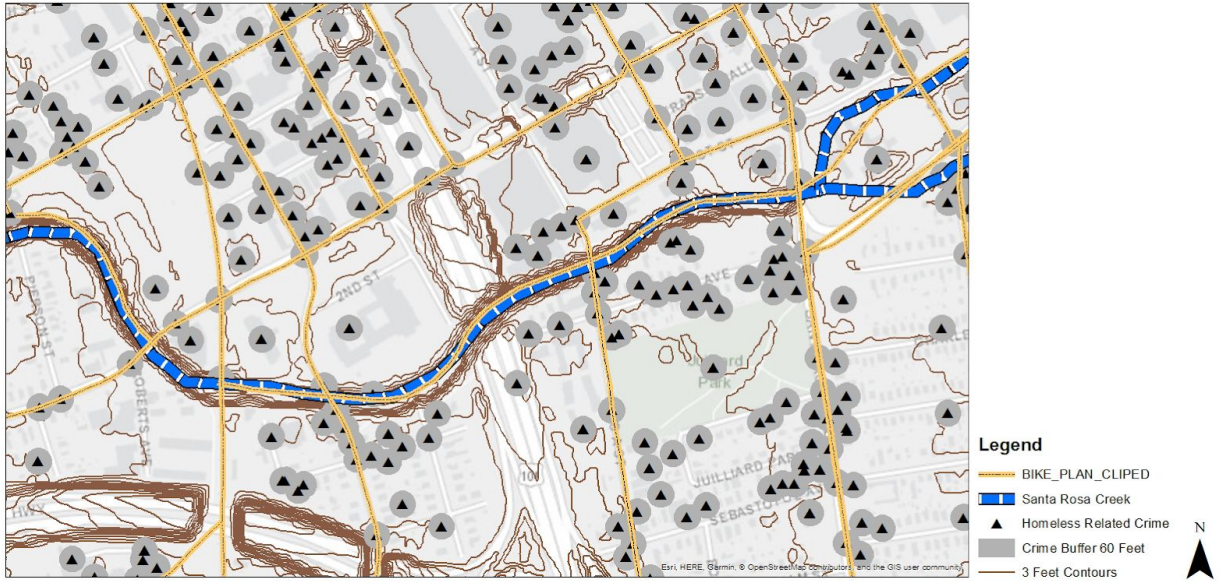
Data Analysis 1 : Crime data + Park System

Resource: USGS, Sonoma County, The City of Santa Rosa
