Vilcabamba and the Archaeology of Inca Resistance

Brian S. Bauer, Javier Fonseca Santa Cruz, and Miriam Aráoz Silva

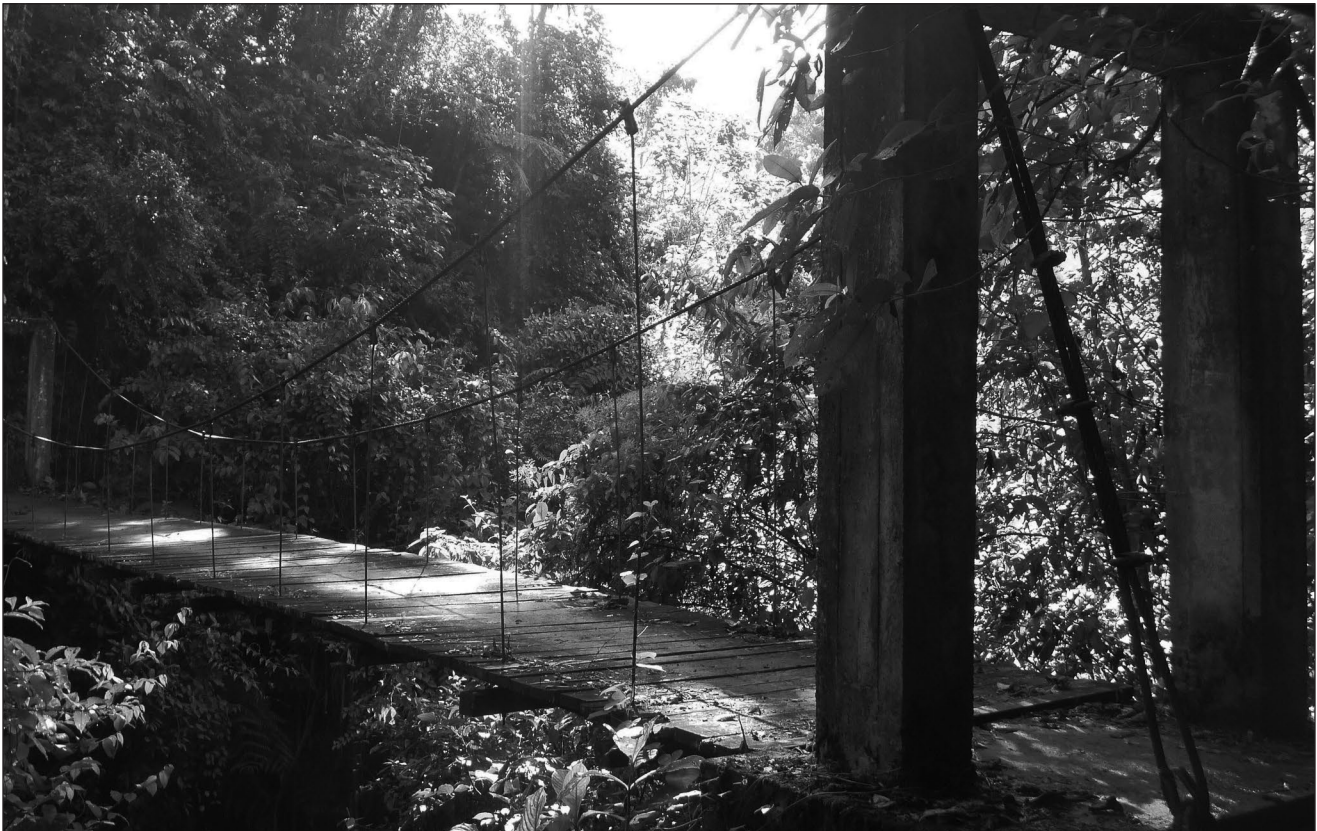
Figure P.1. The last of three suspension bridges built between Azulmayo and Espíritu Pampa, 2010 (photograph by Brian S. Bauer and Miriam Araújo Silva).

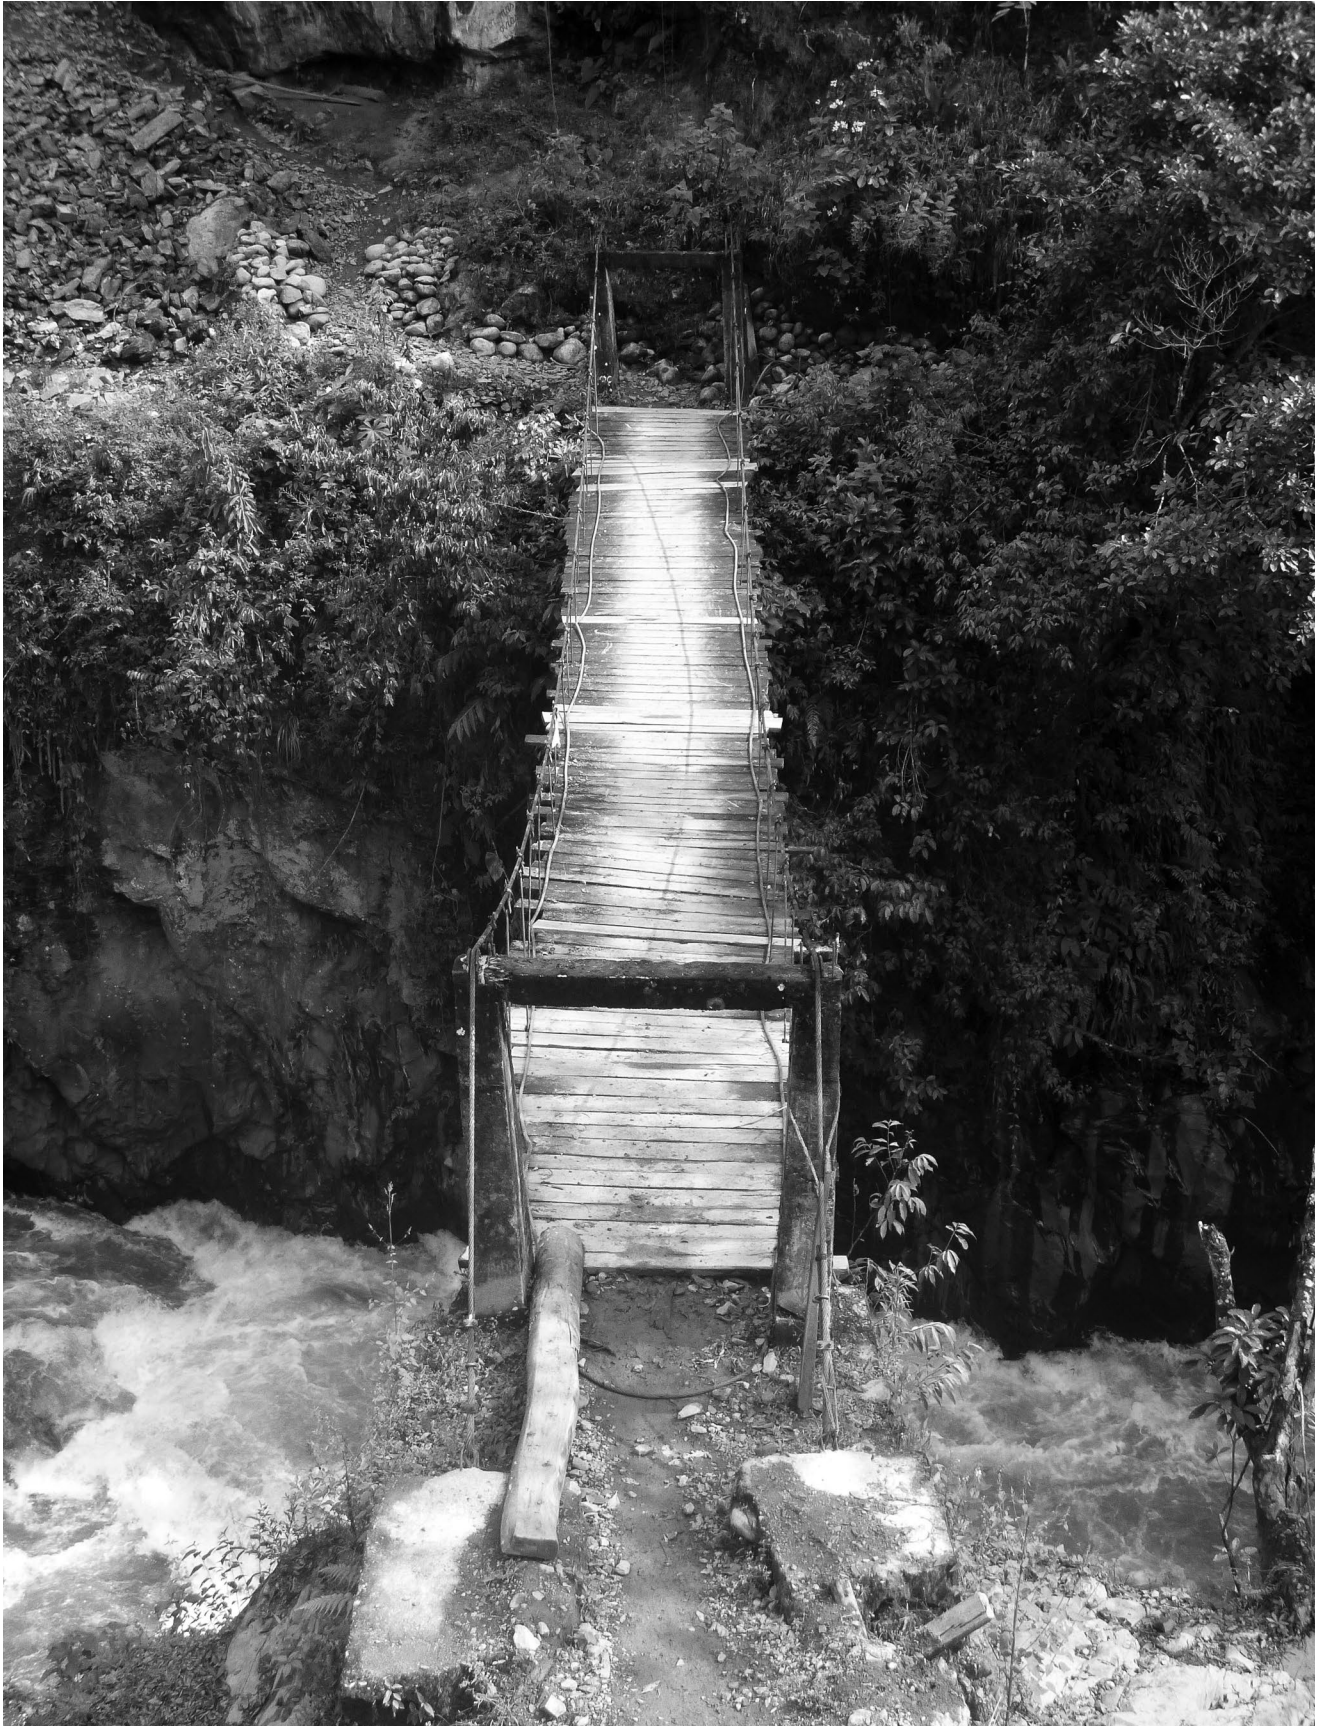
Figure P.2. The Azulmayo Bridge, 2010 (photograph by Brian S. Bauer and Miriam Aráoz Silva).

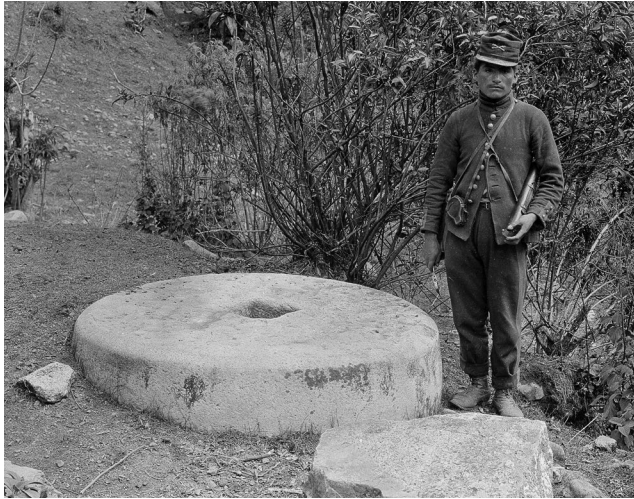
Figure 1.5. Millstone photographed by Bingham in 1911 (National Geographic Image Collection: negative 785895, photograph by Hiram Bingham).

On August 8 Bingham made the short trip from Lucma to Puquiura and crossed the Vilcabamba River at the village of Huancacalle. Near the river crossing he noted the remains of a colonial era ore-crushing mill (Figures 1.5 and 1.6). Bingham was intrigued by the mill, since Baltasar de Ocampo Conejeros (2013:29, 36, 50 [1611]) had written that Cristóbal de Alborno, a longtime resident of Vilcabamba, owned a mill near the town of Puquiura. Bingham continued, passing the ruins of a single large building at Uncapampa, and arrived at the impressive ruins of Rosaspata. Although the site was overgrown, Bingham could tell that it contained a large central plaza as well as a number of impressive structures (Figures 1.7–1.11).²⁵

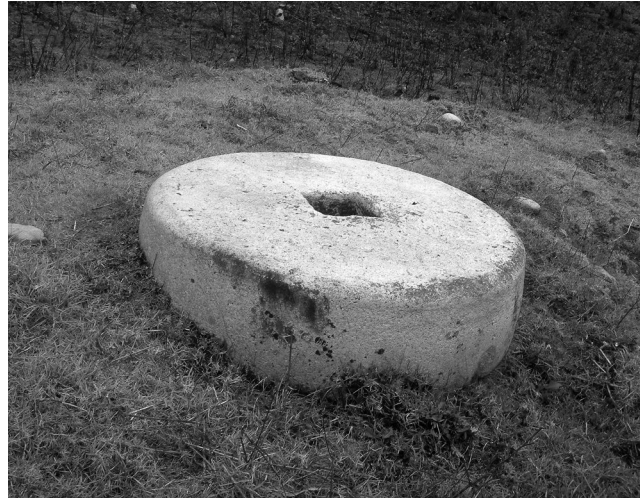
Figure 1.6. Millstone photographed by Bingham in 1911 (photograph by Brian S. Bauer and Miriam Araújo Silva).

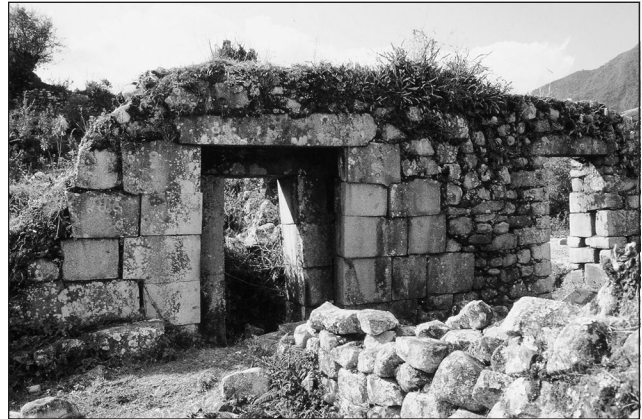
Figure 1.10. Two doorways at Vitcos (Rosaspata), circa 1983 (photograph by David Drew).

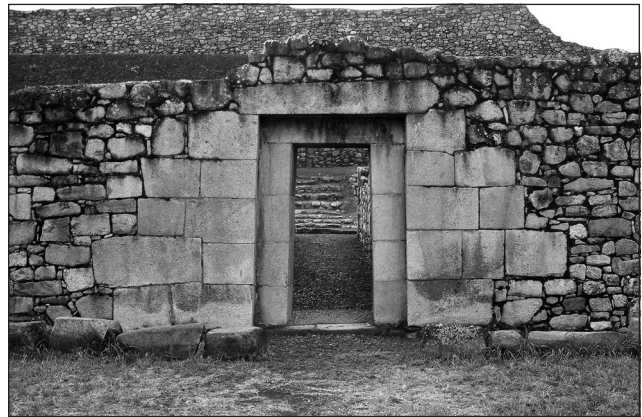
Figure 1.11. Doorway at Vitcos (Rosaspata) after reconstruction (photograph by Brian S. Bauer and Miriam Aráoz Silva).

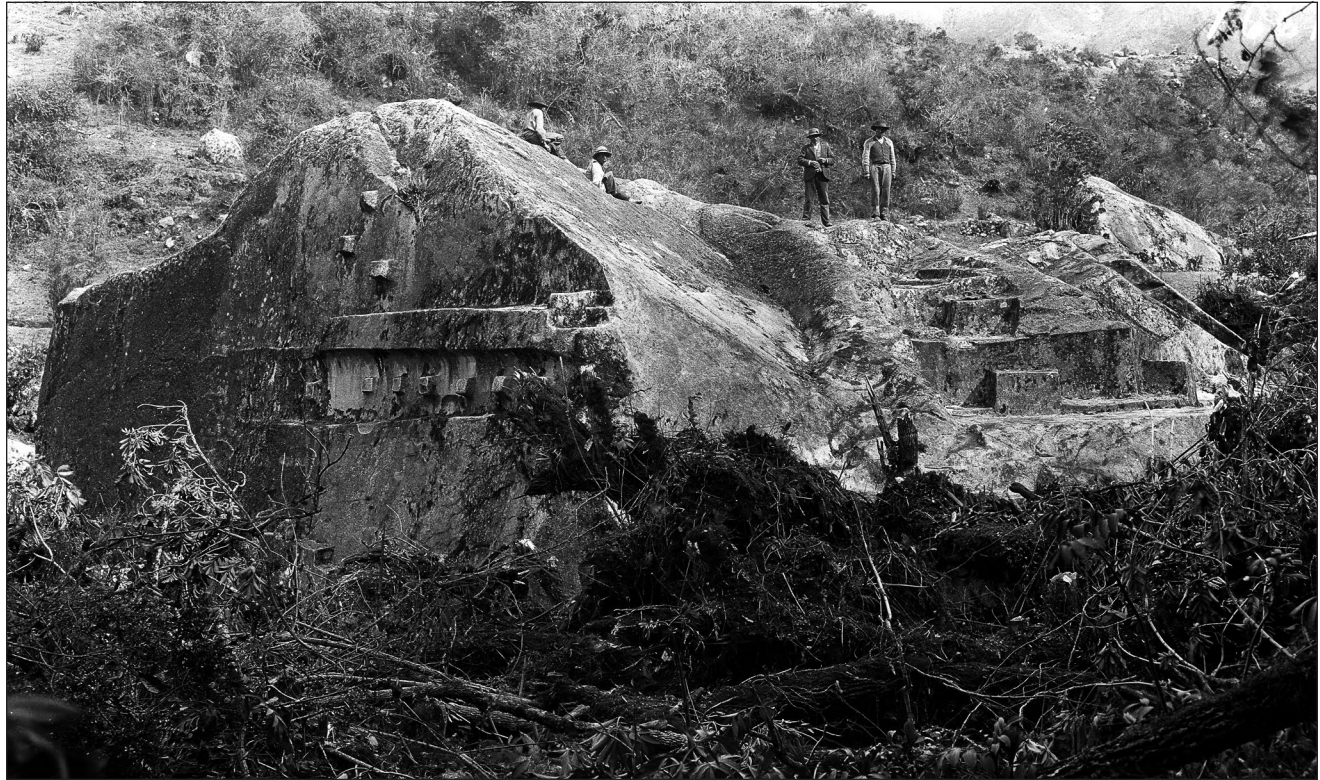
Figure 1.12. The north and west sides of Yurak Rumi being cleared of vegetation in 1911 (National Geographic Image Collection: negative 785910, photograph by Hiram Bingham).

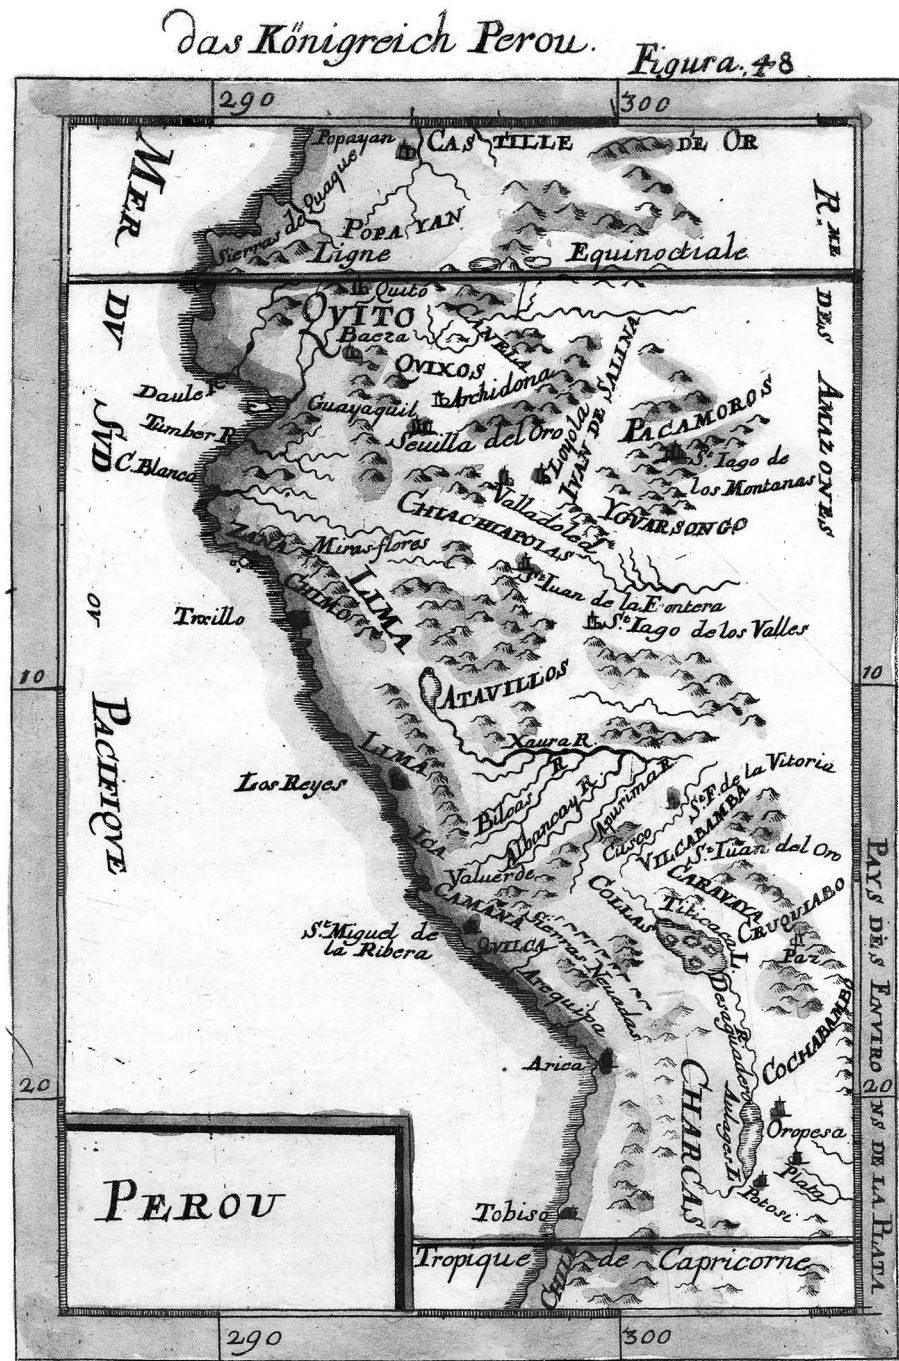
Figure 1.14. A 1683 map showing the Vilcabamba region and the town of Sa(n) F(rancisco) de la Victoria (de Vilcabamba) (Mallet 1683).

Yurak Rumi and Vitcos (Bingham 1912d:185). He then traveled to the Spanish town of Vilcabamba (formally known as San Francisco de la Victoria de Vilcabamba), about three hours away. This town was widely known as a former mining center and is marked on a host of seventeenth- and eighteenth-century maps (Figure 1.14). It was constructed at its current location around 1596, when Spanish settlers wanted their center near the largest mines of the region. Baltasar de Ocampo Conejeros (2013 [1611]) describes the founding of the town and construction of its church in his lengthy *Description of the Province of San Francisco de la Victoria de Vilcabamba* (circa 1611), a document that Bingham had read and perhaps even carried with him into the field.

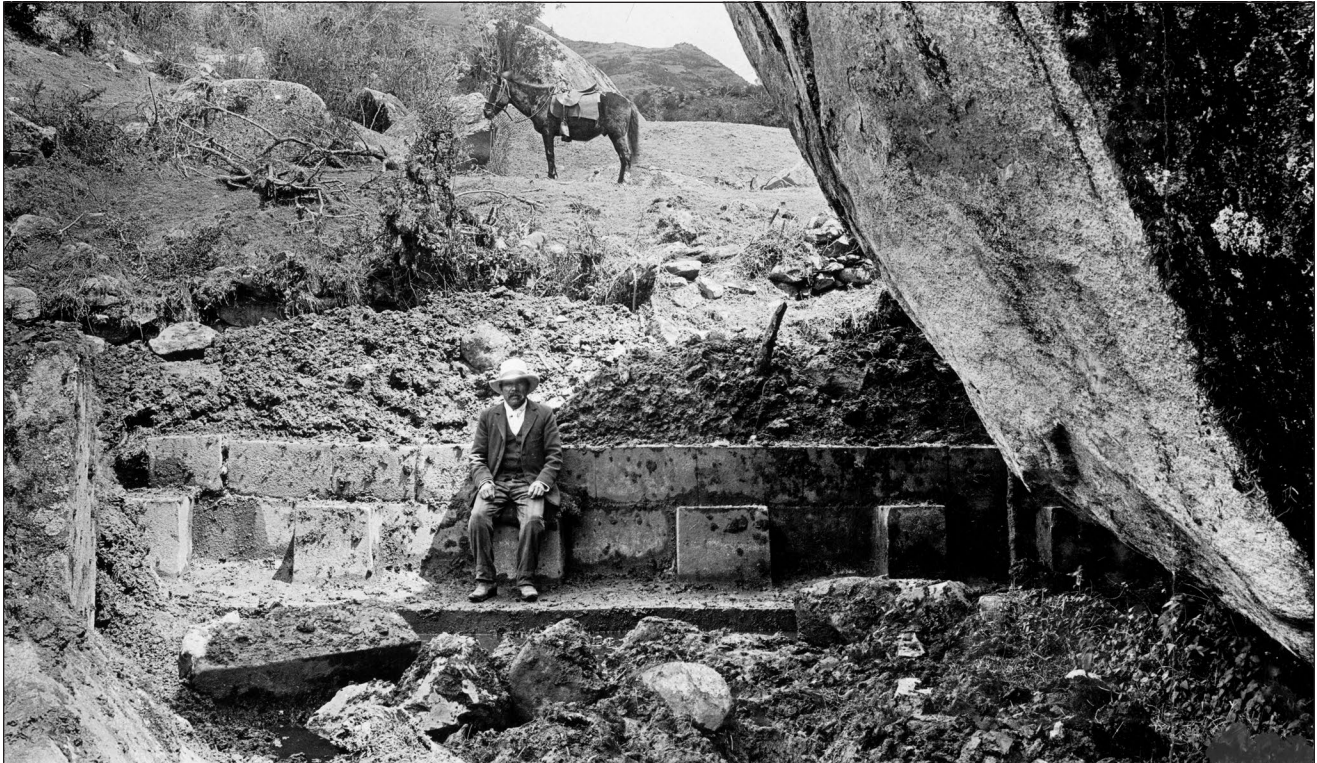
Figure 1.19. Bingham excavated near the base of Yurak Rumi in 1912 (National Geographic Image Collection: negative 786000, photograph by Hiram Bingham).

Bingham’s 1912 fieldwork in the Vilcabamba region beyond Machu Picchu was complicated by widespread epidemics of smallpox and typhoid. Nevertheless, his team conducted several treks across the region, recording a series of Inca roads and various small archaeological sites (Bingham 1913). Bingham also excavated at Yurak Rumi on August 25 with some eleven local laborers, concentrating on the area near the rock where the spring emerged. Bingham (1913:520) notes, “I drained the marshes that partly surround the rock at Ñusta España and excavated as far as was practicable. To our surprise and mortification we were unable to find any artifacts whatever and only a handful of rough potsherds.” He did, however, uncover an exceptionally well-made wall with nine niches at the base of the rock (Figures 1.18–1.20).

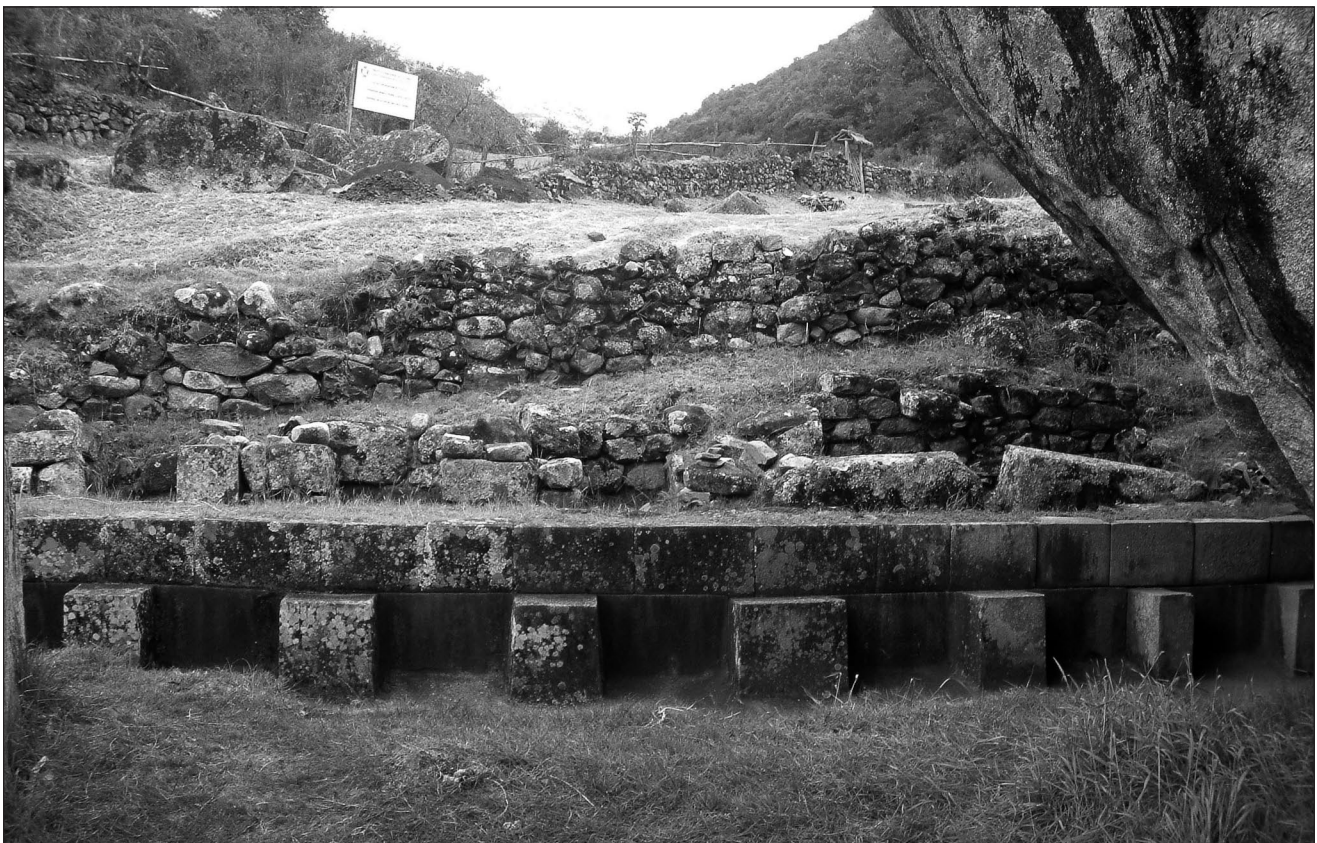
Figure 1.20. The base of Yurak Rumi (photograph by Brian S. Bauer and Miriam Araújo Silva).

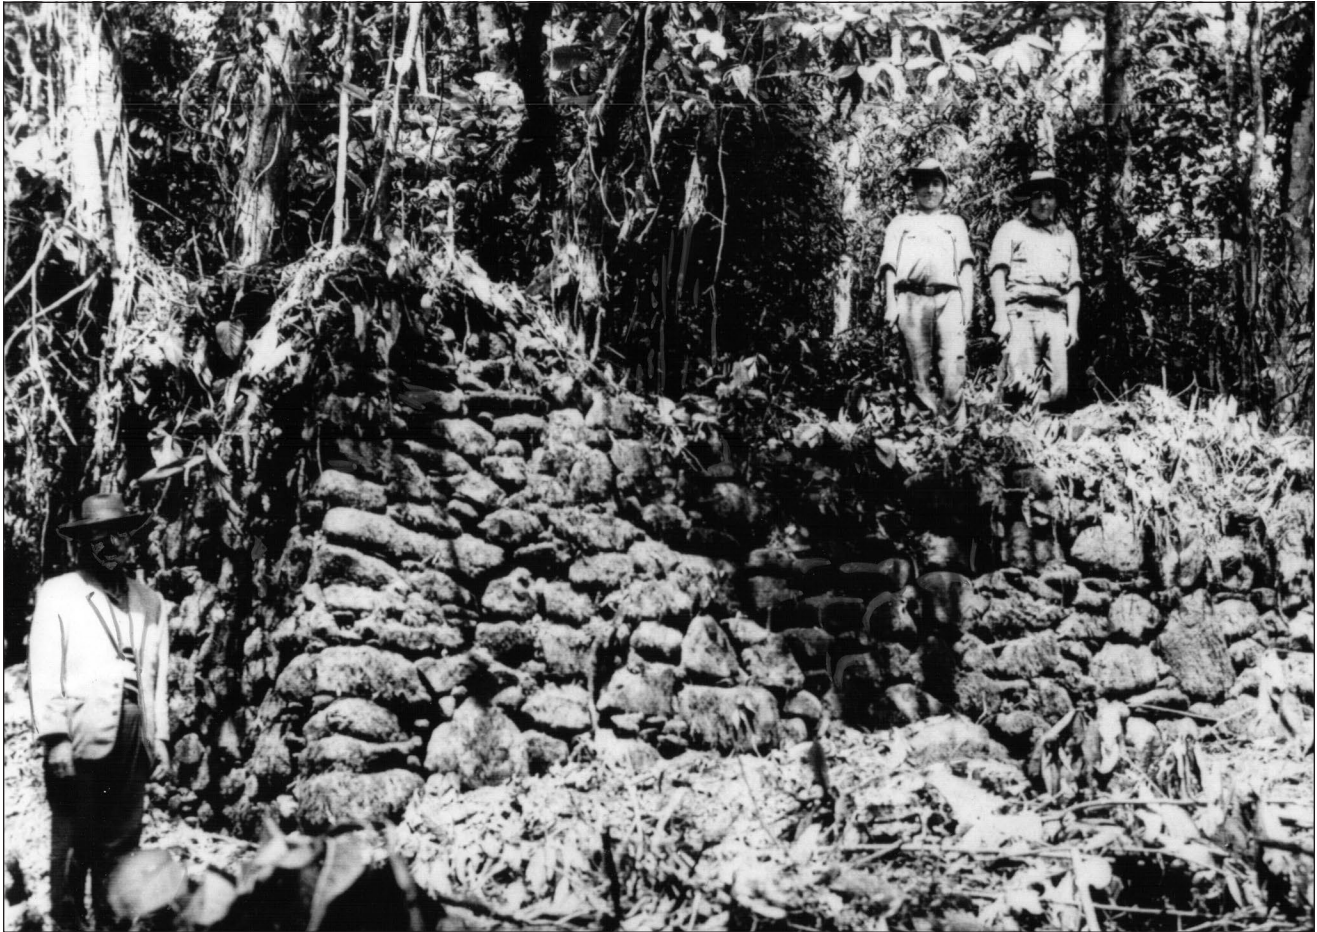
Figure 1.21. Clearing the ruins of Espiritu Pampa. Benjamin and Flavio Cobos stand above a newly cleared building (photograph included in dispatch by the Central Press Association, August 14, 1964, sent by Alberto J. Schazin).

Over the next several days, Savoy paid local workers to clear parts of the central ruins, and slowly the large scale of the ruins became apparent (Figure 1.21). Savoy made three different trips that year (1964–1965) to Espíritu Pampa, clearing the ruins, revisiting sites, and investigating new areas. Although he immediately and unabashedly announced his findings in the *Lima*

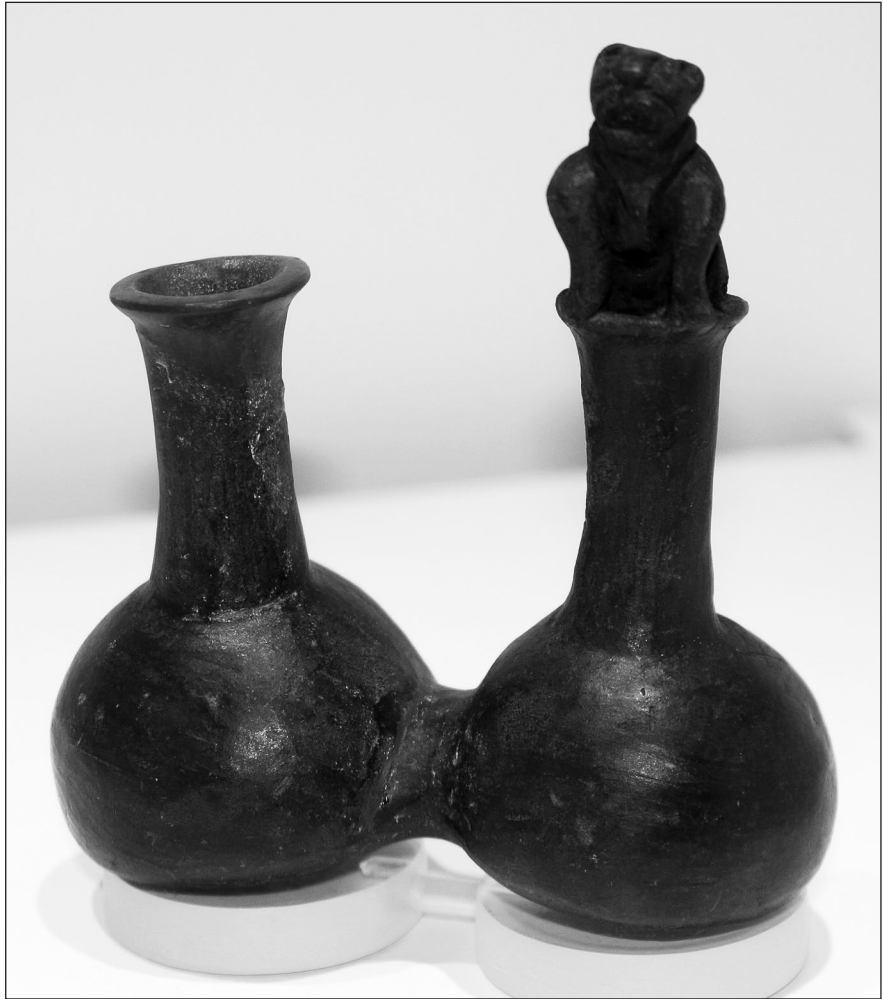
Figure 1.22. A polished black-ware vessel recovered by Amelia Perez Trujillo in 2003 at Vitcos (Rosaspata) (Museo Amazónico Andino Qhapaq Ñan de Quillabamba. Photograph by Brian S. Bauer).

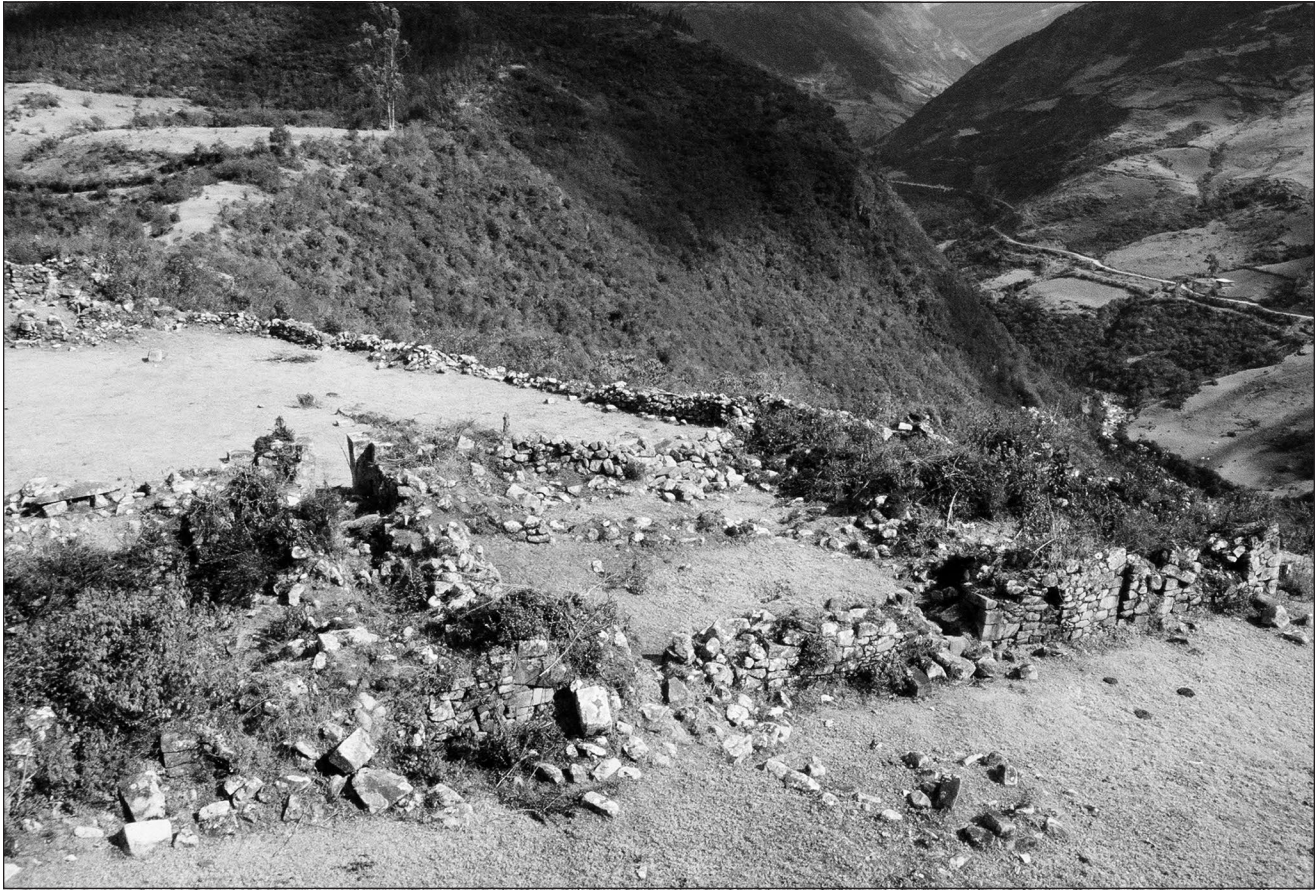
Figure 1.23. Buildings of Vitcos (Rosaspata) before reconstruction, circa 1983 (photograph by David Drew).

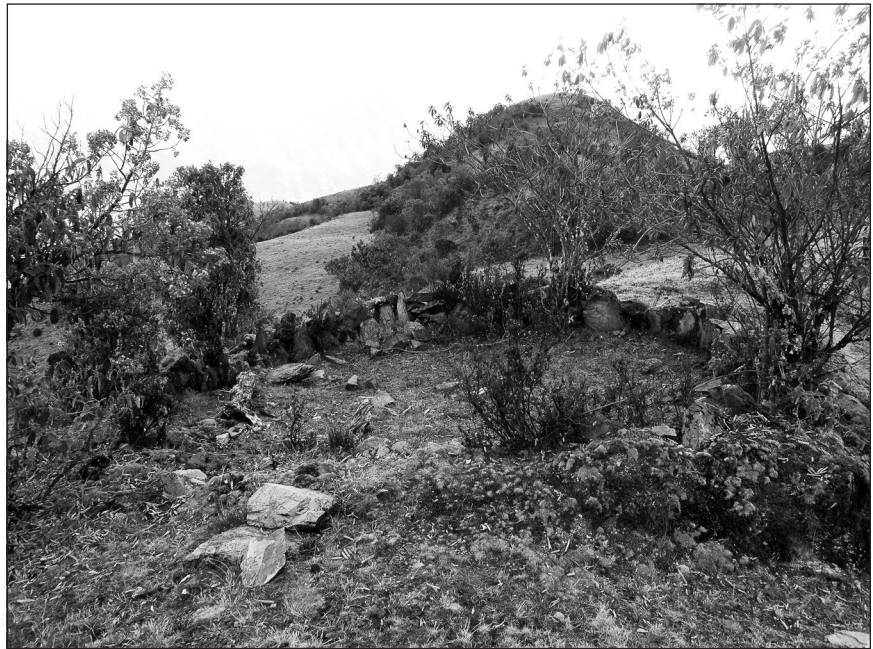
Figure 2.5. An example of a circular building at Site 31 (Kerapata) (photograph by Brian S. Bauer and Miriam Araújo Silva).

The site of Kerapata (also called Cochapata) is spread across a high (3,700–3,800 m), broad, gently rolling ridge east of Huancacalle (Figures 2.5 and 2.6). The site contains more than 28 circular structures, but it is in poor condition, with the locations of many buildings marked by only circular depressions. There are a few better-preserved structures that still display circular foundations and discernable doorways, and one struc-

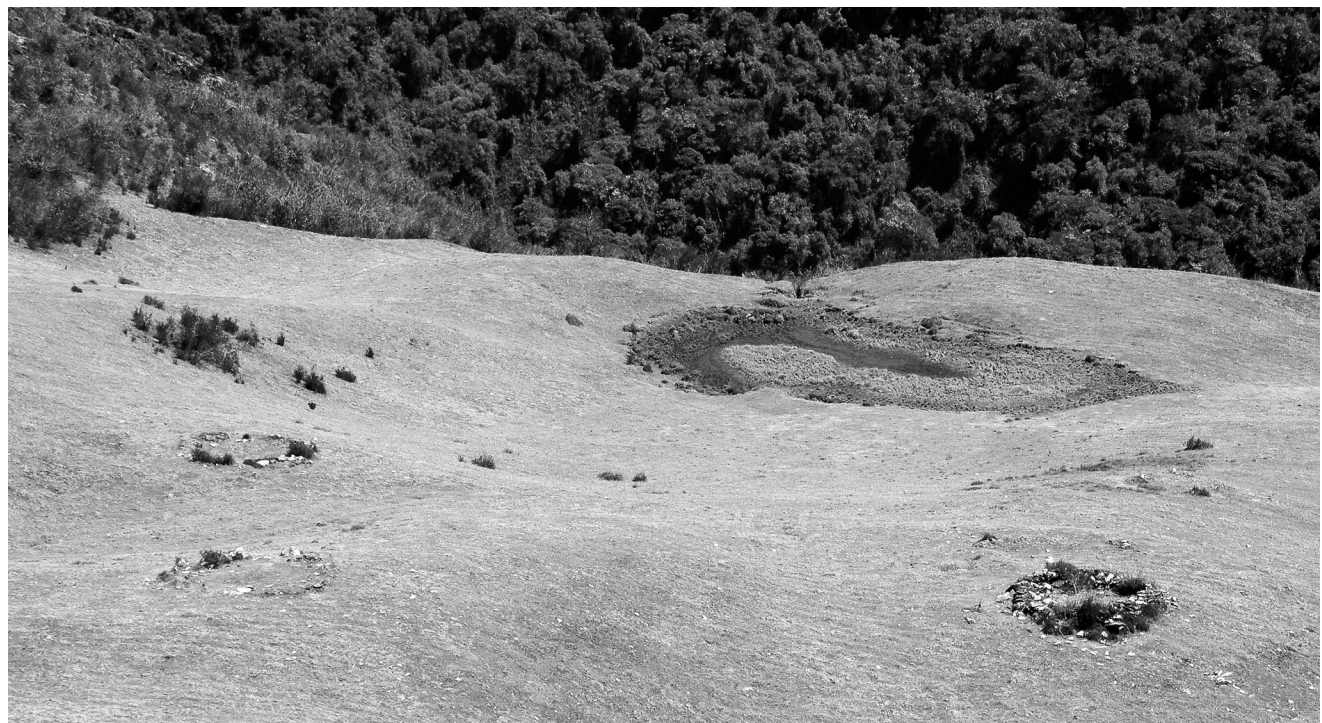
Figure 2.8. Site 72 (Chunchulcuesta). Note the scattered circular buildings and the pond (photograph by Brian S. Bauer and Miriam Aráoz Silva).

plain near the upper altitude of the Chunchulcuesta ridge (3,800 m). This ridge is located to the north of the Viracochan ridge and to the south the Qerapata ridge. Currently there are some 14 large circular foundations (< 4 m in diameter) and various small circular foundations visible on the surface (Figures 2.8 and 2.9). Most of the foundations are in poor condition, and the former location of some buildings can be identified only by depressions in the ground surface. There is a small pond immediately adjacent to the occupation.

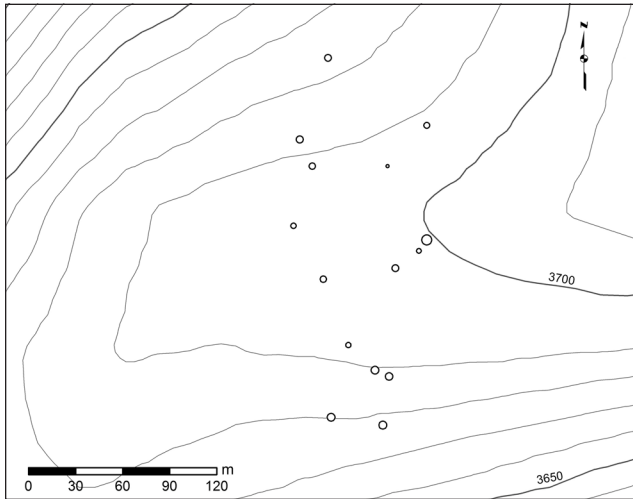
Figure 2.9. The site of Chunchulcuesta (map by Rebecca A. Friedel).

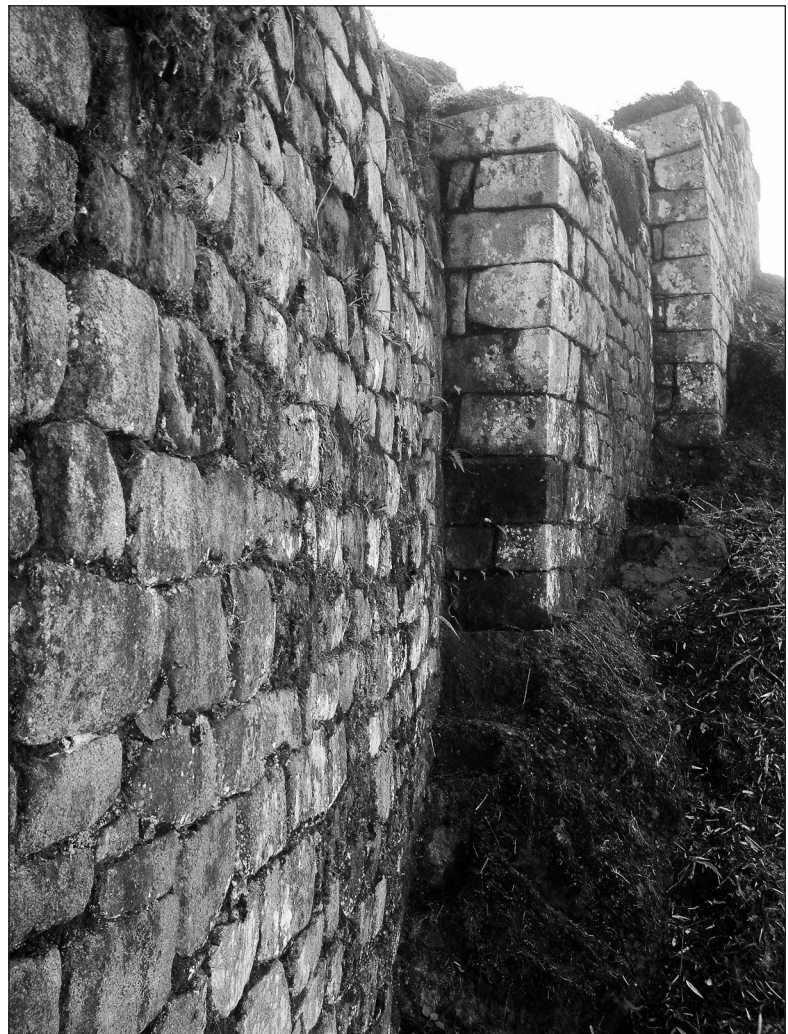
Figure 2.10. Like several sites in the Vitcos area, Pincollunca (Site 78) displays impressive Inca stonework (photograph by Brian S. Bauer and Miriam Aráoz Silva).

made stone blocks, slightly inclining walls, trapezoidal doors, and rectangular-trapezoidal internal niches (Figures 2.10 and 2.11). Radiocarbon samples from our excavations indicate that the Inca constructed the Yurak Rumi shrine complex in the early fifteenth century, a date that is consistent with the expansion of the Inca beyond the Cusco region (Chapter 3). We presume that this is when construction of other Inca installations of the region also began.

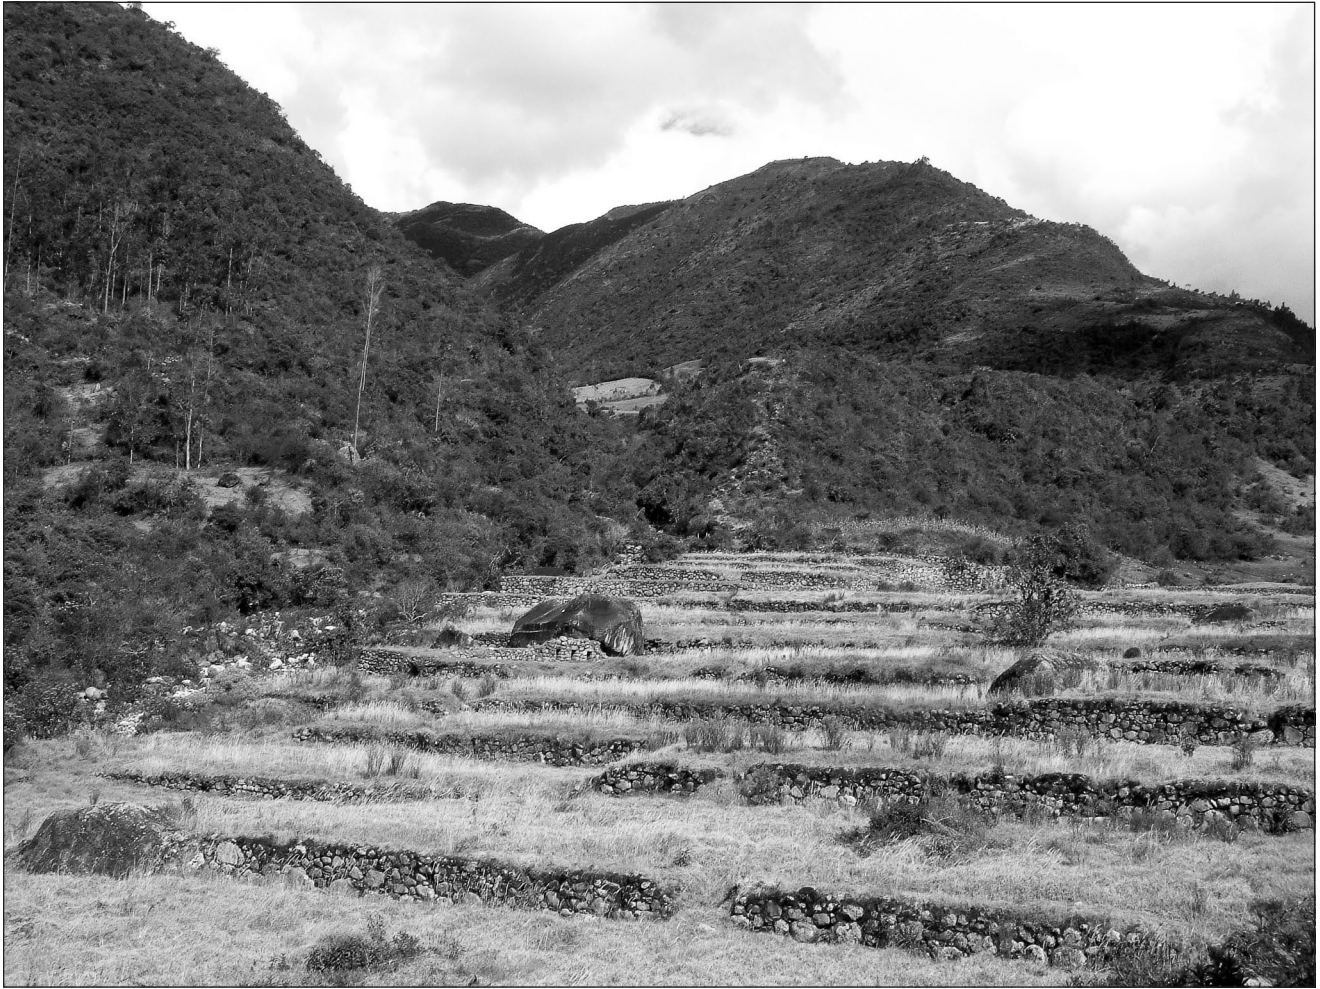
Figure 2.12. Large Inca terrace works at Vitcos (photograph by Brian S. Bauer and Miriam Aráoz Silva).

The strong hand of the Inca state can be clearly seen in the construction of several large terrace complexes near Vitcos. The easy access to water, the moderate climate, and the development of irrigating systems within the terrace complexes assured nearly constant agricultural production (Figure 2.12). It is presumed that the produce from these newly created lands was used to help support the Inca occupation of the region, which included the establishment of elite households as well as ritual complexes such as Yurak Rumi.

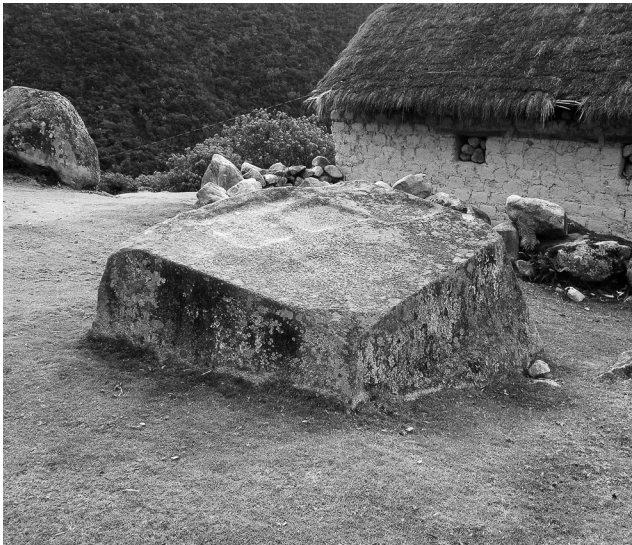
Figure 2.13. A large Inca stone block left in mid-production near Vitcos. Note the pecked areas on its surface (photograph by Brian S. Bauer and Miriam Aráoz Silva).

There are also several stone quarries located within the Vitcos Valley. Like the terrace systems, the quarries present strong evidence of the Inca state organizing the local population and most likely demanding tribute labor to construct the monumental buildings of the region. Inca construction activities at the site of Vitcos most likely started in the early fifteenth century and lasted for more than 150 years, but they were suddenly terminated with the 1572 Spanish raid into the Vilcabamba region.³ Lee (2000:471) has documented the location of many large building stones that appear to have been left en situ on trails within Vitcos; their transportation appears to have been stopped at a specific moment. These blocks indicate that construction was still an ongoing activity at Vitcos when the site was abandoned (Figures 2.13 and 2.14).

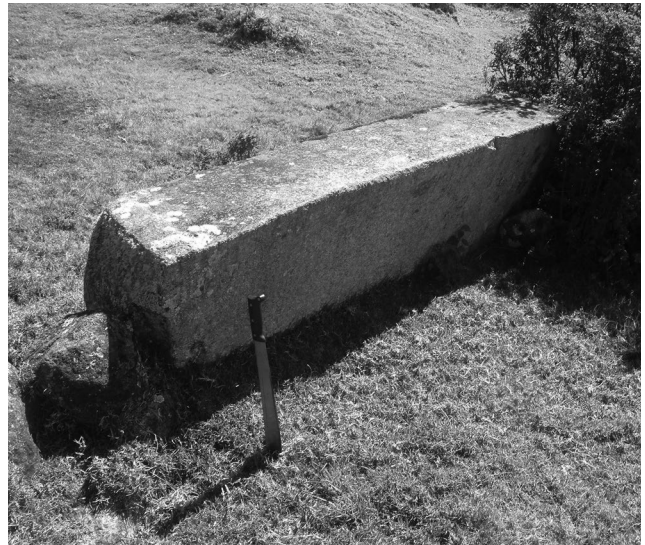
Figure 2.14. A large stone lintel in mid-production near Vitcos (photograph by Brian S. Bauer and Miriam Aráoz Silva).

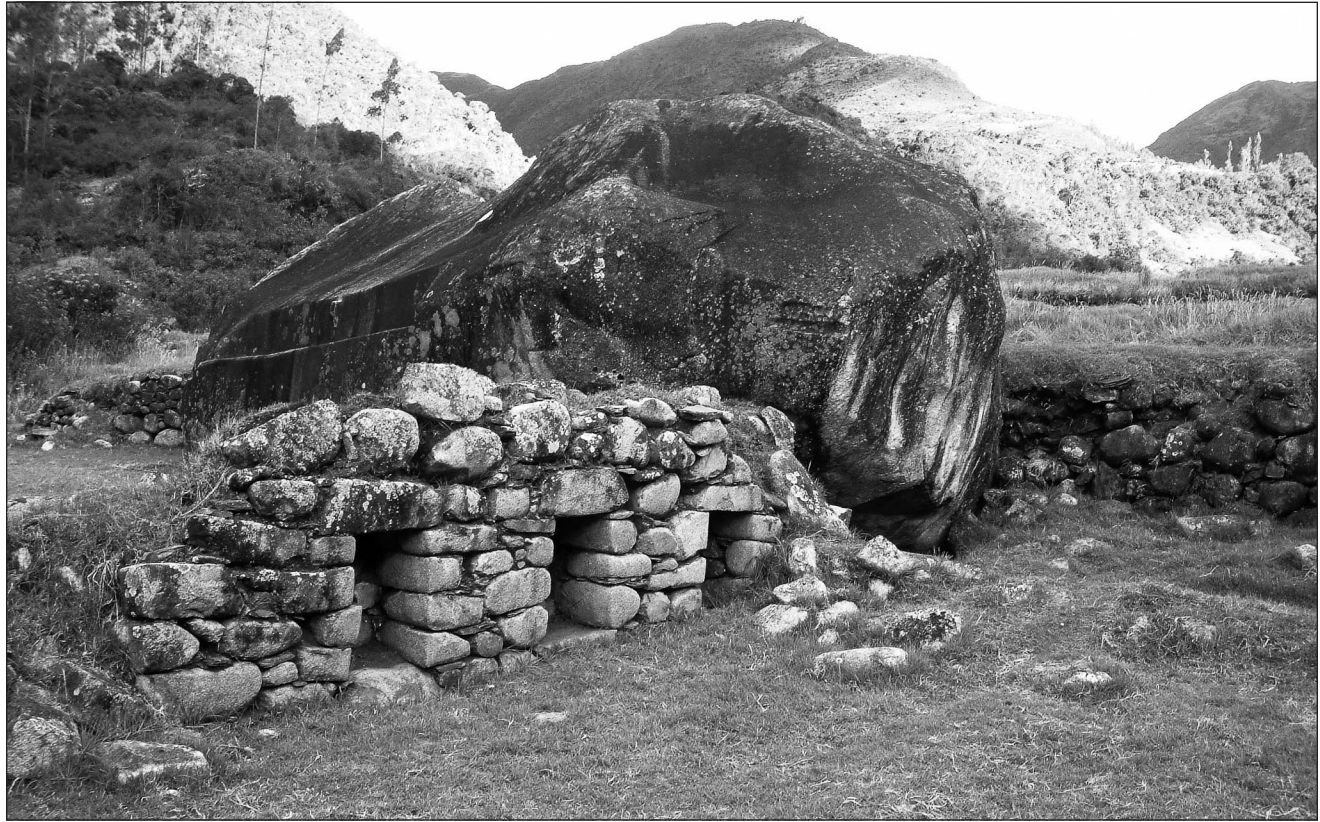
Figure 2.15. A large carved rock and an adjacent niched wall near Vitcos (photograph by Brian S. Bauer and Miriam Aráoz Silva).

Finally, we also note a concentration of carved outcrops on the valley floor. While clusters of carved outcrops are common in the Cusco Valley, they grow increasingly rare in the Inca hinterlands. Although the exact meaning of these carved rocks is not understood, they certainly mark the Vitcos Valley as a special place within the expanding state (Figure 2.15). Several of these carved outcrops appear to be stopped in midproduction, which is another indication that site planning was still occurring when the Spanish took over the region in 1572.

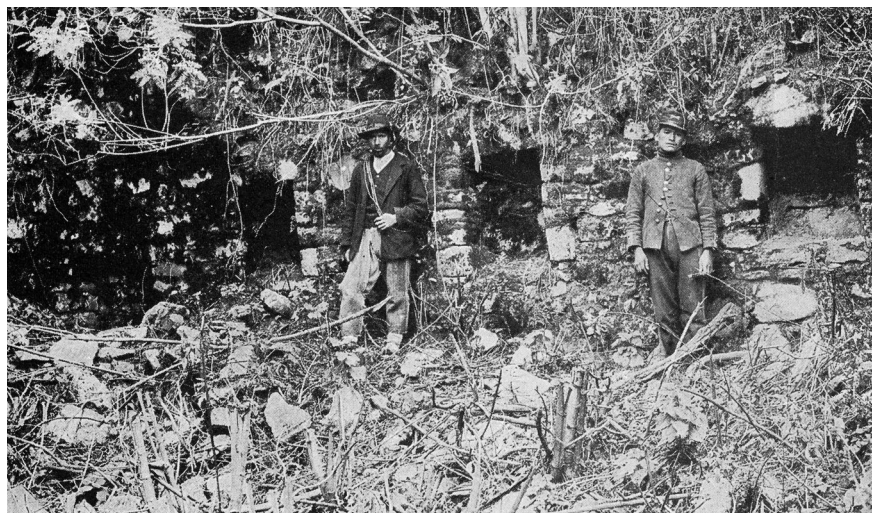
Figure 2.16. Uncapampa at the time of its first clearing in 1911 (Bingham 1912c:689).

Figure 2.11). Bingham documented this building on his first visit to Vitcos in 1911. In his very first publication concerning the results of his Vilcabamba fieldwork, Bingham (1912d:180) notes that his local guide called this building and its immediate terrace Uncapampa. He describes this site as containing “the ruins [of] a single house, 166 feet long by 33 feet wide. . . . There were six doorways in front, none on the ends or in the rear walls.” Bingham also provides a plan of the structure, which shows a series of interior niches that are still visible in the southeastern corner of the building. Elsewhere he provides a photograph of the interior of the building (Bingham 1912d:89). Although Bingham returned to the Vitcos region in 1912 and 1914–1915, there are no indications that he, or any member of his team, conducted excavations at the Kallanka (Figure 2.16).

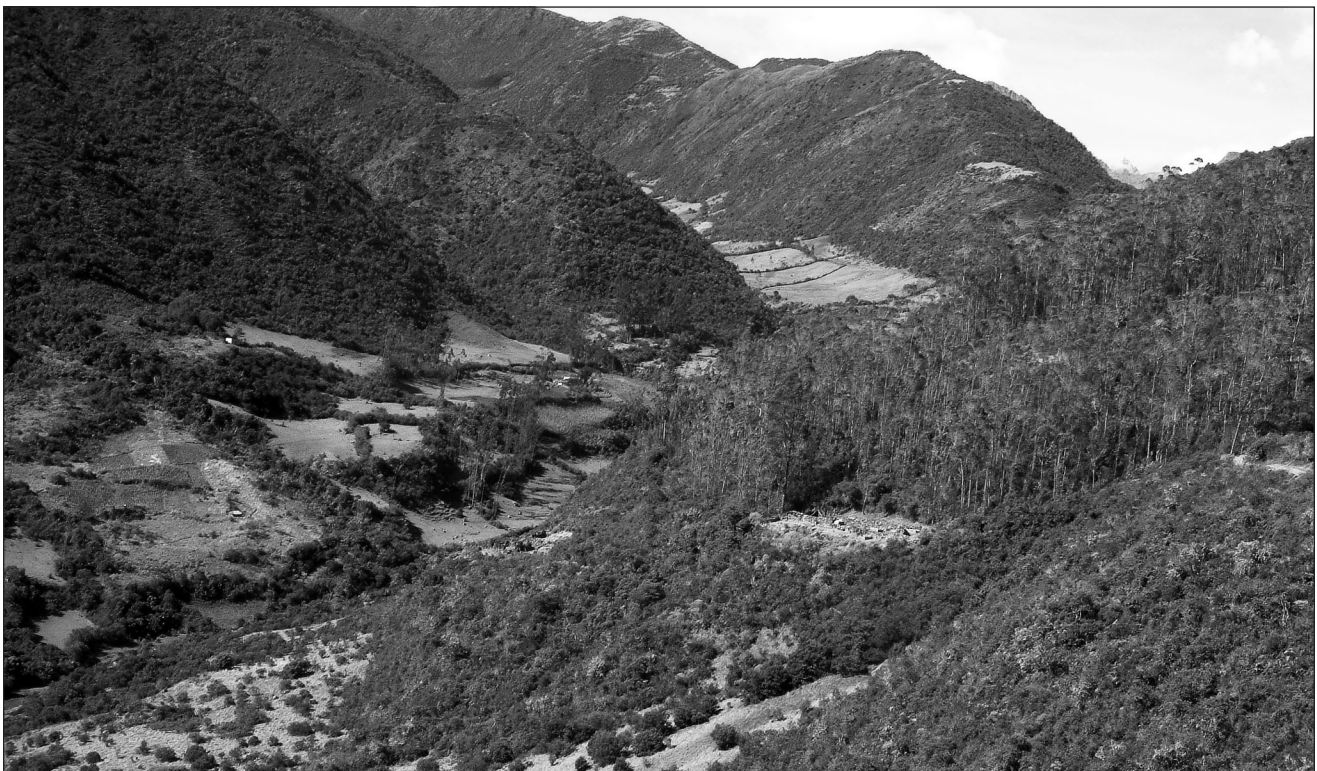
Figure 2.18. The Kallanka is located on a mountain slope within the site of Vitcos (photograph by Brian S. Bauer and Miriam Araújo Silva).

The Kallanka of Vitcos is located on the steep north-eastern slope of Cerro Hatun Moqo within the Rosaspata National Archaeological Park, somewhat isolated from other buildings in the site of Vitcos (Figure 2.18). It is situated approximately .5 km from the monumental sector of Vitcos to the northwest and more than 1 km from the shrine complex of Yurak Rumi to the southeast. To make room for the building, the Inca excavated into the natural subsoil of the mountain slope. There is a small, flat area extending 8 to 10 m directly in front of the building, which was most likely made with the earth removed from the mountain slope as the building was being constructed.
