Vilcabamba and the Archaeology of Inca Resistance

Brian S. Bauer, Javier Fonseca Santa Cruz, and Miriam Aráoz Silva

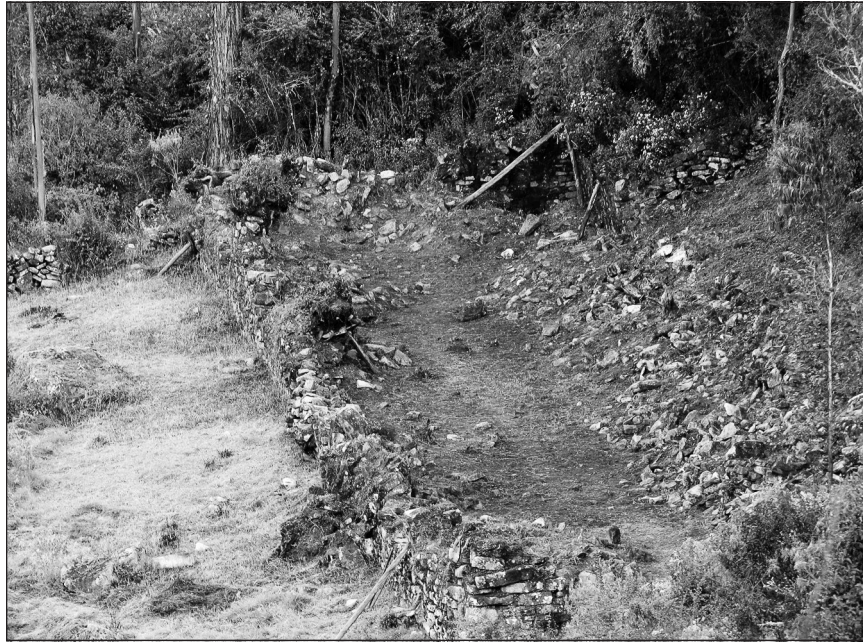
Figure 2.19. The Kallanka after being cleared of vegetation, 2009 (photograph by Brian S. Bauer and Miriam Aráoz Silva).

into the slope of the mountain. The building is in a poor state of conservation, with eroded earth covering most of its back wall and interior. Its front wall, which contains six slightly trapezoidal doorways, is also poorly preserved, with sections in various stages of collapse (Figures 2.19 and 2.20). The building had 5 internal niches on each end wall and perhaps as many 20 niches along its back wall. The remaining interior niches indicate that they were rectangular rather than the traditional trapezoidal shape. It is possible that the building also contained niches between the various doors in its front wall, but no evidence of them has survived.

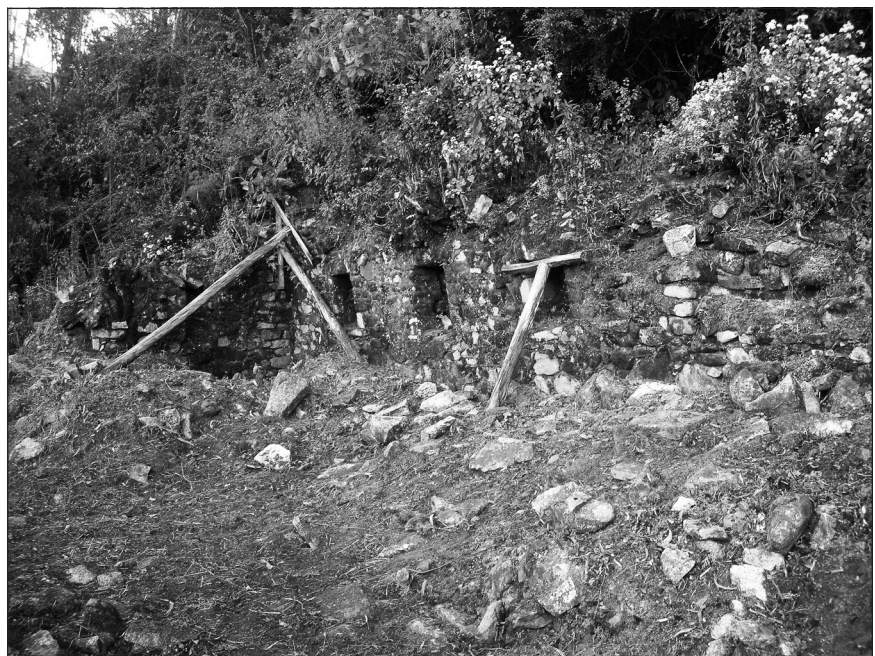
Figure 2.20. The southeastern corner of the Kallanka at Vitcos. The building still displays several features noted by Bingham in 1911 (photograph by Brian S. Bauer and Miriam Aráoz Silva).

- Figure 2.20.** The southeastern corner of the Kallanka at Vitcos. The building still displays several features noted by Bingham in 1911 (photograph by Brian S. Bauer and Miriam Aráoz Silva).

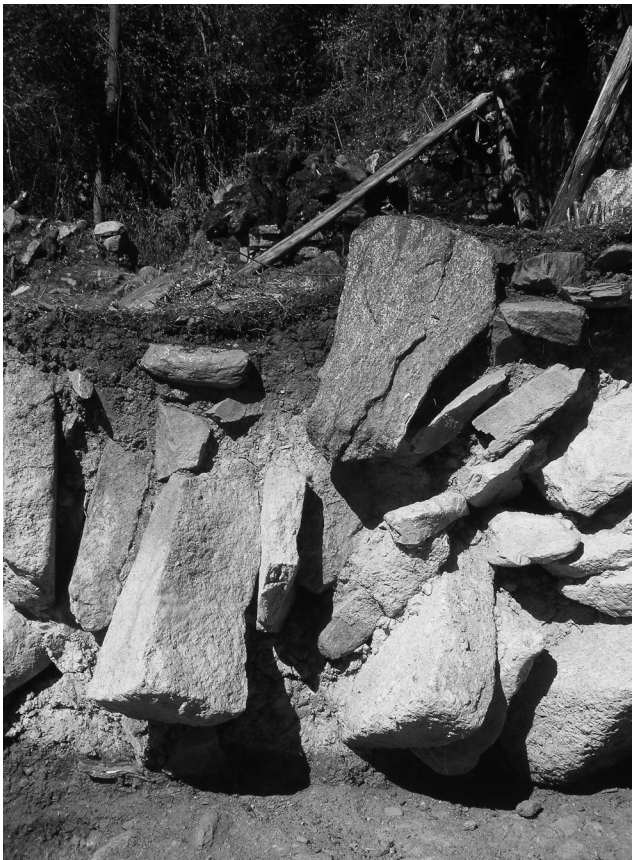
Figure 2.22. Profile of an excavation unit in the Kallanka (photograph by Brian S. Bauer and Miriam Aráoz Silva).

evidence of a well-prepared floor. The occupation level rested directly on the natural subsoil of the mountain that was exposed when the Incas dug into the hill slope to build the building (Figure 2.22).

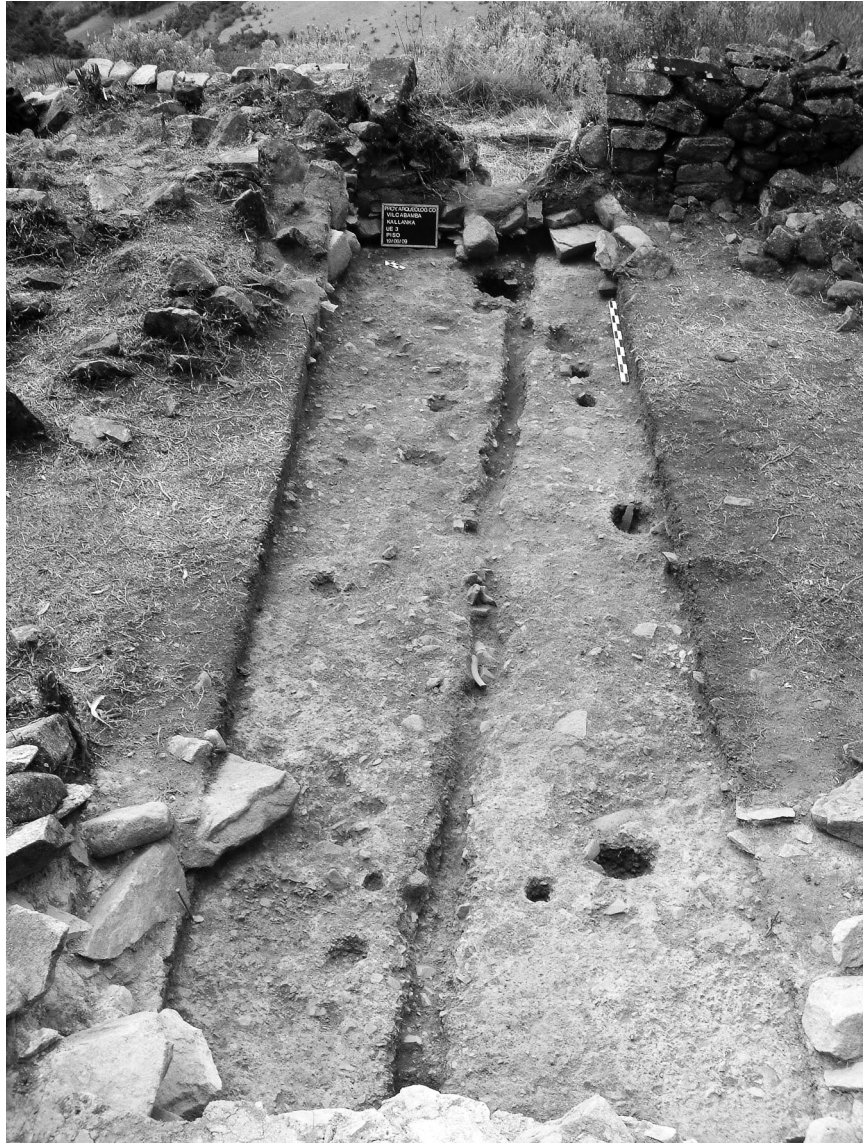
Figure 2.24. Excavations revealed a series of drainage canals under the floor of the Kallanka. Note the many postholes scattered across the floor (Unit 3) (photograph by Brian S. Bauer and Miriam Aráoz Silva).

All three of the excavation units within the Kallanka revealed similar features. There were many slight depressions in the floor, perhaps made to help support the base of large storage vessels. Two of the units exposed numerous postholes scattered across the floor. The postholes averaged 20 cm in width and 20 to 30 cm in depth. Many had pieces of ceramics or small stone slabs wedged around their edges, placed in an effort to better support the posts (Figure 2.23). Our excavation also revealed the remains of narrow drainage canals cut into the subsoil, running perpendicular to the building, in two of the units. These trenches were cut at the time of construction, relieved water pressure on the back (upslope) wall of the building, and allowed groundwater to drain under the building. The drainage channel in Unit 3 was the best defined (Figure 2.24). It crossed the width of the building. A hole at the far end allowed water to pass under the foundation of the building.

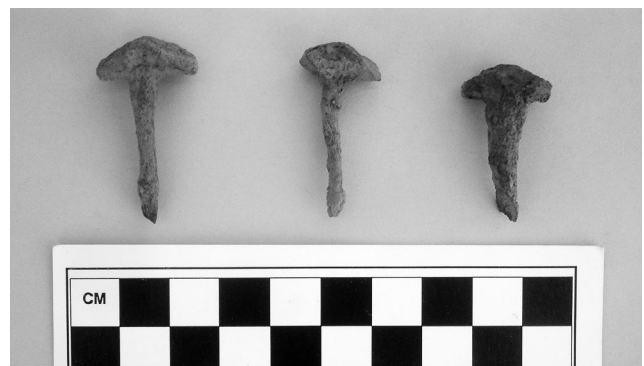
Figure 2.25. Three iron nails were recovered in Unit 5, directly in front of one of the doors of the Kallanka (photograph by Brian S. Bauer and Miriam Aráoz Silva).

proximately 25 cm. A thin level of cultural material, including small eroded pieces of ceramics and three iron nails, was recovered immediately above the floor (Figure 2.25). The location of these nails suggests that they were used in a wooden door, which has long since rotted away. These nails were the only materials of Western manufacture recovered in the building.

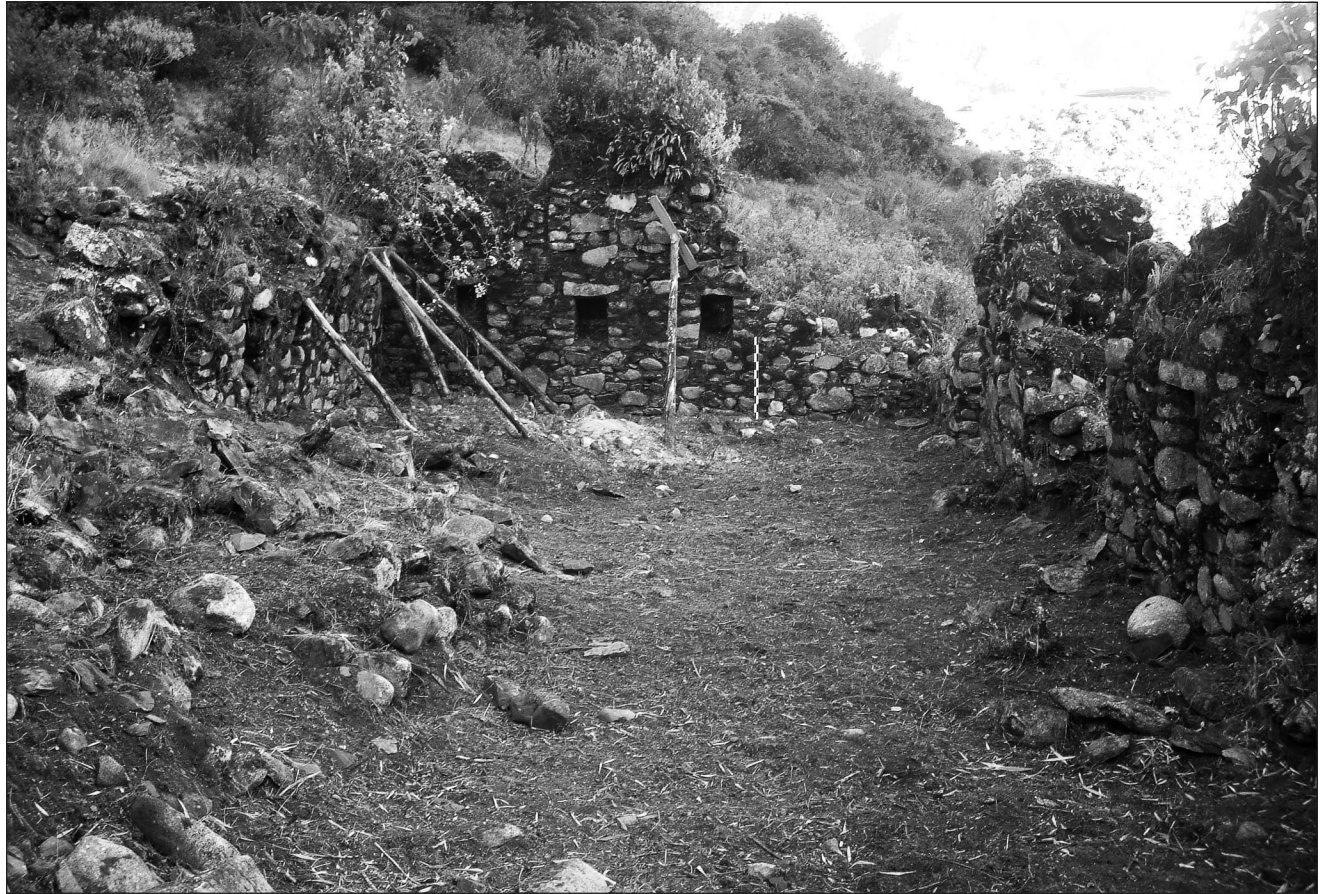
Figure 2.28. The lower structure after clearing but before excavations began (photograph by Brian S. Bauer and Miriam Aráoz Silva).

The buildings were cleared of trees several years before our 2009 work. However, they were heavily overgrown with underbrush. While the structures were still standing and various interior niches could be seen, most of the walls were supported by informal wooden poles and were near the point of collapse (Figures 2.27 and 2.28)

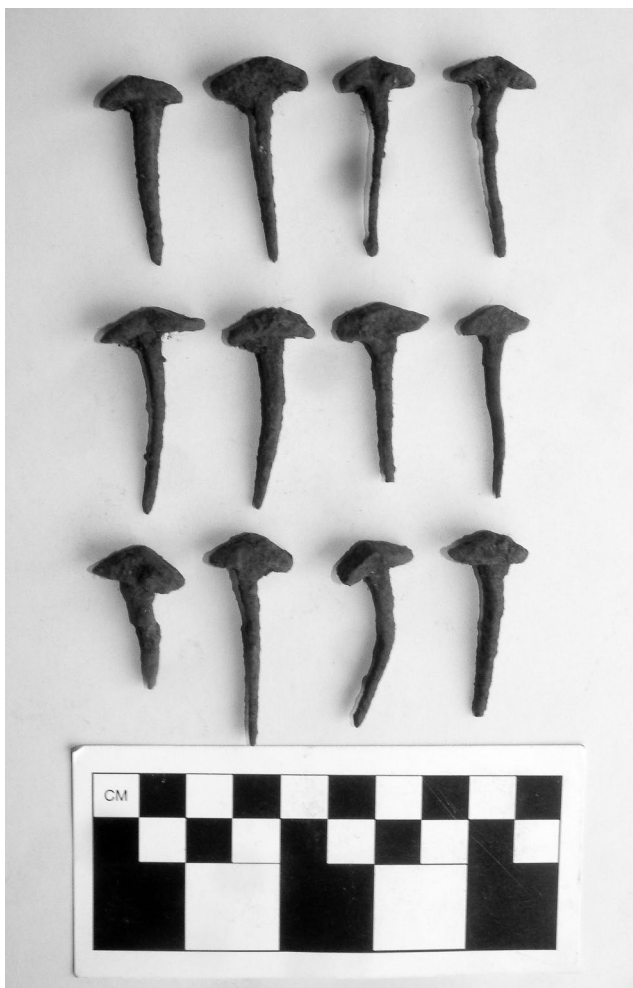
Figure 2.30. A sample of nails recovered from the Double Structures (photograph by Brian S. Bauer and Miriam Aráoz Silva).

in front of a door of the lower building. All three of these units yielded a small number of ceramics and various iron nails (Figure 2.30).

While our excavations in the Double Structures provided very limited ceramics, they did yield various metal objects. Twenty iron nails were recovered in Unit 2. Most of these nails were found near the doorway of the upper building. Unit 3 contained three nails, Unit 4 provided four nails, and Unit 5 yielded a single nail, for a total of 28 iron nails. No other objects of European origin were recovered in the excavations.

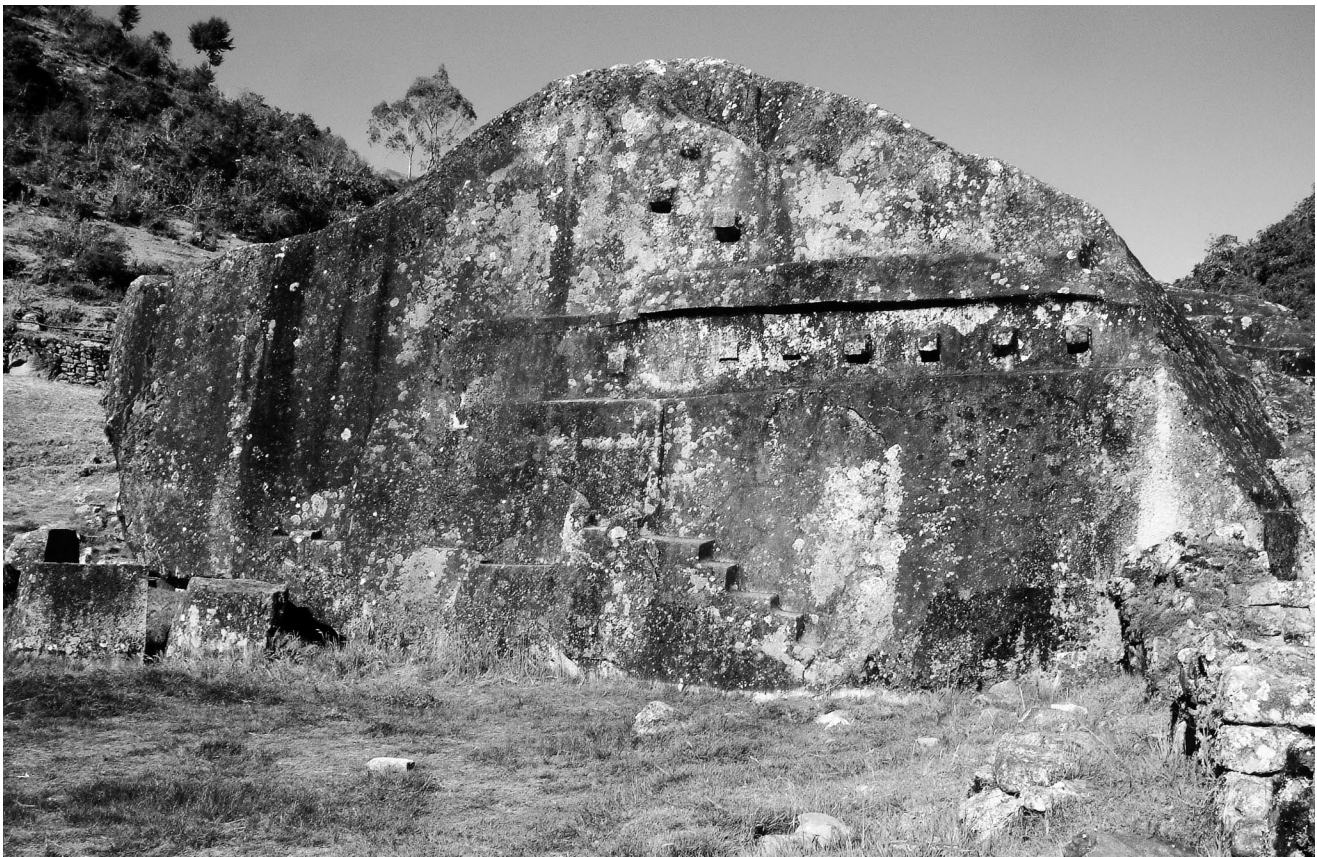
Figure 3.8. The north side of Yurak Rumi contains a steep face and various square protuberances (photograph by Brian S. Bauer and Miriam Araújo Silva).

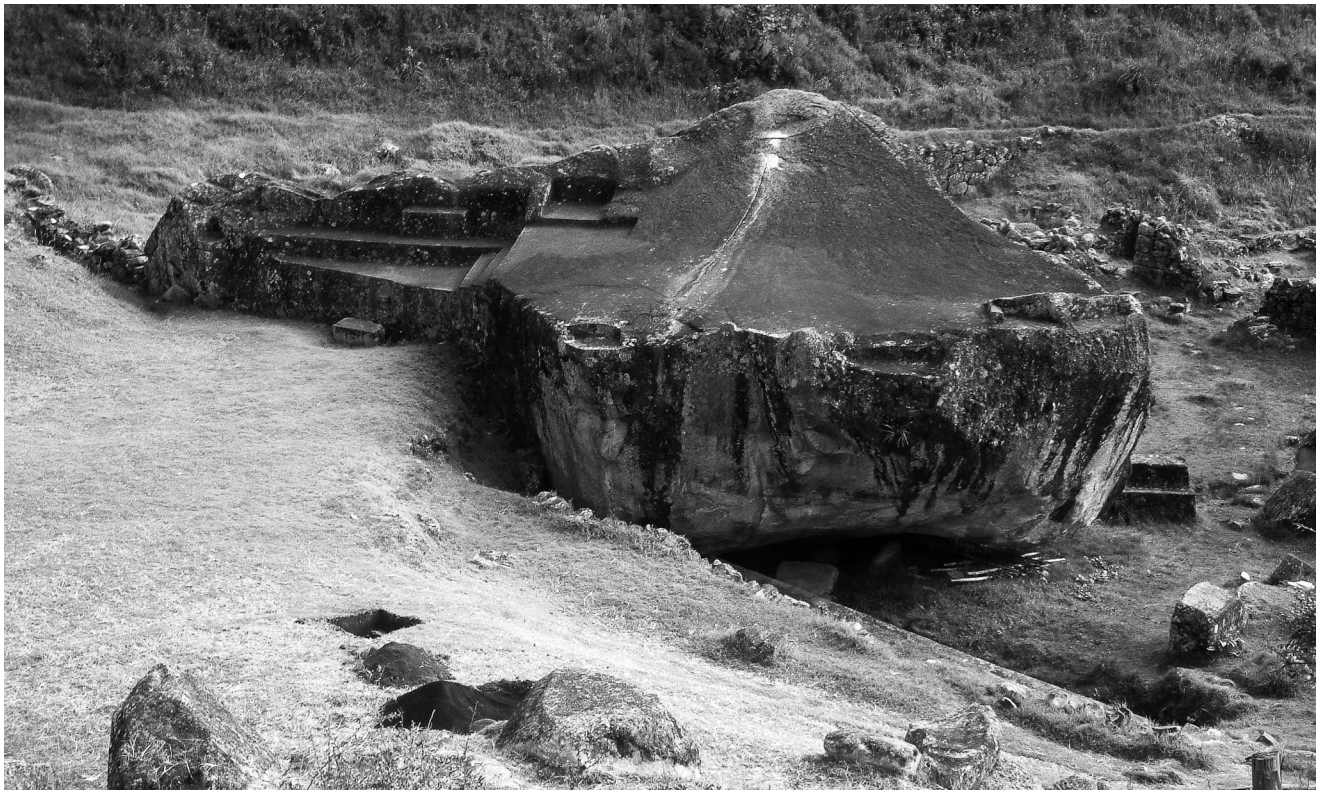
Figure 3.10. The east side of Yurak Rumi contains a few small “seats.” It also overhangs the spring that gives fame to the complex (photograph by Brian S. Bauer and Miriam Aráoz Silva).

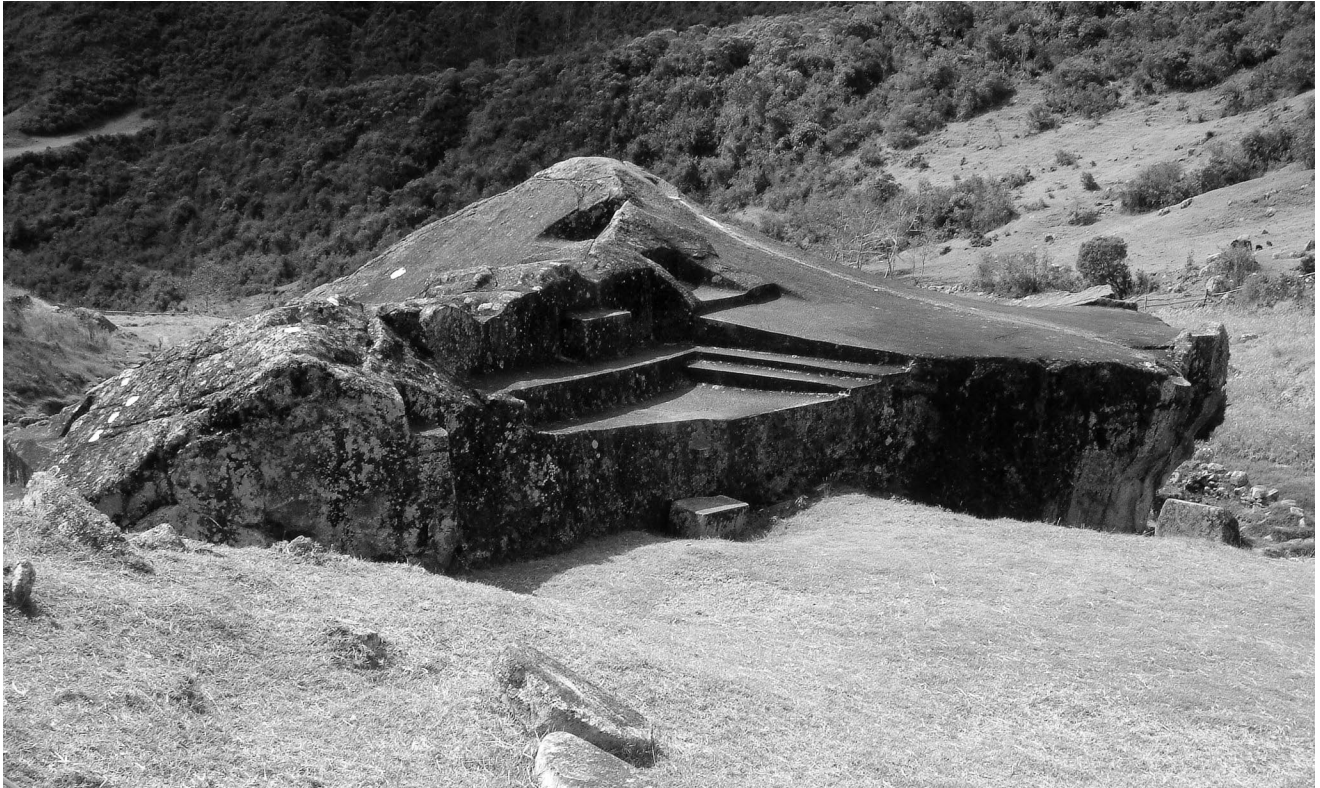
Figure 3.11. The south side of Yurak Rumi contains a series of carved, triangular, horizontal plains. It is a stunning combination of carved and natural surfaces (photograph by Brian S. Bauer and Miriam Aráoz Silva).

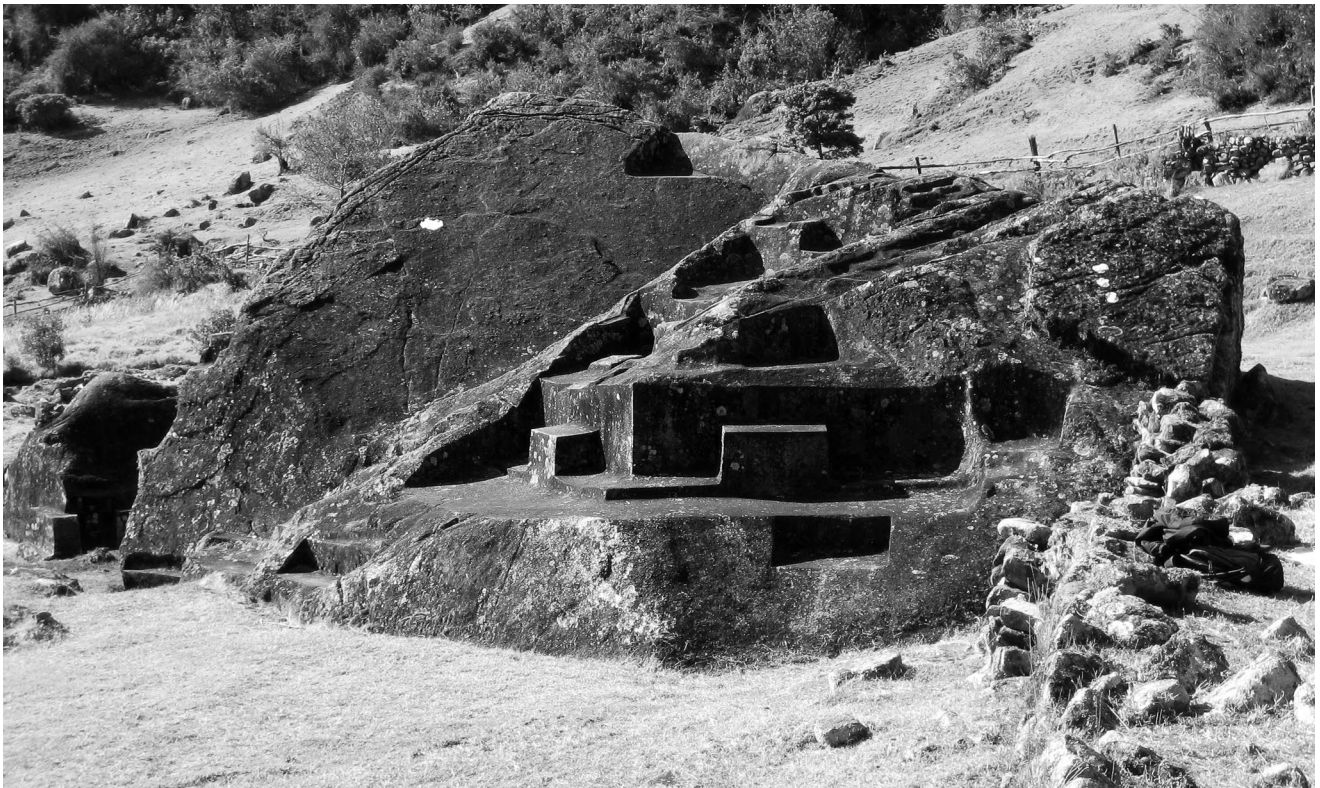
Figure 3.12. The west side of Yurak Rumi is covered in a complex series of carvings (photograph by Brian S. Bauer and Miriam Aráoz Silva).

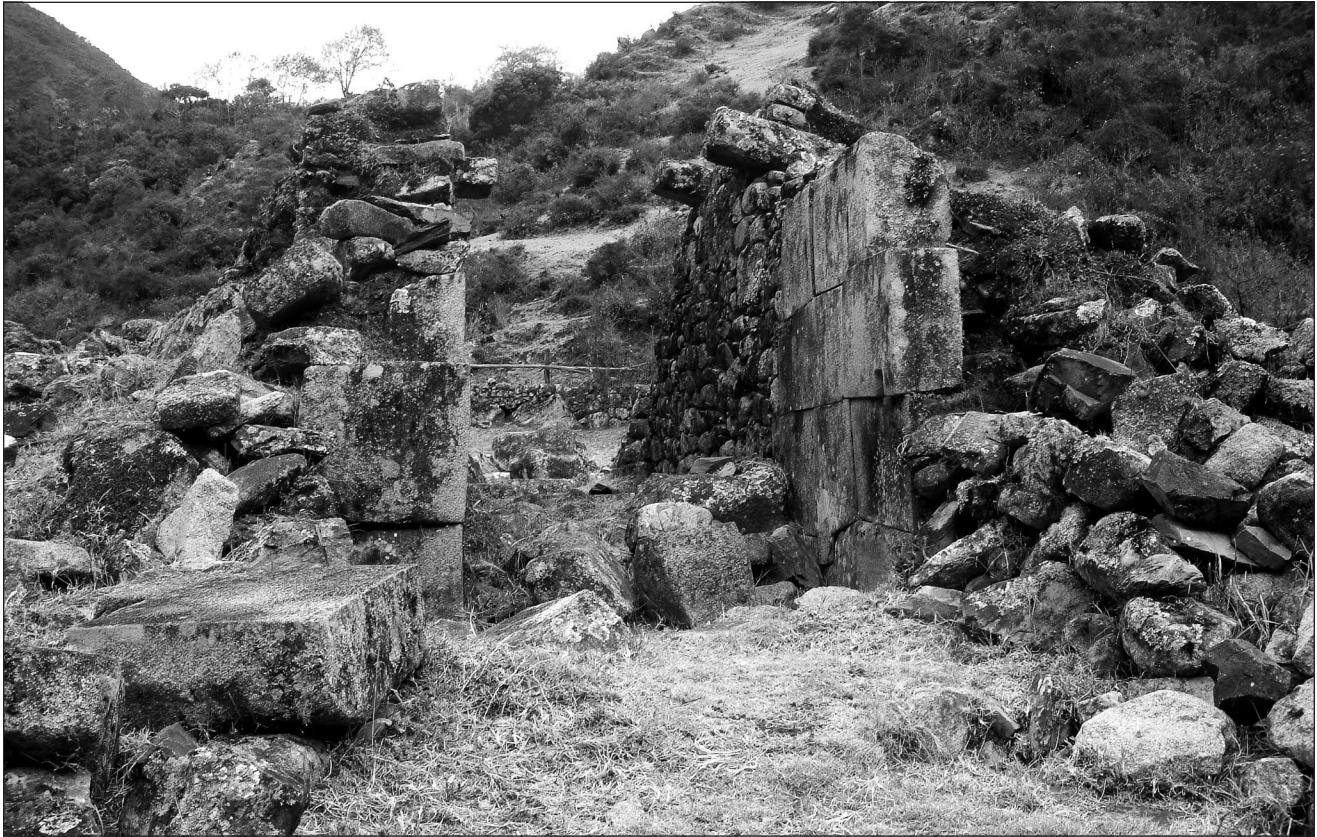
Figure 3.15. An east–west passageway was a major feature of Yurak Rumi at the time of the Inca occupation (photograph by Brian S. Bauer and Miriam Aráoz Silva).

One of the most notable features of the shrine complex is an east–west passageway that leads between the twin buildings and connects the plaza with an interior courtyard (*cancha*). Although now poorly preserved, the entrances to this passageway contain exceptionally large and well-worked granite blocks. Other large blocks, including lintels, are found scattered in disarray on either side of the passageway. The shapes of some of the fallen stones indicate that both of the entrances once contained double niches. The twin buildings on either side of the passageway also display the remains of four large rectangular stones set in the gables.⁷ At the time of occupation, these stones served as entrances to second-story rooms (Figure 3.15).

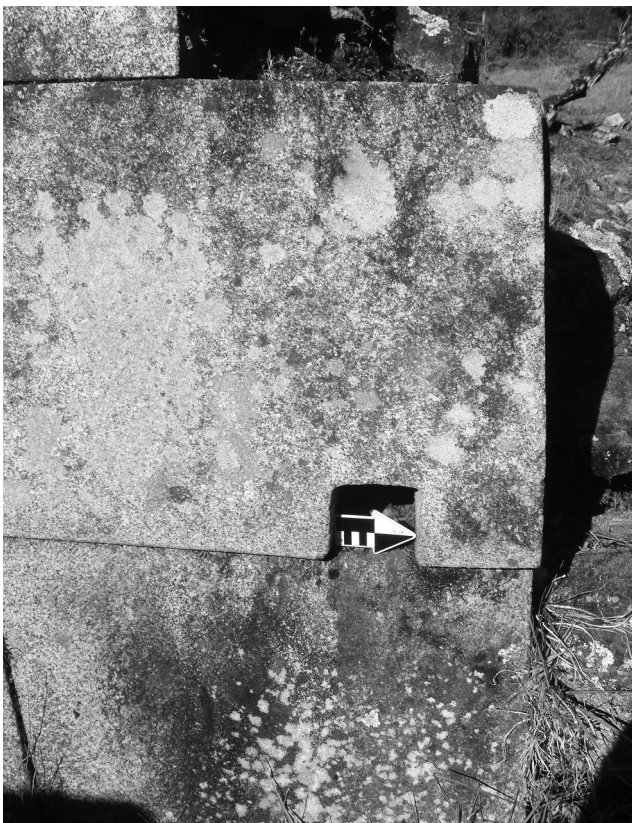
Figure 3.16. (left) Door support hole at Yurak Rumi (photograph by Brian S. Bauer and Miriam Aráoz Silva).

Two small rectangular holes are on either side of the west entrance of the passageway that leads between the plaza area and the southwestern courtyard (Figure 3.16). Similar holes have been noted at many other imperial Inca sites, and they may have supported some kind of door. Identical holes can be found in the three major passageways that lead off the central plaza of Vitcos (Rosaspata).

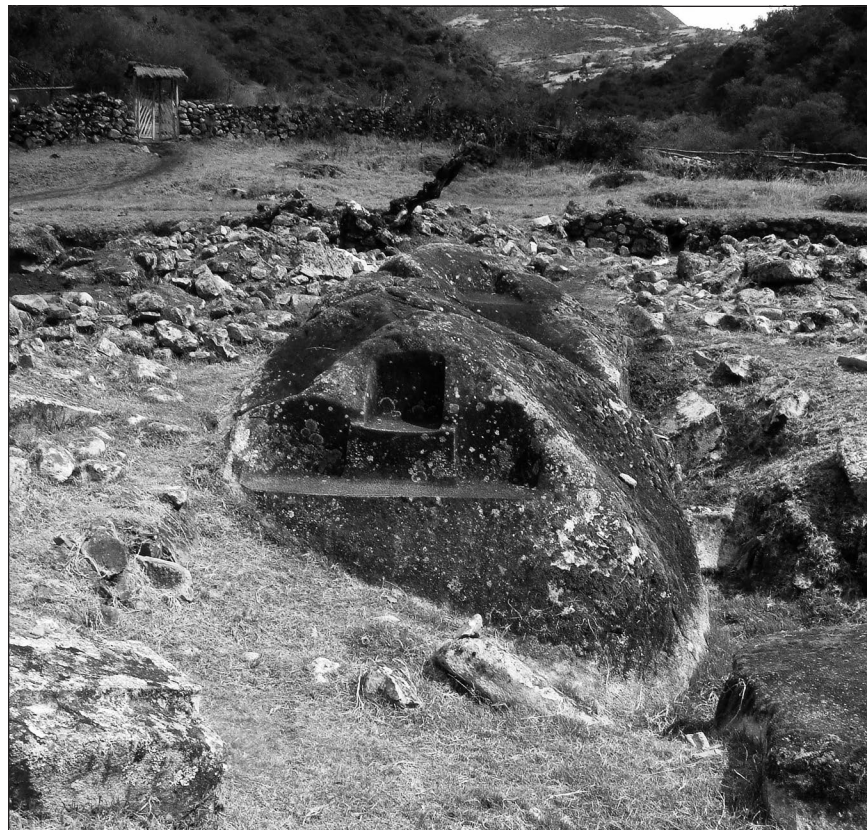
Figure 3.17. Near the center of the southwestern courtyard is a large carved rock. The area surrounding it was looted before Bingham’s 1911 visit (photograph by Brian S. Bauer and Miriam Aráoz Silva).

A large (8 x 4 m) rock, which holds several carved “seats” and “steps,” dominates the center of the southwestern courtyard. An immense looter’s pit and its resulting back dirt surrounds this carved rock (Figure 3.17). The looting event has also exposed a second, slightly smaller rock. Although this second rock is flat, it does not appear to have been worked. We es-

timate that the second rock would have been 1 or 2 m below the surface of the *cancha* while the shrine was in use. The fact that Bingham’s drawing of the site shows this flat rock suggests that the large looter’s pit was dug before his visit to Yurak Rumi in 1911.

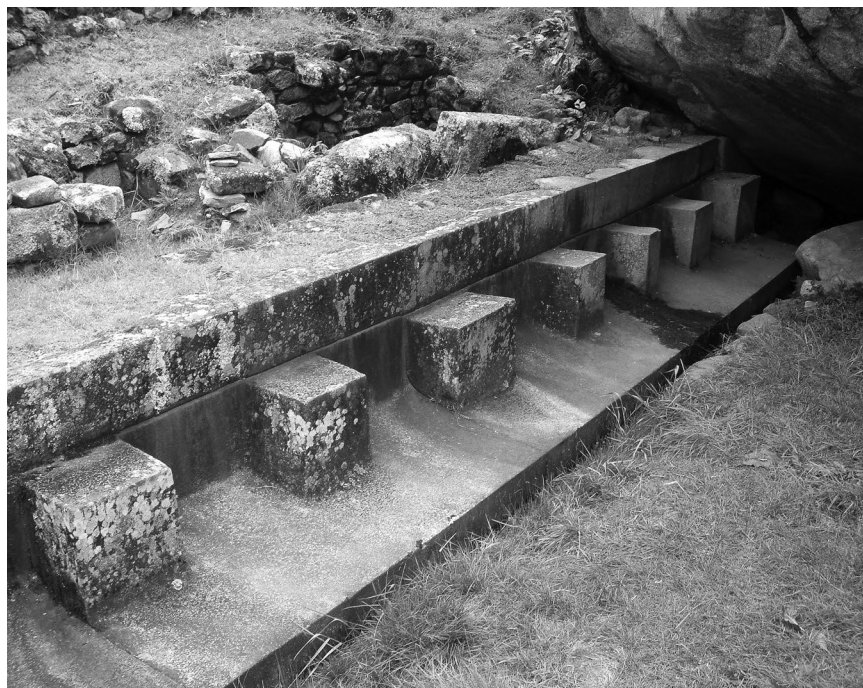
Figure 3.18. A finely carved bench at the base of Yurak Rumi marks the emergence of a sacred spring (photograph by Brian S. Bauer and Miriam Aráoz Silva).

The area to the north of the rock is more than 3 meters lower than the south sector of the shrine complex. Its most important feature, which is marked by a wondrously carved stone bench, is the small spring that emerges from beneath the rock (Figures 3.18 and 3.19). The ground surface at the base of the rock is about at water level, and even a light rain can create areas of standing water and swampy conditions. An informal, shallow ditch now takes surface water from this area and drains it to the north of

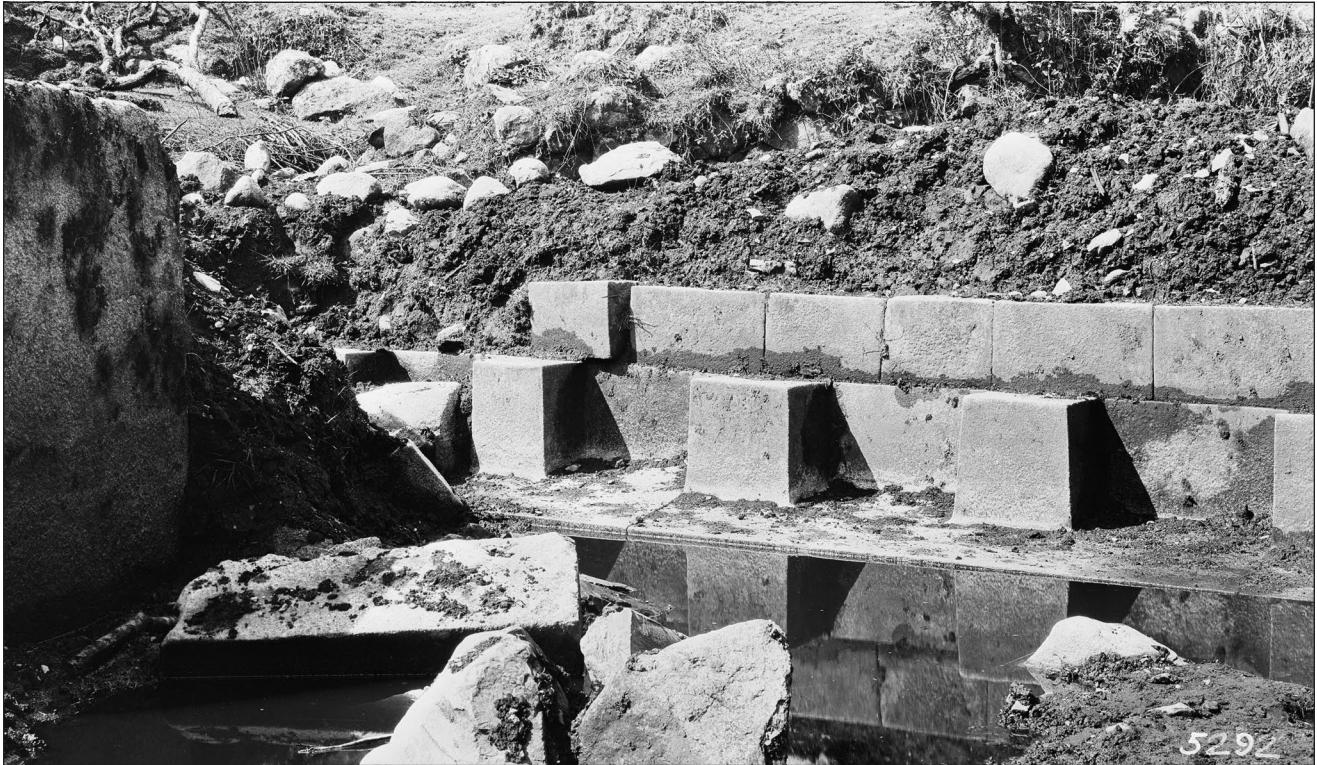
Figure 3.19. (above) The finely carved bench at the base of Yurak Rumi after Bingham’s 1912 excavations (National Geographic Image Collection: negative 786176, photograph by Hiram Bingham).

The spot at which the spring emerges beneath the rock is marked by an exceptionally well-crafted stone bench with a series of nine niches. The bench is approximately 9 m long and has been crafted from four large granite blocks. Bingham was especially impressed with this feature of the site. He took several photographs showing its excavation (Bingham 1913:553–554, 1922:250) and included a drawing of it in his field notes (Figure 3.20).

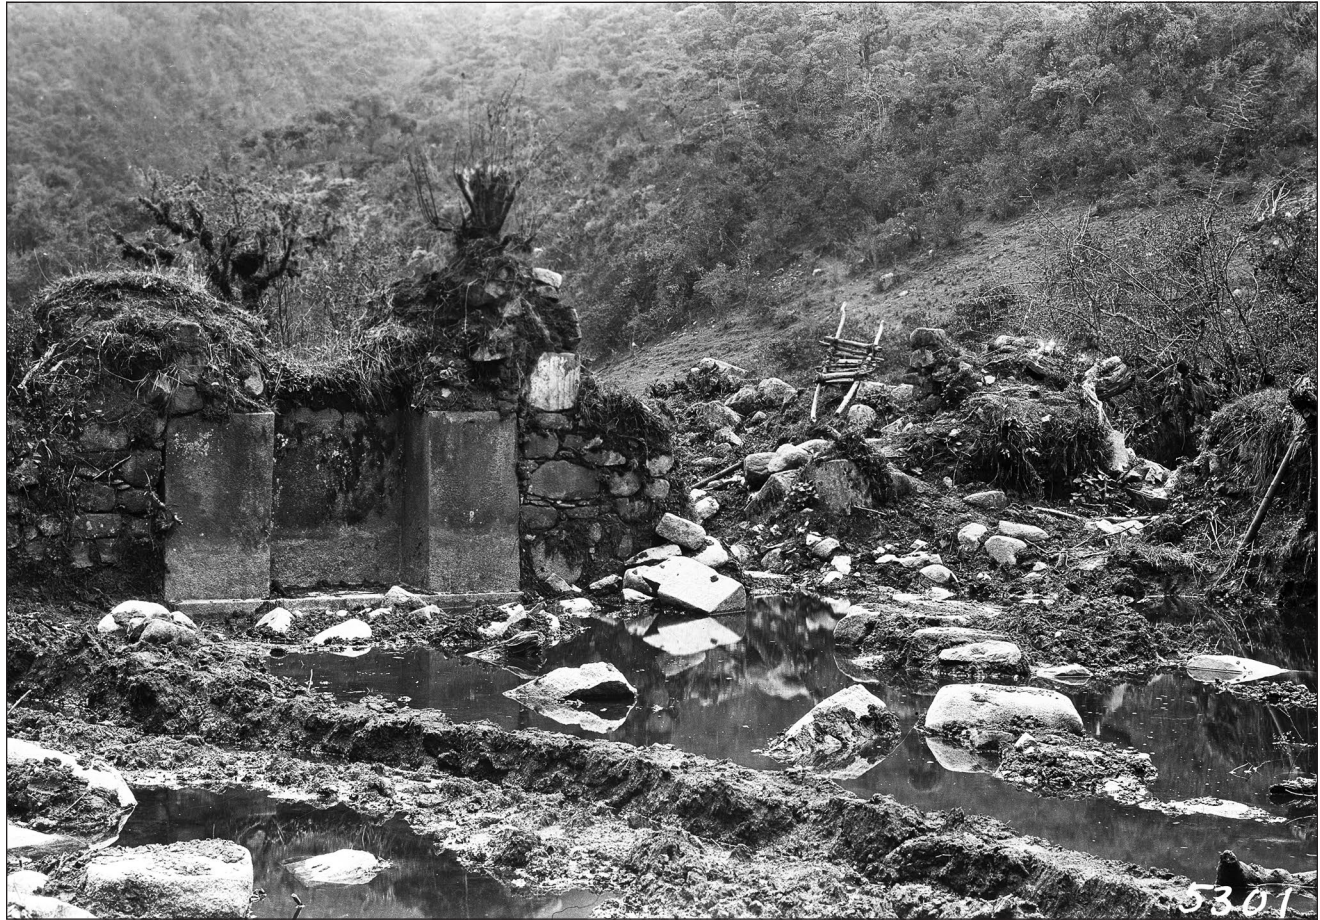
Figure 3.21. The northeastern courtyard during Bingham’s 1912 excavations. The trench that he dug to drain the courtyard can clearly be seen in this photograph, as can the large single-block external niche that faces the Yurak Rumi (National Geographic Image Collection: negative 786180, photograph by Hiram Bingham).

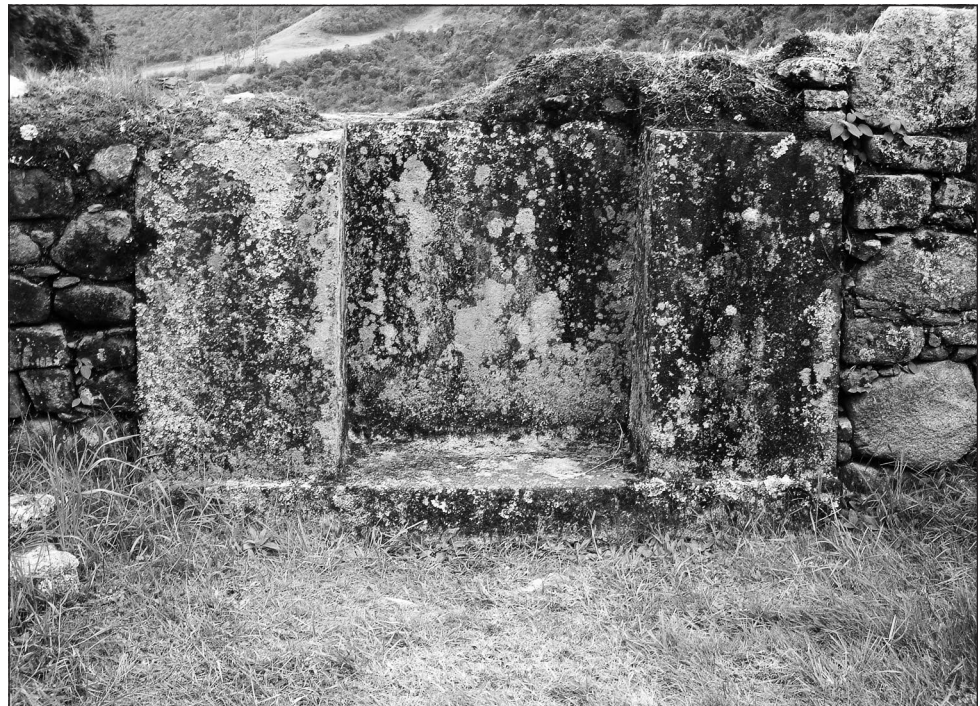
Figure 3.22. The building directly facing the rock contains a large niche made from a single block of granite (photograph by Brian S. Bauer and Miriam Aráoz Silva).

the west side of the courtyard. This building had two doorways and is now badly looted. The northernmost building is the only structure at the site that directly faces the rock. This building has two doorways, but it is most notable for a large central exterior niche, built from an impressive single block of granite, that faces the rock (Figures 3.21 and 3.22). No other building at the site contains a similar feature. The third building, now poorly preserved, forms the northeastern corner of the courtyard.

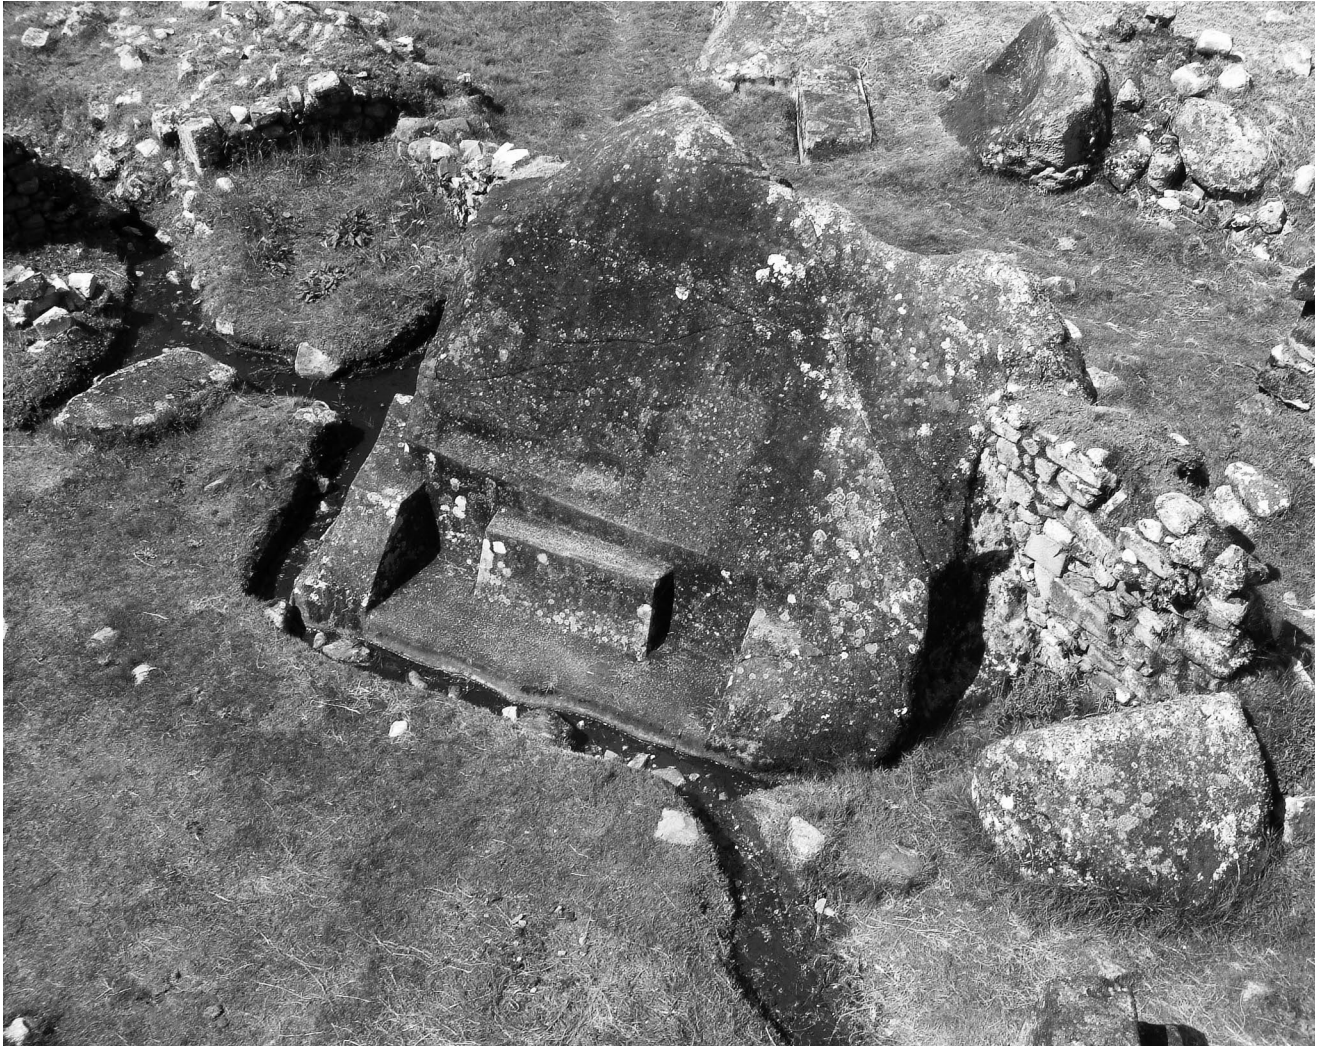
Figure 3.23. There are several carved rocks in the area north of Yurak Rumi. The stream that winds around this carved rock comes from beneath Yurak Rumi. In Inca times, the water would have flowed along a different course within a stone-lined canal (photograph by Brian S. Bauer and Miriam Aráoz Silva).

There are also the remains of a walled passageway that may have once linked the plaza area of the site with the northeastern courtyard, as well as a double-niched doorway that served as the formal north entrance to the shrine complex. Near the center of the northeastern courtyard is a large, ornately carved rock (Figure 3.23); a series of smaller carved rocks are scattered across the

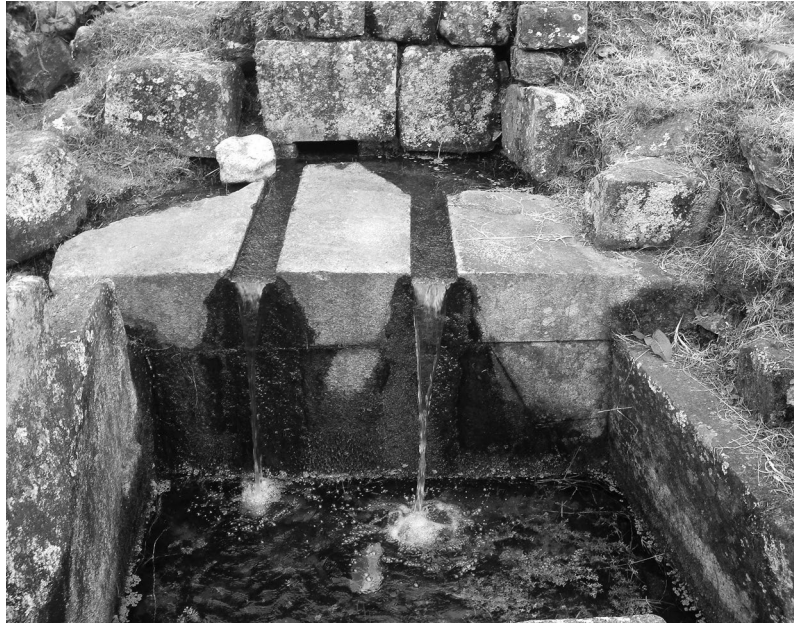
Figure 3.24. The Inca fountain at Yurak Rumi (photograph by Brian S. Bauer and Miriam Aráoz Silva).

A second, much larger spring is located about 45 m north of the rock. The water emerges at the base of a large terrace and flows through a stone-lined canal to an elegant two-spouted fountain and bath (Figures 3.24 and 3.25). The water then continues within a wide canal for some 30 m down the course of the valley.

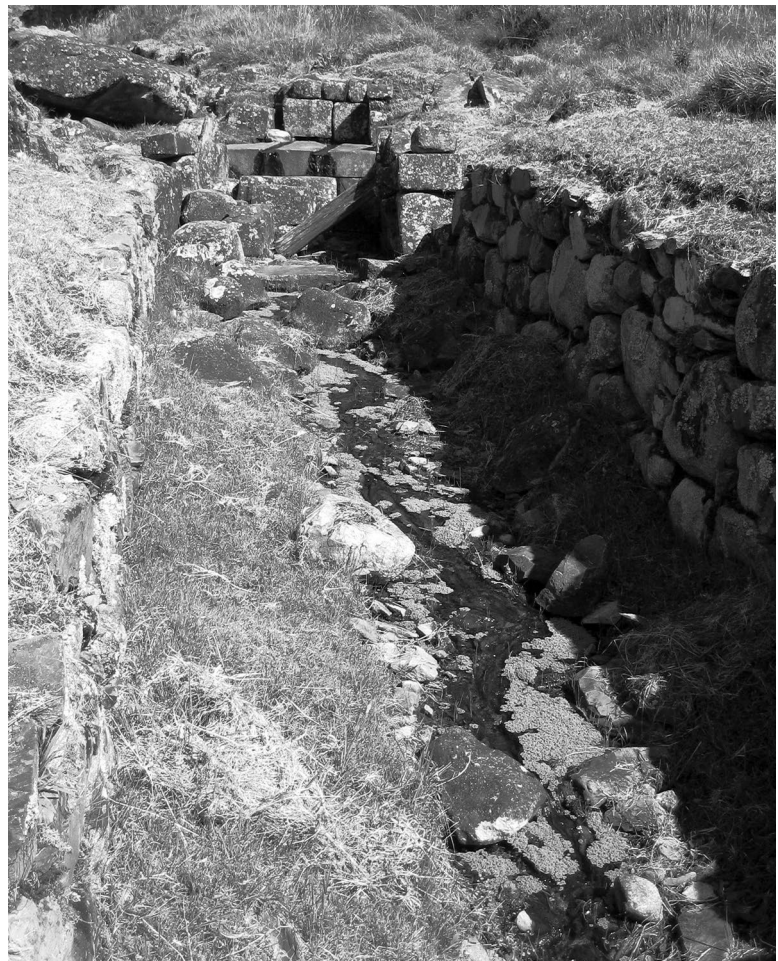
Figure 3.25. The large canal leading down from the dual fountain and bath (photograph by Brian S. Bauer and Miriam Aráoz Silva).

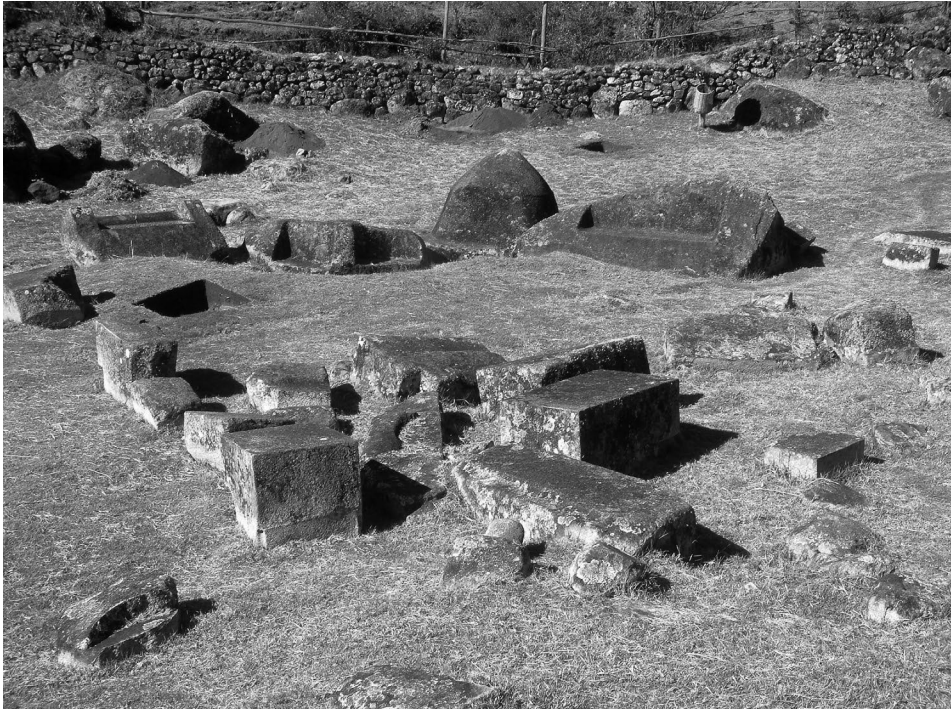
Figure 3.26. The plaza of Yurak Rumi, showing many stone blocks (foreground) used in construction of the buildings and several carved rocks. In this picture, a suite of four carved stones can be seen in the background (photograph by Brian S. Bauer and Miriam Araújo Silva).

The shrine complex also contains more than a dozen smaller carved stones (Figure 3.26). Most of these appear to be boulders that were deposited in the valley during its glacial past and then worked by the Inca. While most of the carved rocks seem to be in their final desired forms, one of the largest carved rocks at the site contains an incomplete “shelf,” suggesting that the carving may have been ongoing until the site was abandoned (Figure 3.27).

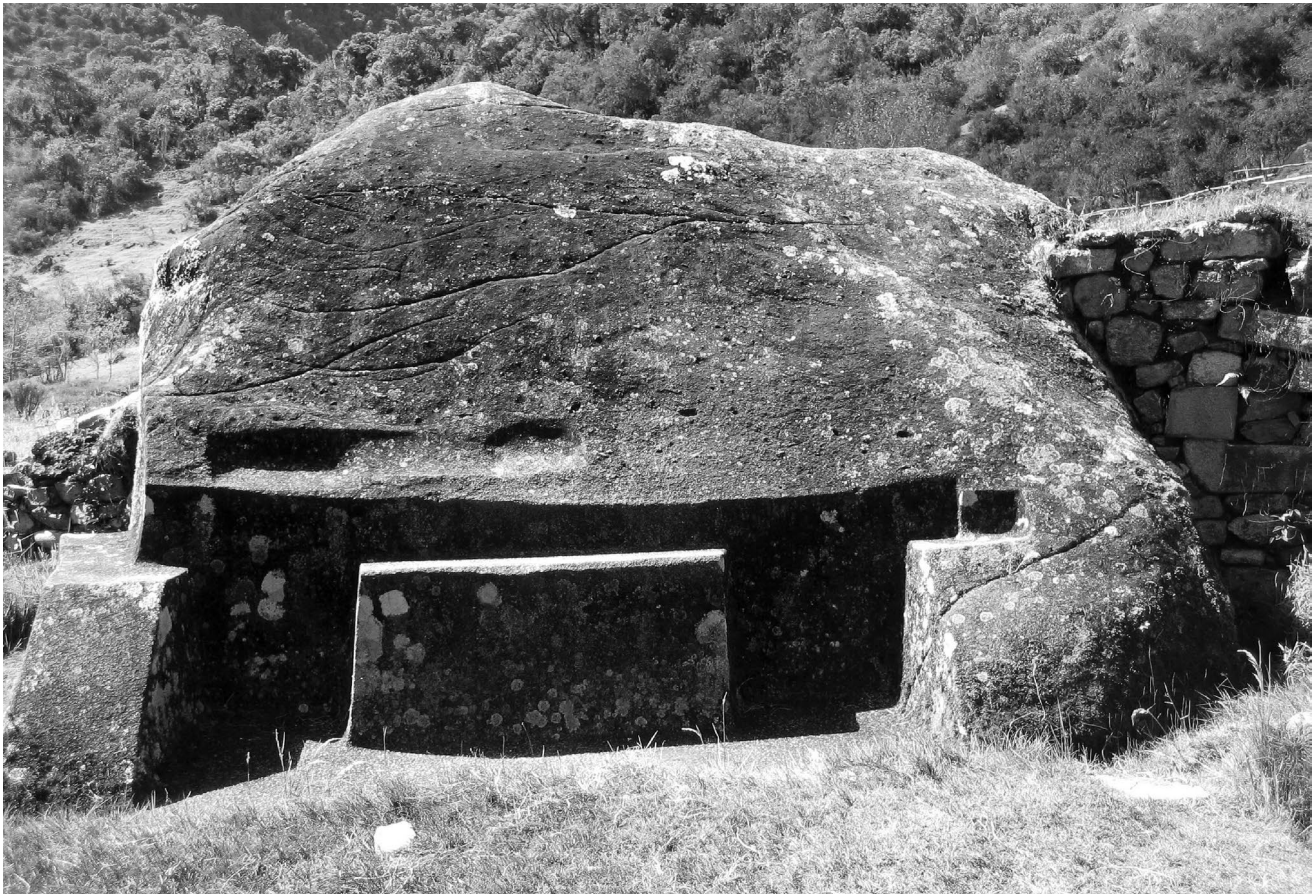
Figure 3.27. This large outcrop, located in the northeastern courtyard, has an unfinished “shelf.” Craftsmen were working from the left side toward the center of the stone but stopped midway through the process. This suggests that rock carving was a continuous process occurring at the site until its final abandonment (circa 1572) (photograph by Brian S. Bauer and Miriam Araújo Silva).
