Vilcabamba and the Archaeology of Inca Resistance

Brian S. Bauer, Javier Fonseca Santa Cruz, and Miriam Aráoz Silva

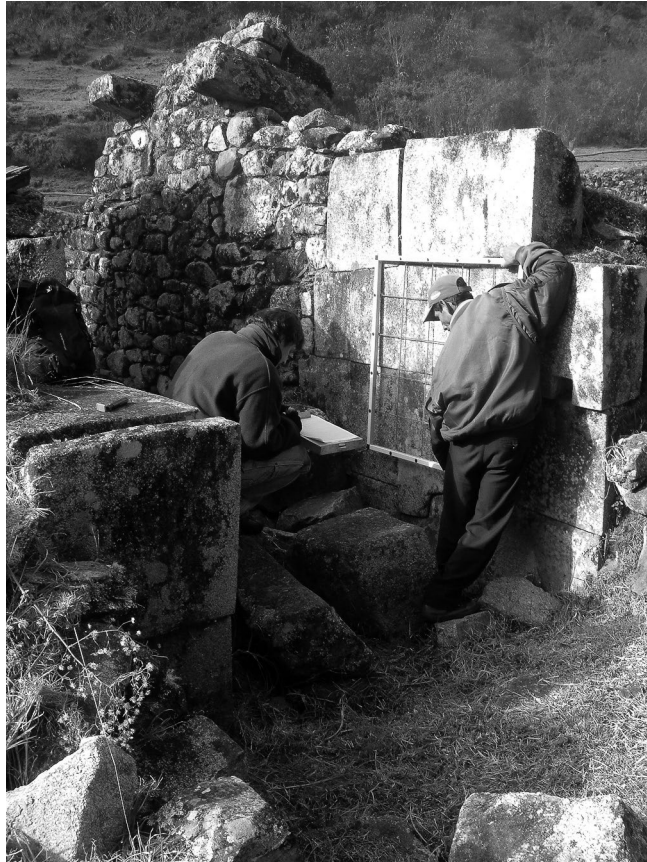
Figure 3.28. (left) The large passageway stone blocks at Yurak Rumi (photograph by Brian S. Bauer and Miriam Aráoz Silva).

The buildings at the site are mostly made of moderately sized worked and natural stones held together with small spacer stones and earth mortar. The doorways, corners, and niches of the buildings are built with slightly larger, well-shaped, closely fitting granite blocks (Figure 3.28). The stones that define the entrances to the southwestern courtyard represent exceptions. Like the blocks used in the doorways in the plaza of Vitcos (Rosaspata), the courtyard passageways at Yurak Rumi were outlined with large stone blocks, many measuring more than 1 m in length and height. The entrances also contained massive lintel stones, which can still be seen lying nearby.

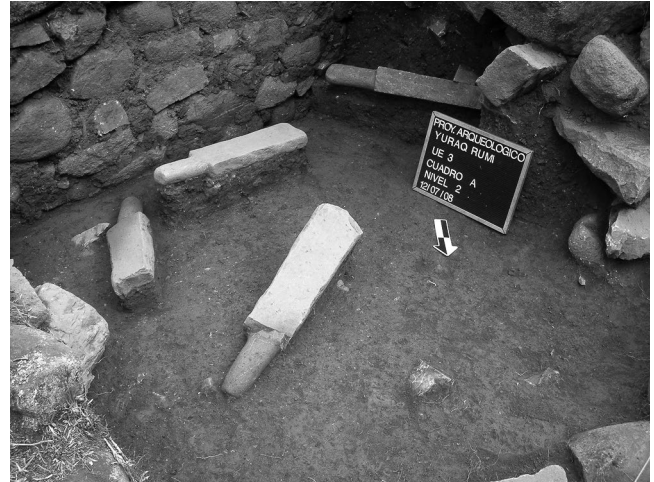
Figure 3.29. (above) Unit 3 contained various roof pegs at the same level. They appear to have been pulled from the gables after the building was abandoned (photograph by Brian S. Bauer and Miriam Aráoz Silva).

Our excavations recovered various stone pegs, used to secure the roofs of buildings to the walls. Similar roof pegs can be seen in place in many different Inca sites in the Vilcabamba region and across the imperial heartland. As the pegs were generally recovered well above the 1570 destruction level, it seems that they were pulled from the gables during a later looting or general desecration event; in some cases, they may have simply fallen as the upper walls of the buildings became unstable over the centuries (Figure 3.29).

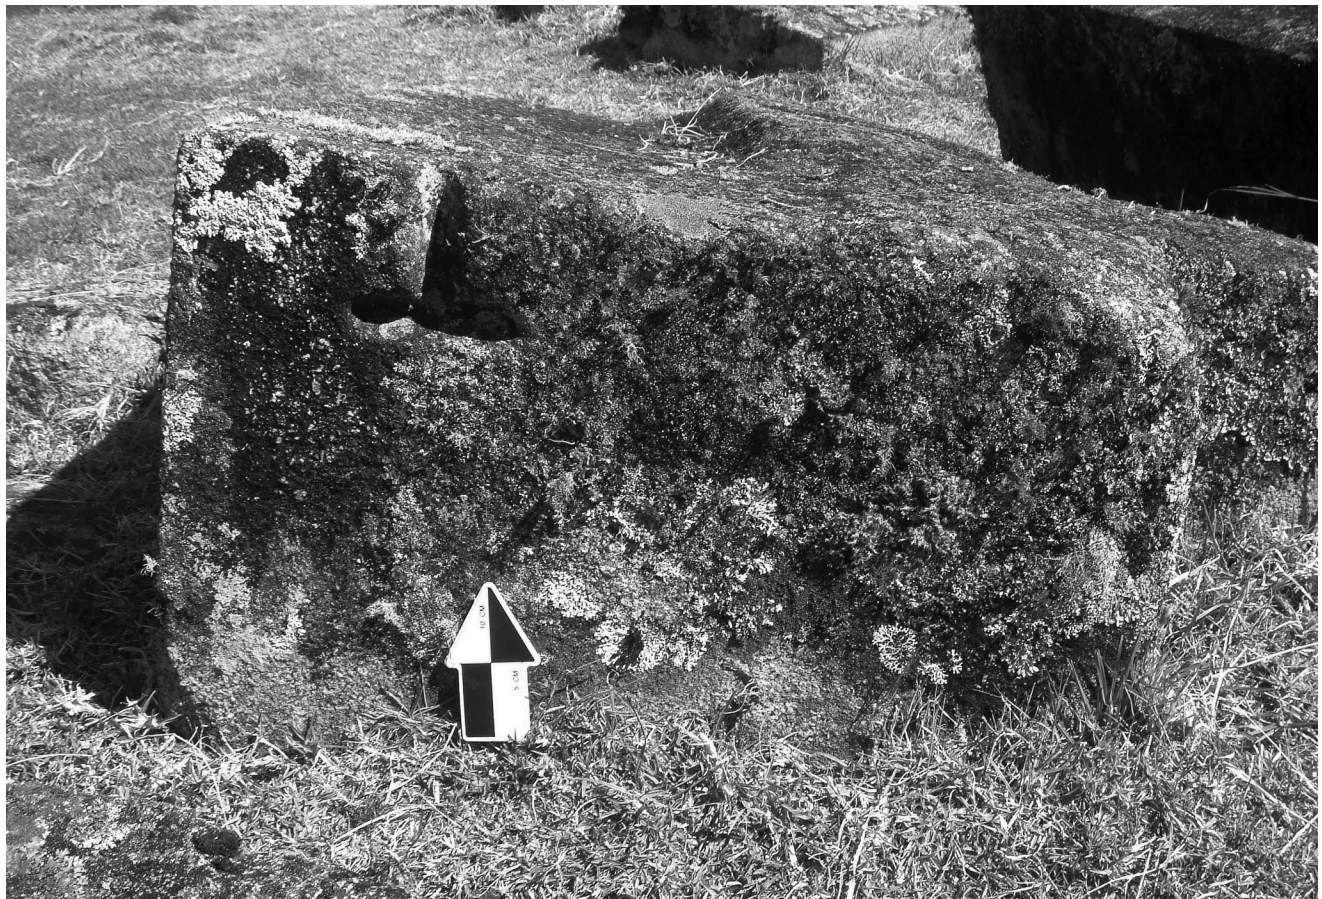
Figure 3.30. (below) Stone with a T-shaped joint in Yurak Rumi (photograph by Brian S. Bauer and Miriam Aráoz Silva).

It is worth noting that one of the larger blocks found in the plaza area has a T-shaped joint carved into its surface (Figure 3.30). While rare, T-shaped joints have been noted at important Inca compounds, including within the Coricancha in Cusco and in Ollantaytambo.¹⁰

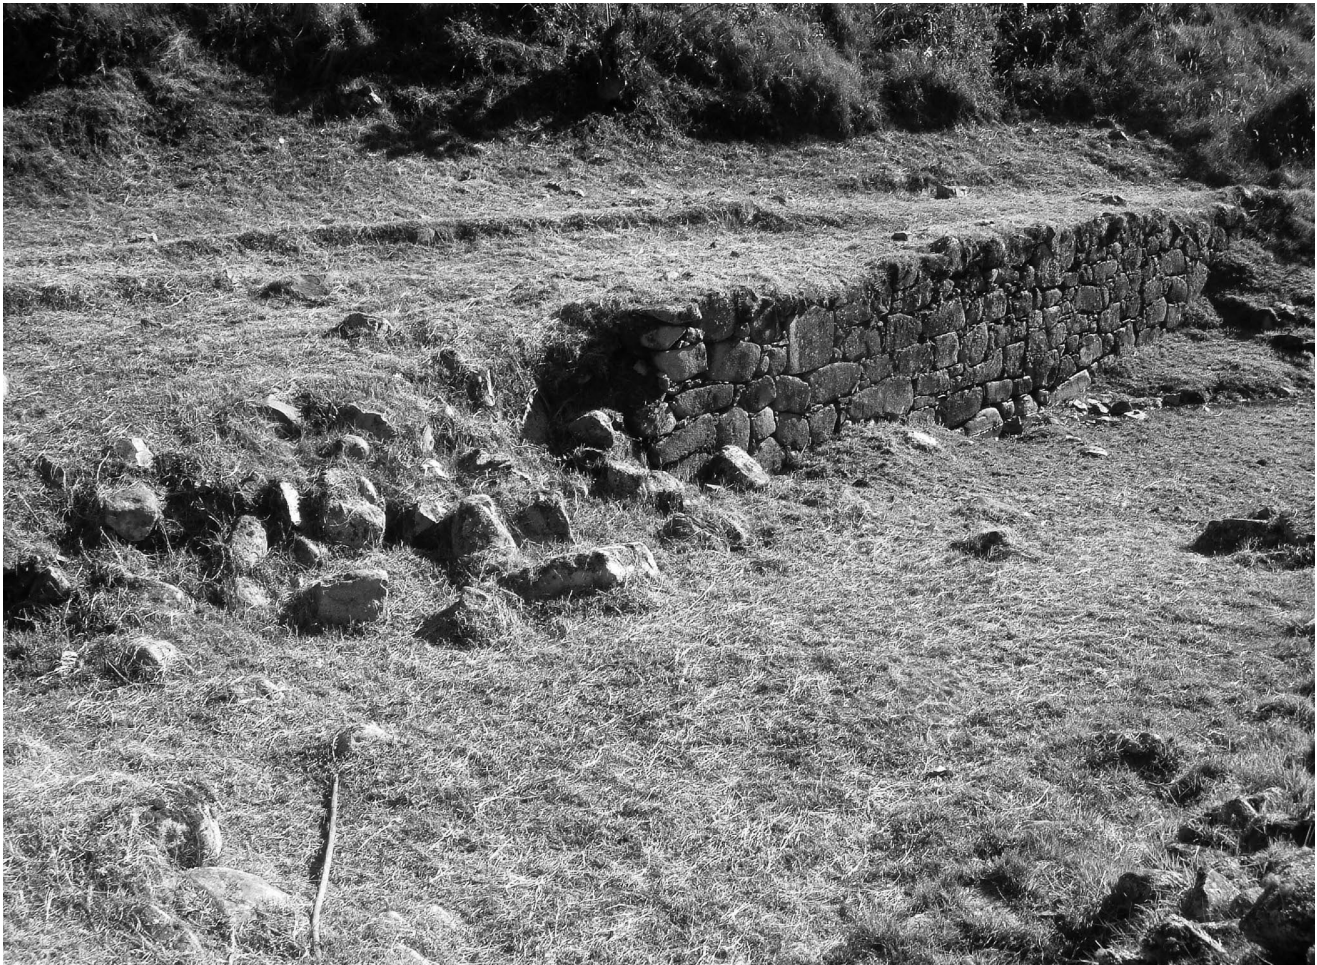
Figure 3.31. The third and lowest terrace of Yurak Rumi is made with large, well-worked stones (photograph by Brian S. Bauer and Miriam Araújo Silva).

The Yurak Rumi compound is located in the middle of a narrow valley. The ground level drops approximately 15 m across the length of the site. This declination is divided between four sets of terraces that run perpendicular to the valley. The southernmost terrace stands about 1.3 m high and is composed of natural stones of varying sizes supported with small filler stones and earth mortar. The second terrace is of slightly better construction and stands between 1.5 and 2 m in height. At the edge of the valley slope, this terrace makes a 90-degree turn and runs for approximately 40 m, forming a retention wall for the western side of the site. The third terrace is substantial, standing more than 2.5 m high. It separates the northern and southern halves of the site. This terrace is composed of moderately sized, roughly shaped stones. The final terrace begins adjacent to the sacred rock and runs west for approximately

11 m before it makes a 90-degree turn, forming a western retaining wall for this area of the site. This terrace is composed of much larger worked stones, many of which are over 1 m long (Figure 3.31).

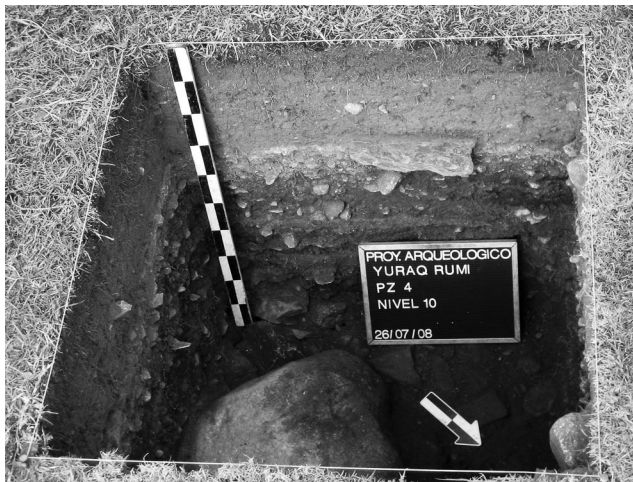
Figure 3.33. The southwestern profile of P4. Note the gravel floor, about 40 cm below the current ground level, which was built on many levels of fill (photograph by Brian S. Bauer and Miriam Araújo Silva).

Test Excavations P4–P6 were dug as a line of test units through the center of the plaza. These pits were spaced approximately 10 m apart and were offset from Units P1–P3 to provide better coverage of the plaza. Each unit was excavated to the natural bedrock and yielded a few small eroded ceramic sherds. Excavation P4 was placed near one of the carved rocks near the center of the plaza. The northwestern corner of the unit intersected a narrow pit (30 cm in diameter, 70 cm deep) sealed with small capstones. The pit was dug long after the site had been abandoned. It may have once held an offering, which has not endured. The excavation also revealed a compact, well-preserved gravel floor constructed on more than 1 m of multilayered fill deposits (Figure 3.33). A single flat slab of green schist was found resting on the gravel floor. Similar green schist slabs were also noted in excavations U4, U5, and U6 and are believed to have been used during the brief re-occupation of the site after its destruction in 1570. Excavation P5 was located near the center of the plaza on the edge of a looter’s pit. This excavation revealed a concentration of redeposited burnt plaster, similar to

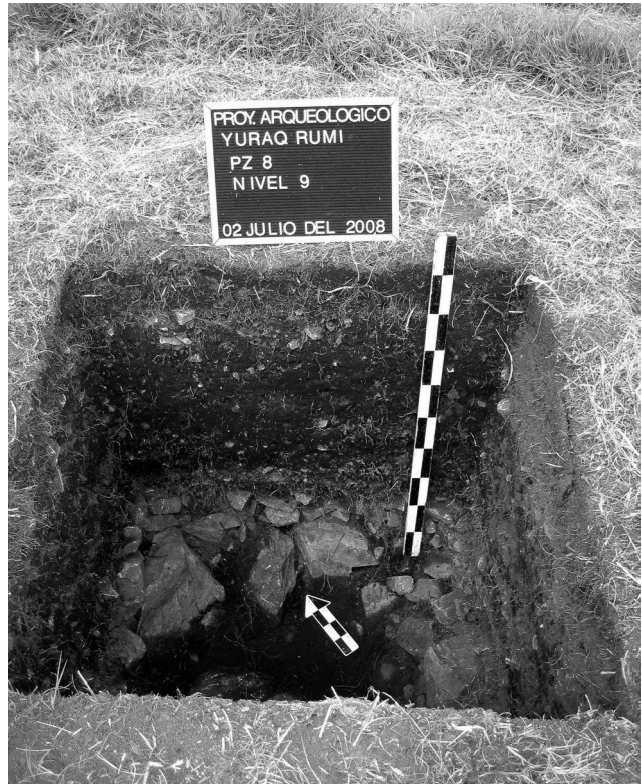
Figure 3.34. The northeastern profile of P8 (photograph by Brian S. Bauer and Miriam Araújo Silva).

Test Excavations P7 and P8 were placed approximately 10 m apart on an artificially constructed agricultural terrace in the southwestern corner of the complex. The terrace stands some 1.5 m high. Although the profiles of the two pits differed slightly, they both revealed a similar construction sequence for the terrace. The modern plow zone was followed by an organically rich terrace fill, approximately 80 cm deep, of soil and small rocks (Figures 3.34 and 3.35). Next came a prepared level of red clay and gravel (3 to 6 cm thick), which appears to have been laid down to seal the bottom of the terrace fill. The base of the terrace was established with cobble-sized rocks resting on bedrock.

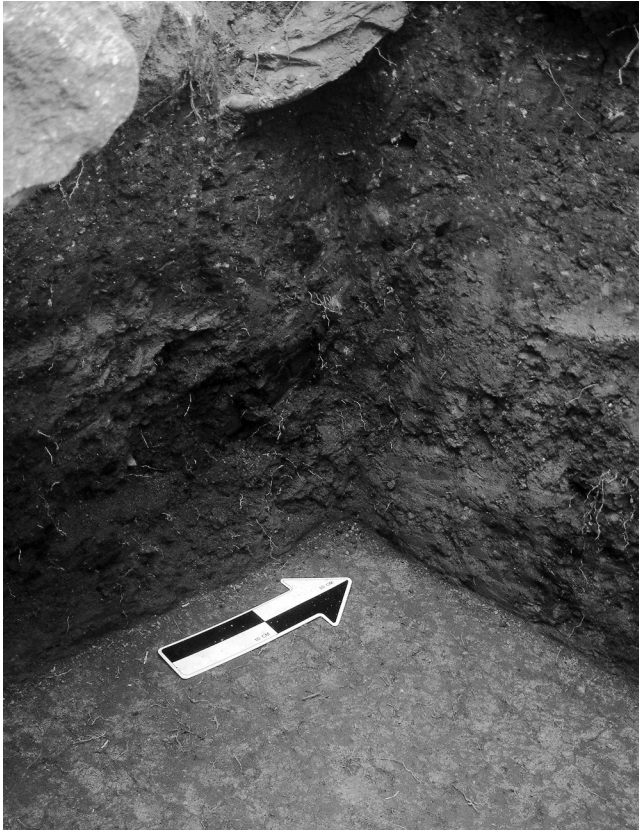
Figure 3.37. (left) Detail of Inca floor covered by destroyed building materials in P10 (photograph by Brian S. Bauer and Miriam Aráoz Silva).

Test Excavation P10 was located against the interior back wall of one of the buildings that define the southwestern courtyard (Figure 3.37). In this unit we first removed the current topsoil and a level of wall fall.

We then encountered a thin level of redeposited materials and melted adobe, within which we found a small piece of blue-on-white majolica ceramic. The next level consisted of a 30 cm thick stratum of destroyed building materials, including burnt wall plaster and carbonized roof remains, which rested on a prepared floor made of green clay.¹¹ Fragments of a crushed storage vessel were recovered on the floor.

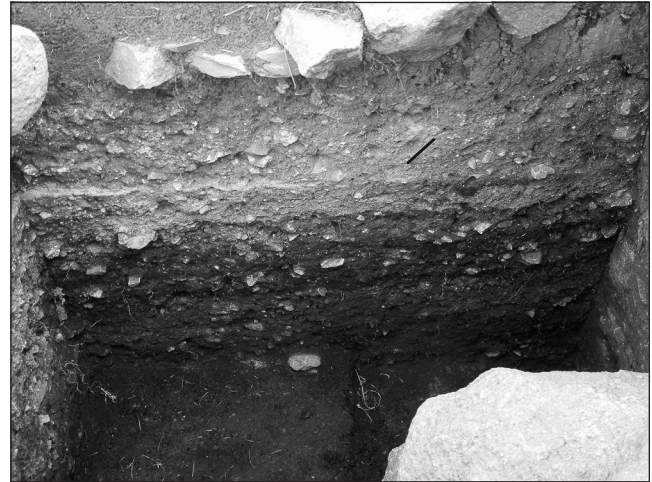
Figure 3.38. (above) Northwestern profile of P11. The crushed-white-granite floor is marked with a slash (photograph by Brian S. Bauer and Miriam Aráoz Silva).

Test Excavation P11 was a 1.2 x 1 m unit placed in the northeastern sector of the site against the back wall of the building that faces the sacred rock (Figure 3.38). The excavations soon revealed a hard-packed but very irregular earth-and-pebble floor with large fragments of classic Inca pottery, carbon, and some minute burnt bone fragments (Figures 3.39 and 3.40). Beneath the earthen floor was a fill level, approximately 20 cm thick, which rested on a second thin (2 to 4 cm) fill level, followed by a second floor of crushed white granite. This second floor was flat and well made. It rested above a thin (less than 1 cm) level of red

clay, which may have been used as a sealant to protect the granite floor in this waterlogged area of the site.¹² Beneath the red clay level was a thick stratum (50 to 60 cm) of multiple fill levels, which appear to have been used to raise the interior area of the structure.

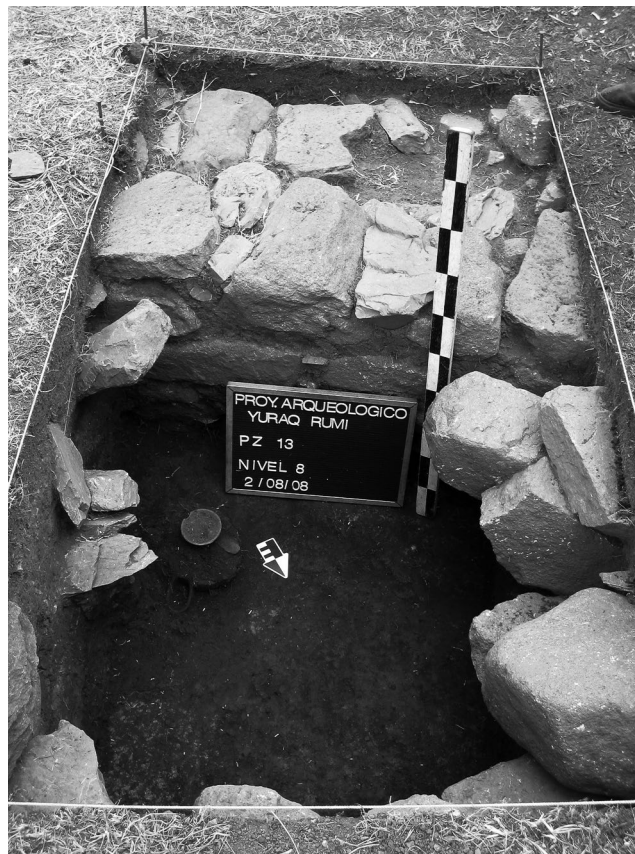
Figure 3.41. This test excavation exposed a patio-facing wall and a vessel resting upside down on the floor of the building (photograph by Brian S. Bauer and Miriam Aráoz Silva).

Test Excavation P13 was a 1 x 1.5 m unit placed within the structure that marks the northern edge of the southwestern courtyard (Figure 3.41). The excavation helped define the courtyard-facing wall of the building that was no longer visible on the surface and that had not been well documented in early studies. The excavation also identified a thick (30 cm) stratum of burnt building materials within the structure. Below this destruction level was a green-clay floor, on top of which rested a complete, although upside down, pedestal vessel (Figure 3.42).¹³

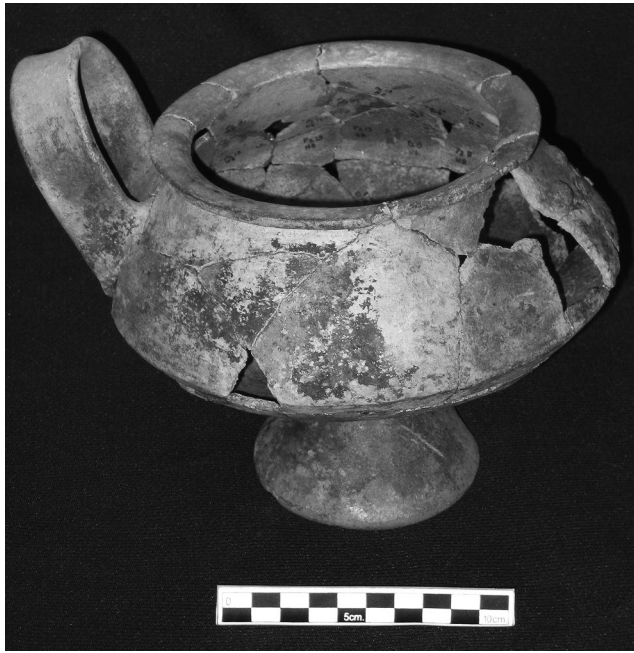
Figure 3.42. The pedestal vessel recovered in P13 (photograph by Brian S. Bauer and Miriam Aráoz Silva).

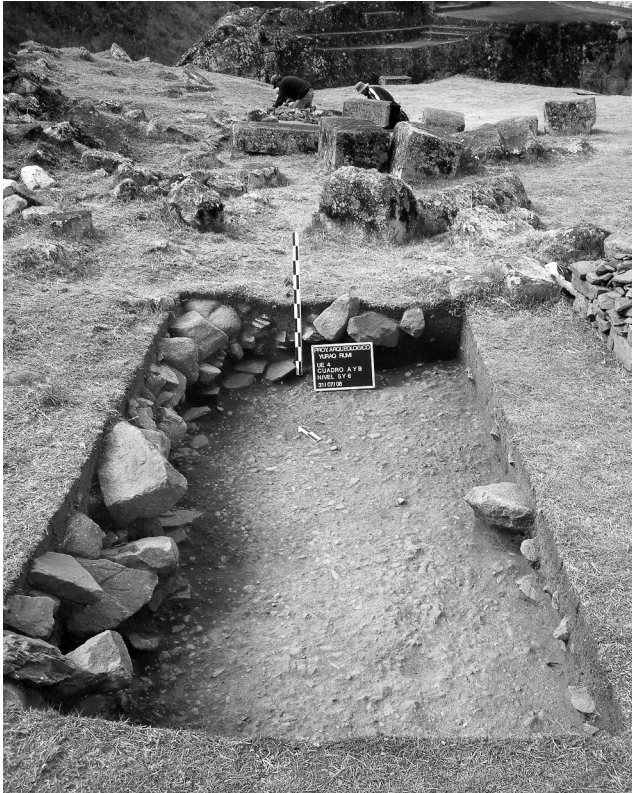
Figure 3.48. Unit 5 showing the gravel floor and Yurak Rumi in the background (photograph by Brian S. Bauer and Miriam Aráoz Silva).

Excavation U5 was a 2 x 2 m unit situated in the plaza in front of the twin structure nearest to the sacred rock. The first two strata included topsoil followed by wall fall and other redeposited materials. As with U4, we then found a well-preserved gravel floor that had been partially resurfaced with flat slabs of green schist (Figure 3.48).

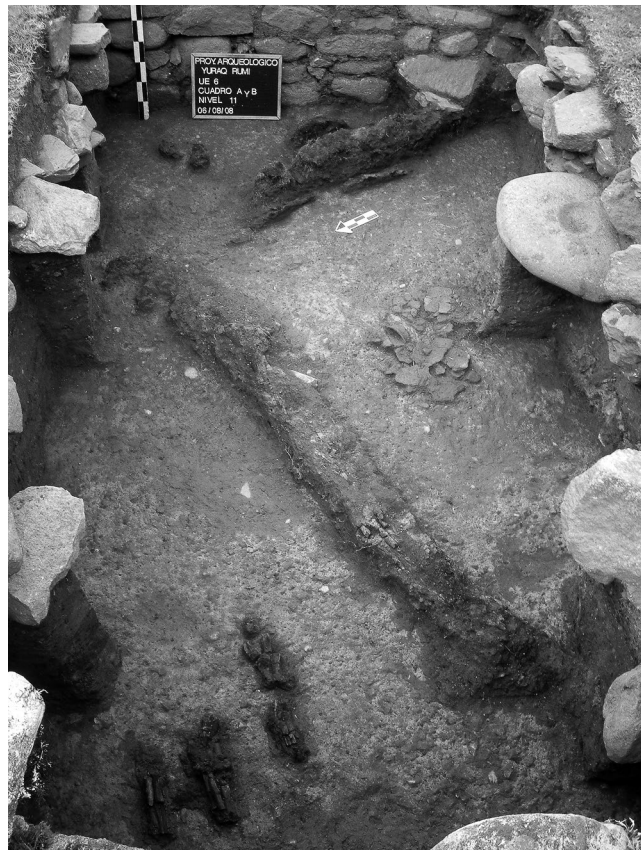
Figure 3.49. Excavations in U6 revealed various burnt but well-preserved parts of the roof of the building as well as a crushed storage vessel on a green-clay floor (photograph by Brian S. Bauer and Miriam Aráoz Silva).

southwestern courtyard. Excavations began with removal of the topsoil and recent wall fall from the structure. Beneath the wall fall was a flat living surface with much carbon, which we believe represents a brief reoccupation of the building following the burning of the site by the Augustinian priests. At this level we recovered the remains of two iron nail fragments and several sherds of white majolica pottery. The next stratum consisted of nearly 30 cm of burnt plaster and other building materials resting on a green-clay floor. The burnt materials were especially well preserved within this building, and we were able to identify pieces of the collapsed roof, including rafters, battens, thatch (burnt and unburnt),¹⁵ and rope. These materials are discussed in more detail below (Figures 3.49–3.52). We also re-

covered a complete but shattered storage jar and the remains of a carved carbonized staff on the floor of the building.

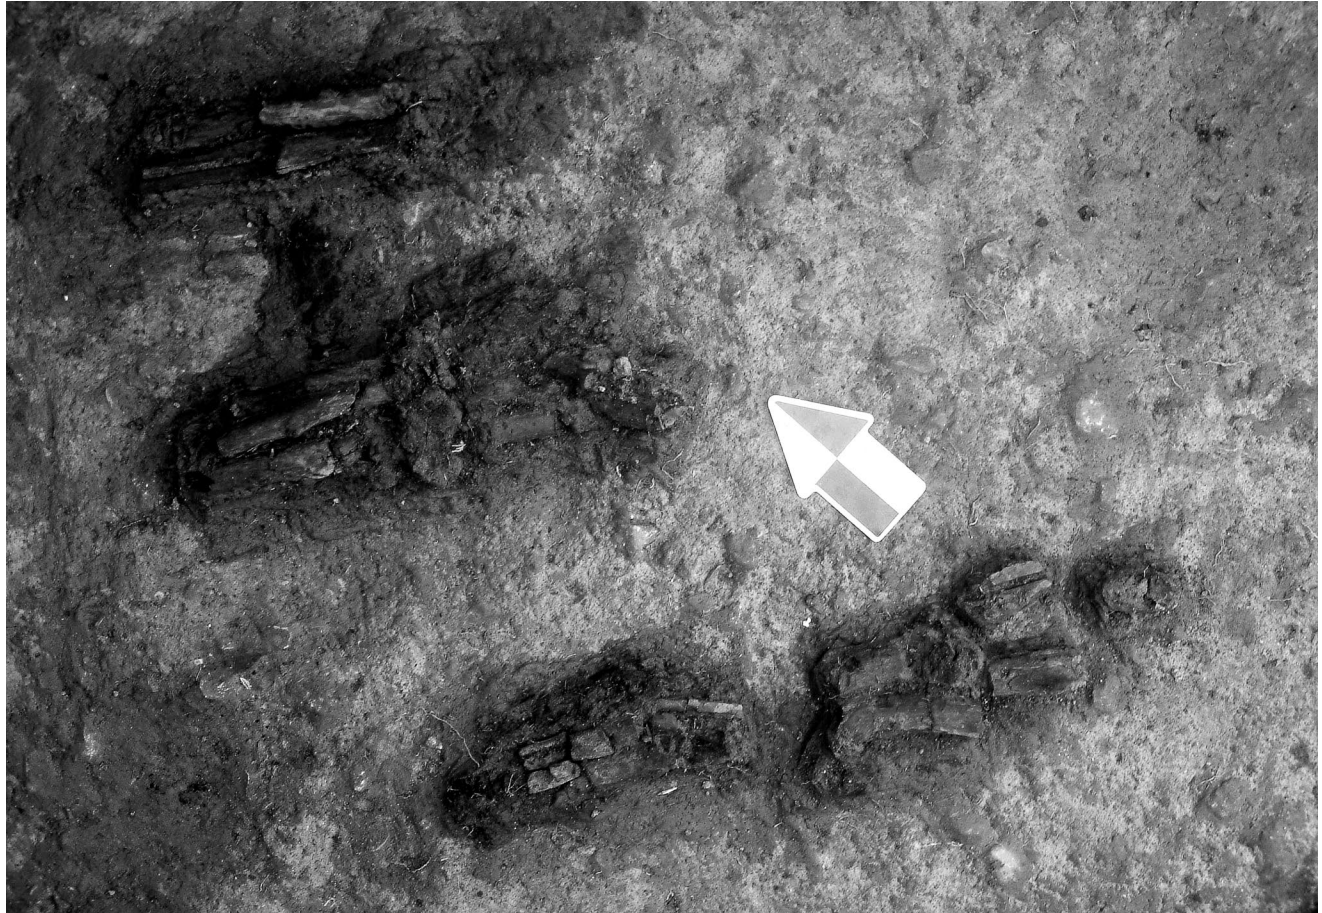
Figure 3.50. (above) Carbonized roof battens held together with rope resting on the green-clay floor in U6 (photograph by Brian S. Bauer and Miriam Aráoz Silva).

- Figure 3.48.** Unit 5 showing the gravel floor and Yurak Rumi in the background (photograph by Brian S. Bauer and Miriam Aráoz Silva).
- Figure 3.49.** Excavations in U6 revealed various burnt but well-preserved parts of the roof of the building as well as a crushed storage vessel on a green-clay floor (photograph by Brian S. Bauer and Miriam Aráoz Silva).

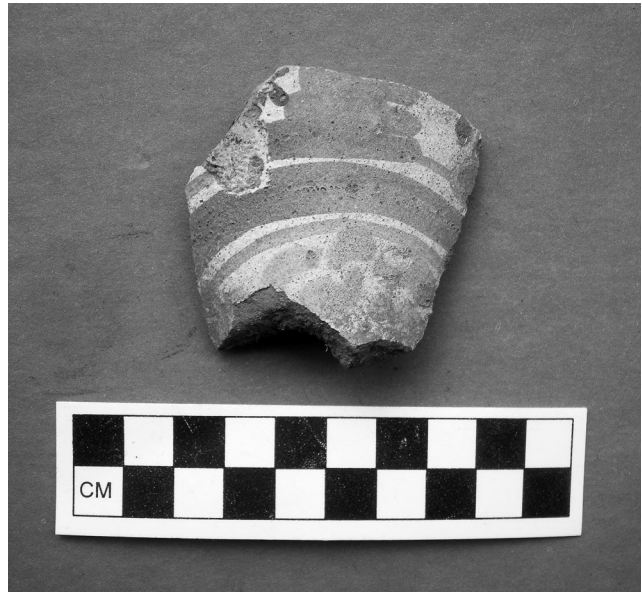
Figure 3.55. (above) A majolica sherd (green and red-brown over yellowish white) from a narrow-mouth jar found at Yurak Rumi (photograph by Brian S. Bauer and Miriam Aráoz Silva).

primarily green but also white, yellow, red/brown, and blue (Figures 3.55–3.57).

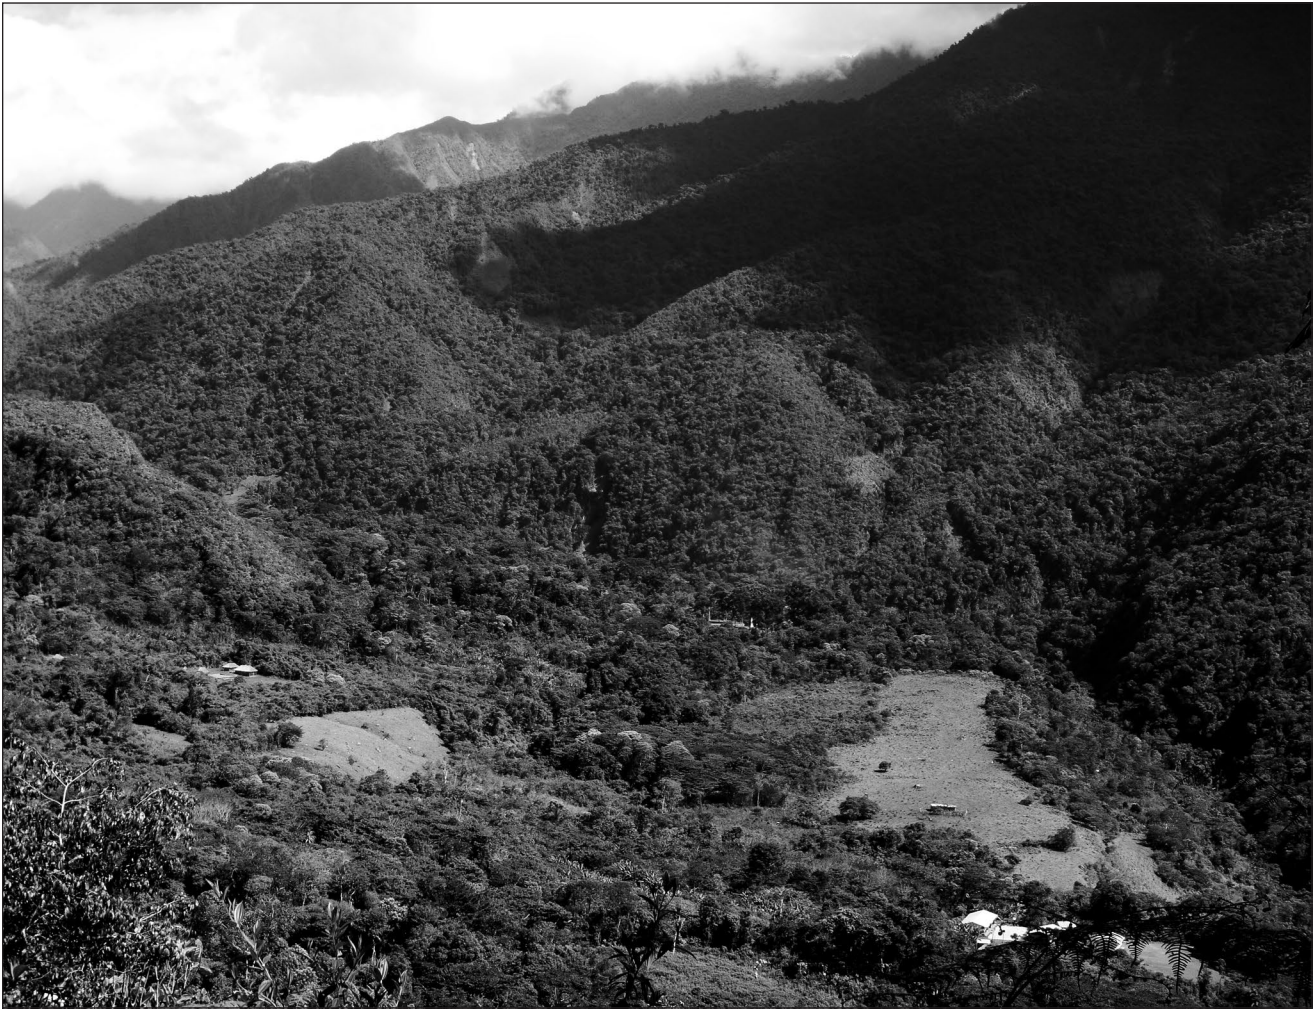
Figure 4.1. The monumental core of Espíritu Pampa is located beneath the trees between the two open fields in this photograph. However, the site is much larger, and scattered foundations can be found across the valley (photograph by Brian S. Bauer and Miriam Araújo Silva).

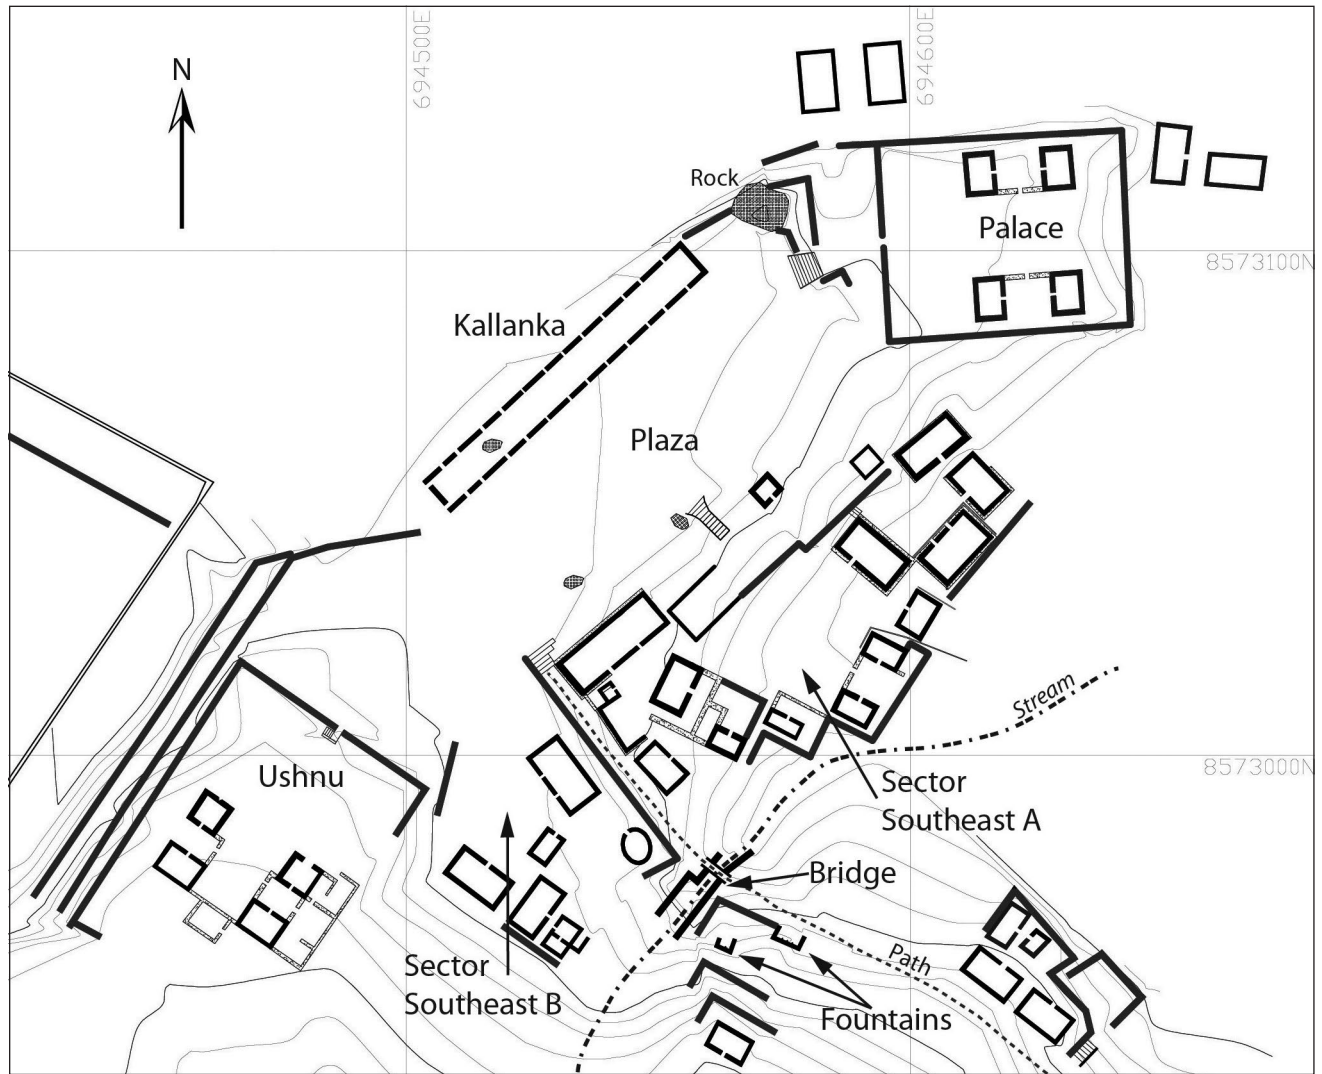
Figure 4.3. The monumental core of Espiritu Pampa (map by Axel Aráoz Silva and Gabriel E. Cantarutti).

formation are available on these different projects, and some of the reports have already been lost or were never completed. Nevertheless, it is important to review the previous projects because they provide a history of research at the site and an introduction to the organization of the monumental core of Espiritu Pampa (Figure 4.3).

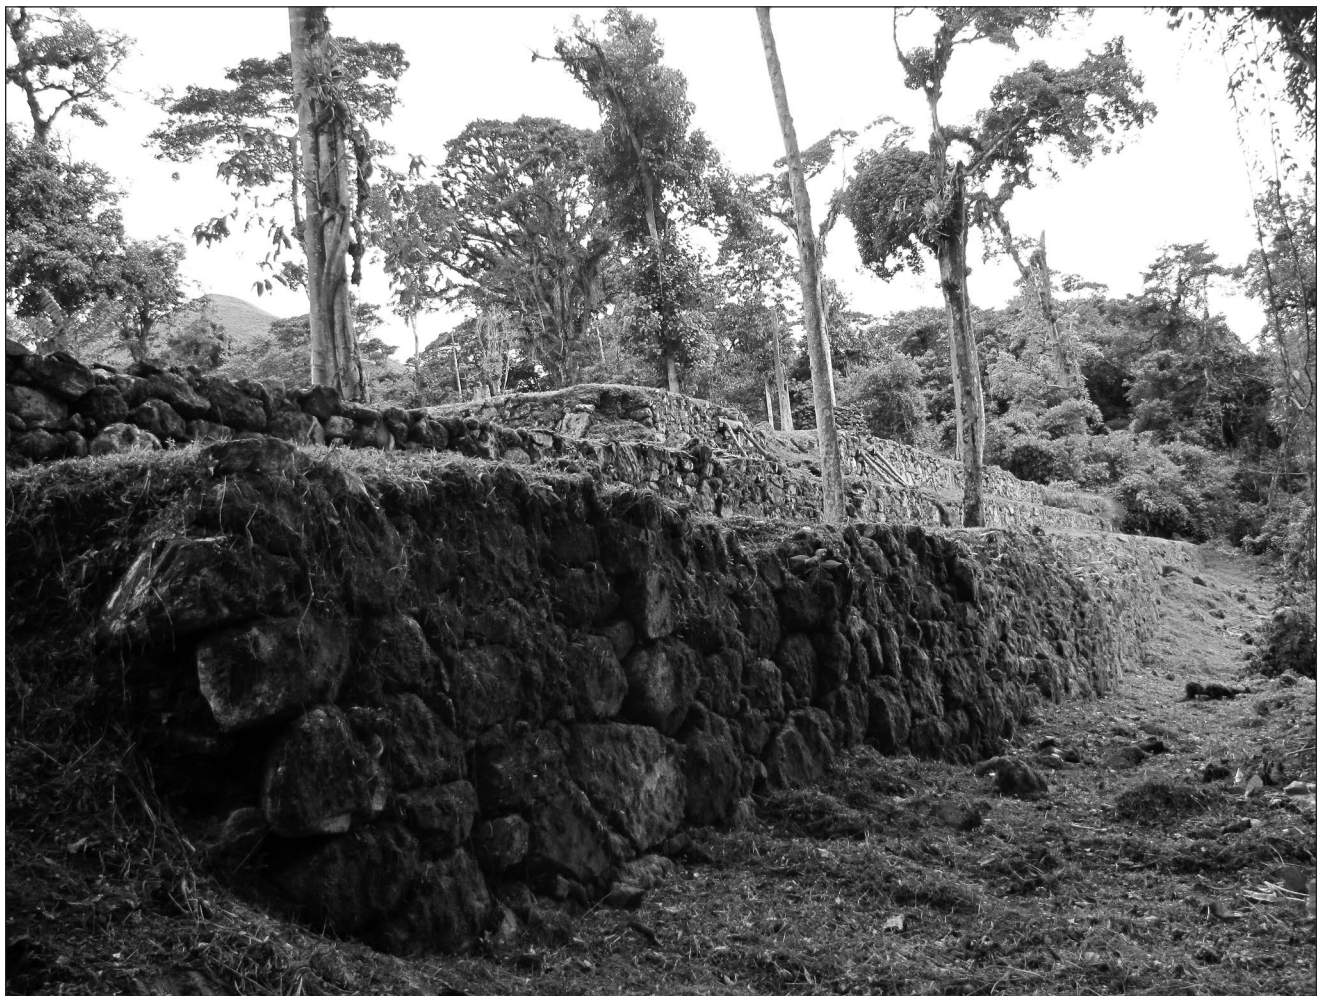
Figure 4.4. The largest terraces of the site are found on the northwestern side of the Ushnu (photograph by Brian S. Bauer and Miriam Araújo Silva).

At the southern end of the plaza is a large, multitiered platform currently called the Ushnu (Figure 4.4). (An *usbnu* is a terraced, platform structure.) This name is largely a misnomer, as the complex is strikingly dissimilar to other central-plaza terraced platforms found elsewhere in the empire. An impressive L-shaped stairway

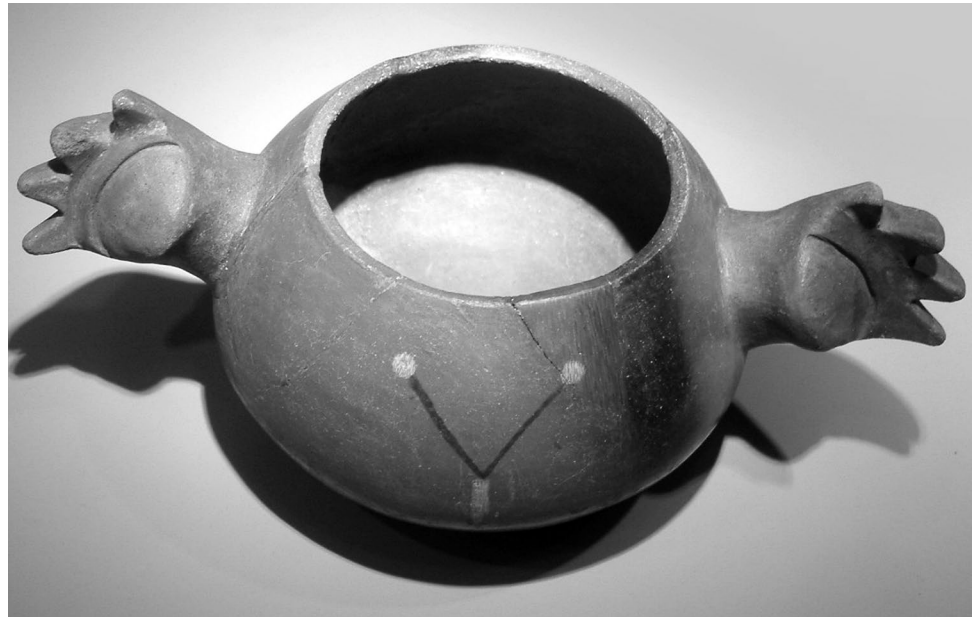
Figure 4.5. A bowl with two puma-paw handles recovered by José Pilares Daza in 2003. The vessel is currently housed in the Museo de Garcilaso de la Vega in Cusco (photograph by Brian S. Bauer).

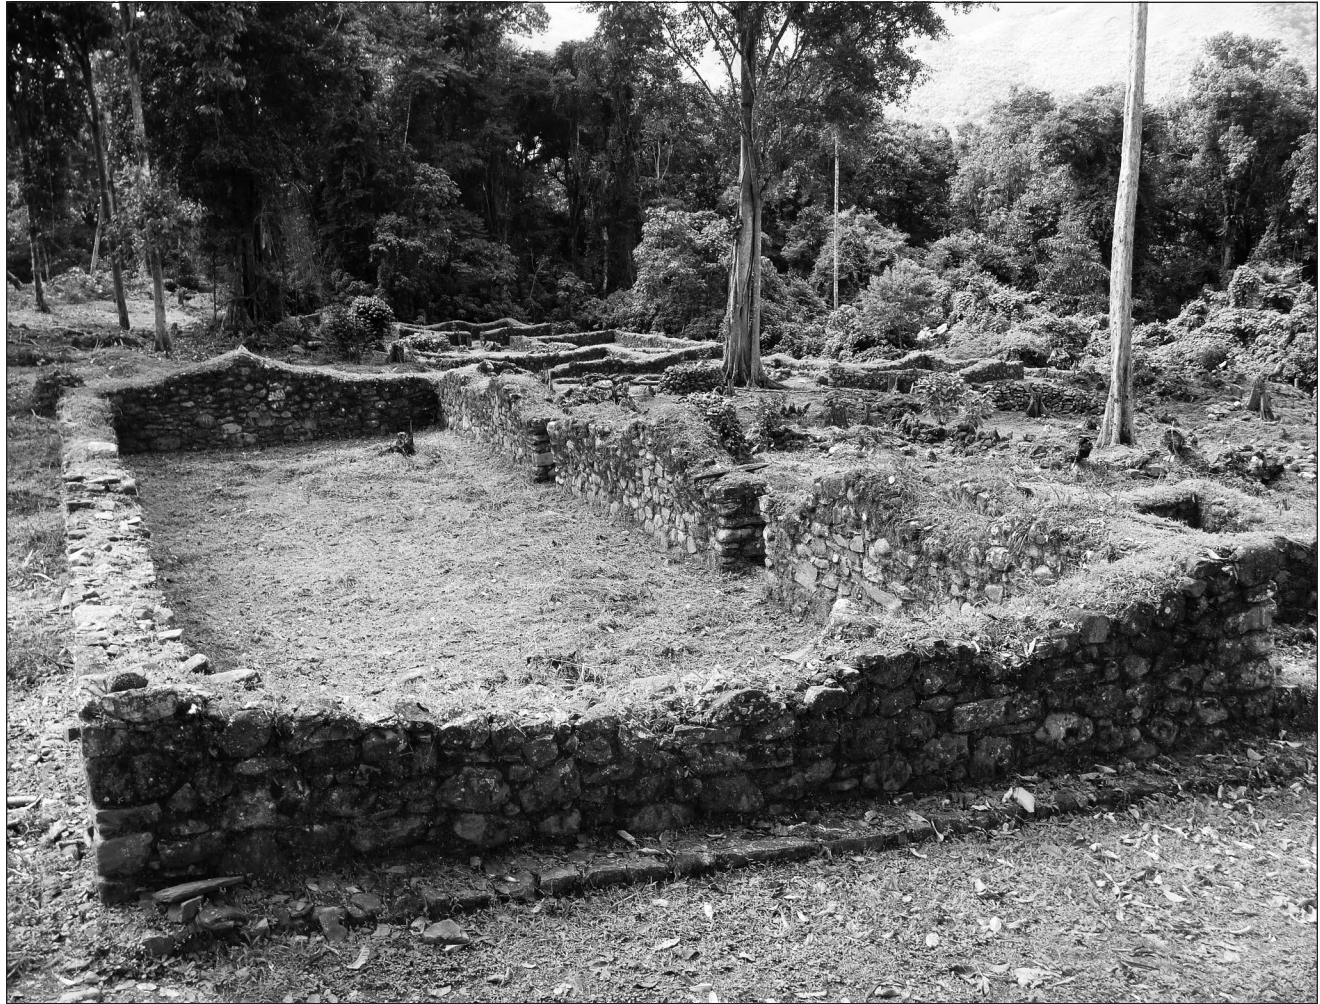
Figure 4.8. The largest building on the east side of the plaza. This building may have once held as many as 13 interior niches. Note that this building, like many others in the sector, is built on a wide foundation (photograph by Brian S. Bauer and Miriam Aráoz Silva).

Figure 4.8. The largest building on the east side of the plaza. This building may have once held as many as 13 interior niches. Note that this building, like many others in the sector, is built on a wide foundation (photograph by Brian S. Bauer and Miriam Aráoz Silva).

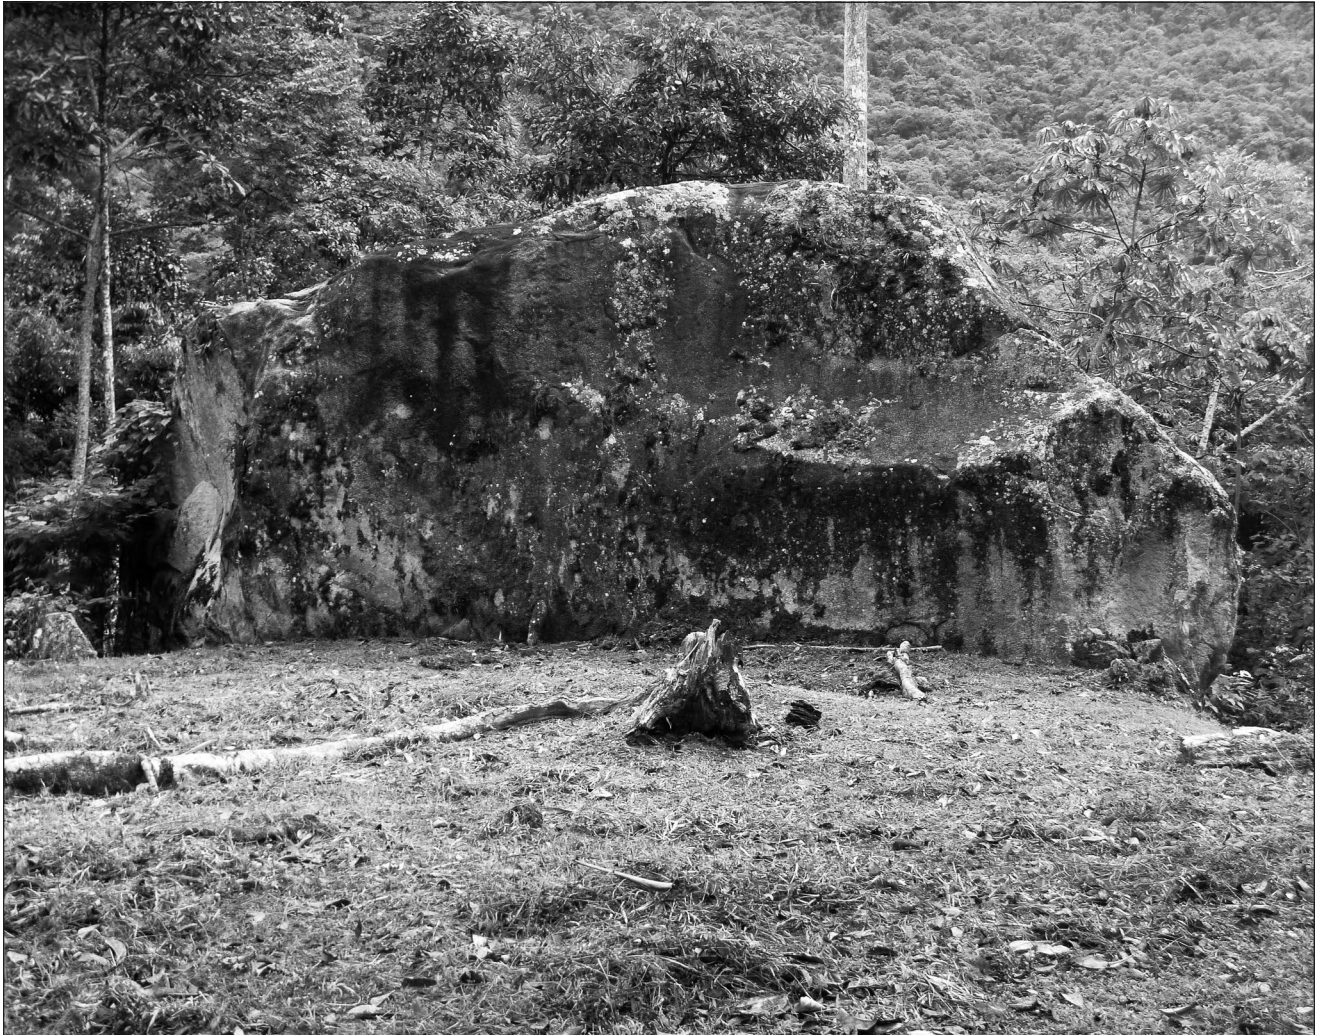
Figure 4.9. A large, isolated, unworked boulder at the north end of the plaza may have been worshipped as a shrine by the Inca (photograph by Brian S. Bauer and Miriam Aráoz Silva).

and ceremonies that he held [there]” (Murúa 1987:270; translation by authors).¹⁰ While certainly impressive, the fact that this stone has not been carved makes it difficult to assess with full certainty that it held special importance for the inhabitants of the town (Figure 4.9).

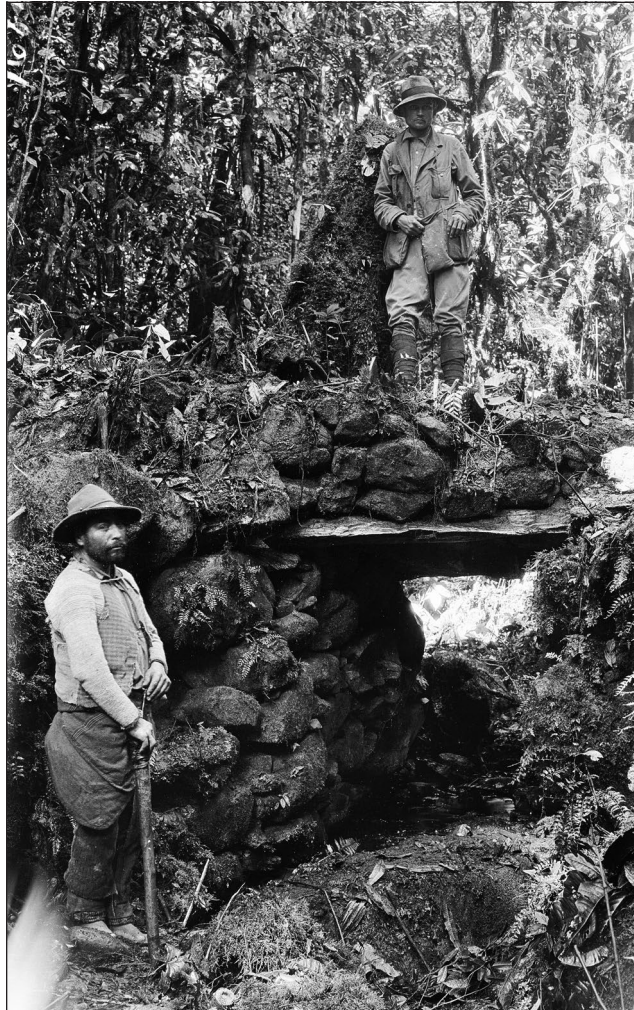
Figure 4.10. Bingham stands on top of the central bridge leading into Espíritu Pampa. The other man may be Juan Cancio Saavedra. (National Geographic Image Collection: negative 785908, photograph by Harry Ward Foote).

A small stream runs through the site of Espíritu Pampa, and there is a well-preserved stone bridge near the center of the ruins. The bridge abutments are made of rough stones, and the span is composed of long schist slabs. Bingham (1922:296) noted this bridge during his visit and had his picture taken on it (Figures 4.10 and 4.11).

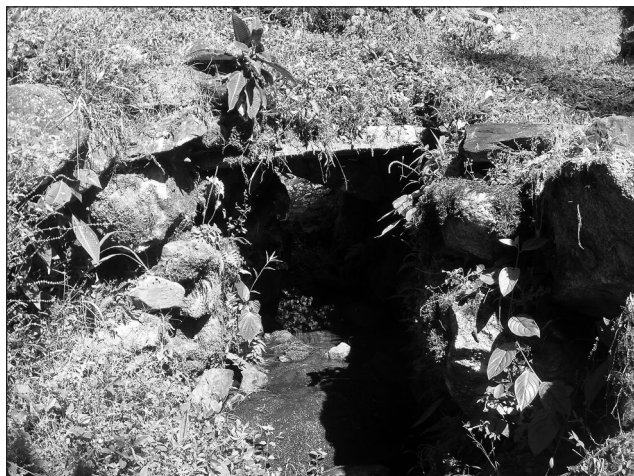
Figure 4.11. The stone bridge of Espíritu Pampa (photograph by Brian S. Bauer and Miriam Aráoz Silva).

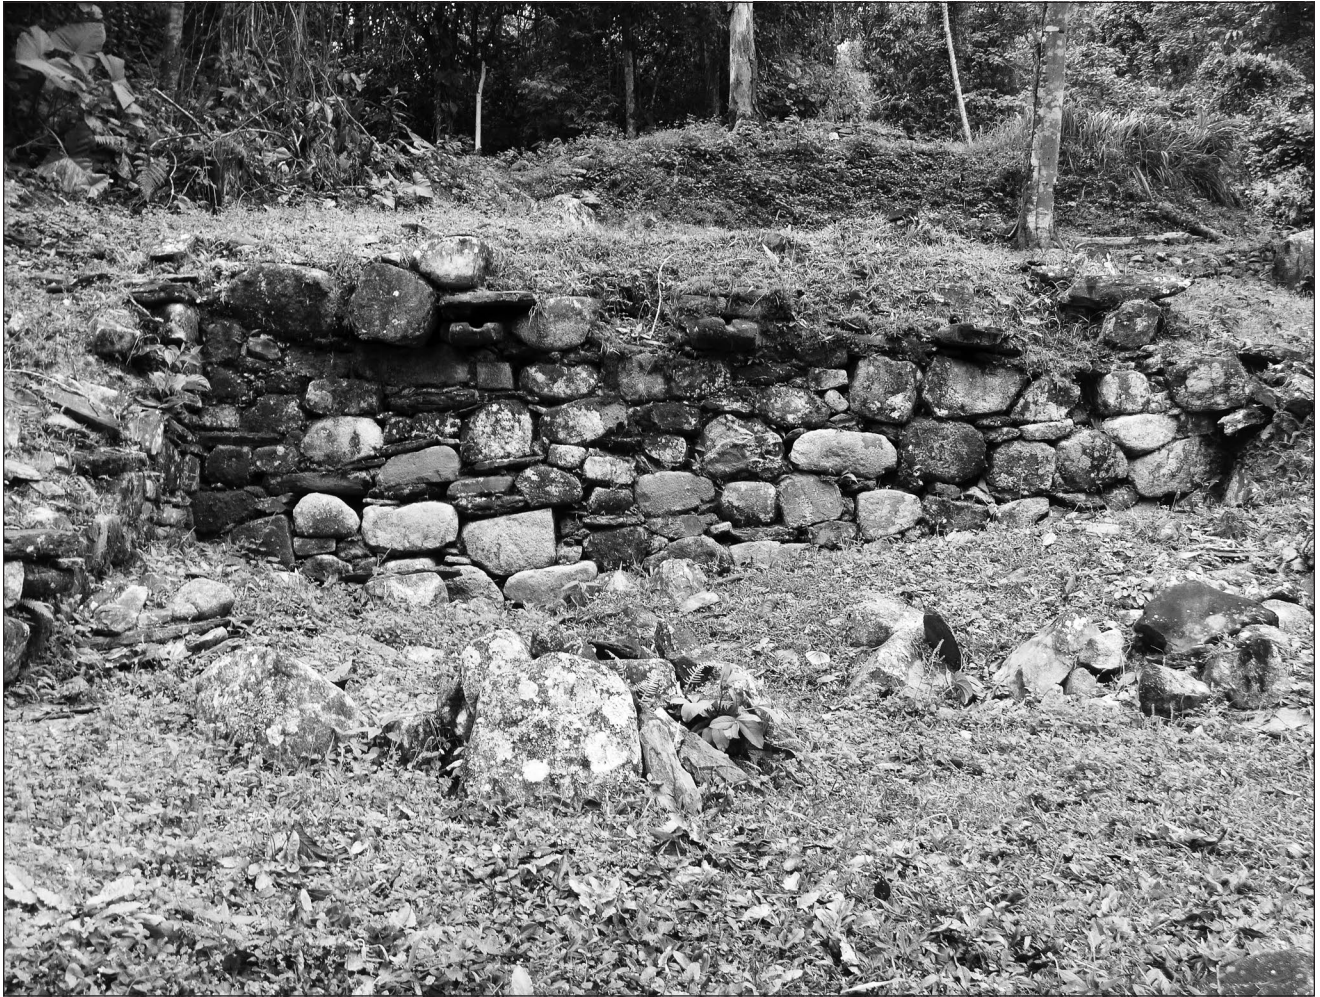
Figure 4.12. The three-spouted fountain at Espiritu Pampa (photograph by Brian S. Bauer and Miriam Araújo Silva).

There are two fountains on the hillslope above the bridge (Figure 4.12). The lower of the two fountains has three spouts, while the upper fountain has one.

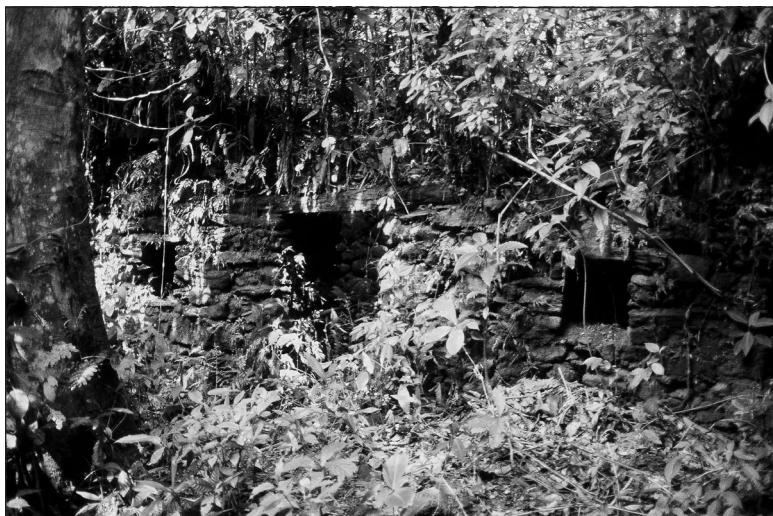
Figure 5.7. Interior of Building 1, circa 1980 (photograph by David Drew).

Building 1 measures approximately 8 x 5 m, with walls that reached up to 3 m high (Figure 5.7).⁷ Excavations within the building were conducted using a grid system of eight units. At the time of the excavation, the interior of the building was covered with thick vegetation, and a large yanay tree was growing near the center of the building. Fallen stones from the two gables were notable at both ends of the building, and a number of roof pegs could be identified on the ground. A few roof tile and aryballos fragments were recovered as the humus was cleared from Building 1. With the removal of the second excavation level, the remains of a crushed cooking vessel were found near the northwestern corner of the building, and several ceramic vessels and tiles were identified within the northern wall fall area (Figure 5.8).⁸
