Vilcabamba and the Archaeology of Inca Resistance

Brian S. Bauer, Javier Fonseca Santa Cruz, and Miriam Aráoz Silva

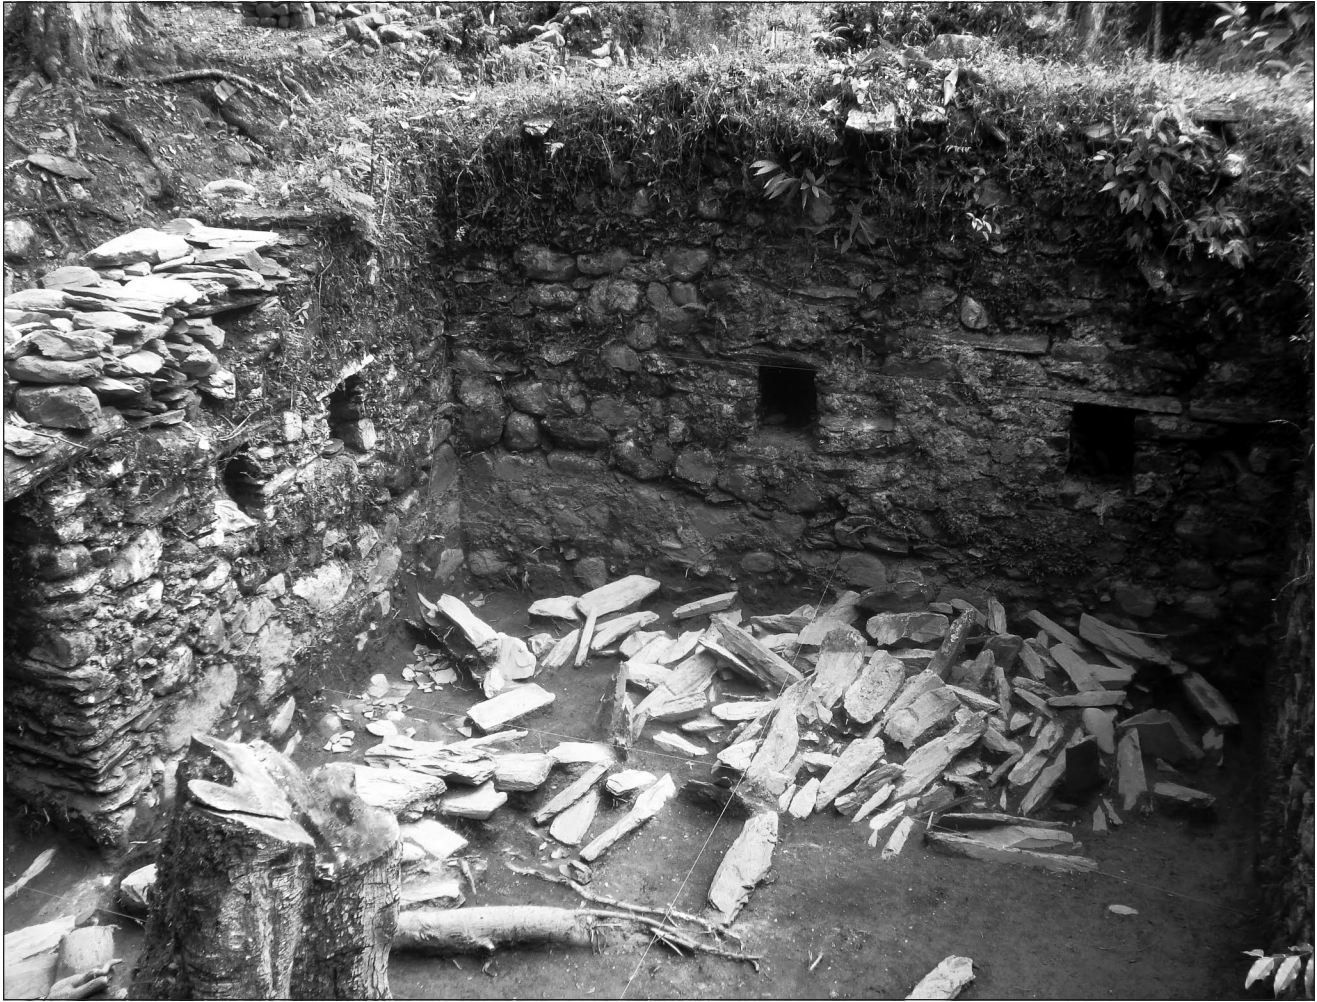
Figure 5.9. The south end of Building 1. Note the materials from a fallen gable and the irregularly spaced niches on the end wall (Ministerio de Cultura; photograph by Javier Fonseca Santa Cruz).

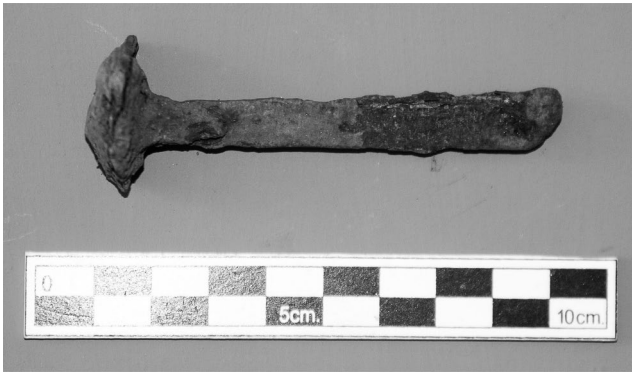
Figure 5.11. One of two iron nails found in Building 2 (Museo Amazónico Andino Qhapaq Ñan de Quillabamba; photograph by Brian S. Bauer).

A large concentration of cultural objects was found about 2 m from the northern wall and 1.5 m from the door. This concentration included fragments from *urpus/rakis*, plates, a miniature plate, and one of the two iron nails found in the building. Iron nails have been recovered in other buildings of Espíritu Pampa and at other post-contact Inca sites such as Vitcos and Huánuco Pampa (Morris et al. 2011). The nails are especially interesting since they are highly portable objects that were brought into the region and are linked to Spanish influence (Figure 5.11).

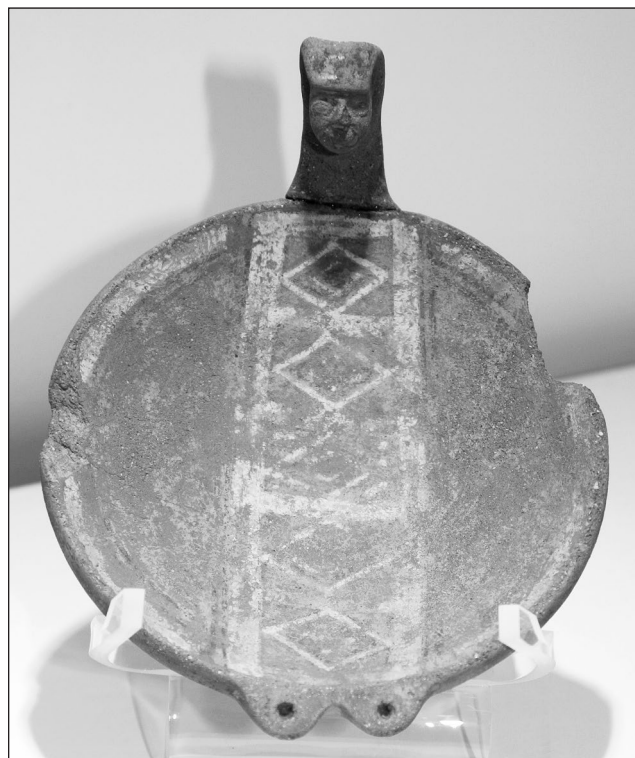
Figure 5.13. (left) Plate with a handle in the shape of a human head from near the door of Building 3 (Museo Amazónico Andino Qhapaq Ñan de Quillabamba; photograph by Brian S. Bauer).

included pieces from plates, ollas (cooking pots), aryballo, and a few roof tiles. Bits of charcoal were found on the floor level, but no large concentrations were noted. Just west of the door, a complete but fragmented plate was recovered. The plate is painted with a central band of white-and-red geometric designs and a handle adorned with a human head (Figure 5.13).¹³

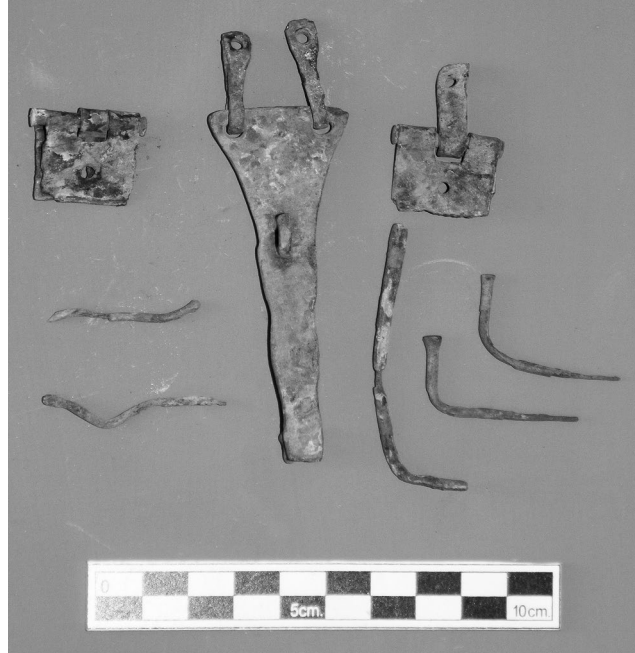
Figure 5.15. A copper latch, two hinges, and five nails were recovered from Building 4 (Museo Amazónico Andino Qhapaq Ñan de Quillabamba; photograph by Brian S. Bauer).

copper hinges, complete with their accompanying nails, were recovered near the southwestern corner. These were most certainly the hardware of a small wooden chest that has long since decomposed (Figure 5.15).

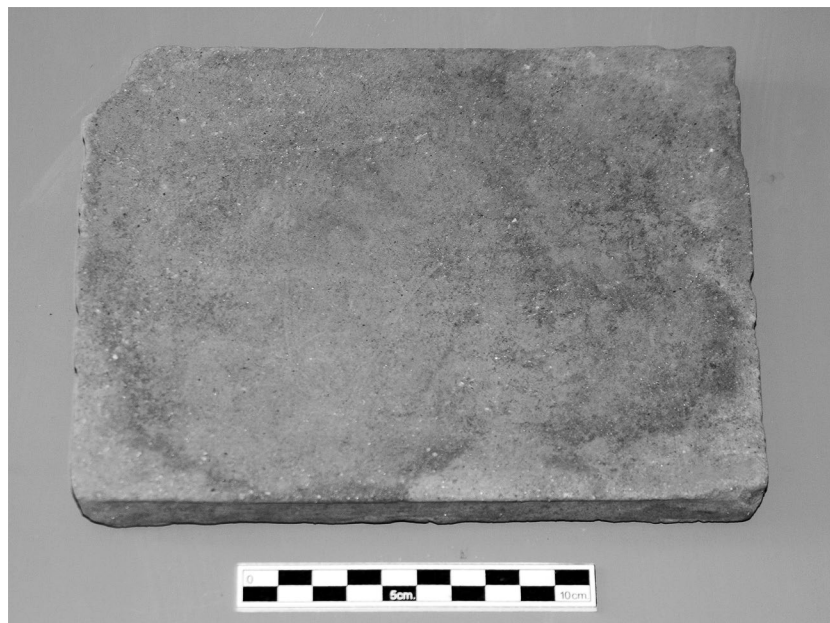
Figure 5.16. A nearly intact clay floor tile was found along the north wall of Building 4 (Museo Amazónico Andino Qhapaq Ñan de Quillabamba; photograph by Brian S. Bauer).

ing that it may have been imported into the area (Figure 5.16). The neck of a small *tikachurana* (see Julien 1989:8, Form 1b; Pardo 1938) was also recovered along the north wall of the building.

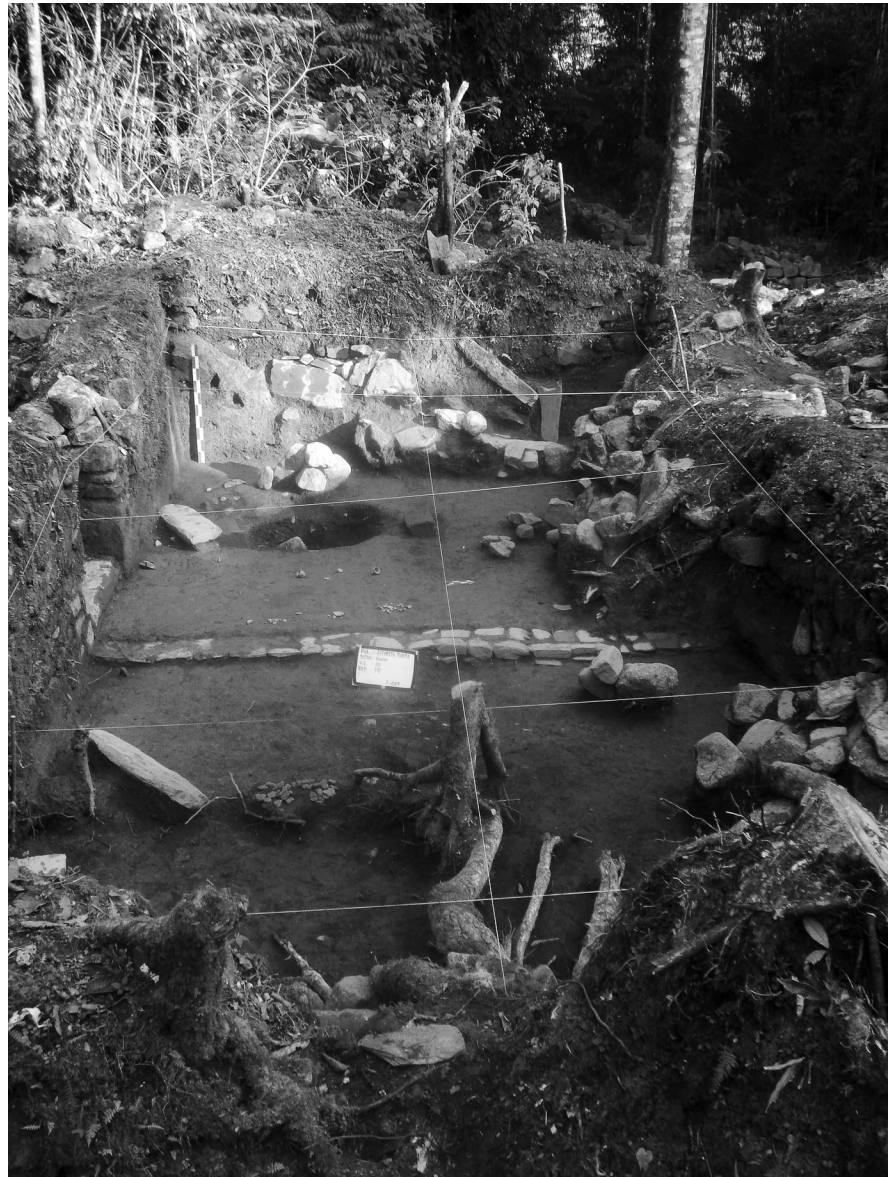
Figure 6.8. Building D. Note the looter's pit, the division wall, and the fallen lintels. Preserved adobes can also be seen near the looter's pit and in the south corner (upper right) of the building (Ministerio de Cultura; photograph by Javier Fonseca Santa Cruz).

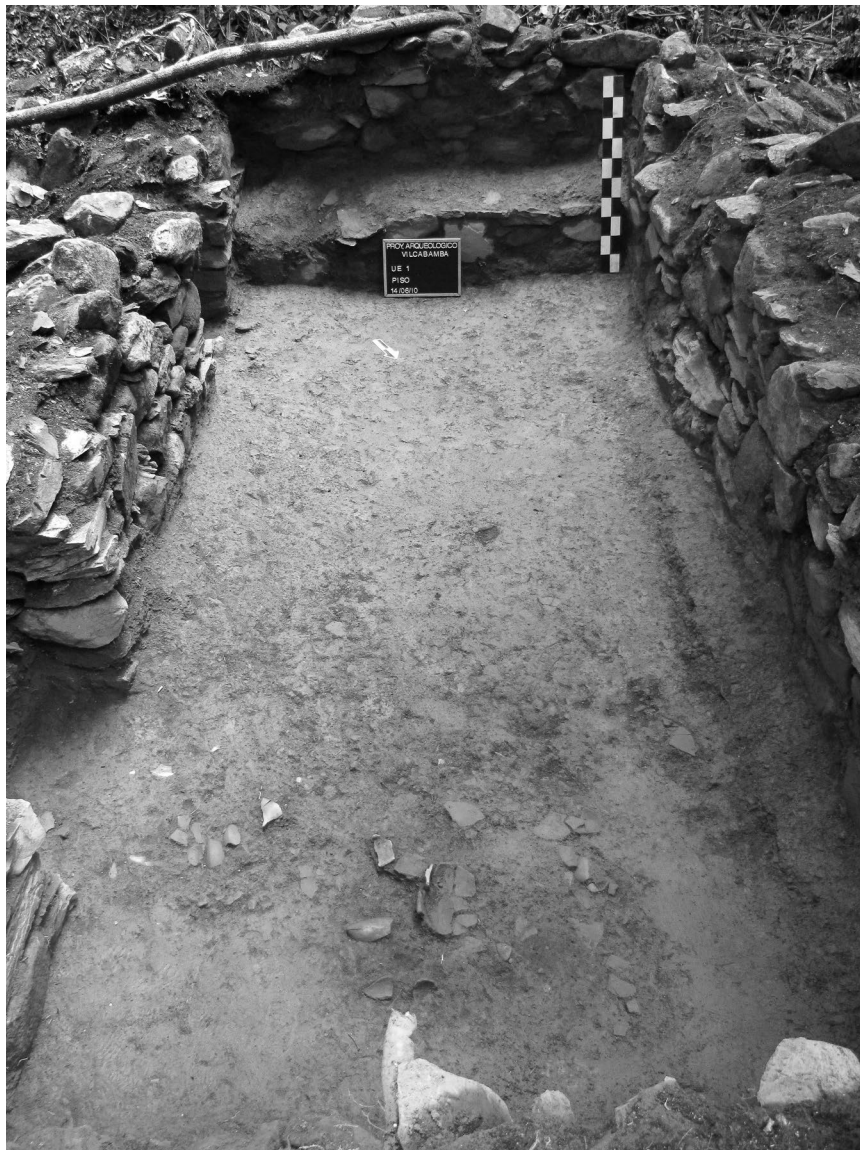
Figure 7.5. Unit 1 after excavation. Note the bench at the far end of the room and the remains of a hearth in the foreground (photograph by Brian S. Bauer and Miriam Aráoz Silva).
