CAL/APT Program: Asphalt Treated Permeable Base (ATPB), Laboratory Tests, Performance Predictions and Evaluation of Caltrans and Other Agencies Experience

**CAL/APT PROGRAM — ASPHALT TREATED PERMEABLE
BASE (ATPB)**

**Laboratory Testing, Performance, Predictions, and Evaluation of
the Experience of Caltrans and Other Agencies**

July 1999

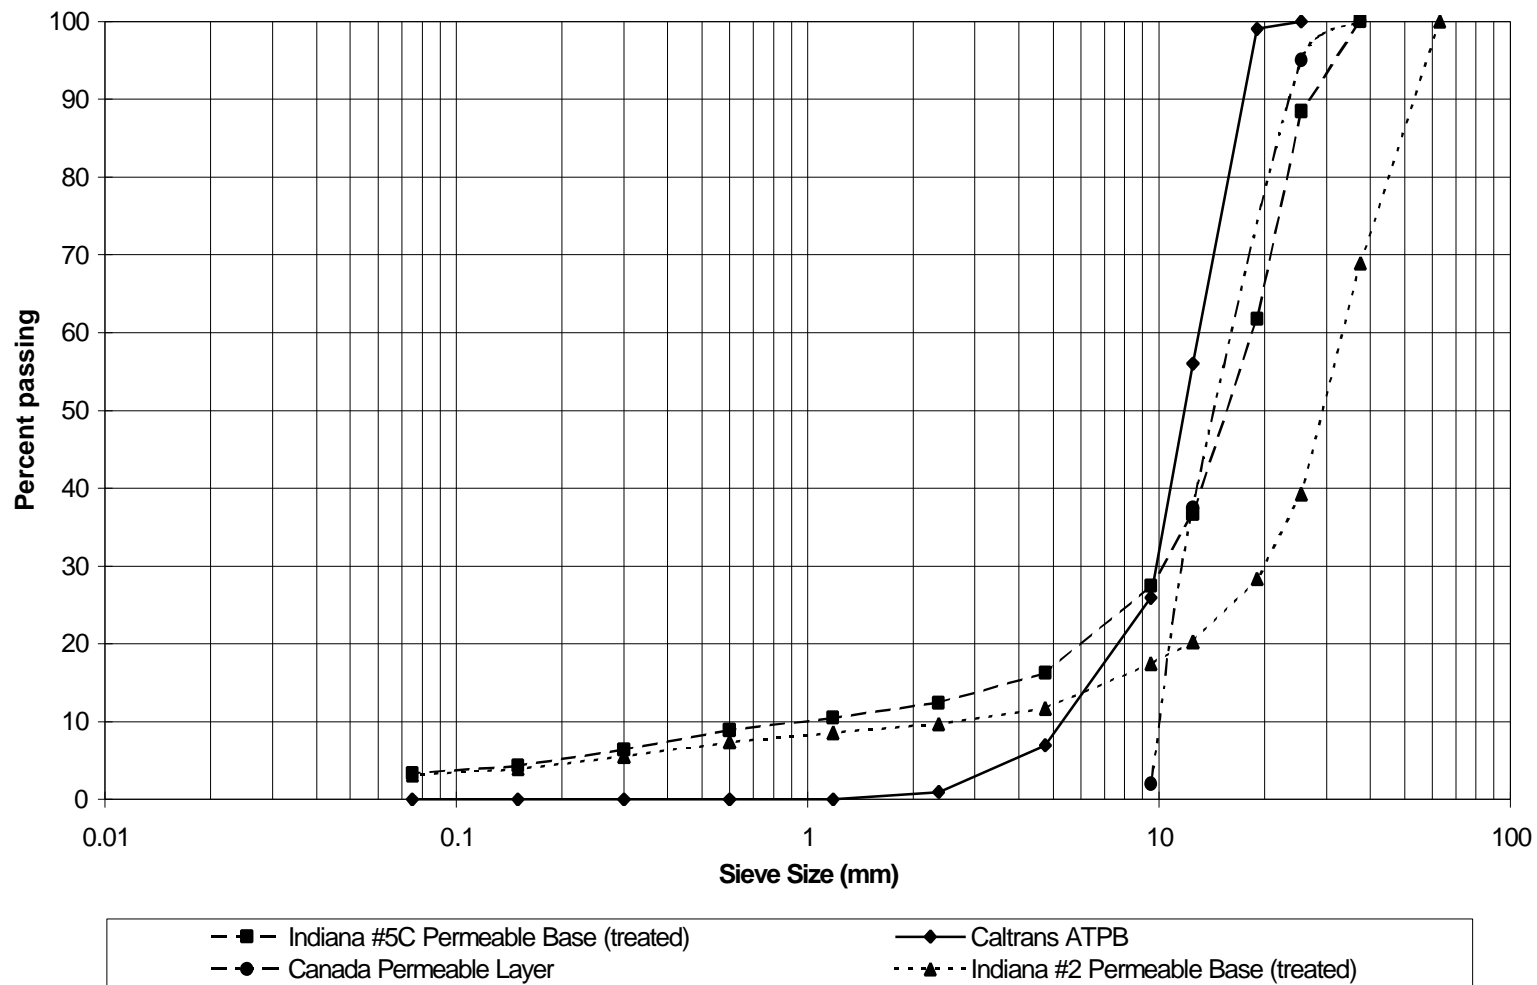
Figure 3.1. Comparison of Drainage Layer Gradings (Average of Upper and Lower Specification Limits).

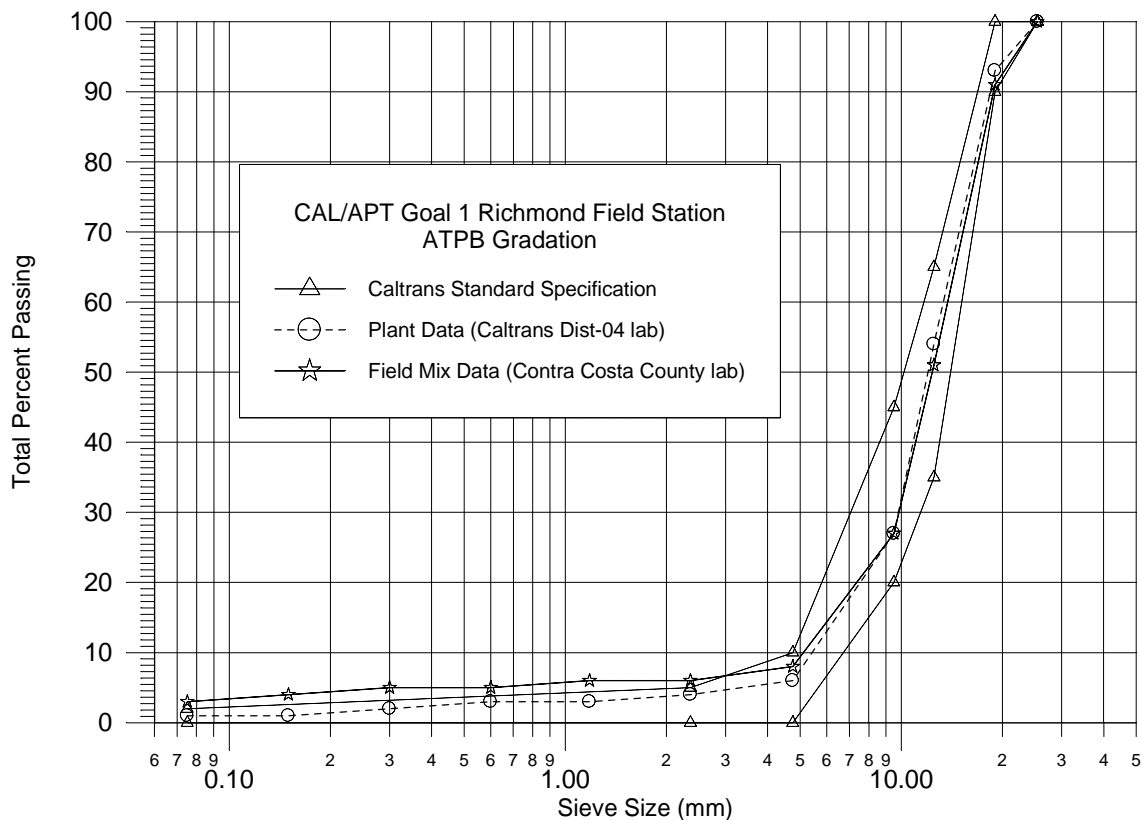
Figure 4.1. CAL/APT Goal 1 ATPB gradation test results and specification limits.

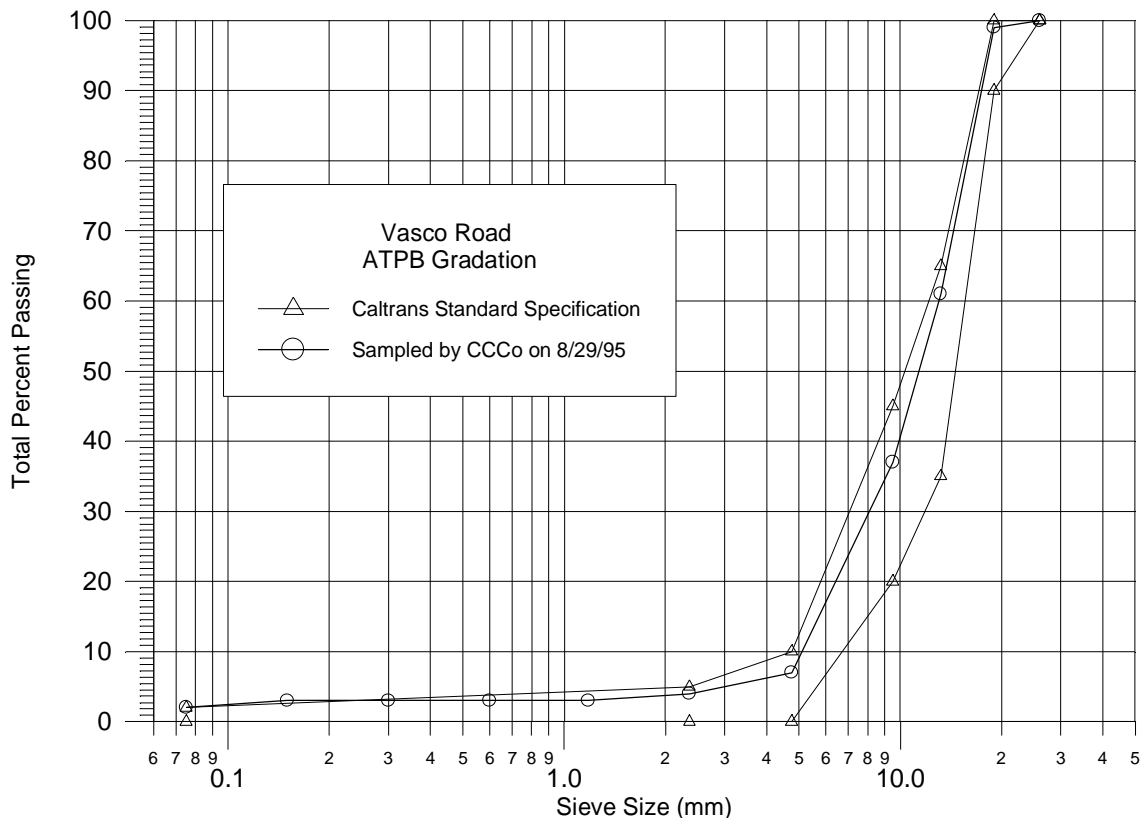
Figure 4.2. Vasco Road (Contra Costa County) ATPB Gradation Test Results and Specification Limits.

Aggregate gradations were determined from samples collected on three separate dates: 5 July, 11 August, and 29 August 1995. Samples taken on the first two dates were obtained from the construction site while samples taken on the last date were obtained from the hot mix plant. Figure 4.2 shows the aggregate gradation for the sample collected on 29 August. The samples

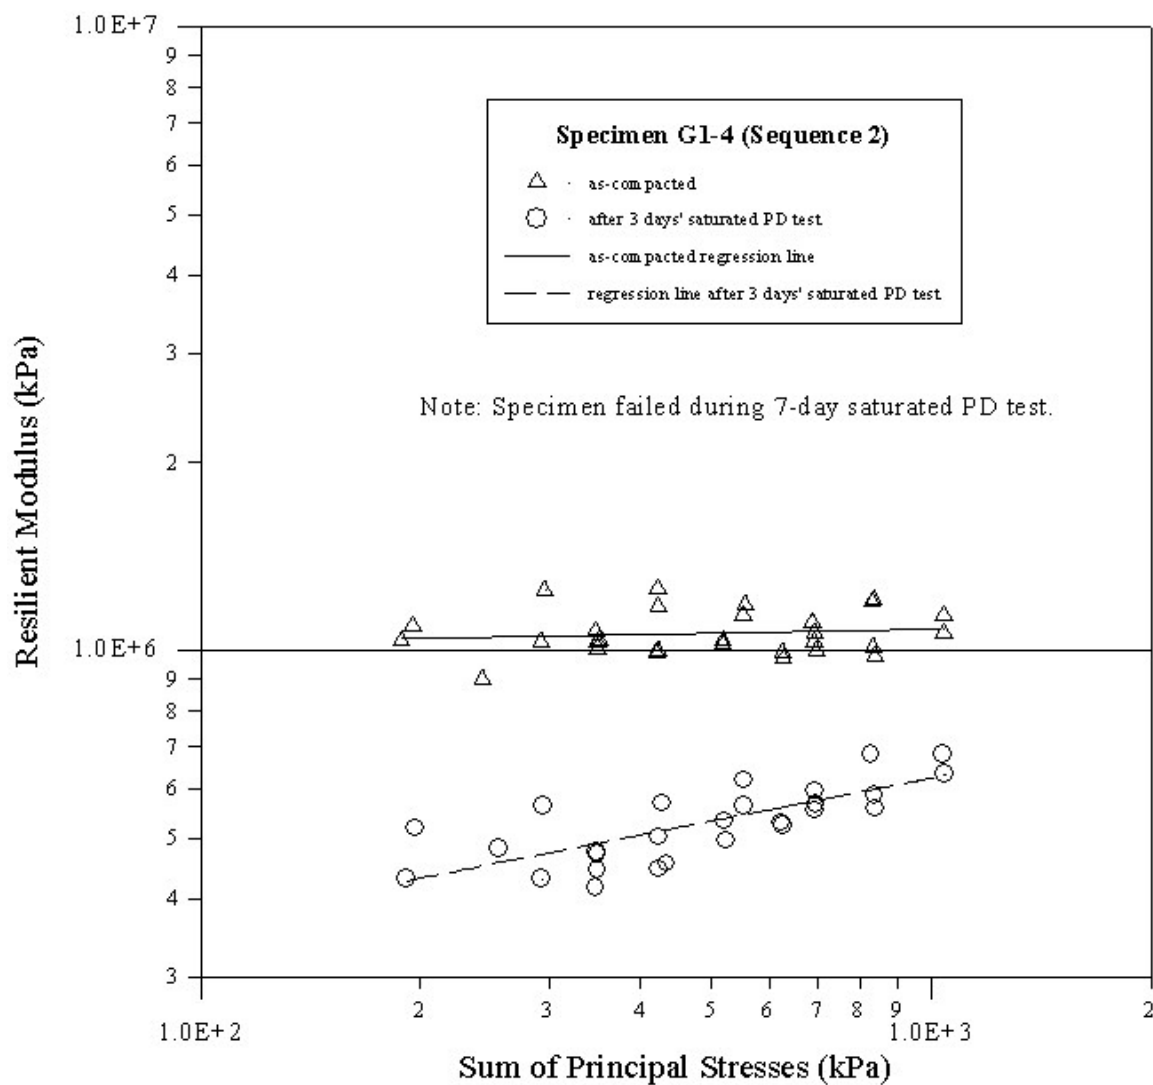
Figure 4.7. Resilient Modulus Test Results and the Corresponding Regression Lines for Specimen G1-4 with Air-Voids = 35.0 Percent (CAL/APT Goal 1).

The as-compacted resilient modulus test results for the specimens are shown in Figures 4.4 through 4.7. It can be seen that there is a great deal of variance in the resilient moduli of the as-compacted tests for these four specimens; average values range from about 0.8 Gpa (1.2×10^8 psi) to 2.0 Gpa (2.9×10^5 psi) (Appendix B contains the test data used to plot these figures). It is thought that the most likely cause of the high variance is the ratio of the size of specimen to the maximum aggregate size. For this ATPB material, the aggregate size is fairly uniform and about 70 percent by mass of the aggregate is between 10 mm and 20 mm in its least dimension (Figure 4.1). The maximum aggregate size was about 25 mm. Thus, the ratio of the

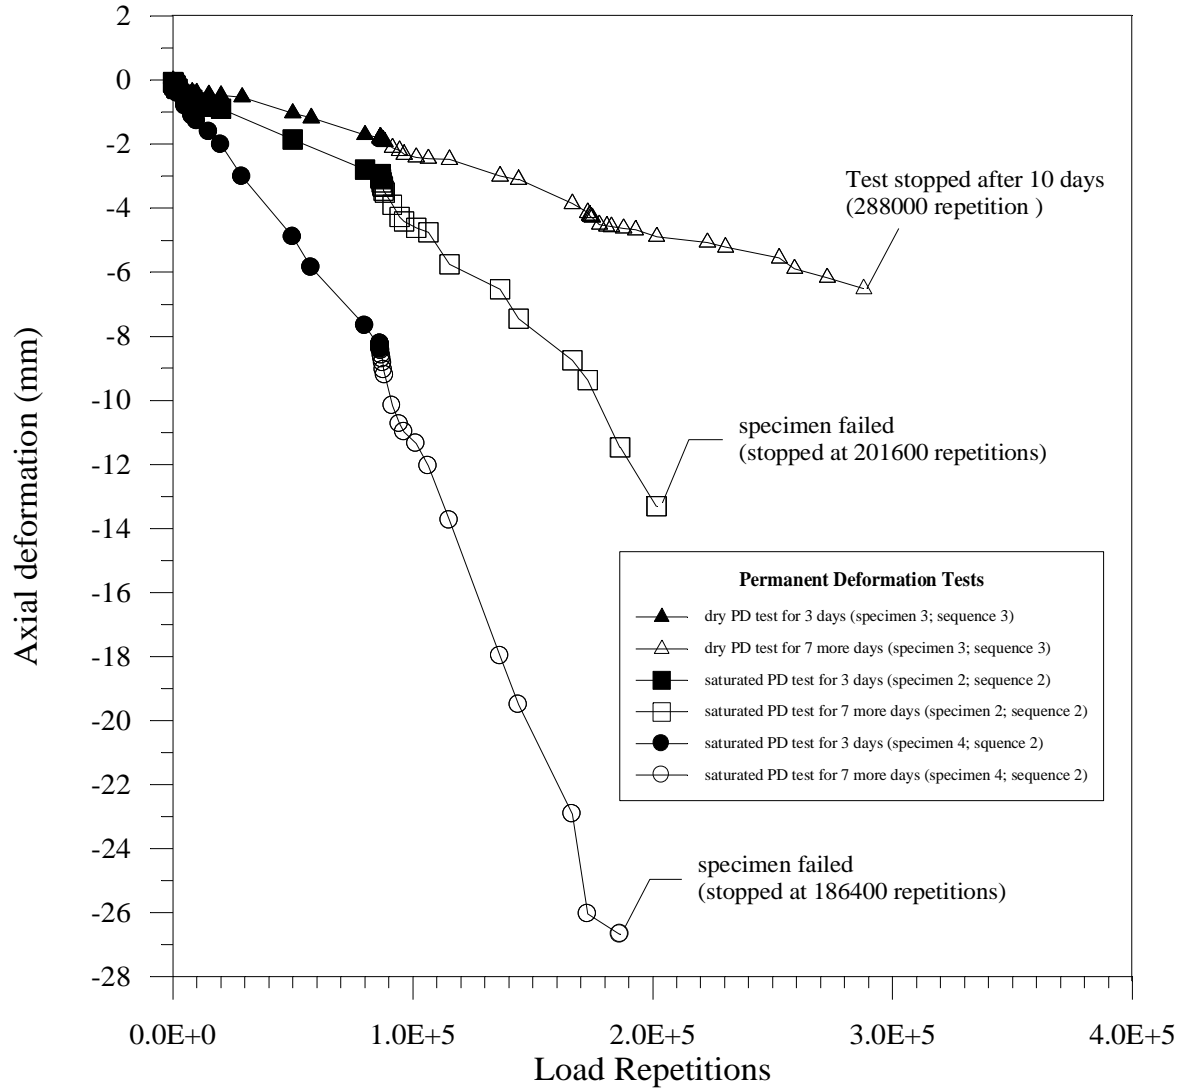
Figure 4.9. Permanent Deformation Test Results for ATPB Specimens G1-2, G1-3, and G1-4 Subjected to a Pulse Loading of 138 kPa (20 psi) and Zero Confining Pressure (Loading Time: 0.1 Seconds; Rest Period: 2.9 Seconds).

Specimen G1-4, which had a slightly greater air-void content and a lower initial M_R , exhibited more permanent deformation versus load repetitions and failed sooner than did Specimen G1-2. This difference in performance could be due to the difference in degree of compaction, the difference between the material samples, or a combination of these two factors.

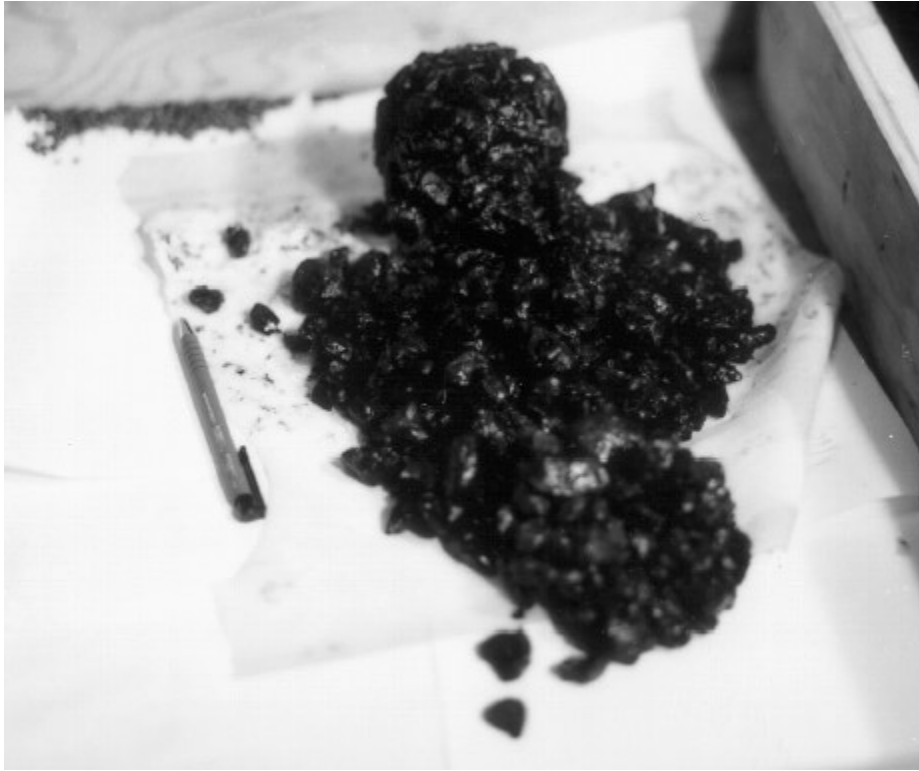
Figure 4.10. Goal 1 ATPB Specimen Failed in Saturated Permanent Deformation Test.

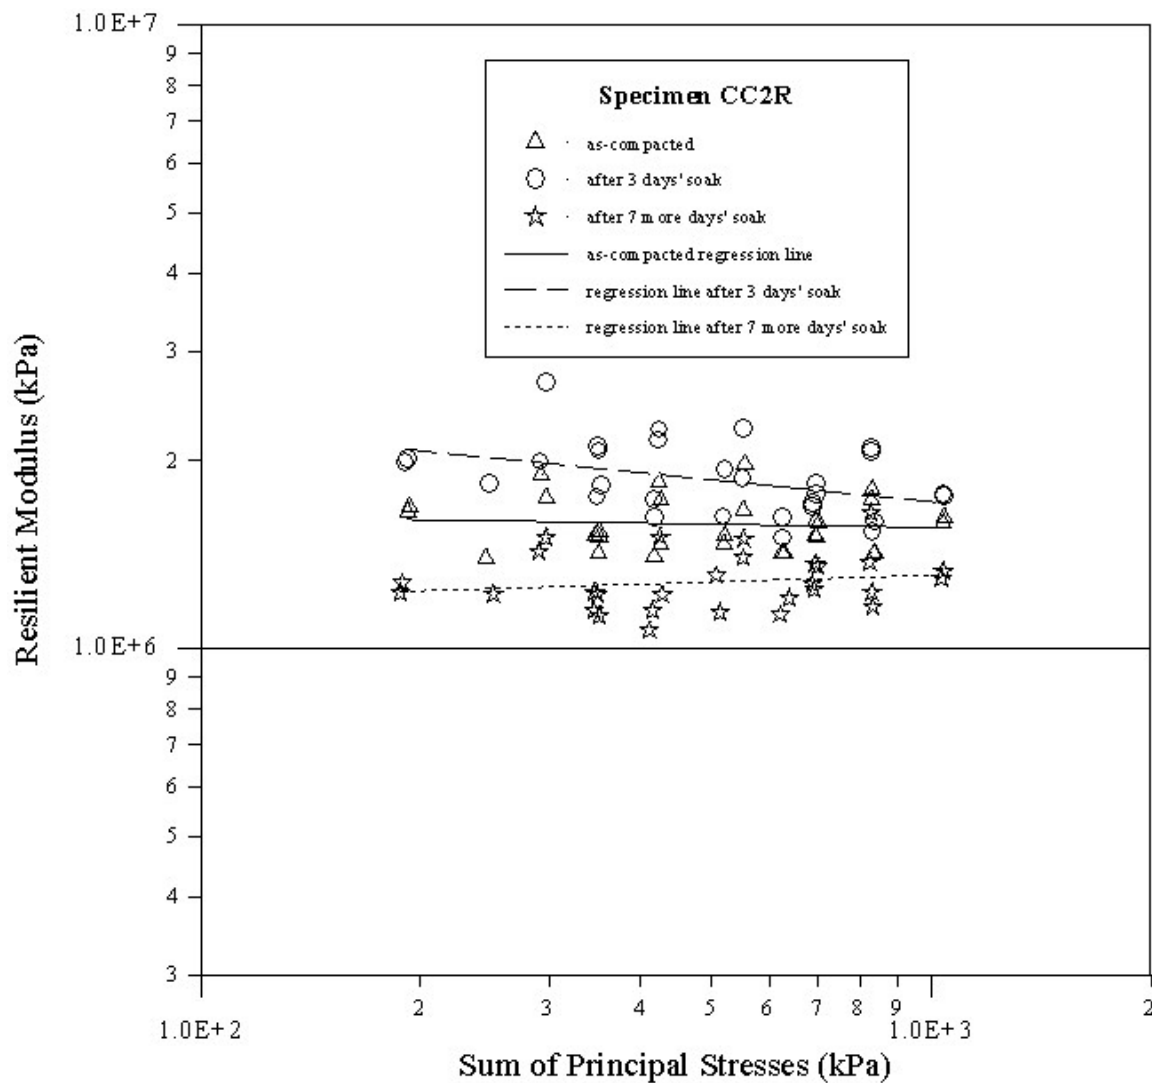
Figure 4.14. Resilient Modulus Test Results and the Corresponding Regression Lines for Specimen CC2R with Air-Voids = 32.5 Percent and Nominal Asphalt Content = 2.0 Percent (Vasco Road).

The resilient modulus test results for the four specimens are shown in Figures 4.12 through 4.15; detailed test results are included in Appendix C. Specimens CC5R and CC2R, with a nominal asphalt content of 2.0 percent, show some sensitivity to ten days of soaking. On the other hand, Specimens CC1L and CC2L, with a nominal asphalt content of 2.5 percent, do not exhibit this sensitivity. Although the sample size of this study was too small to make statistical statements and the variance of the results is large, increased asphalt content appears to reduce the damage caused by soaking. Table 4.11 shows the regressions between M_R and SPS for the four specimens and their corresponding M_R values at three values of sum of the principal stresses: 200 kPa, 500 kPa, and 1000 kPa. There does not appear to be any difference in as-compacted stiffness as a result of changes in asphalt content directly, as can be seen in Figure 4.16 and Table 4.11.

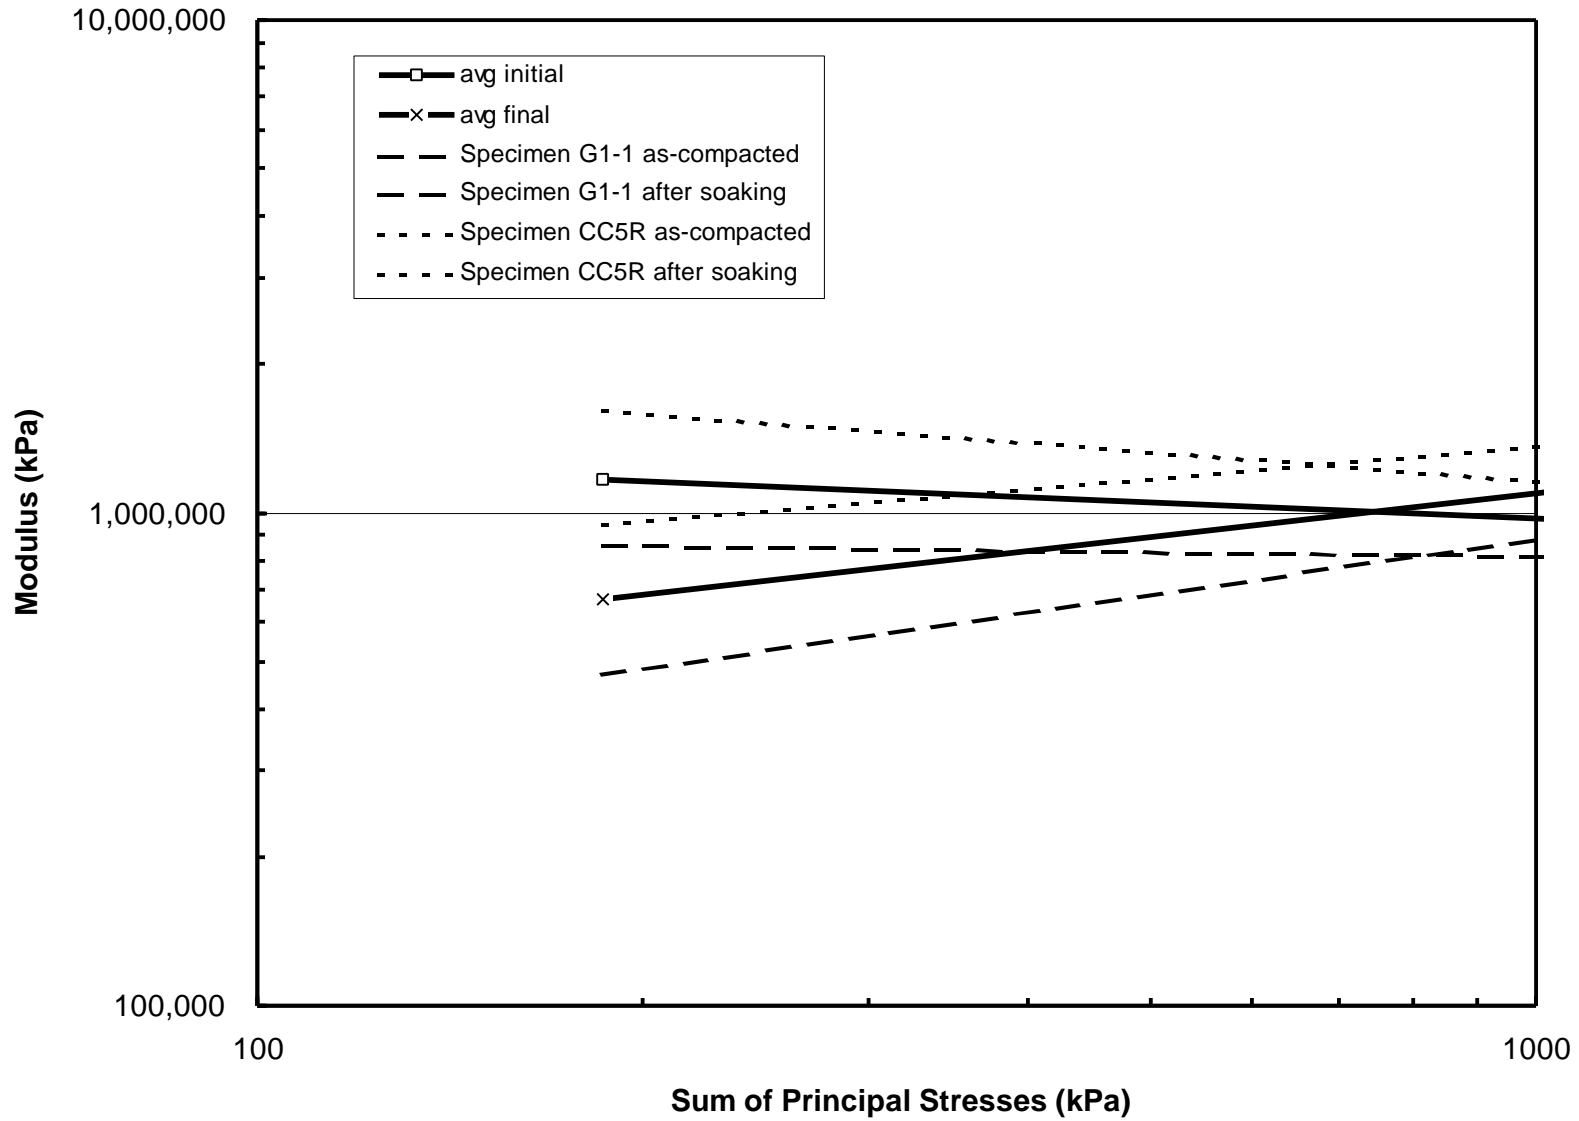
Figure 5.1. Resilient Modulus Results Used to Select Representative As-Compacted and Soaked Elastic Moduli for ATPB.

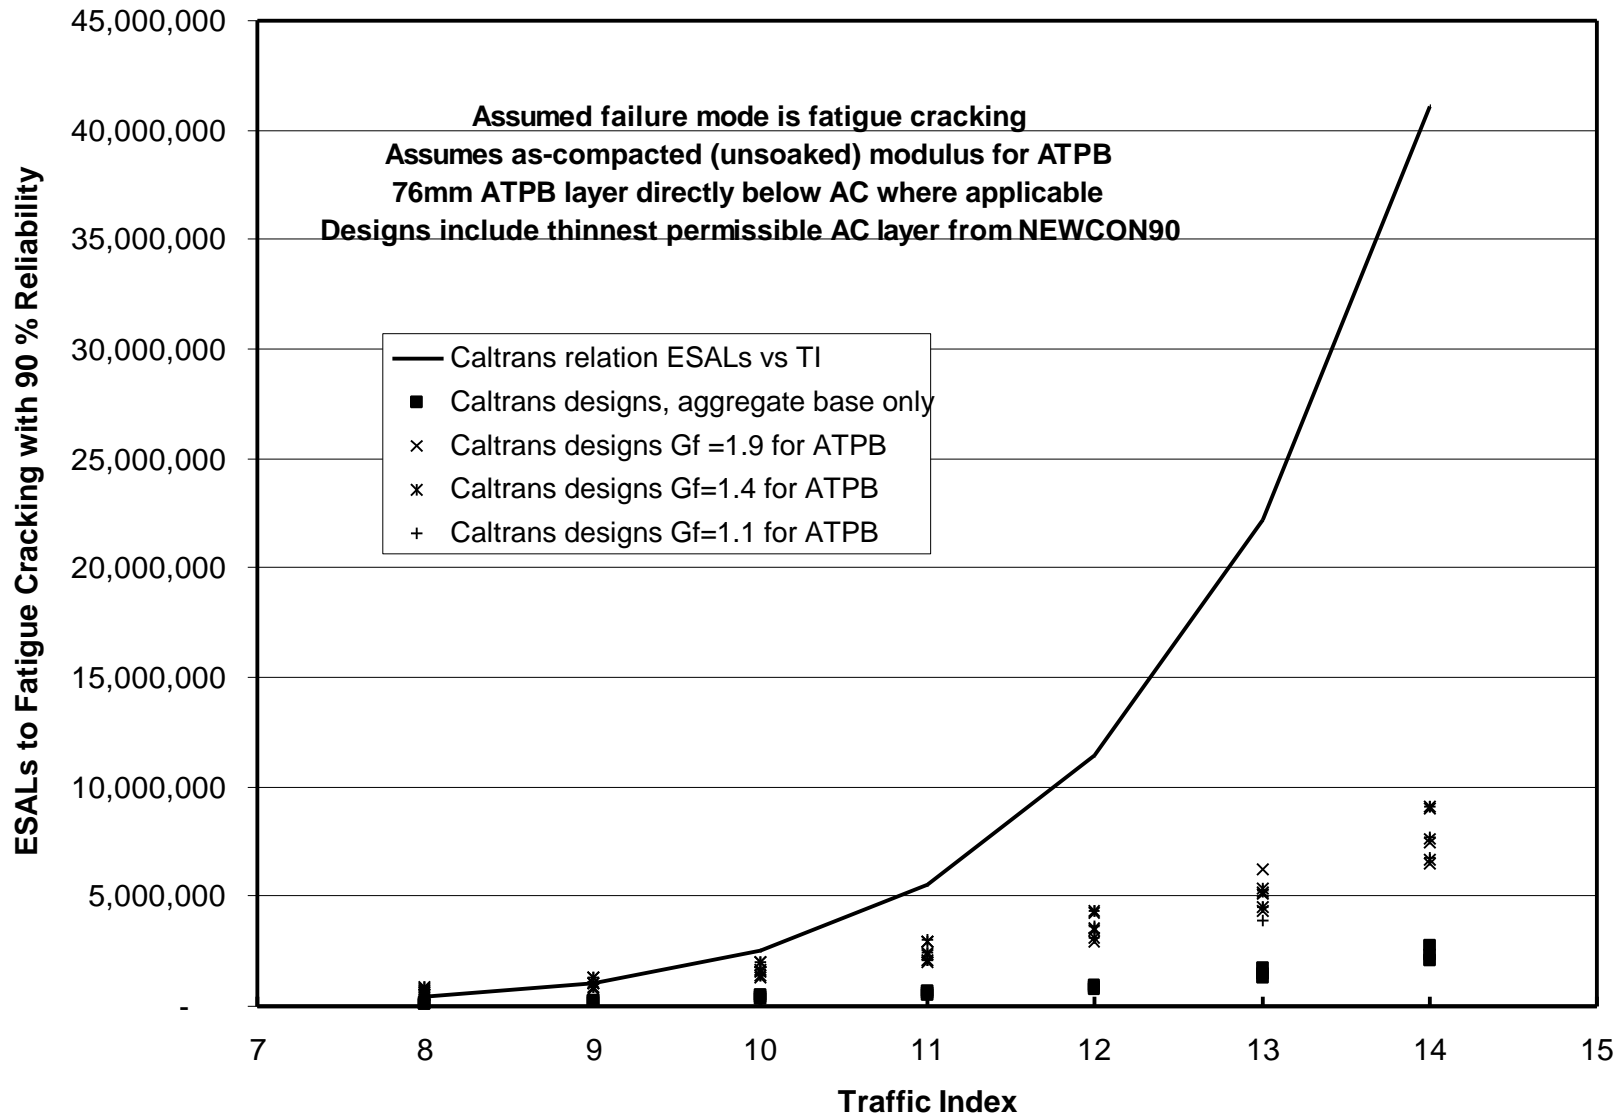
Figure 5.4. Comparison of Caltrans Traffic Index (TI) versus Equivalent Single Axle Loads (ESALs) Relation and Pavement Fatigue Life with 90 Percent Reliability for Pavements with As-Compacted ATPB and with Aggregate Base Only.

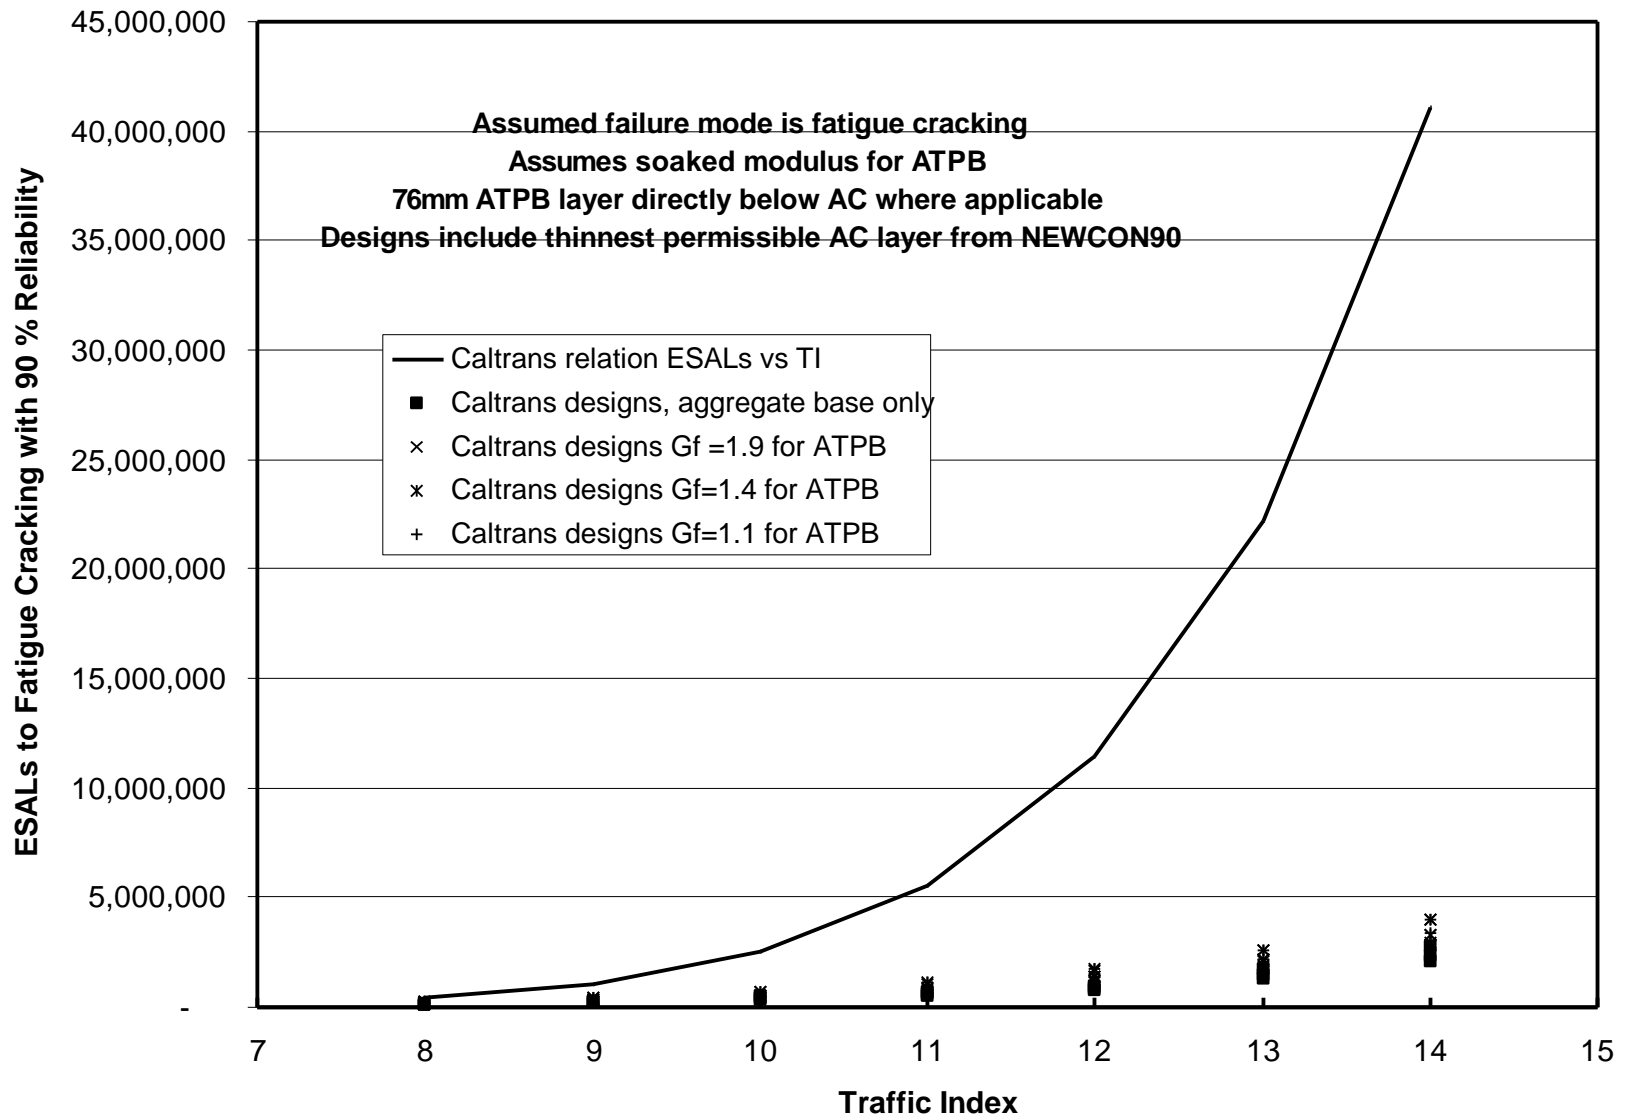
Figure 5.5. Comparison of Caltrans Traffic Index (TI) versus Equivalent Single Axle Loads (ESALs) Relation and Pavement Fatigue Life with 90 Percent Reliability for Pavements with Soaked ATPB and with Aggregate Base Only.

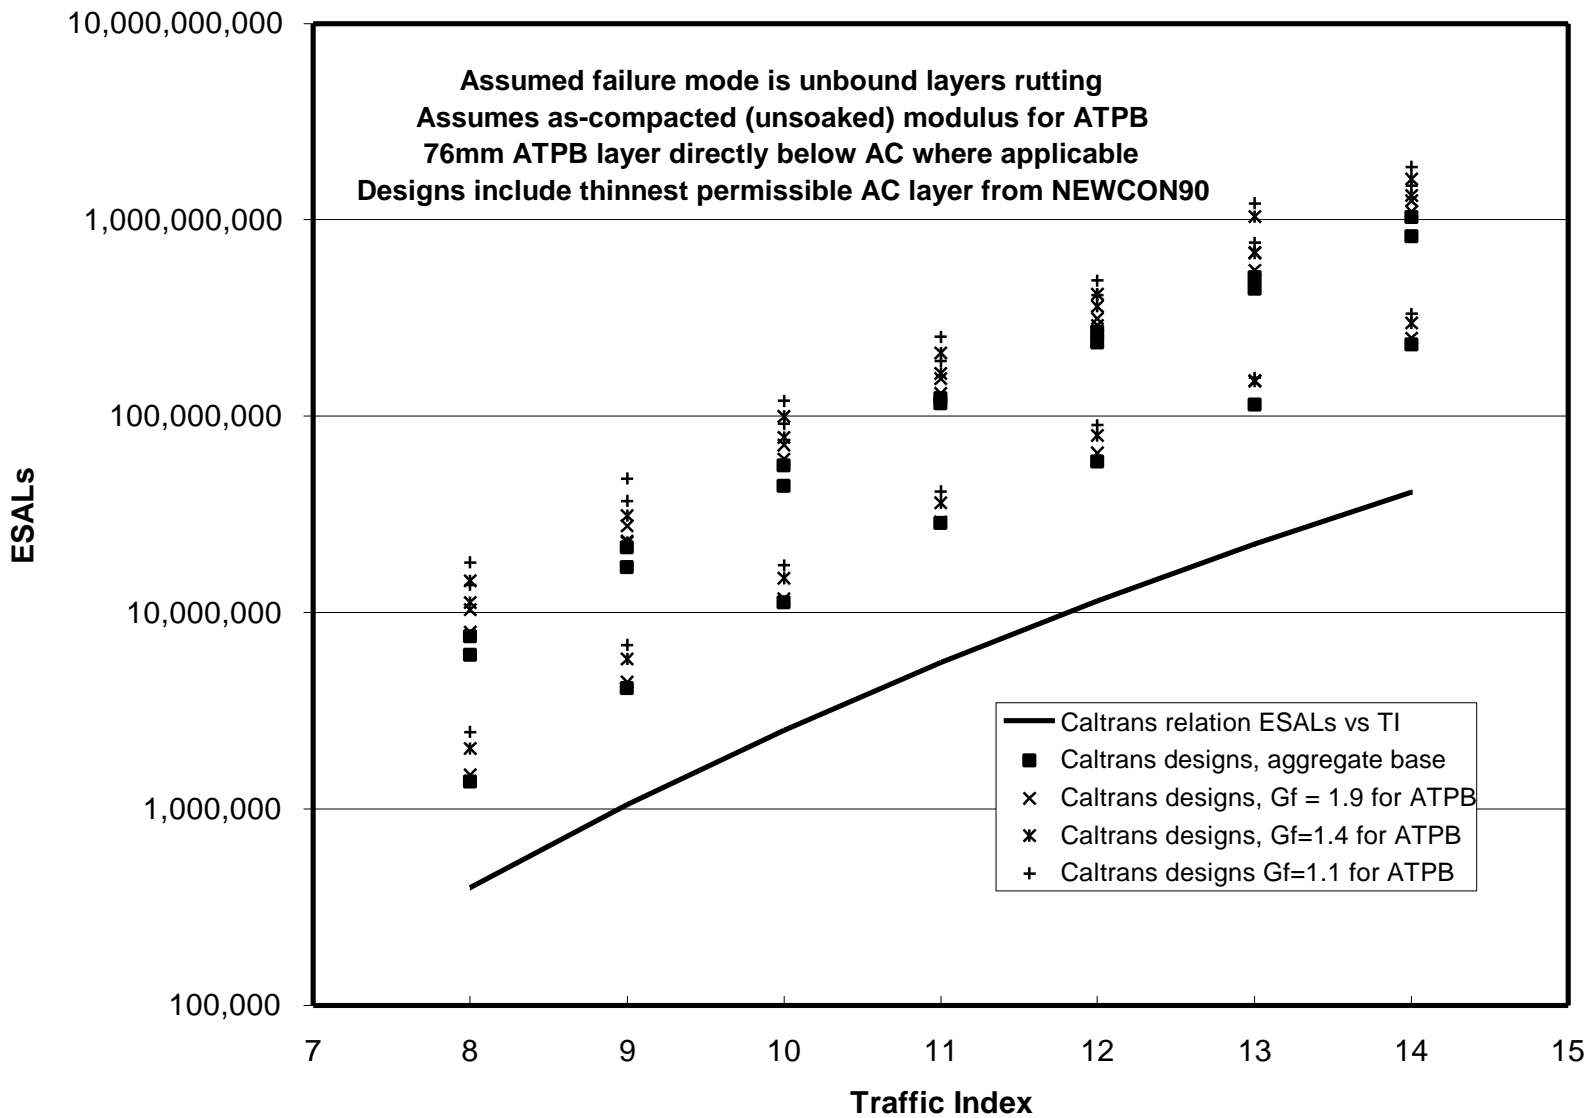
Figure 5.6. Comparison of the Caltrans Traffic Index (TI) versus Equivalent Single Axle Loads (ESALs) Relation and Design Pavement Rutting Life for Pavements with As-Compacted ATPB and with Aggregate Base Only (Rutting in Unbound Materials, Asphalt Institute Criterion [21]).

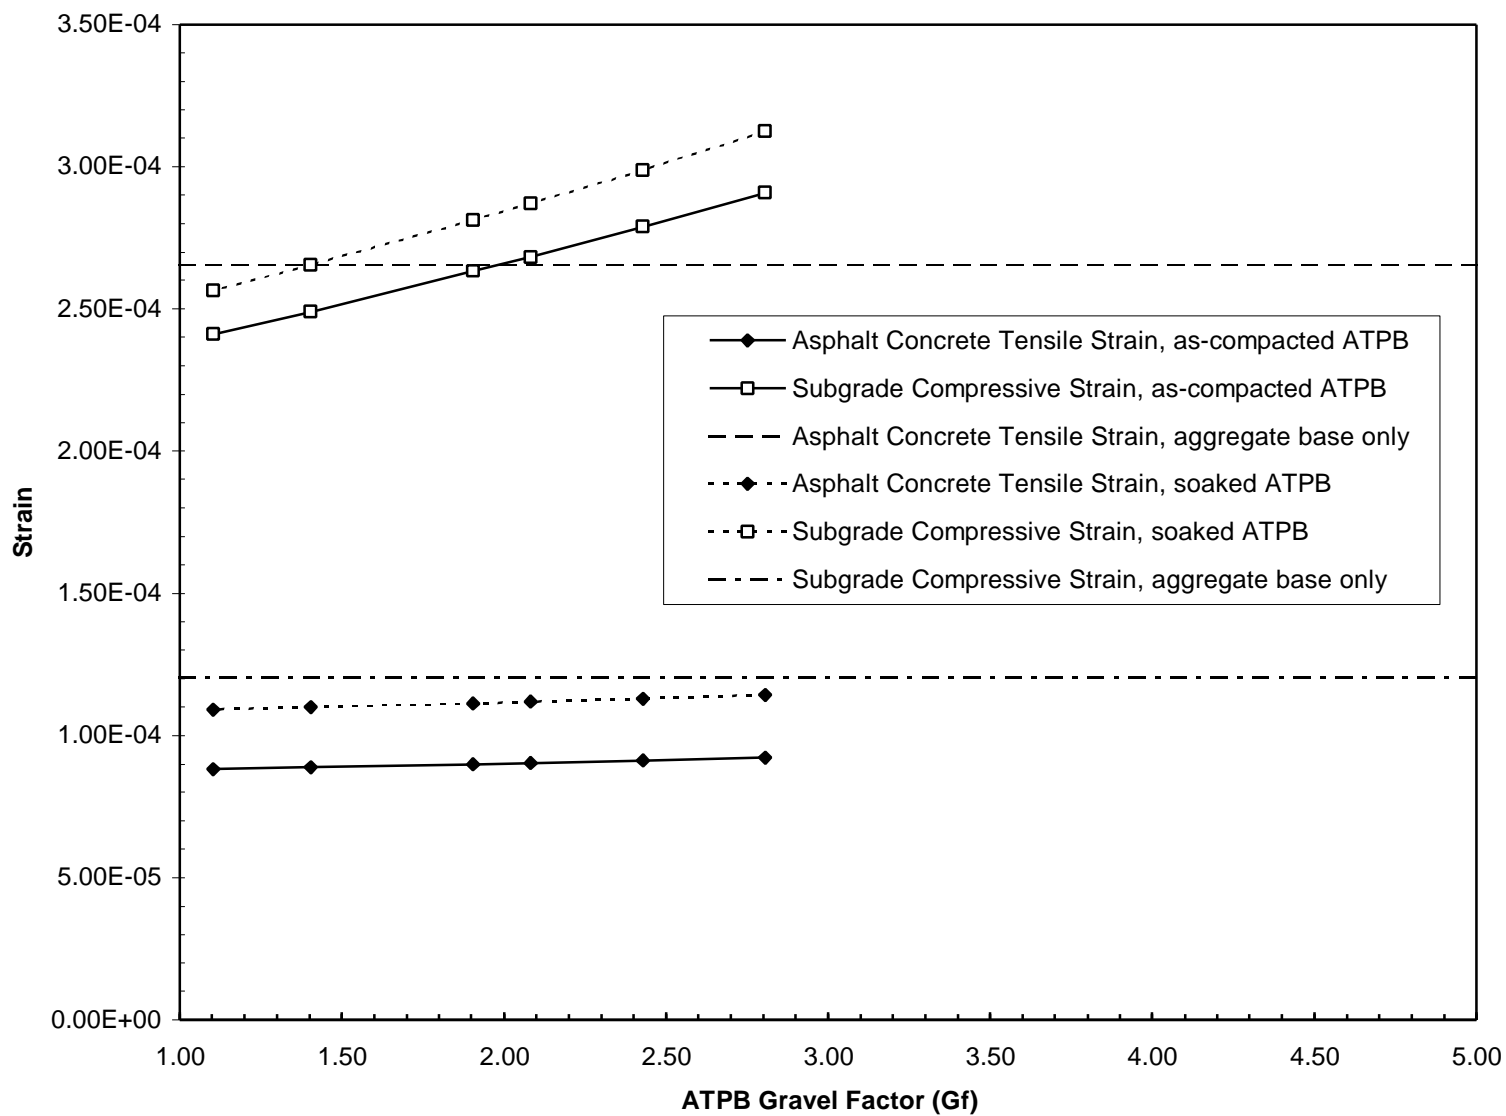
Figure 5.8. Influence of the Magnitude of the ATPB Gravel Factor on Vertical Compressive Strain at the Subgrade Surface and the Tensile Strain at the Underside of the Asphalt Concrete Layer (TI=10, R-value=5).
