Experimental Investigation of Postearthquake Vertical Load-Carrying Capacity of Scoured Reinforced Concrete Pile Group Bridge Foundations

Journal of Bridge Engineering, 26(12)

Zhou, Lianxu  
Barbato, Michele  
Ye, Aijun

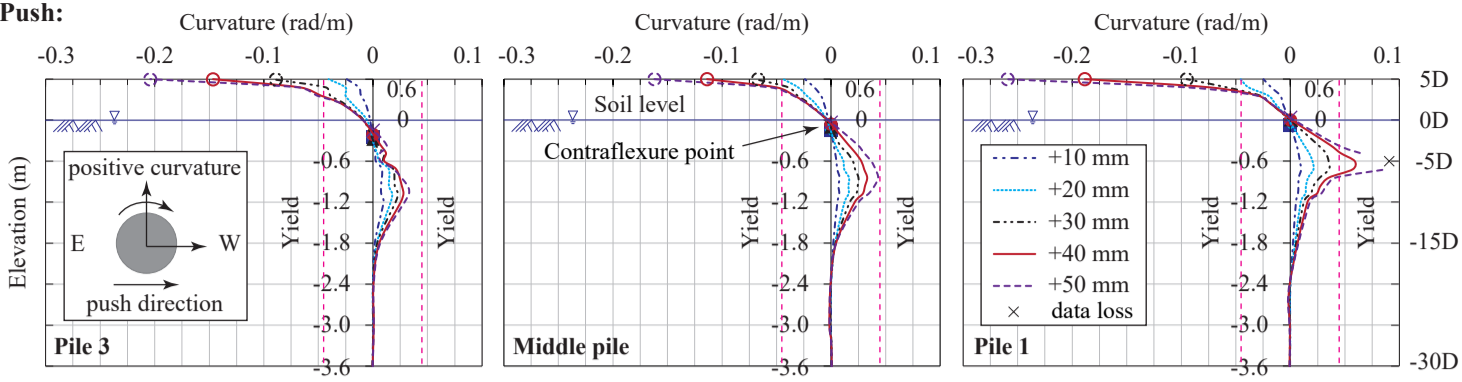
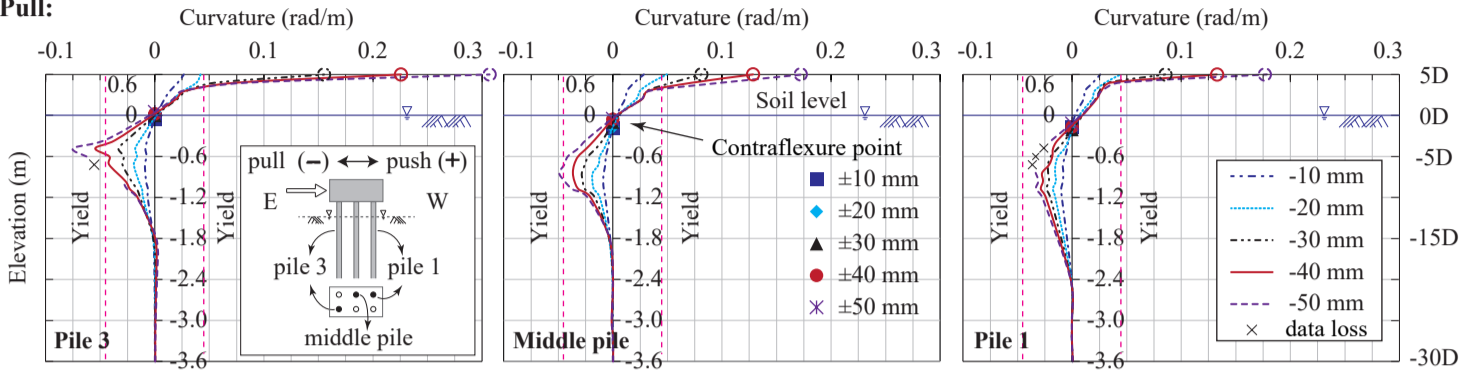
256 The equivalent yielding curvature of the pile section, which was found to be equal to 0.045 rad/m from the  
257 moment-curvature analysis, is also represented in Figure 8 as vertical dashed lines. This quantity is used as the basis  
258 to identify whether the pile section yields at a given displacement level. It is observed that the lateral loading phase  
259 of the test produced two plastic hinges on each pile in the scoured pile group: the first hinge was located at the pile  
260 head, whereas the second hinge occurred on the pile shaft below the ground surface, and the contraflexure point

261 (indicated by filled markers) was located near the ground surface, as shown in Figure 8. This phenomenon also implies  
262 that the three piles standing in a line along the lateral loading direction formed a frame-like structure. By comparing  
263 the curvature envelopes of different piles at the same displacement level, it is observed that the curvature of each pile  
264 section at the same elevation decreased from the leading to the middle pile and from the middle to the trailing pile.  
265 This result implies that the leading pile carried a larger proportion of the lateral loads on the pile group foundations  
266 than the middle and trailing piles, due to the pile group effect. This phenomenon was also reported by Rollins et al.  
267 (2005). In addition, the embedded depth of the maximum curvature for a belowground pile section gradually increased  
268 when going from the leading (i.e., between -5D and -6D), to the middle (i.e., between -7D and -8D), to the trailing

269 (i.e., between -9D and -10D) piles. Within the same pile, the embedded depth of the belowground section with  
270 maximum curvature tended to decrease with the increase of the displacement levels. It is also observed that the section  
271 curvature at the pile head was larger than that of all other sections along the pile shaft under any displacement level.  
272 These findings indicate that the leading pile, and especially its pile head, was more prone to seismic damage than the  
273 other piles, as both the first aboveground and first belowground plastic hinges originally occurred on it. This  
274 conclusion is also consistent with the experimental results reported by Liu et al. (2020).

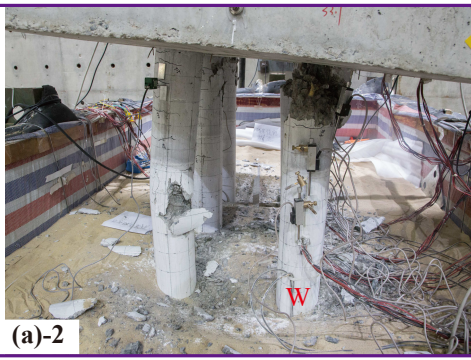
416 The residual vertical load-carrying capacity of specimen #1 was 1505 kN, which corresponded to 89.6% of the  
417 initial vertical load-carrying capacity of the undamaged 2×3 pile group. It is observed that the lateral displacement of  
418 the pile cap slightly decreased during the vertical loading phase until the peak vertical force was reached. After  
419 reaching the peak resistance and maintaining it for approximately 1 mm of vertical displacement increment (Figure  
420 13a), the vertical resistance of specimen #1 suddenly dropped. As shown in Figure 14(a)-1, the pile heads of the three  
421 piles on the south side of the specimen failed in shear, whereas the three piles in the north side of the specimen  
422 exhibited a flexural failure mode, which was induced by the cap tilt along the north-south direction.

- 653 Figure 14. Post-test observations of the physical specimens after soil removal: (a) specimen #1, (b) specimen #2, and  
654 (c) specimen #3
- 655 Figure 15. Vertical load capacity degradation data and fitting curve

438 third row with respect to the direction of the cap residual displacement. The embedded depth of the plastic hinge  
 439 centers on the belowground pile shafts were approximately 4D, 5D, and 6D in sequence, which corresponded to  
 440 shallower depths than those obtained from curvature measurements during the cyclic loading phases of the test and  
 441 reported in Figure 8. This phenomenon was observed because specimens #2 and #3 experienced relatively large lateral  
 442 displacements (i.e., more than 12 cm) induced by the vertical loads applied during the pushdown phase, and the  
 443 embedded depth of the belowground plastic hinge in each pile tended to decrease for increasing lateral displacement  
 444 levels. It is noteworthy that no cracks were observed on the piles at a depth higher than 14D from the soil surface.  
 445 Finally, by using a plumb bob hung from the bottom of the cap (see Figures 14(a)-3 and 14(c)-3), it was observed that

446 the belowground portions of the pile shafts remained almost vertical and undamaged in specimen #1, whereas they  
 447 remained practically vertical and undamaged below the belowground plastic hinges in specimens #2 and #3. Therefore,  
 448 it is concluded that the pile damage induced by lateral loads were mainly concentrated in the pile heads and in the  
 449 upper portions embedded in the sand (i.e., between 3D and 10D below the soil surface) for the scoured pile groups.  
 450 This pile damage led to a permanent displacement and tilt on the cap, and dominated the residual vertical load capacity  
 451 and the vertical failure mode of the pile group foundations.

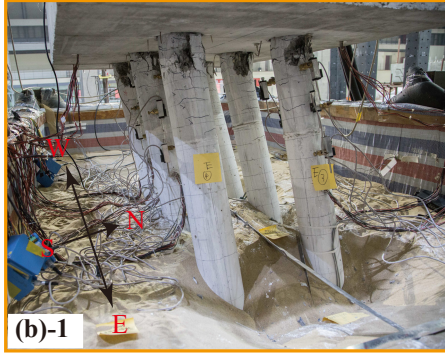
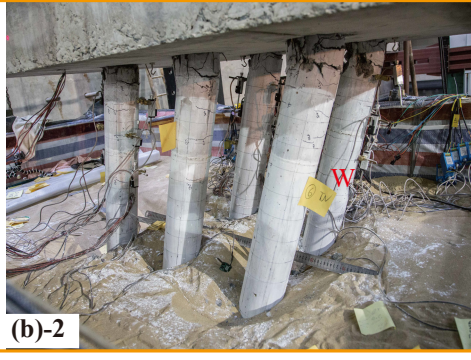
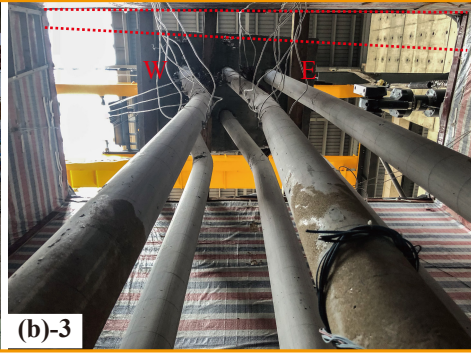
423 The residual vertical load-carrying capacity of specimen #2 was 882 kN, which corresponded to 52.5% of the  
424 initial vertical load-carrying capacity of the pile group. It is observed that the cap lateral displacement for this  
425 specimen remained almost constant until the peak vertical resistance was reached at approximately 4.3 mm. After the  
426 peak vertical strength was reached, the lateral displacement of the cap started increasing significantly until the  
427 specimen suddenly failed in flexure (see Figure 14(b)-1), with the cap rotating vertically about the north-south axis  
428 (Figure 14(b)-2) and twisting about the vertical axis (Figure 14(b)-3). The twisting of the cap is highlighted by the  
429 non-parallel traces of the container wall and the cap edge, which are shown by dashed red lines in Figure 14(b)-3.

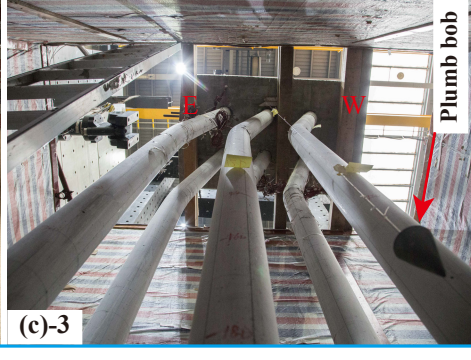
430 The residual vertical load-carrying capacity of specimen #3 was 440 kN, which corresponded to 26.2% of the  
431 initial vertical load-carrying capacity of the pile group. Figure 14(c) shows some pictures of the post-test conditions  
432 of the physical specimen. This specimen failed following a flexural failure mode with a pronounced rotation of the  
433 cap in the north-south direction. As shown in Figure 13(b), the cap lateral displacement gradually increased from the  
434 initial residual displacement for increasing vertical displacement.

435 As shown in Figure 14(c)-2, the confinement effect provided by the sand inhibited the spalling of cover concrete  
436 in the plastic hinge regions of the belowground pile shafts, even after the pile shaft suffered severe flexural damage.  
437 For specimens #2 and #3, the flexural deformation gradually decreased from the piles in the first row to those in the
