Riparian vegetated buffer in Chinese urban wetlands: a case study of Xixi wetland, Hangzhou

Karen Jin and Jingyi Chen

UC Berkeley, Landscape Architecture 227: River Restoration

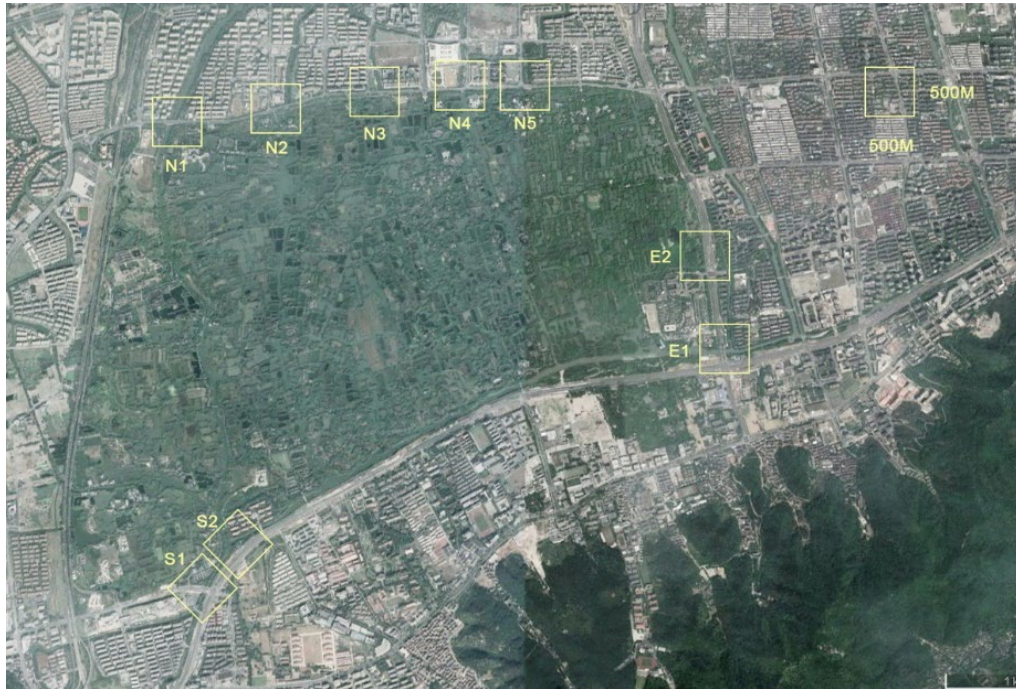
Figure 4: Nine intersections where adjacent rivers intersect with the wetland

To select representative sites along the edge for field study, we first identified locations where adjacent urban rivers and streams intersect with the hydrological network in the wetland through examining google earth imagery. We drew a 500x500m block at each intersection for land use analysis later (Figure 4).

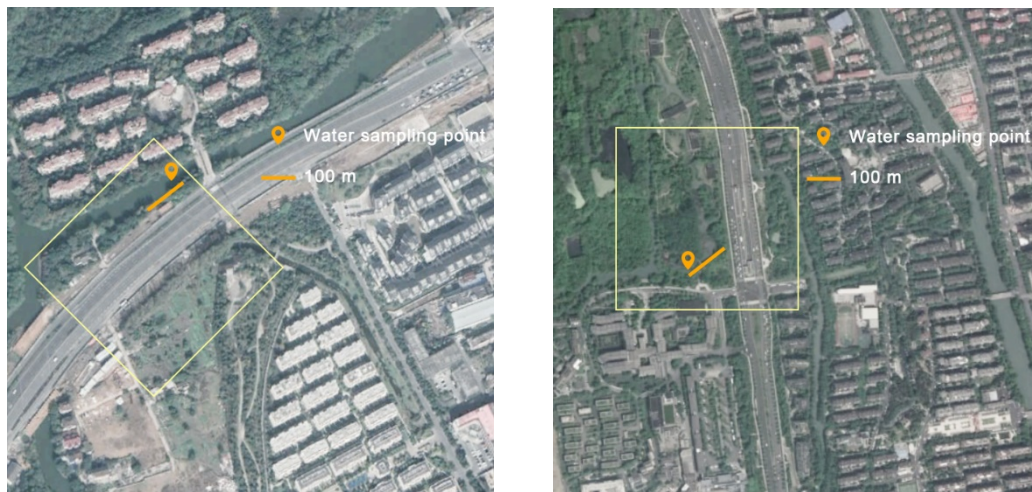
Figure 7: Plant survey and water sampling locations at site S2 (left) and E2 (right)

the design of the current riparian buffers, we estimated the average buffer width and slope using a combination of footstep measurement and visual inspection. To get a preliminary understanding of the riparian vegetation composition at each site, we conducted a plant survey by documenting the major tree and shrub species we saw across a ~100m transect along the bank (Figure 7).

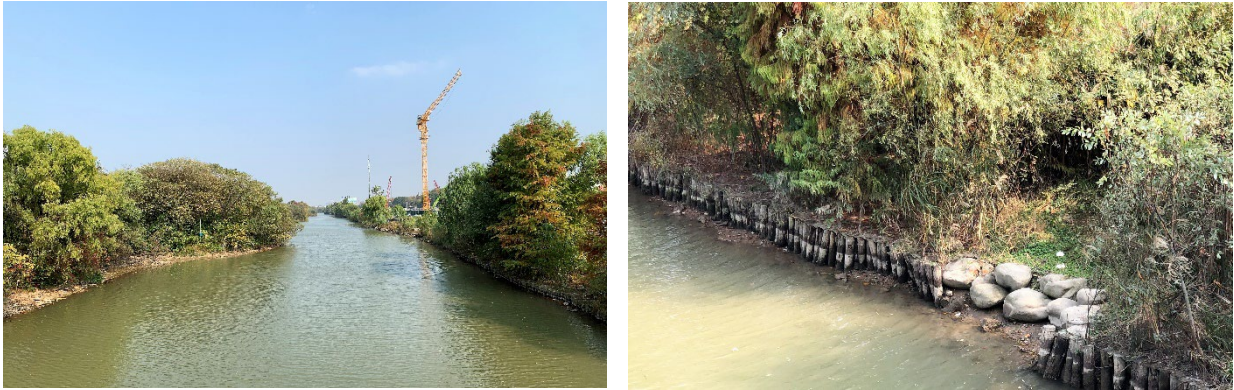
Figure 8: River channel at transect S2: aerial view (left) and bank protection measures (right)

The average riparian buffer width at transect S2 was about 15m with a slope about 30%. The width of the channel was about 40m. We noticed that wooden stakes were used for bank protection on the side closer to the road, whereas the gravel bar closer to the wetland was left unprotected (Figure 8). There is an ongoing metro line construction project on Tianmushan Road, parallel to the river.

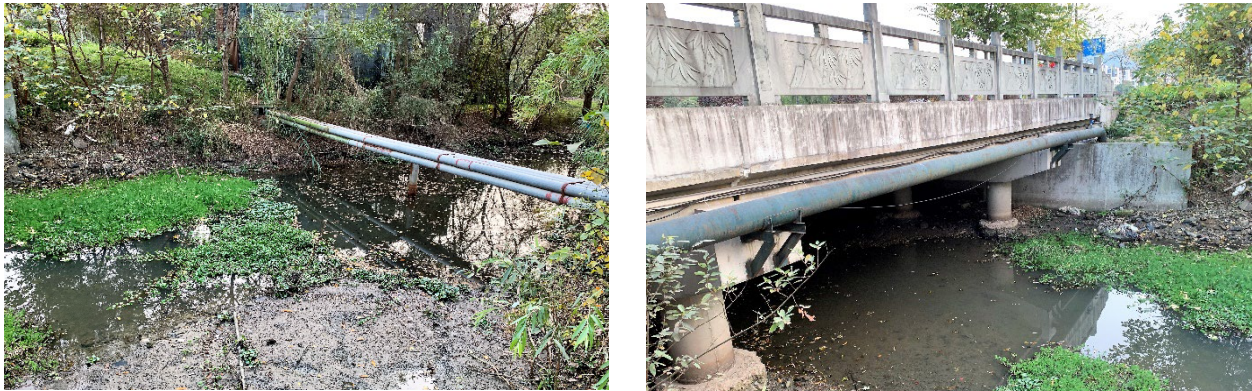
Figure 10: River channel at transect E2: aerial view (left) and intersection at major road (right)

The average buffer width was about 100m at transect E2 with a slope of about 10%. The river channel is perpendicular to a major road (Zijinggang Rd.) nearby and extends to residential

areas in the neighborhood. The channel immediately adjacent to the road was much narrower (about 15m on average) compared to the portion in the inner area of the park (Figure 10). We did not observe any bank protection measures in the channel at our transect. We observed aquatic plants including some species of water milfoil which was not found at transect S2.

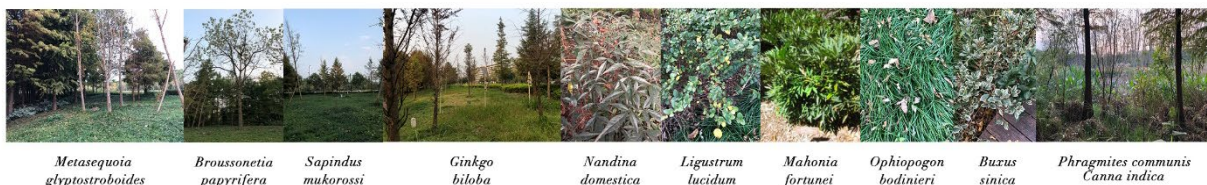
Figure 11: Common woody plants, shrubs and herbaceous plants at transect E2

We found similar tree species (i.e. *Metasequoia glyptostroboides*, *Sapindus mukorossi* and *Salix babylonica*) in the riparian buffer at transect E2 as at transect S2, with the exception of *Ginkgo biloba* which was only found at transect E2. We also observed small shrubs including *Nandina domestica* (sacred bamboo), *Ligustrum lucidum* (glossy privet), *Mahonia fortunei* (barberry) and *Buxus sinica* (Korean boxwood) (Figure 11). Common herbaceous plants we found include *Ophiopogon bodinieri* (Chinese lilyurf) and *Phragmites communis* (reed).

The general spatial arrangements of the vegetation were similar at the two riparian buffers, with a grassy VFS on the outer edge and large woody plants near the channel. One difference was that woody plants were also planted on the outer edge near the road at transect S2, likely because the buffer was wider and therefore had more space for planting. Similar major tree species were found at both transects including species well-adapted to riparian environment and tolerant of high water levels such as dawn redwood and willow. Other tree species included those commonly used

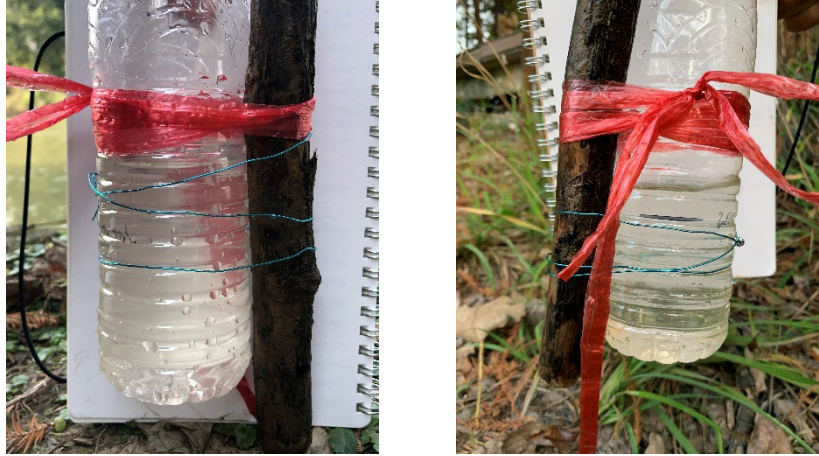
Figure 10: Water samples at transect S2 (left) and transect E2 (right)

We did not observe any suspended solids greater than 0.1cm which could be filtered by our mesh. The water samples at both transect looked approximately equally transparent, with a slight brownish color and small suspended particles not large enough to be filtered but visible by eye (Figure 10). At transect E2, we noticed oily substance floating on top of the water near a building with unknown functions in the buffer zone, but we did not observe similar pollution problems at S2. Water samples collected inside the park did not look very different visually from those collected in the river buffers in our transects, but we did observe polluted standing water at some locations inside the park as observed at transect E2 (Appendix A).

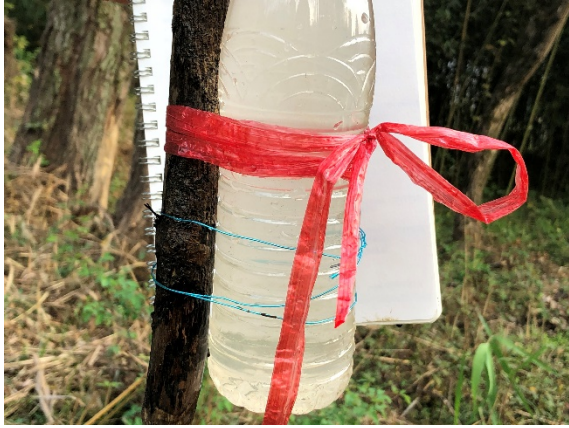
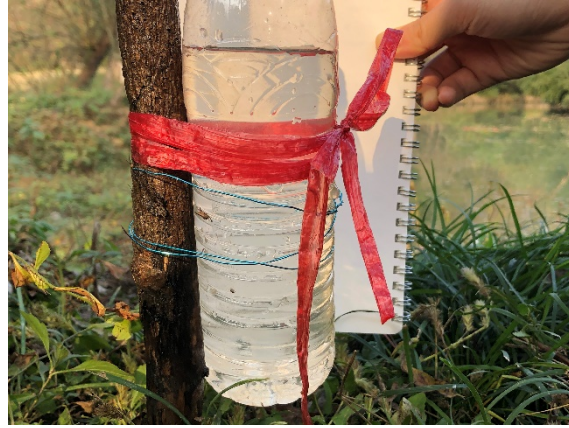
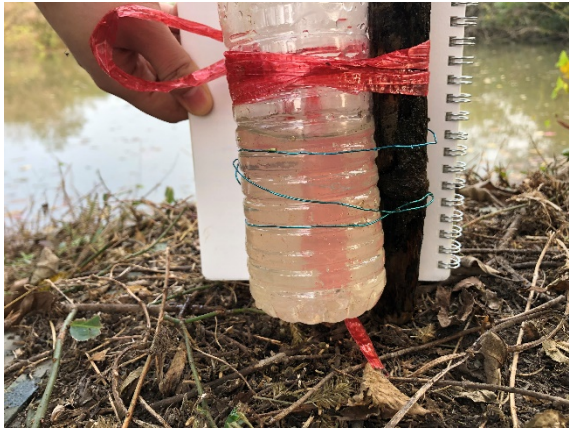
Appendix A: Water samples collected from rivers and streams inside the wetland park
