Contemporary streamkeepers : a comparison of two urban horticultural restoration programs

Contemporary Streamkeepers: A Comparison of Two Urban Horticultural Restoration Programs

Course: Landscape Architecture 227 - Restoration of Rivers and Streams

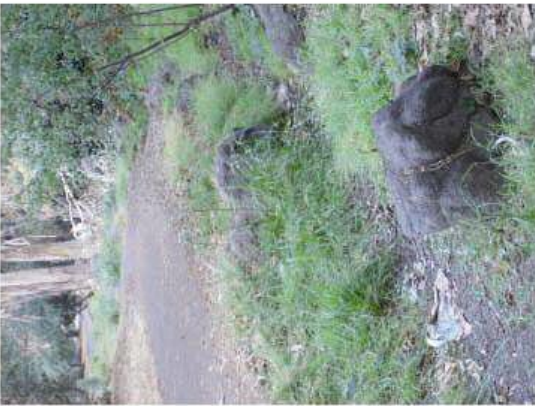
(A) BEFORE: The 'reconstituted' conditions of 'Faux' Temescal Creek indicate little evidence of water and the absence of native riparian vegetation along the reach of Clarke St. to Clifton St.

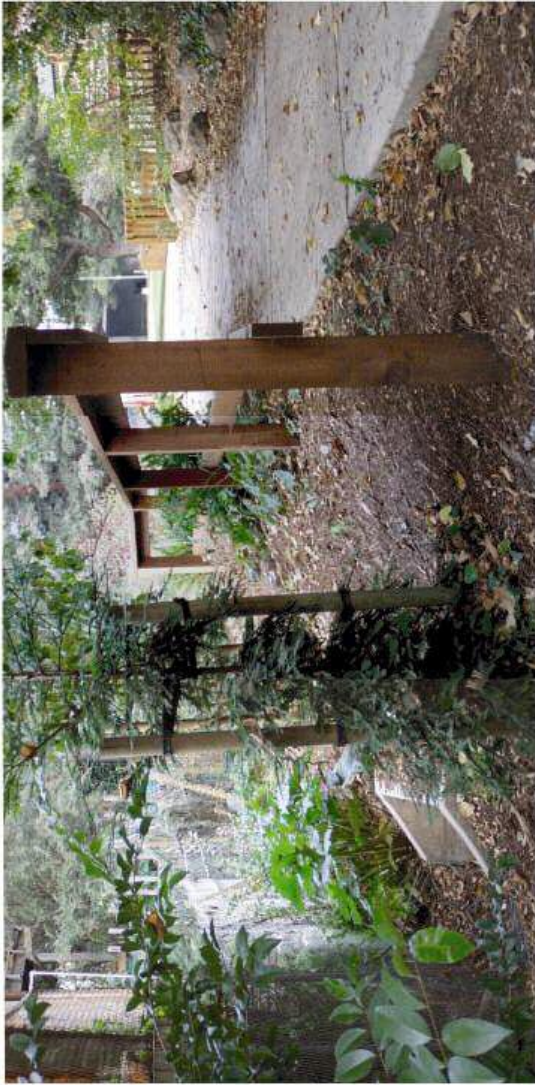
(B) AFTER: Recent redesign of Temescal Creek reveals encroachment limitations, where a storm drain collects any drainage along the constructed 'thatweg' (far left). Both the concrete path and a new landscape program belie the existence of either the culverted creek 20' below the surface, or a re-composed streambed.

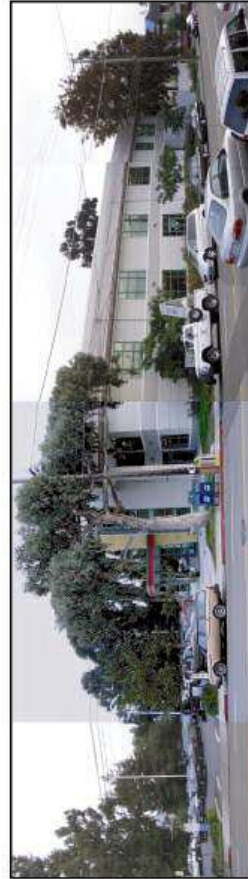
(C) Current View From Claremont Avenue Entrance to Temescal Creek on Claremont Avenue near Telegraph, in Oakland, California. Both the remnant channel of 'Faux Temescal' and the greenway are not visible from the public right-of-way.

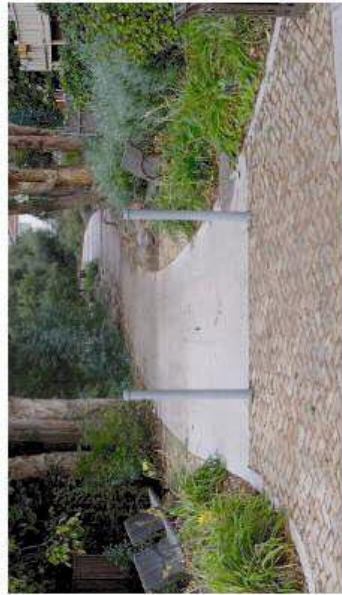
(D) Entrance to 'Frog Park' at Clifton Street: The redesign completes the transition from a 'reconstituted' creek to a recreational greenway. The primary objectives involve managing flood control problems and providing a much needed outdoor space within a highly urban context.

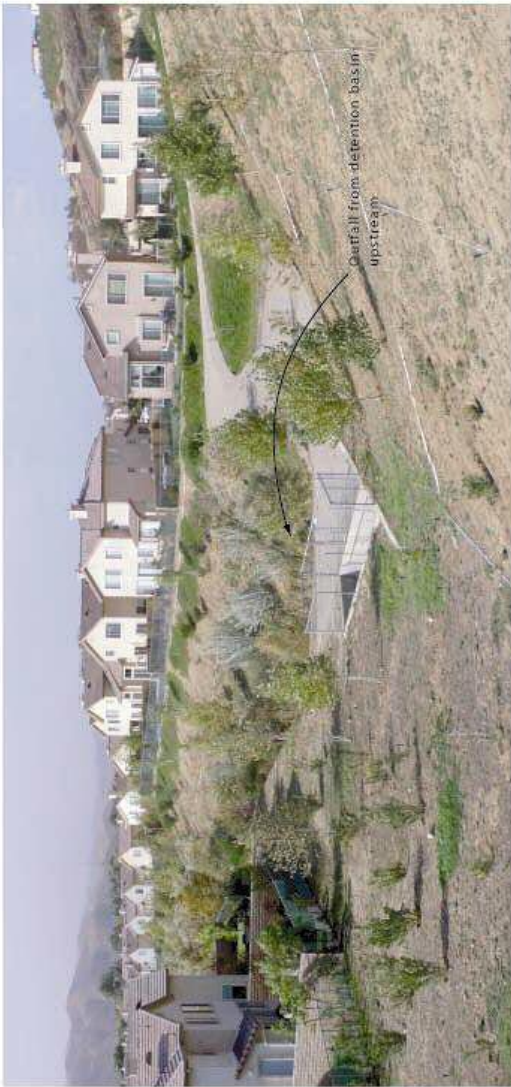
A White Oak Creek, Simi Valley, California - Residential Housing development manages flood control through a "re-created" creek bed with engineered perennial flow, riparian vegetation and upland species. Metal enclosures surround the project, minimizing human disturbance during the establishment period. Backyards are oriented to the planned future views of a riparian corridor.

The Standard Pacific Homes restoration included a subdivision of land which set aside about three acres of riparian restoration which is served by conducting stored detention waters beneath a manufactured, at grade, “re-constructed” streambed alignment. This reconstructed streambed carries a perennial flow of up to 195 c.f.s. through a diversion from the immediately upstream detention structure (within the Mount Sinai Memorial Park project). The upstream detention basin gathers both neighborhood street discharge, as well as potential irrigation run-off from the Memorial Park as well as storm water flows. The diversion was designed to support a range of riparian vegetation in the streambed. The gradients between the cemetery and residential projects were carefully adjusted and matched. In contrast to the Temescal Creek program, this artificial streambed was designed, disclosed in detail, and is considered a success by both the regulatory agency and the lead agency (City of Simi Valley). The current state of the restoration effort and relationship between development, conservation buffer and the streambed is illustrated in Figure 4 (Current Conditions: White Oak Creek).

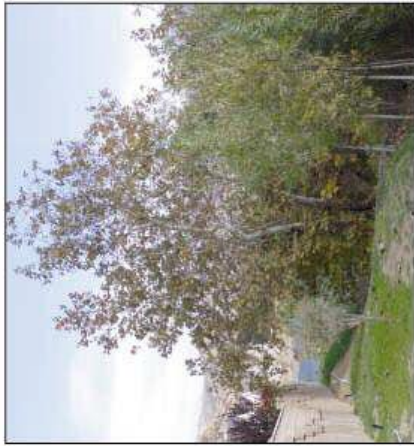
C A Reference Species, *Platanus racemosa* (the California Sycamore), is the last remaining specimen within this reach. Replanting from direct propagation was not performed and nursery stock was used instead. Protective grading was enacted to avoid damaging roots and manage exposure to perennial flow.

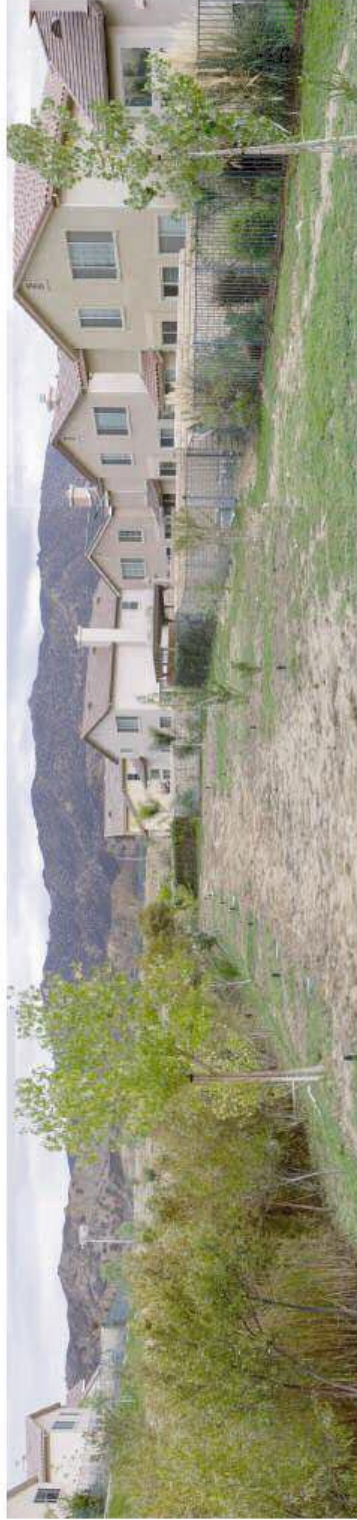
B Left Bank North View: The setback of the upper terrace illustrates the relationship between the constructed channel, the flood zone, residential back yards, and the protection of developing riparian habitat. The enclosure provides a protected common area, a view corridor and buffer zone that is not easily accessible. Pampas grass on adjacent private property (right) reveals the difficulties of limiting the introduction of exotic species in the future. Perhaps future planning guidelines for Homeowners Associations should address limiting invasive exotics near riparian corridors.
