Twenty-Year Performance Review of Long-Life Jointed Plain Concrete Pavements

Report No. UCPRC-TM-2023-08 | June 2024

Partnered Pavement Research Center (PPRC)  
Strategic Plan Element Number 3.58: Continued Calibration  
of Mechanistic-Empirical Design Models with Pavement  
Management System Data  
(DRISI Task 3764)

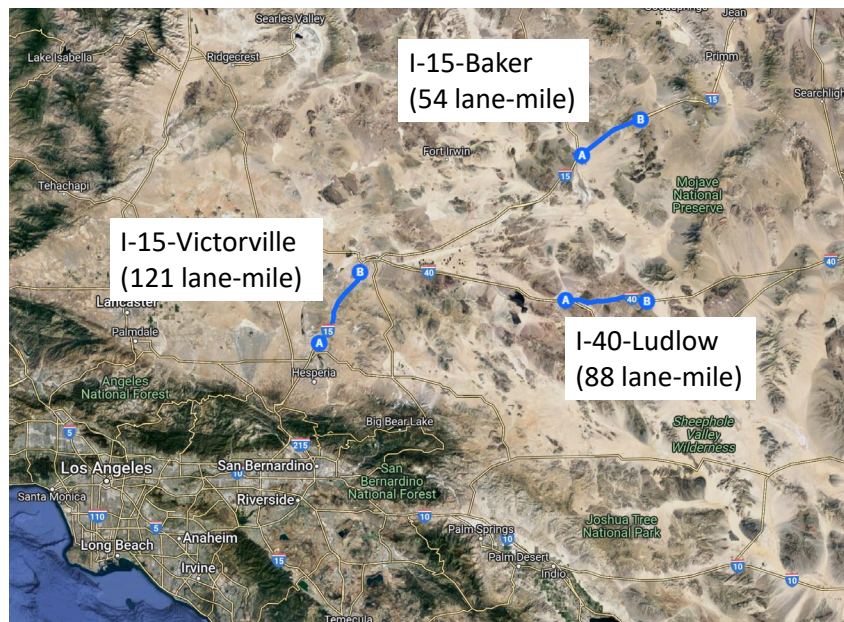
**Figure 1.1: JPCP long-life projects location.**

The list of JPCP long-life projects is shown in Table 1.1. The table includes the construction window; the expenditure authorization (EA), a code used by Caltrans to identify each construction project; and the project postmile (PM) range. All projects are located in or close to the Mojave Desert, northeast of Los Angeles in Southern California (Figure 1.1).

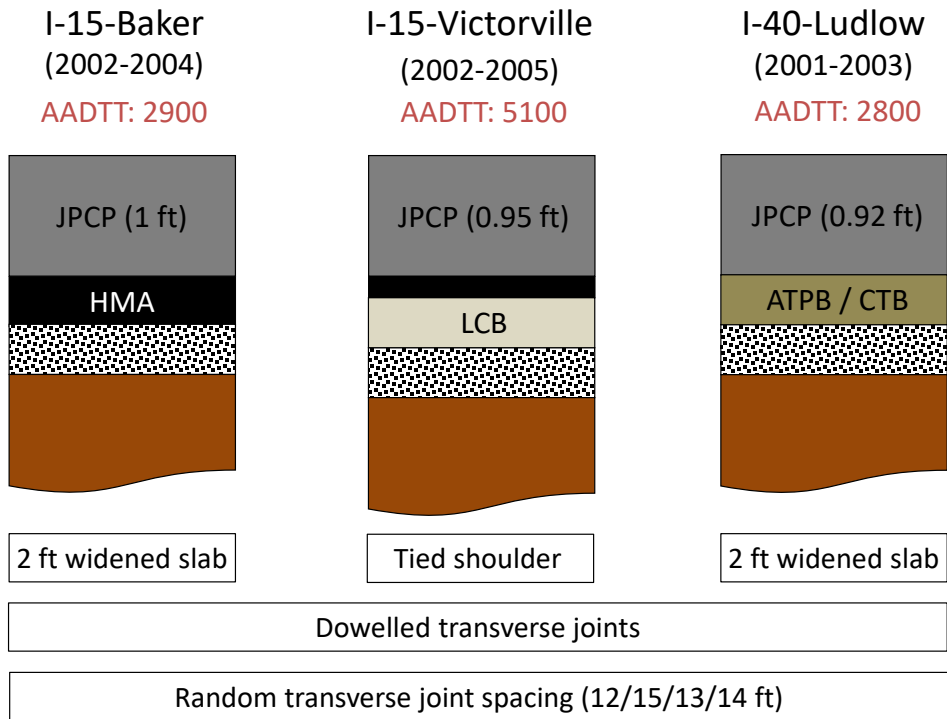
Figure 1.2 shows the typical pavement cross section of each project. The figure also shows the construction years, the annual average daily truck traffic (AADTT) of the truck lane, and some design features for each project. The three projects included tied longitudinal joints and doweled transverse joints. The mandatory use of dowels at the transverse joints was implemented by Caltrans in the early 2000s, when these projects were built, and the practice is still in place. The three projects have random transverse joint spacings of 12, 15, 13, and 14 ft., a practice that was discontinued by Caltrans around 2010. Current Caltrans practice for new JPCP is 14 ft. (fixed) transverse joint spacing.

**Configuration of the base of the different projects beneath the concrete**

I-15-Baker	<ul style="list-style-type: none"> <li>• 0.05 ft. newly placed hot mix asphalt (HMA) overlay on cold-milled asphalt pavement; or</li> <li>• 0.50 ft. newly placed HMA on aggregate subbase, after removing existing asphalt pavement</li> </ul>
I-15-Victorville	<ul style="list-style-type: none"> <li>• 0.10 ft newly placed HMA overlay on 0.40 ft newly placed lean concrete base (LCB)</li> </ul>
I-40-Ludlow	<ul style="list-style-type: none"> <li>• 0.35 ft. newly placed asphalt treated permeable base (ATPB); or</li> <li>• 0.50 ft. existing cement treated base (CTB)</li> </ul>

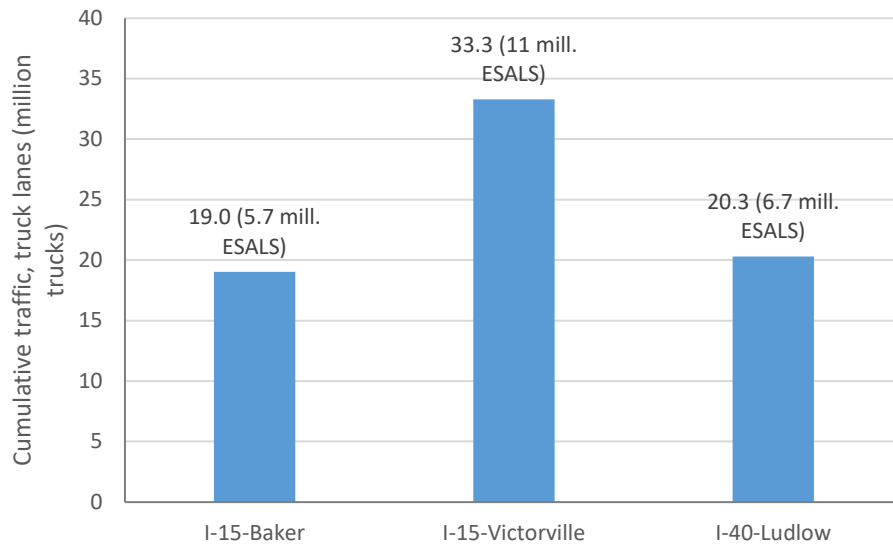
**Figure 1.3: Cumulative traffic, truck lanes (from construction to 2021).**

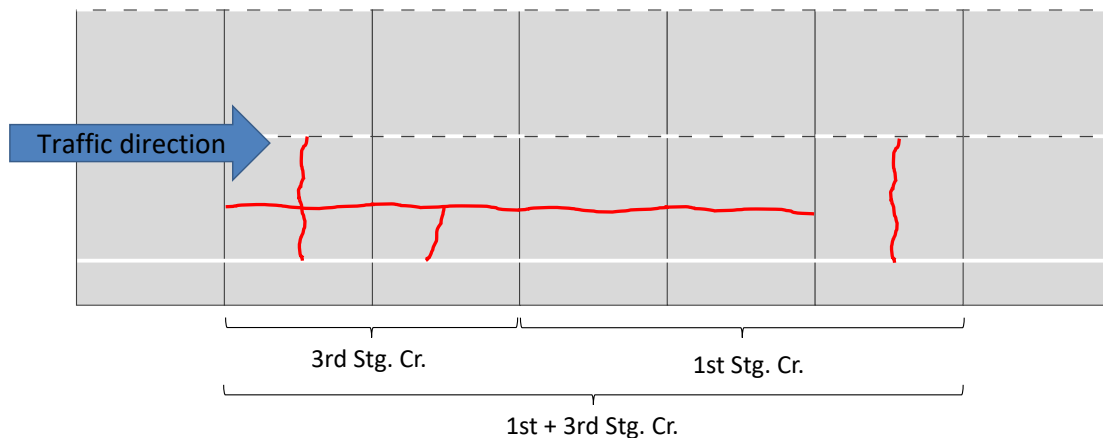
- Cracking:
  - First- and third-stage cracking:
    - First-stage cracking (1st Stg. Cr.) is a single crack, either longitudinal or transverse, in the slab. Third-stage cracking (3rd Stg. Cr.) consists of two or more longitudinal and/or transverse cracks, frequently two cracks that intersect each other and break the slab into three or more pieces (Figure 2.1). Corner cracking is not considered first-stage cracking.

**Figure 2.1: Definition of first- and third-stage cracking.**

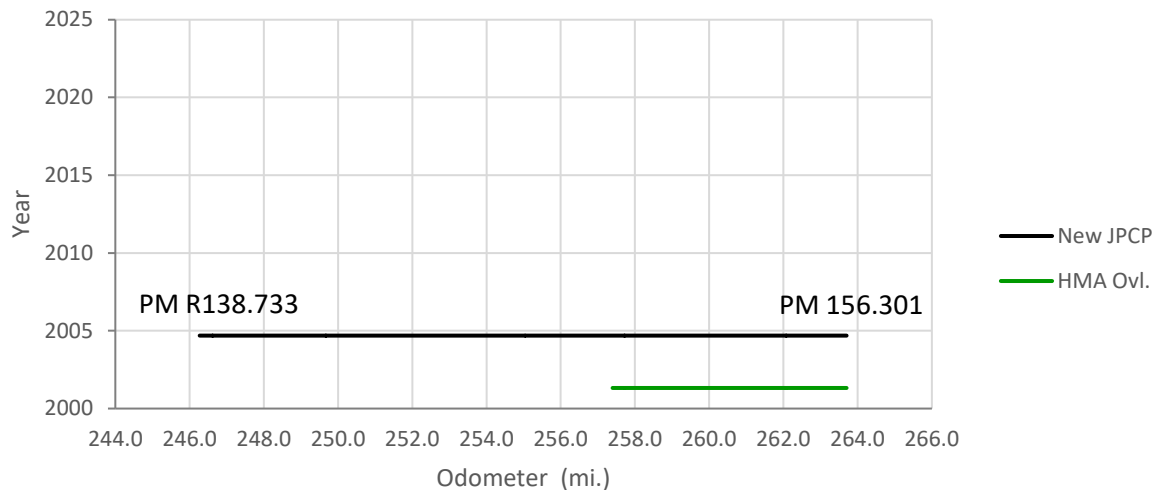
None of the JPCP long-life projects has required any maintenance or rehabilitation activity (e.g., individual slab replacement or grinding) since their construction. An example Highway chart (H-chart) output from the Caltrans pavement management system (PaveM) for one of the project's lanes (I-15-Baker, Lane N3) is shown in Figure 2.2. The H-chart is a plotting tool used by Caltrans for pavement management purposes. The plot shows the highway segment boundaries on the x-axis and the timing on the y-axis for different maintenance and rehabilitation activities. The H-chart in Figure 2.2 shows the I-15-Baker project construction in 2004 (end of construction) and an HMA overlay applied on the previous pavement in 2001. No activity occurred after the JPCP long-life project was built in 2004. The H-chart showed similar results for all the other projects, with no work since their long-life construction.

**Figure 2.2: H-chart for I-15-Baker, Lane N3.**

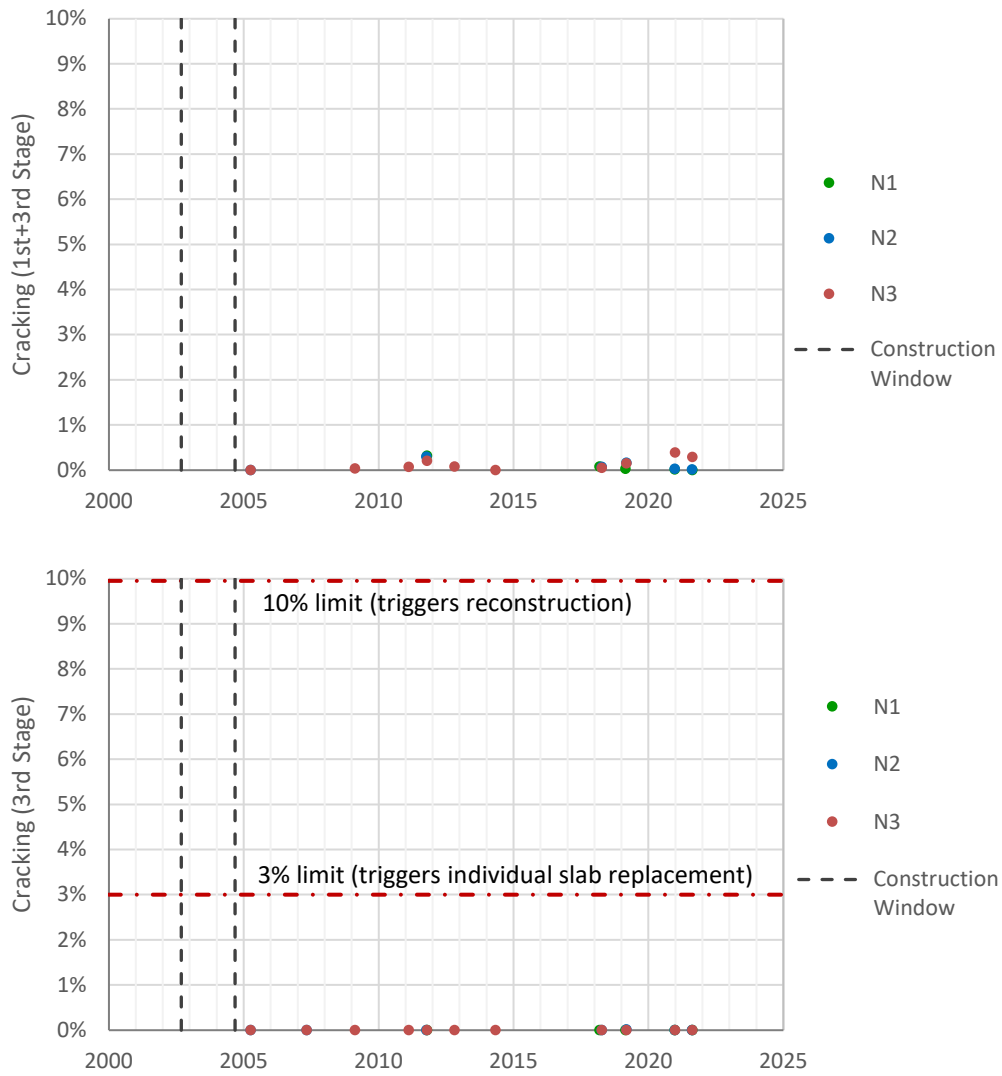
The cracking measured in the JPCP long-life projects is shown in Figure 2.3 (I-15-Baker), Figure 2.4 (I-15-Victorville), and Figure 2.5 (I-40-Ludlow). Overall, cracking performance is excellent as the third-stage cracking remains essentially zero in all lanes of the three projects, which total 263 lane-miles. Some lanes present some first-stage cracking: I-15-Victorville northbound Lane 3 (N3) and southbound Lane 3 (S3), with around 4% of slabs with first-stage cracking in 2021, and I-40-Ludlow eastbound Lane 2 (E2), with around 7% of slabs with first-stage cracking in 2021. This cracking is almost entirely longitudinal, shown in Figure 2.6. In this figure, the percentage of slabs with longitudinal cracking and the percentage of slabs with transverse cracking are shown for the three previously discussed lanes (I-15-Victorville N3 and S3 and I-40-Ludlow E2). Of the first-stage cracking, 91% to 94% was longitudinal.

**Figure 2.3: Measured first-stage (top) and third-stage (bottom) cracking, I-15-Baker.**

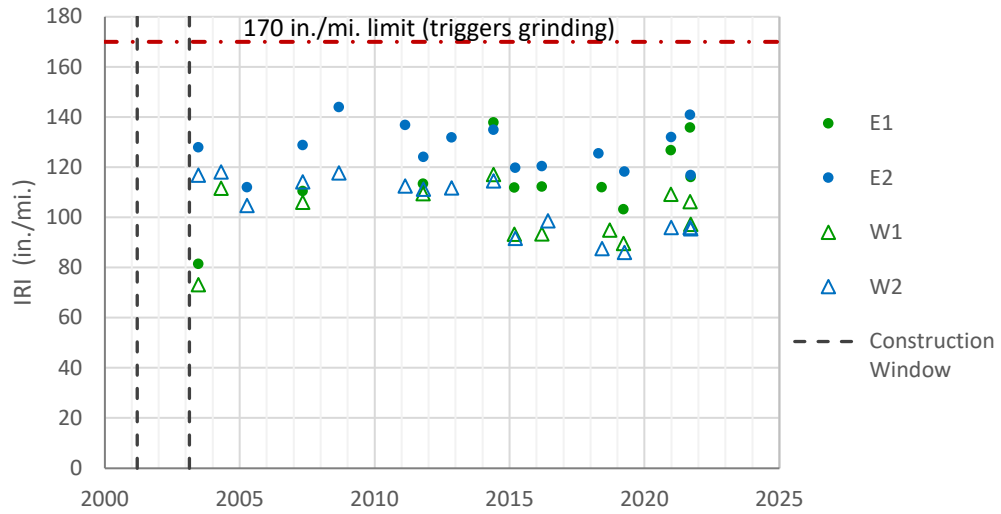
**Figure 2.12: Measured IRI, I-40-Ludlow.**

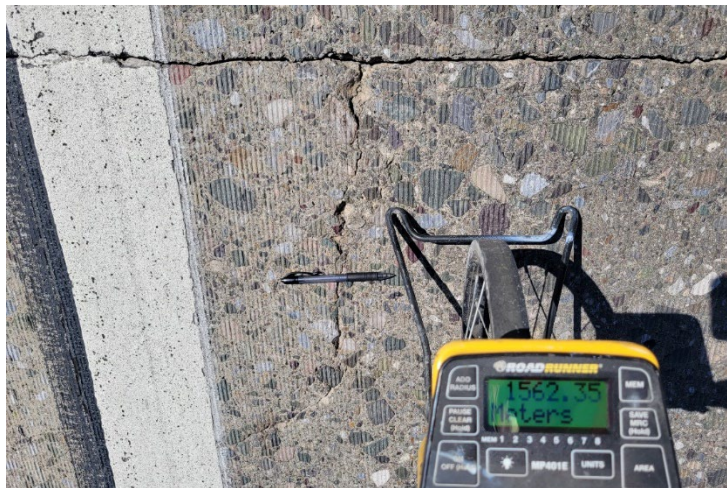
The I-15-Baker section exhibited pavement in good condition. Only two transverse cracks and one corner crack (Figure 3.2) were observed over the mile surveyed. The transverse joints were in good to fair condition with some low severity spalling, as shown in Figure 3.3. Localized diamond grinding, which likely occurred during construction, was observed, shown in Figure 3.2 and Figure 3.3. Hairline map cracking was present in the wheelpaths.

**Figure 3.2: Corner crack, I-15-Baker.**

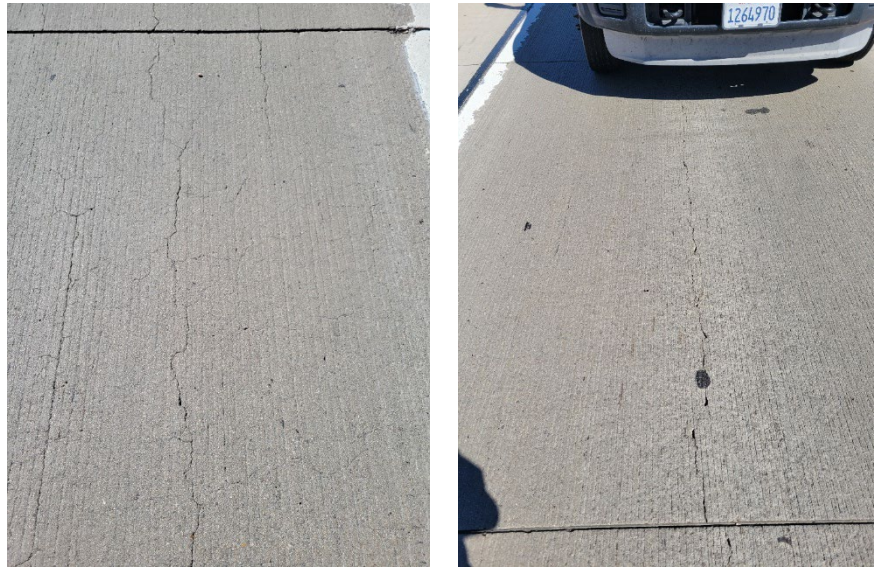
The I-15-Victorville section was in very good condition. Some longitudinal cracking was observed in both wheelpaths as well as between the wheelpaths. Except for two locations with moderate severity longitudinal cracks, the longitudinal cracks were low in severity, shown in Figure 3.4. Localized diamond grinding was evident in some areas (left picture), which was likely done during construction. Hairline map cracking (left picture) was observed over the one mile surveyed. Some low severity transverse cracking was observed (right picture). The joints were in good condition with some low severity spalling.

**Figure 3.4: Low severity longitudinal cracks, I-15-Victorville.**

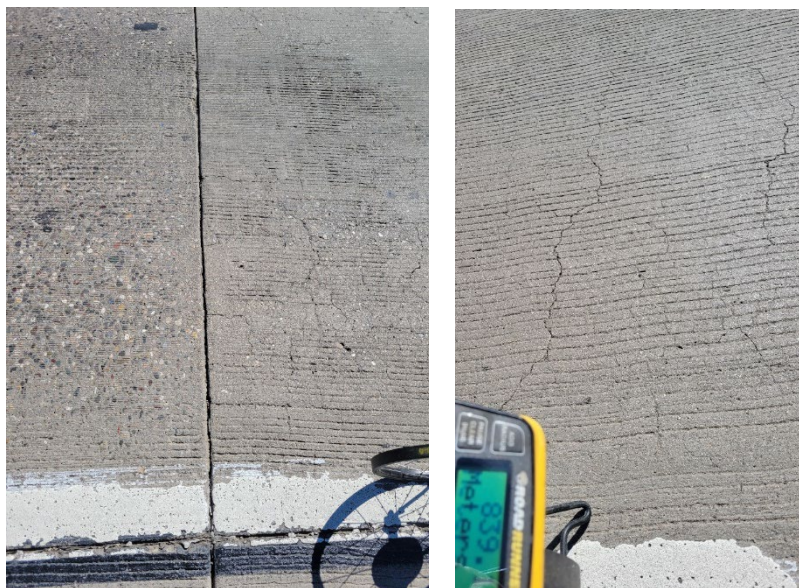
**Figure 3.5: Map cracking (left) and transverse cracking (right), I-15-Victorville.**

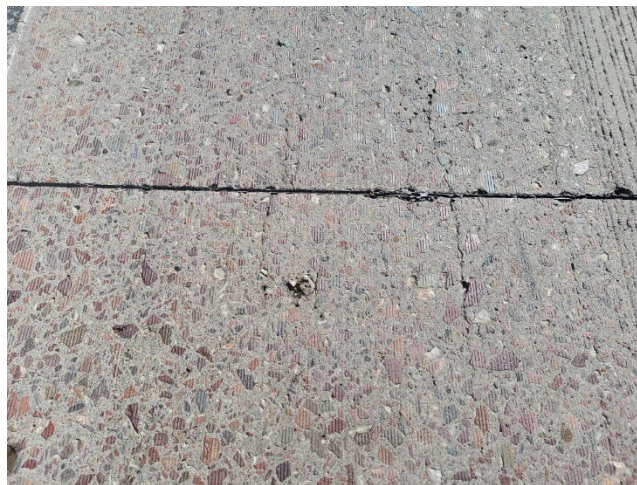
The Ludlow section exhibited a pavement in good condition. Moderate severity spalling was present at the transverse joints and corners, shown in Figure 3.6. Low severity longitudinal cracks were present at the wheelpaths (Figure 3.7). Hairline map cracking existed throughout the section. Most joints were in good condition. Localized diamond grinding was evident in some areas.

**Figure 3.7: Low severity longitudinal cracking at wheelpath, I-40-Ludlow.**

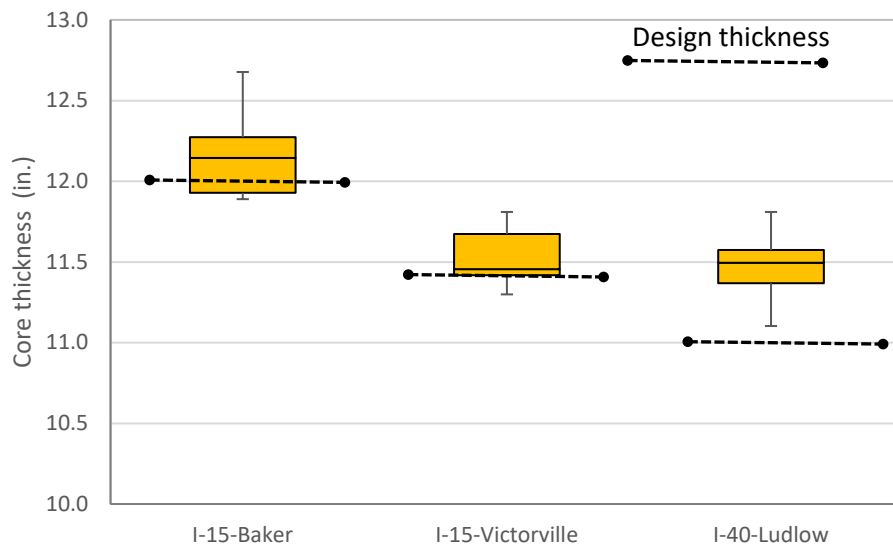
Seven to eight cores, each 6 in. in diameter, were extracted from each of the projects. The cores were extracted at the middle of the slabs. The quartile plots of the measured core thickness are shown in Figure 3.8. Overall, the measured thickness is at or above the design thickness, as expected. Based on the extracted cores, the type of base was asphalt concrete in the three projects and the base was debonded from the PCC in most cores.

**Figure 3.8: Comparison of design thickness versus thickness measured from cores.**

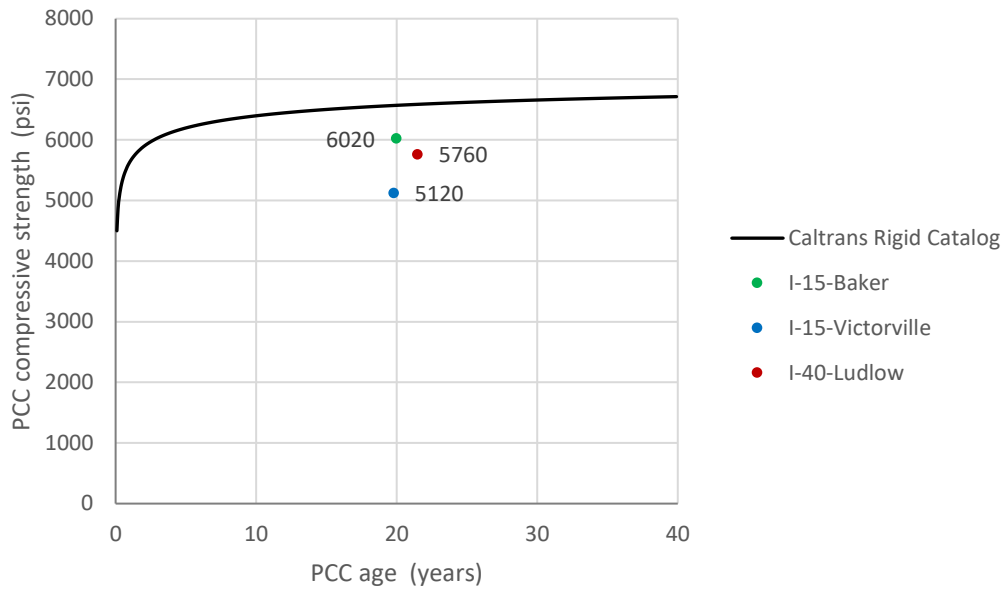
The PCC cores were trimmed (top and bottom) and then used for determining strength ( $f_c$ ) and modulus of elasticity ( $MoE$ ), following ASTM C39-21 and ASTM C469-22, respectively. One core was used for the initial estimation of  $f_c$ , a parameter required for modulus of elasticity testing. Then three cores were tested for  $MoE$  followed by  $f_c$  testing. The results of the testing are shown in Figure 3.9 ( $f_c$ ) and Figure 3.10 ( $MoE$ ). The figures also include the PCC properties assumed for developing the new Caltrans rigid pavement design catalog, which are based on a 28-day compressive strength of 4500 psi, the ACI formula for converting  $f_c$  to  $MoE$  ( $MoE = 33 \times \rho^{1.5} \times f_c^{0.5}$ , where  $\rho$  is PCC density in pcf), and the default *Pavement ME* strength evolution function (13). Overall,  $f_c$  and  $MoE$  are below the values assumed for developing Caltrans rigid pavement design catalog. Lower  $f_c$  generally hurts cracking performance while lower  $MoE$  generally improves cracking performance because it results in lower stresses for a given temperature and/or drying shrinkage difference between the top and bottom of the concrete slabs.

**Figure 3.9: Portland cement concrete (PCC) compressive strength.**

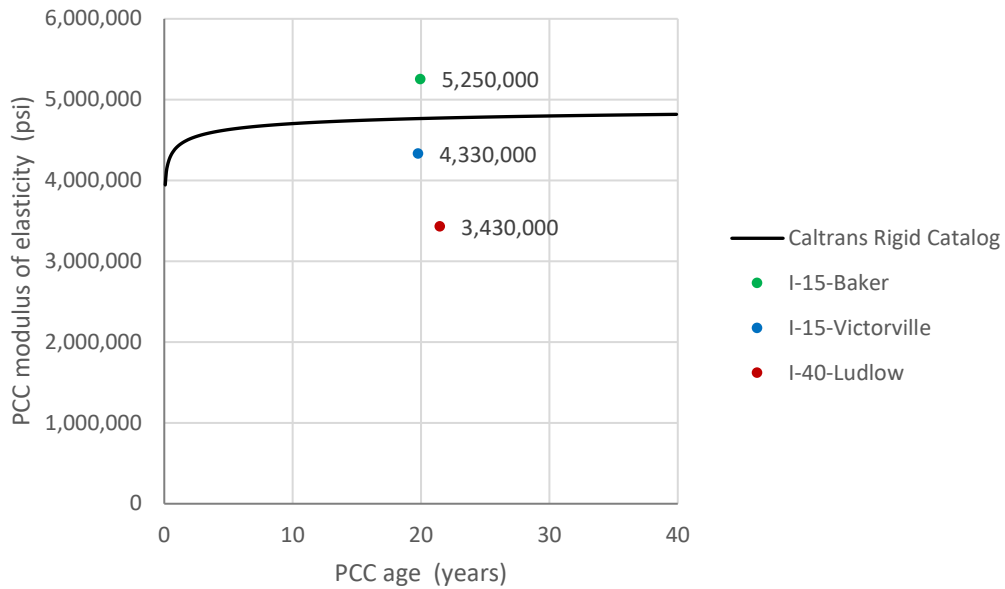
**Figure 3.10: Portland cement concrete (PCC) modulus of elasticity.**

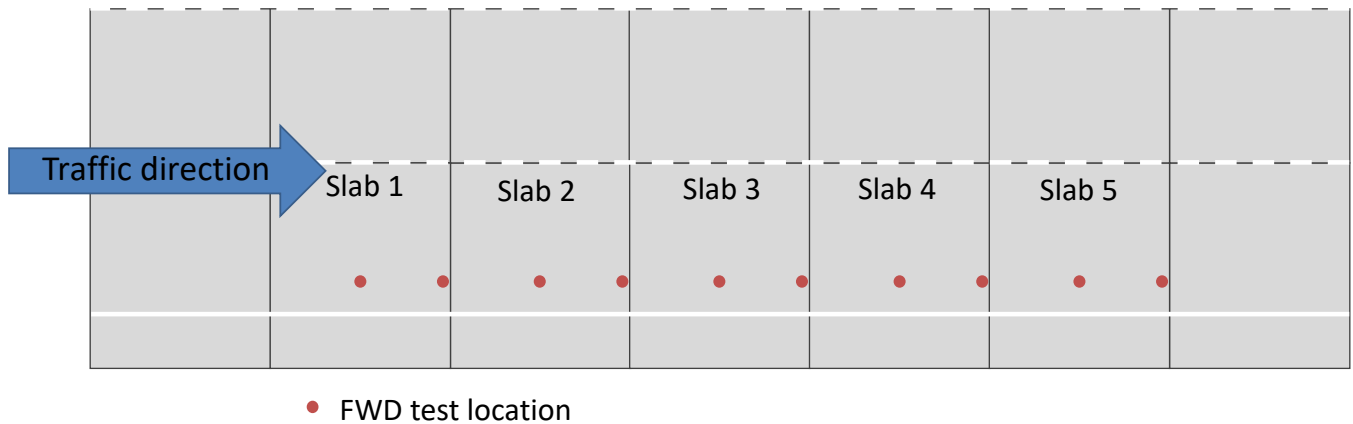
Each JPCP long-life project was tested with the FWD on five sets of slabs. Each set consisted of five consecutive slabs, shown in Figure 3.11. The five sets were uniformly distributed along the one-mile lane closure. As shown in Table 3.1, the tested lanes were N3 on I-15-Baker, S3 on I-15-Victorville, and W2 on I-40-Ludlow, all of which are truck lanes. Each slab was tested at two locations along the right wheelpath, mid-slab and the approaching edge of the transverse joint (Figure 3.11). Each location was

tested twice, first in the morning and then in the afternoon, to capture possible thermal effects on the LTE of the transverse joints. In summary, 100 FWD tests were conducted per project: (5 sets of slabs) × (5 slabs per set) × (2 locations per slab) × (2 tests [morning and afternoon] per location).

**Figure 3.11: Layout of one set of slabs (five consecutive slabs) for FWD testing.**

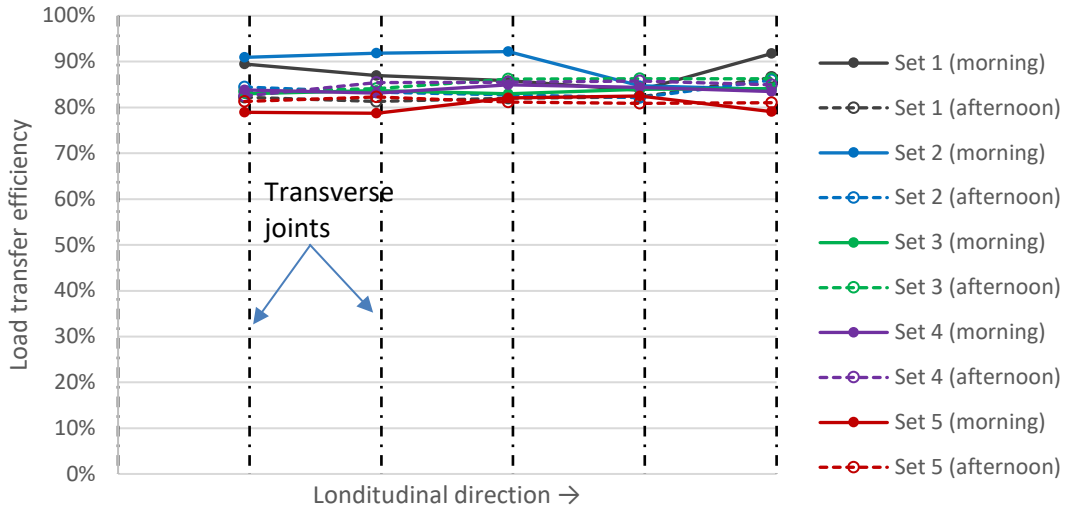
The LTE measured in all the projects was high, as expected from JPCP with good-performing dowels. The average LTEs were 83%, 84%, and 80% for I-15-Baker, I-15-Victorville, and I-40-Ludlow, respectively, with LTE defined as  $D_{12}/D_0$ , where  $D_0$  is the deflection measured under the loading plate and  $D_{12}$  is the deflection measured at a distance of 12 in. from the loading plate center, which is on the other side of the transverse joint. Further, the LTE was very uniform along the sections and presented minimal diurnal variation (morning versus afternoon), indicating that the dowels have not loosened. The LTE values are shown in Figure 3.12 (I-15-Baker), Figure 3.13 (I-15-Victorville), and Figure 3.14 (I-40-Ludlow).

**Figure 3.13: LTE measured with the FWD in I-15-Victorville project (Load = 15.7 kips).**

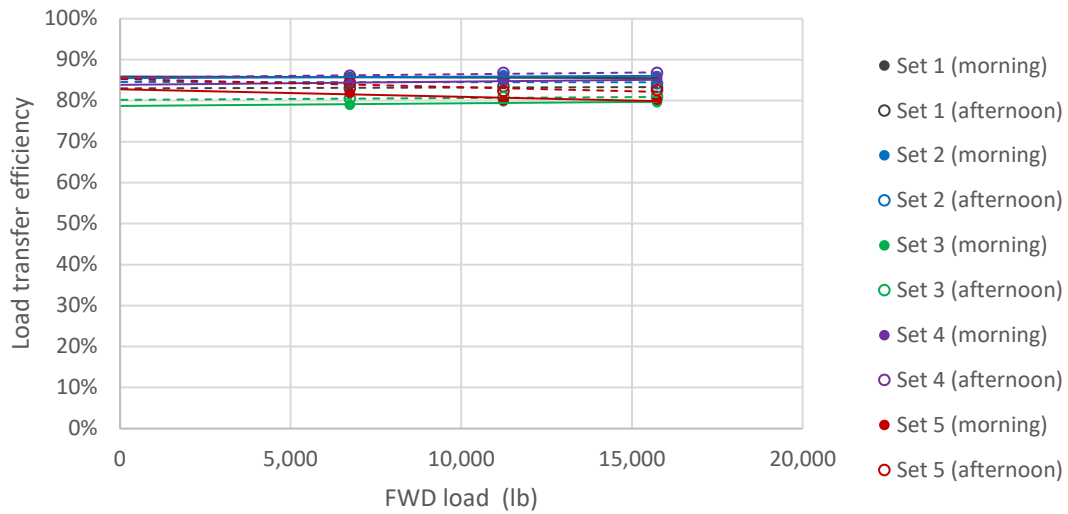
Three load levels were applied in each FWD test: 6.7, 11.2, and 15.7 kips (30, 50, and 70 kN). The LTE values presented in Figure 3.12 to Figure 3.14 correspond to the highest load level (15.7 kips). In any case, the LTE was roughly constant versus the load level, which indicates that it is unlikely that there are gaps between the concrete and the asphalt base below the transverse joints. The LTE versus load level results can be seen in Figure 3.15 (I-15-Baker), Figure 3.16 (I-15-Victorville), and Figure 3.17 (I-40-Ludlow).

**Figure 3.15: LTE versus load level in I-15-Baker project.**

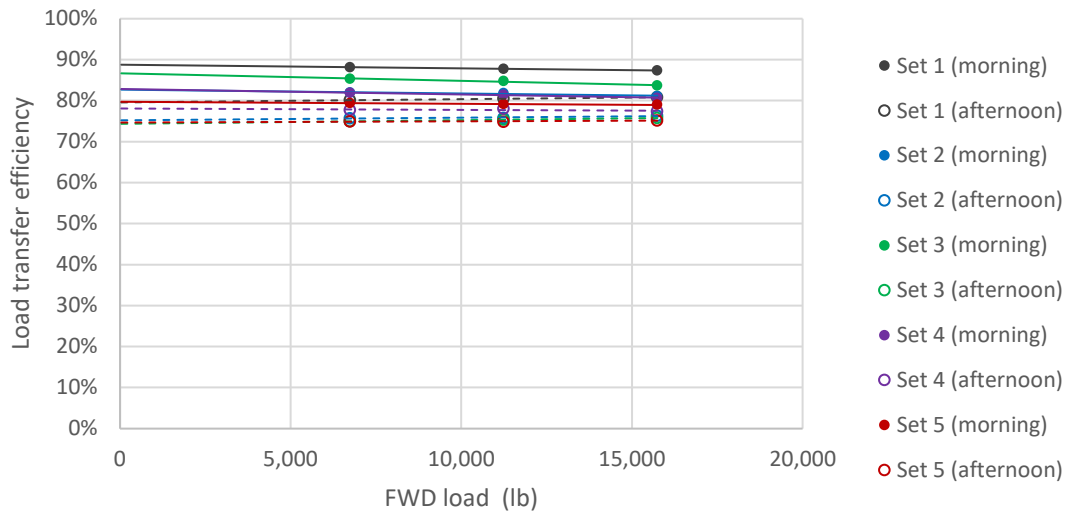
**Figure 3.17: LTE versus load level in I-40-Ludlow project.**
